Archaeological Watching Brief  
at  
**COSSHAM HOSPITAL,**  
**LODGE ROAD, KINGSWOOD, BRISTOL.**  
for  
NHS South Gloucestershire

Report No. 2270/2011  
BHER No. 24859

Archaeological Watching Brief  
at  
**COSSHAM HOSPITAL,  
LODGE ROAD, KINGSWOOD,  
BRISTOL.**

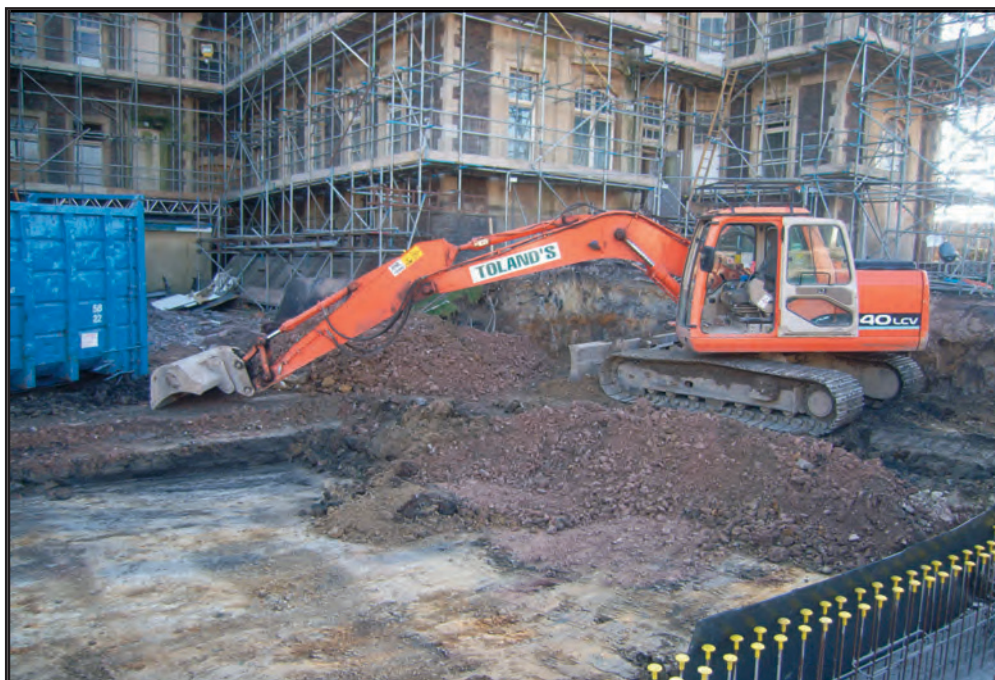
- Cover Working view during excavation of the attenuation tank, the main hospital building in the background. Looking south-west.
- Plate 1 Sample section of test pit C showing the interbedded layers of clay and coal seams, looking north-east
- Plate 2 Brick manhole next to the stairwell area of the site, looking west
- Plate 3 Attenuation tank area, excavated down to natural yellow clay, looking south-east
- Plate 4 Top of the coal shaft before consolidation, looking north

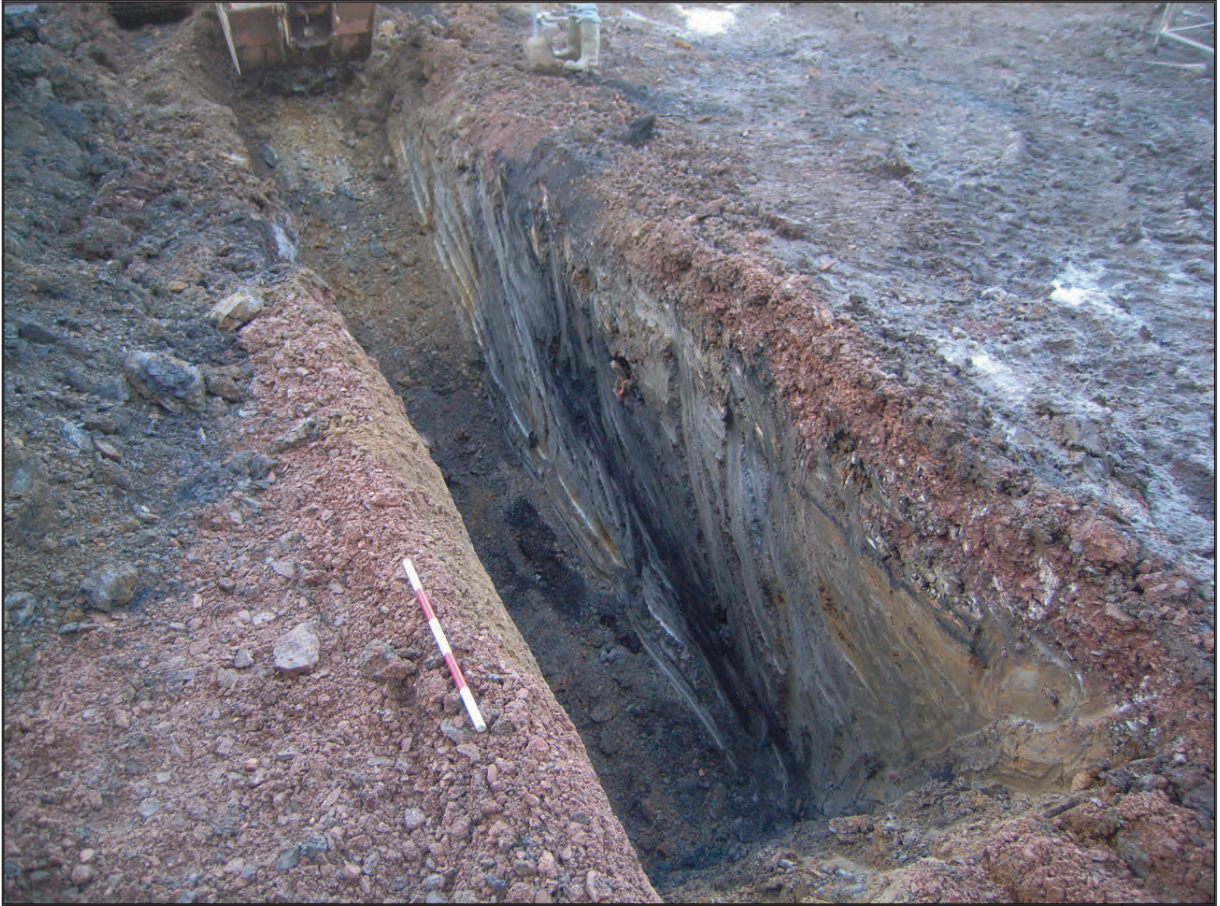
- 5.5 Test Pit C was excavated to a maximum depth of 2m below ground level and as in Test Pit B, a further deposit of yellow-brown clay (301) was overlain by gritty grey clay (302) which again contained a coal seam (303). Modern scalpings (300) overlay a sequence of interbedded natural clays with inclining bands visible in section.

Plate 1 Sample section of test pit C showing the interbedded layers of clay and coal seams, looking north-east

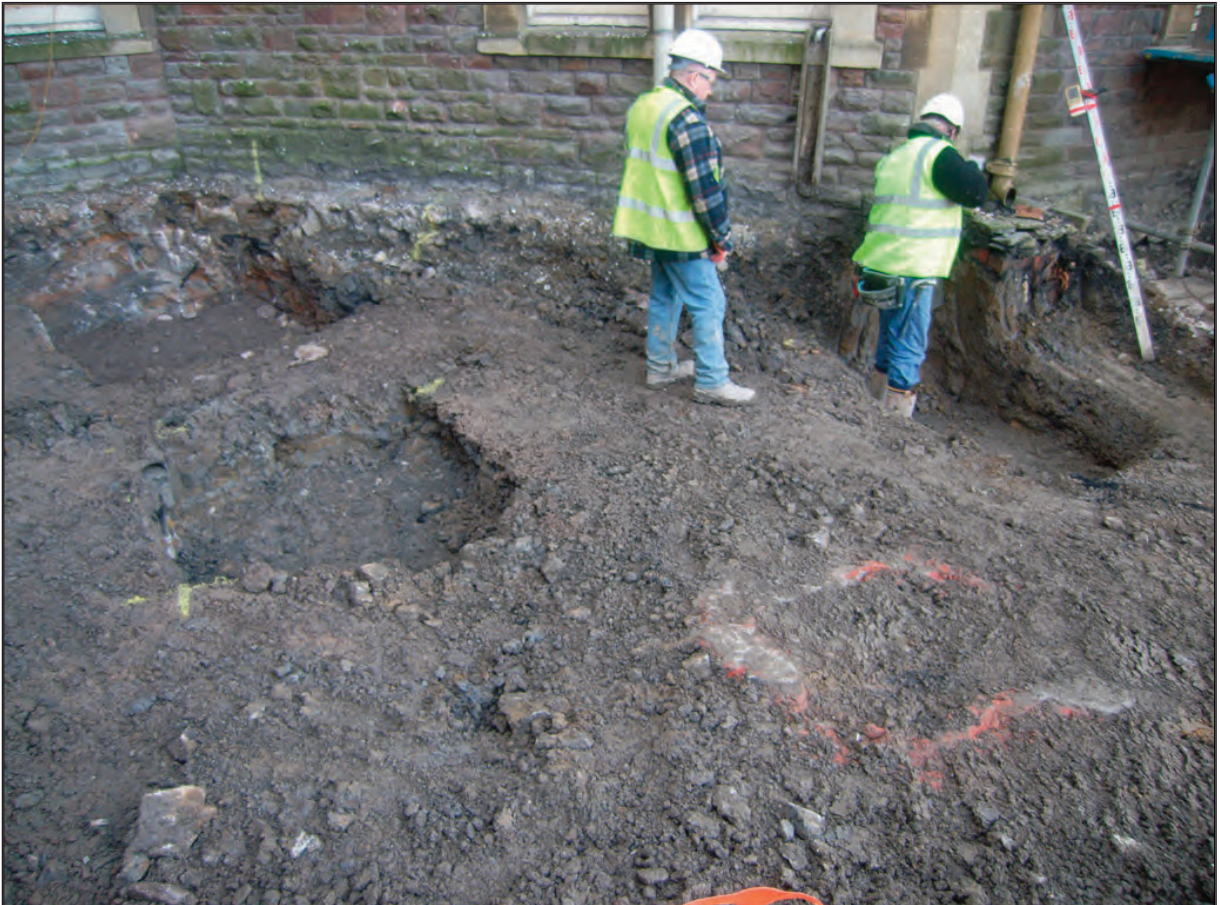
- 5.6 A number of trenches including strip foundations and box foundations were excavated for a stairwell, to a maximum depth of 1.4m below ground level. Above the natural limestone (402) the only deposits observed comprised interbedded mudstone (400) and clay (401). Remnant topsoil < 0.1m thick was topped with modern gravel. Immediately north of this area a brick manhole was discovered. This was 0.96m square and made of red brick with grey compact mortar. The bricks had dimensions 230 x 115 x 65mm. The manhole was not disturbed as it was found during a light clean by the machine. It potentially could be early 20th century in date.

Plate 2 Brick manhole next to the stairwell area of the site, looking west

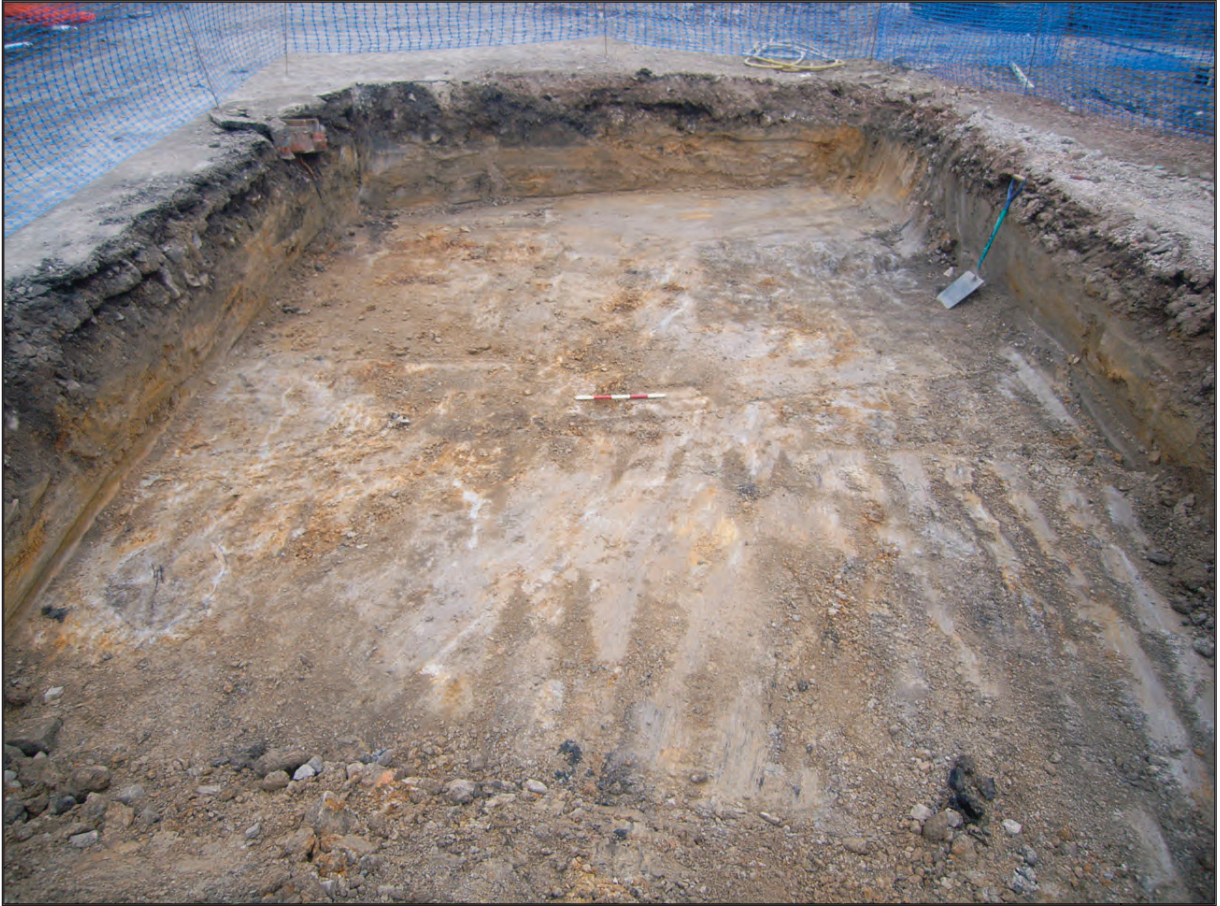
- 5.7 A pit for a large water-storage tank was excavated as part of the groundworks. Excavation of the pit was observed to a maximum of depth of 2m below ground level. At the northern end of the pit deposits of archaeologically sterile clay (502) were overlain by redeposited natural clay lenses up to 0.8m thick and covered by topsoil (501). The rest of the pit was excavated solely into natural clay (502).

Plate 3 Attenuation tank area, excavated down to natural yellow clay, looking south-east

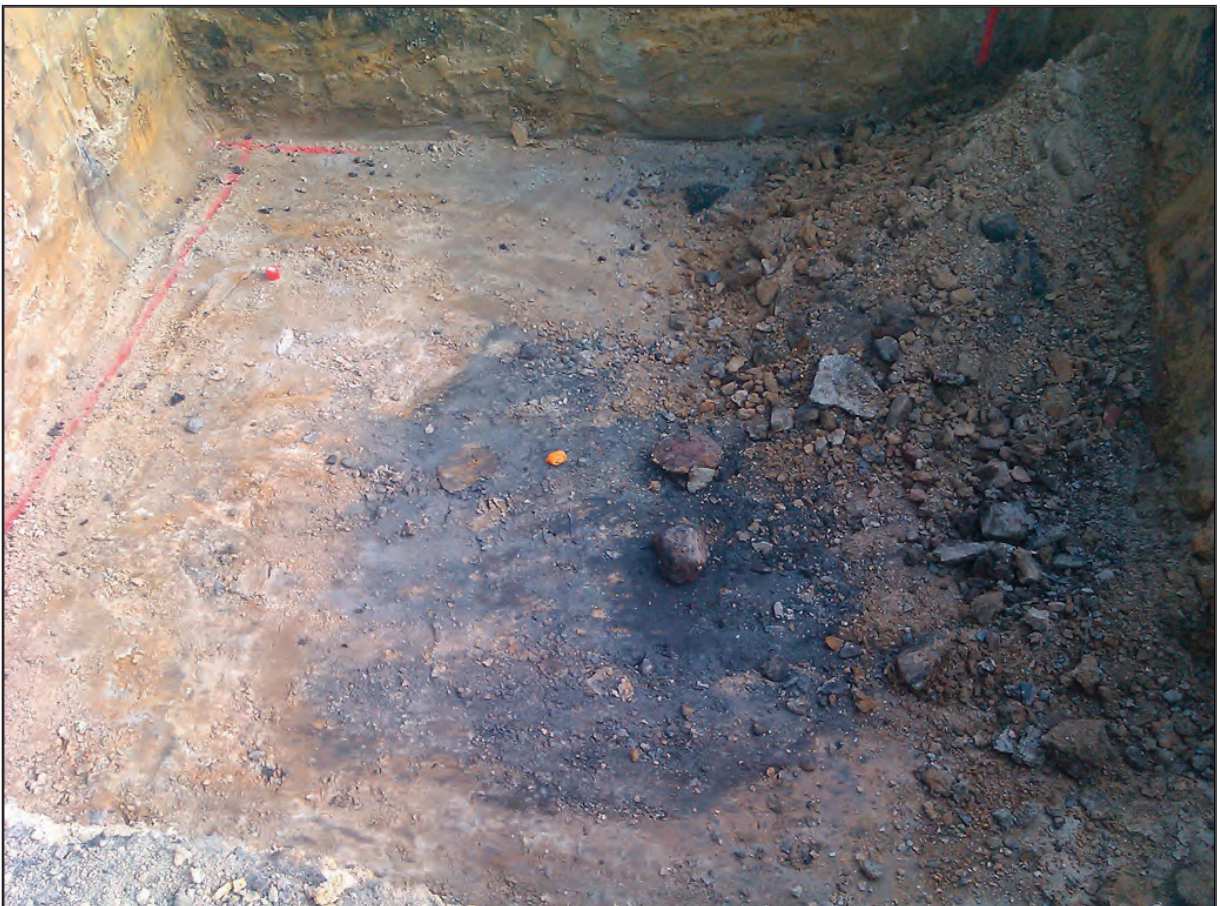
5.6 A backfilled mineshaft [601] was located near the north-west corner of site. The shaft had a diameter of approximately 1.5m. It was deemed too dangerous to explore in any great detail and was consolidated by the ground crew. No finds were recovered relating to the feature.

Plate 4 Top of the coal shaft before consolidation, looking north
