Archaeological Watching Brief

**SOUTH VIEW,
STIBBS HILL, ST GEORGE,
BRISTOL.**

Mi-Space (UK) Ltd.

Report No. 2259/2012

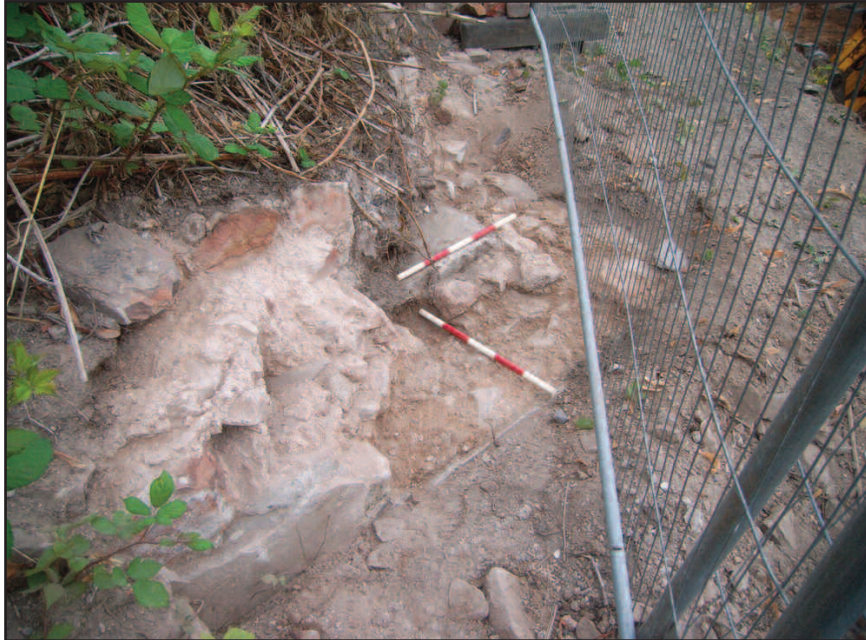
5.3 The earliest feature on the site was the corner of an early 19th-century house later known as 'South View'. Most of this building lay in area designated as a wildlife reserve and remained unaffected by the construction work. The exposed part of the building comprised a 0.5m-thick wall (109), constructed with random uncoursed sandstone bonded with a pale creamy brown lime mortar. A small area of flagstone flooring (110) was exposed on the north side of the wall (**Plate 1**).

Plate 1
Wall (109), viewed from
the south-west

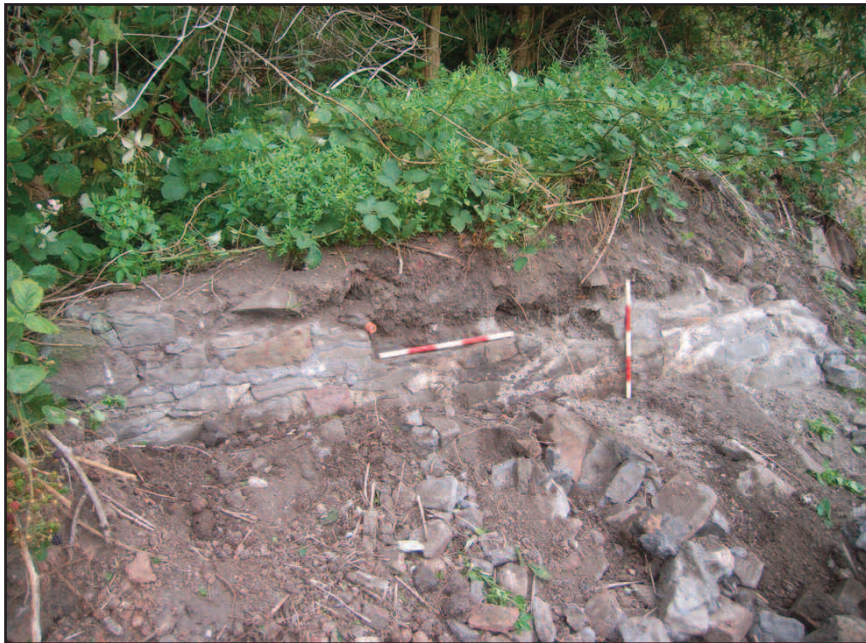
5.4 Walls (111) (**Plate 2**), (112) and (113) (**Plate 3**) were all constructed with random uncoursed sandstone bonded with a greyish white lime mortar. Wall 112 abuts wall 113. These walls are all parts of ancillary buildings built in the mid to late-19th century to the rear of South View.

Plate 2
Wall (111), viewed from
the south-west

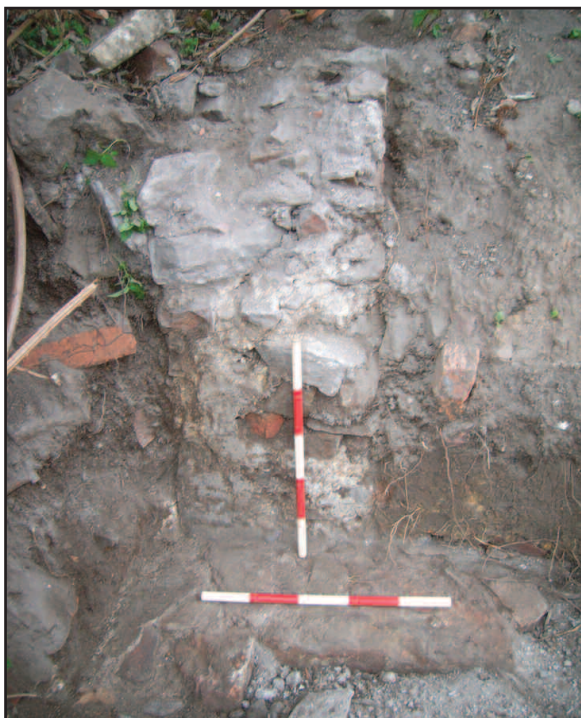
113	Structure	Stone wall. Constructed with random uncoursed sandstone rubble, bonded with an off-white lime mortar. Over 0.6m long, 0.35m wide and survives up to 0.1m high.	19th/20th century
114	Structure	Brick wall. Truncated end of a wall exposed in section by reduced level excavation. Red bricks (240mm x 110mm x 70mm) bonded with a hard grey mortar. 0.23m wide, survives up to 0.6m high.	19th/20th century
115	Layer	Subsoil. Reddish brown sandy silt.	Unknown
116	Structure	Floor/yard surface. Constructed with a mixture of Pennant Sandstone and bricks.	20th century
117	Structure	Foundations of wall (118). Constructed with random uncoursed stone with occasional bricks bonded with a hard dark grey mortar. 0.7m wide, 14m long, 0.1m high.	20th century
118	Structure	Stone retaining wall. Constructed with random uncoursed stone with occasional bricks bonded with a hard dark grey mortar. 0.4m wide, 14m long, survived up to 0.6m high.	20th century

Plate 3
Wall (112) and (113),
viewed from the south

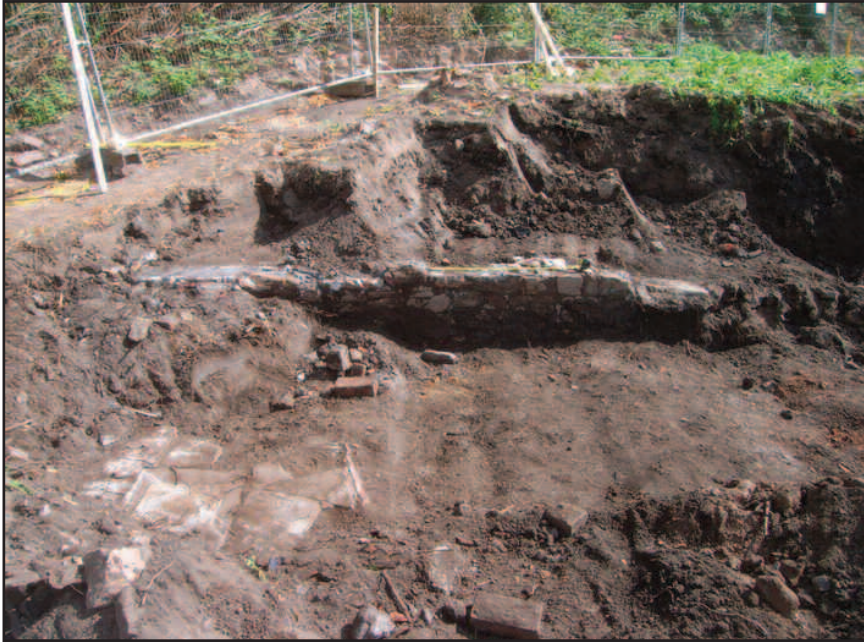
5.5 Two stone-built retaining walls (104)/(106) (**Plate 4**) and (117)/(118) (**Plate 5**) were uncovered to the south of walls 109 and 111-3. The retaining walls were both constructed with random uncoursed sandstone bonded with a dark greyish black mortar. Both walls overlie buried soil layer (128), which forms an extensive horizon that seals 19th-century quarry fills (102), (103) and (127). The quarry backfill comprised a mixture of redeposited natural clay, stone rubble, topsoil and shaly coal. The area to the south of wall 104/106 dropped away steeply due to extensive quarrying which accentuated the natural hill slope.

Plate 4
Wall (104)/(106), viewed
from the south-west

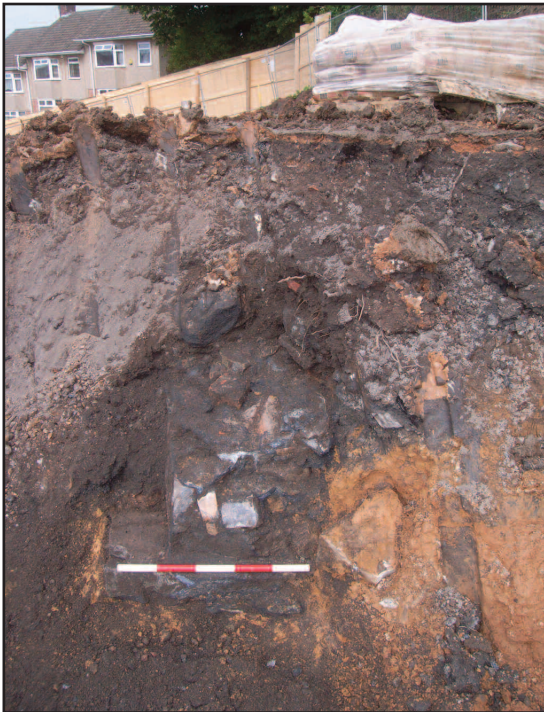
Plate 5
Wall (117)/(118), viewed
from the east

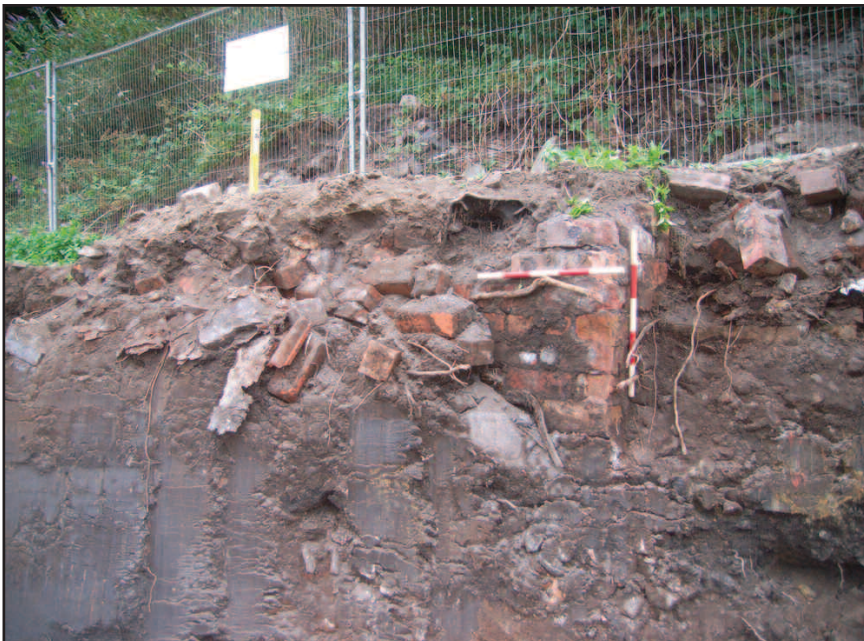
5.6 Brick walls (108) and (114) (**Plates 6-7**) were uncovered to the east of walls 111-3; these walls were bonded with a hard grey mortar. Cartographic evidence suggests these walls formed parts of outbuildings built between 1904 and 1913.

108	Structure	Brick wall. Constructed with red bricks (240mm x 110mm x 70mm), laid to with alternating header-stretcher bond. Bonded with a hard grey mortar. Survived up to 0.7m high, 5.5m long and 0.24m wide.	20th century
109	Structure	Stone wall. Corner of a building. Constructed with uncoursed, irregularly sized sandstone rubble with occasional brick fragments, bonded with cream/pale brown lime mortar. The wall survived up to 0.6m high, 0.50m wide, 1.7m NW-SE and 1.1m SW-NE.	Early 19th century
110	Structure	Flagstone floor. Constructed with Pennant sandstone slabs. Floor within building (109).	19th century
111	Structure	Stone wall. Part of a building. Constructed with random uncoursed, sandstone rubble bonded with pale grey/white lime mortar, re-pointed with grey lime mortar. Some traces of white render. Over to 3.5m long, 0.35m wide and survived up to 0.5m high.	19th/20th century
112	Structure	Stone wall. Part of a building. Constructed with random uncoursed sandstone rubble with occasional brick and tile fragments, bonded with an off-white lime mortar. Over 0.9m long, 0.35m wide and survives up to 1.2m high.	19th/20th century

Plate 6
Wall (108), viewed from
the south

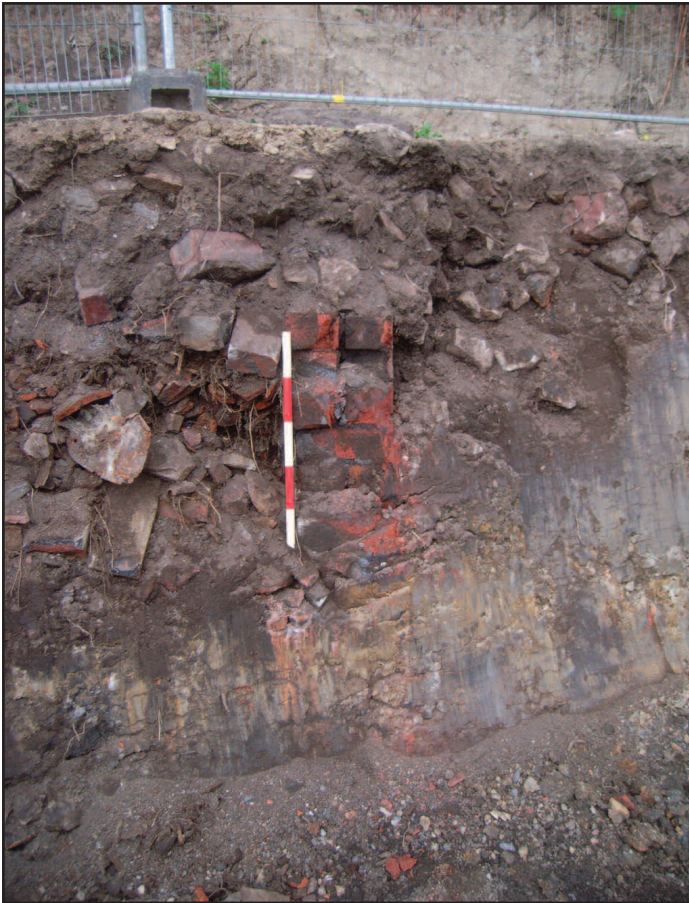
Plate 7 Wall (114), viewed from the south

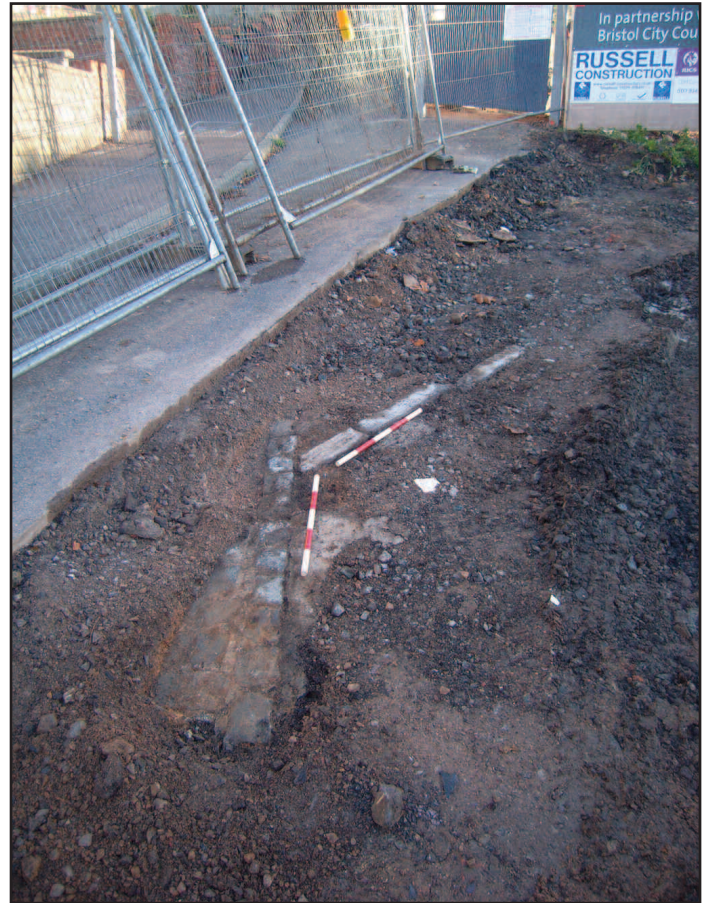
5.9 A modern tarmac road surface (129) with granite-sett edging (128) and Pennant Sandstone kerbs (130) (**Plate 8**) was uncovered beneath the present road on the west side of Stibbs Hill.

Plate 8 Road surface and edging (128), (129) and (130), viewed from the south-west
