Archaeological Watching Brief  
at  
**CHURCH HAYES, LEA,  
NEAR MALMESBURY, WILTSHIRE.**  
for  
Mr Alexander Badenoch

Report No. 2288/2010

Archaeological Watching Brief  
at  
**CHURCH HAYES, LEA,  
NEAR MALMESBURY, WILTSHIRE.**

Centred on  
N.G.R. ST 9576 8617

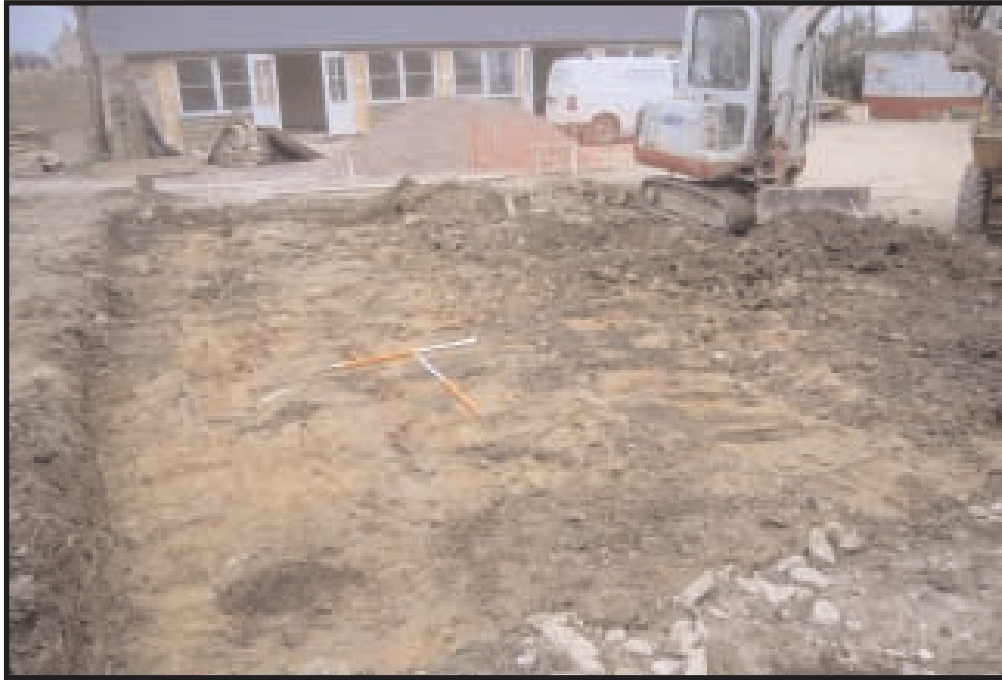
- Cover Excavation work on the initial Reduced Level Platform, looking north-west, 2m scale
- Plate 1 The southern half of the platform as excavated, looking west, 1m scale
- Plate 2 Foundation trench excavation in the south-east corner of the footings, looking north-east, 1m scale
- Plate 3 Foundation trench excavated through cut [105] and fill (106) looking east, scales 2m 0.5m
- Plate 4 General view of the site near the completion of groundworks, looking east

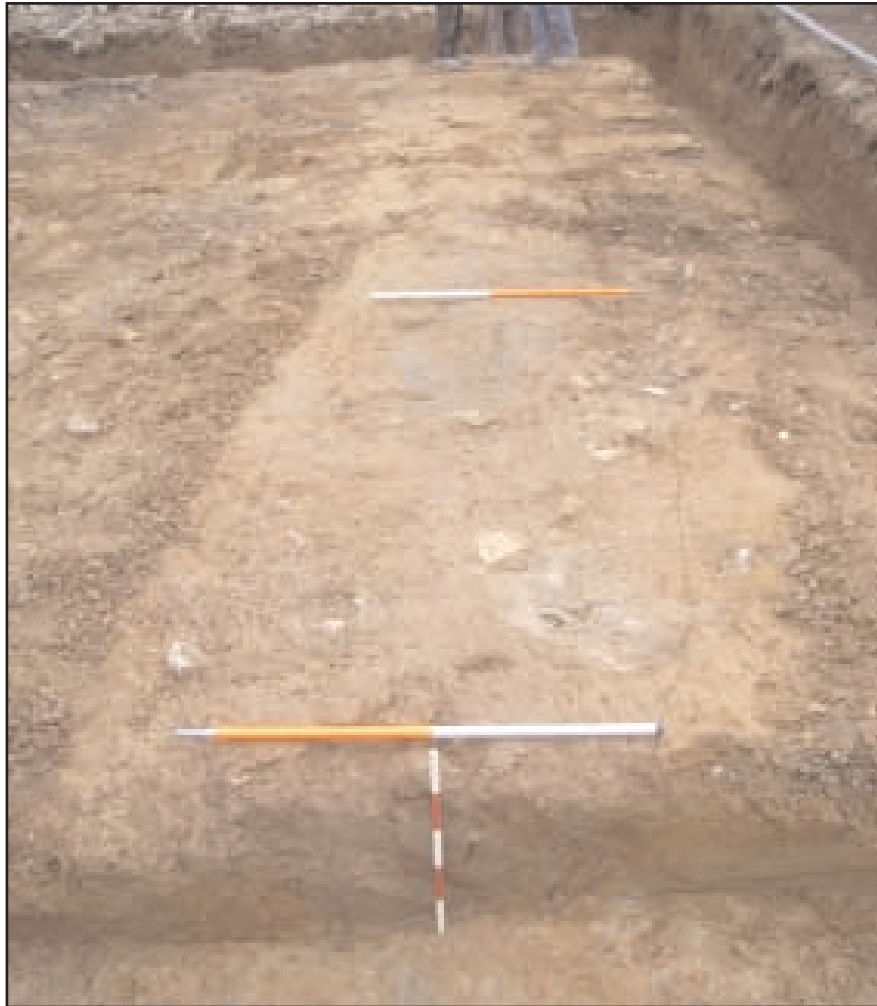
- 5.5 Exposed below context 102 was archaeologically sterile fine sandy clay into which two possible features were cut. Feature 104 was sub-rounded and approximately 1.5 x 1.8m in diameter and up to 550mm deep, this was believed to have been a former tree-bole hole. The second feature, cut 105, fill 106 (**Plate 3**) appeared to be a small ditch and this was dated from pottery recovered from it to the post-medieval period.

Plate 3 Foundation trench excavated through cut [105] and fill (106) looking east, scales 1m & 0.5m in foreground

- 5.6 The footings for the new garage comprised a rectangle approximately 10m x 6.7m in size. The footings were excavated to a maximum of 900mm, on the west side of the platform but averaged about 450mm deep over the remainder of the block.
- 5.7 Cut 105/fill 106 had a section excavated through it by the foundations enabling detailed recording to be undertaken, Feature 104 was twice sectioned by the footings and conclusively proven to be a tree-bole hole but no new features or deposits were exposed during the foundation work. A modern post-hole (cut and fill 108, **Fig. 2**) with a rotted post remaining in-situ was also exposed in the foundation trench on the west side of the garage.
- 5.8 No features or deposits of archaeological significance were observed and no artefacts predating the modern period were recovered during intrusive groundworks at the site.
