Archaeological Building Recording

**THE OLD SORTING OFFICE,
LANGFORD ROAD, WESTON-SUPER-MARE.**

Report No. 2421 /2010

Archaeological Building Recording
 at
**THE OLD SORTING OFFICE,
 LANGFORD ROAD, WESTON-SUPER-MARE.**

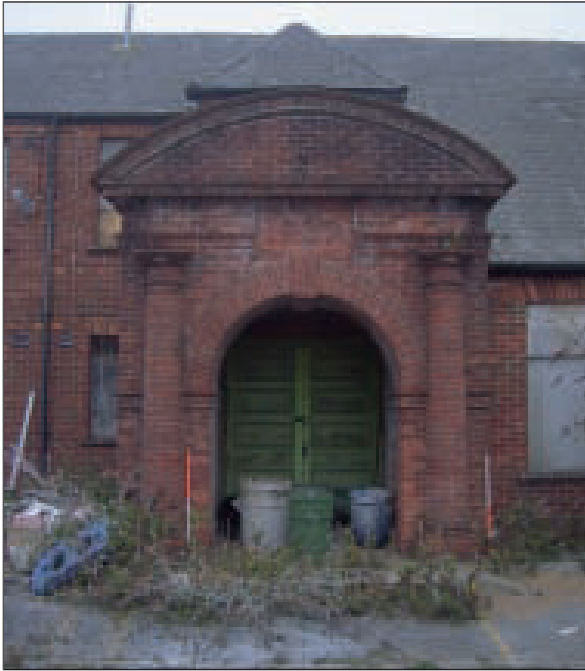
Plate 1 Front view of the brick porch, looking north

- 5.1 The former Home Guard Battle HQ and TA centre building is composed of three elements, a central block, a western two storey block, and on the north and east sides of the building single-storey flat roofed blocks. All are constructed from red bricks, with the central and western blocks sharing a single hipped roof. Linking the central and western blocks on the north elevation is an ornate brick built porch with the date 1937 displayed prominently on the front (**Fig. 3 & Plate 1**). The porch has two pilasters either side of the entrance, which is surmounted by a round arch. A blind arch is present on the west facing elevation of the porch.

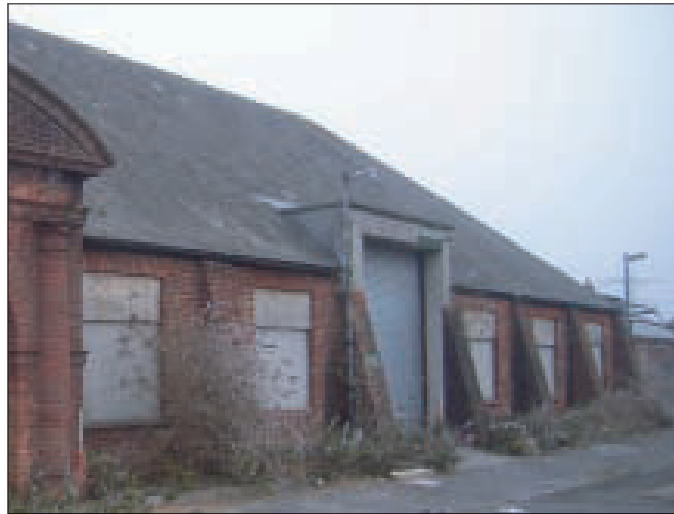
Plate 2 South elevation of the central block, looking north-east

- 5.2 Only the south external elevation of the central block is visible, constructed from red bricks in stretcher bond with six buttresses (**Plate 2**). In between the buttresses were five blocked windows and a modern inserted shutter door. Each of the windows had brick sills and voussoirs.

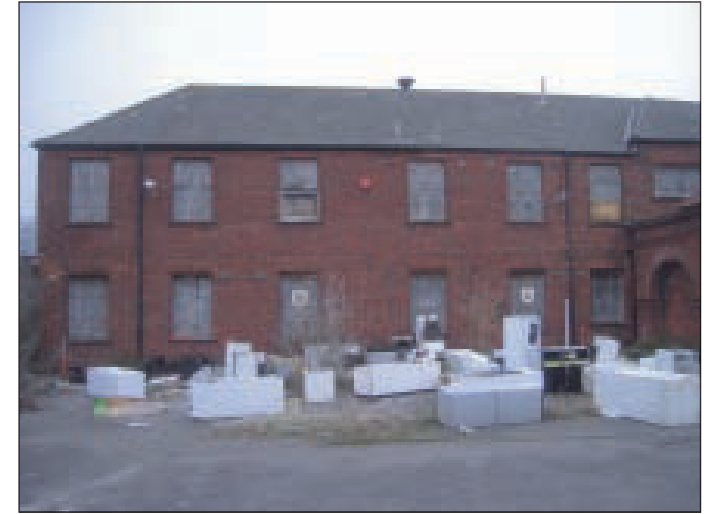
Plate 3 South elevation of the two storey block, looking north

- 5.3 The two-storey western block appears to be of the same construction as the south elevation of the central block, red brick in stretcher bond with brick sills and voussoirs. The south elevation has twelve windows, six on each floor, with those on the first floor directly above the ground floor windows (**Plate 3**). A fire escape is located on the west elevation with a staircase running from a first floor doorway on the south side of the elevation and a window is present on the north side (**Plate 4**). Only the first floor of the north elevation is visible externally and has six windows mirroring those on the south elevation.

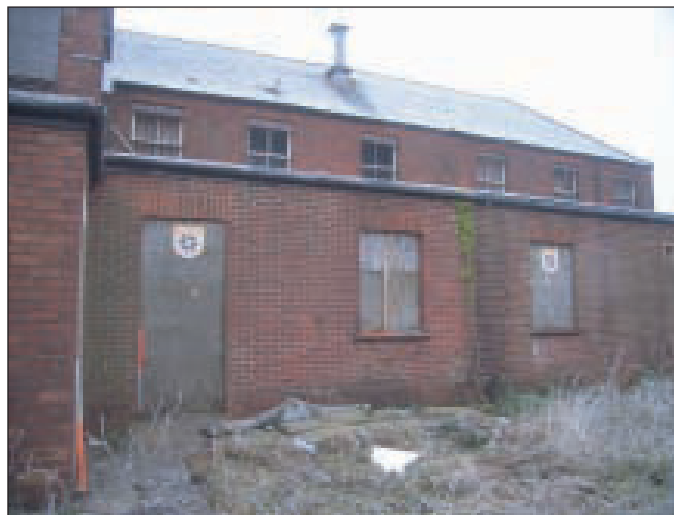
Plate 5 North (rear) elevation of west end of the building, looking south-west

- 5.4 There are four single-storey flat roofed blocks forming the north and east sides of the building. The western most of these is of the same construction as the two larger blocks (**Plate 5**). Immediately north of the central block is a single-storey block constructed in a variation of English garden wall bond (**Plate 6**), with five stretcher courses between the header courses. To the north of this is another block constructed in English garden wall bond (**Plate 7**) (three stretcher courses between the header courses). Finally on the east side of the building is a modern single storey flat roofed block (**Plate 8**), probably added when the building was in use as a sorting office, constructed in red brick in stretcher bond.

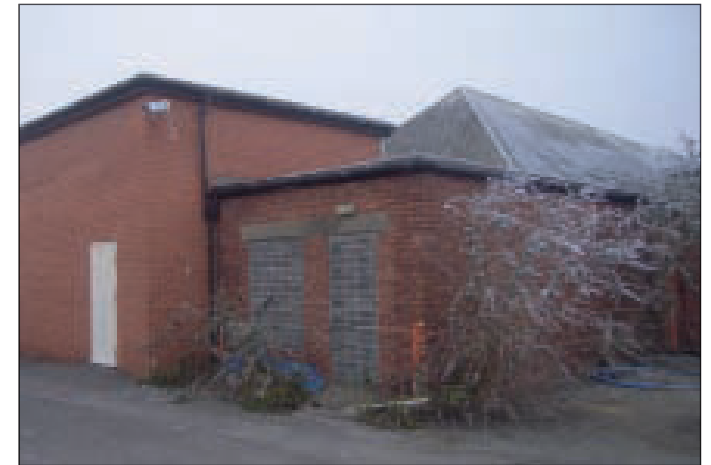
Plate 6 North and east elevations of the English garden wall bond variation block, looking south-west

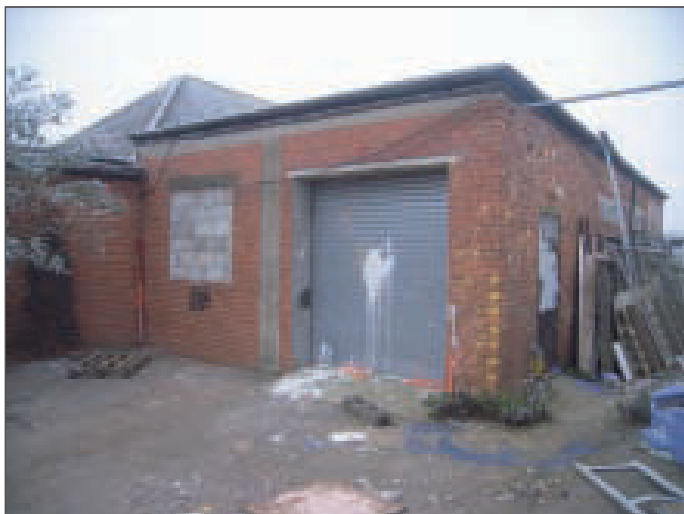
Plate 7 North and east elevations of the English garden wall bond block, looking south-west

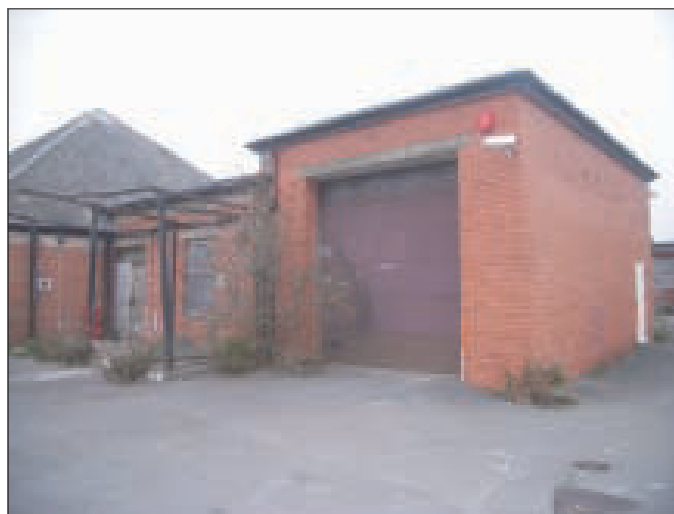
Plate 8 South and east elevations of the east end of the building, looking north-west

- 5.5 Each of these elements is present on the 1954 Ordnance Survey 1:2500 plan (**Fig. 4**) with the exception of the eastern block. A smaller block than currently exists is depicted on the east side of the building, and a remnant of older brickwork in the south elevation of the current eastern block indicates its former extent. The different brick bonds may indicate a sequence of construction, however the east and west internal elevations of the central block are constructed in the English garden wall variation bond, which suggests this and the stretcher bond elements at least are contemporary with each other. The northernmost block may have been added later but within seventeen years of the original building being constructed.

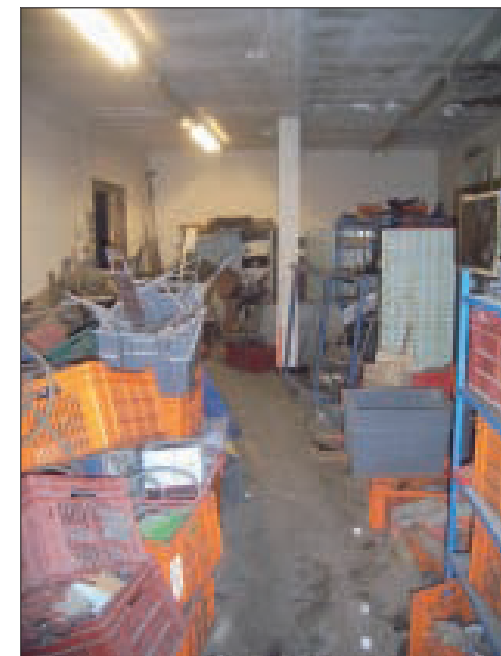
Plate 18 Room 15, looking west

- 5.6 Internally the building comprised of thirty rooms the majority of which contain few if any original features, many of them being used as storage space (**Plates 18, 21 & 26**). Exceptions include Room 21 where the ‘shadow’ of a former parquet floor is present (**Plate 24**) and the hallway accessed via the porch contains the original staircase (**Plates 30 & 31**). Three of the ten rooms on the ground floor of the western side of the building were used as toilets (**Plates 20, 23 & 27**). The first floor of the building has a large meeting room and a smaller room linked by a corridor, while the roof of the two-storey west block is supported by timber king post trusses. The most striking of the internal features is the roof structure of the central block, which is a single large open space internally (**Plates 12, 13, & 14**). This large open space was probably originally used a drill hall for the TA and Home Guard. The roof is composed of five steel trusses whose locations correspond to the external buttresses of this building on which they rest, each truss linked together by steel struts. On the north side of the room the trusses rest on steel stanchions (**Plate 40**), allowing the space to extend and include the first of the flat-roofed blocks to the north. The central block and many of the rooms immediately to its

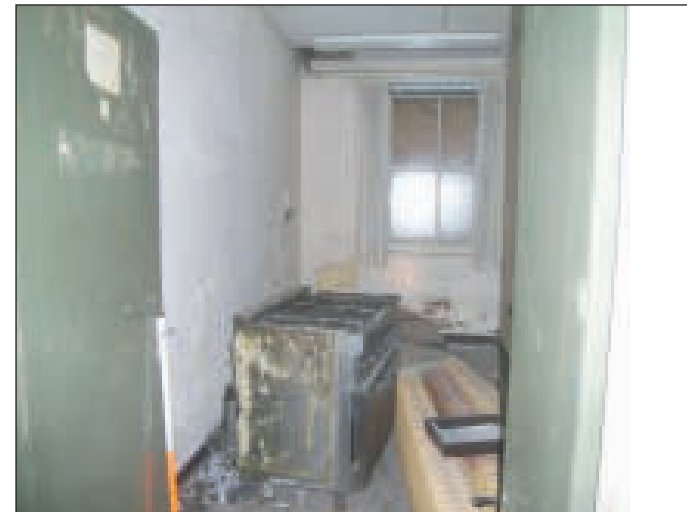
Plate 21 Room 18 used for storage of kitchen equipment and old radiators, looking south

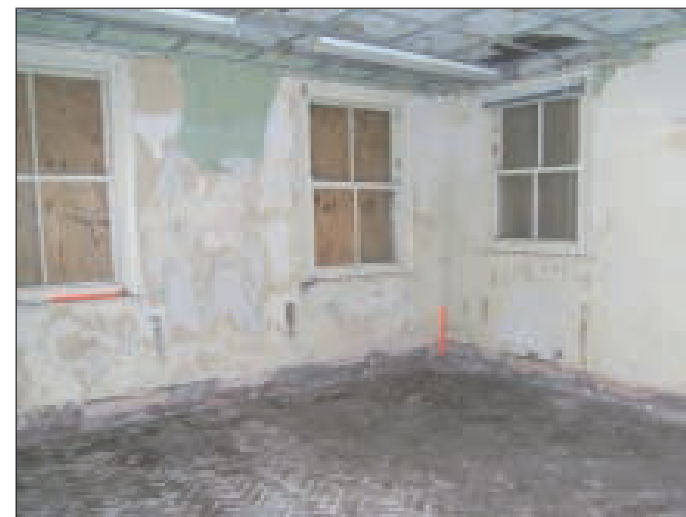
Plate 24 Room 21 with the 'shadow' of a parquet floor visible, looking south-west

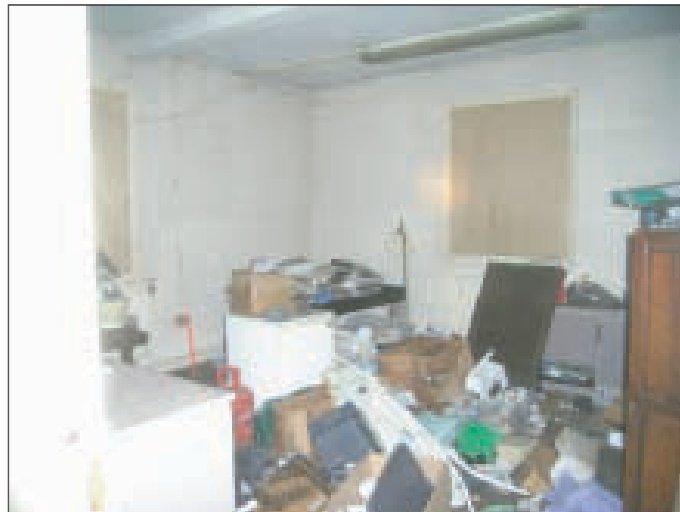
Plate 26 Room 23, looking north-west

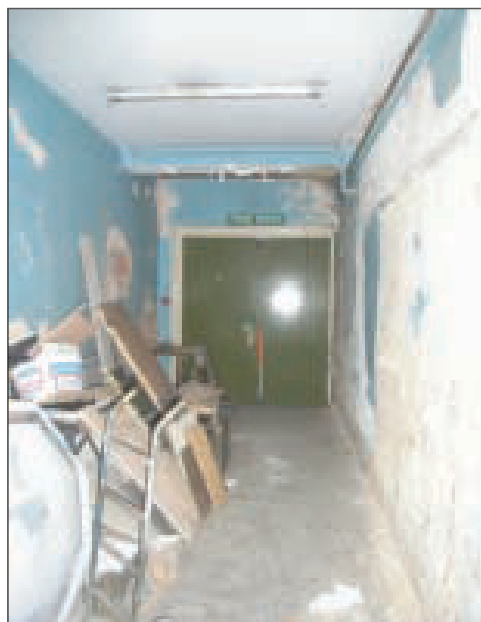
Plate 29 Room 26, hallway leading to the porch,
looking south

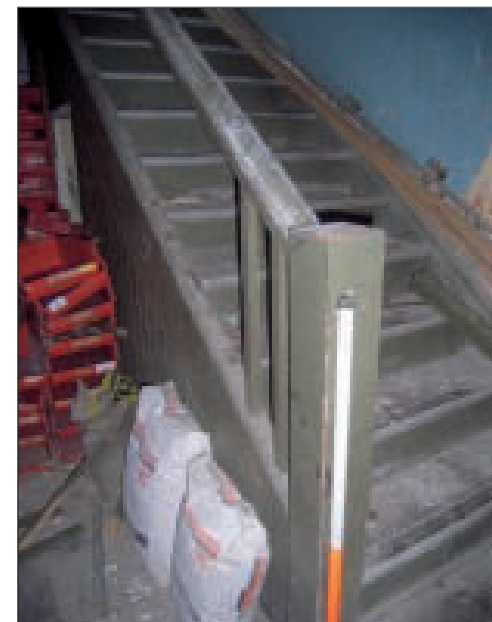
Plate 30 Room 26, staircase in the hallway lead
ing to the porch, looking north-east

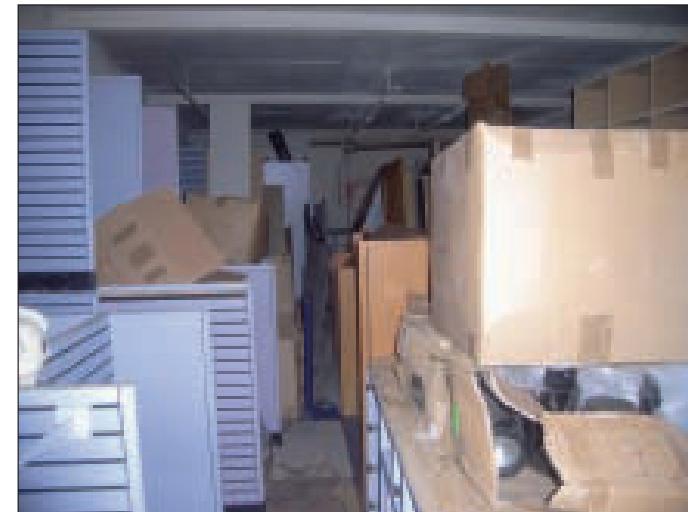
Plate 39 Room 8, looking west

north and east were until recently used as a garage. The most northern flat-roofed block was formerly the boiler room, now used as storage space (**Plate 39**).

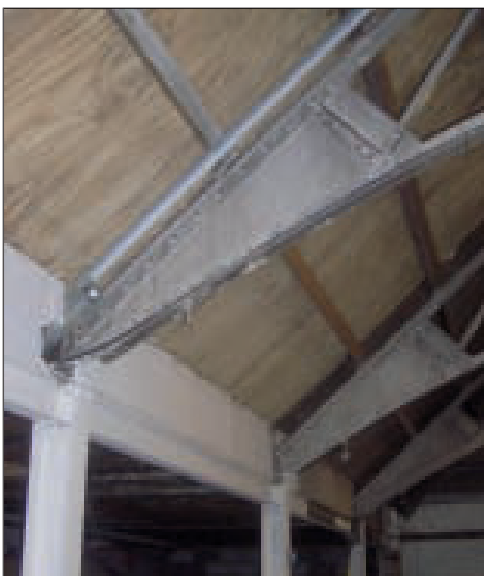
Plate 40 North end of a roof truss of the central block, Room 9, looking north-east

- 6.2 Both internally and externally the majority of the building is utilitarian in form and appearance with few if any distinctive features. The exceptions to this are the ornate porch, which links the two main parts of the building, and the central block that has a quite elaborate roof structure supported by buttressing on the front elevation of the building.

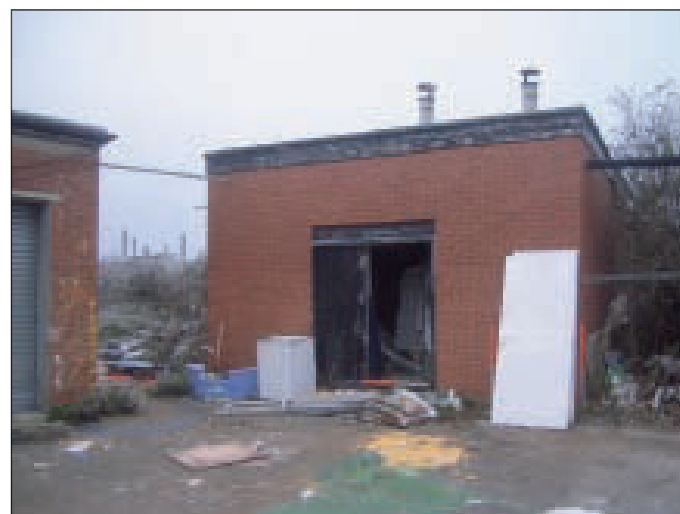
Plate 41 Brick built outbuilding, looking north-east

- 5.7 No evidence of the air raid shelters (HER 45885) was found on site. Two small outbuildings located close to the main building were examined, however one was of very modern brick construction (**Plate 41**) similar in date to the sorting office extension of the main building and the other was a wooden temporary structure (**Plate 51**). Examination of the 1954 Ordnance Survey 1:2500 plan (**Fig. 4**) appears to show two possibilities for the location of the air raid shelters, an L shaped building located to the north-east of the main building, and a pair of rectangular buildings facing each other and located further to the east behind what is now a joinery workshop. The first of these has been demolished and in its place are the two small buildings described above. The second appears the more likely in terms of its form as depicted on the 1954 plan to be the air raid shelters recorded in the HER. These have also been demolished and are located outside the current study area.

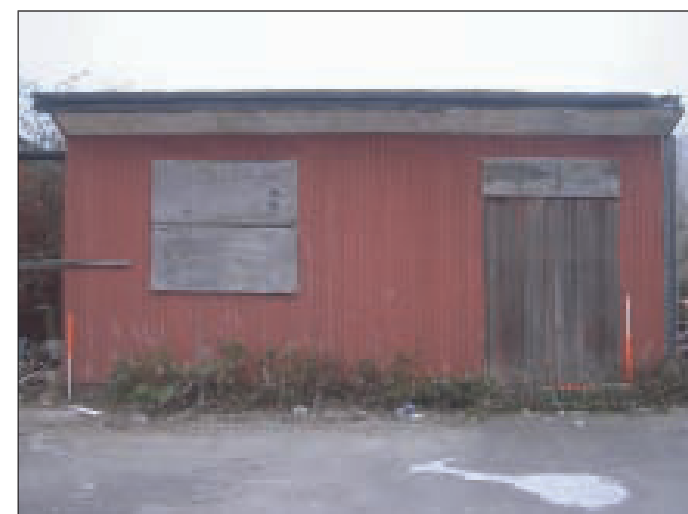
Plate 42 Temporary construction outbuilding, looking north-east
