Archaeological Evaluation  
at  
**SOUTHLANDS, WESTON, BATH**  
for  
Somerset Community Housing Trust

Report No. 2273/2011

Archaeological Evaluation  
at  
**SOUTHLANDS, WESTON, BATH**

Centred on  
N.G.R. ST 7257 6647

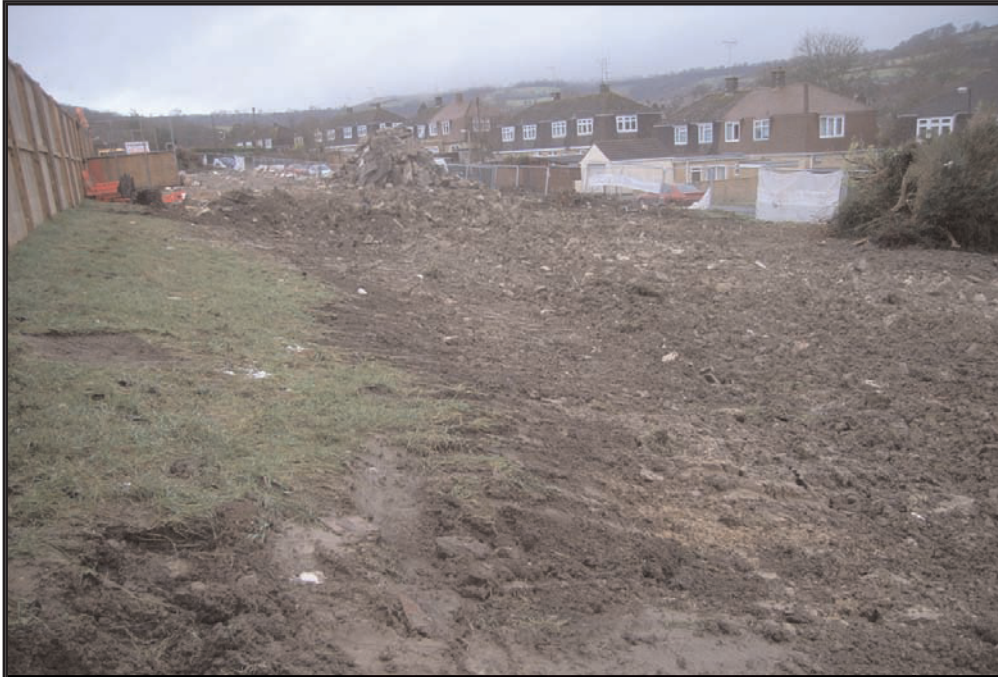
- Cover View across compound of Trenches 2 and 4, looking north-west
- Plate 1 Trench 4, looking east
- Plate 2 Feature 404, Trench 4, looking north
- Plate 3 Drain 403, Trench 4, looking south
- Plate 4 Trench 7, looking west
- Plate 5 Detail of Trench 7, showing feature (702) looking south-east

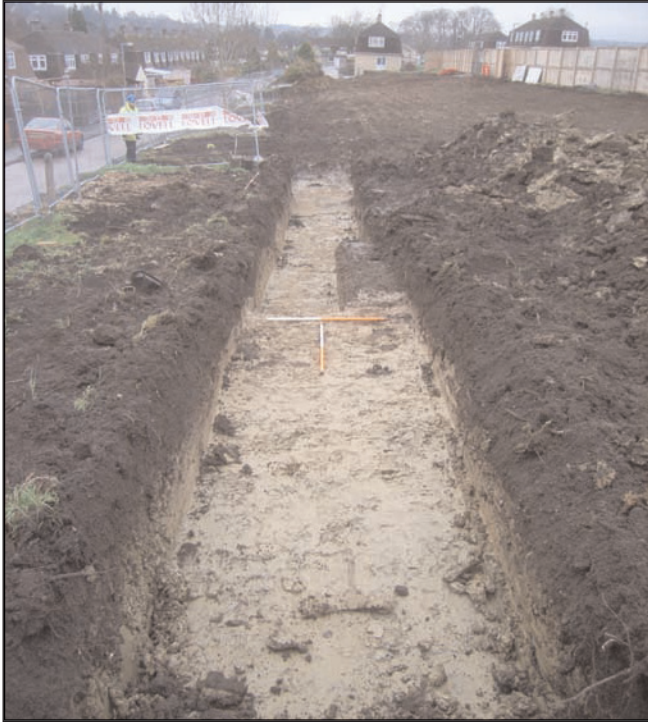
Plate 1  
Trench 4, looking east

- 5.2 Trench 4 measured 20m x 1.5m and was located in the garden area of the former Cornish Unit properties numbered 47-51 (**Plate 1**). The top of the undisturbed natural clay (402) was exposed at a height of approximately 65m aOD. There was minimal preservation of subsoil (401) in the area of Trench 4, which only survived to a maximum depth of 0.12m at the eastern end of the trench, this is likely to be due to disturbance caused by construction of the estate in the 1940s. Set within the natural clay at the western end of trench 4 was a single line of unworked stones (404), no artefactual evidence was present and this feature is likely to have been a form of field drain (**Plate 2**).

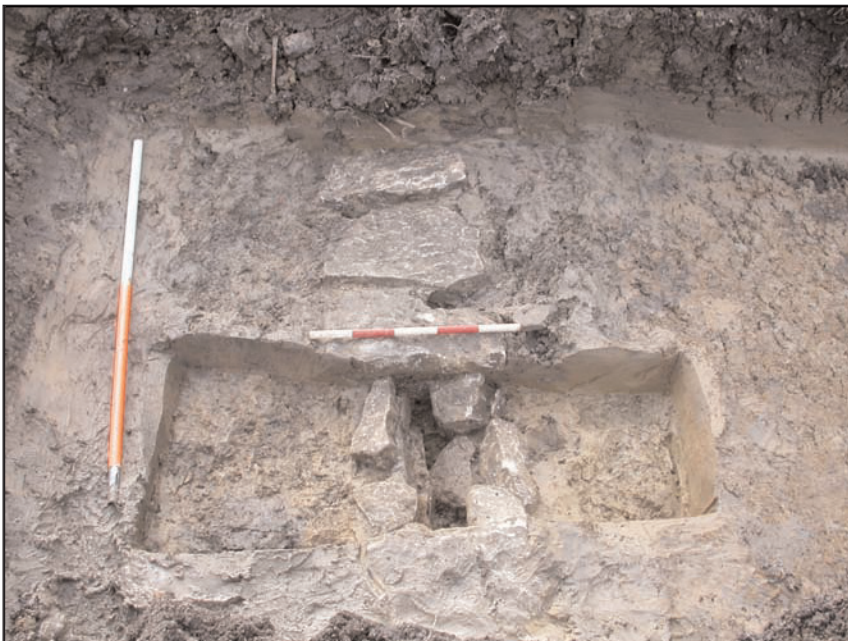
Plate 3  
Drain 403, Trench 4,  
looking south

- 5.3 Cut through the surviving subsoil and into natural clay, at the eastern end of the trench, was a partially collapsed drain sloping downwards from south to north, and comprising three courses of rough-hewn stones to either side of a channel 0.124m in width, with capstones up to 0.17m x 0.08m in size (**Plate 3**). The fill of this drain (405) contained residual fragments of animal bone, clay tobacco-pipe stem, and both medieval (possibly Crockerton Ware) and 19th-century pottery sherds.

- 5.4 Topsoil up to 0.33m in depth sealed the greyish-brown, silty clay backfill (407) of drains 403 and 404.

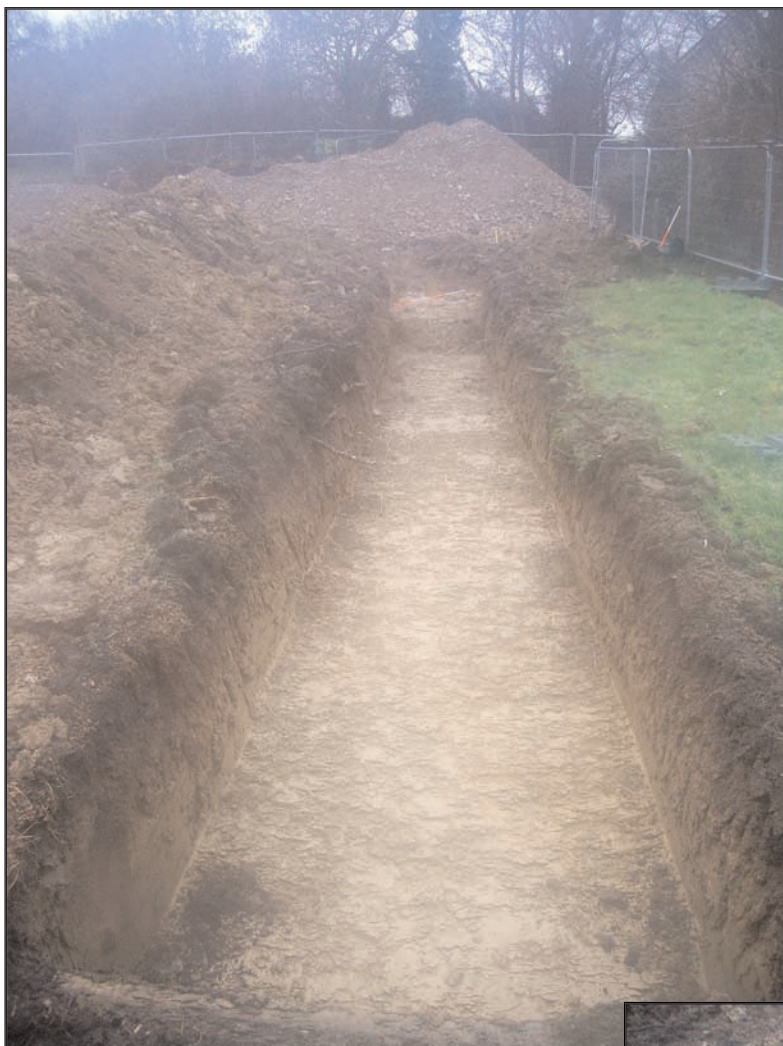
Plate 4  
Trench 7, looking west

- 5.6 Trench 7 measured 17m x 1.5m and was located in the garden of the former Cornish Unit properties numbered 100-104 (**Plate 4**). The top of the undisturbed natural (704) was exposed at a height of approximately 67m aOD. Above the natural clay was a pale brown, silty-clay, characteristic of degraded natural (703) up to 0.3m in depth. Roughly midway along the trench a modern ceramic land drain was partially exposed running diagonally from south-west to north-east.

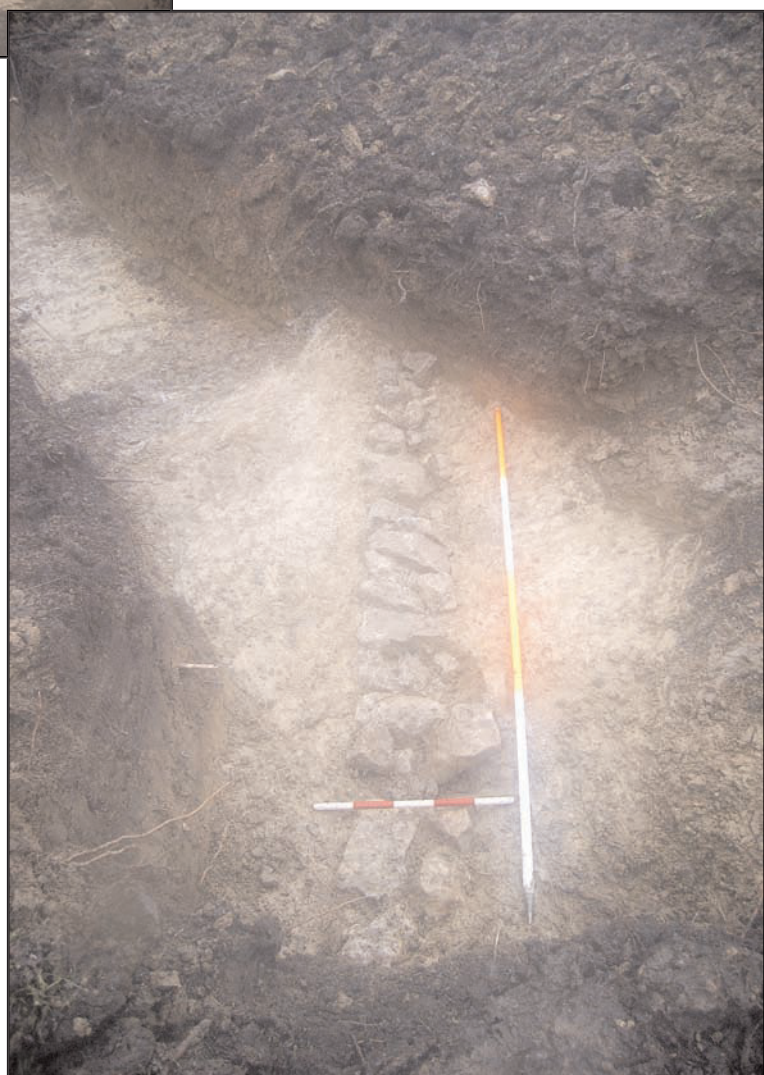
Plate 5  
Detail of Trench 7  
showing feature 702,  
looking south-east

- 5.7 At the western end of trench 7, cut into 703 and extending for 2.9m on a north-west to south-east alignment, was a linear feature comprising two courses of unworked stones (702), up to 0.49m in width and 0.2m in depth (**Plate 5**). Fragments of clay tobacco-pipe stems and 19th-century pottery sherds were recovered from 703 in the immediate vicinity of feature 702. It is likely that these stones represent a form of field drain, similar to feature 404 exposed in trench 4.
