Archaeological Watching Brief
at
**ST JOHN THE BAPTIST CHURCH,
CHURCH LANE, MIDSOMER NORTON,
B&NES.**

Report No. 2419/2011

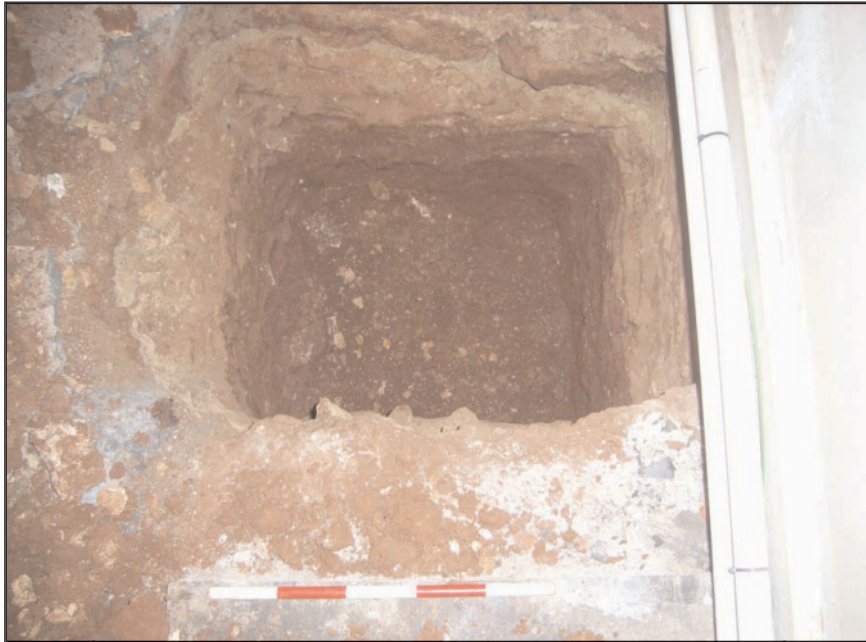
Plate 1
Trench 1 as excavated,
looking west

This trench was excavated to a depth of 1.3m against the north aisle wall of the church to provide a footing for the mezzanine loft staircase (**Fig. 3 & Plate 1**). A layer of dark red silty clay (107) containing lenses of white mortar and small stones was sealed by a deposit of compacted white mortar and rubble (106) that clearly sloped away from the wall of the church. Deposit 106 was in turn sealed by a mixed layer of mortar, rubble and clay (103) immediately underneath the bedding for two layers of limestone slabs forming the aisle floor (102, 101). No finds were recorded in this pit, it may be the case that deposit 106 was associated with the 1830s rebuilding of the church.

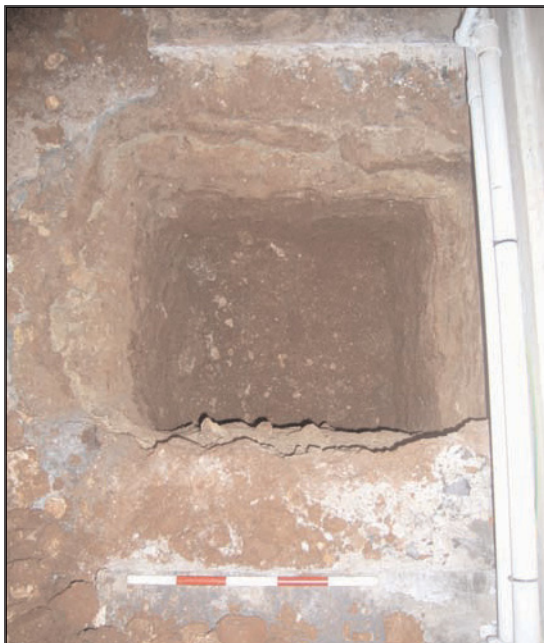
Plate 2
Trench 2 as completed,
looking north-west

Trench 2 abutted the western wall of the nave and was excavated to a maximum depth of 1.3 m. A similar sequence of deposits to those in trench 1 were observed. A 0.65m depth of red clay containing moderate inclusions of white mortar flecks and stone rubble (207) was sealed by a lens of white mortar up to 0.1m in depth (206). Two more mixed deposits of interbedded clay, stone and white mortar rubble (204, 205) up to 0.48m in depth were in turn sealed by the slab floor of the nave (203). The stepped, northern footing of the western archway of the nave contained a piece of re-used faced stone, other than this, nothing of any archaeological significance was observed (**Plate 2**).

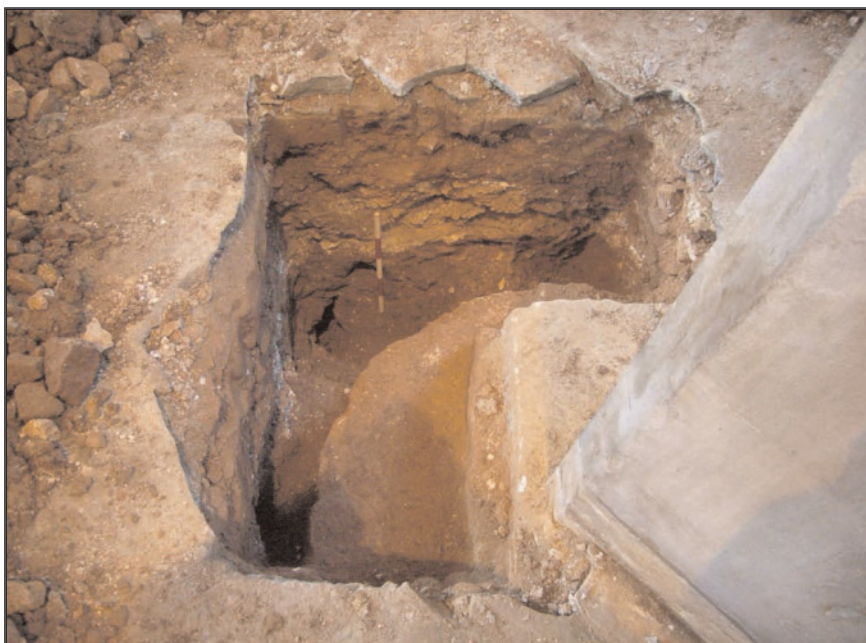
Plate 3
Detail of the rounded
column base in Trench
3, looking north-east

Trench 3 was excavated to a maximum depth of 1.3m adjacent to the southernmost supporting column of the northern side of the nave (C5 on plan, see **Fig.3, Plate 3**). The lower stratigraphic sequence largely mirrored that revealed in trenches 1 and 2 namely up to 0.55m of redeposited, reddish-brown, silty-clays with inclusions of lime-mortar flecks and stones (305, 303). These deposits sealed the lower courses of Column C5, which comprised a rounded footing that may be evidence of pre-1830s construction beneath a stepped, square base (308). In addition, at the eastern end of the trench, on a north-south alignment and adjoining the rounded footing, were the remains of a wall 0.5m in width (306), extending beyond the limits of the trench and sealed by deposit 305.

On a similar alignment at the western edge of this trench, the remains of a badly damaged culvert (304) up to 0.25m in width had been cut through deposit 305.

Overlying 305 was 0.3m of compacted white mortar and stone rubble (302), dumped after the construction of the stepped column base and probably representative of the 1830s rebuild, sealed by 0.3m of mixed rubble, clay and mortar (301). The floor of the nave comprised a double surface of Lias Limestone slabs.

- 6.2 Traces of a wall footing and the remains of a culvert in trench 3 were probably associated with a phase of the church pre-dating the 1830s. Similarly, the large rounded footings, located beneath the squared, stepped footings of the fluted church columns may represent parts of an earlier phase of construction, surviving below the level of the present church building. The faced stone fragments, reused in the footings of the nave archway, observed in trench 2 also tend to support this idea. However, it is also possible that this stone came from an outside source and the difference between the upper and lower parts of the column footings does not represent a change in phasing but rather in materials/technique.

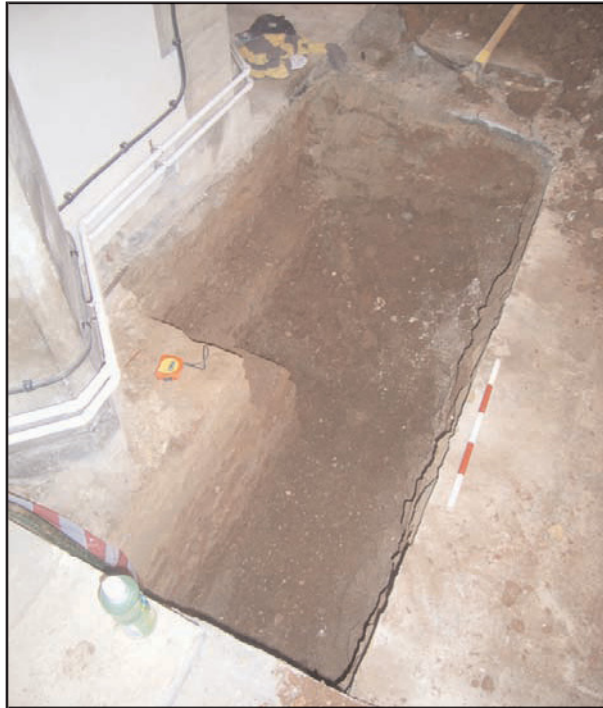
Plate 4
Trench 4 as
excavated, looking north-
west

This trench abutted the western wall of the nave and was excavated to a maximum depth of 1m. The stratigraphic sequence revealed was almost identical to that recorded in trench 2 (**Plate 4**). Two fragments of a round column were recovered, though not retained, during the excavation of this trench. The larger of the column fragments had been reused as part of the bedding for the nave floor and may have come from the pre-1830s phase of the church.

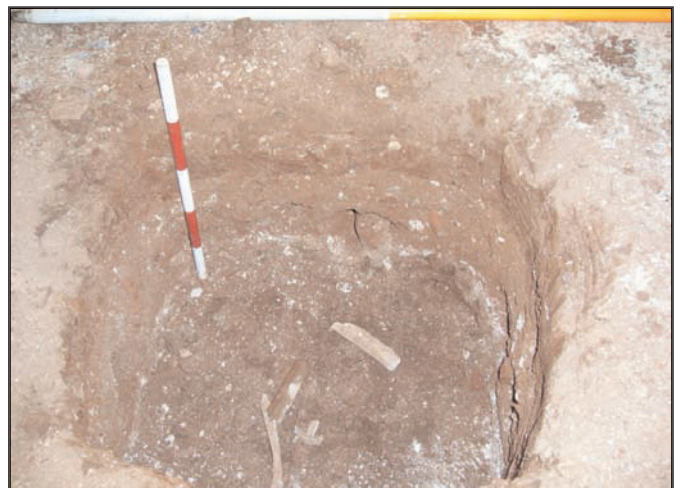
Plate 7 Trench 6 as excavated, looking south

The trench for the new soak-away for the repositioned font was excavated to a depth of 0.72m below floor level. The stratigraphy followed the pattern seen in the other trenches of a dark red clay over 0.3m in depth, containing moderate inclusions of small stones, white mortar flecks, fragments of wall plaster, one fragment of clay tobacco-pipe stem and disarticulated human bone (601), underlying a mixed deposit of clay, mortar and rubble (600). More disarticulated human bone was retrieved from deposit 600 and reburied at the base of the new font soak-away (**Plate 6**).

- 6.3 Fragments of disarticulated human bone recovered during the course of the watching brief were retrieved and re-interred within the church, in the new soak-away pit for the repositioned font.
