Archaeological Watching Brief  
to the rear of  
**NO. 126 HIGH STREET,  
MIDSOMER NORTON, SOMERSET.**  
for  
Smith Design & Build

Report No. 2352/2011

An archaeological watching brief was carried out during groundworks associated with excavation of foundations for a pair of semi-detached town houses behind No. 126, High Street, Midsomer Norton, Somerset.

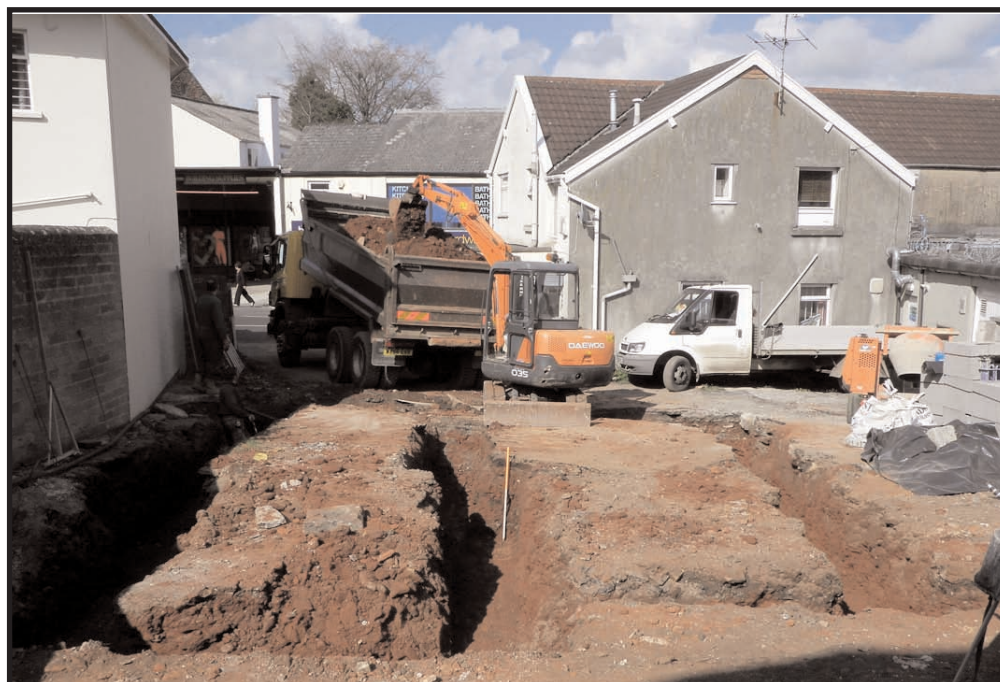
- Cover General view of the footings, near completion, looking north-east, scale 0.5m
- Plate 1 Test Pit 4 as excavated, with Wall (106) on right, looking south-east, scale 0.5m
- Plate 2 Overall view of work in progress, including initial excavation of Trench 4, looking north-east, scale 0.5m
- Plate 3 Wall (110) as exposed in House Plot 1, Trench 1, looking south, scale 2 x 0.5m
- Plate 4 General view of the footings, near completion, looking north-east, scale 0.5m

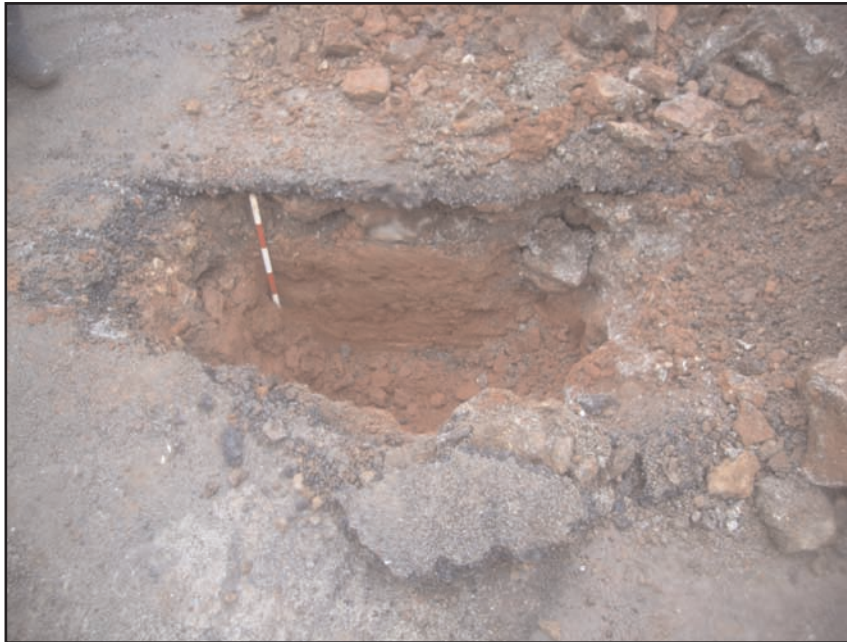
5.6 Was located in the north-east of the site and was excavated to a maximum of 800 mm deep. The uppermost deposit comprised the remains of a modern carpark surface of tarmac (107) and bedding material for this (108). Below these deposits was a post-medieval wall (105) that had been built in a cut directly into the archaeologically sterile sandy clay (103). Below this was the upper surface of sandstone (104).

106	Wall truncated by Test Pit 4. Small section of wall exposed in pit 500mm x 500mm x 300mm high. Comprises unworked limestone rubble of large size (max c. 500 x 300 x 200mm) bonded with grey mortar with abundant inclusions of charcoal and lime. 1 or 2 courses remain. Appears similar to Wall (114).
107	Tarmac surface over Test Pit 4 and the north half of the site, 20mm thick or less.
108	Bedding material under parts of Deposit (107). Crushed/mixed rubble (includes brick, limestone and sandstone fragments) and mortar deposit. Averages 200mm thick.
109	Modern gravel and rubble, thin deposit of redeposited topsoil, gravel and demolition rubble – similar to (111).
110	Wall and return in Trench 1, House Plot 1. Approximately 2m of wall orientated E to W, remains to a height of 500mm. Nearly all materials used are brick but small Lias limestone rubble has also been used. Bricks are mostly stretcher laid, but the exact pattern is not known. White lime mortar bond. The return (to the south) is only visible over 200mm but appears identical to the main body.

Plate 1  
Test Pit 4 as excavated,  
with wall (106) on right,  
looking south-east.  
Scale 0.5m

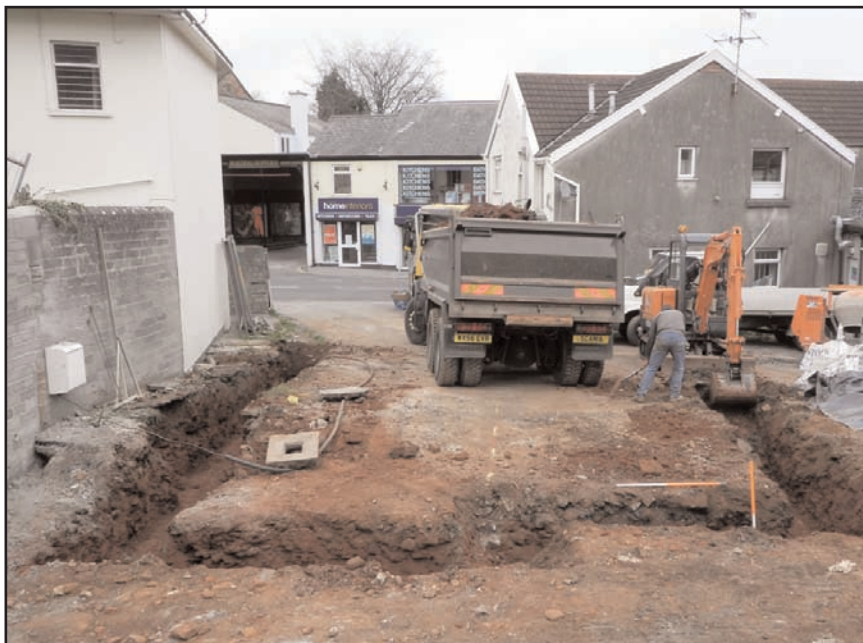
- 5.11 Excavation of this trench revealed deposits identical to those exposed in Trench 3. The overall depth of excavation was 900mm.

Plate 2  
Overall view of work in  
progress, including initial  
excavation of Trench 4,  
looking north-east, scale  
0.5m

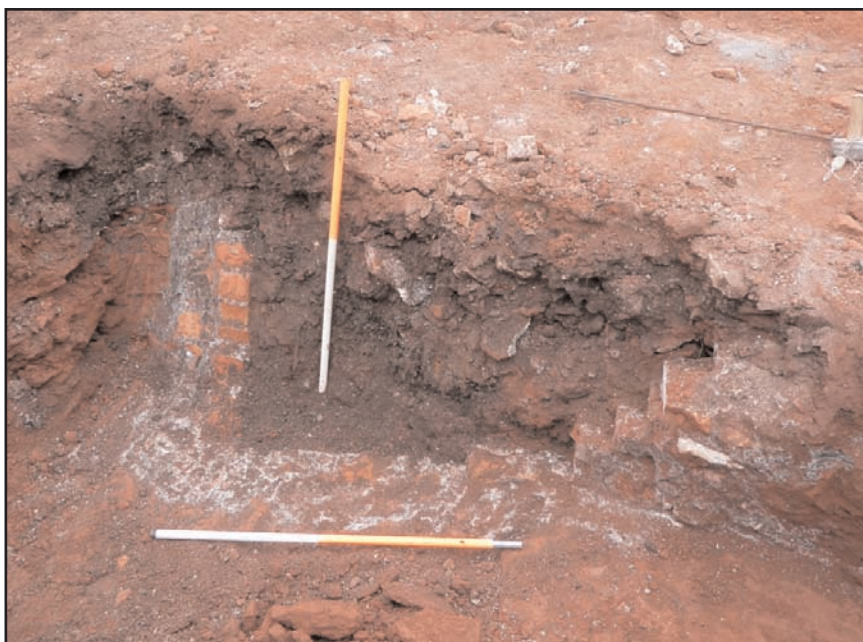
5.8 The trench was excavated to 650mm deep and the majority of this trench was excavated directly into deposits of archaeologically sterile sandy clay (103) though some deposits of made-ground (111) remained *in situ* over this in irregular patches. At the base of excavation was the upper surface of sandstone (104). A short length of wall (Wall 110, plate 3) of post-medieval date, orientated roughly east to west, and with a return to the south at the east end, was also recorded in the north-facing section and the base of the trench.

Plate 3  
Wall (110) as exposed in  
House Plot 1, Trench 1,  
looking south, scale 2 x  
0.5m

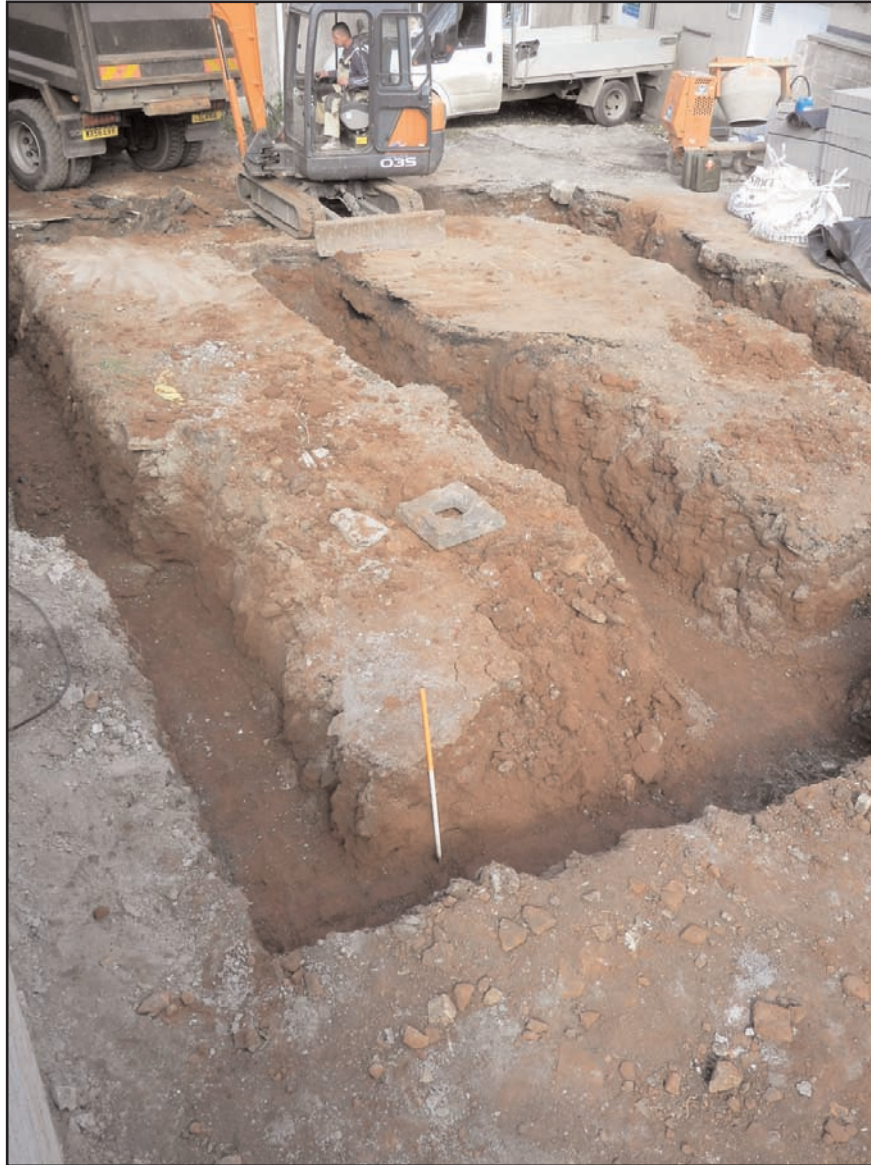
Plate 4 General view of the footings, nearing completion, looking north-east, scale 0.5m
