Beaulieu: Zone R

Topographic Survey

OA East Report No: 2038

Report Number: 2038
Site Name: Beaulieu Zone R
HER Event No: -
Date of Works: November 2016
Client Name: Countryside Zest
Client Ref: -
Planning Ref: -
Grid Ref: TL 7359 1056
Site Code: SPBP16
Finance Code: XEXBEP14
Receiving Body: Chelmsford Museum
Accession No: -
Prepared by: Gareth Rees
Position: Project Officer
Date: 8th May 2017

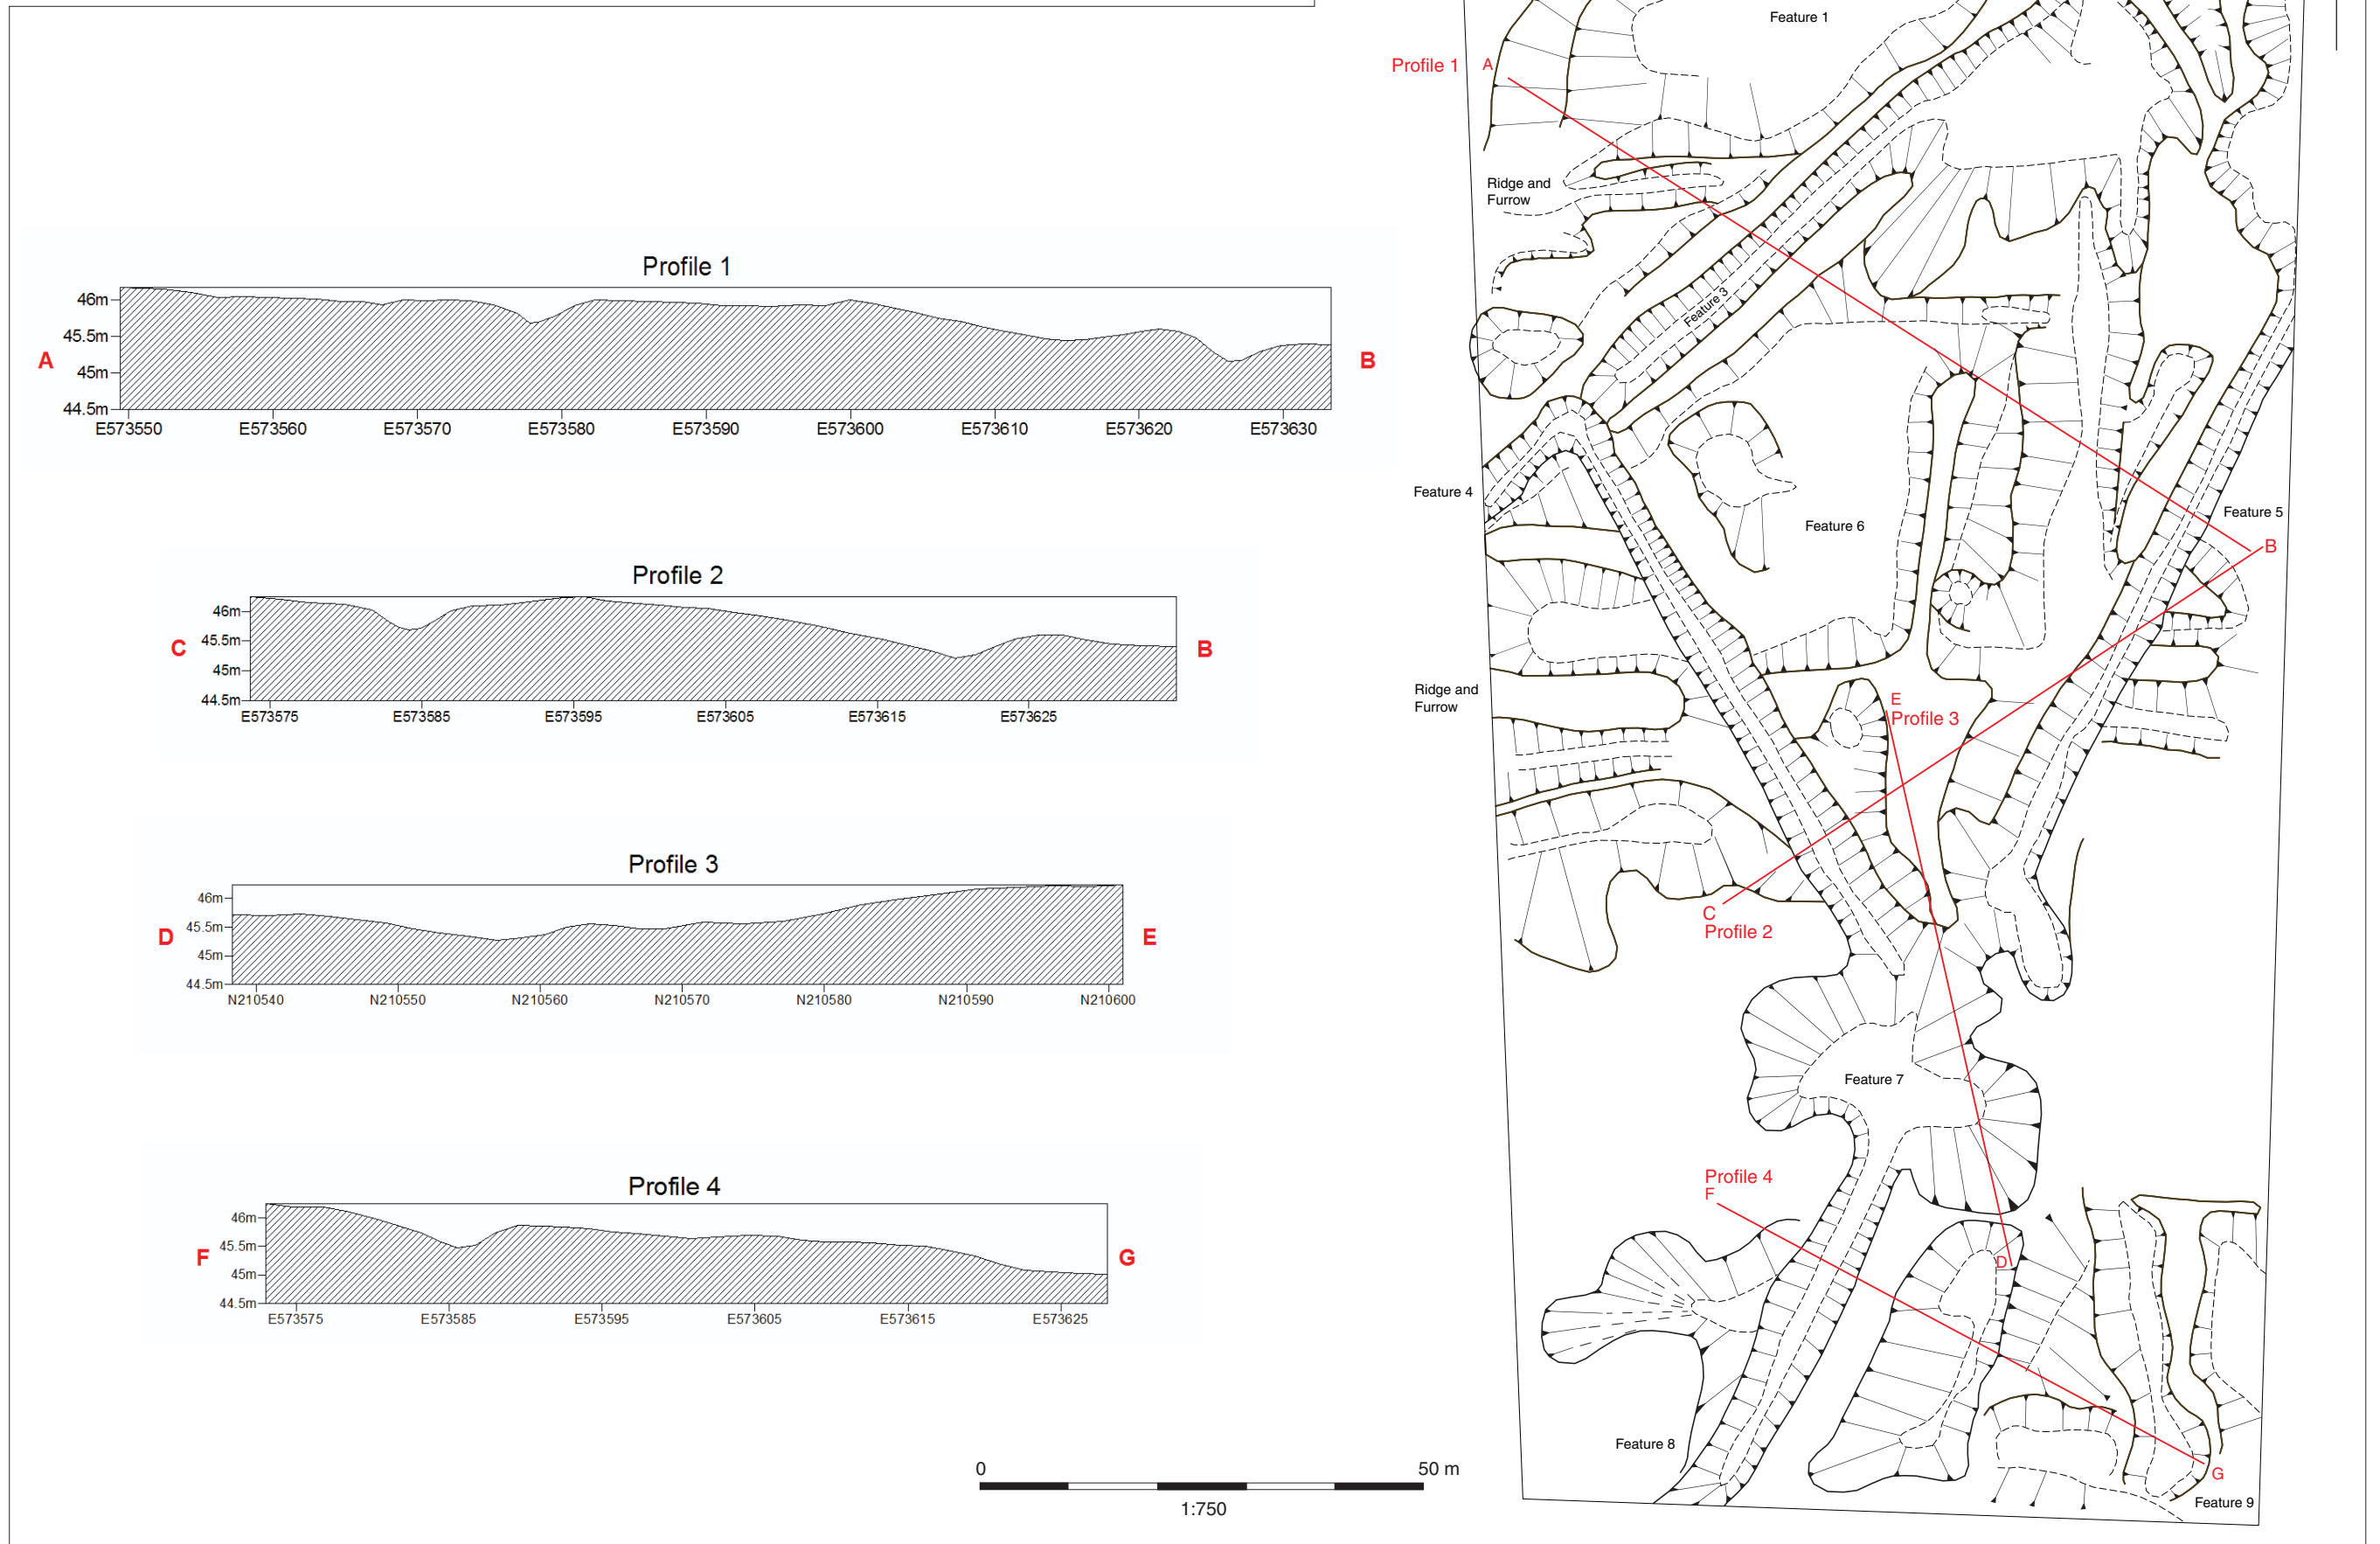
Figure 2: Interpretive plan of earthwork features and associated profiles

2.2.3 This survey was complimented by an interpretive survey carried out using a survey grade Leica GS08 dGPS connected to the Leica SMARTNET RTK network. Lines were recorded at the top and bottom of slopes of all features visible on the ground. Four profiles were recorded across the features by measuring points between 1m and 2m apart (Figure 2).

3.1.1 The results below are presented by the Feature number assigned to each identified earthwork. The ridge and furrow are discussed first since they appear to be the earliest feature. All other features are discussed from north to south. Feature location are shown on Figure 2 along with profiles showing relative heights across the site. The surviving topography is illustrated by way of a contour map (Figure 3), whilst the results are illustrated three-dimensionally in a DTM (Figure 4).

3.2.1 Three areas of earthworks were identified that are thought to be the remains of medieval ridge and furrow cultivation. These were located to the north-west, west and east of the site (Figure 2). All of these features survived only as shallow earthworks which had been subject to large amounts of erosion and truncation by later features.

- 3.6.1 An area (Feature 6) surrounded by these ditches (Features 3, 4 and 5) appeared to have been levelled along its western side adjacent to the bank material of Feature 4. This area, measuring 82m from north to south and 52m from east to west, contained an internal bank along its eastern edge (Figure 2 and Figure 4). This bank, measuring up to 8m wide and less than 0.10m high, appeared to respect the location of that associated with Feature 3 to the north. The ground in this area sloped gently from south to north and dropped away sharply to the east of the internal bank (Plate 2). Several small depressions were located in this area.

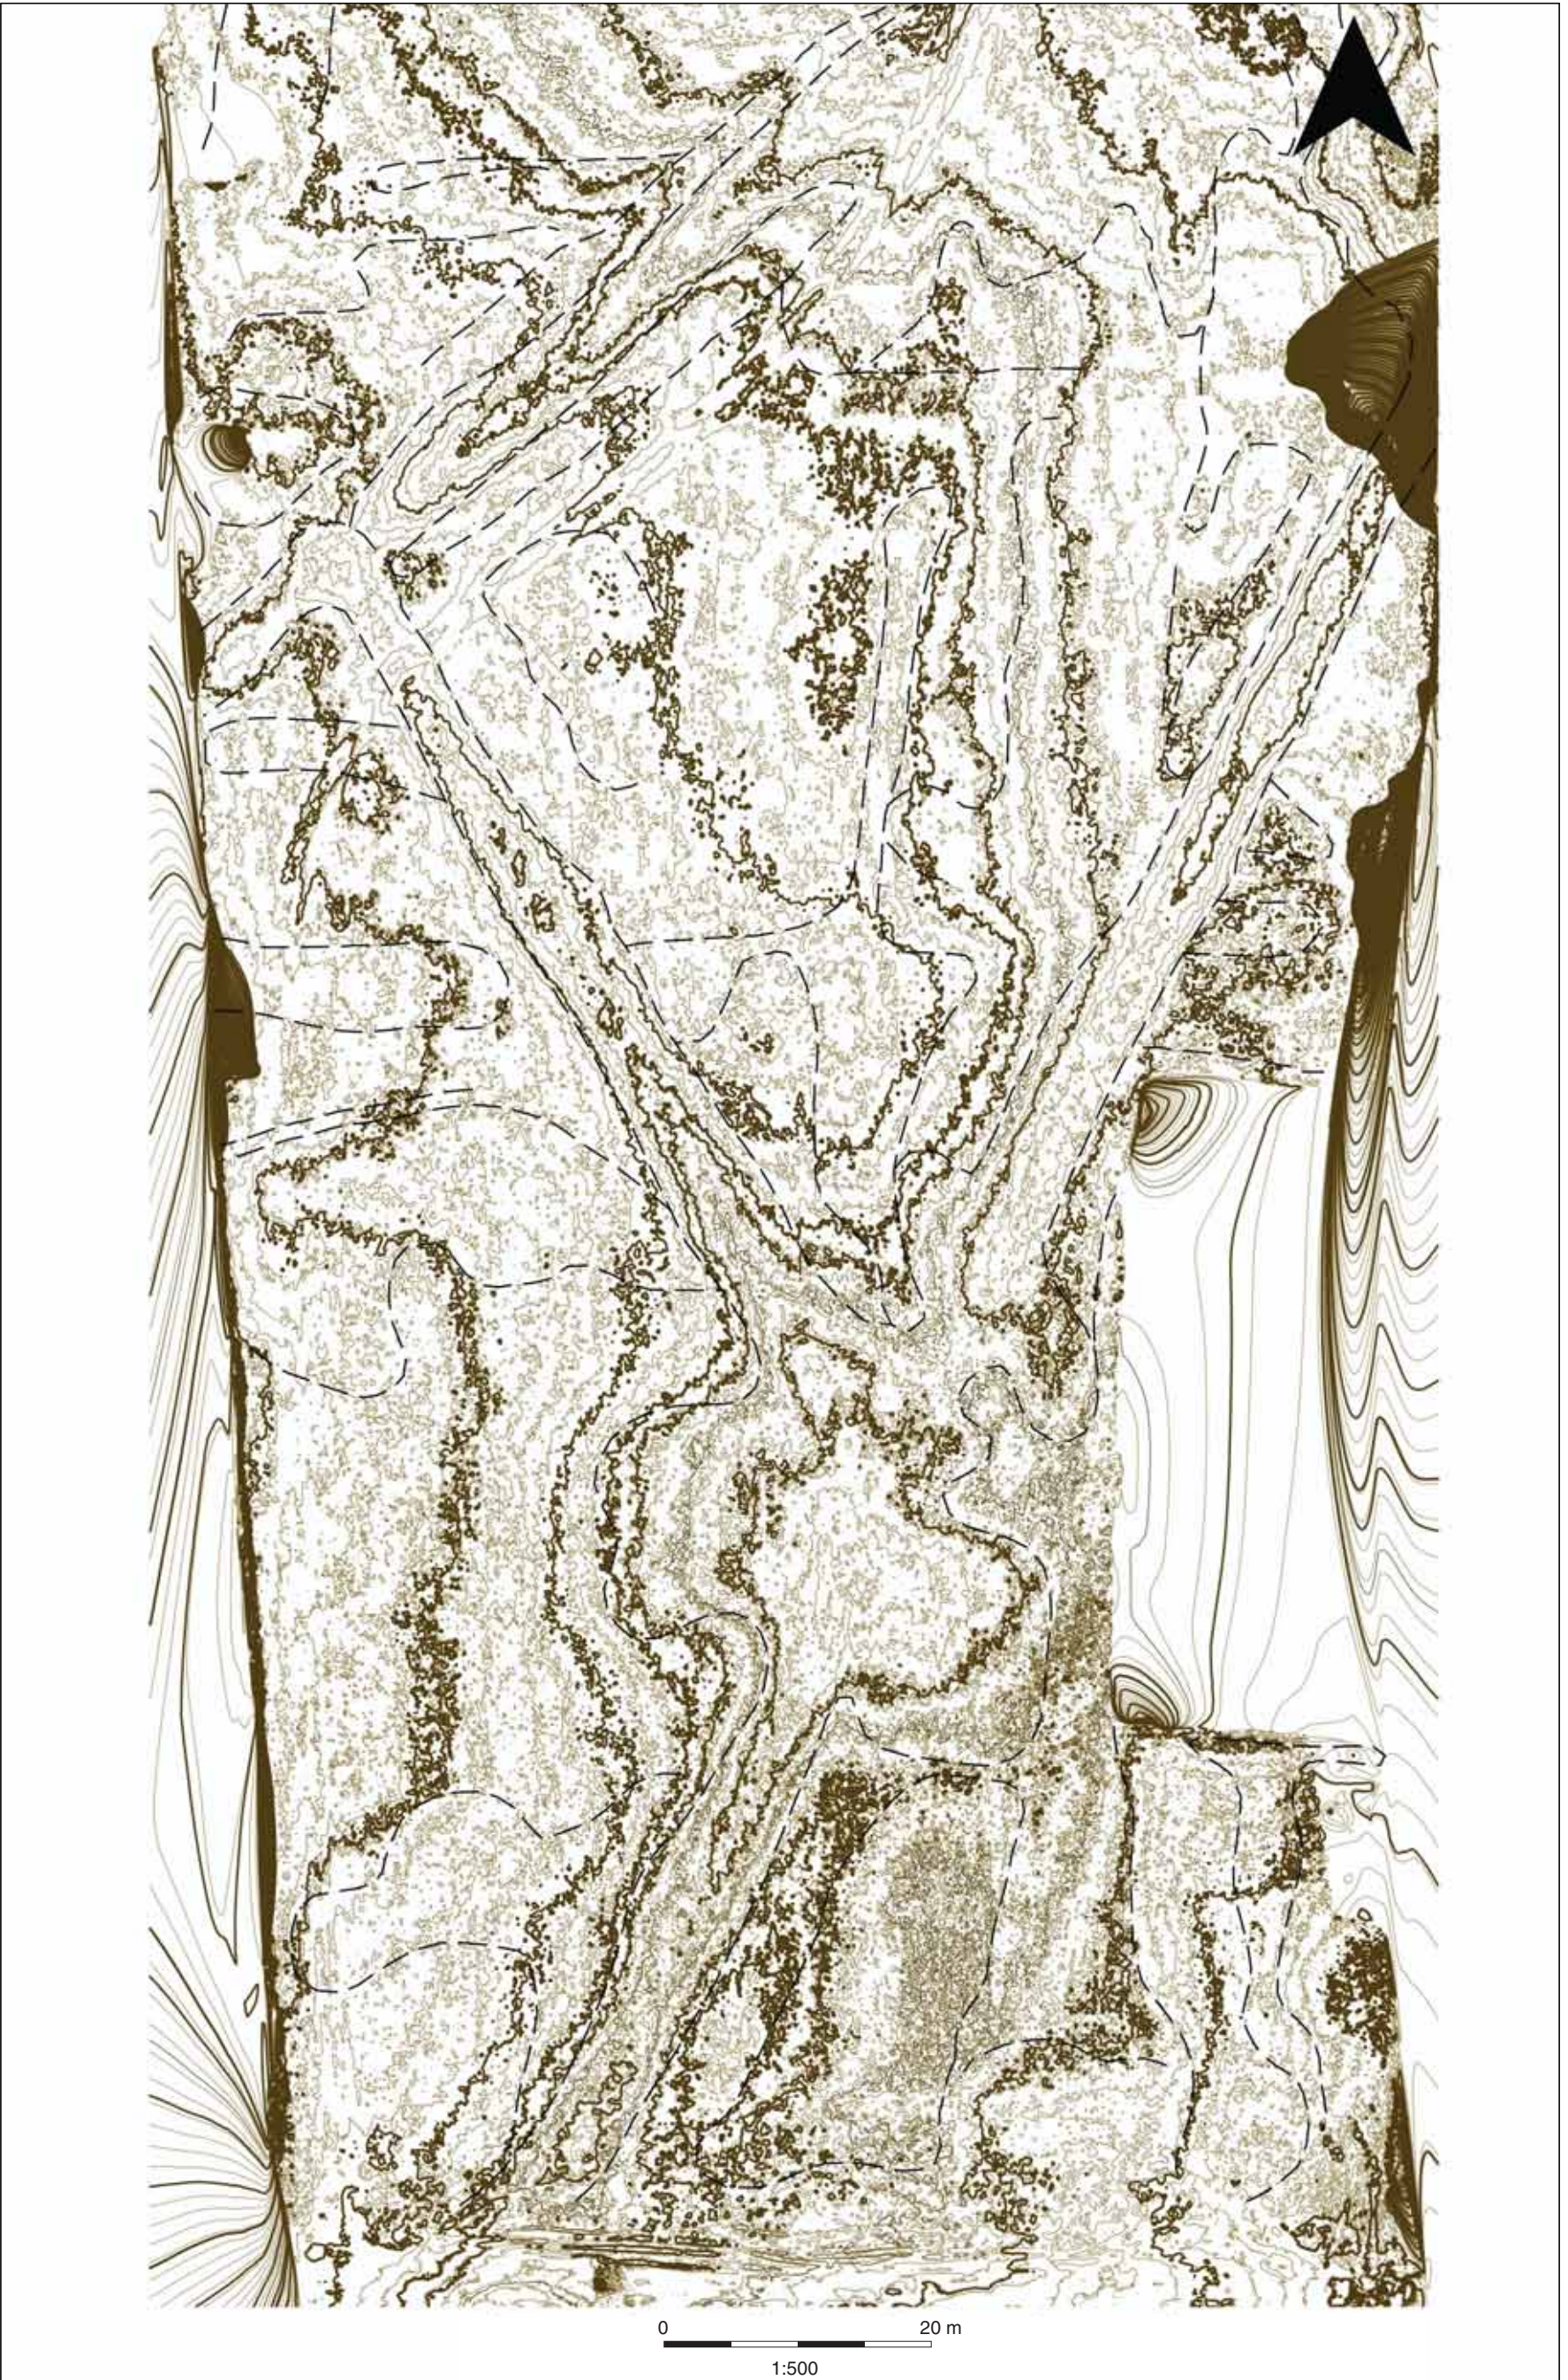
Figure 3: Contour map

- 4.2.1 The earthworks on this site survived in various states of preservation. The best preserved were ditch Features 3, 4, 5 and 8, along with hollow Feature 7. Earthworks derived from upcast were barely perceptible on the ground but are clearly visible after modelling of the photogrammetric data (Figure 3 and Figure 4). No features survived to greater than 0.40m. The greatest measured variation of 0.80m was between the eastern part of Feature 6 and the base of ditch Feature 5. All of the earthworks were covered by pasture and as such are currently stable. Some degradation were apparent due to a track running from a gate in the western boundary of the field to a gate in the northern boundary.

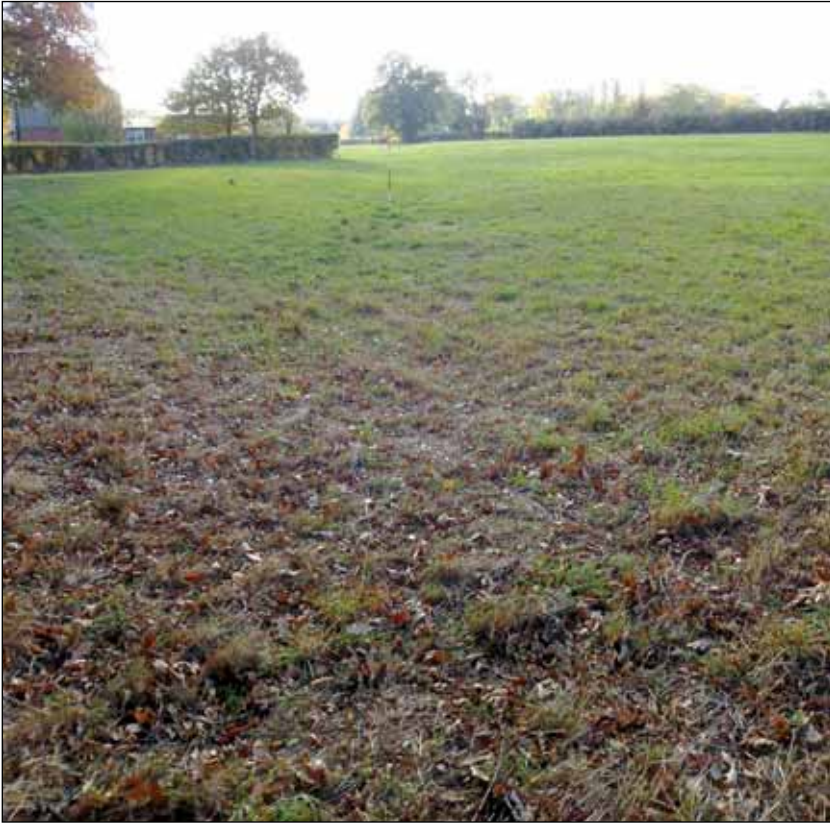
Plate 1: View of Feature 5, facing south-west along ditch

- 3.5.4 Another ditch (Feature 5) was located at the west of the site (Plate 1). This ditch, measuring 77m long, between 4m and 6.50m wide and up to 0.32m deep, was orientated south-west to north-east and appeared to have drained in to an area around Feature 2 to the north-east. This ditch also narrowed at its north-eastern end. A bank may have been present on the north-western side at its northern end (Figure 1, Profile 1).

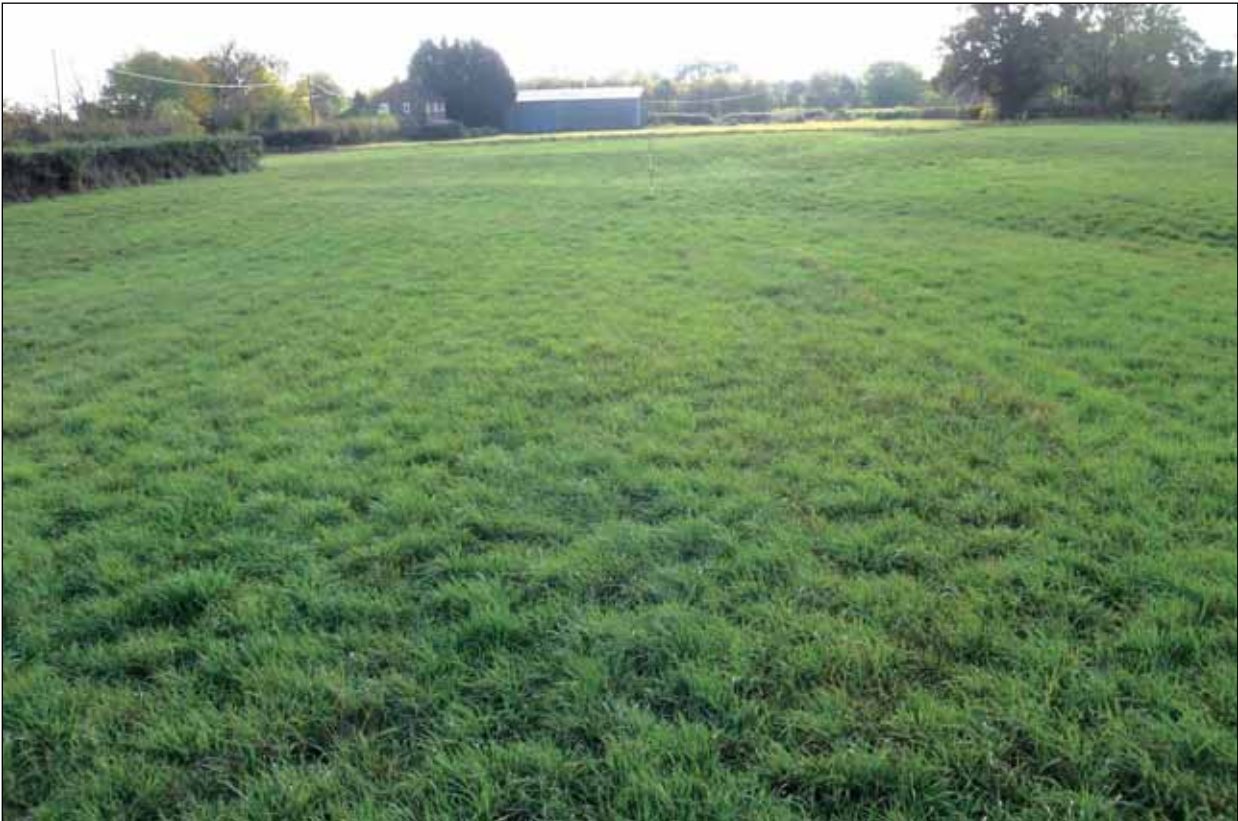
Plate 2: Feature 6, facing south towards Feature 7
