# No. 3 St Botolph's Church Walk, Colchester, Essex

## Archaeological Watching Brief Report

May 2020

**Client: Anglian Water**

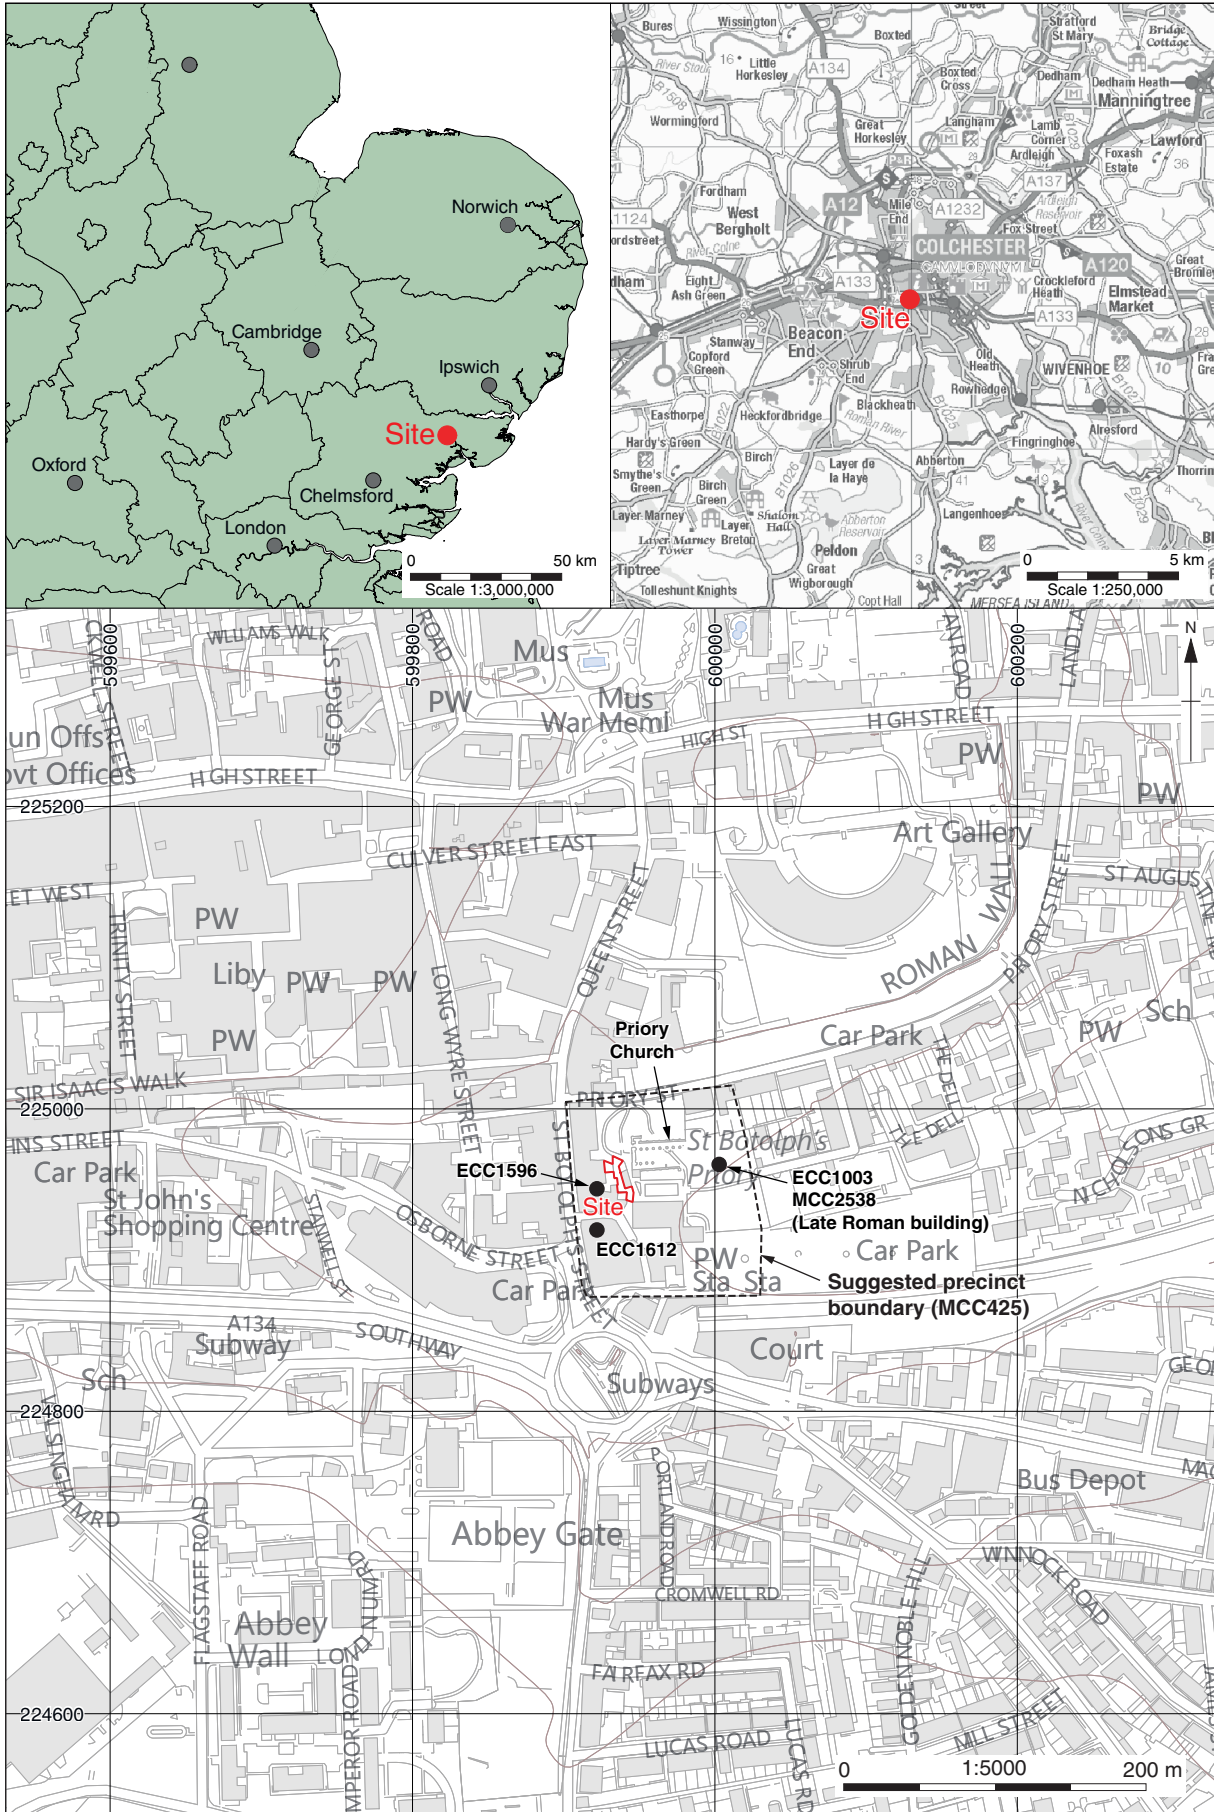
Figure 1: Site location showing (the likely extent of) the Precinct and Priory church (and selected ECC entries)

- 1.1.1 Oxford Archaeology East was commissioned by Anglian Water to undertake a watching brief on emergency repair works to a sewer main to the rear of No. 3 St Botolph's Church Walk, within the bounds of St Botolph's Augustinian Priory (Scheduled Monument No. 26301, HA 1013764; NGR TL 99941 24941; Fig. 1). Scheduled monument consent was obtained prior to the works taking place.
- 1.1.2 The requirements for the work were set out in the Written Scheme of Investigation (WSI; Gilmour 2020) and were agreed in consultation with Dr Jess Tipper, archaeological advisor to Colchester County Council and Will Fletcher, Inspector of Ancient Monuments for Historic England.

- 1.3.4 Founded between 1093 and 1100, the Priory of St Julian and St Botolph was one of the first Augustinian priories in England, built mainly of flint and reused Roman brick. Following the Dissolution in 1536 the priory was granted to the Lord Chancellor, Lord Audley, although part of the priory church remained in use as a parish church. In 1648 it was largely destroyed by cannon fire during the Civil War siege of Colchester and has remained a ruin ever since. The current watching brief was located at the western edge of the scheduled area, close to the church and potentially within the priory graveyard. The full extent of the precinct is not known, although its suggested outline is shown on Fig. 1 (MCC425).

- 1.3.5 Two watching briefs are recorded as having taken place in the vicinity of the site, at Nos 33-34 St Botolph's Street (ECC1596, 1988) roughly 20m south-west of the site, which recorded no significant finds, and at No. 31a St Botolph's Street (ECC1612, 1989) roughly 36m south-southwest of the site (Fig. 1). The watching brief at No. 31a St Botolph's Street encountered a band of white mortar at 1m below ground level and a large wooden object at a depth of 1.6m; possibly part of a medieval wooden drain.

4.3.2 The disturbed upper deposits match those described in the Colchester Archaeological Trust's reports for work conducted at Nos 33-34 St Botolph's Street (ECC1596, 1988), south-west of the site and No. 31a St Botolph's Street (ECC1612, 1989), south-southwest of the site (Fig. 1). The latter report also notes a 'band of whitish mortar' at a depth of 1m: this is perhaps equivalent to the well compacted light 'whitish' grey deposit (8) encountered at a similar depth in Trench 2.

- 4.4.1 As this excavation took place near the former southern gate of Roman Colchester, outside the town wall, and within sight of a known Late Roman building to the north-east of the site (ECC1003, MCC2538; Fig. 1), it is perhaps not surprising that a small quantity of (redeposited) Romano-British artefacts were recovered. The general paucity of finds and absence of deposits directly related to St Botolph's Priory or church may, at least in part, be due to the extensive disturbance evident across the monitored area.

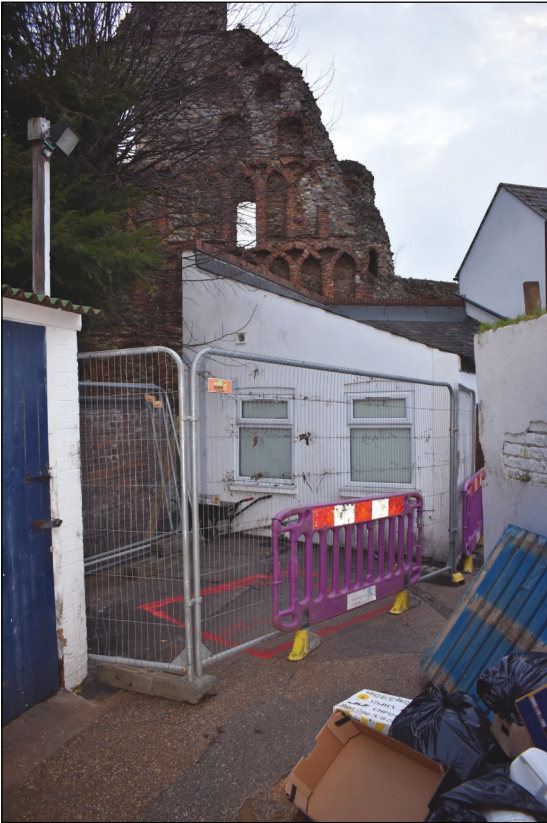
Plate 1: Pre-excitation (Trench 1), looking east towards St Botolphs Priory

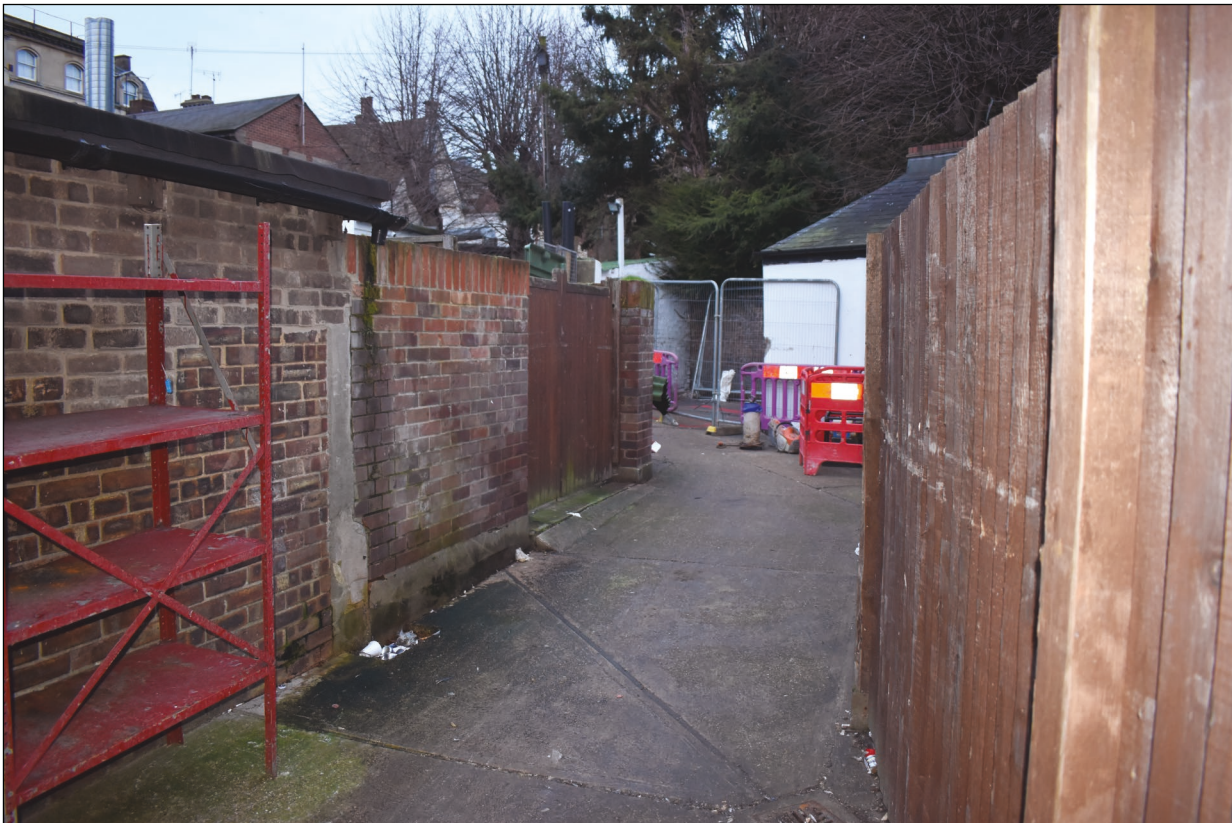
Plate 2: Pre-excitation (Trench 2), looking north along pipe route

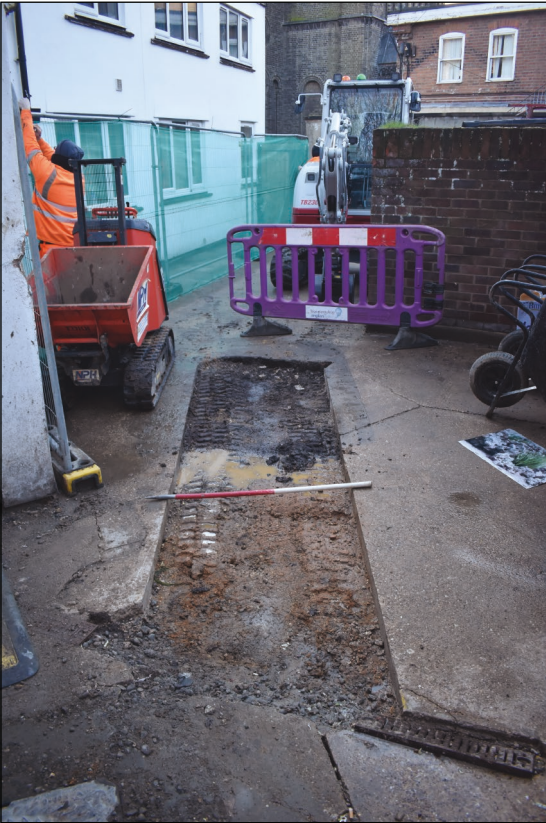
Plate 3: Pre-excavation (Trench 2), looking south-east along pipe route

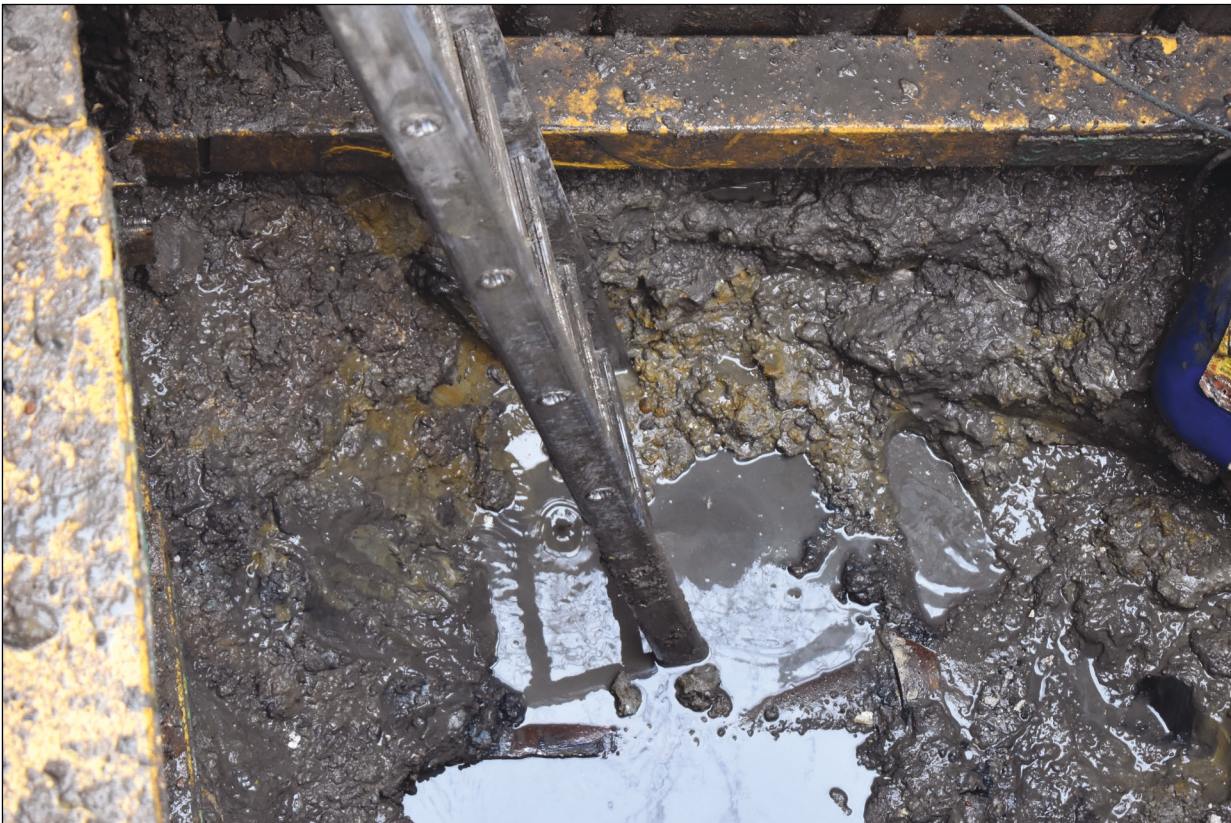
Plate 4: Working shot (Trench 1) showing geology and pipe

3.2.1 The initial trench measured 1.5m north-south and 2m east-west at the surface and had a total depth of 2.5m. This was the only location where the natural geology, a yellowish grey sandy clay was briefly observed at the base of the trench (Fig. 3, S. 1 and Plate 4).

3.2.2 Overlying the natural was a 2m-thick deposit of mixed dark brownish-grey clay (5), the backfill of the original pipe trench. Within this – at a depth of 0.6m – a disused foul sewer pipe was encountered running east-west, 0.2m from the northern limit of excavation. At 0.3m below ground level, a domestic freshwater service was also encountered within this deposit, located in the north-east corner of the trench (Plates 4 and 5).

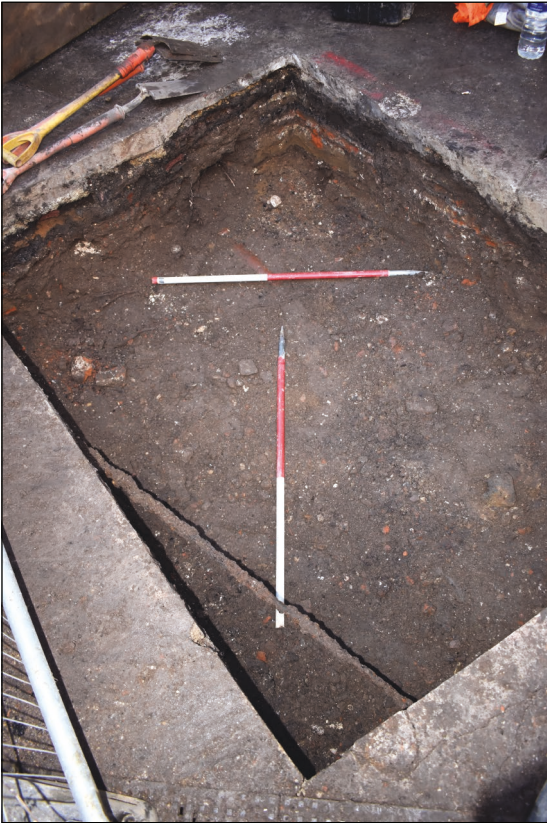
Plate 5: Upper deposits (Trench 1) showing disturbance/modern services

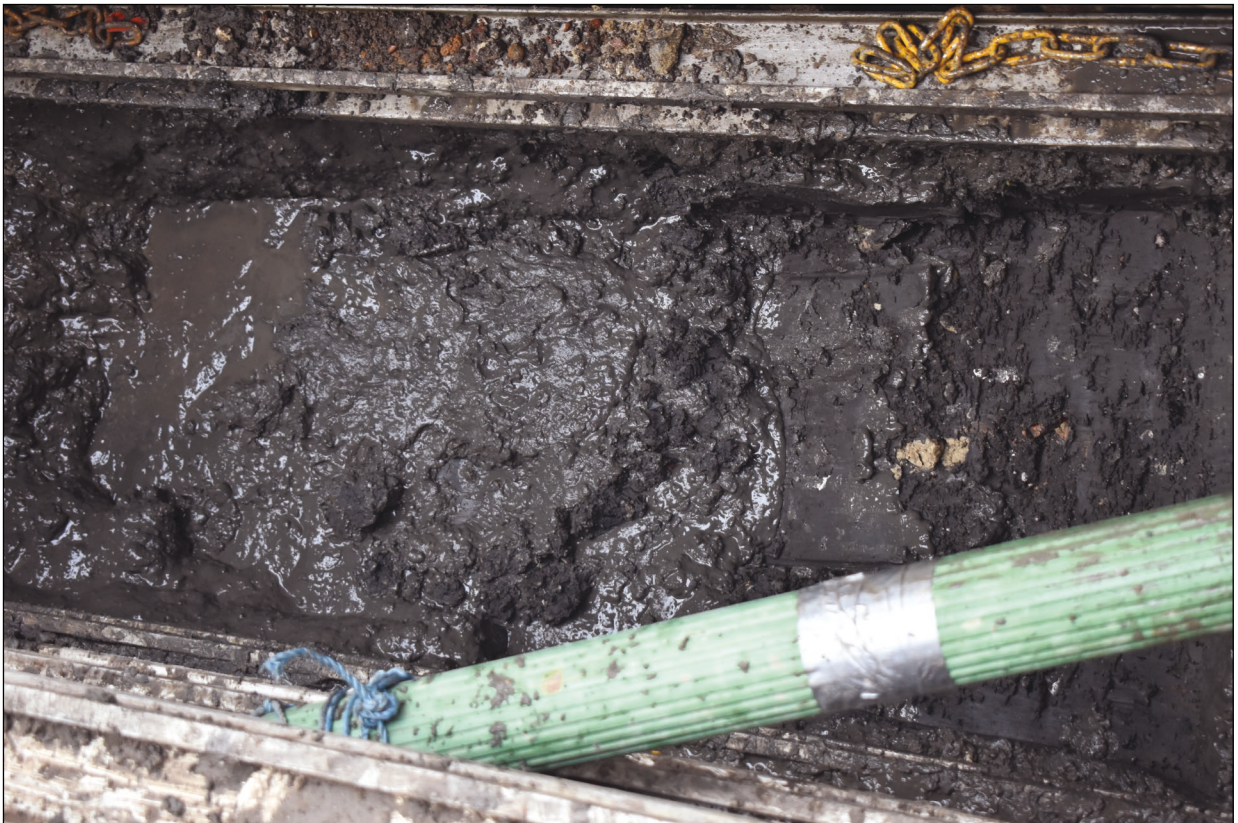
Plate 6: Trench 2: mid grey layer 12, from which Roman finds were recovered

3.3.2 Overlying this was a soft mid to dark grey silty clay (12; Plate 6) which yielded several large fragments of Roman ceramic building material, including a partial box flue tile (Appendix B.3; Plate 8), which was scattered through the deposit but was mostly found near the northern end of the trench. A damaged iron object – a probable Late Iron Age to Early Roman trumpet brooch (SF 1) – was also recovered from this layer towards the southern third of the trench (Appendix B.1).

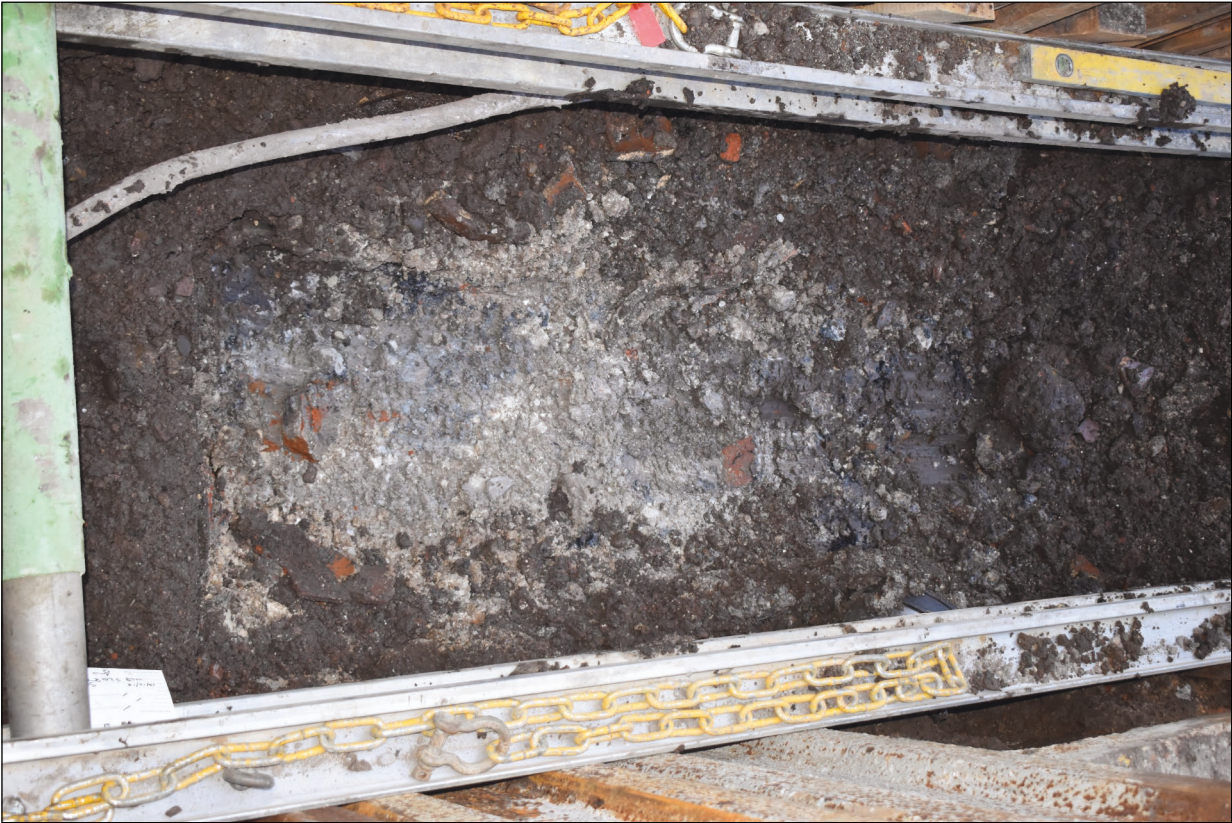
Plate 7: Trench 2: compacted layer 8, showing brick inclusions

- 3.3.4 These deposits were sealed by a 0.3m-thick layer of very compacted light 'whitish' grey sandy silt (8; Plate 7) that contained occasional undiagnostic fragments of clay tobacco pipe and crushed construction rubble (not retained). Above this was a 0.8m-thick made ground deposit (7) of dark brownish grey silty clay with modern brick and occasional plastic fragments, similar in character to deposit 5 (pipe trench backfill) in Trench 1.
- 3.3.5 This made ground was sealed by the same concrete yard (1) that was observed in Trench 1.

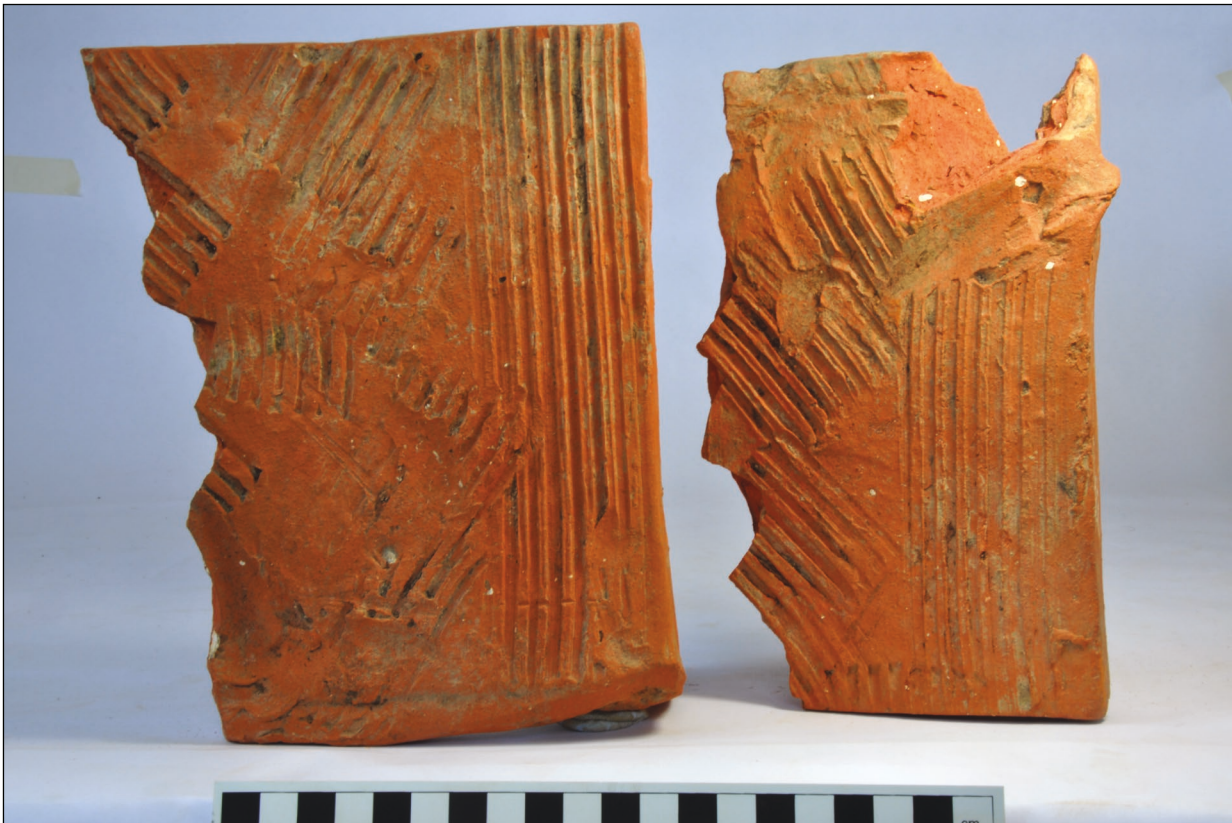
Plate 8: Roman tile from layer 12

- B.3.3 The small assemblage of CBM was recovered by machine from various points along the excavated trench (Trench 2), dispersed within context 12. The most obvious of the Roman material recovered is an incomplete box flue tile (2.152kg), consisting of two joining fragments, broken vertically across the combed pattern and through the rectangular cut-outs (Plate 8). The most complete cut out shows the clay was removed while it was almost leather hard, with several attempts made to remove the clay and create the corner of the rectangular or square cut-out, and there is evidence of an over-cut into the wall of the tile at the lower/upper corner of the cut out, which is roughly 70mm high. The box flue tile is wider than it is tall, 200mm high by 250mm wide with a depth in excess of 90mm, the thickness of the clay slab varies from 20-24mm. The surface pattern is vertical combing (7-8 lines) each side and short lengths of diagonal combing (7-8 lines) inside the border, right to left on one side and left to right (depending on the tile's orientation) with a single short length of vertical combing roughly in the centre of the tile. The fabric is hard fired, with fully oxidised orange-red surfaces and margins and a slightly darker core, quartz tempered with occasional calcareous inclusions.

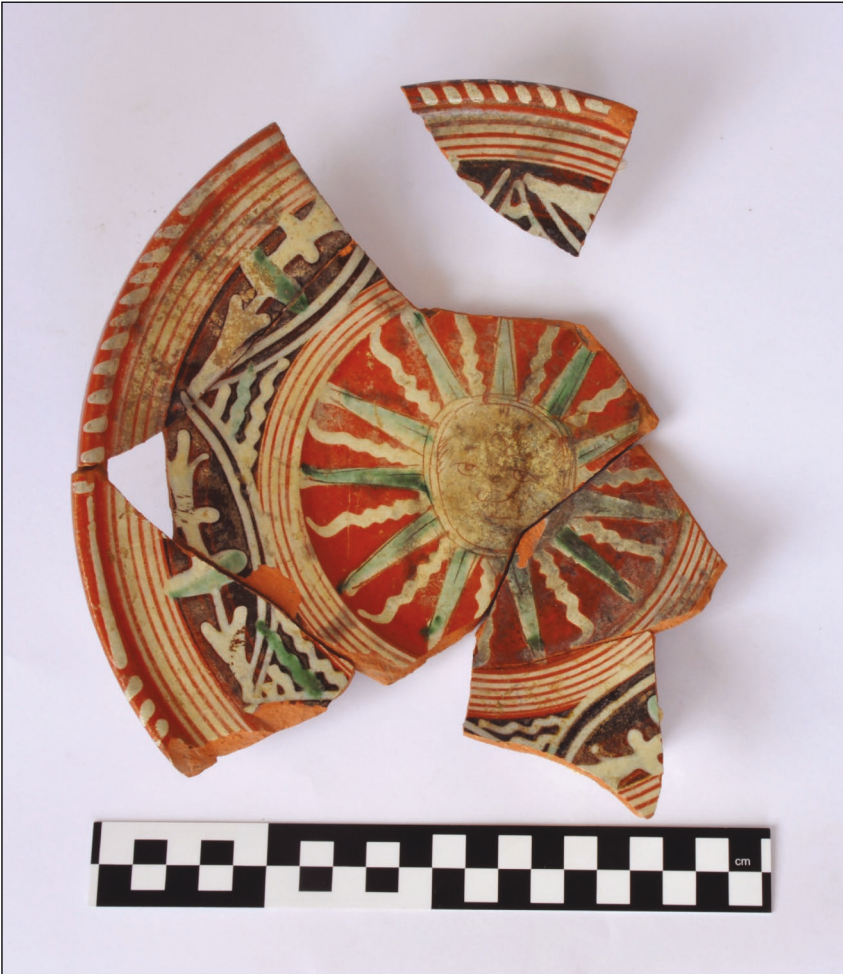
Plate 9: Highly decorated German Werra slipware dish from layer 11

3.3.3 Towards the south, this deposit was covered by a thin layer of pale grey silty sand (11) which produced the majority of a highly decorated German Werra slipware dish

undergone differential burial conditions, leading to discolouration of some of the refitting sherds, although most of the breaks appear to be old. The vessel is a highly decorated German Werra slipware (Fabric 44B) dish, with internal clear lead glaze that extends over the hammer-headed rim (diameter 260mm, estimated vessel equivalence 40%). The central design of this flared dish is a personified sun (Plate 9), with the face and pointed rays in sgraffito, and green glaze highlights have been added to the sgraffito rays. Other (wavy) rays are present only as slip decoration.

- B.2.4 Surrounding the central sun motif/medallion are concentric lines, the middle zone of which is dark brown with arcs (infilled with wavy lines) and foliage with occasional green lines or streaks. Beyond this is are further concentric lines with groups of oblique dashes inside the rim edge, separated by long horizontal lines. Demuth indicates that allegorical depictions of the sun were very common on Werra ware and a similar design to the central image on the Colchester dish was recovered from excavations at Bryggen, Norway (Demuth 2001, 106, fig. 18). The design surrounding the central motif is, with the exception of the long horizontal lines on the rim, almost identical to one described and illustrated by Hurst *et al.*, although on Hurst's vessel the central design is of a Cavalier, dated to 1597 (Hurst *et al* 1986, colour plate XIV, 243). The present vessel is unfortunately undated, although Cotter writes that most examples of Werra (from Colchester) occur in mid to late 17th- and even 18th-century contexts and that they were almost certainly for display, rather than general use, and were likely to have been old when discarded (Cotter 2000, 292).
