Manor Farm, Church Lane, Croydon, Cambridgeshire

Archaeological Evaluation Report

April 2021

OA Report No: 2467

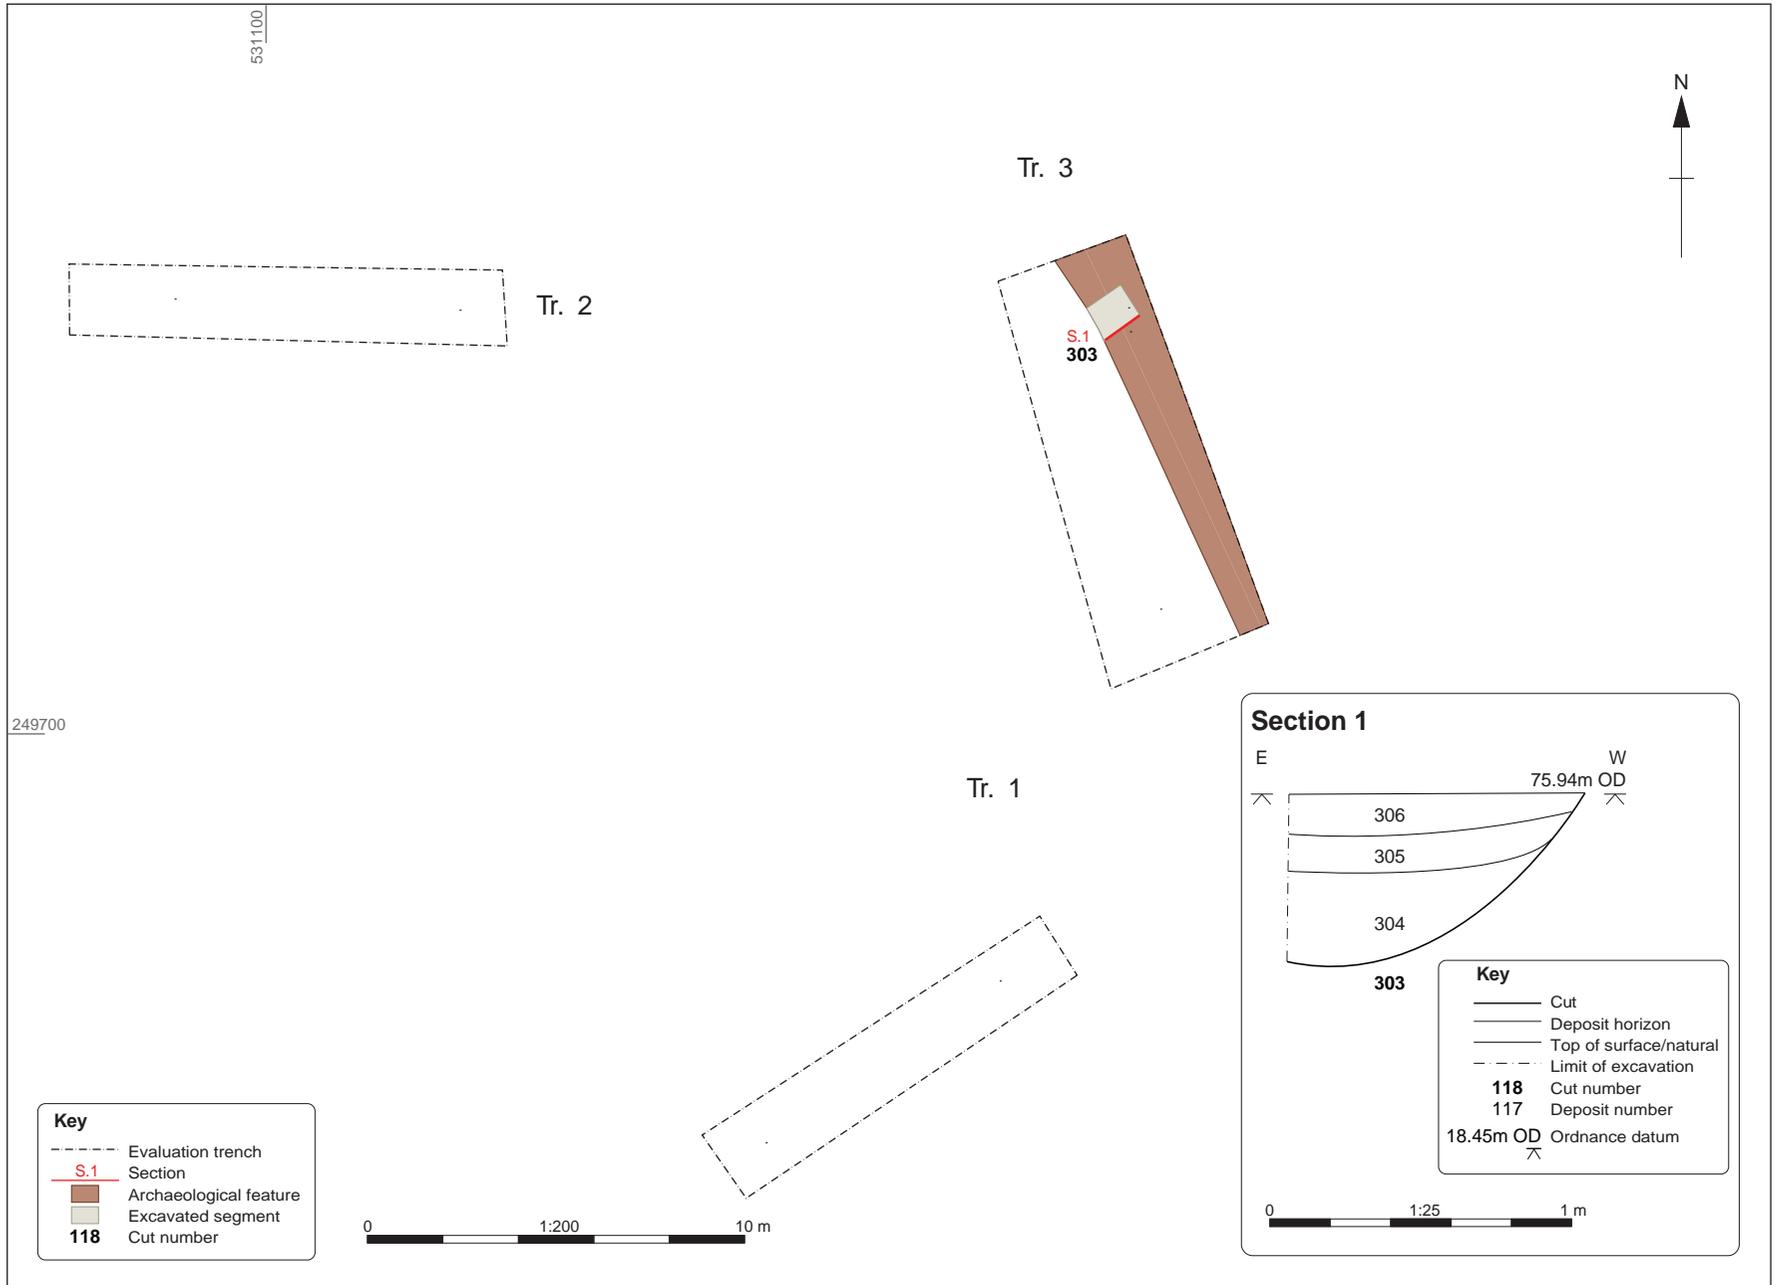
Figure 3: Trench plan and inset of Ditch 303, section 1

3.1.1 The results of the trial trench evaluation are presented below and include a stratigraphic description of the trenches that contained archaeological remains. The full details of all trenches with dimensions and depths of all deposits can be found in Appendix A. Figure 3 provides an overall plan of the results of the evaluation, including the section of ditch 303.

3.3.1 Archaeological features were present only in Trench 3 (Fig. 3).

3.6.2 Ditch **303** ran on a north-northwest to south-southeast alignment along the length of eastern side of the trench. Even with the subsequent widening of the trench to double its original width, the full breadth of this ditch was not revealed. The ditch was cut through the subsoil, only being sealed by topsoil (Plate 3). It measured at least 3.5m wide at the interface with the topsoil and was 0.87m deep with gently sloping sides and a concave base (Plate 4). The primary fill (304) comprised a 0.3m thick mid brownish grey silty clay, which produced a fragment of post-medieval roof tile. This fill was overlain by a dark brownish grey silty clay (305) that measured 0.12m thick. The

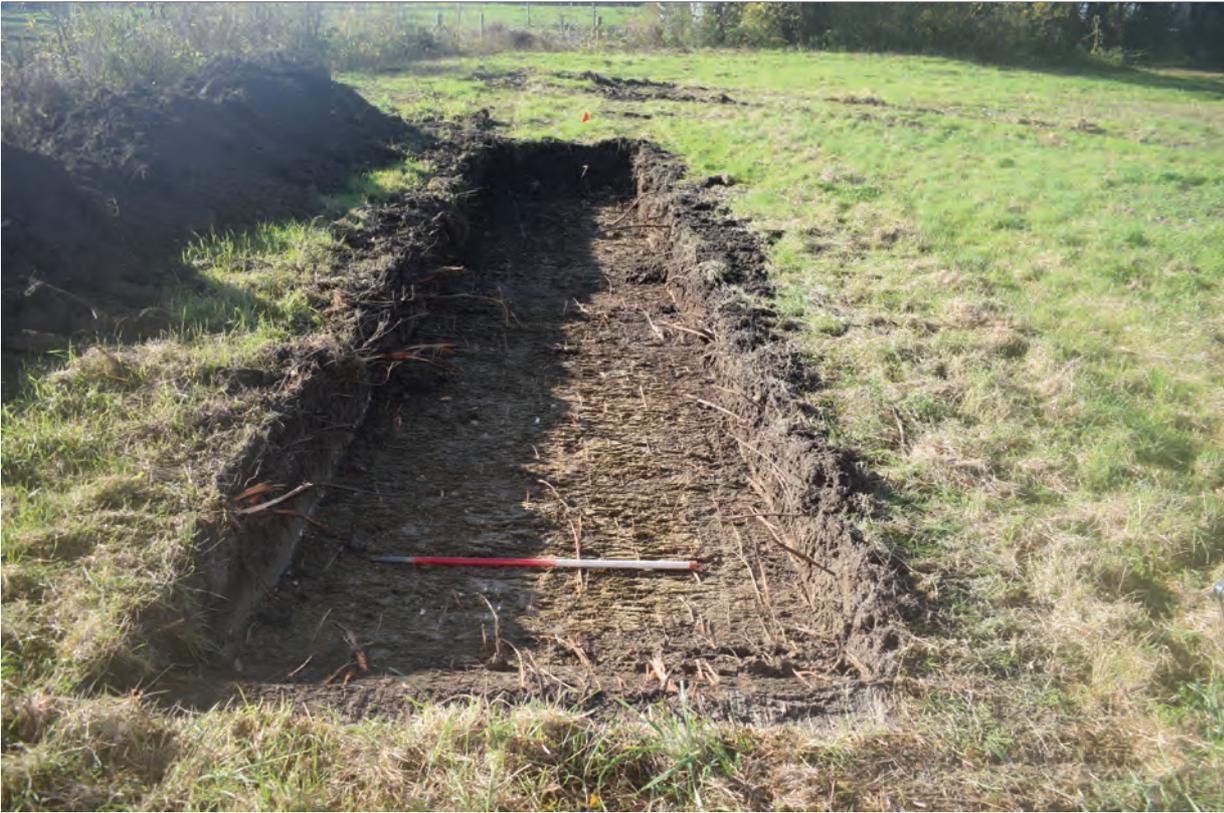
Plate 1: Trench 1, looking west

3.4.1 This trench was 10m in length and 1.8m wide, with an average depth of 0.46m. It was in the southern part of the development area on a north-east to south-west alignment. The chalky clay natural was overlain by a clayey subsoil and topsoil. No archaeology was present in this trench (Plate 1).

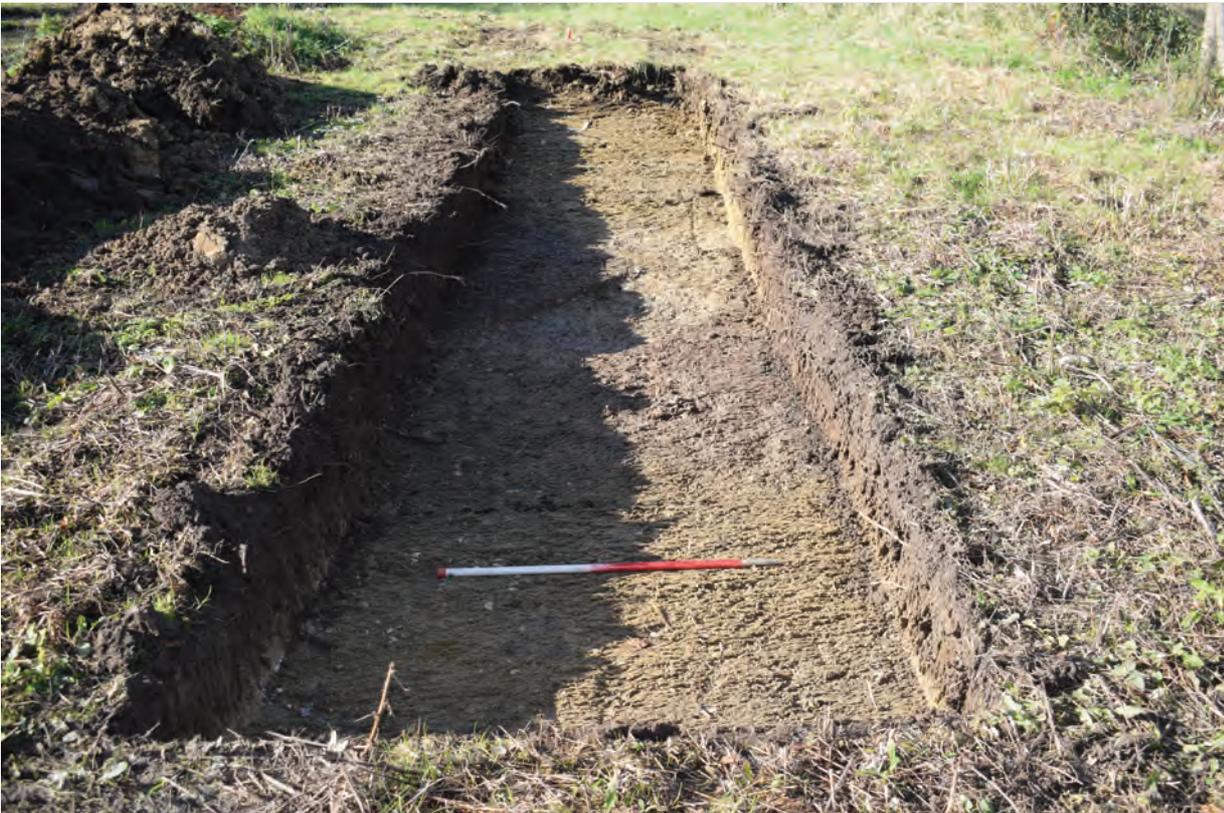
Plate 2: Trench 2, looking west

3.5.1 This trench was 10m in length and 1.8m wide, with an average depth of 0.38m. It was in the north-western part of the development area on an east-west alignment. The chalky clay natural was overlain by a clayey subsoil and topsoil. No archaeology was present in this trench (Plate 2).

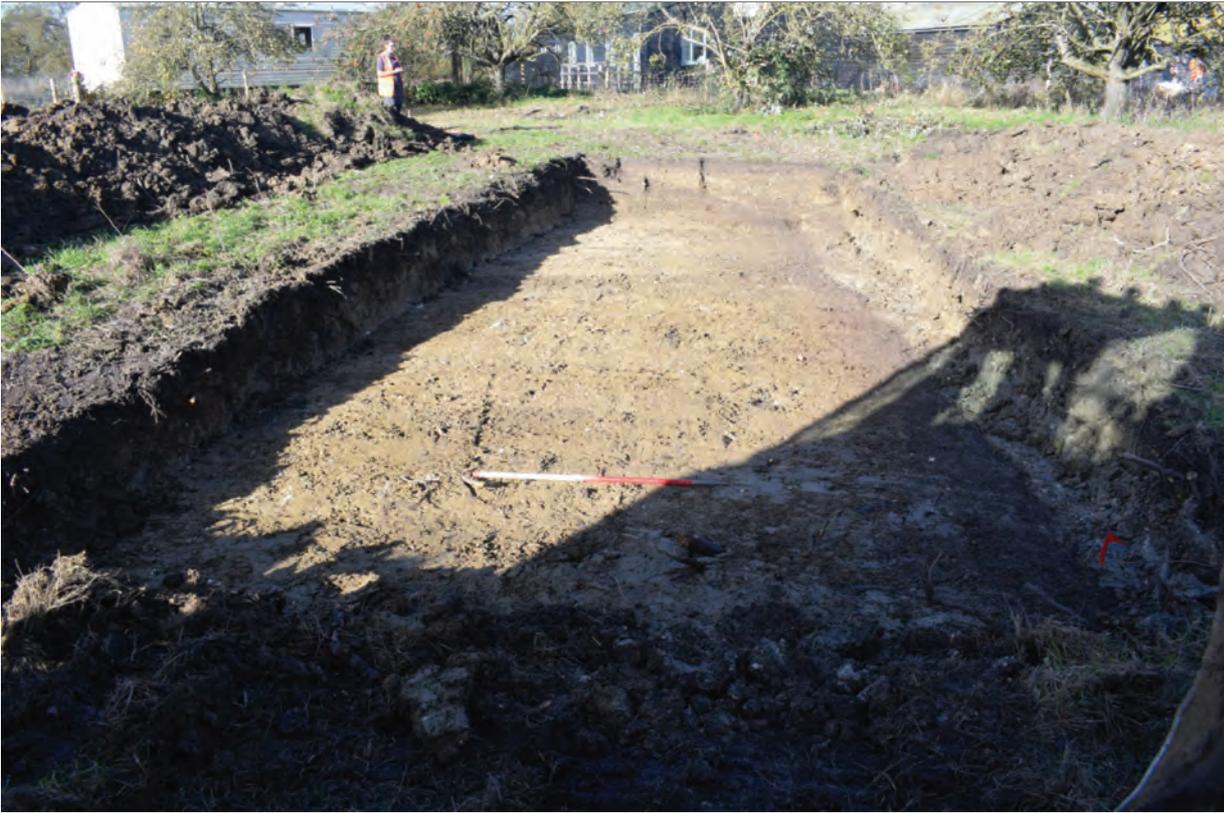
Plate 3: Trench 3, looking north

3.6.1 Trench 3 was 10m in length and 3.6m in width, with an average depth of 0.3m (Plate 3). It was in the eastern part of the development area on a north-northwest to south-southeast alignment.

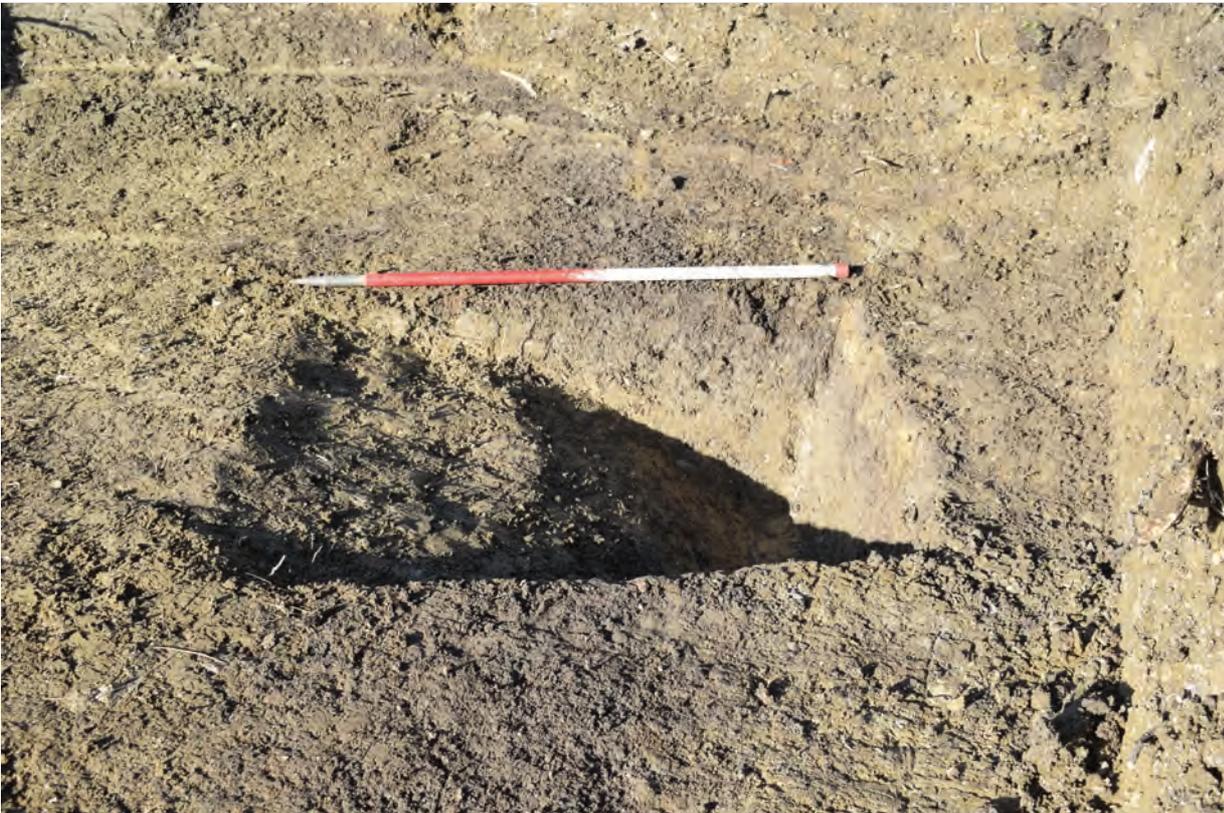
Plate 4: Ditch 303, looking north

uppermost fill comprised a mid-yellowish brown redeposited natural (306), which measured 0.45m in thickness.

- 4.2.1 Based on the single fragment of roof tile, ditch **303** appears to be post-medieval in date. The lack of any other features across the trenches suggests that this parcel of land is situated outside of the medieval settlements which surround it.
- 4.2.2 The cropmarks for Manor Farm (CHER 01218, NMR 368514) which is located just to the north-west of the site are orientated on broadly the same alignment as the ditch identified in Trench 3, as is the medieval/post-medieval road (MCB25886) to the south-west, suggesting that whilst this ditch is unlikely to be contemporary (with the Manor Farm remains at least), there is a clear continuation of orientation in the laying out of land boundaries.
