Town Lodge and No. 29 Gernon Road, Letchworth Garden City Historic Building Investigation and Recording

March 2021

Town Lodge and 29 Gernon Road, Letchworth Garden City

Historic Buildings Investigation and Recording

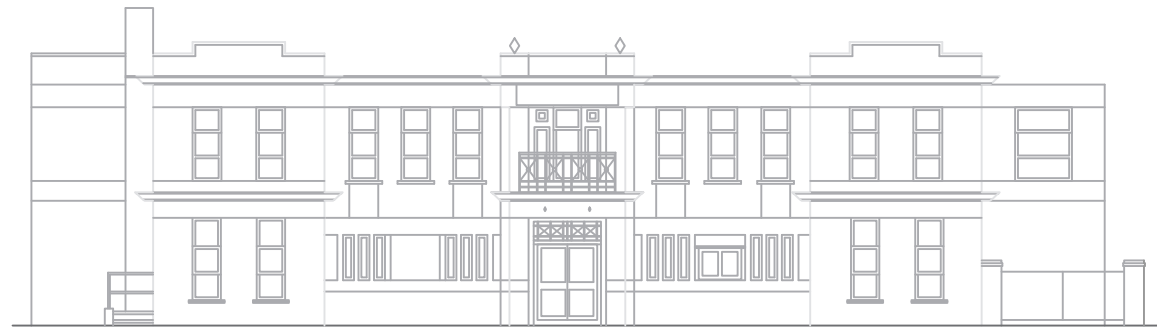
Figure 4

North Elevation

- 4.1.1 The north facing facade of the building had a length of 29.44m and a height of 8.4m. It was a two-storey building with a flat roof and was constructed of red bricks which measured 0.23m x 0.10m x 0.07m. These were mainly laid in a running bond but with some variations surrounding doorways and windows. A hard, sandy mortar had been used between the bricks. At various locations of the building re-pointing of the mortar had been undertaken.

- 4.1.2 The east and west ends of the elevation projected slightly from the building with a less pronounced projection centrally.
- 4.1.3 Surface rendering had been applied in bands around the central first floor windows and either side of the main entrance first floor windows. Crenelated parapets that topped the wall projections had pronounced banding which were capped with finials over the central part of the building that gave the northern elevation an art deco appearance.

- 4.1.4 The north facing elevation contained 29 windows with 16 on the ground floor and 13 on the first floor. All of these windows were modern Neo-Georgian UPVC units. These had replaced the earlier metal framed casement type that were commonly used in the early buildings of Letchworth. Slit windows were located either side of the main entrance to the building. These measured 1.26m x 0.30m.

- 4.1.5 Stepped brickwork surrounded the main entrance to the building. The wooden centrally opening double doors measured 2.10m x 1.58m which were a replacement of original doors of the same dimension. Above the door was a simple geometric

decorative metal framework that had been retained from the original doorway. This is an original feature which was placed there when the building was constructed in 1923. The geometric design of this metal framework was replicated in the balcony framework directly above on the upper floor.

- 4.1.6 A date stone of 1923 was inset directly above the door. A further stone known to have borne the word 'Madonna' was probably hidden by modern signage on the upper first floor.

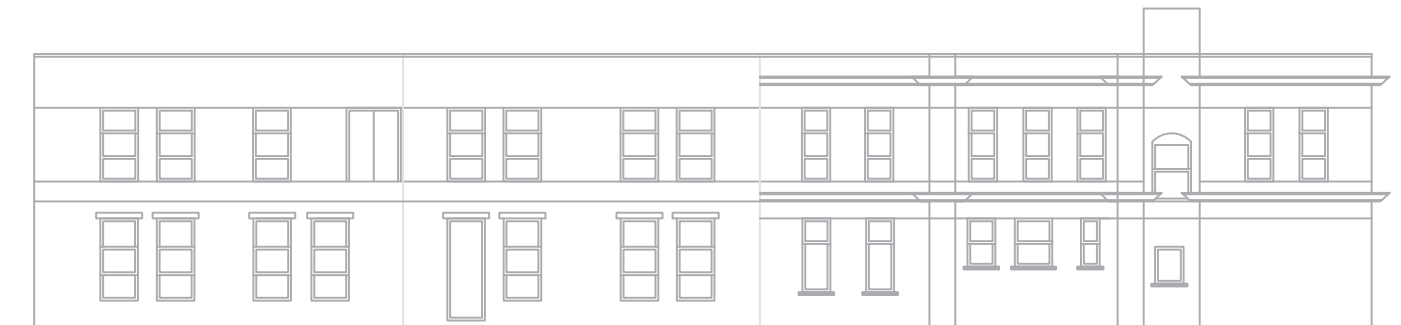
Figure 5

West Elevation

- 4.1.15 The west facing elevation had a length of 35.39m and a height of 8.4m. It was of a similar construction to the other elevations described above. A total of 34 windows were observed on the western side of the building; more than the eastern side of the building. Areas of replacement brickwork surrounding some of the windows suggest that some of these replaced original doorways. Alternatively, these later areas of brickwork represent wall repairs carried out during installation of the windows.

- 4.1.16 The later construction of this 1950s extension to the original building was clearly evident on the western side due to the discolouration of the later brickwork. The location where this later phase of construction tied into the earlier building was more prominent than that on the eastern side.

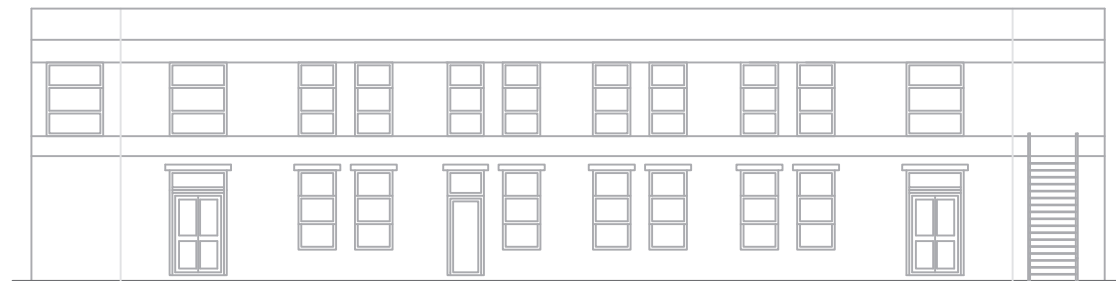
Figure 6

South Elevation

- 4.1.13 The south facing elevation had a length of 28.4m and a height of 7.2m. It was constructed from the same materials as the east facing elevation. As with the east elevation little had been done to hide the utilitarian use of the building. The same vertical fluted decorative brickwork was observed along with the continuation of the surface rendered banding.
- 4.1.14 Three doors and seventeen windows constructed in UPVC were observed on the southern elevation. These features would probably have replaced original steel framed units of similar dimensions.

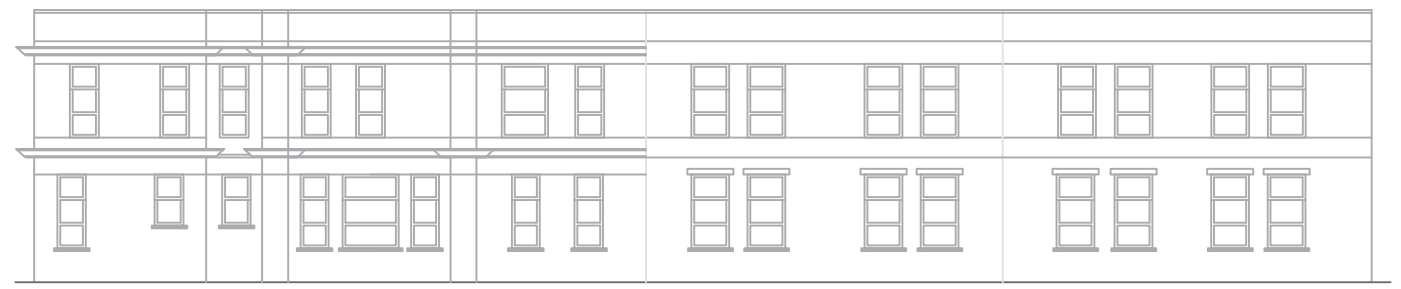
Figure 7

East Elevation

- 4.1.7 The east facing elevation had a length of 35.39m and a height of 7.2m and was constructed from similar materials to the northern elevation. The later 1950s extension to town lodge by Letchworth Council was evident. This later building work stepped outwards significantly from the original wall line with the bricks of a slightly darker hue (Plate 15).

- 4.1.8 Although this 1950s building extension was of a more utilitarian design, care had been taken to continue the surface rendered banding around the building. A vertical fluted brick decoration that measured 1.90m x 0.23m had also been added to this later phase of construction.

- 4.1.9 A total of 30 windows exists on the eastern elevation and displayed a modern UPVC design.
- 4.1.10 A chimney stack was observed on the eastern elevation that related to the heating system of this later building. The Council boiler room was located directly below ground.

- 4.1.11 At the southern end of the 1950s extension was the later addition of a fire escape. This was metal framed and aided escape from the first floor.

- 4.1.12 An interesting feature was noted on the eastern elevation in regard to the first phase of the building. A blocked-up doorway had been replaced with a window (Plate 8). This doorway possibly acted as a side entrance for staff to the former school. A set of steps that led up to this entrance was observed, although the handrail was more likely a contemporary feature of the 1950s extension. This feature suggests the doorway was still in use for a period after the later alterations.
