# Worked Stone Fragments from Holy Trinity Church Great Paxton

**Historic Buildings Recording**

OA East Report No: 1146

## **Worked Stone Fragments From Holy Trinity, Great Paxton**

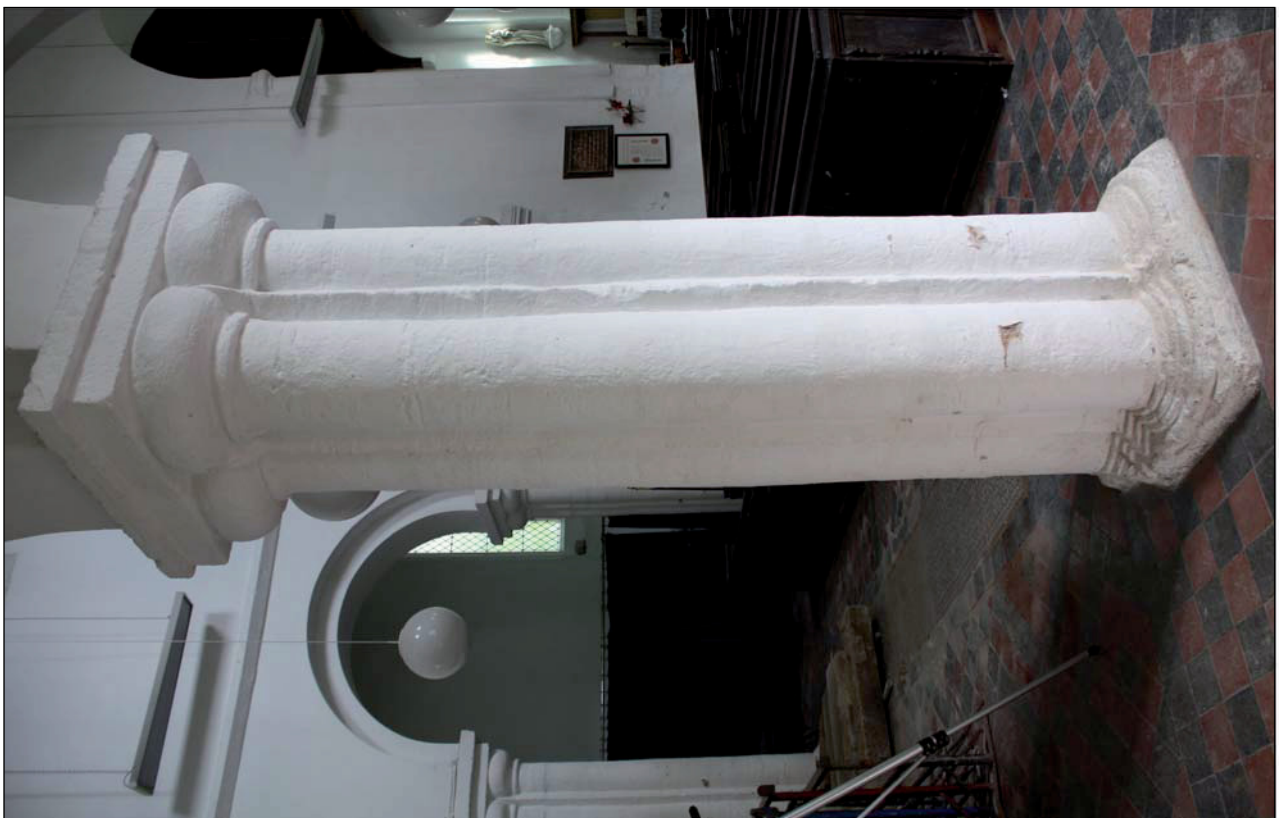
Plate 2: One of the Saxon piers

- 1.3.2 Probably built in the early half of the 11th century, Great Paxton Church was comparatively large and unique in Britain for a Saxon church. It is thought to have been a minster church with an aisled nave, the architectural style of which has been compared to Germanic styles of the 10th and 11th centuries, and is unique in England. The pier capitals are particularly unusual (Plate 2).

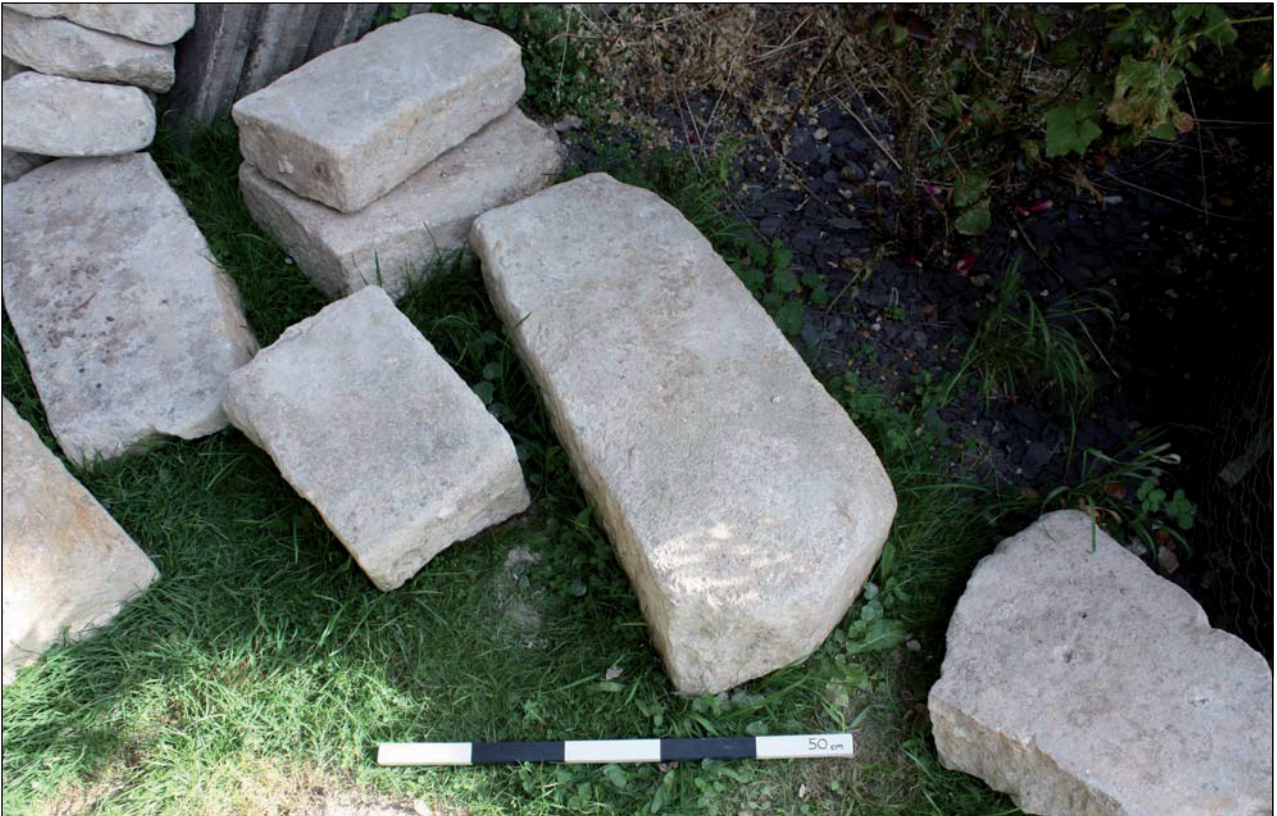
Plate 3: A selection of plain worked stone fragments (Stone 31 centre right)

3.1.1 There were several pieces of very plain worked stone, none of which had any particularly defining features or markings (Plate 3). There were also many fragments of rubble or broken stonework that had no discernible form or evident working (Plate 4). Each stonework fragment that did show any obvious tool marks or carving is individually described and discussed below, as well as being considered in their group context.

- 3.2.32 **Stone 31 (Plate 3):** A large stone measuring approximately 0.8m by 0.3m by 0.2m, Stone 31 is a rectangular block with fairly worn surfaces. It could have been used as a quoin or a step, but again the regular form with no distinctive marks means it could be medieval or post-medieval. Together with Stone 30, Stone 31 is typical of several other fragments discovered that were not individually recorded due to their regularity, all of which could have been used as quoins or steps prior to their re-use as floor slabs in the tower.

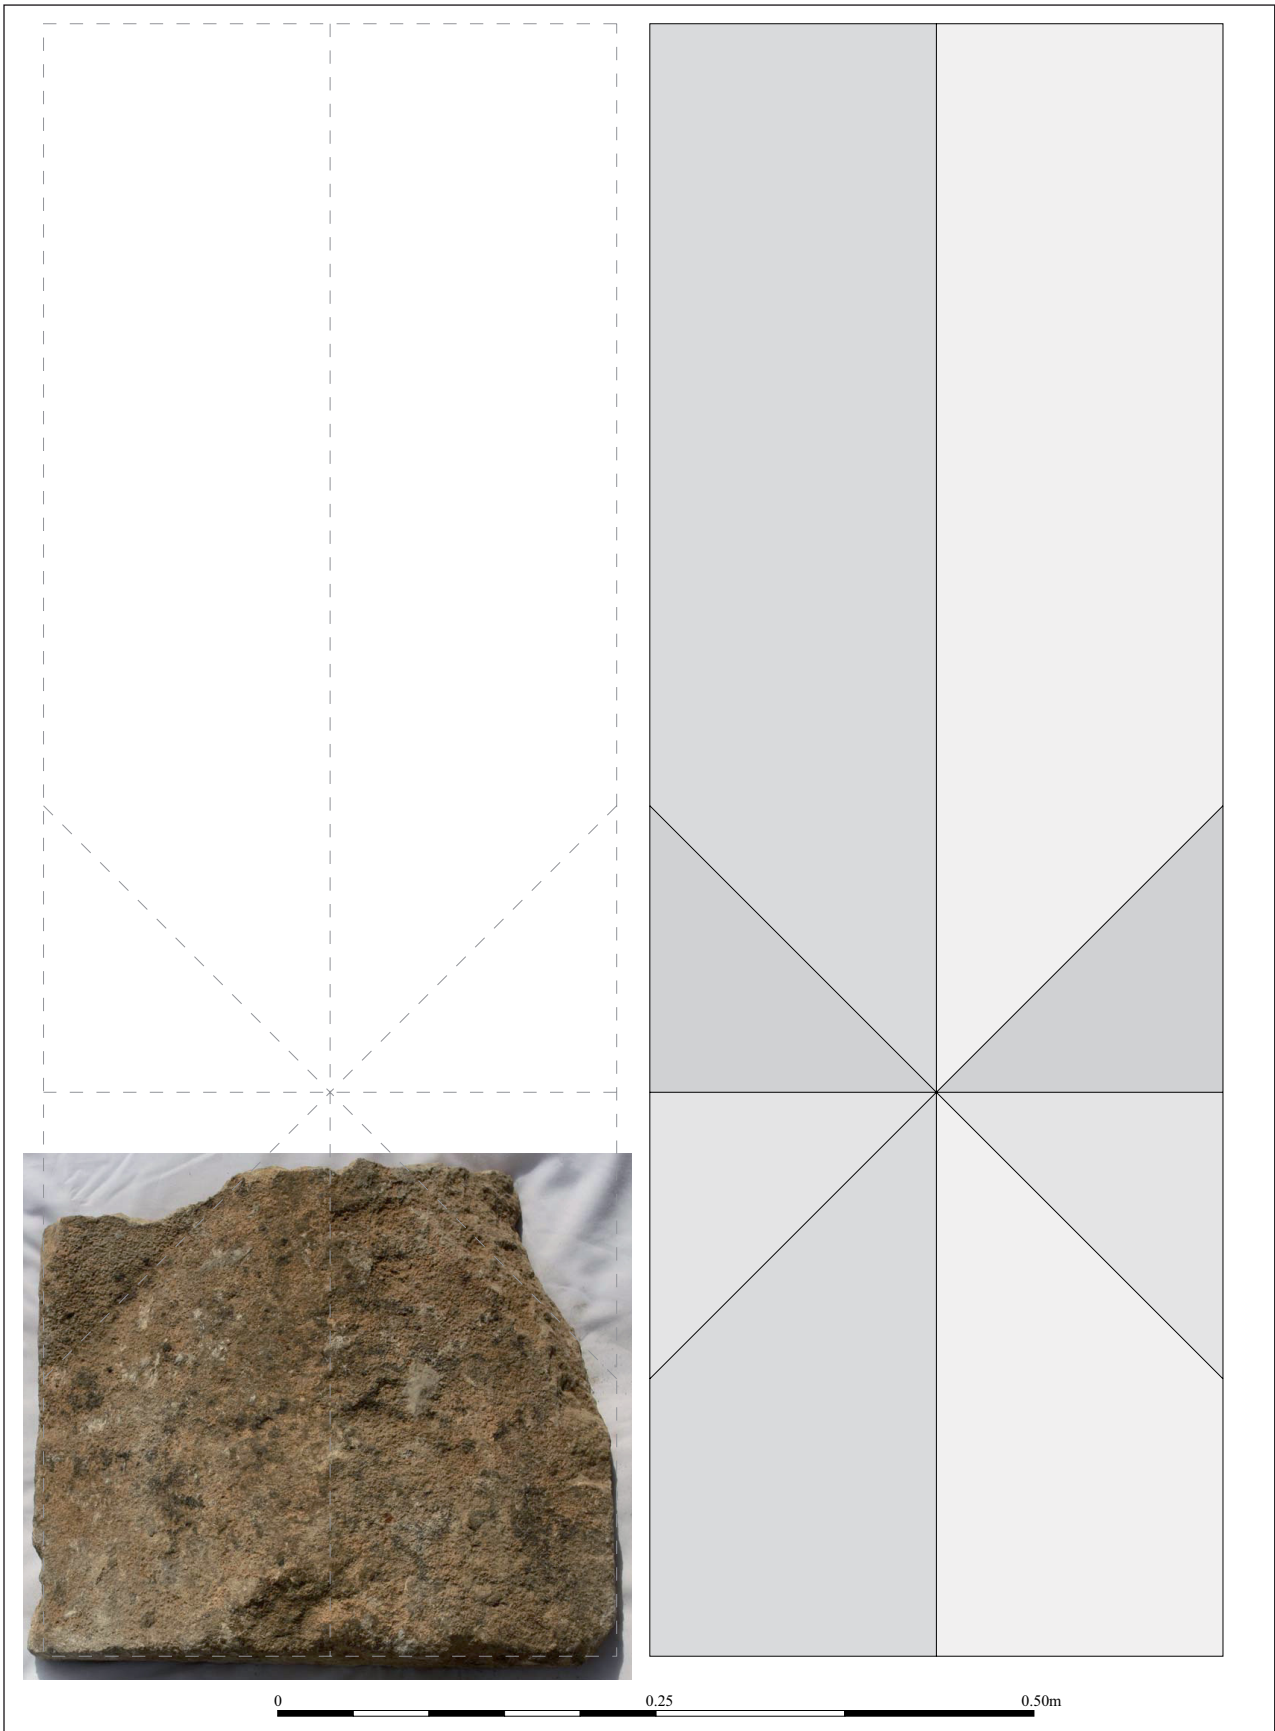
Figure 2: Possible re-construction of Stone 14 showing cruciform shape to top surface

- 3.2.14 **Stone 14 (Plate 18):** Stone 14 measures approximately 0.4m by 0.4m by 0.1m, and although quite abraded, it is still possible to see elements of a carved design on one face. Several angled faces have been carved into the top surface, that give the impression this fragment was once part of a much larger one, and the design appears to be part of a cruciform design (Fig 2). It is therefore likely that this fragment is part of a coped grave slab. The heavy abrasion that has occurred to this fragment might suggest it was of some age, as is the design, but this design was also common in the 19th century (<http://www.hertsfhs.org.uk/hfphs34.html> accessed 1/12/09), so it is difficult to give a precise date for this fragment – it could be medieval or Post-medieval.

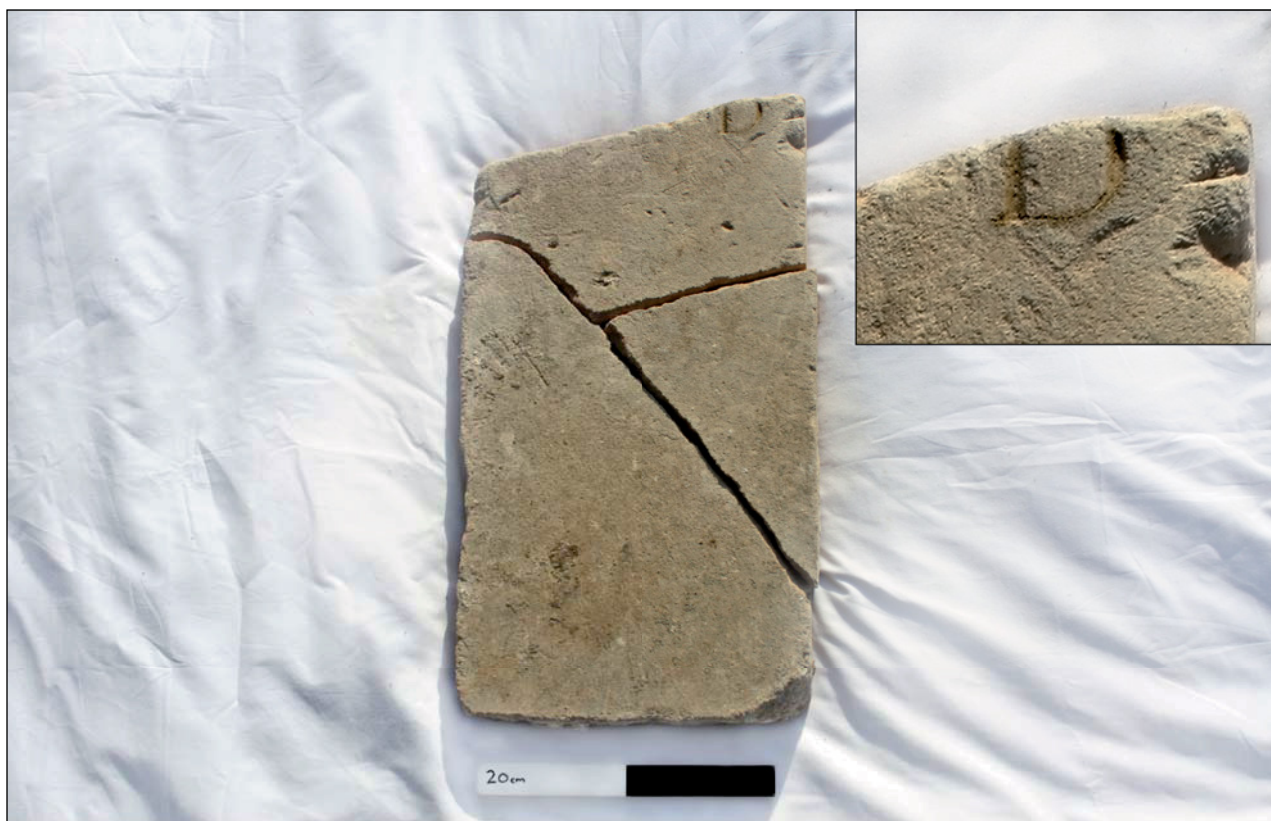
Plate 5: Stone 1, with close-up of letter

3.2.1 **Stone 1 (Plate 5):** Three small fragments make up this stone that when put together measures approximately 0.43m long, 0.22m wide and 0.05m deep, although there is clearly a fragment missing. A partial letter – probably a “D” or “B” - is visible at one end of the stone. Due to the rectangular form of the stone and the partial letter, it is thought that the original use for this stone was a a gravestone/marker – the letter being one initial. The style of the stone and lettering would suggest it was of 18th or 19th century date.

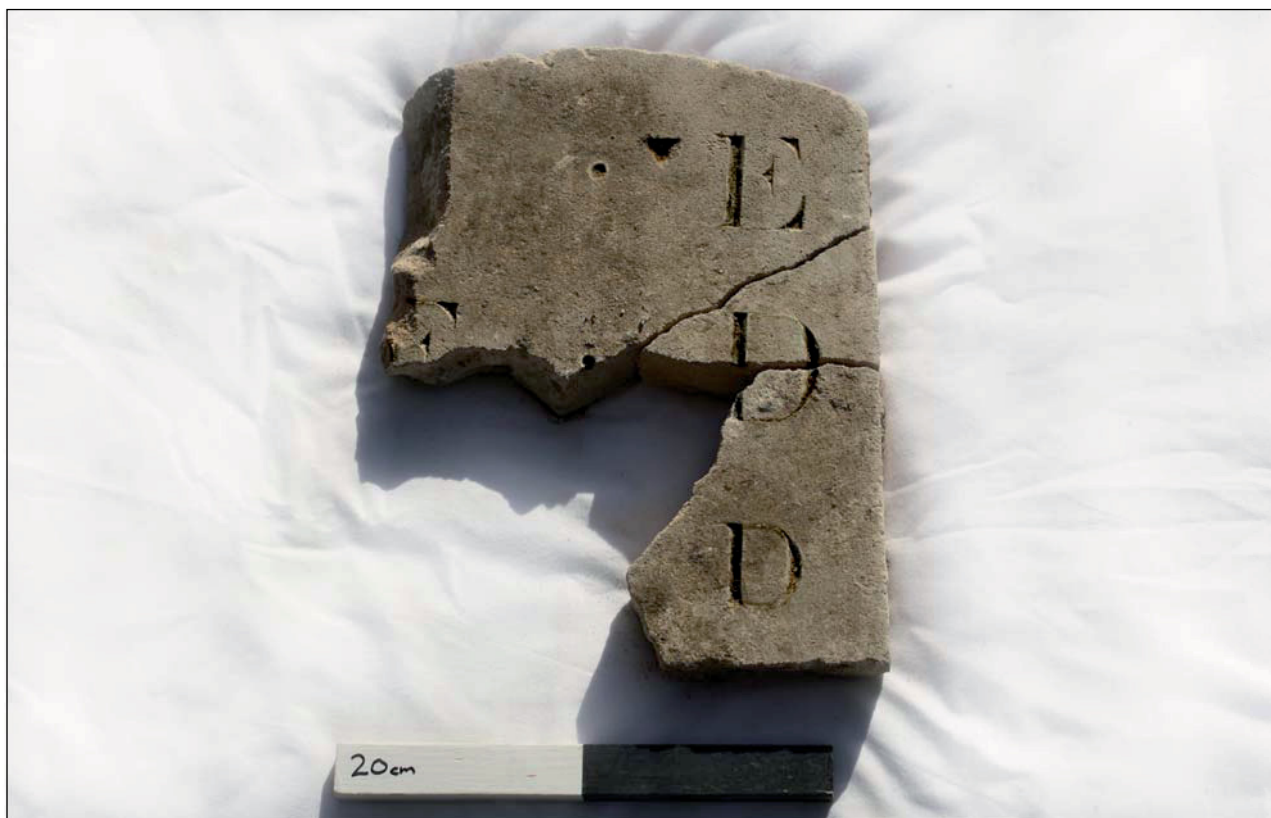
Plate 6: Stone 2

3.2.2 **Stone 2 (Plate 6):** Stone 2 comprises of three small fragments and is clearly missing a large portion of its original form. In its present state it measures approximately 0.25m long, up to 0.2m wide and 0.05m deep. The form of the stone strongly suggests it was rectangular in shape with a convex top. Several letters have been carved into one surface, although it is likely that further letters are missing. It is thought there would originally have been three lines of text, each line consisting of two letters, with each pair separated by a central dot. As such the inscription reads: “? - E, ?(possibly an E or F) – D, ? - D”. This inscription means it is likely to have been a small gravestone/marker – although if all the letters are initials it might suggest the grave contained more than one person. The style of the stone and lettering suggests an 18th or 19th century date.

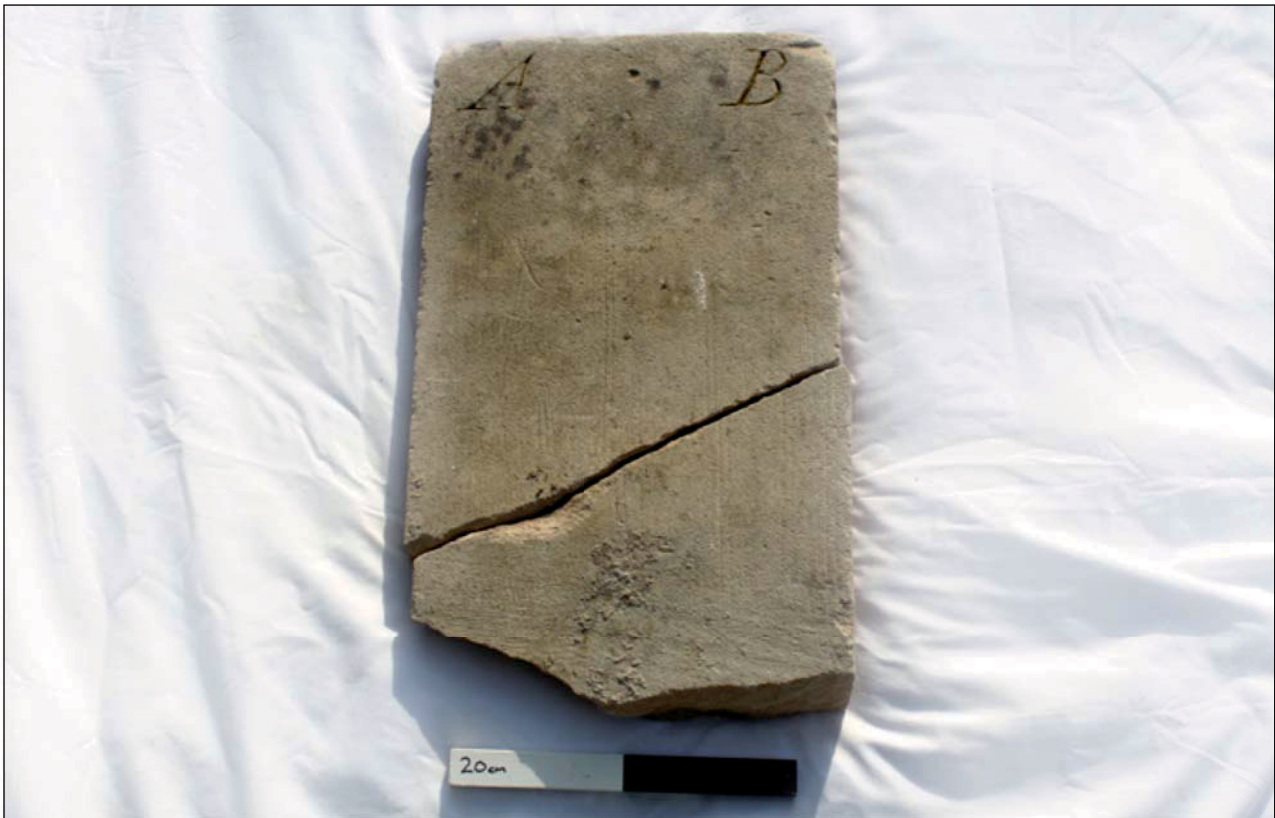
Plate 7: Stone 3

3.2.3 **Stone 3 (Plate 7):** Stone 3 is flat and rectangular in form, consisting of two pieces it appears some small fragments may be missing from the bottom corners. Together the two pieces measure approximately 0.4m long, 0.25m wide and 0.05m deep. The top of the stone is flat, although the two remaining original corners have been slightly rounded. The letters “A” and “B” have been carved, separated in the middle by a dot, into one face at what would be the top – these are likely to be initials. It is thought, as with Stones 1 and 2, that Stone 3 was a small gravestone/marker dating to the 18th or 19th century.

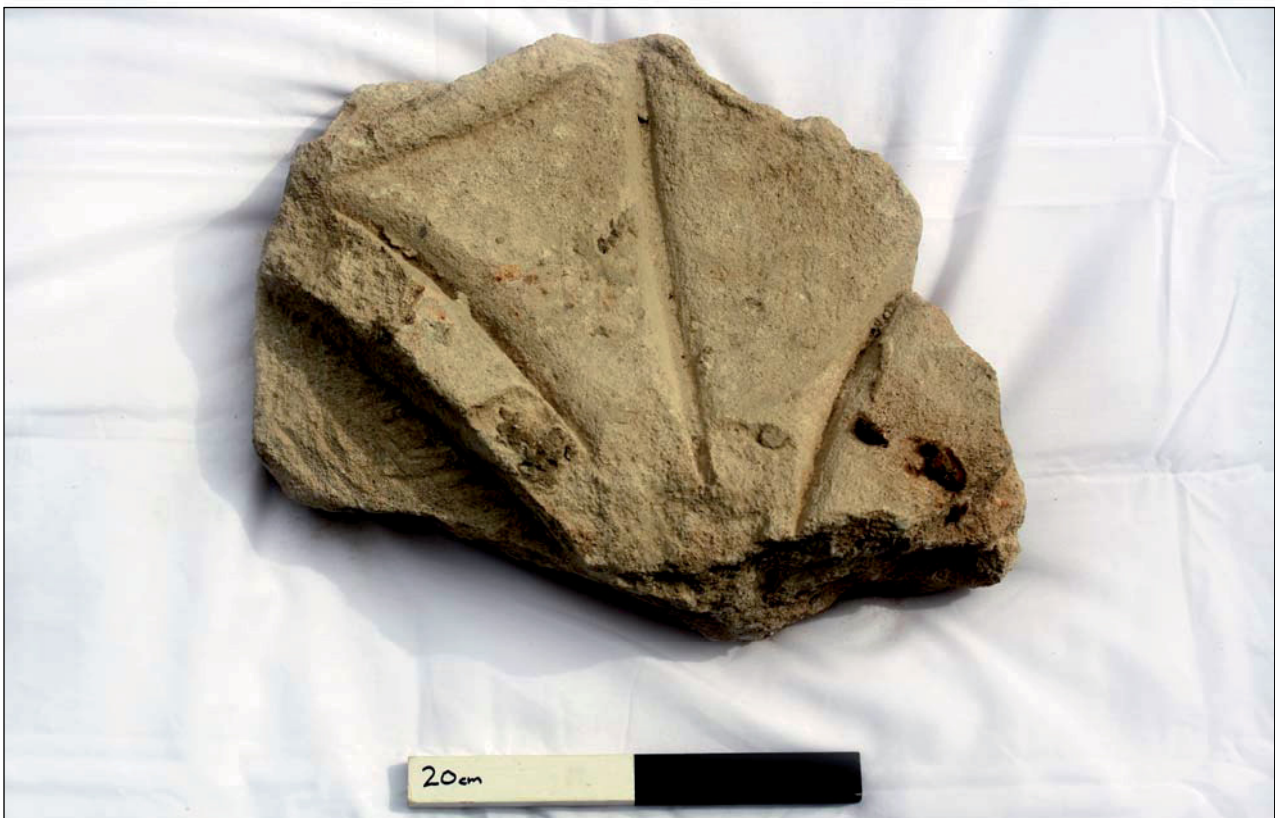
Plate 8: Stone 4

3.2.4 **Stone 4 (Plate 8):** Measuring approximately 0.3m by 0.25m by 0.1m, Stone 4 has an irregular shape and has been decoratively carved. The scallop-like design and form of this stone suggest it may have possibly been a capital for a pillar or arch, or part of a window. There are still many rough chisel marks on parts of the stone, suggesting that perhaps it was an unfinished or possibly abandoned piece. It is estimated that Stone 4 is of a Late medieval/Post-medieval date, although if it is an unfinished/abandoned piece then it would perhaps be most likely to date to the time at which the floor was laid. This would perhaps logically coincide with a major phase of other development work at the church. The earliest possible date would be during construction of the tower – late 14th century – although it appears the ground level has been raised, which could tie-in to the late 19th century refurbishments at the church.

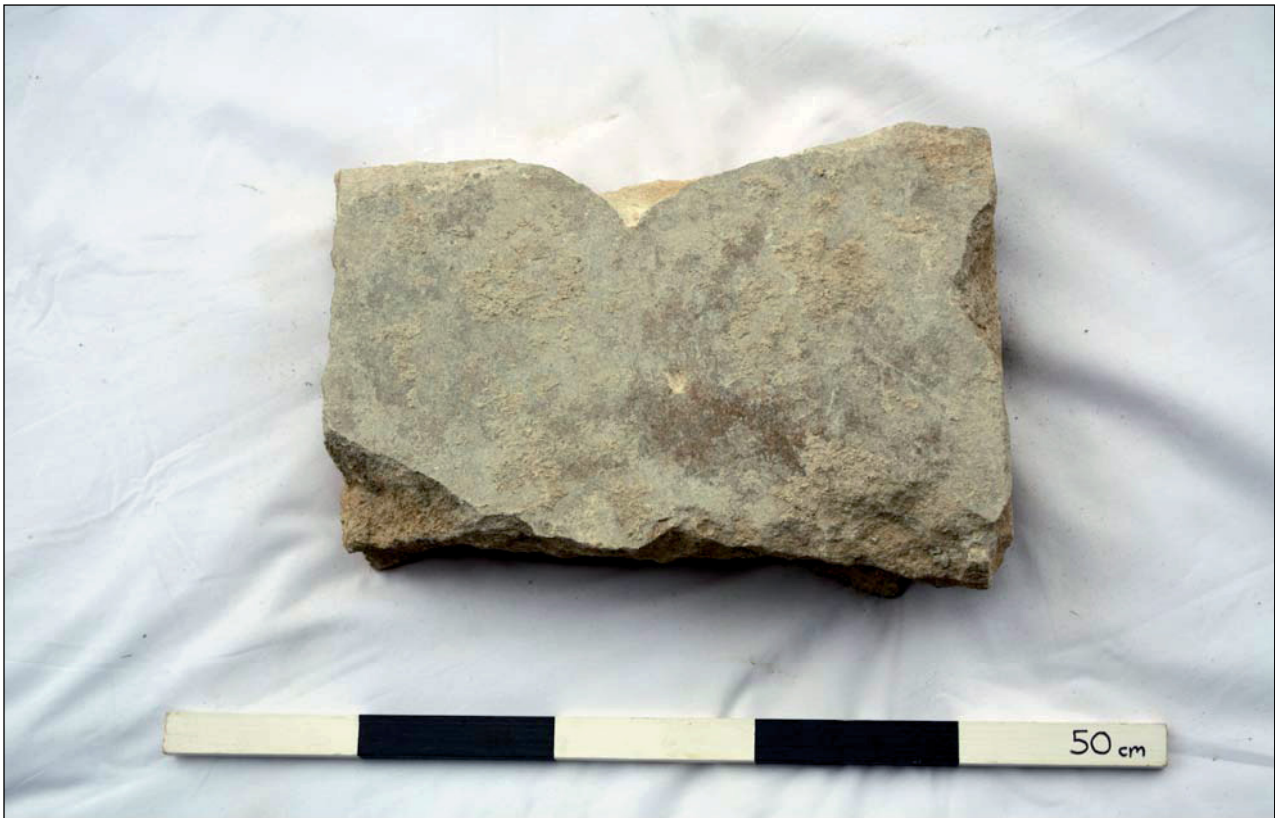
Plate 16: Stone 12

- 3.2.12 **Stone 12 (Plate 16):** Stone 12 measures approximately 0.45m by 0.2m by 0.1m and has been worked on several sides. The front has been smoothly faced and worked along one edge, with varying degrees of quality. It is therefore possible that this is another unfinished or abandoned fragment of decorative stonework. There is also a rebate carved into the rear face of this fragment. It is likely that this fragment is Post-medieval, and originates from a phase of re-working at the church.

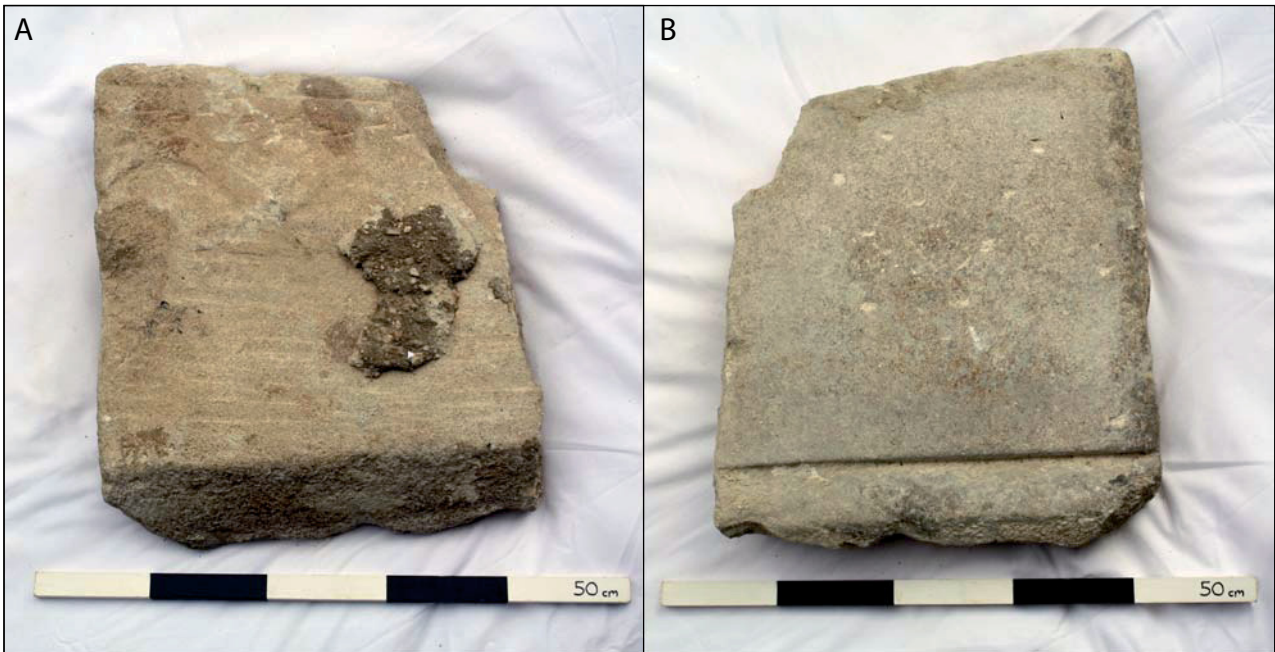
Plate 17: Stone 13, underside (A) and top (B) faces

- 3.2.13 **Stone 13 (Plate 17):** Measuring approximately 0.4m by 0.4m by 0.1m, Stone 13 has been smoothly faced on one surface and worked along one edge. The worked edge has an incised/carved ovolo moulding on the smoothly faced surface, and an angled (approximately 45 degrees) edge on the rear. It is likely that this fragment is of Post-medieval date, but its function is unclear.

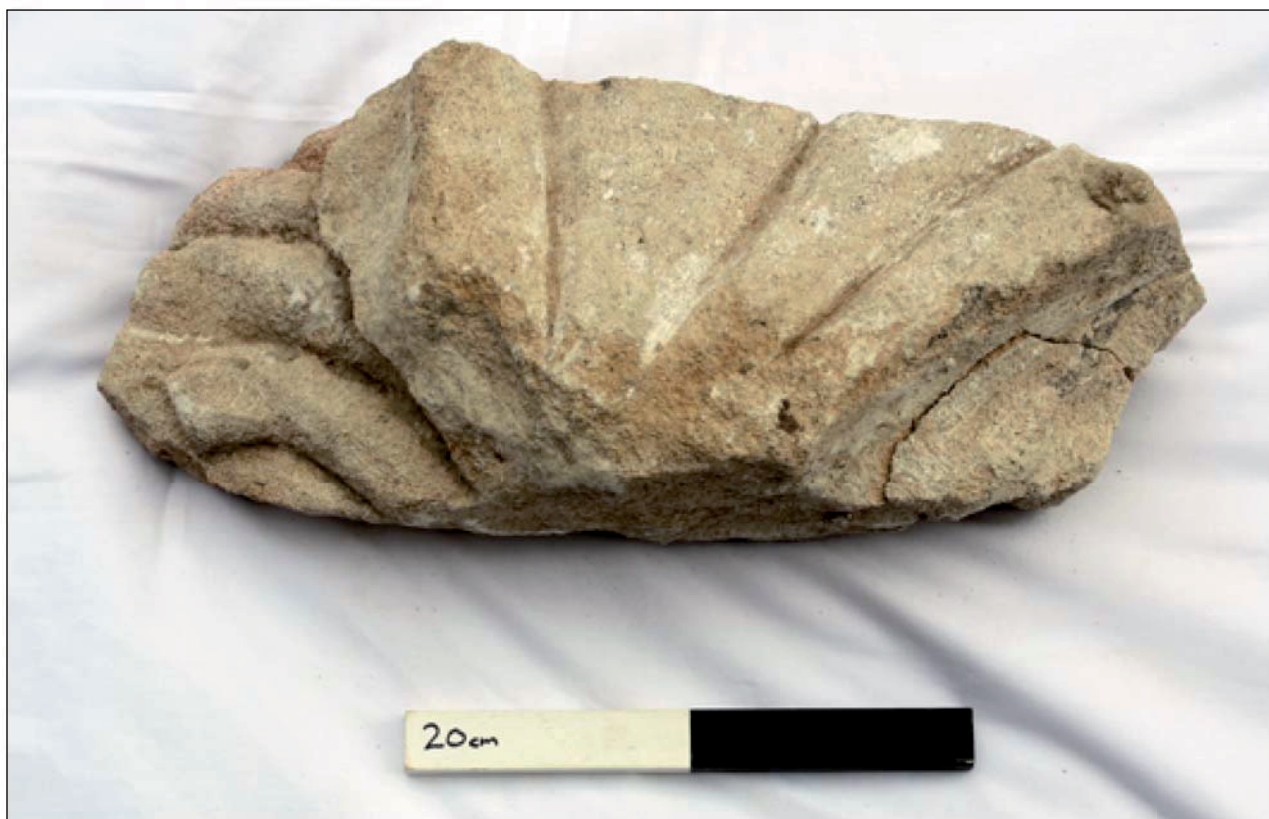
Plate 9: Stone 5

- 3.2.5 **Stone 5 (Plate 9):** An irregular shaped piece of limestone measuring approximately 0.35m by 0.15m by 0.15m, Stone 5 is carved with various ribs fanning out in several directions. It is likely to have been a capital or other piece of decorative stonework that received ribbed vaults from various angles. The stone is incomplete, making it difficult to tell much more about its function or even it was a completed and used. There is not a great deal of ribbed vaulting visible in the church as it is today, so could this and potentially other fragments have come from another building? Either way, it is thought this fragment is likely to be of a similar late medieval/Post-medieval date to Stone 4.

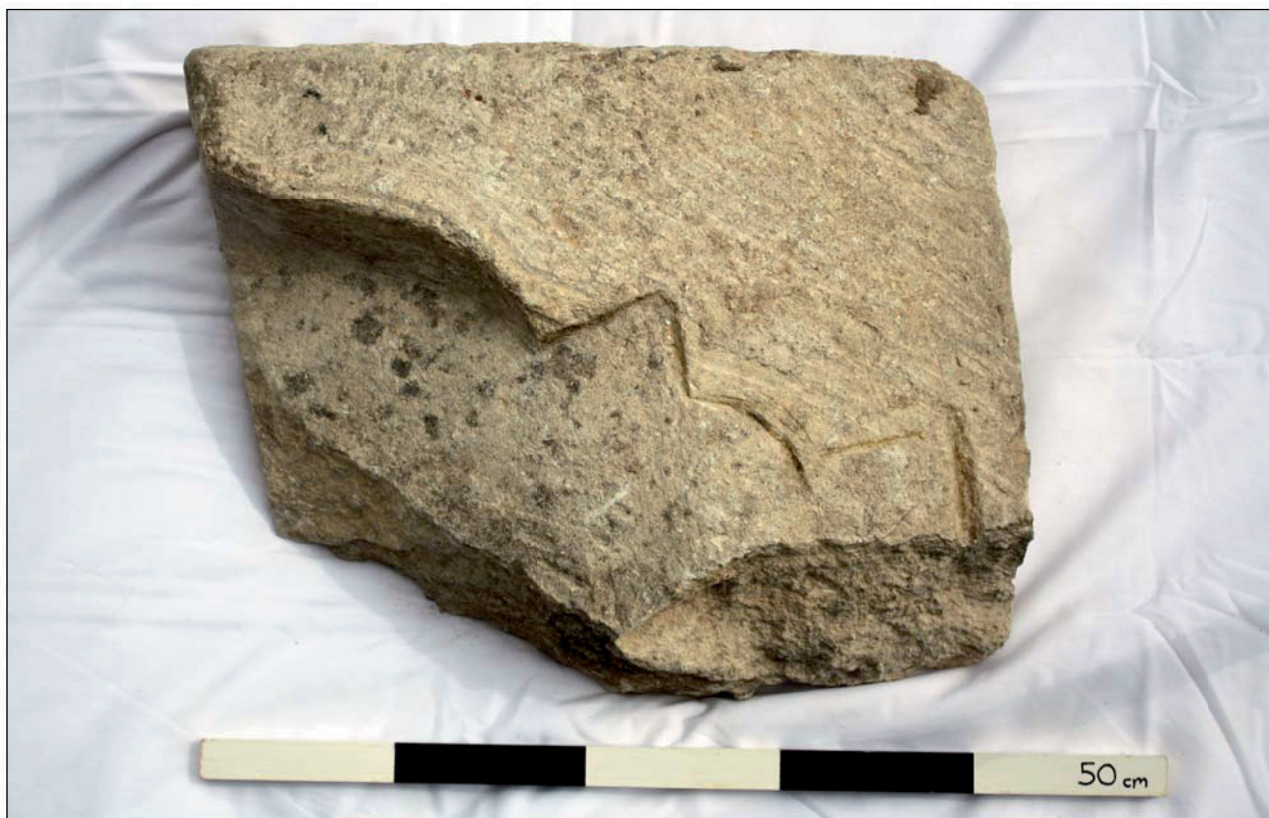
Plate 10: Stone 6

- 3.2.6 **Stone 6 (Plate 10):** A roughly hewn block that measures approximately 0.4m by 0.3m by 0.15m and has some partially carved tracery work on one side – more of the design can be seen to have been scored into the face. This piece of decorative masonry could have been intended for use as window sill, but the carving has clearly been abandoned before the piece was finished. Stone 6 possibly dates to the medieval period.

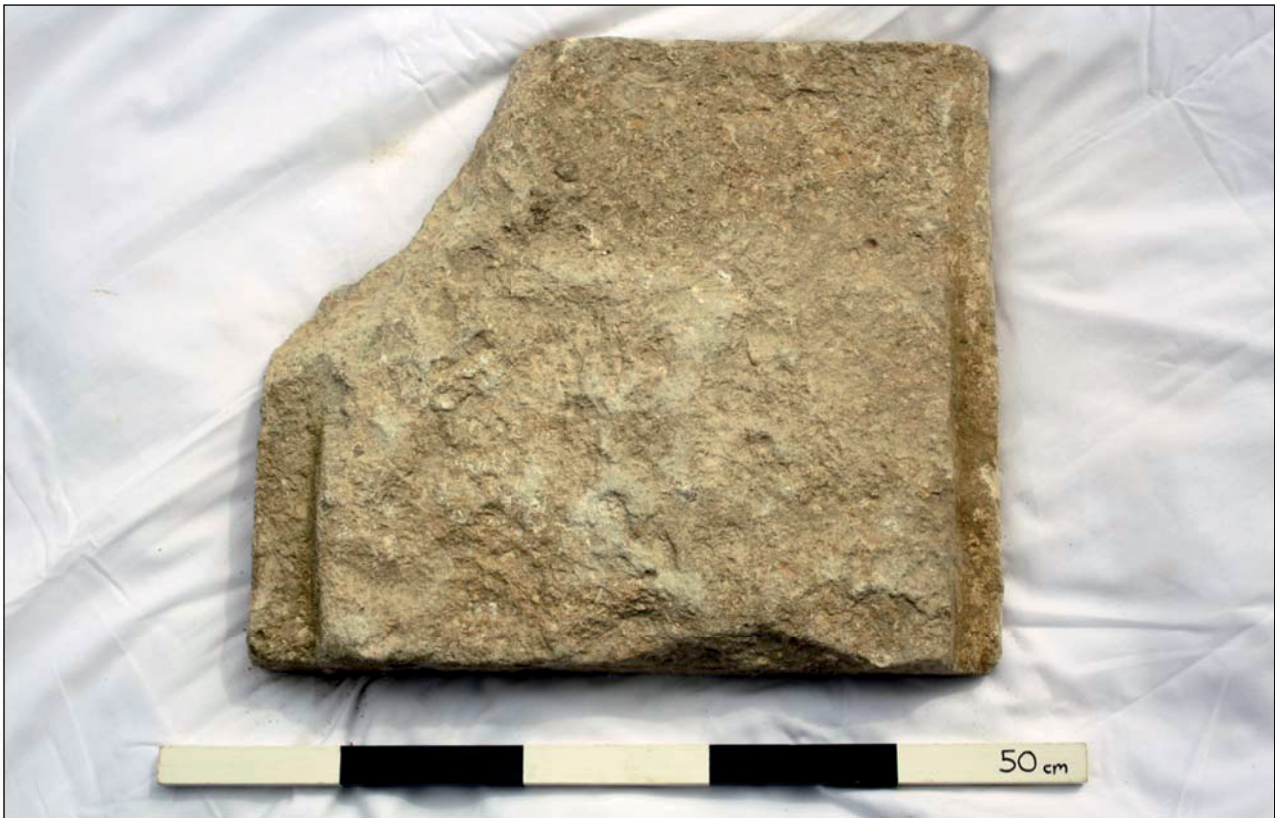
Plate 11: Stone 7

- 3.2.7 **Stone 7 (Plate 11):** Stone 7 is a flat, almost square block measuring approximately 0.4m by 0.3m by 0.1m, but missing one corner. There are incised rebates/fillets along two edges. The function of this piece is unclear, although the fillets/rebates suggest it could possibly have been a lid – perhaps for a coffin. It is difficult to date this fragment, as there is not much stylistic evidence, but it is probably of Post-medieval origin.

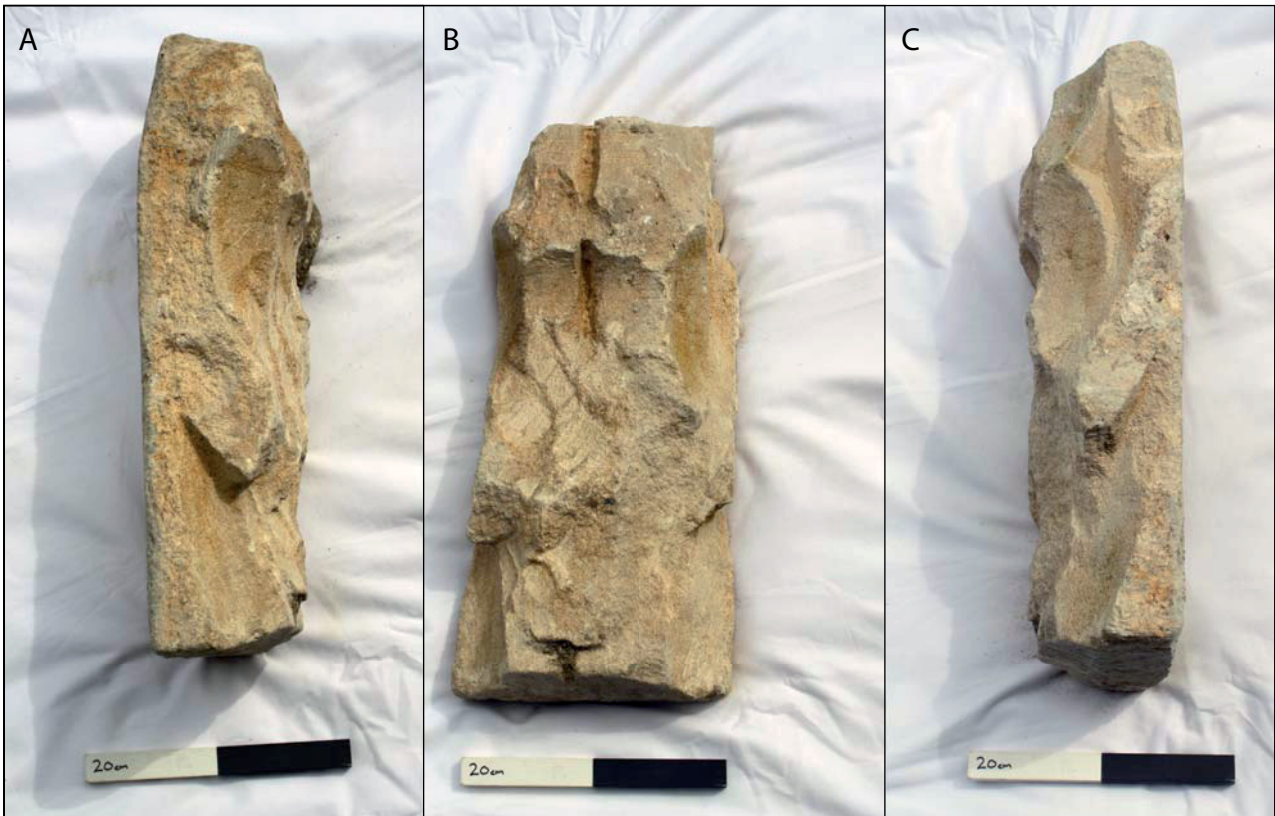
Plate 12: Stone 8

- 3.2.8 **Stone 8 (Plate 12):** An interesting piece of limestone tracery, Stone 8 measures approximately 0.45m by 0.2m by 0.1m. It is unclear if it is an unfinished piece or has just been heavily abraded/damaged. The curved form and cusped design suggest that it is likely to have been/intended to be a window surround, and probably dates to the 14th or 15th century. A similar design is seen on the sedilia in the chancel, which dates to the Late 14th century.

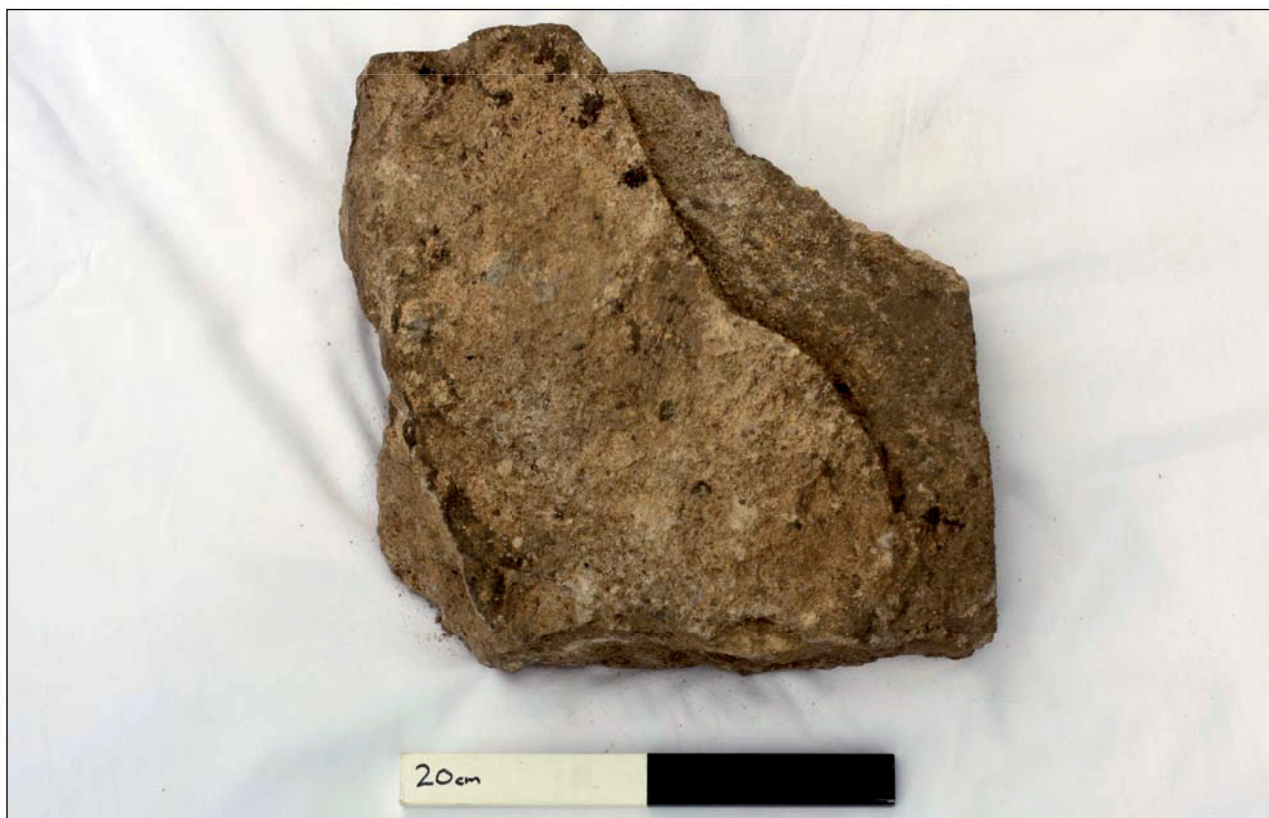
Plate 19: Stone 15

- 3.2.15 **Stone 15 (Plate 19):** Stone 15 measures approximately 0.3m by 0.3m by 0.1m, and whilst it has no smoothly finished faces, it has clearly been worked. There are several flat edges/faces and one curved edge. It is possible that this fragment has been heavily abraded, but it appears more likely that it is an unfinished or discarded piece of decorative masonry. It is therefore likely to have a similar date to the other unfinished fragments that have occurred at some point of re-refurbishment on the church during the medieval or post-medieval periods.

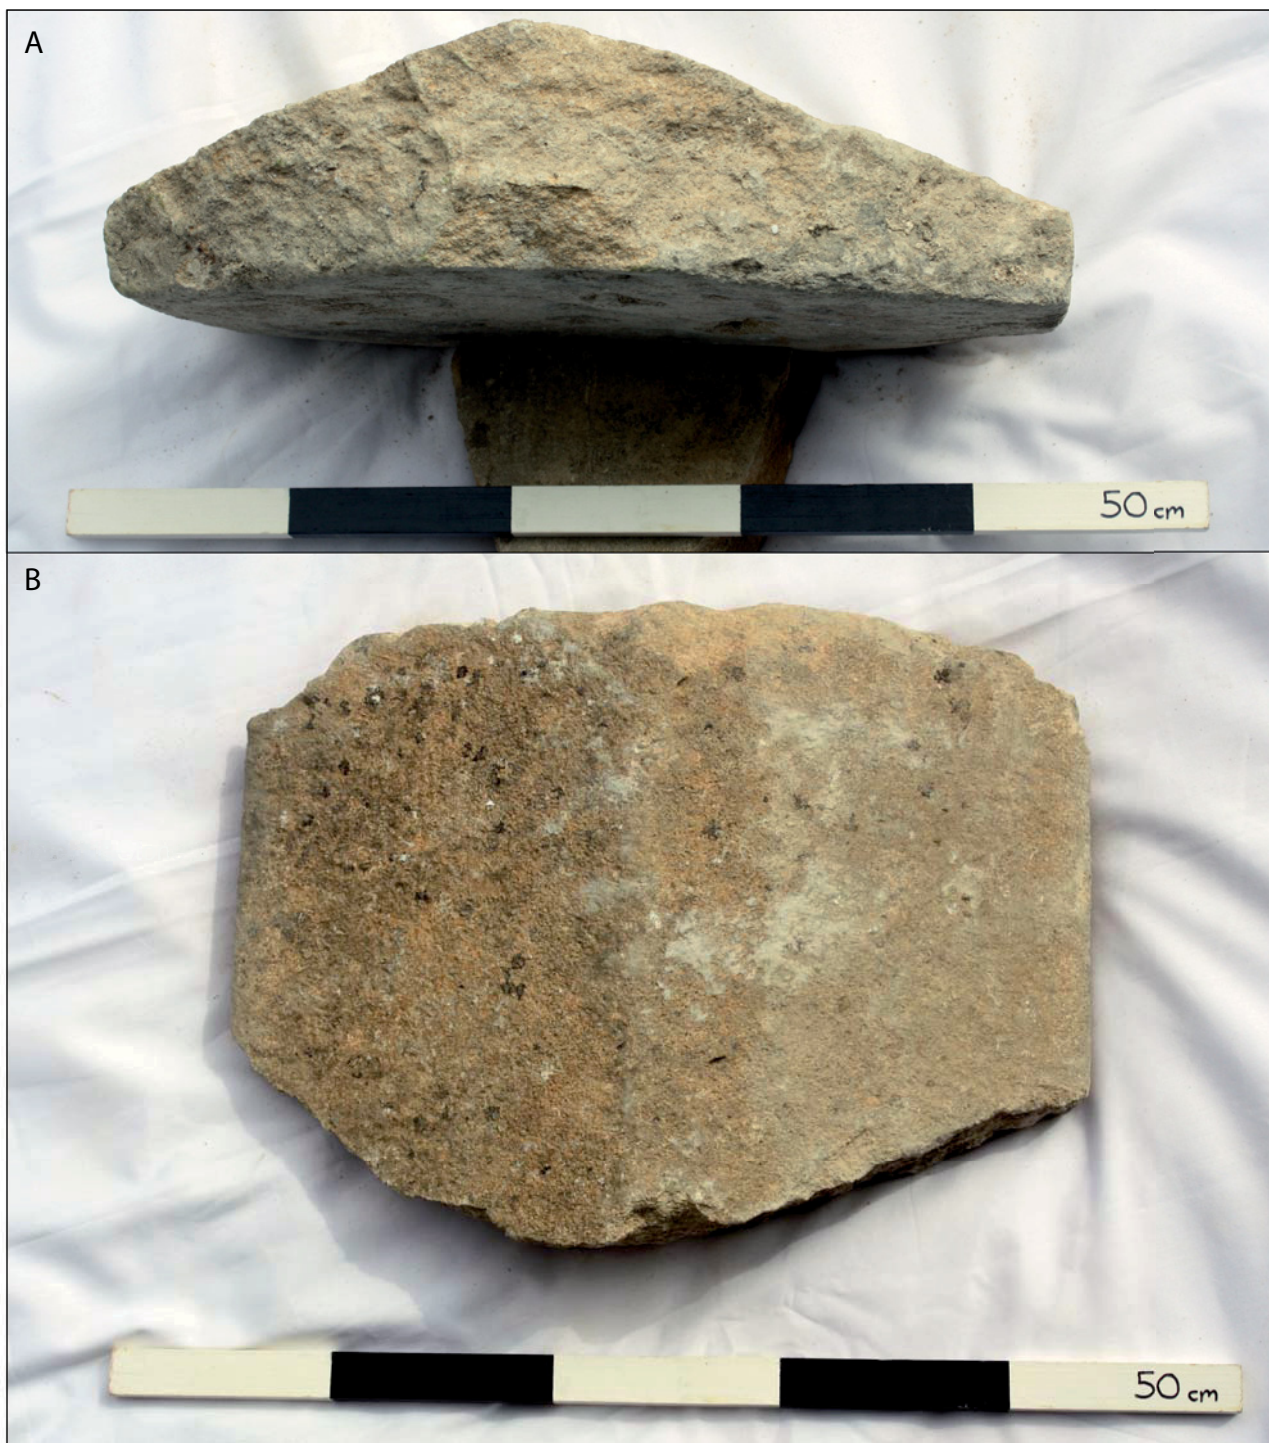
Plate 13: Stone 9, profile (A) and top surface (B)

- 3.2.9 **Stone 9 (Plate 13):** Stone 9 is a fragment measuring approximately 0.4m by 0.3m by 0.1m, with two opposing sloped faces on one side. It is likely that this stone is a fragment of a grave slab/coffin lid, but could perhaps also be a coping stone. Stone 9 little datable stylistic design, but probably dates from the medieval/post-medieval periods.

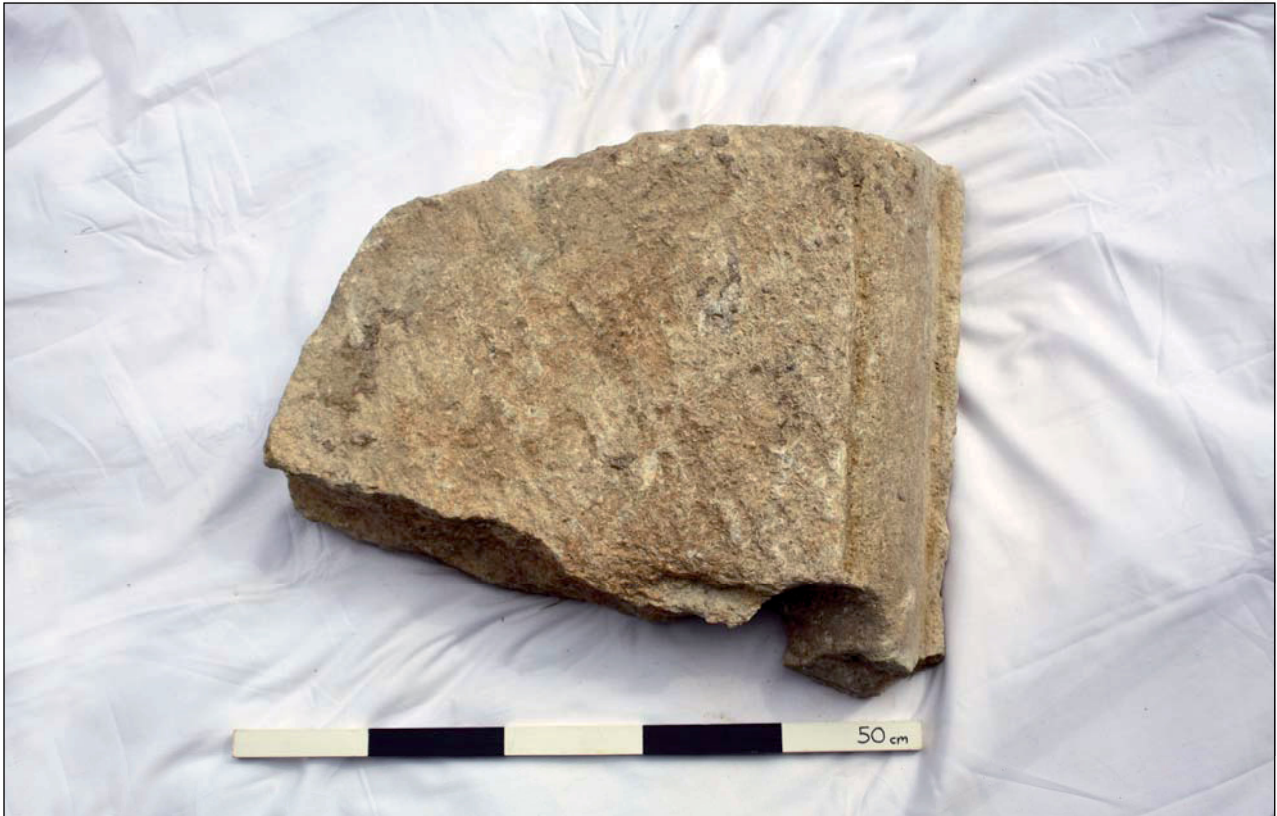
Plate 14: Stone 10

- 3.2.10 **Stone 10 (Plate 14):** A curious slab fragment measuring approximately 0.5m by 0.4m by 0.1m, Stone 10 has an ovolo moulding on one edge, and oddly part of a possibly drilled hole. The most likely function of this piece of stonework is that it was part of an abacus. It could potentially be part of a grave slab, or a door surround, but only the ovolo moulding is a smoothly finished surface, making this a less likely explanation. It is likely to date to the Post-medieval period, but the partial hole is almost certainly more recent than this, perhaps being carried out in the 19th century to allow for the insertion of pipework or for drainage.

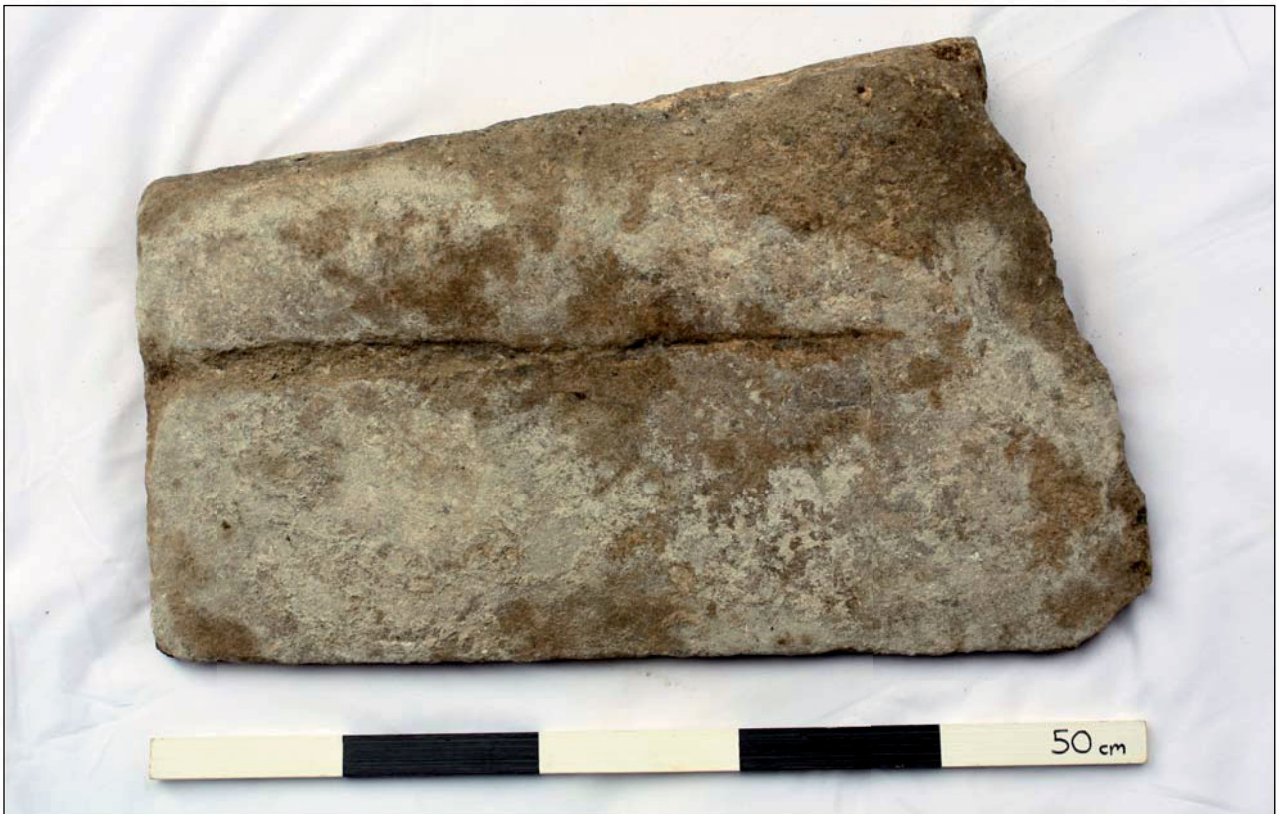
Plate 15: Stone 11

- 3.2.11 **Stone 11 (Plate 15):** Stone 11 has a convex top surface, measures approximately 0.5m by 0.3m by 0.1m and tapers in on two edges towards one end. The corners are quite rounded, the two at the thinner end possibly by abrasion, but the one surviving corner at the wider end looks to have been carved as a rounded corner. There is an incised line running down the centre (from the wide to narrow end) stopping in a gradual point about 0.1m from the widest end. It is thought this fragment would have formed part of a grave slab with an incised cross design as would have been common in the 12th or 13th centuries (Dirszty 1978, 76). The tapering form of the grave slab means it is highly likely to precede 1275 AD, as after this date they were the same width at both ends (Needham 1944, 43 and Dirszty 1978, 76).
