# Worked Stone Fragments from Holy Trinity Church Great Paxton

**Historic Buildings Recording**

OA East Report No: 1146

## **Worked Stone Fragments From Holy Trinity, Great Paxton**

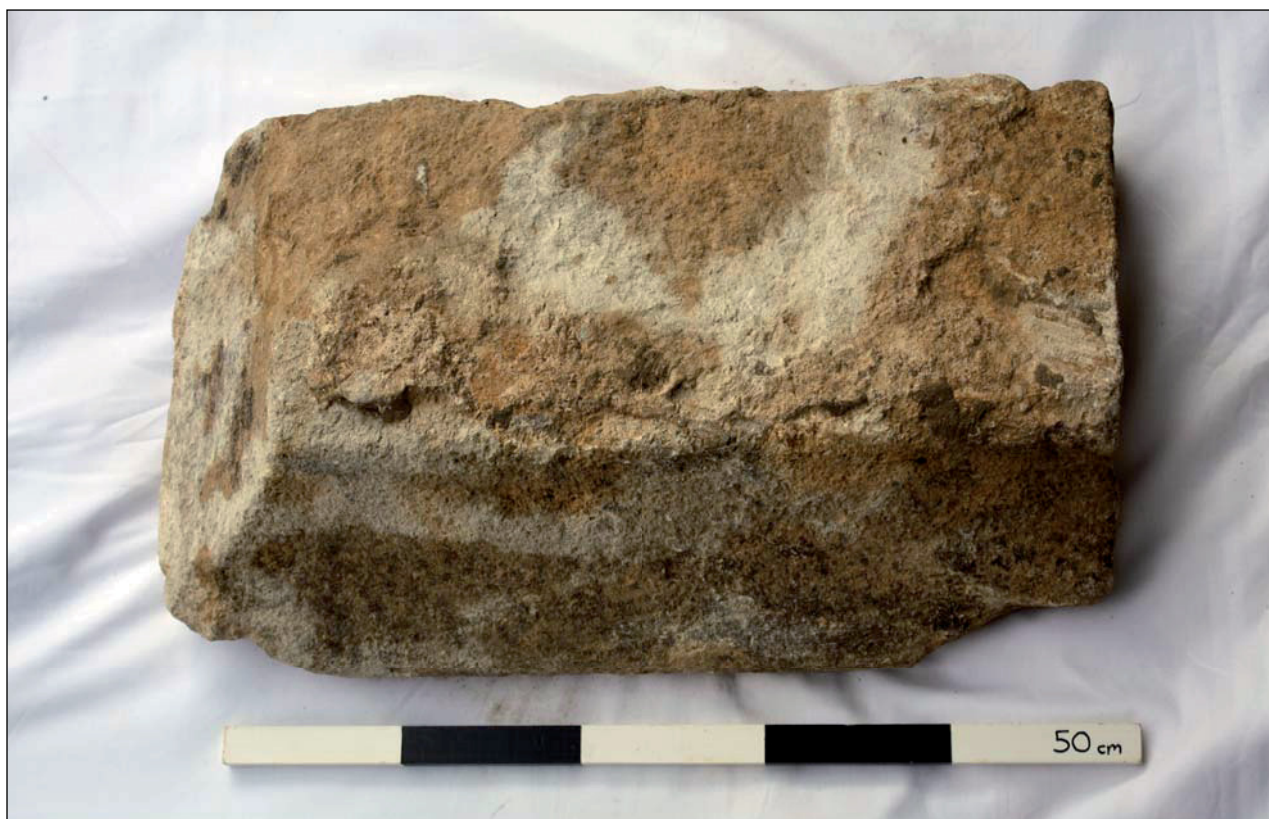
Plate 20: Stone 16

- 3.2.16 **Stone 16 (Plate 20):** Measuring approximately 0.5m by 0.4m by 0.2m, Stone 16 has a fairly worn surface, but also a cavetto moulding along two edges. The other two edges are fairly cleanly cut, so whilst this fragment could have been part of a bigger slab to cover a grave, it is also likely due to these edges that Stone 16 was part of a pier base or plinth for a monument. Due to the moulding style, it is most likely that this stone fragment dates from the Post-medieval period.

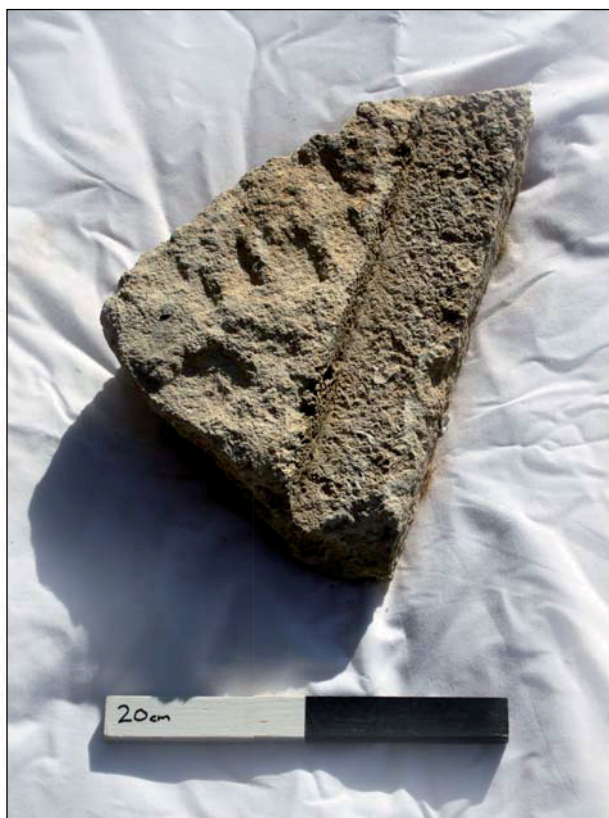
Plate 21: Stone 17

- 3.2.17 **Stone 17 (Plate 21):** Measuring approximately 0.2m by 0.1m by 0.15m, Stone 17 is a small fragment of limestone that has a rebate along one edge. Its function is unclear, but it is likely to date to the Post-medieval period.

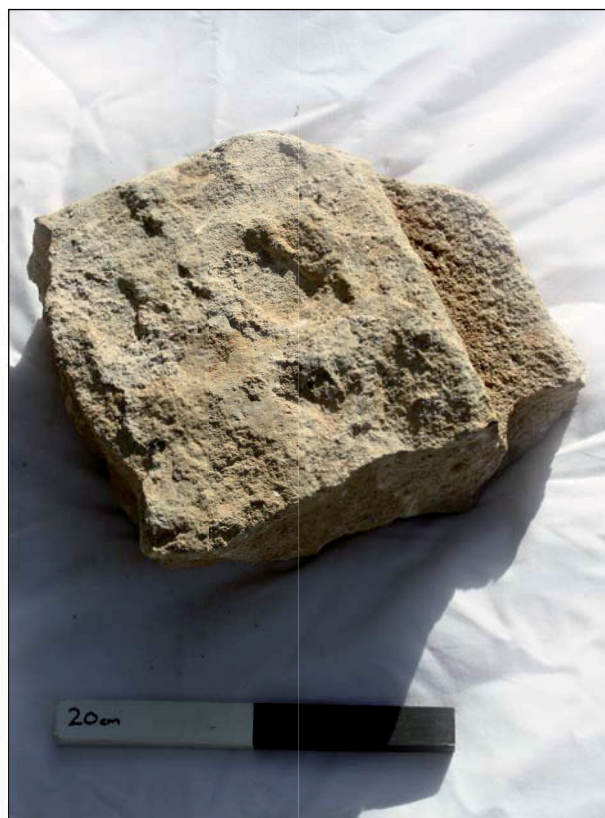
Plate 22: Stone 18

- 3.2.18 **Stone 18 (Plate 22):** Measuring approximately 0.2m by 0.2m by 0.1m, Stone 18 is a small roughly square limestone fragment with a rebate along one edge. It is similar to several other fragments, and is likely to date to the Post-medieval period.

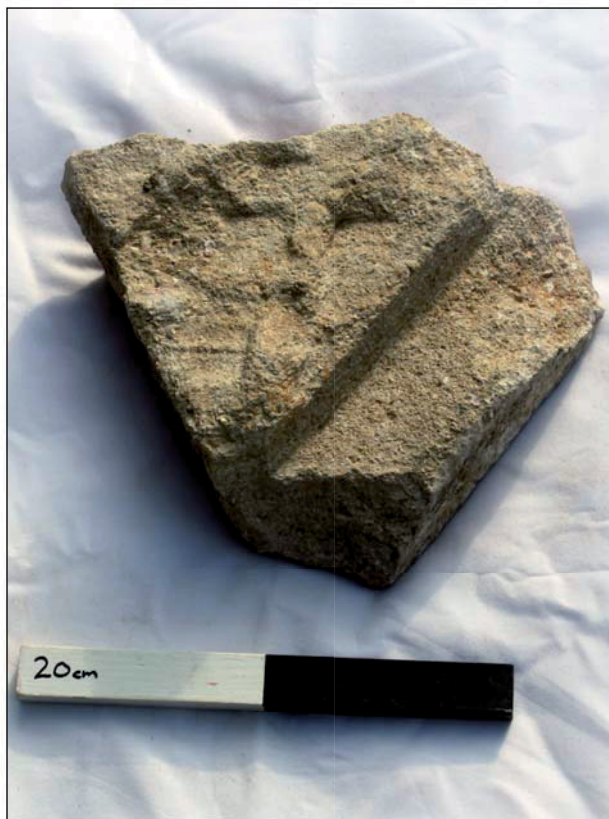
Plate 23: Stone 19

- 3.2.19 **Stone 19 (Plate 23):** Stone 19 is another fragment similar to Stone 17; likely to be of Post-medieval date, it measures approximately 0.2m by 0.2m by 0.1m and has a rebate along one edge.

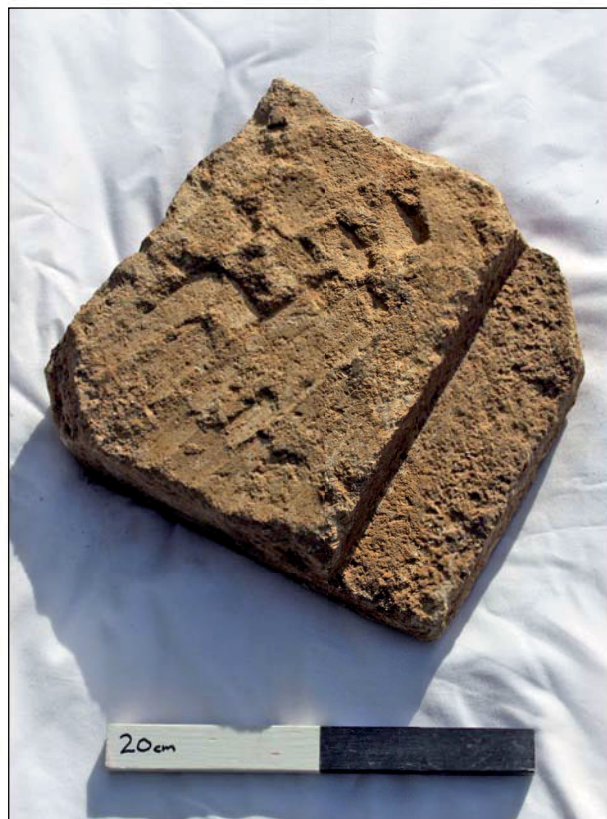
Plate 24: Stone 20

- 3.2.20 **Stone 20 (Plate 24):** Similar to Stone 18 and again likely to be of Post-medieval date, Stone 20 measures 0.2m by 0.2m by 0.1m, is roughly square in shape, has a rebate along one edge and has many rough chisel marks on one face.

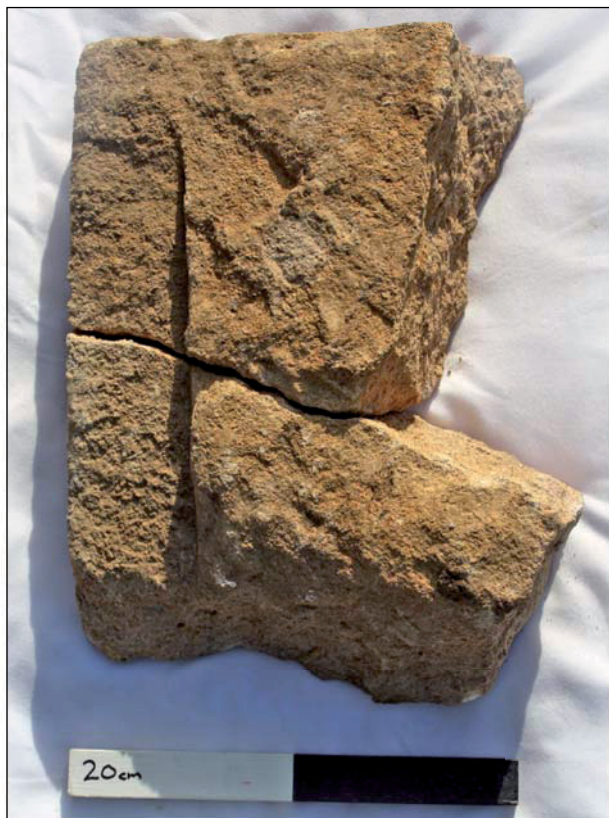
Plate 25: Stone 21

- 3.2.21 **Stone 21 (Plate 25):** Two fragments together make up Stone 21, which measures 0.3m by 0.2m by 0.1m. Much like Stones 17-20, it has a rebate along one edge, is quite roughly hewn and probably dates from the Post-medieval period.

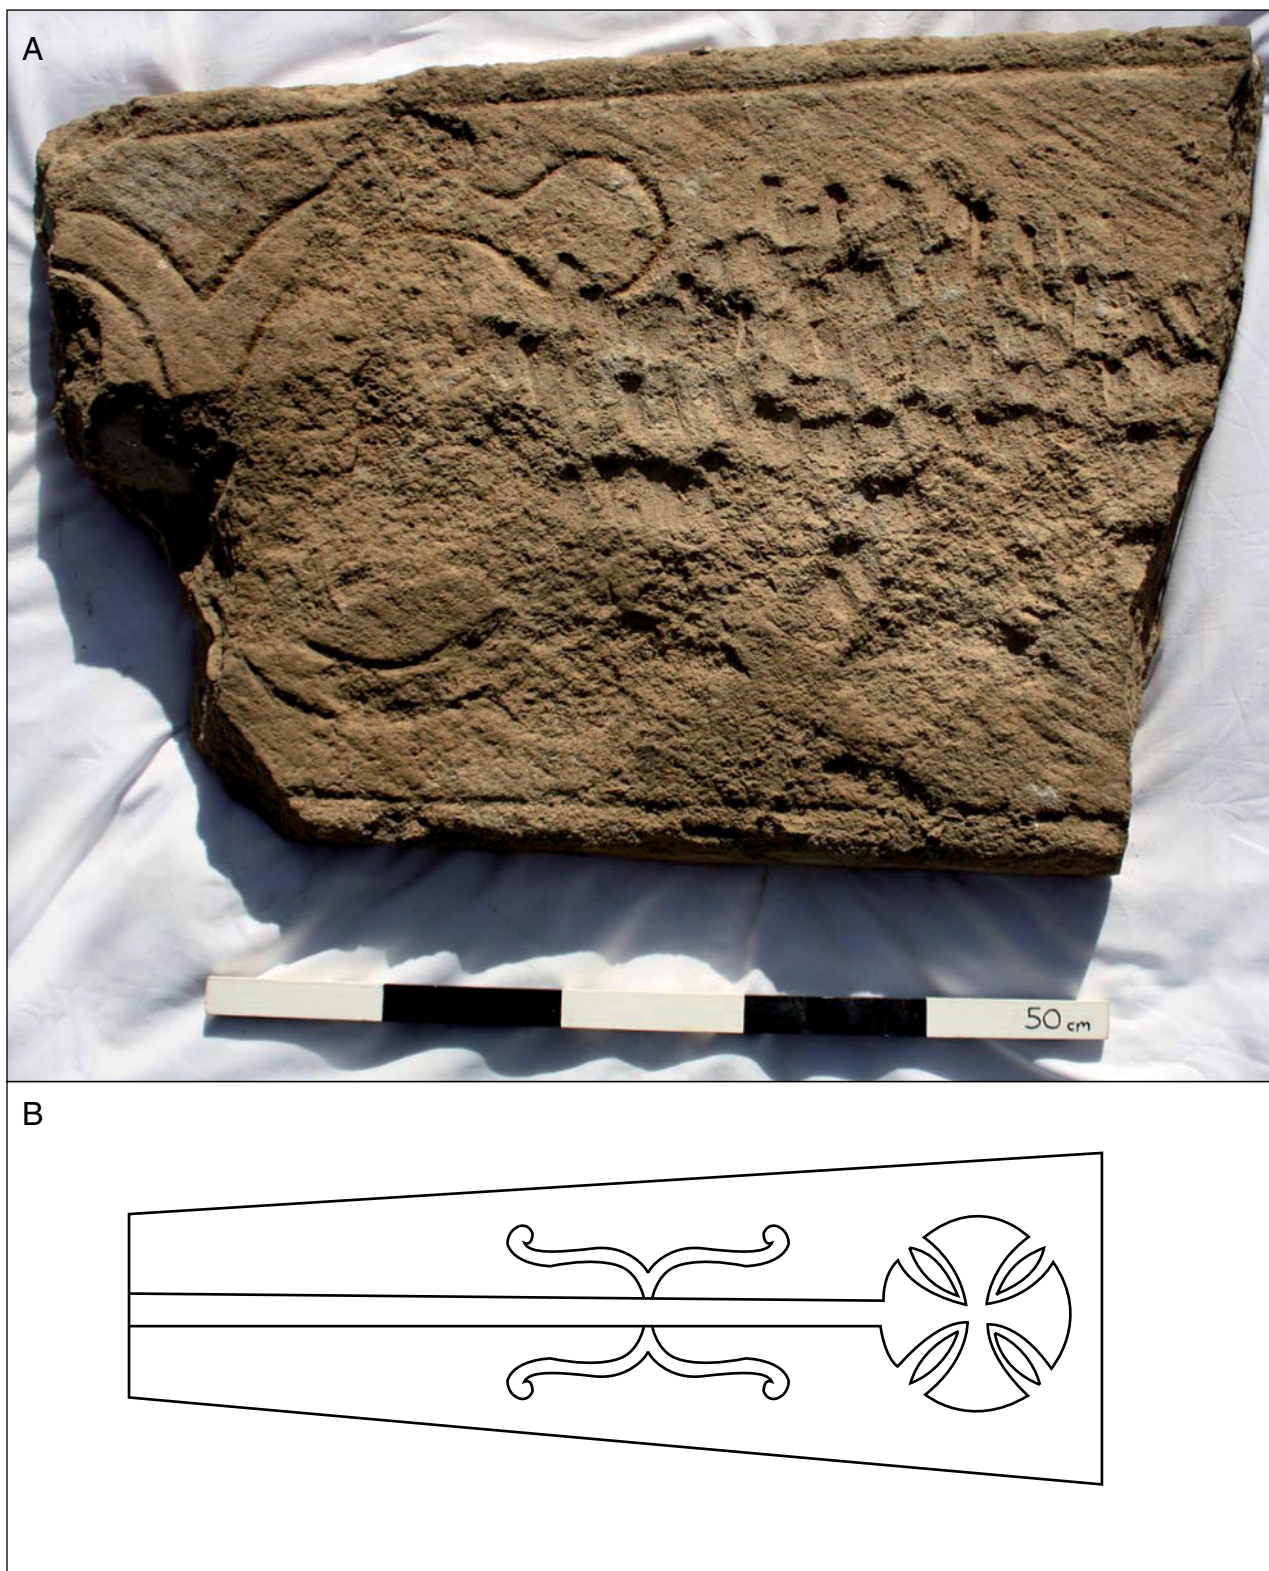
- 3.2.22 **Stone 22 (Plate 26 A):** This particularly interesting fragment measures approximately 0.7m by 0.5m by 0.1m. On one surface there are incised borders along two edges, some remnants of a design and some large chisel marks. The two bordered edges taper inwards towards one end, and the other engraving appears to make up a torc-like design, although the design clearly extended further than the limits of this remaining fragment. The large chisel marks are unusual, and it perhaps appears that some of the design, possibly where a cross may have been engraved, has been chiselled away at some point. It is almost certainly part of a coffin slab, the tapering form implying that it pre-dates 1275 (Needham 1944, 43 and Dirsztay 1978, 76). Although only partially remaining, the design could be 13th century or earlier, so Stone 22 could well date from early on in the churches history.

- 3.2.23 The torc-like design visible on Stone 22 is similar in design to a stone coffin lid found at St Vigor's Church, Fulbourn (<http://www.bvsda.org.uk/fulbournpcc/DisplayArticle.asp?ID=8896> accessed 1/12/09). This torc-like form appears on several other grave slabs discovered locally, in addition to this one at Fulbourn, there are examples found at Steeple Gidding, Oakington, Trumpington and Landbeach as well as slightly further afield in Norfolk (Cutts 1849, 44 and plates 53 and 54 – from which an example is shown here in Plate26,B). Whilst this design is found further afield, it does seem to be more common locally and within the east of England which is quite interesting. Although it is unclear what this part of the design represents, some of these examples also have crosses of a type that is associated with the Knights Templar (Cutts 1849, 43-44), but unfortunately, any evidence of a cross on Stone 22 has been lost or vandalised.

Plate 26: Stone 22 (A) and a grave slab of a similar design from Norfolk (B), after Cutts 1849, plate 53

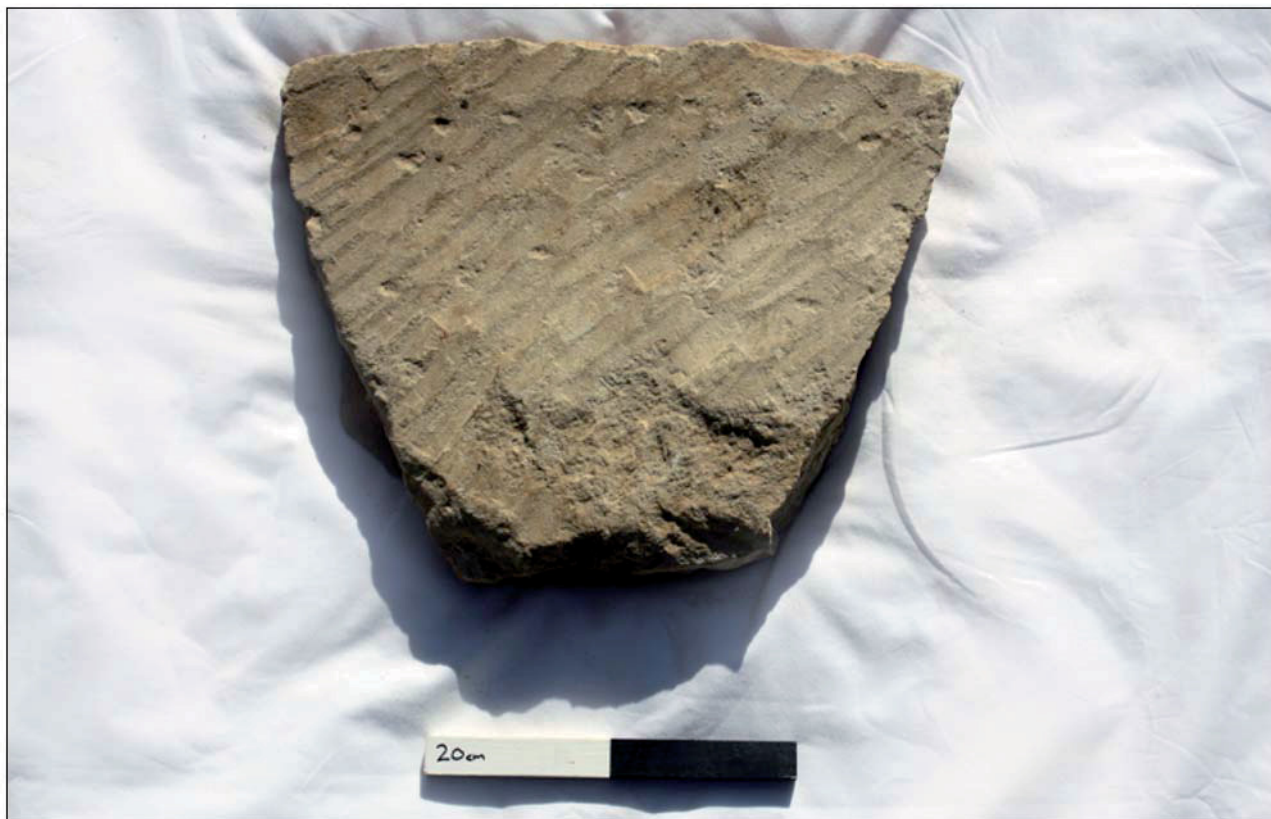
Plate 27: Stone 23

- 3.2.24 **Stone 23 (Plate 27):** Stone 23 measures approximately 0.3m by 0.3m by 0.1m. It has two straight edges that taper in towards one end and the other two edges are both curved. There are large chisel marks, perhaps indicating the fragment was never fully faced. The form of this fragment might suggest the original intention was to use it in some sort of arch – probably to span either a window or door. It is possible this fragment was unfinished, so it is difficult to assign a stylistic date, and although it is likely to be Medieval or Post-medieval it could possibly have been a voussoir or keystone from one of the earlier arches in the church – the large chisel marks could have been made at the time of re-use.

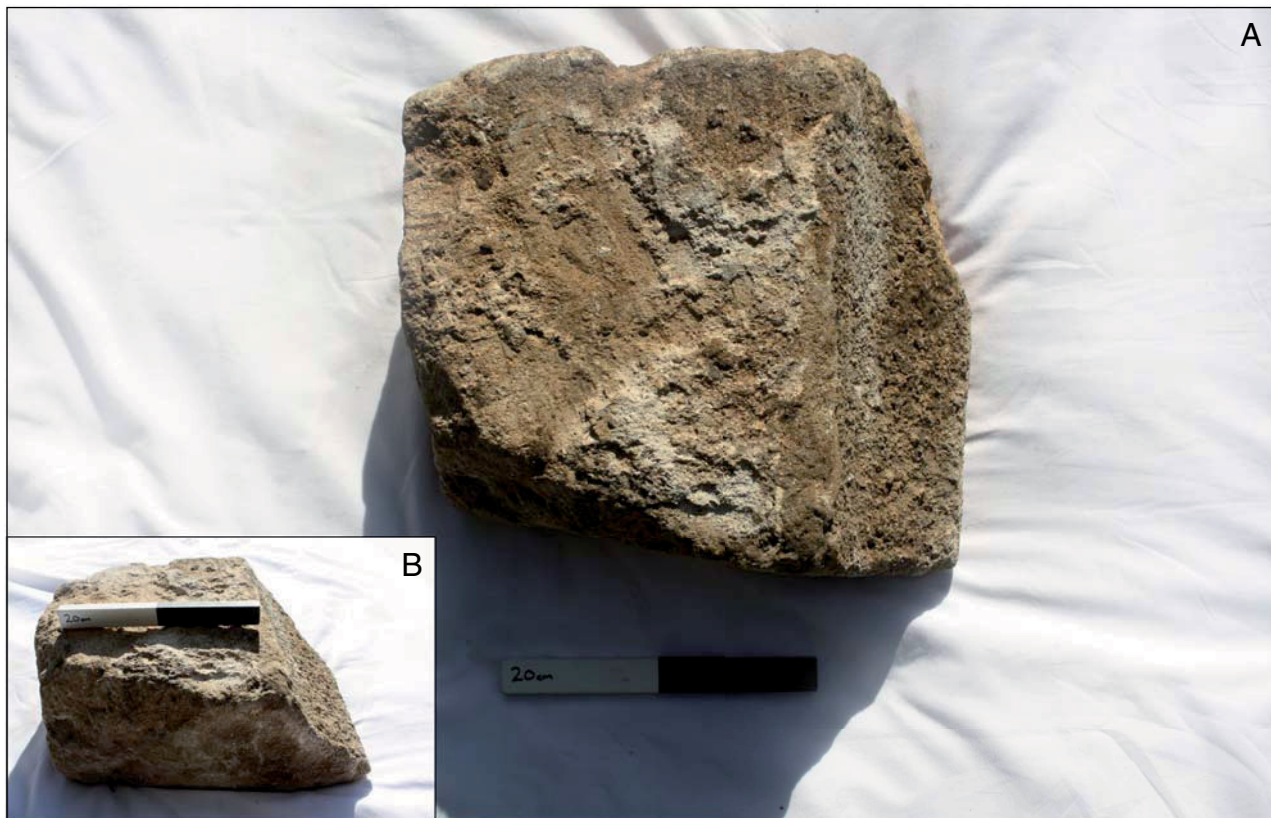
- 3.2.25 **Stone 24 (Plate 28):** Measuring approximately 0.3m by 0.3m by 0.1m, Stone 24 has a hollow chamfered edge along one side. It is unclear what the function may have been although it could perhaps have been an abacus, base or other architectural member. As with many other fragments, Stone 24 could be Medieval or Post-medieval.

Plate 28: Stone 24, from above (A) and profile (B)

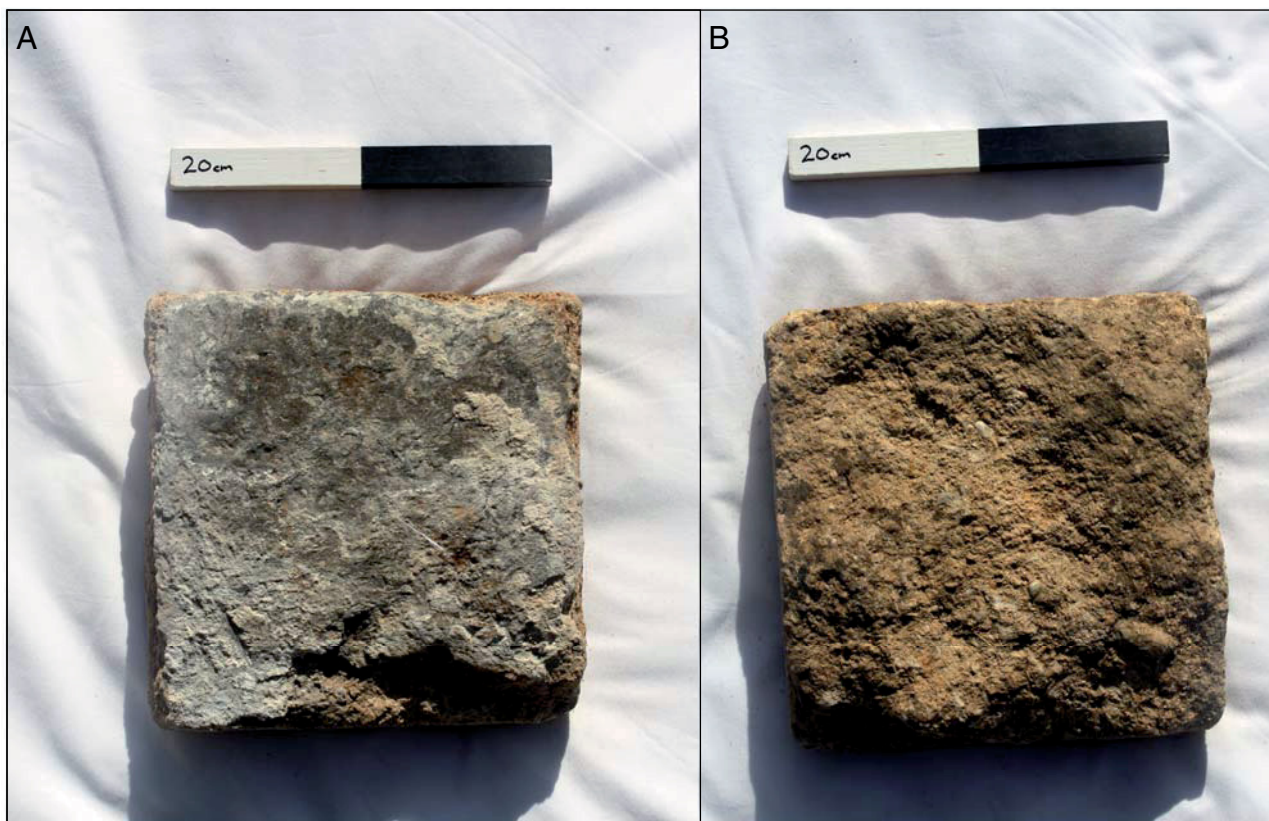
- 3.2.26 **Stone 25 (Plate 29):** Probably a square stone paviour, Stone 25 approximately measures 0.2m by 0.2m by 0.05m. It is possibly Purbeck marble – a different stone type to the majority of the stone both present in this assemblage and in the church. It could be of Medieval or Post-medieval date.

Plate 29: Stone 25, top (A) and bottom (B) faces

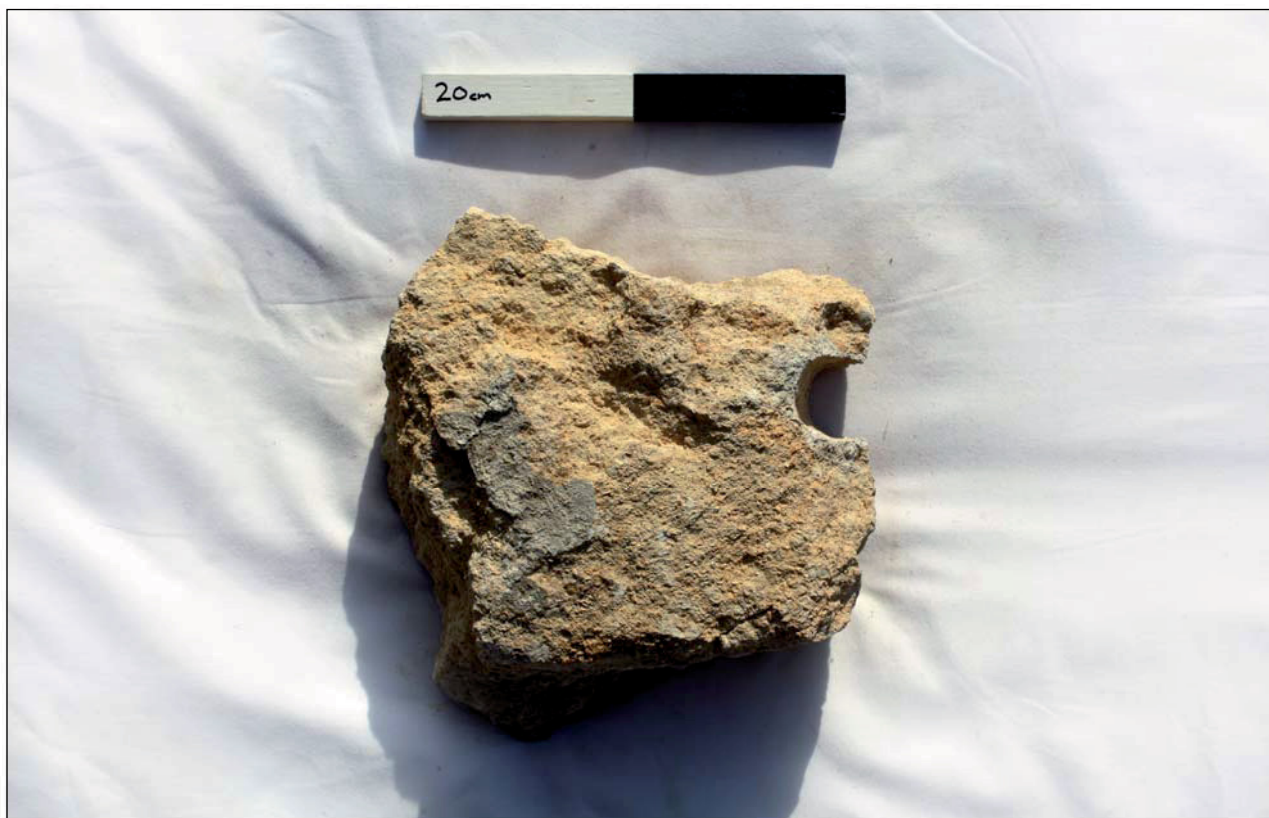
Plate 30: Stone 26

- 3.2.27 **Stone 26 (Plate 30):** Stone 26 measures approximately 0.2m by 0.2m by 0.1m, and appears to be a small broken fragment of masonry that has part of a hole in it. It is likely this hole has been made in more recent times to allow the insertion of pipework, so the date and function of fragment is unclear.

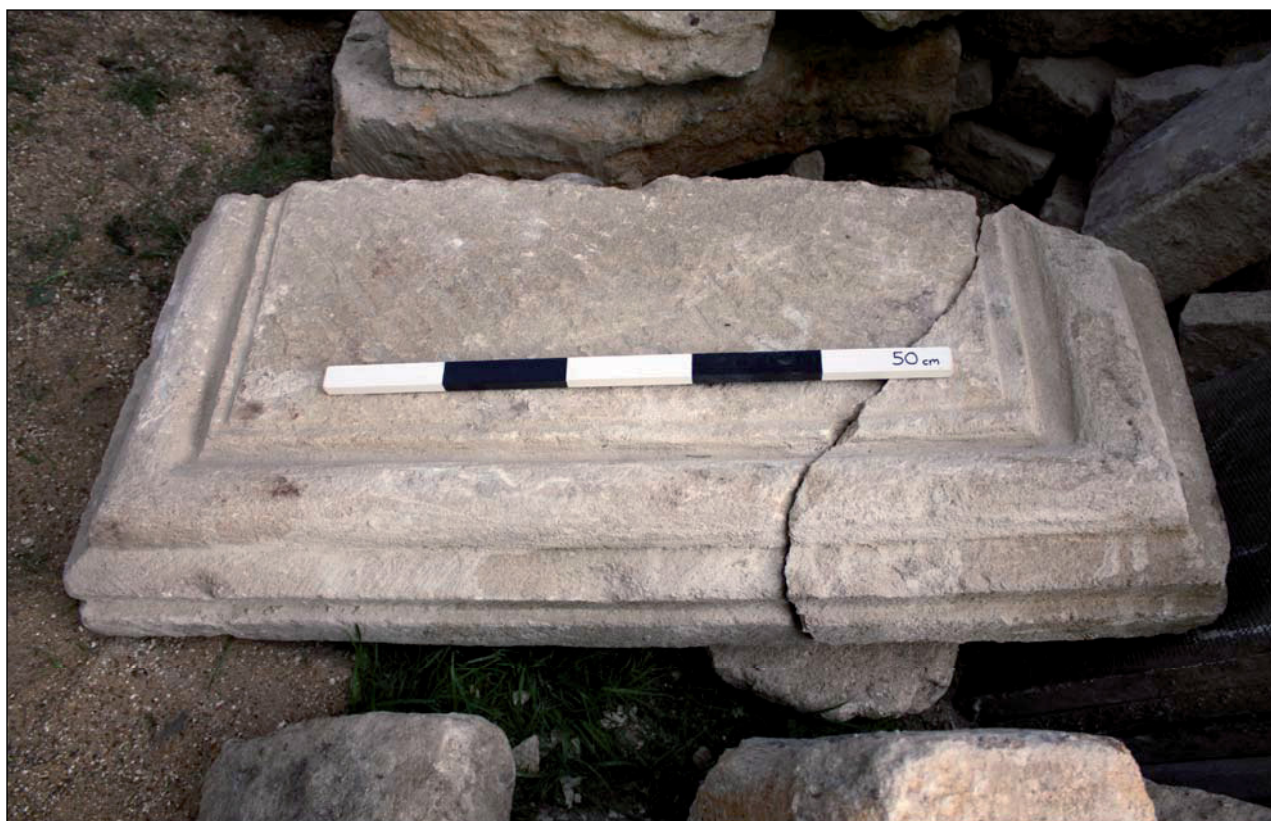
Plate 31: Stone 27

- 3.2.28 **Stone 27 (Plate 31):** Comprising of two fragments, Stone 27 is one of the largest stones recorded, measuring approximately 0.8m by 0.4m by 0.25m. It has a boldly

carved border in a roughly Classical style along three edges, suggesting it probably dates to the 17th or 18th century. Stone 27 could have been a tomb lid or other funerary monument, but given the lack of the rest of the stone, it is also possible that it could have been a base or plinth for some other architectural purpose. If it was indeed part of a tomb lid it is likely to have been a table-tomb – there being too much relief to the moulding to have been a floor slab. The whole dimension remaining – approximately 0.8m – might also suggest a sizeable tomb, possibly big enough for two side by side burials, so perhaps a husband and wife.

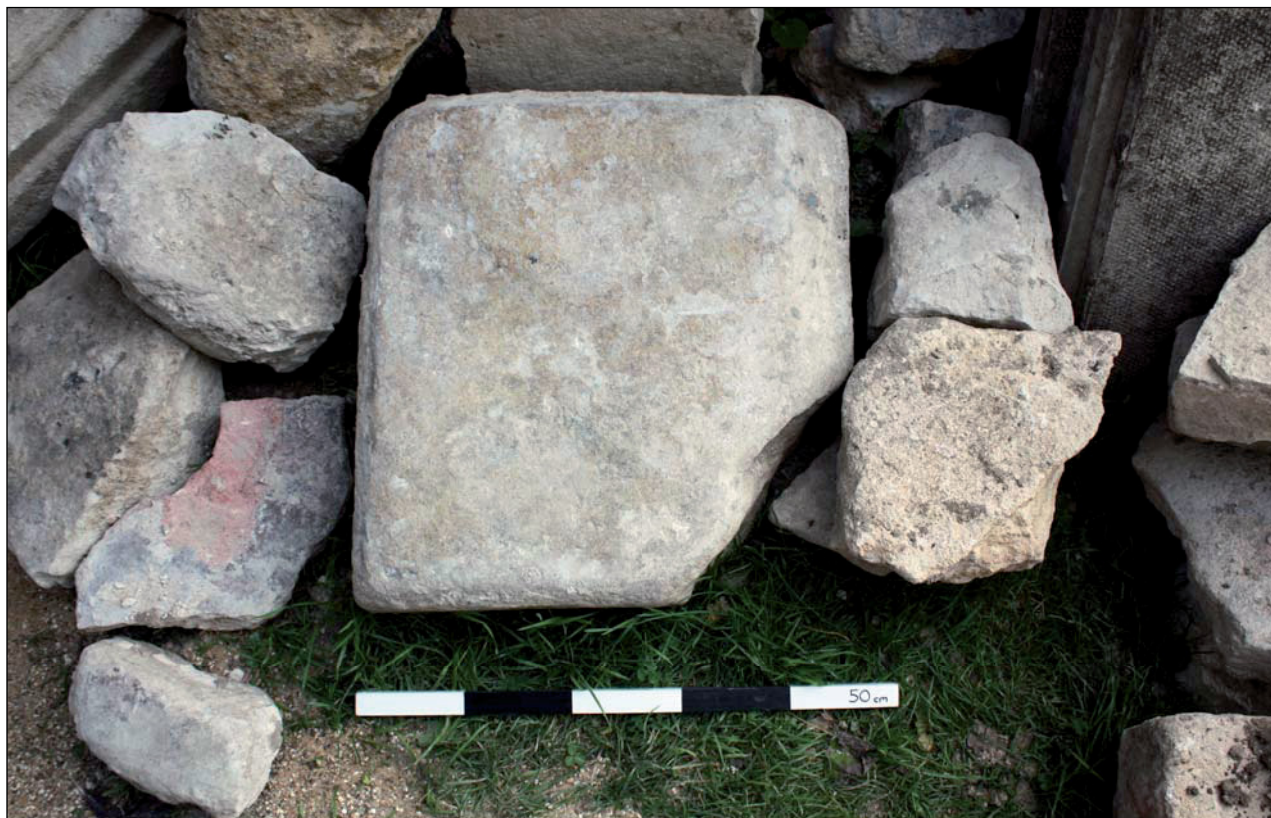
Plate 32: Stone 28 (centre)

- 3.2.29 **Stone 28 (Plate 32):** Square shaped with four slightly rounded edges to one face, Stone 28 approximately measures 0.5m by 0.5m by 0.2m. It could have been a flagstone, but its depth might indicate it was perhaps a step or base for something. There are no obviously datable features.

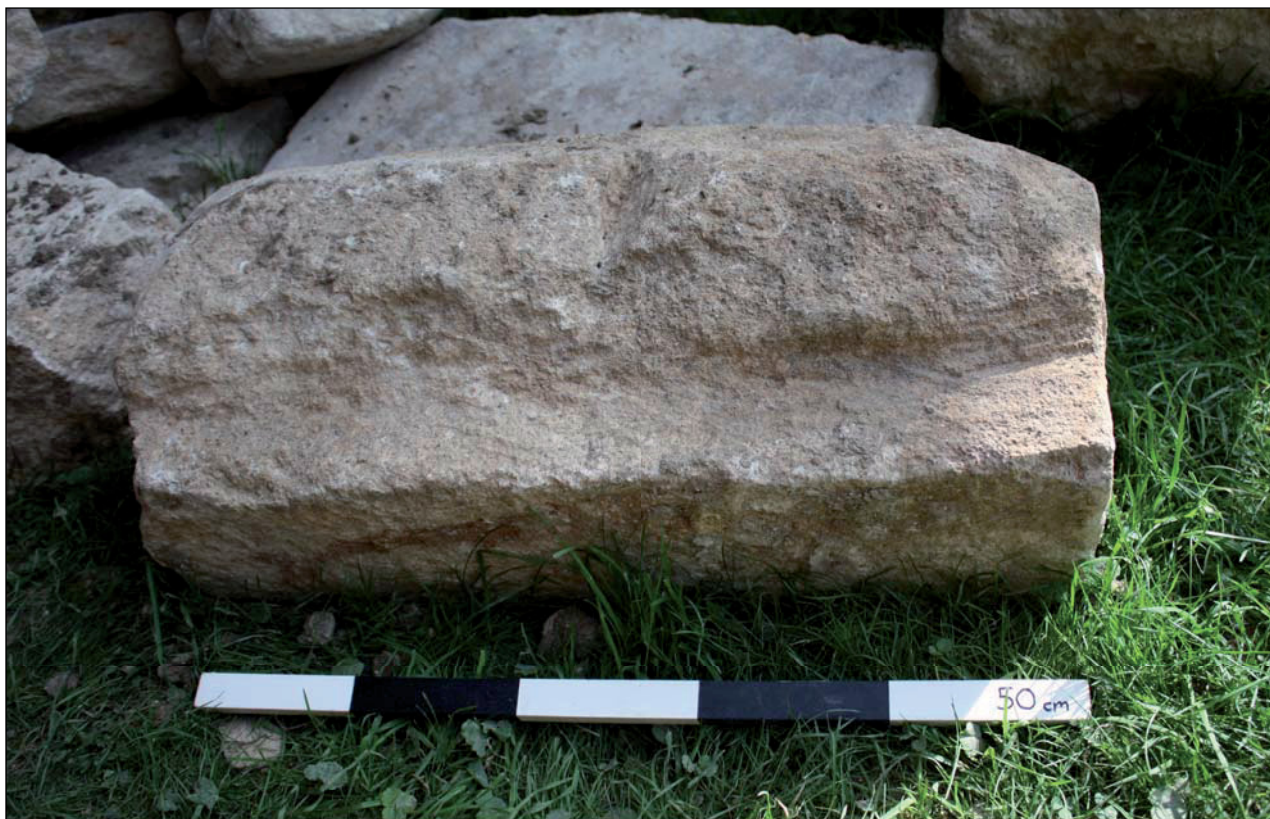
Plate 33: Stone 29

- 3.2.30 **Stone 29 (Plate 33):** Measuring approximately 0.5m by 0.2m by 0.2m, Stone 29 is very roughly hewn/worn and has a rebate along one edge. Its function is unclear, but it could perhaps be a partially prepared/rough out for a corbel. The date of this stone is equally ambiguous, but it is likely to have originated in either the Medieval or Post-medieval periods.

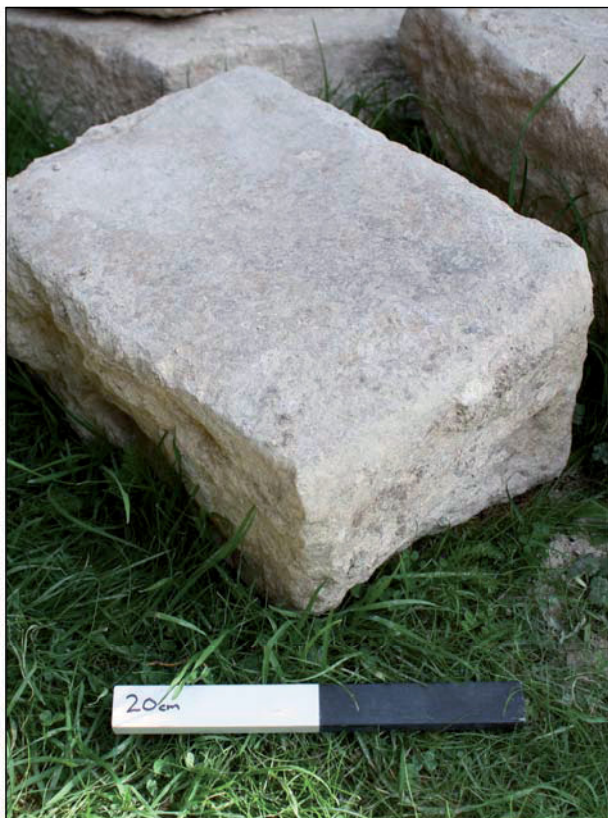
Plate 34: Stone 30

- 3.2.31 **Stone 30 (Plate 34):** An ashlar block with fairly worn surfaces, probably used as a quoin. It measures approximately 0.4m by 0.2m by 0.15m, and would be difficult to date due to the ambiguous form, but it likely to be medieval/post-medieval.

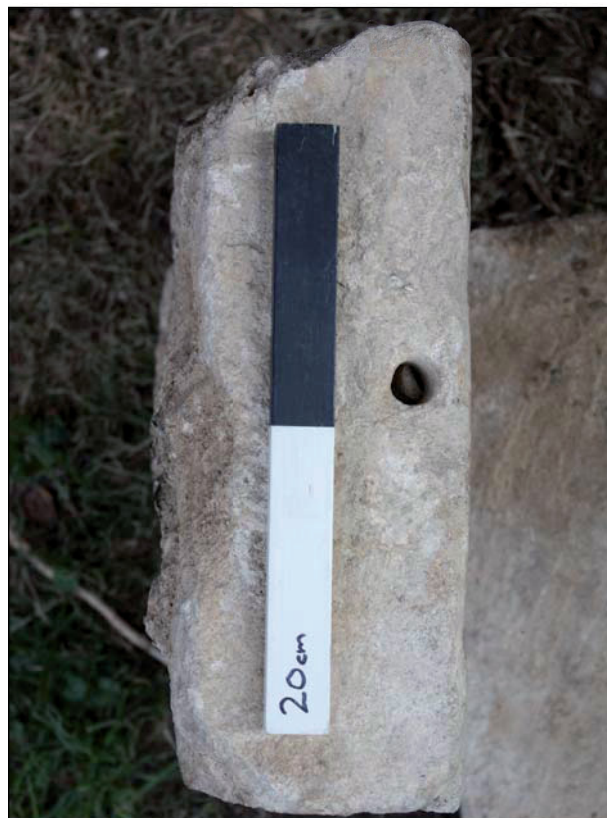
Plate 35: Stone 32

- 3.2.33 **Stone 32 (Plate 35):** Stone 32 is a long, fairly flat rectangular block measuring approximately 0.4m by 0.25m by 0.1m. Some of the edges and one of the larger surfaces have been smoothly faced, whilst the other large surface is fairly rough in comparison, and most of the edges are very worn. One feature that sets this fragment apart from others is a small hole in one end. It is thought the probable purpose of this hole would have been to support a metal bar, making Stone 32 likely to have been part of a window, which probably dates to the medieval or post-medieval periods.

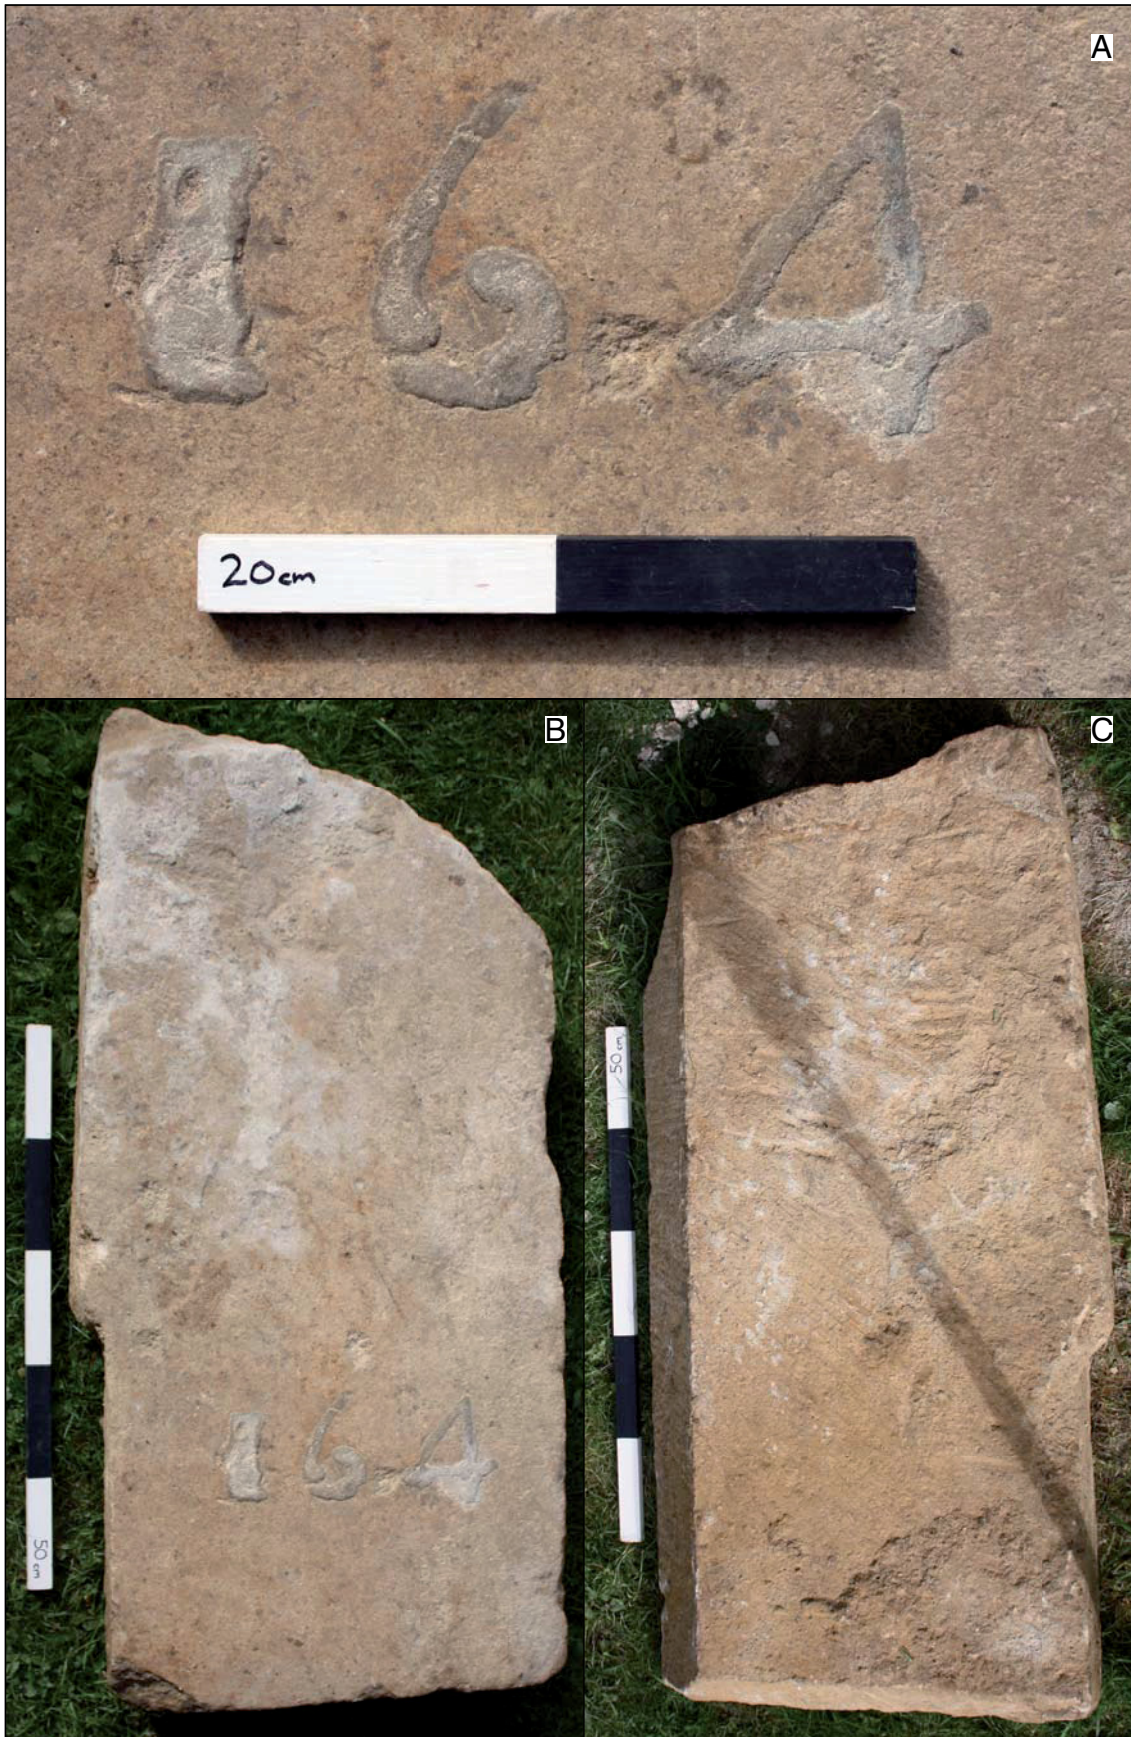
- 3.2.34 **Stone 33 (Plate 36):** Stone 33 is a large fragment that measures approximately 0.8m by 0.45m by 0.2m and was probably part of a larger slab. This fragment is quite interesting as, on one side, there are some numbers carved and filled with lead that read “164”, of which can be discerned no meaning without the possible and heavily worn superscript numeral “0” between the “6” and “4” (Plate 36A) - In which case the number could be the date “1604”, making it likely the fragment dates from the 17th century. The style of the script would fit a 17th century date. Having a date means it is likely that this fragment has come from a grave slab/marker. Although on the reverse side, two of the edges have been chamfered, with a number of straight chisel marks visible (Plate 36C).

- 3.2.35 It is then odd that the intention is clearly that the two sides would have been visible at the same time – perhaps meaning this fragment was part of a standing grave marker/stone. But the numbers are too low down in relation to the remaining straight edge to enable enough of the stone to be buried and give it sufficient support to remain

standing. Perhaps then, the edges were either chamfered in order for the stone to fit in its original place – an attempt to avoid any flush edges for some purpose.

Plate 36: Stone 33, close up of numerals (A) front face (B) and rear face (C)

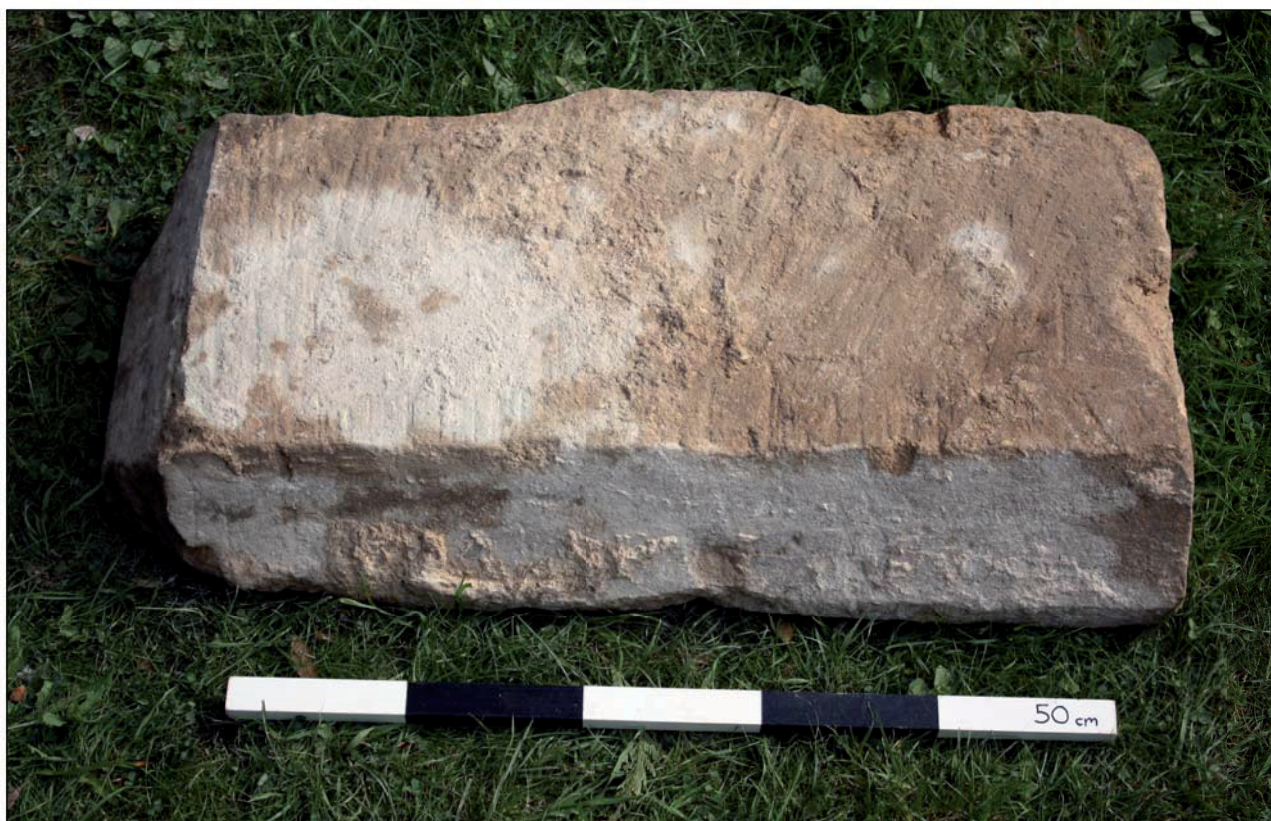
Plate 37: Stone 34

- 3.2.36 **Stone 34 (Plate 37):** Similar in form to Stone 33, although lacking the numerals, Stone 34 measures approximately 0.6m by 0.4m by 0.25m and also has two chamfered edges and many visible chisel marks on its surfaces. Again, this fragment could be from a grave slab or even a coping stone, and probably dates to the post-medieval period.

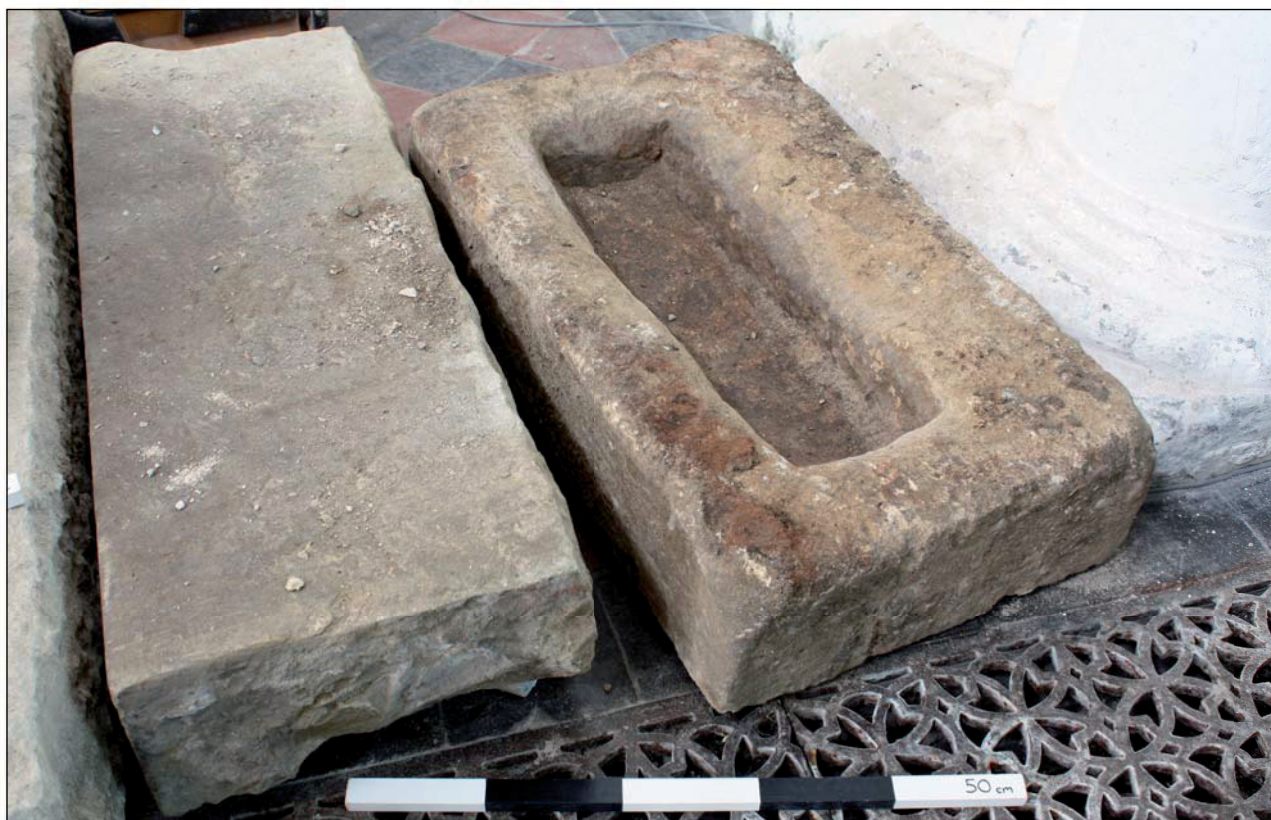
Plate 38: Stone 35

- 3.2.37 **Stone 35 (Plate 38):** Stone 35 is a fairly rectangular block measuring approximately 0.6m by 0.4m by 0.25m, it is very worn/fairly roughly carved and curiously there is a very worn rectangular hollow carved out of one side. It is this hollow that makes this piece of stone particularly interesting, as this is perhaps indicative of a piscina/stoup or some other kind of water holder. The degree of wear would indicate the stone is of some age, so perhaps dates back as far as Saxon/Early Medieval times. Given the size and lack of drainage, it is more likely to have been a stoup, which could perhaps have been in a previous porch or entrance way prior to the present porch which was added around the same time as the present piscina and sedilia in the mid 14th century (Dickinson 1995, 6). Or perhaps the south aisle extension in the late 15th century removed the previous position of this stoup, leaving it free to be used as building material.

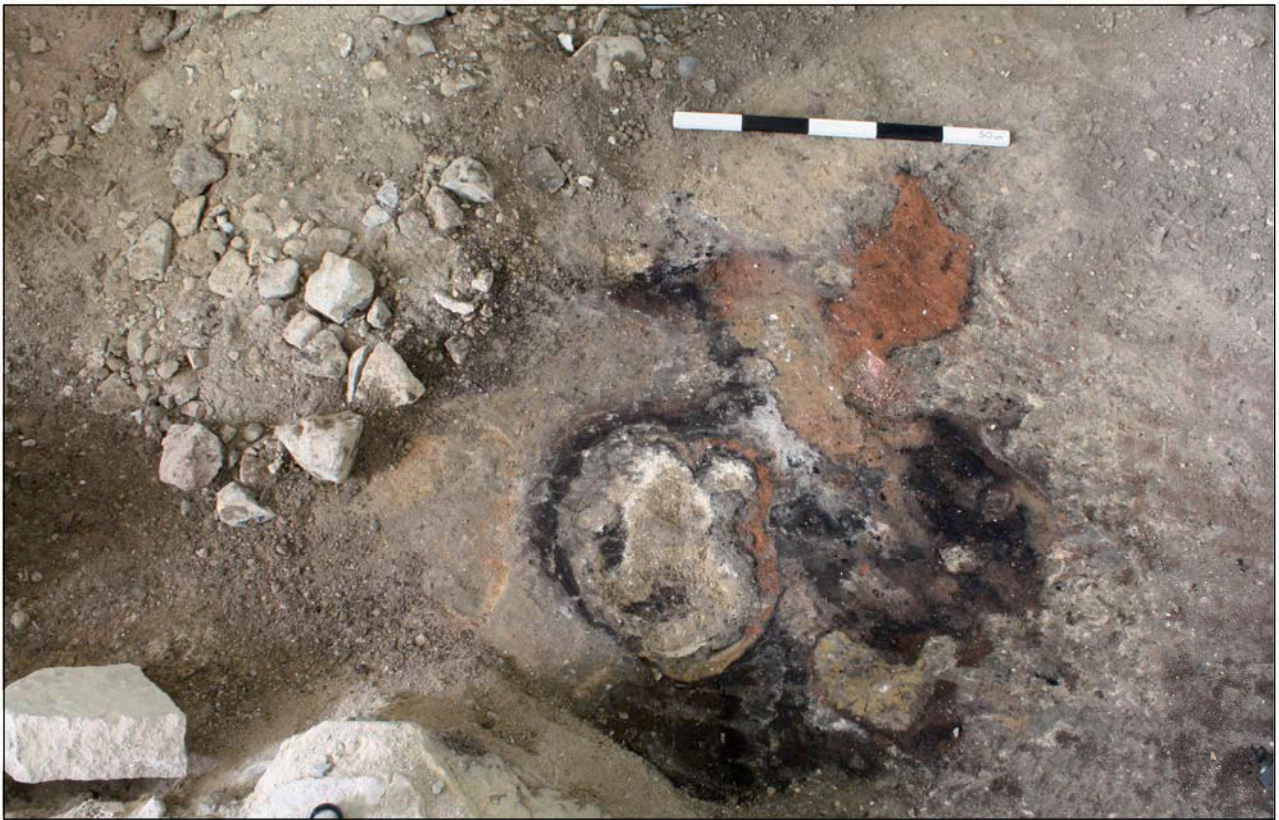
- 3.3.2 A fragment of clay pipe – not retained – was found amongst the fabric that made up the floor of the tower. There was also a flue that passed through the northeast corner of the tower and some evidence of burning under the floor (Plate 39). These are remnants of a heating system that was probably inserted during works in the 1880. This suggests the floor level was raised at this time to allow the insertion of this heating system.

Plate 39: Burning under the floor
