Conisbrough Castle
South Yorkshire

Archaeological Watching Brief

Report No. 2096

Conisbrough Castle South Yorkshire

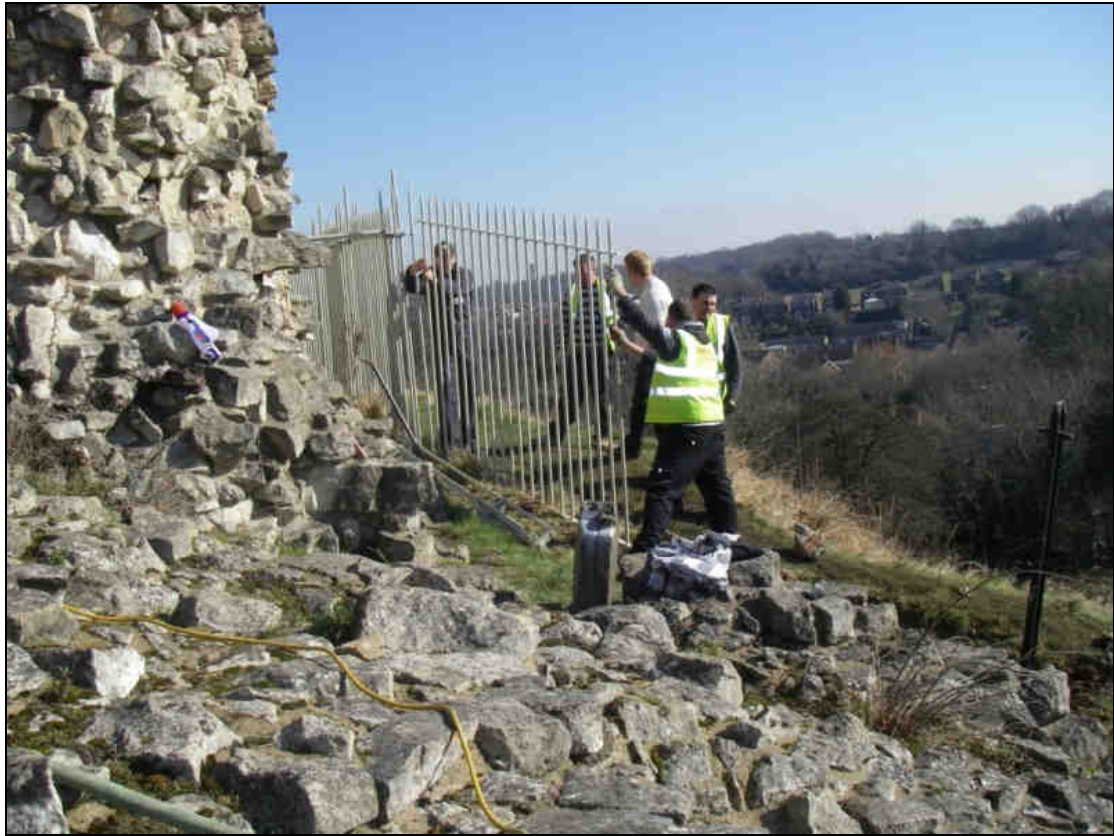
Plate 3. New fence, looking east

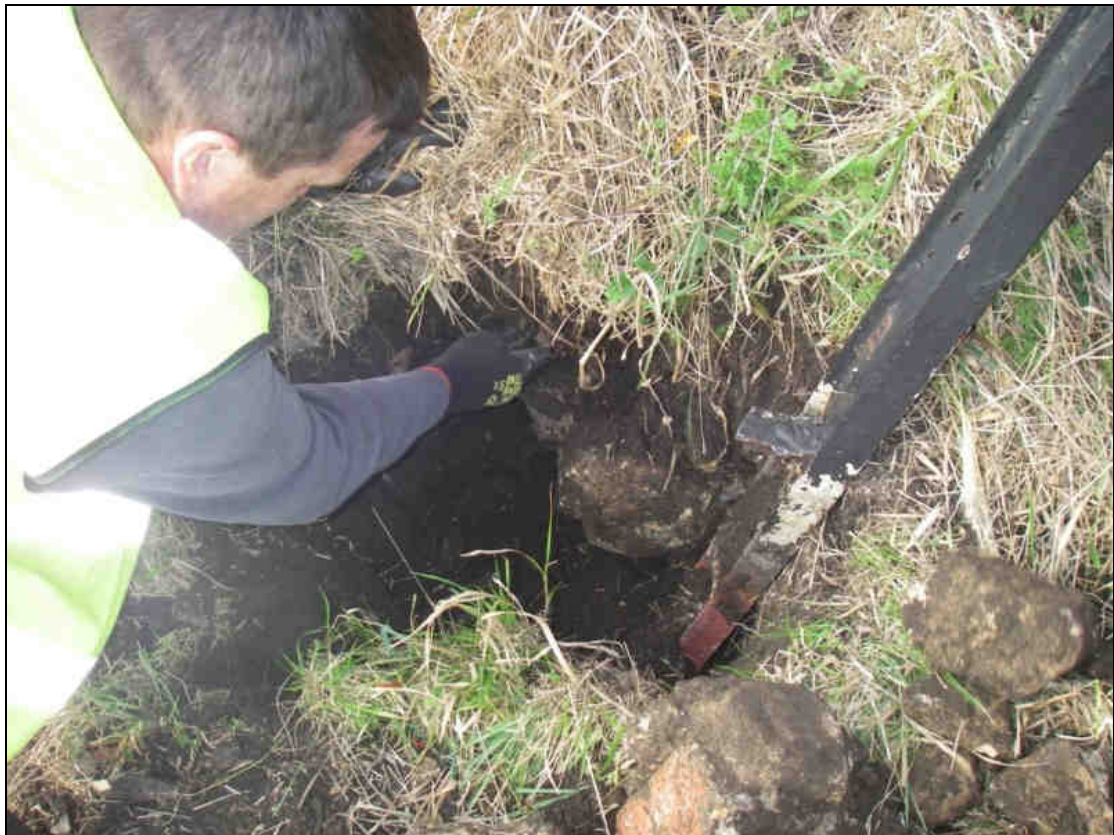
Twenty four pits were hand excavated from east to west along the collapsed section of the southern curtain wall at the top of the moat slope. The dimensions of the square pits varied between 0.50m and 0.70m in width and between 0.80m and 0.95m in depth. In pits 1-17 and 21-24 (see Fig. 2) a 0.20m deposit of topsoil overlaid a 0.20m thick deposit of rubble in a brown sandy matrix (102). In the excavations undertaken in the 1970s this deposit was identified as the residue of the collapsed portions of the superstructures of the gatehouse (Johnson, 1980, pg.60). Under this deposit, evidence of the collapsed curtain wall (101) was identified.

Plate 4. Stones from a collapsed section of the curtain wall, looking north

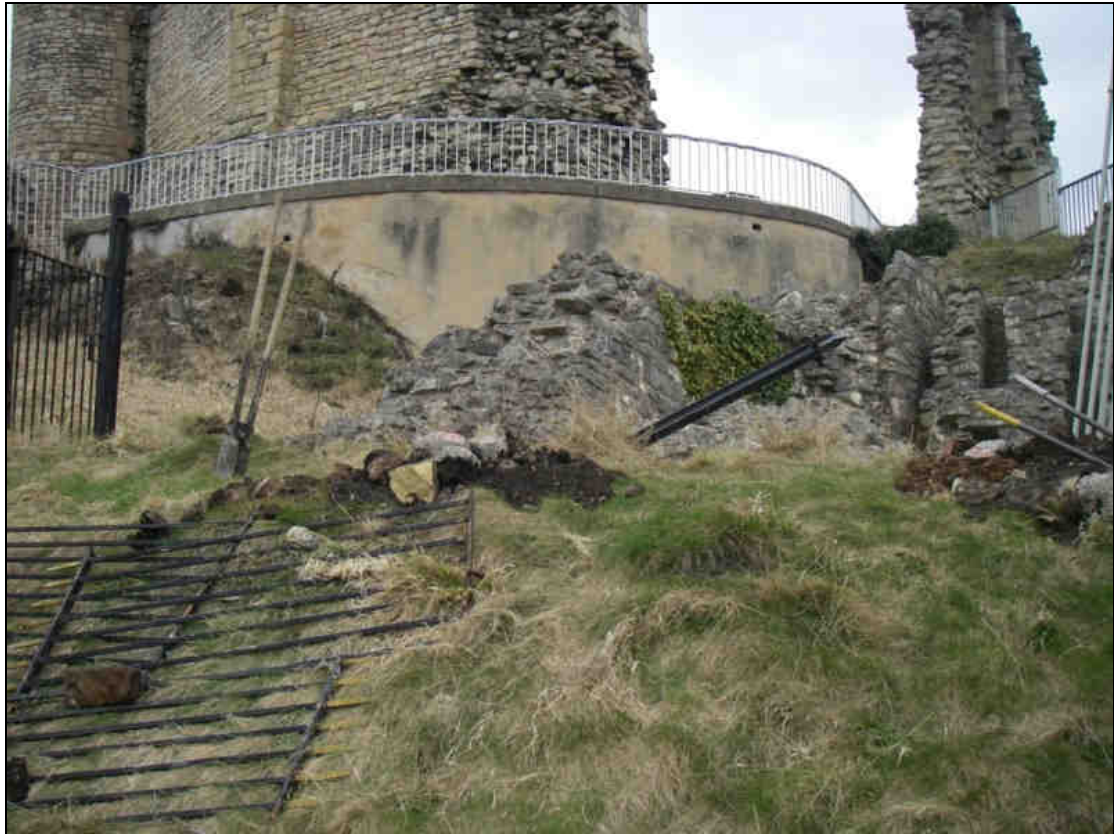
In pits 18, 19 and 20 (see Fig. 2, Pl.6) the topsoil appeared to be overlying a rich, organic, black deposit containing fragments of animal bones, oyster shells and a few fragments of pottery. This deposit may be related to the collapsed latrine double chute just metres away.

Plate 5. Pits 18 and 19 and the collapsed latrines, looking north

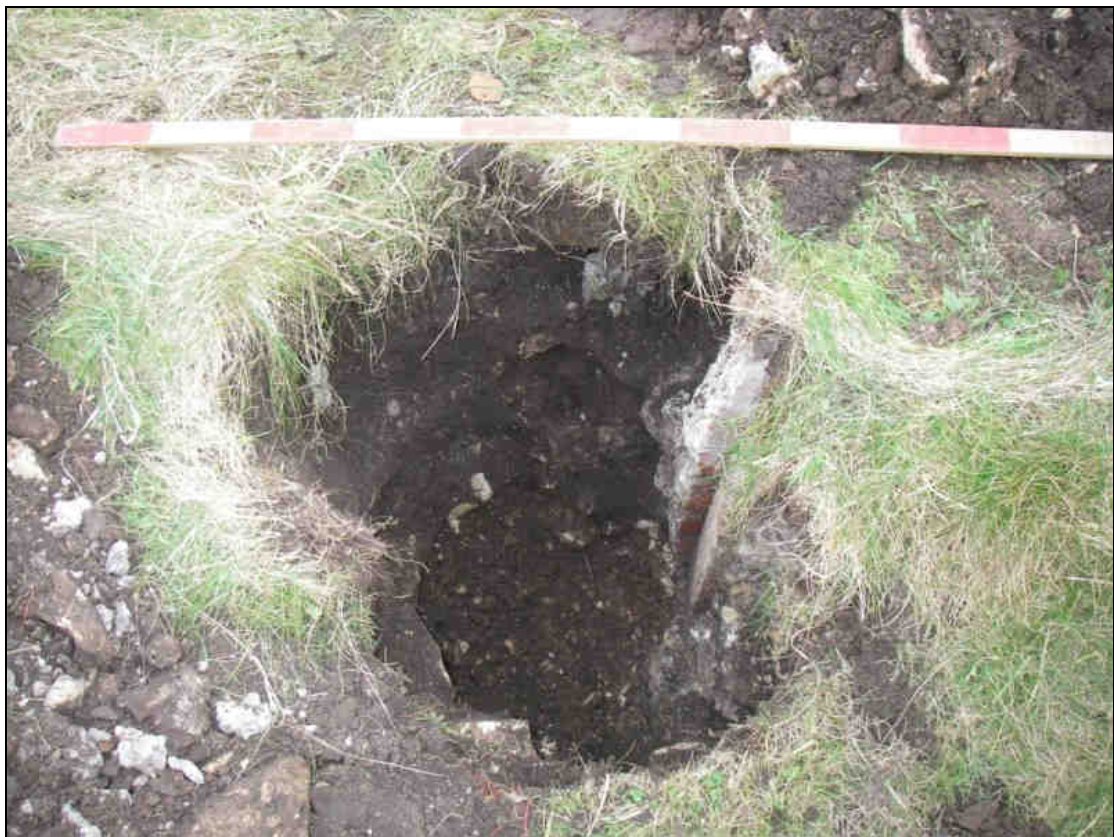
Context 103: One sherd of Coal Measures Purple ware with thick purple glaze externally; 15th to 16th century.

Context 103: One sherd of fine Coal Measures Whiteware, unglazed and undecorated; Late 13th to late 14th century.

Context 103: one small, abraded sherd in a fine buff/orange fabric containing abundant fine rounded quartz grit and occasional dark non-crystalline inclusions, probably a Coal Measures ware but much finer than normal; probably later 13th to 14th century.

Plate 6. Pit 18, looking north

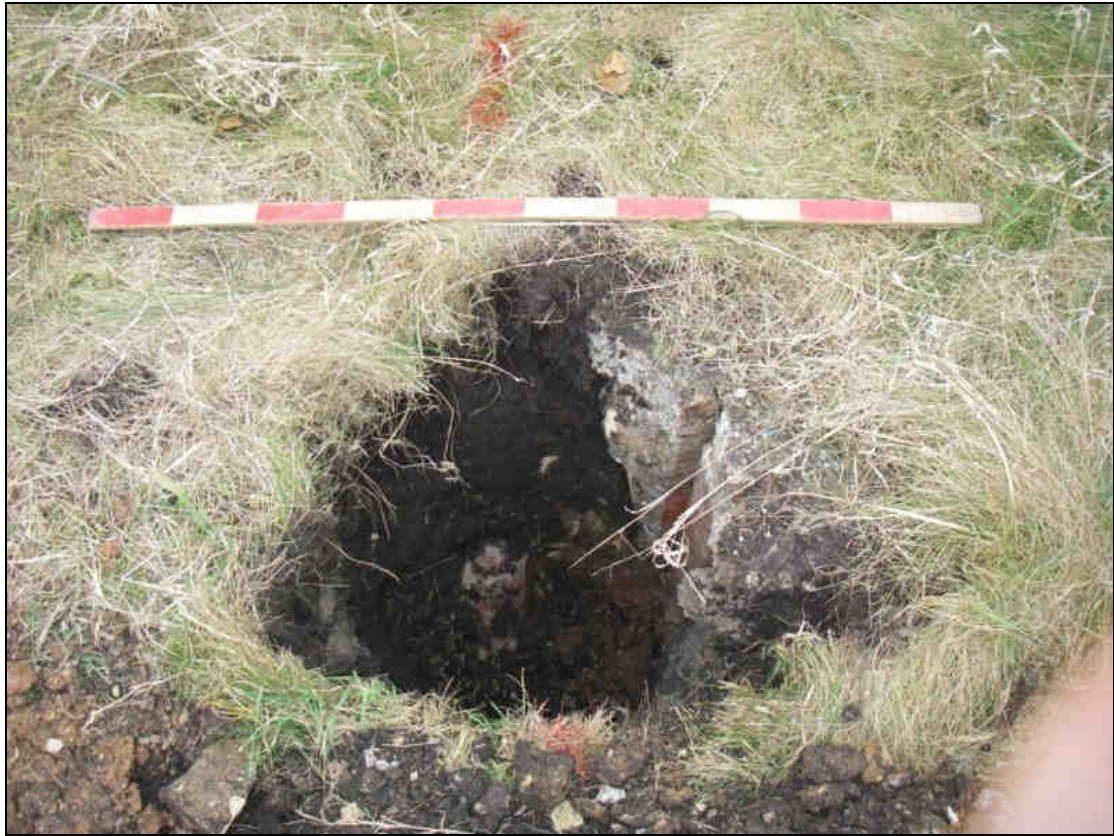
Context 104: Two joining sherds in a fine Coal Measures whiteware fabric; hard, fine, unglazed and undecorated; Late 13th to late 14th century.

Plate 7. Pit 19, looking north

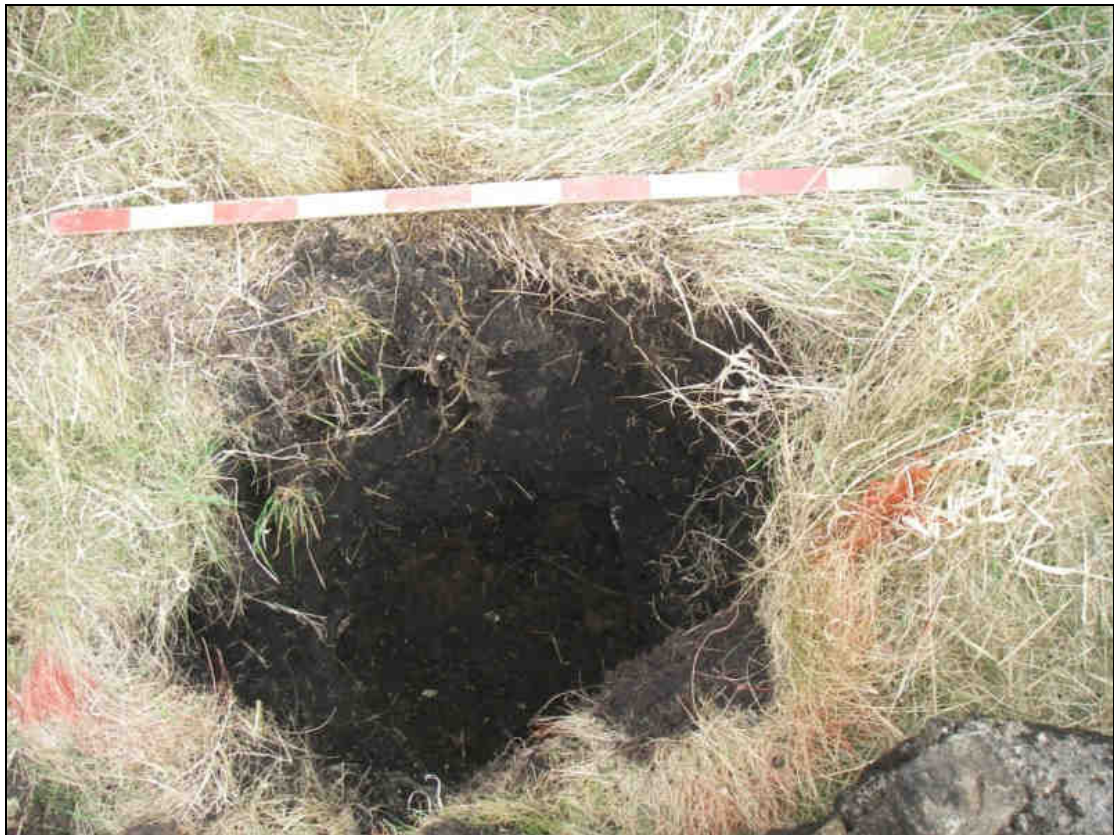
Plate 8. Pit 20, looking north

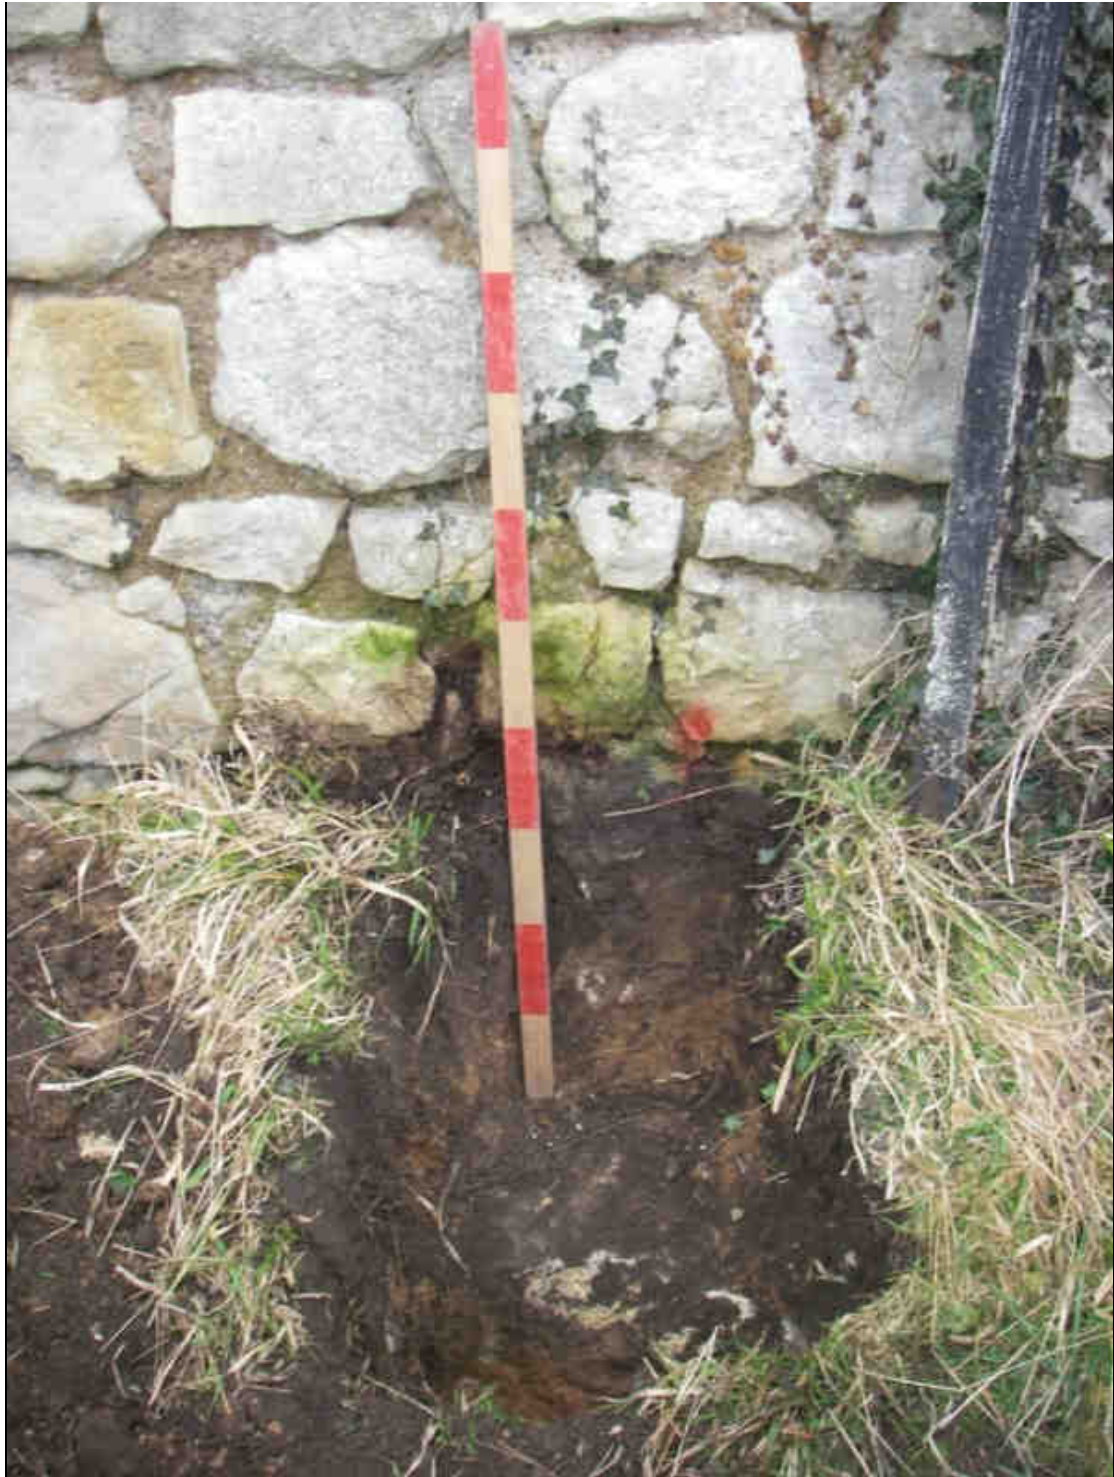
Plate 9. Pit 24 and top of the Barbican wall footing, looking north
