Wetherby Health Centre
St James Street
Wetherby
West Yorkshire

Archaeological Evaluation

Report No. 2115

**Wetherby Health Centre
St James Street
Wetherby
West Yorkshire**

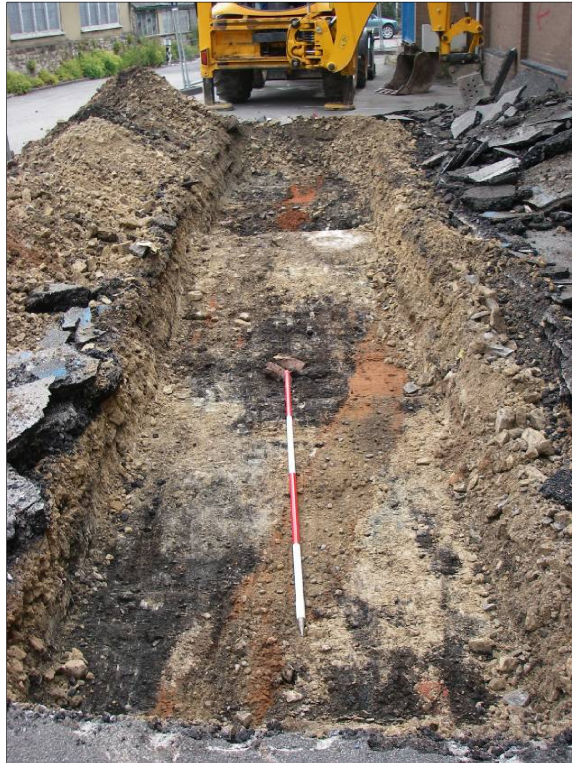
Plate 1. Trench 1, looking east

Trench 1 was located north of the health centre building in an area of tarmac. In order to maintain access to domestic residences and a funeral directors the trench had to be moved as close as possible to the health centre. Two service pipes and a large concrete capped pipe were present preventing any excavation in excess of 0.65m below ground level although made ground was encountered at this level.

Sample section: East end, south facing (0.00 = 28.23m aOD)		
Orientation: E/W		Dimensions: 10m by 2m
Context	Depth	Description
103	0.00 – 0.15m	Tarmac surface
104	0.15 – 0.50m	Limestone hardcore bedding for 103
108	0.50 – 0.65m	Loose layer of limestone backfill also bedding for 103
105	0.65m+	Made ground deposit. Dark grey to black with limestone inclusions and rubble

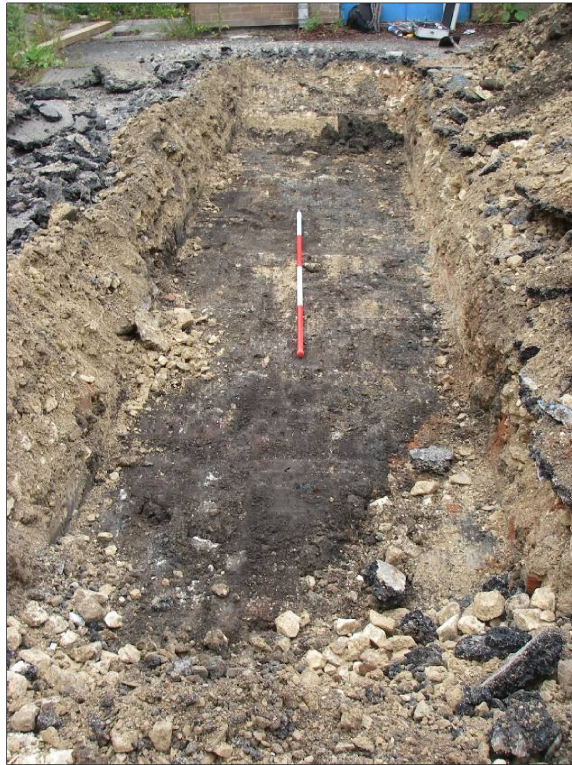
Plate 2. Trench 2, looking west

Trench 2 was located along the north-eastern side of the health centre. The trench was shortened by 2m at its eastern end due to the presence of gas and electric services. The western part of the trench also contained modern drains with a large concrete covered pipe running north to south, 3.8m from the western edge of the trench. A sondage was excavated down to a depth of 1.53m below the ground surface in the centre of the trench. This was excavated through several layers of made ground and dump deposits that are interpreted as quarry backfill. Natural deposits were not reached.

Sample section: Central part of trench, north facing (0.00 = 28.22m aOD)		
Orientation: E/W		Dimensions: 8m by 2m
Context	Depth	Description
103	0.00 – 0.08m	Tarmac surface
104	0.08 – 0.38m	Limestone hardcore bedding for 103
108	0.38 – 0.63m	Loose layer of limestone backfill also bedding for 103
105	0.63 – 1.43	Made ground deposit. Dark grey to black with limestone inclusions and rubble
109	1.43 – 1.53	Thin sandy layer, dump deposit
110	1.53+	Dark purple, black industrial cinder waste

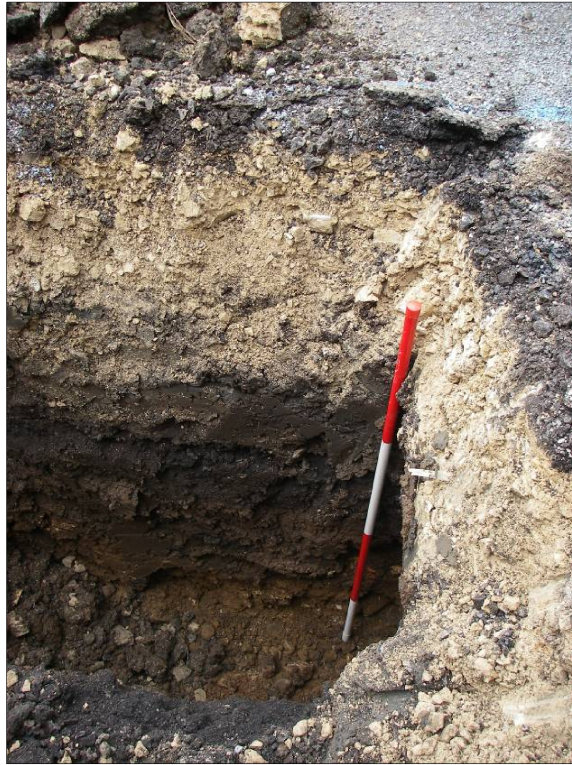
Plate 3. Sondage within Trench 3, looking west

Trench 3 was located against the eastern boundary of the site against the graveyard boundary wall. This trench had to be shortened to allow access and car parking for adjacent businesses. The northern part of the trench was, however, excavated down to a mid brown clayey sandy

deposit 2.00m below the ground surface. This deposit has been interpreted as a natural layer although close *in situ* inspection was not possible due to the friable nature of the deposits and the restricted access.

Sample section: North end, east facing (0.00 = 27.98m aOD)		
Orientation: N/S		Dimensions: 5m by 2m
Context	Depth	Description
103	0.00 – 0.15m	Tarmac surface
104	0.15 – 0.50m	Limestone hardcore bedding for 103
105	0.50 – 1.30m	Made ground deposit. Dark grey to black with limestone inclusions and rubble
115	1.30 – 2.00	Greyish brown sandy silty clay contains limestone inclusions and cobbles
102	2.00+	Mid yellowish brown sandy deposit – possibly natural?

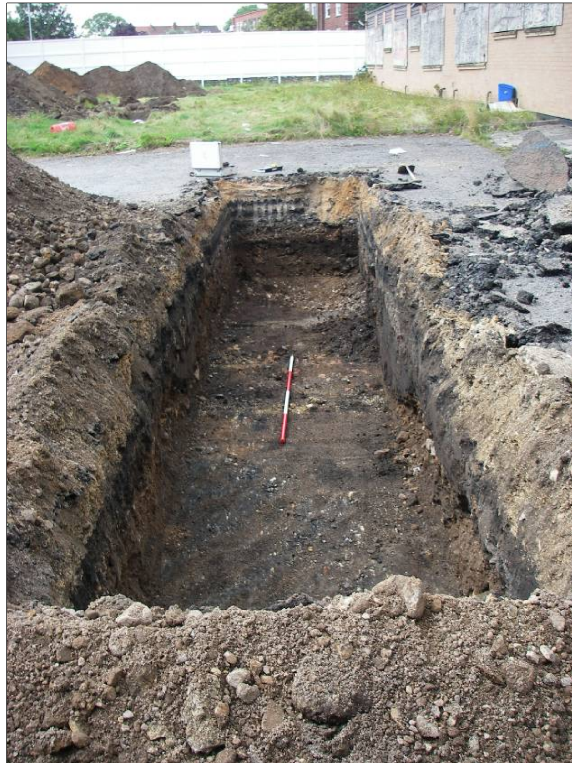
Plate 4. Trench 4, looking west

Trench 4 was located immediately south of the health centre as close as possible to the building in order to reduce disruption. The trench was excavated down to a depth of 1.40m below the current ground surface along its whole length exposing made ground and dump deposits infilling the old quarry workings. No deeper excavation was possible as the upper deposits 115 contained an abundance of unconsolidated material that collapsed part of the northern section of the trench.

Sample section: East end, North facing (0.00 = 28.34m aOD)		
Orientation: E/W		Dimensions: 10m by 2m
Context	Depth	Description
103	0.00 – 0.05m	Tarmac surface
104	0.05 – 0.30m	Limestone hardcore bedding for 103
105	0.30 – 0.60m	Made ground deposit with intermittent bands of sandy material
115	0.60 – 0.75	Greyish brown sandy silty clay contains limestone inclusions and cobbles
116	0.75 – 0.95	Mid brown stony clay
117	0.95 – 1.40+	Black made ground deposit with abundant gravels

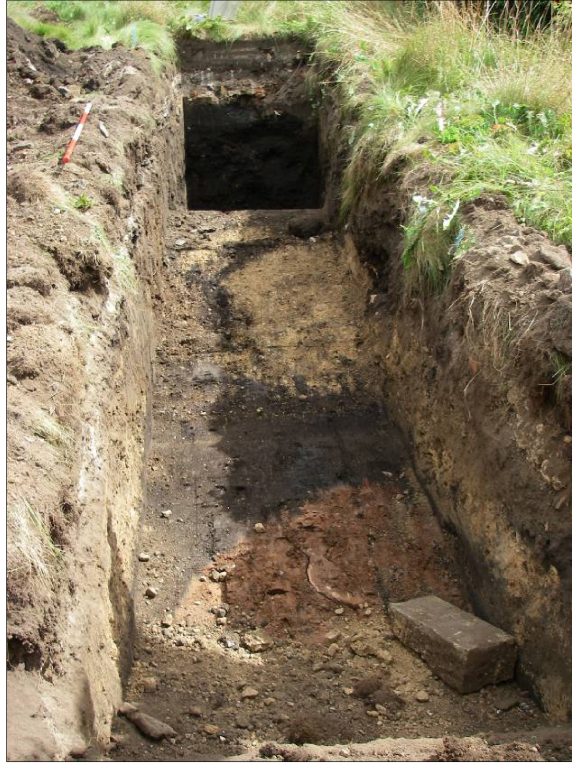
Plate 5. Trench 5 with sondage at far end of trench, looking east

The whole trench was excavated to 1.2m below the current ground level with a sondage excavated at the eastern end of the trench to a depth of 2.7m. A small area of possible natural material was identified at the base of the sondage, but only along the southern side. This may

indicate a stepped area or banked area along the edge of the former extraction zone. The remainder of the trench contained dumped deposits comprising limestone material overlying a mid reddish brown unconsolidated brick. These deposit were sealed by the made ground deposit 105. All deposits are interpreted as quarry backfill.

Sample section: East end, south facing (0.00 = 28.34m aOD)		
Orientation: E/W		Dimensions: 10m by 2m
Context	Depth	Description
100	0.00 – 0.30	Topsoil
113	0.30 – 0.40	Tarmac / concrete surface
105	0.40 – 2.70	Made ground deposit. Dark grey to black with limestone inclusions and brick rubble
103	2.70+	Natural deposit?

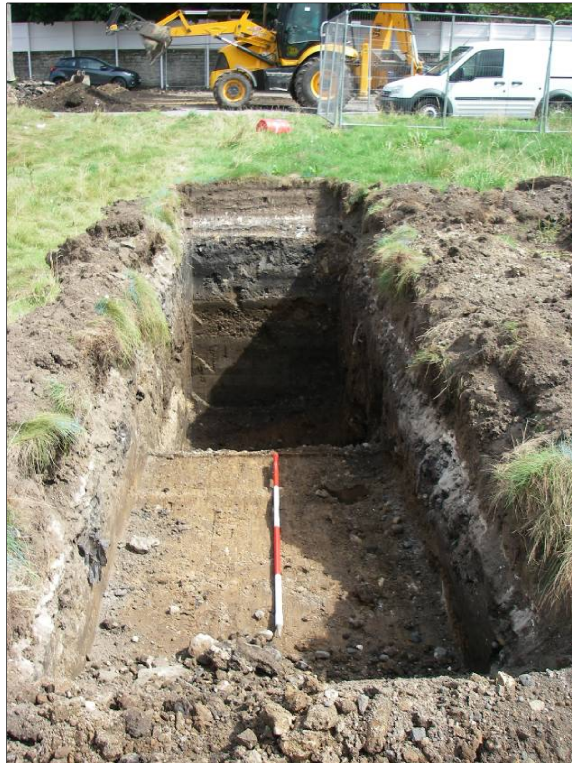
Plate 6. Trench 6 with sondage at far end, looking west

Trench 6 was located in the grassed area to the south of the health centre. The western half was excavated to 1.30m below the current ground level with the eastern half taken down to 2.40m below the ground surface. Once again only layers of made ground were uncovered with a tarmac and concrete surface identified just below the topsoil. The remainder of the deposits are interpreted as layers of backfill material. Natural deposits were not encountered.

Sample section: East end, South facing (0.00 = 28.34m aOD)		
Orientation: E/W		Dimensions: 10m by 2m
Context	Depth	Description
100	0.00 – 0.40	Topsoil
113	0.40 – 0.60	Tarmac / concrete surface
105	0.60 – 1.70	Made ground deposit. Dark grey to black with limestone inclusions and rubble
111	1.70 – 2.00	Layer of limestone material dump, sandwiched between made ground deposits
105	2.00 – 2.40	Made ground deposit. Dark grey to black
112?	2.40+	Dark brown stony clay exposed but not excavated

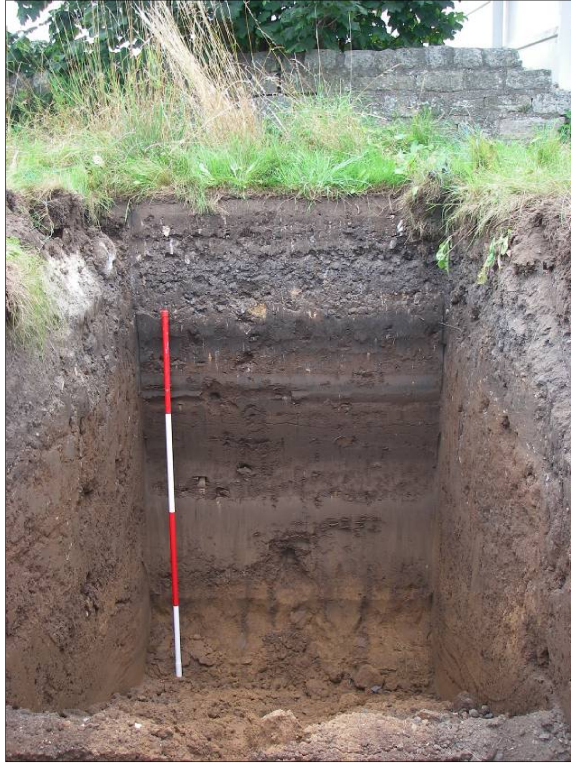
Plate 7. Southern section of Trench 7, looking south

Trench 7 was located on the western side of the development area immediately east of the public footpath known as *The Ginnel* and to the north of the stone boundary wall that runs east/west across the site. The trench was excavated down to a depth of 1.2m with a sondage down to 2.5m at the southern end of the trench. The sondage revealed a redeposited subsoil layer overlying a sandy deposit that may have been truncated or disturbed natural. Close investigation was not possible due to the depth of the trench.

Sample section: East end, south facing (0.00 = 28.60m aOD)		
Orientation: N/S		Dimensions: 10m by 2m
Context	Depth	Description
100	0.00 – 0.20	Topsoil
113	0.20 – 0.35	Tarmac / concrete surface
105	0.35 – 0.85	Made ground deposit. Dark grey to black with limestone inclusions and rubble
118	0.85 – 1.80	Brown sandy silt subsoil, buried soil layer
102	1.80 – 2.50+	Yellow brown medium sand, possibly natural.

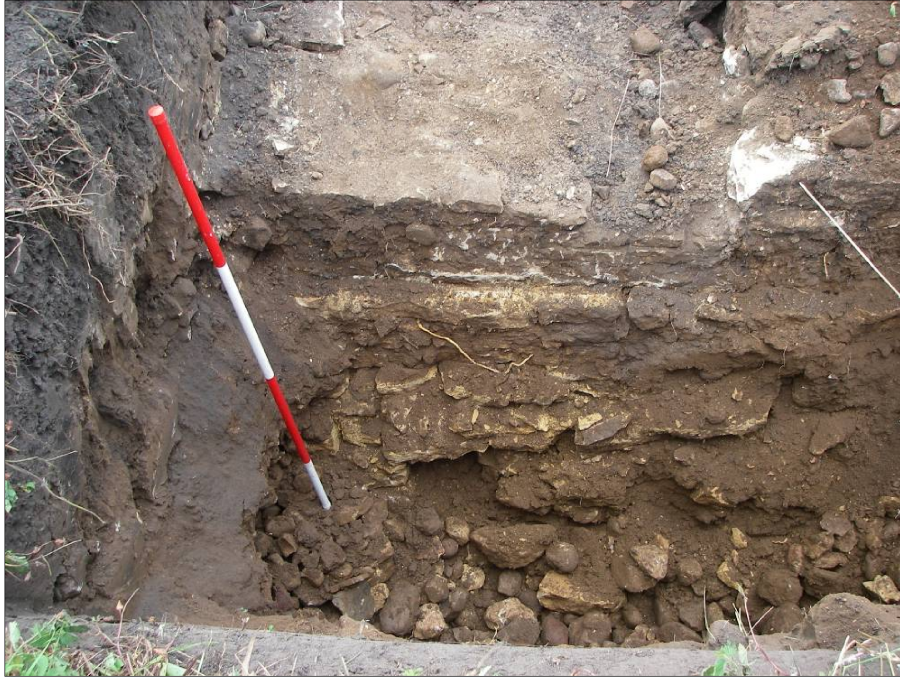
Trench 8 was located in the overgrown area in the southern part of the site. The northern end of the trench butted up against the extant stone boundary wall (106). The remains of an earlier boundary wall were encountered 1m below the current ground surface immediately south of the current boundary wall. In order to ensure safe working the northern end of the trench was stepped out to the west to enable safe investigation of this feature. The wall was aligned east/west, was constructed from un-bonded limestone and is interpreted as the boundary to the former gravel extraction area. The wall was 0.90m wide and at least 1.50m deep although its full extent was not determined due to collapse during excavation of deposits on the northern side of the feature. A slight step was recorded, 0.45m from the top of the exposed wall, and appears to form a type of foundation. The lower part of the wall was also notably rougher and more coarsely constructed.

To the north of the wall a sondage was excavated to a depth of 2.8m from the current ground level. This revealed topsoil 0.60m thick beneath which was a stony subsoil 1.10m thick that contained an abundance of modern pot and animal bone. This was in turn above a deposit of large pebbles/cobbles (108) between 0.1m and 0.3m in size. About 1m of this deposit was excavated out before it collapsed, undermining part of the northern section, therefore prohibiting any further excavation.

Plate 9. Trench 8, showing Wall 106 with slot excavated down its north face, looking south

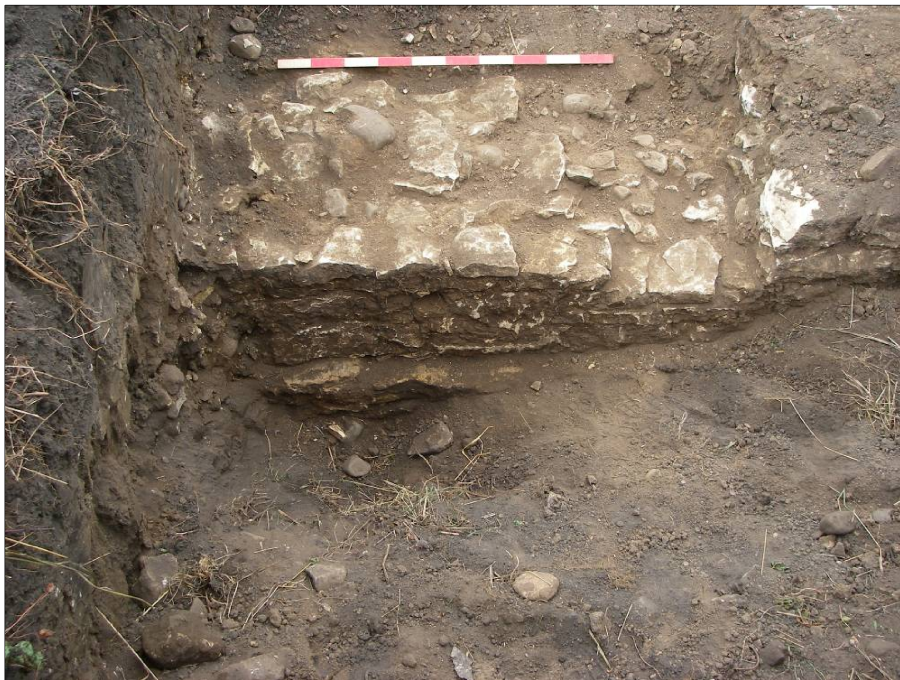
Plate 10. Upper part of Wall 106, looking south

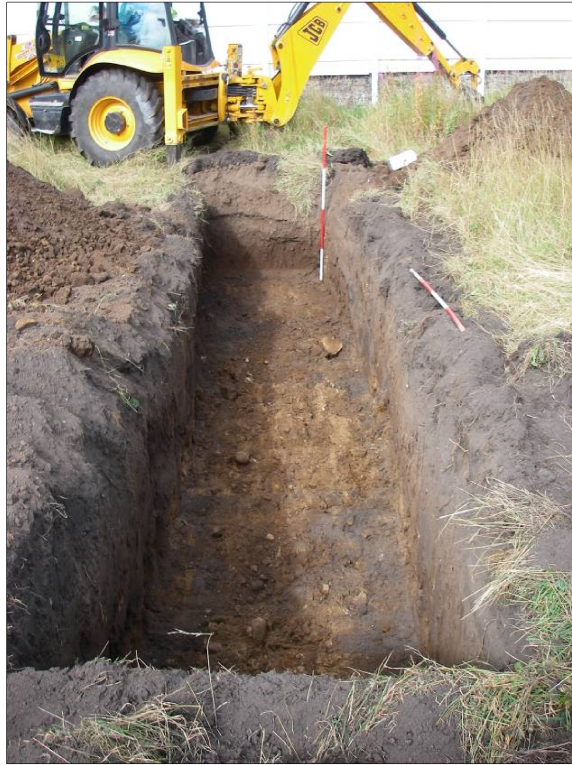
Plate 11. Trench 9, looking west

Trench 9 was also located in the overgrown patch of land to the south of the development site. Only topsoil and subsoil deposits were exposed within this trench with natural gravels encountered between 1.40m and 1.65m below ground level. No archaeology was exposed within the trench.

Sample section: South end, west facing (0.00 = 28.56m aOD)		
Orientation: E/W		Dimensions: 10m by 2m
Context	Depth	Description
100	0.00 – 0.60	Topsoil
101	0.60 – 1.65	Subsoil deposit. Very thick deposit may be product of stockpiling subsoil from quarried area to north
102	1.65+	Mid brown sandy gravels with thin sandy interface to subsoil 101
