**Fishlake Endowed School, Fishlake
South Yorkshire**

Report no. 2486

July 2013

Archaeological Building Recording

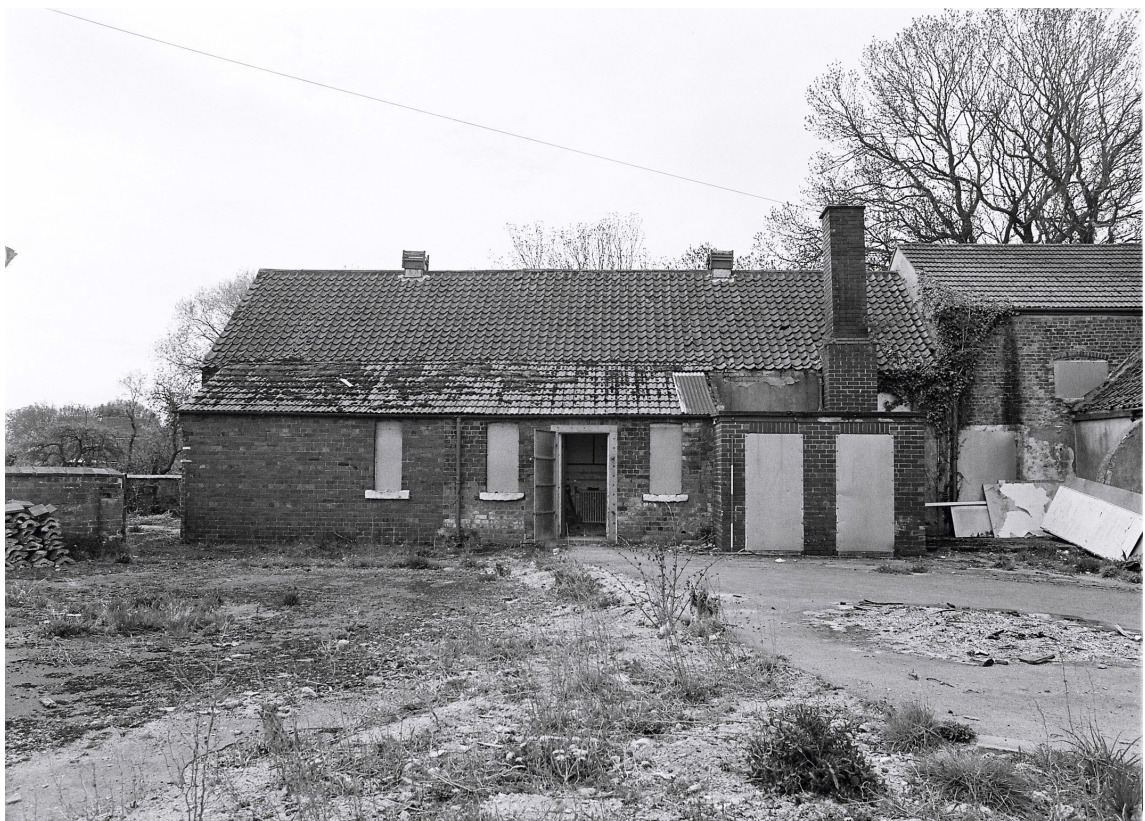
Photograph 2 Film 4_001 Direction S

The lean-tos, attached to the north elevation of the single-storey extension, principally functioned as cloakroom rooms (Photograph 2). Internally there are two separate cloakroom areas. The cloakroom to the east is lit by a single window opening with a stone sill and a segmental brick arch. Externally, there is a straight joint in the brickwork between the two cloakrooms. The cloakroom to the west has a central doorway with a stone step, although, no further detail was noted due to the presence of modern boarding. The door is flanked on either side by two windows, both with stone sills and segmental brick arched heads (Photograph 2). At the west end of the lean-tos there is a later attached flat-roofed extension that projects beyond the line of the lean-tos and houses a modern boiler, this later extension has two doorways in the north elevation, each with a stone step and a brick segmental arch. Projecting above the flat roof and over the boiler house, is a tall stepped, modern brick chimney stack (Photograph 3). On the west elevation of boiler house there is a small central window opening that has a wooden sill and a rowlock brick head. West of the boiler house, the remaining visible part of the north elevation of the eastern extension is heavily rendered

North elevation of the schoolroom extension and the lean-tos with the later boiler house to the right of the picture

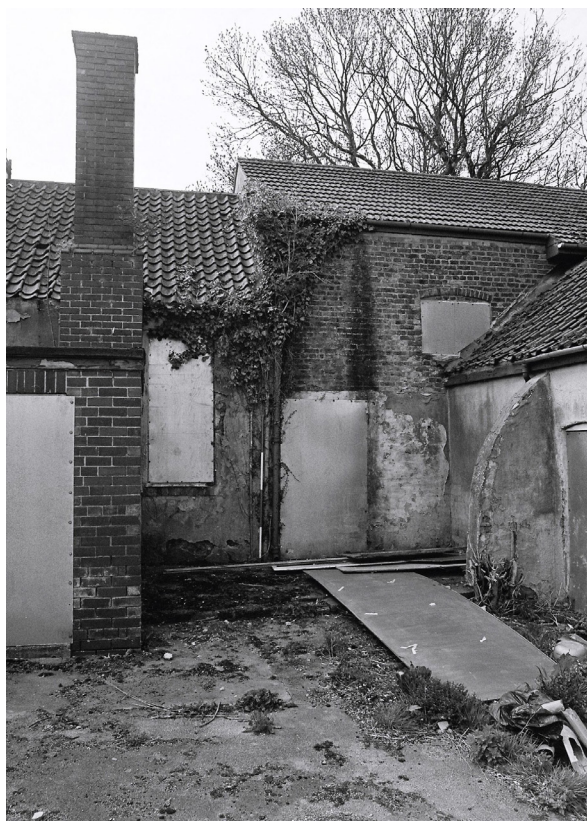
Photograph 4 Film 4_005 Direction S

and contains a single window opening fitted with a wooden frame and a brick sill (Photograph 4).

Exposed brickwork on the north elevation of the schoolhouse

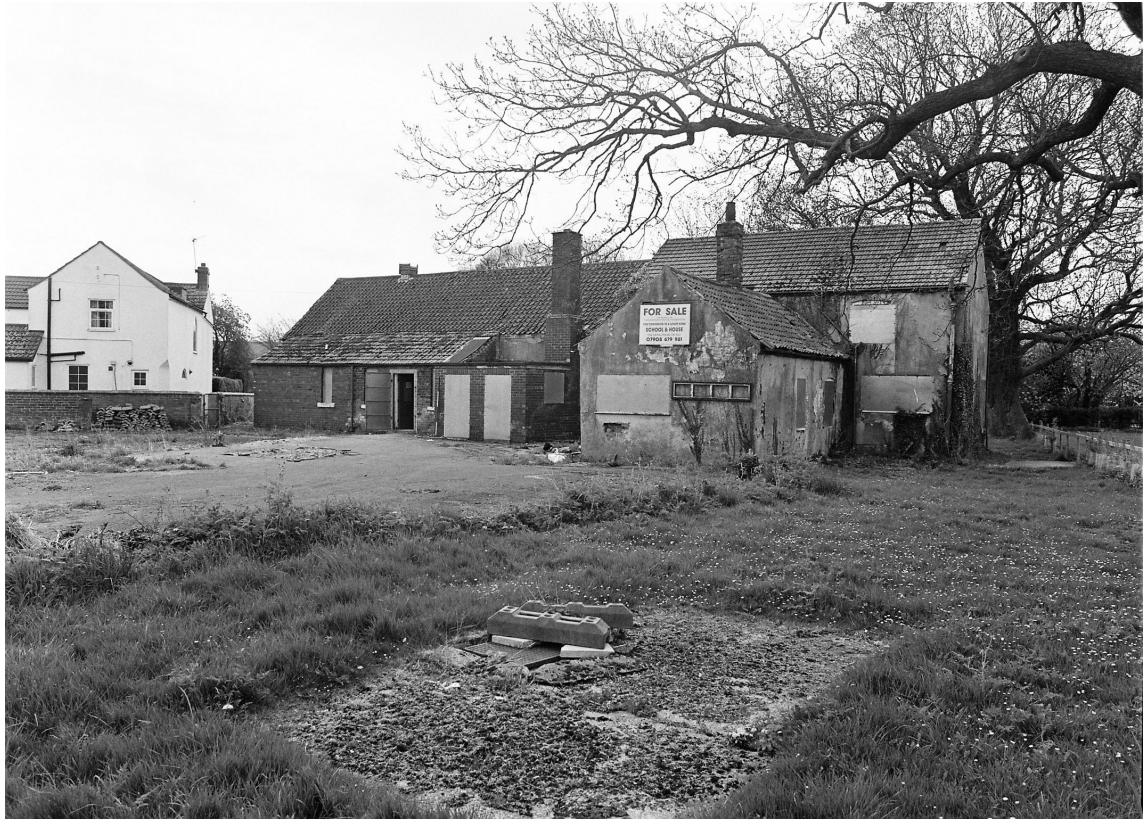
Photograph 5 Film 4_003 Direction SE

The north elevation of the schoolhouse is partially obscured by the single-storey extension (Photograph 5). Due to an internal wall thickness change in the north elevation, the roof over north-west corner of the schoolhouse slightly overhangs the north extension. (Photograph 4). The north elevation of the schoolhouse has two window openings to the first floor. The eastern window opening is cut by the northern extension and the head has been altered to accommodate a later window frame (Photograph 4). At ground-floor level there is a blocked doorway to the east side of the northern extension and a blocked window opening to the west. The north elevation of the schoolhouse to the east of the extension has an area of exposed early handmade brickwork at first-floor level with an English Garden wall bonding. At ground-floor level, the brickwork is obscured by the remains of a plaster coating, left over from a now demolished structure.

The northern extension has a pitched roof and all the external walls are heavily rendered (Photograph 5). The north elevation is gabled, and has a wide window on the ground floor and an air vent to the attic space above. The east elevation of the extension has a curved buttress, to the north of which are two boarded entrance doorways with a boarded window opening between (Photograph 6). The west elevation of the extension has a central window opening with a wooden sill and a segmental arched-headed window opening to the right. In this area some of the render has come away to reveal the brickwork beneath (Photograph 7).

General view of the school showing the extension to the north

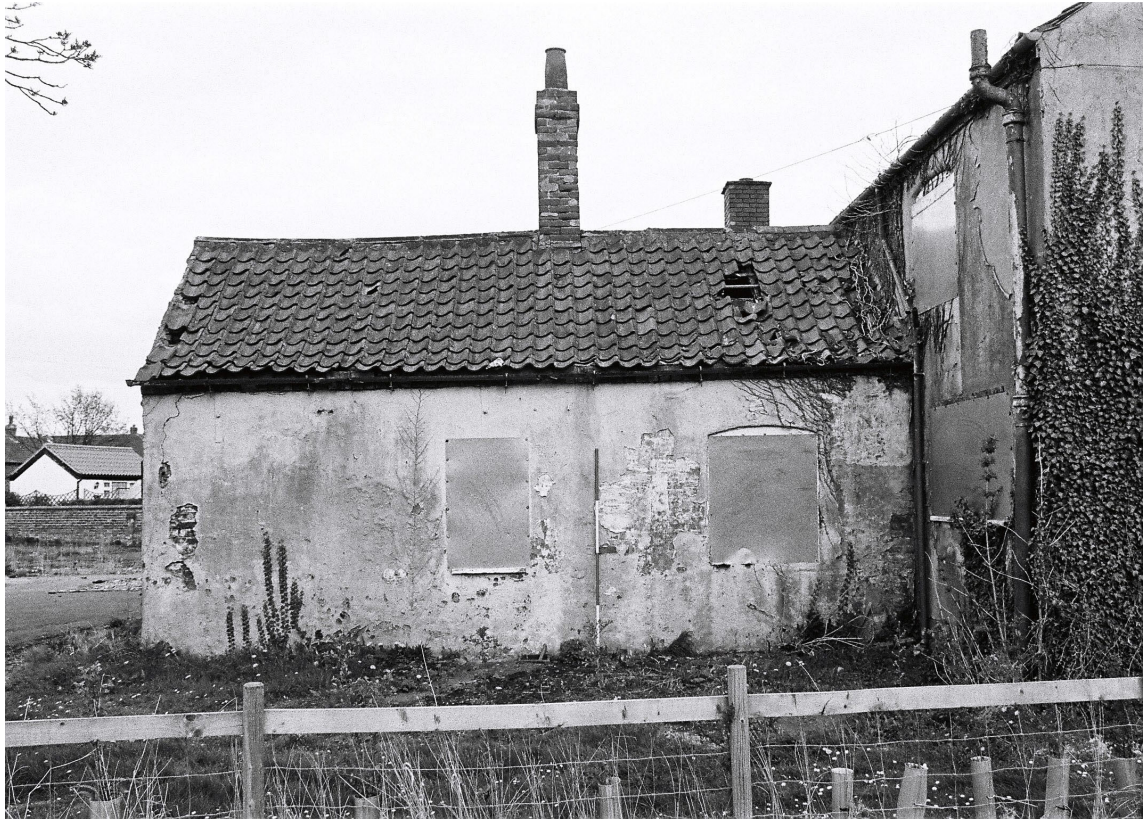
Photograph 7 Film 1_030 Direction E

West elevation of the northern extension to the schoolhouse

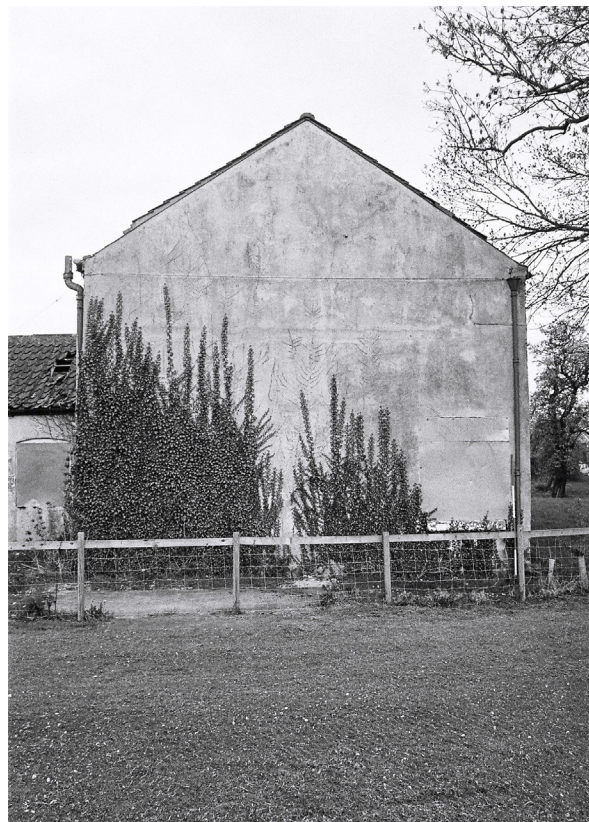
Photograph 8 Film 1_031 Direction E

The west elevation of the main schoolhouse is gabled and heavily rendered with extensive ivy growth. At ground-floor level there is a boarded over window opening with a stone sill towards the southern end of the gable. (Photograph 8).

Rendered west gable of the schoolhouse

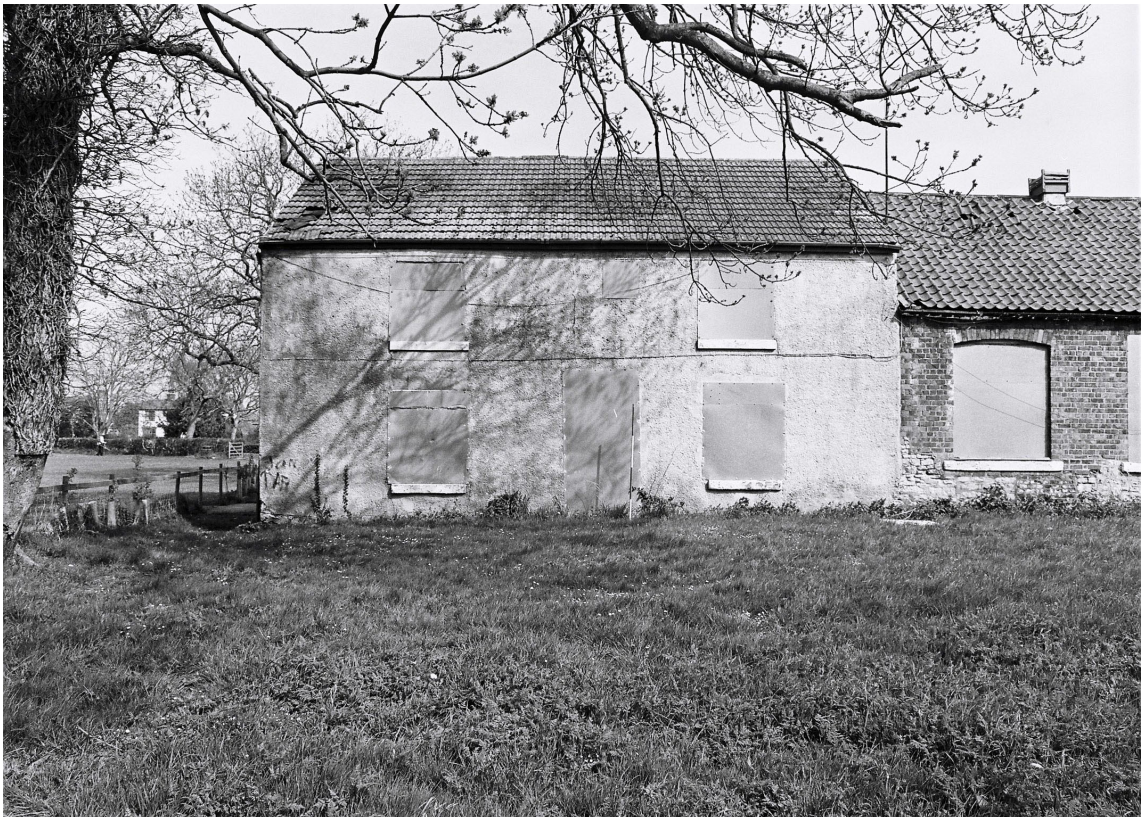
Photograph 12 Film 4_007 Direction N

The south elevation of the schoolhouse is also rendered. On the ground floor there is a central doorway flanked either side by a window opening with a stone sill, and to the first floor there are two similar window openings. Above the doorway and in line with the heads of the first-floor windows there is a small inserted square window opening (Photograph 12).

South elevation of the schoolhouse

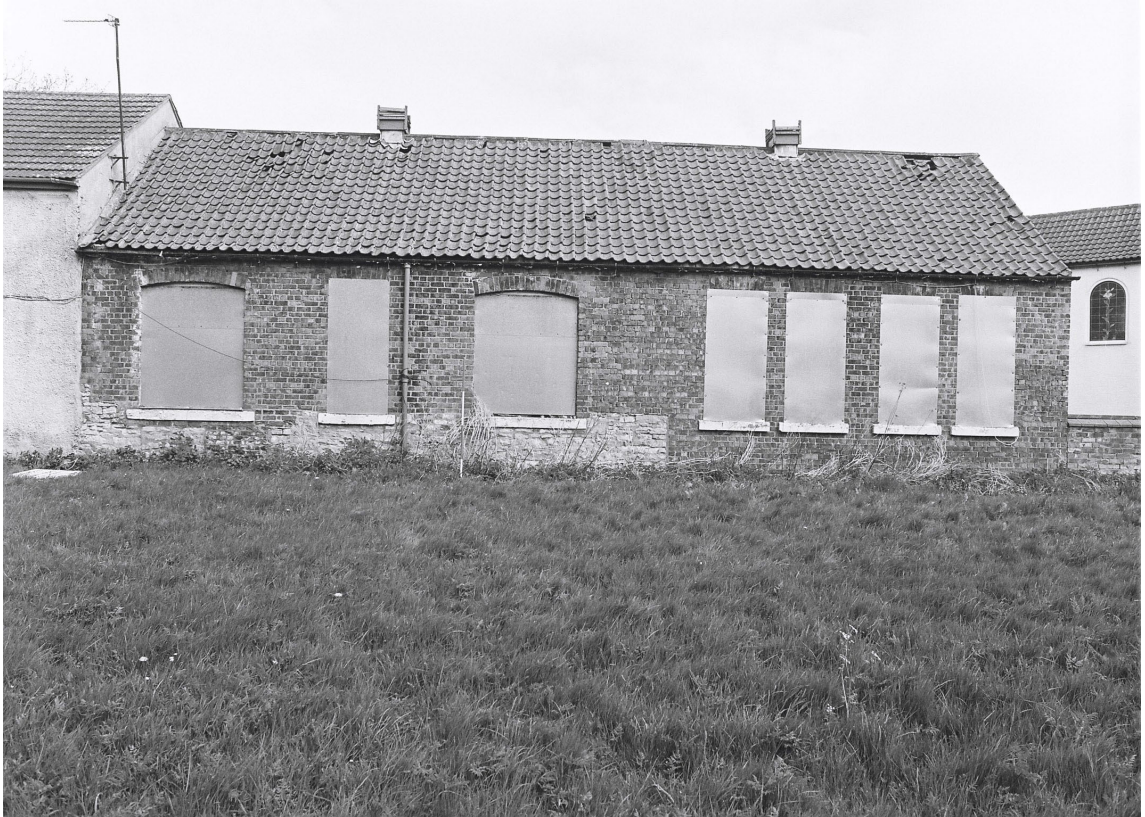
Photograph 13 Film 4_010 Direction N

The south elevation of the eastern classroom extension is built largely of brick, although the lower courses, up to and including the sills, of the western most classroom are constructed in stone (Photograph 14). Above the stonework the brickwork appears to be continuous with the rest of the elevation. The western classroom is lit by three window openings, one narrow central opening with two wider openings either side. All the window opening have stone sills and brick segmental arches (Photograph 14). The eastern classroom has two pairs of windows, all rectangular in shape with flat brick arches and stone sills (Photograph 13).

South elevation of the classroom extension to the west of the schoolhouse

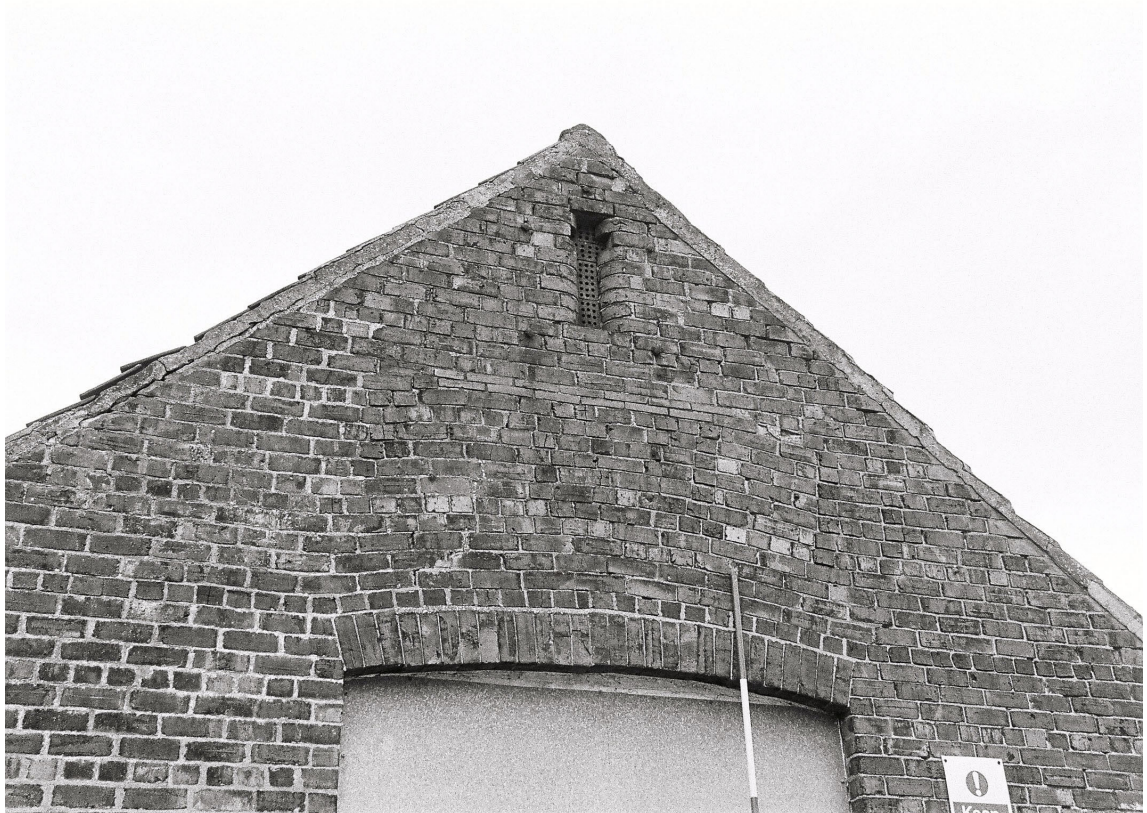
Photograph 18 Film 1_023 Direction W

The eastern elevation of the extension is gabled with a large window opening with a stone sill and a segmental brick arch. There is a central arrow slit ventilator with a brick grill at the apex of the gable (Photograph 18). Between the window and the air vent there is a decorative pattern of burnt brick headers forming the date of "1874" (Photograph 16-17). The only other feature of the east facade is the presence of a blocked doorway in the lean-to.

Detail of showing the decorative brickwork above the window and the ventilator at the apex of the gable

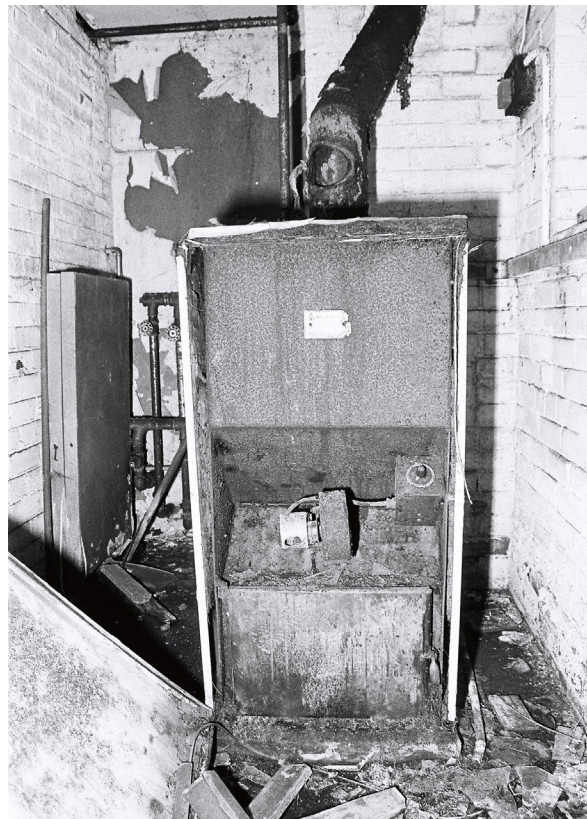
Photograph 22 Film 1_027 Direction S

The boiler room (G1) is self contained and can only be accessed from the outside via a doorway in the north wall. In the south wall there is a blocked window which would have originally lit classroom G4. The boiler room is lit from the west by a window opening with a stone sill. Centrally there is, what remains of, a modern boiler with ducting leading into the main building (Photograph 22).

Remains of the modern boiler in the boiler room G1

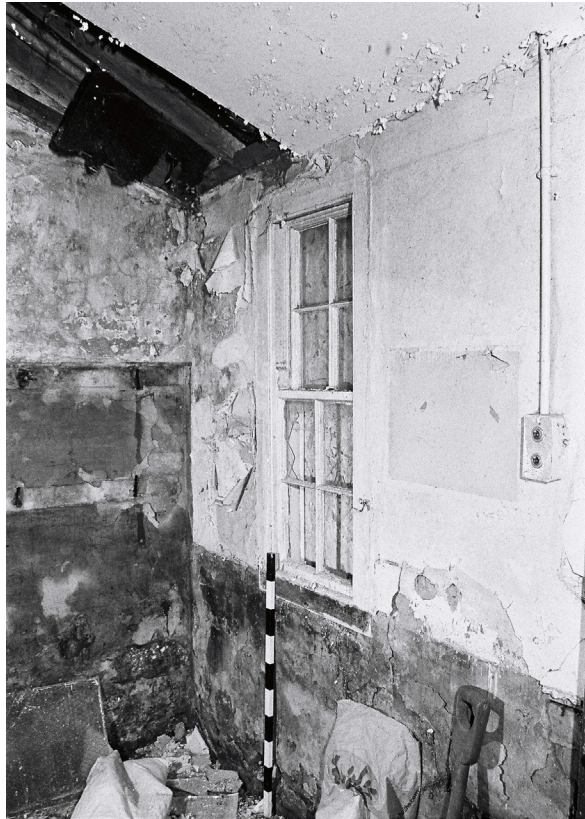
Photograph 23 Film 1_012 Direction NW

The current access doorway to the school in the north wall of the lean-to leads into a small cloakroom (G2). There is a four-over-four wooden vertical-sliding sash window to the west of the doorway in the external wall (Photograph 23). The walls are plastered and painted, and there are two further doorways off G2. One of the doorways is in the east wall leads to a storeroom (G3). G3 is lit by an identical four-over-four vertical-sliding sash window to the one that is noted in G2 (Photograph 24). The remaining doorway off G2 is in the south wall and leads to classroom G4.

Four-over-four light vertical-sliding sash window to the west of the current entrance in G2

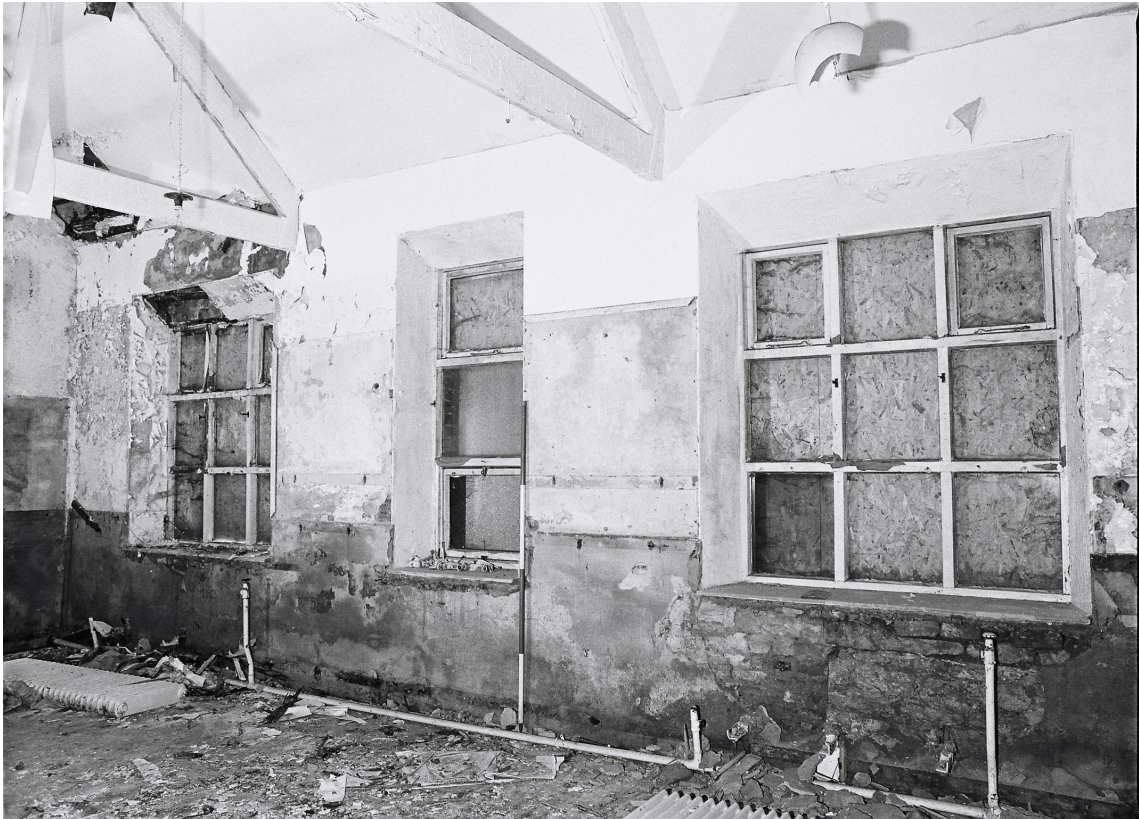
Photograph 25 Film 3_004 Direction SE

Classroom G4 is a large open space divided into three bays by two exposed shouldered king post trusses and the apex of each truss is underdrawn (Photograph 28). To the left of the entrance door, in the north wall, are two narrow chamfered window openings. One is blocked externally by the boiler room G1 and the other contains a three-light window frame with a top and bottom opener (Photograph 26). In the western wall there is a single doorway leading to the stairwell (G7) and the ground floor of the schoolhouse. On the north wall some of the plaster has been removed to reveal the underlying stone and brickwork (Photograph 25). The south wall of G4 contains three window openings. The central window opening has a three-light window frame identical to the one in the north wall. This is flanked either side by larger openings that contain nine-light frames with top and bottom openers (Photograph 25). In the east wall there is a blocked fireplace with an insert cast-iron fire back (Photograph 27), and a single chamfered doorway leading to classroom G5. There are four radiators that lay unconnected on the floor. The piping suggests that there were originally two on the north wall and two on the south wall (Photograph 25-26).

Window openings and frames in the south elevation of classroom G4

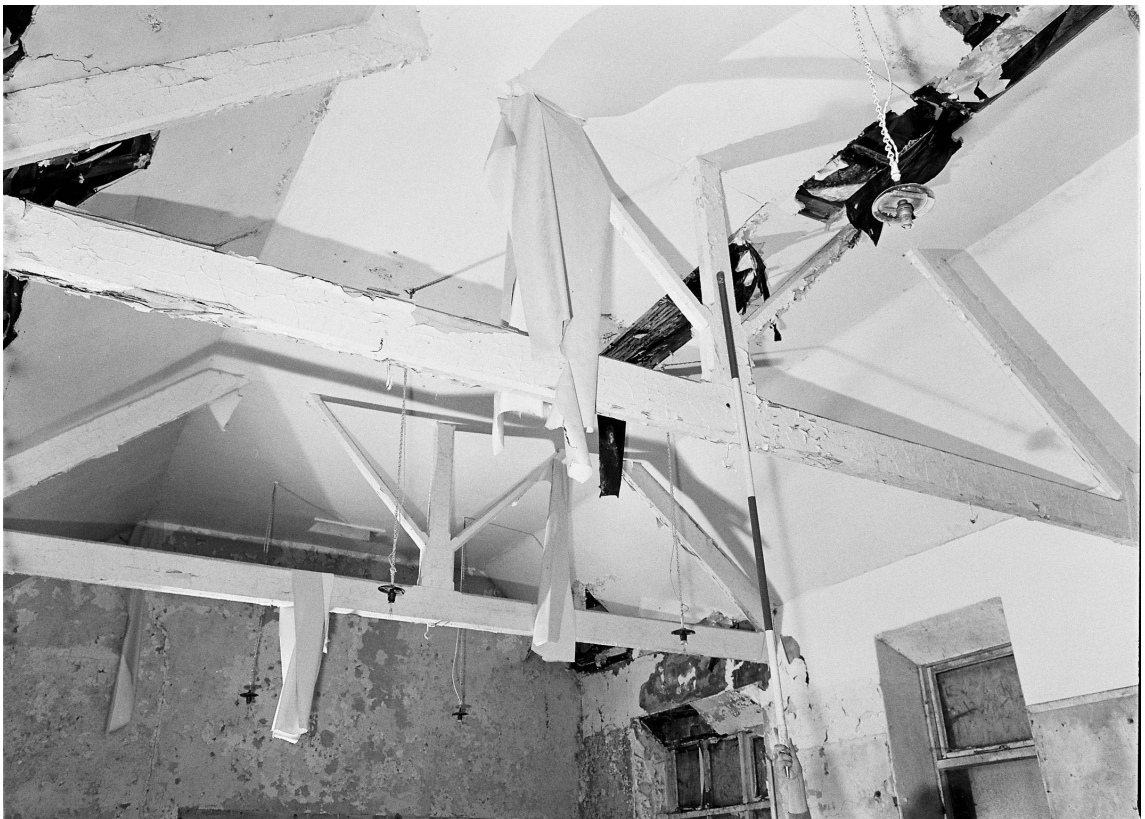
Photograph 28 Film 3_005 Direction SE

Shouldered king-post roof truss over classroom G4

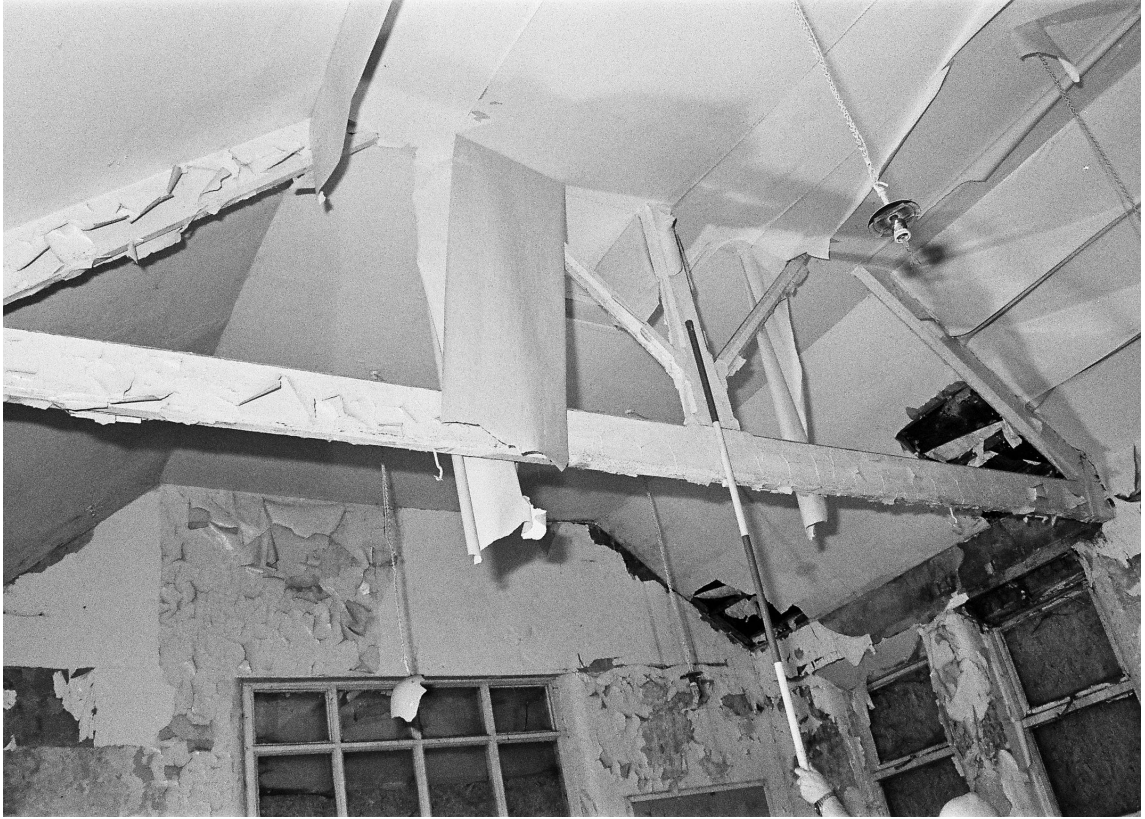
Photograph 31 Film 1_008 Direction SE

Classroom G5 has a single exposed shouldered king post truss of identical form to the one over G4, similarly the apex is also underdrawn (Photograph 31). All the internal wall surfaces are plastered and painted. There is dado rail with match boarding to the north, south and east walls below the line of the windows (Photograph 36). Overall classroom G5 is slightly smaller than G4 with a connecting door in the west wall. To the south of the connecting door there are also two blocked fireplaces in the west wall (Photograph 34), where some early

Shouldered king-post roof truss over classroom G5

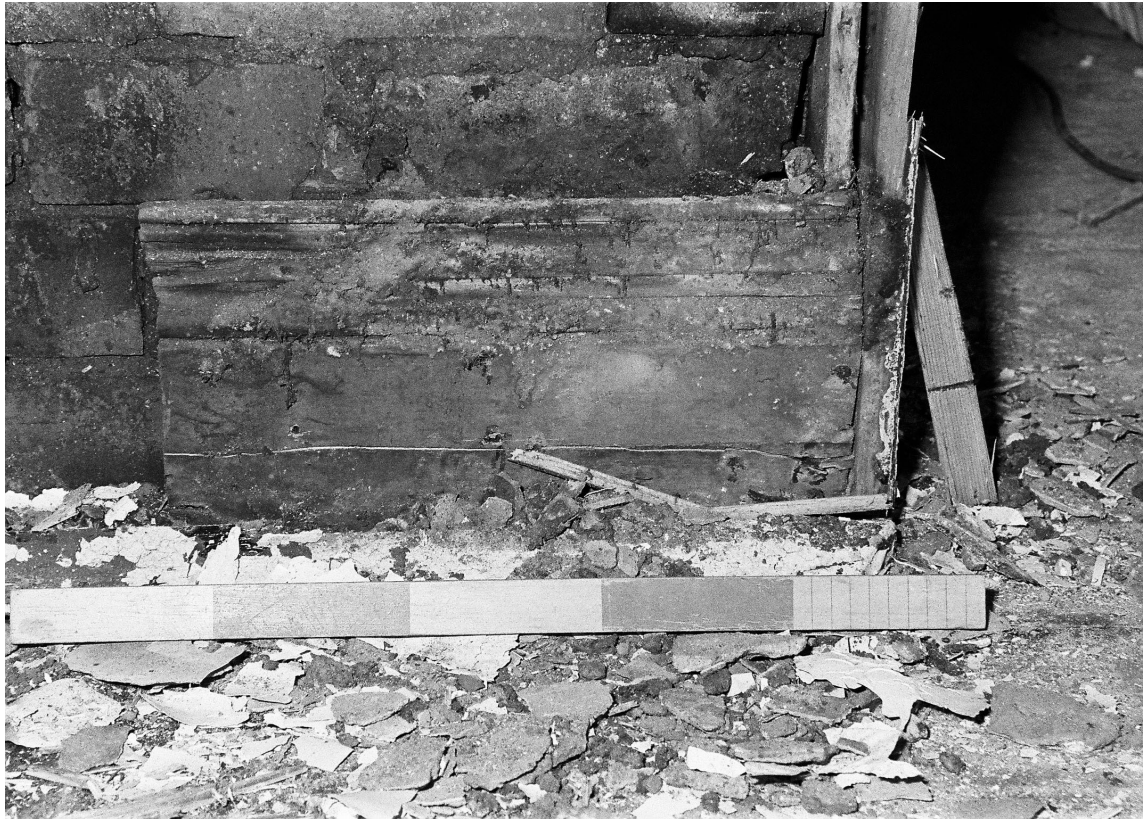
Photograph 33 Film 1_006 Direction W

skirting board survives (Photograph 33). In the south wall, there are four tall chamfered window openings with inserted three-light wooden frames that have top and bottom openers, in the same design as the central window openings in G4. There are cast-iron radiators under two of the window openings in the south wall (Photographs 29 and 35). In the east elevation, there is a central window opening in the gable end of the building with a single eight-light wooden window frame, with a large radiator below (Photograph 30). On the south elevation there is a radiator to the east side of an off-centred doorway that steps down into cloakroom G6.

Detail of a skirting board in classroom G5

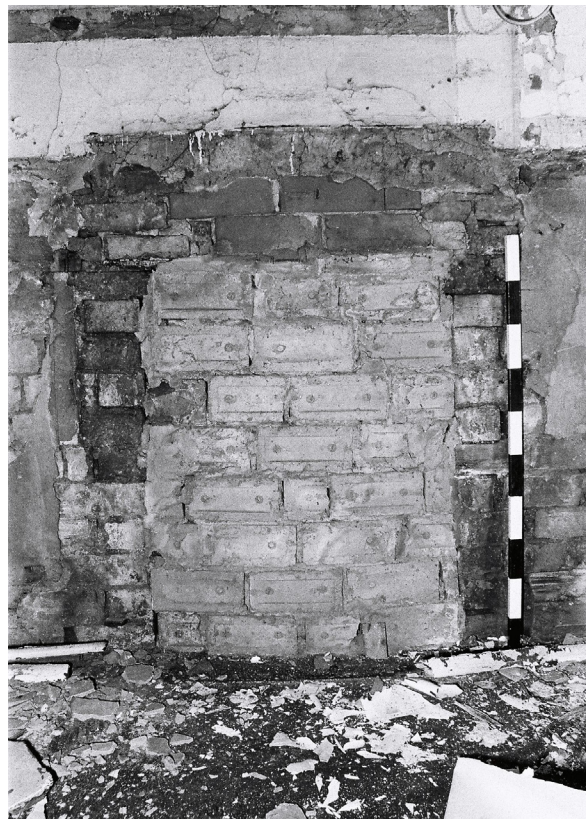
Photograph 34 Film 1_001 Direction W

Brick-blocked fireplace in the west wall of classroom G5

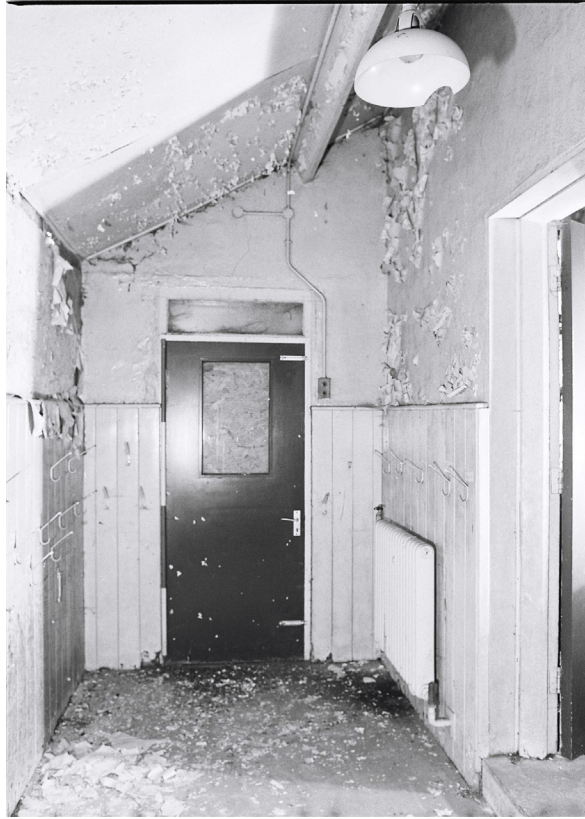
Photograph 37 Film 3_001 Direction E

Cloakroom G6 has a concrete floor with plastered and painted walls. The east side of the cloakroom has match boarding to the lower half (Photograph 37) with a number of coat hooks attached (Photograph 38). The west side of G6 is largely tiled (Photograph 39), and on the east elevation there is an entrance door to the playground to the north of the school. To the south of the entrance door, there is a cast-iron radiator fitted to the wall. The north elevation has a four-over-four vertical-sliding sash window (Photograph 40), matching these in cloakroom G2 and storeroom G3. The west elevation has two sinks fixed to the wall and the pipework for a third (Photograph 39).

Former entrance door into cloakroom G6 at the east end of the northern lean-to

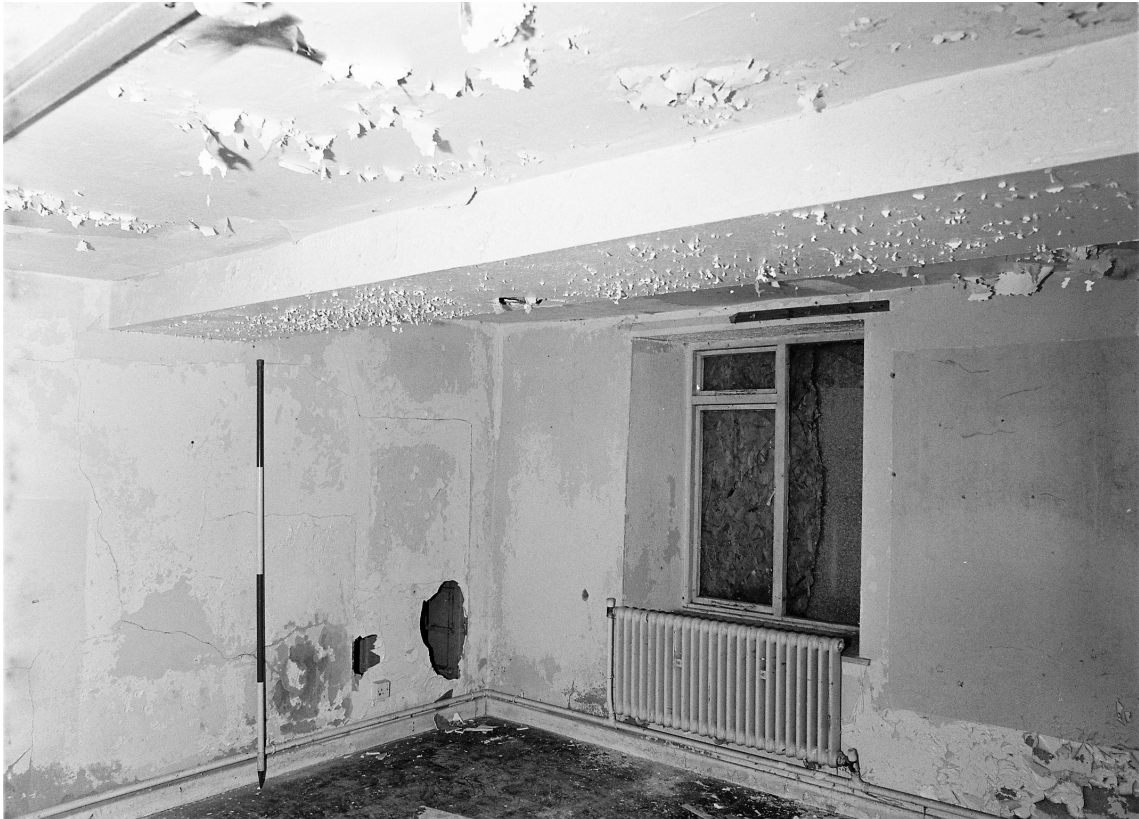
Photograph 43 Film 3_007 Direction SE

There are two possible modern dining areas in the schoolhouse (Areas G8 and G9). Area G8 is entered from the north side through a doorway leading from the stairwell (G7). It has modern plaster and painted walls with a recessed doorway in the south elevation (Photograph 42). There is also a modern wooden two-light, casement window with a single top opener (Photograph 43). Below this window there is a cast-iron radiator, and in the east elevation a blocked fireplace. To the south of the fireplace there is a wooden cupboard that is obscured by modern plaster board (Photograph 43). Part of the dividing wall separating G8 and G9 has been removed to make an open plan ground-floor room in the schoolhouse (Photograph 43).

Classroom G8, showing the position of the chimney breast now obscured behind modern plasterboard

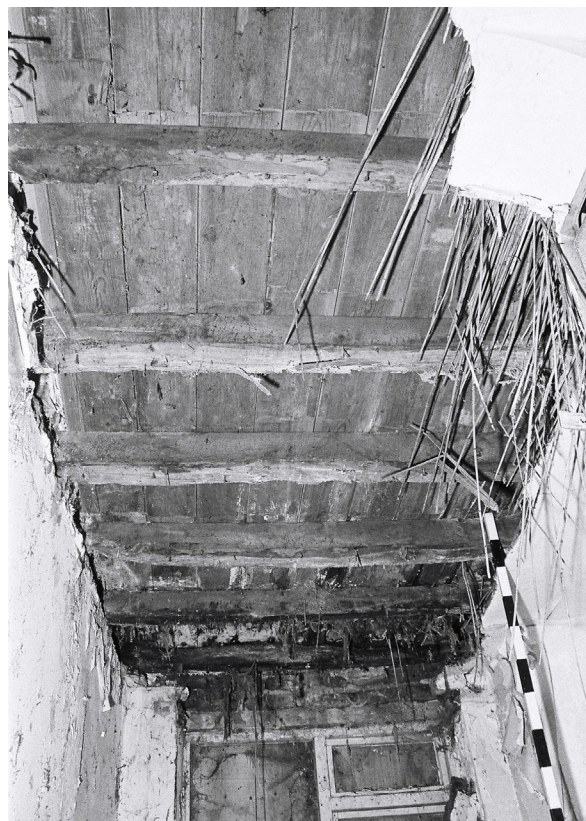
Photograph 46 Film 1_017 Direction W

Joists and floorboards revealed after the collapse of the reed and plaster ceiling in G9

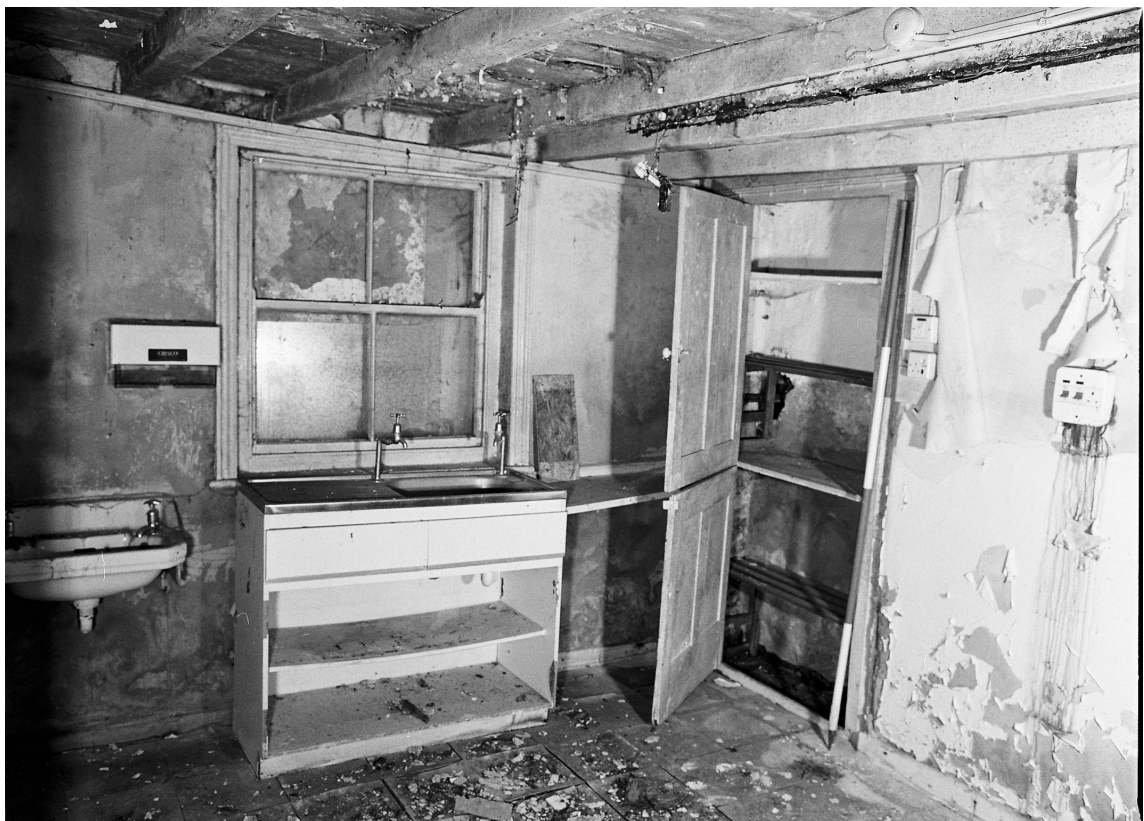
Photograph 48 Film 3_010 Direction NW

Room G11, in the northern extension to the schoolhouse, functioned in its final phase as a staff room. In the west wall, there is a central two-over-two vertical-sliding wooden sash window frame. Below this is a modern fixed cupboard with a utility sink and to the north of

this is a ceramic hand basin (Photograph 48). Against the north wall there is a blocked fireplace and a wooden cupboard with panelled doors fitted into the western alcove (Photographs 48-49). To the right of the blocked fireplace is a doorway leading to wash area and water closet G12 and G13. In the east elevation, there is a boarded external entrance and the ceiling above the south east corner of G11 has a hatch leading to the loft space above (Photograph 50).

Staff room with 19th-century cupboard doors in G11

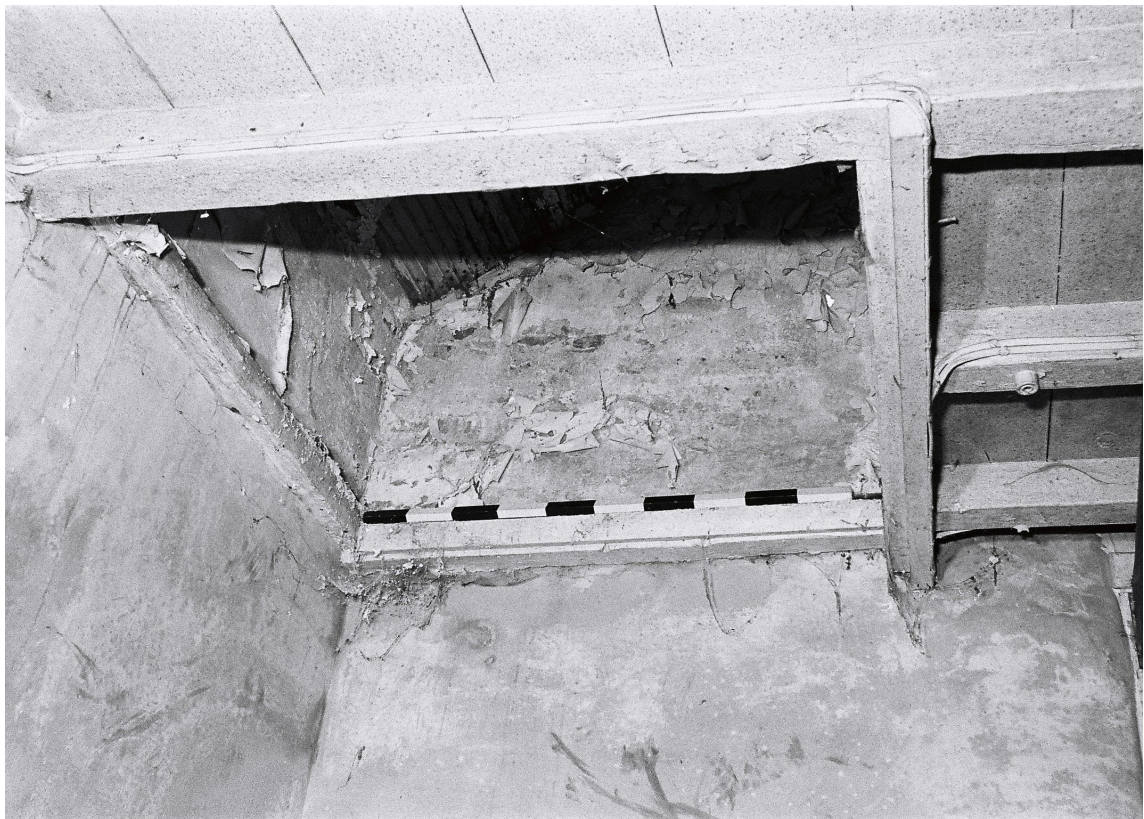
Photograph 50 Film 1_014 Direction S

Trap door above the staff room G11

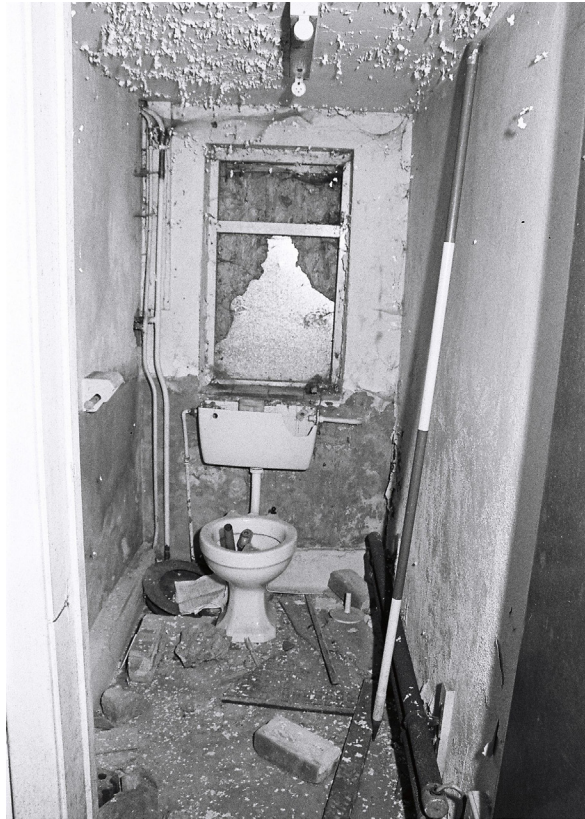
Photograph 51 Film 1_015 Direction W

Area G12 is a small wash area with a small two-light fixed window frame in the east wall and to the west, a doorway leads to water closet G13. A modern toilet is housed in G13 and the room is lit from the west by a small two-light fixed window frame (Photograph 51).

Toilet G13 in the northern extension

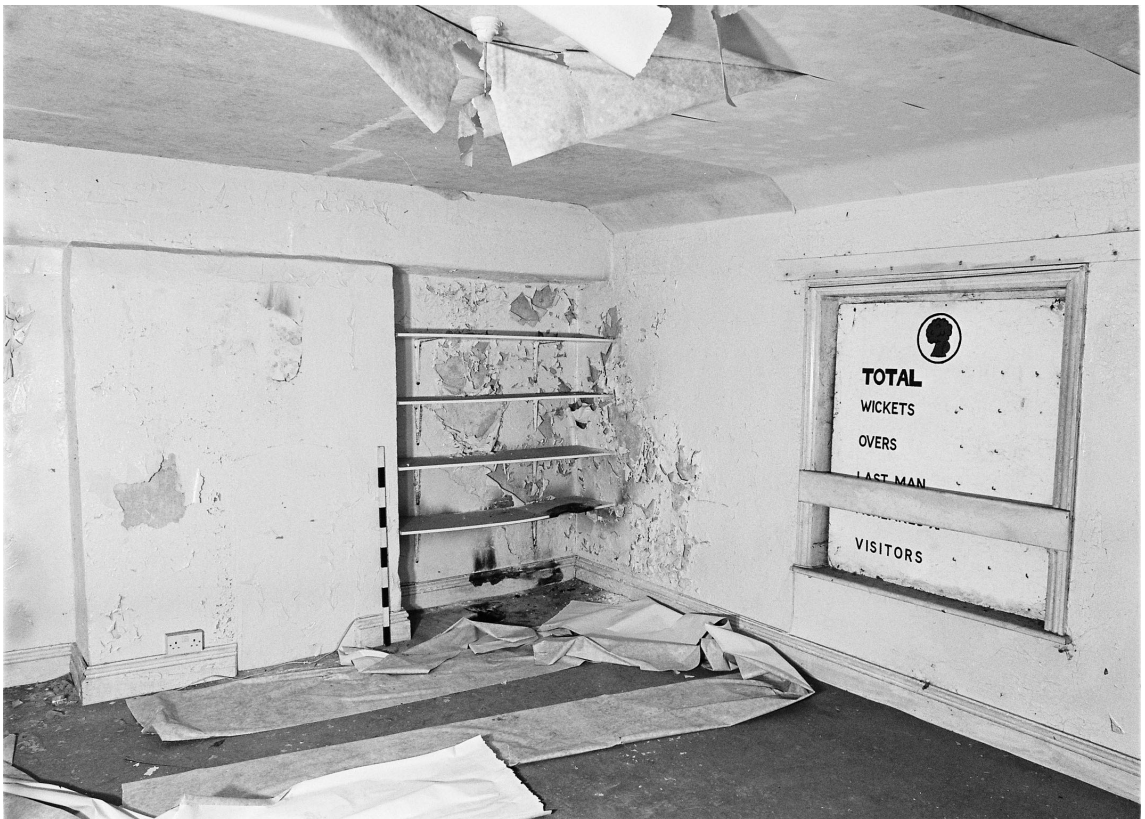
Photograph 54 Film 3_012 Direction SE

Classroom FF1 has a walk-in store cupboard in the north-east corner of the room with a wooden shelf approximately 1.3m above the height of the floor. In the east wall of FF1 there is a blocked fireplace with modern shelving to the south alcove. The top of the fireplace has been cut to accommodate an inserted concrete beam that runs north-south across the width of the schoolhouse (Photograph 54). In the south wall of FF1 there is a window with a wooden frame, the detail of which is obscured by modern boarding. There is also a small high-level single-light window to the west with a simple wooden frame (Photograph 55). There is good survival of late 19th-century skirting board to all of the internal walls (Photograph 53), with the exception of the south west corner (Photograph 55) and a small section near to the blocked fireplace in the west wall (Photograph 54). In the west wall, a doorway leads to classroom FF2.

Classroom FF1 on the first-floor looking towards the chimney breast

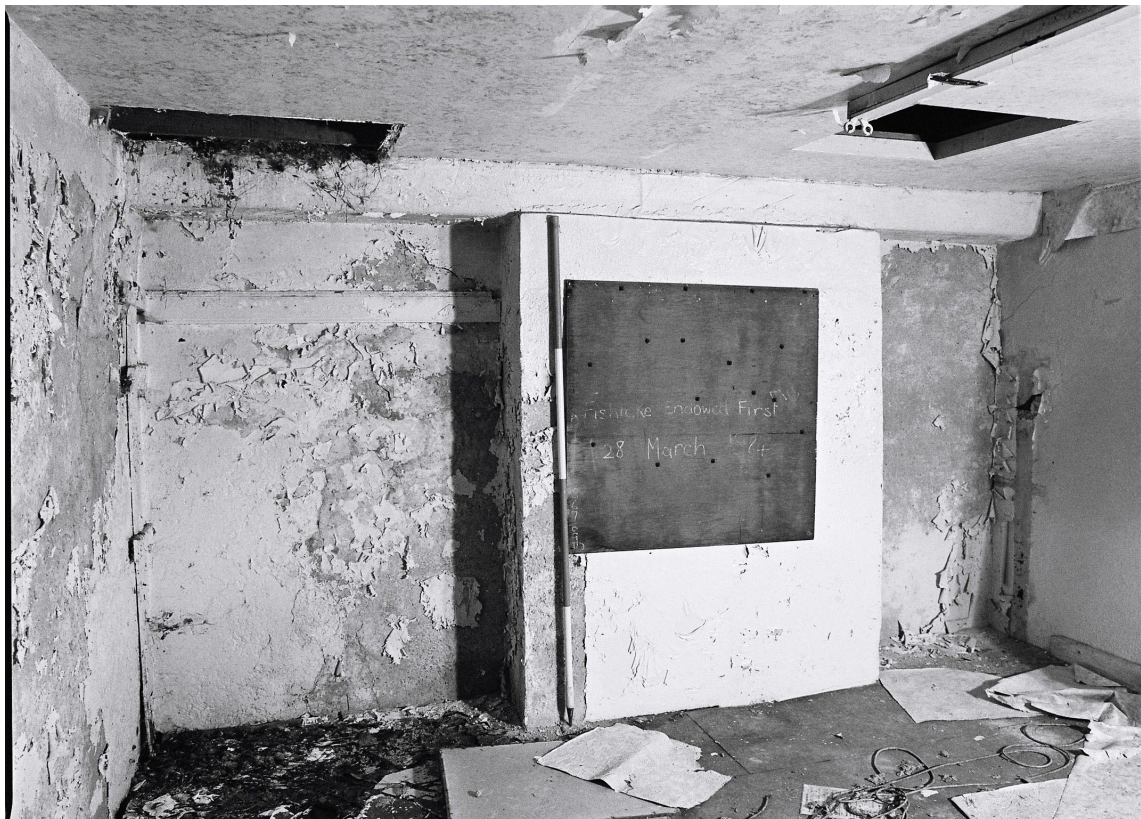
Photograph 56 Film 3_014 Direction NW

In the south wall of classroom FF2 there is a central boarded over window opening (Photograph 56). The blocked fireplace is cut by another modern concrete beam running north-south across the full width of the west end of the schoolhouse. All the internal walls are plastered and painted, and there is an access hatch to the loft.

Classroom FF2

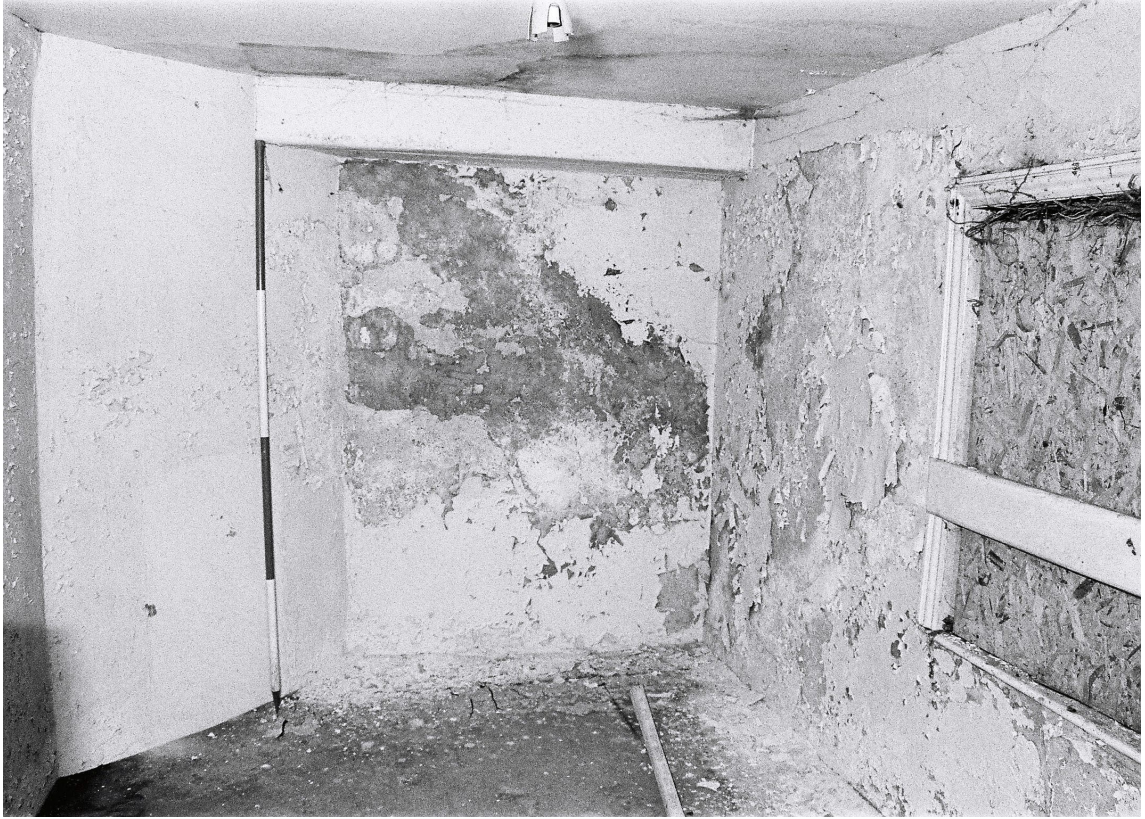
Photograph 57 Film 1_021 Direction W

In storeroom FF3 there is a blocked inserted corner fireplace in the south west corner of the room (Photograph 57), and a window opening in the north wall with the wooden frame partially obscured by modern boarding (Photograph 58).

Storeroom FF3 to the north of classroom FF2
