**Fishlake Endowed School, Fishlake
South Yorkshire**

Report no. 2486

July 2013

Archaeological Building Recording

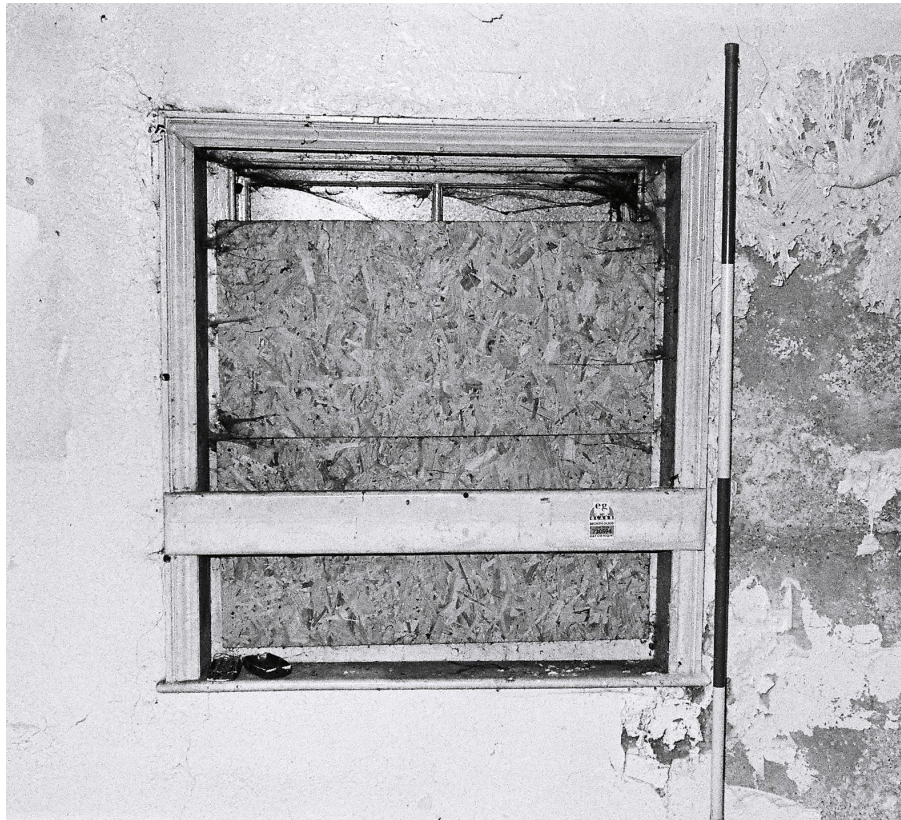
Photograph 58 Film 1_018 Direction N

In storeroom FF3 there is a blocked inserted corner fireplace in the south west corner of the room (Photograph 57), and a window opening in the north wall with the wooden frame partially obscured by modern boarding (Photograph 58).

Window in the north wall of the storeroom FF3

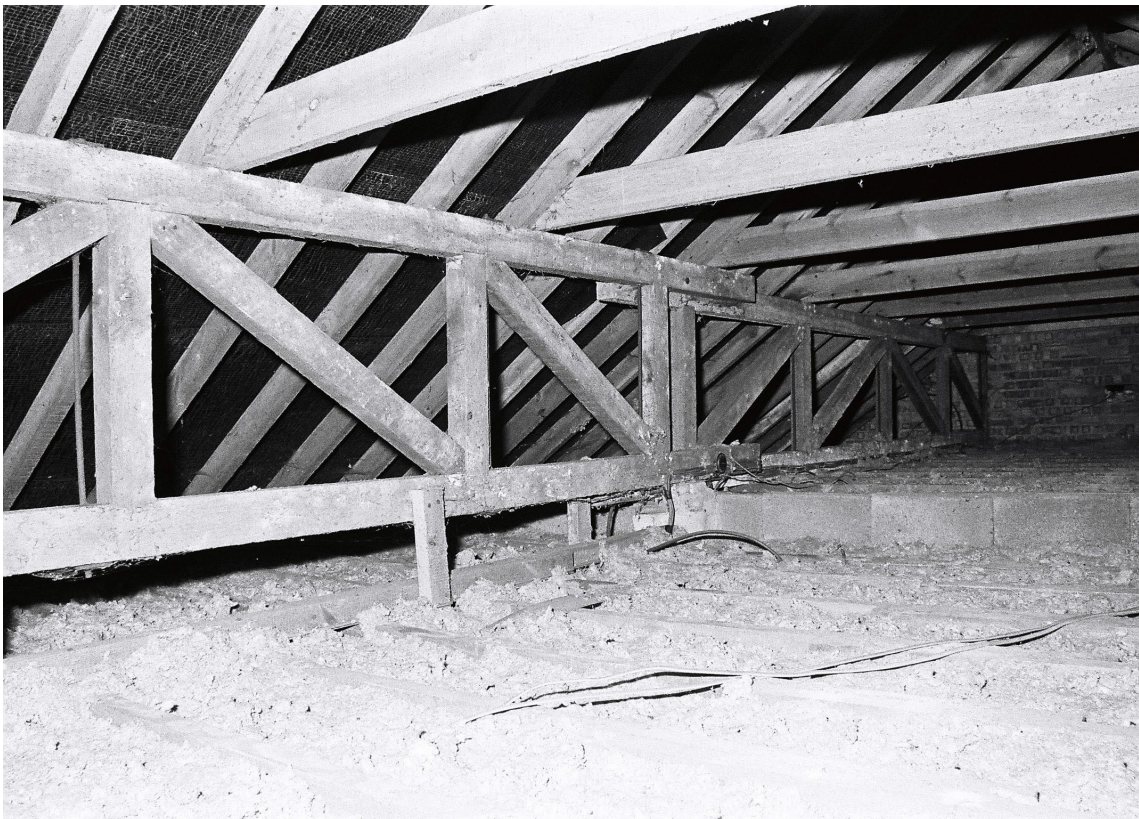
Photograph 60 Film 1_022 Direction NE

Modern bracing supporting the rafters of the modern roof structure over the schoolhouse
