**Thornhill Hall Moated Site Project
Rectory Park, Thornhill
West Yorkshire**

Archaeological Watching Brief

Report no. 2570

January 2014

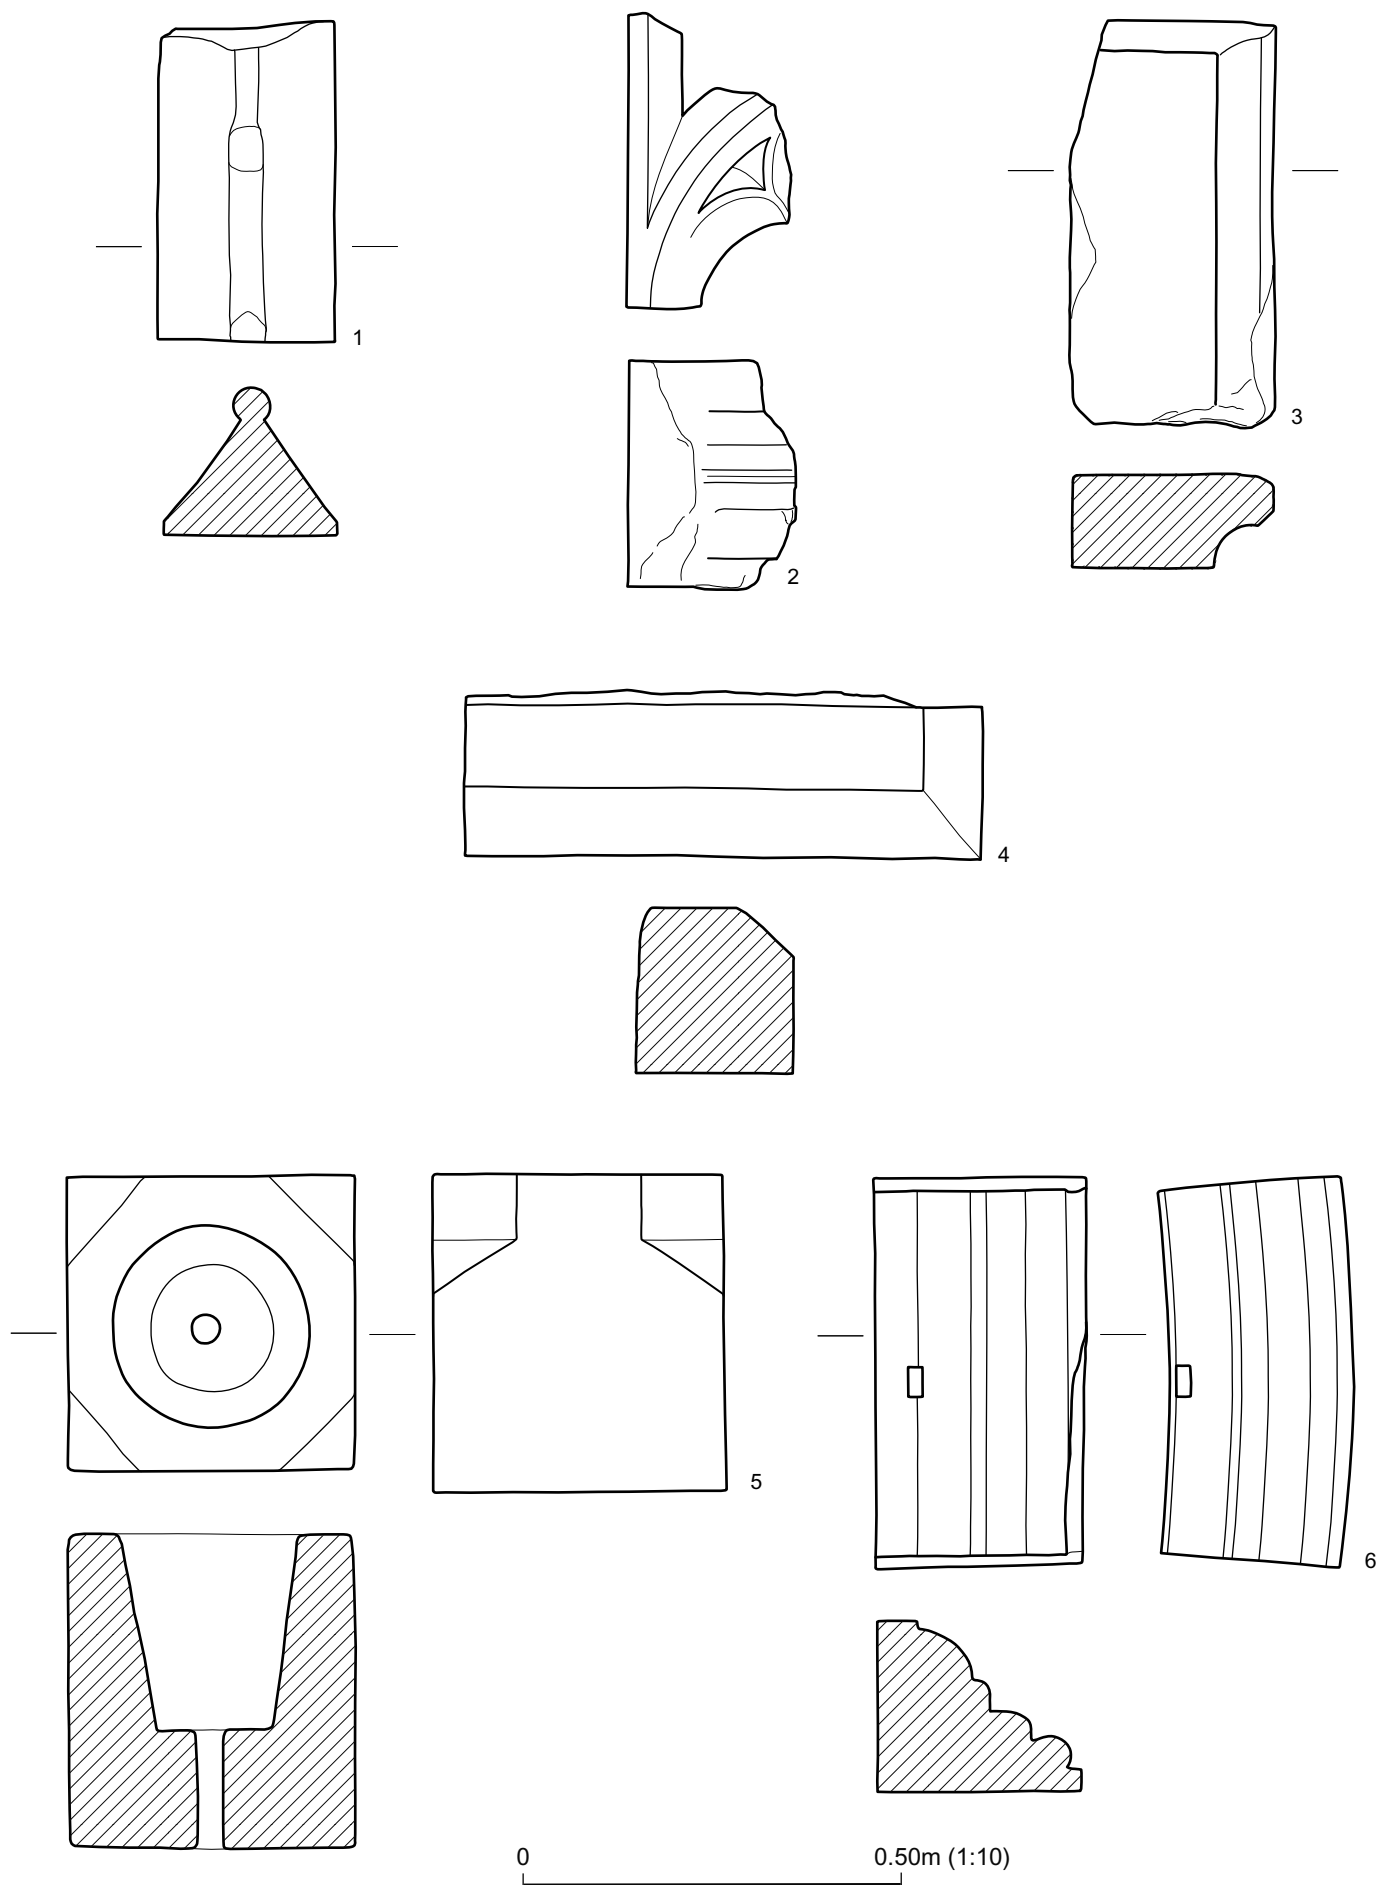
Fig. 5. Sandstone architectural fragments (Cat. Nos 1-6)

- 1 Incomplete triangular sandstone coping with broken roll apex. Formerly part of the Victorian bridge parapet over the moat (Plate 4). L. 420mm; w. 235mm; h. 200mm.

- 2 Incomplete moulded sandstone window tracery with cusp and glazing bar rebate. Formerly part of the stone-built hall (Plate 5). H. 390mm; w. 220mm.
- 3 Incomplete sandstone hood mould with hollow (cavetto) chamfer. Formerly part of the stone-built hall (Plate 6). L. 540mm; w. 270mm; h. 145mm.

- 4 Incomplete sandstone plinth corner with plain chamfer. Formerly part of the stone-built hall (Plate 7). L. 680mm; w. 210mm; h. 220mm.
- 5 Complete sandstone block with stopped chamfers to the corners and roughly circular large radius (240 mm) central hole with a smaller radius drain hole (40mm). Formerly part of the stone-built hall, possibly a garden feature (Plate 8). L. 390mm; w. 390mm; h. 425mm.

- 6 Incomplete sandstone voussoir with roll and quadrant mouldings. Small rectangular mortice in face probably housed metal bar. Formerly part of the Victorian bridge gate arch (Plate 9). L. 520mm; w. 280mm; h. 230mm.

Cat. Nos 1, 6 and possibly Cat. No. 7 appear to be from the bridge and gateway. The triangular coping with the roll apex (Fig. 5, Cat. No. 1) and the moulded voussoir are similar in style to the masonry as shown in Plate 17. The arch voussoir with the roll moulding (Fig. 6, Cat. No. 7) could be either from the bridge or hall.

The large architectural stonework (Fig. 5, Cat. No. 5) is something of an oddity. This piece does not conform to any architectural masonry. The substantial stone is decorated with stopped chamfered corners. There is large roughly circular tapering central hole (240mm radius) leading to smaller roughly circular drain hole (40mm radius). This may have been used as a planter in the garden to the hall.

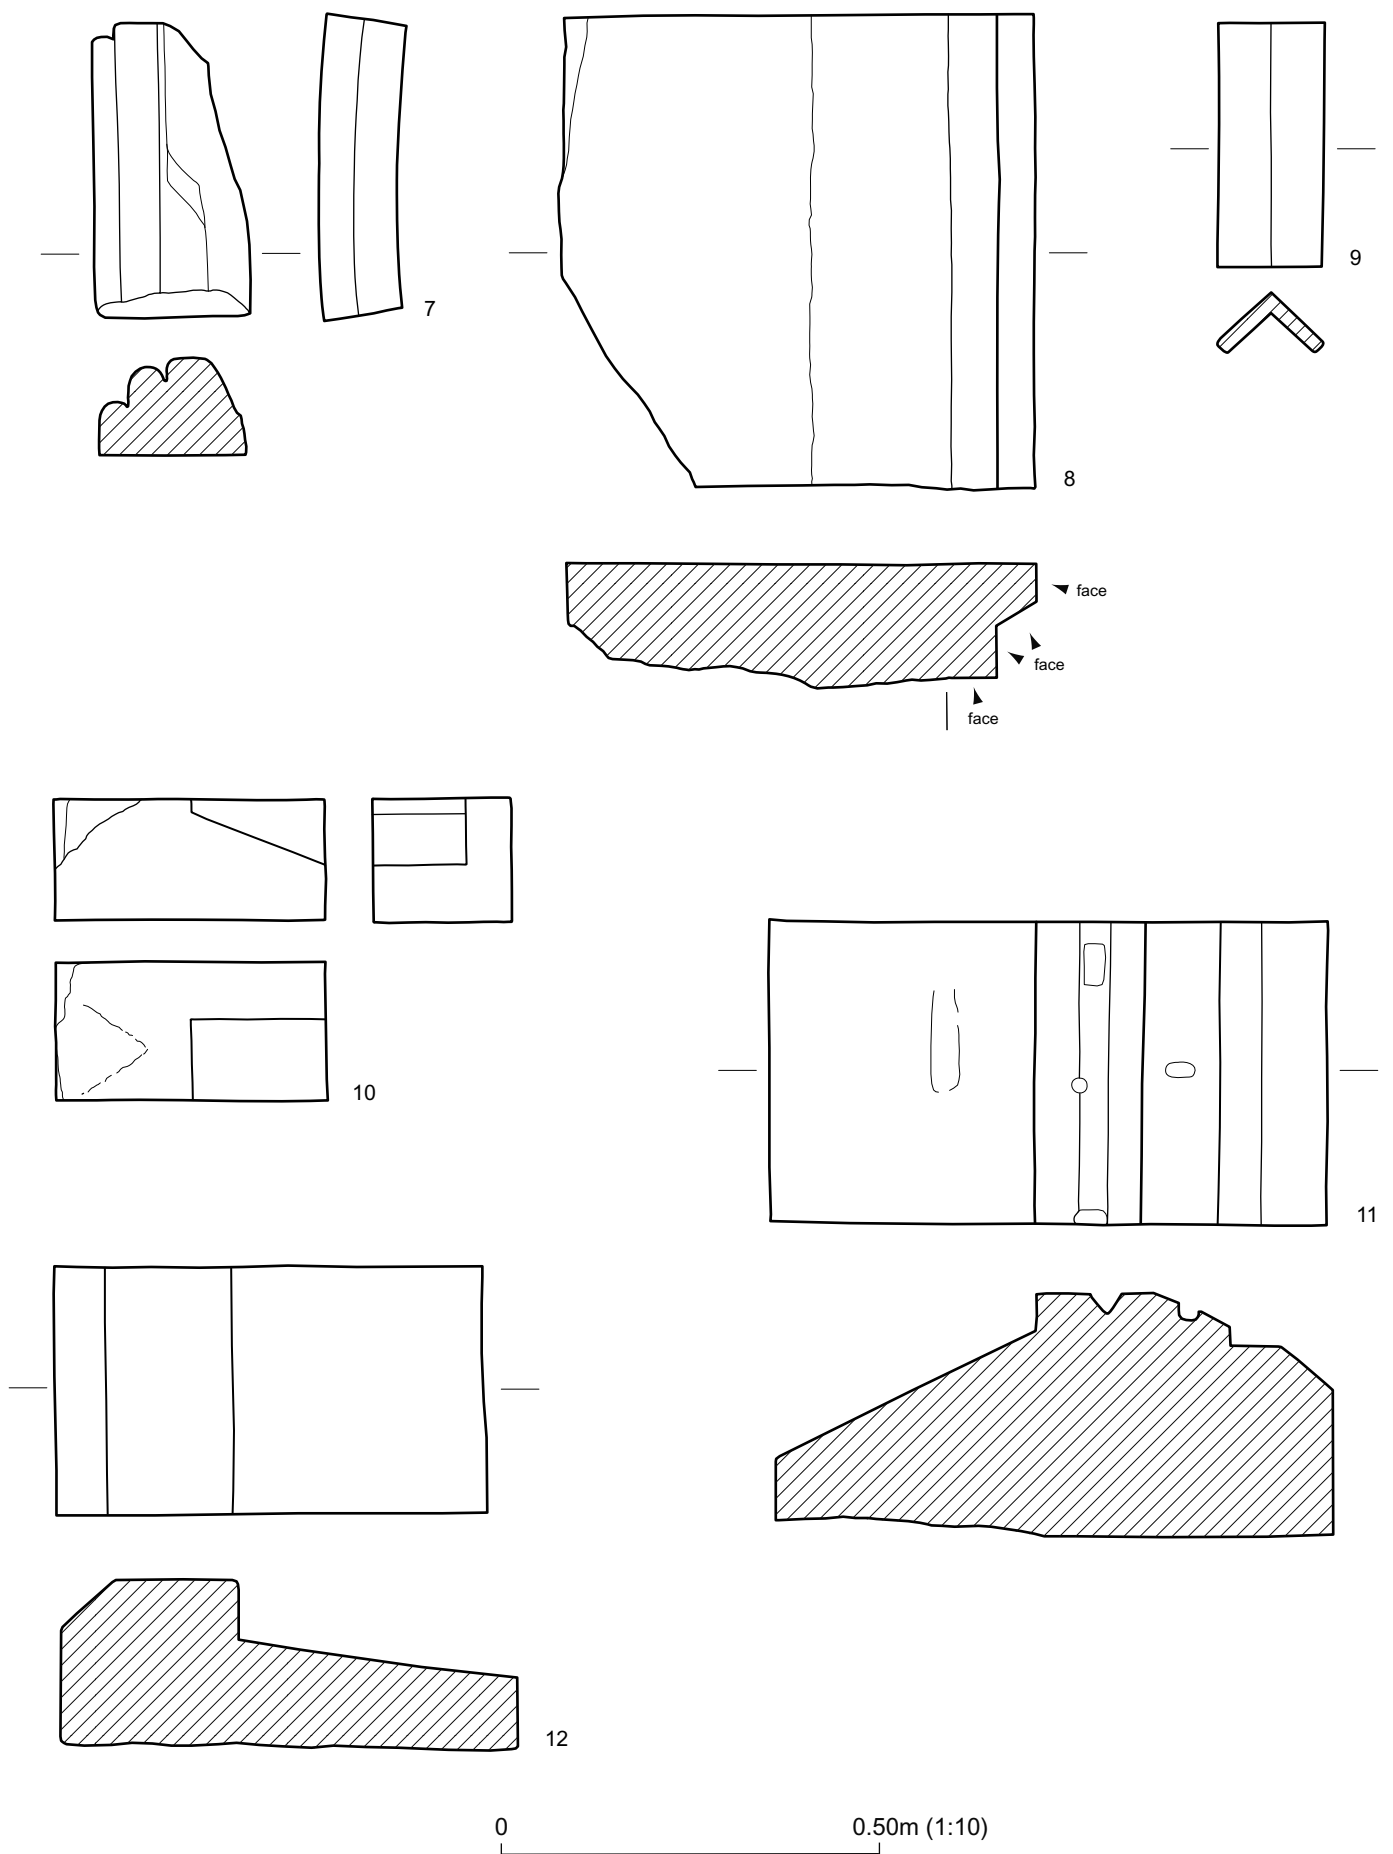
Fig. 6. Sandstone architectural fragments (Cat. Nos 7-12)

- 7 Incomplete sandstone voussoir with roll and quadrant mouldings. Could be from the bridge or the hall (Plate 10). L. 405mm; w. 210mm; h. 160mm.
- 8 Incomplete sandstone cornice with four finely dressed faces to the front one of which is chamfered. The remainder of the substantial block is roughly tooled. Formerly part of the stone-built hall (Plate 11). L. 630mm; w. 630mm; h. 155mm.

- 9 Complete sandstone ridge piece. Inverted V shaped masonry. Formerly part of the stone-built hall (Plate 12). L. 325mm; w. 140mm; h. 080mm.
- 10 Incomplete sandstone splayed sill. Formerly part of the stone-built hall (Plate 13). L. 360mm; w. 185mm; h. 165mm.

- 11 Complete splayed and chamfered sandstone window reveal with glazing frame rebate and glazing bar mortices. Formerly part of the stone-built hall (Plate 14). L. 740mm; w. 325mm; h. 405mm.

- 12 Complete splayed and chamfered sandstone door jamb. Formerly part of the stone-built hall (Plate 15). L. 570mm; w. 220mm; h. 330mm.

The stonework appears to originate from two sources, the stone-built hall and the Victorian bridge and gateway. The hall masonry is represented by Cat. Nos 2, 3, 4, 5, 8, 9, 10, 11, 12 and possibly Cat. No. 7. This masonry consists of various architectural pieces ranging from window reveals and window tracery to ridge pieces and door jambs. The window tracery (Fig. 5, Cat. No. 2) and the window reveal (Fig. 6, Cat. No. 11) appear to correspond to the masonry as shown in Plate 16. The door jamb (Fig. 6, Cat. No. 12) with an inner splay and plain outer chamfer is a typical 16th to 17th-century style.

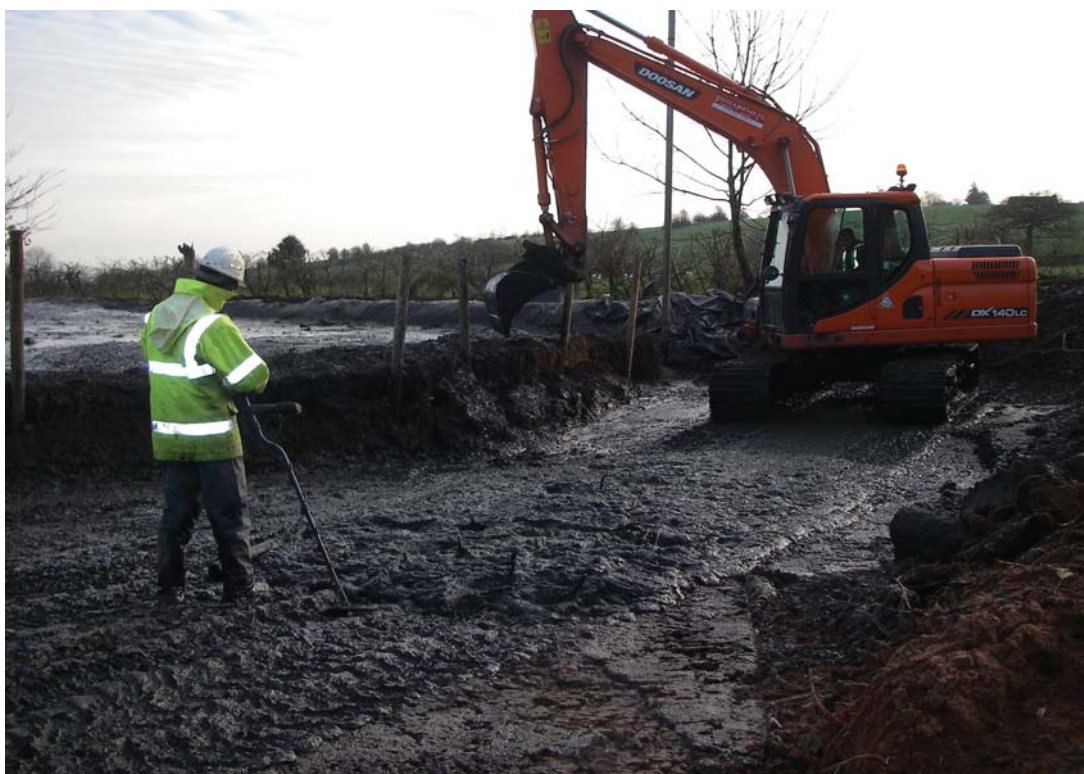
Plate 2. Inspecting silt 1000 from the moat

was transferred to a dumper truck positioned on the bank. The silt was then spread out for inspection adjacent to a purpose-built lagoon. Each dumper truck of silt was examined visually and scanned with a metal detector (Plate 2). Once examined, the silt was placed in the lagoon for storage and drying.

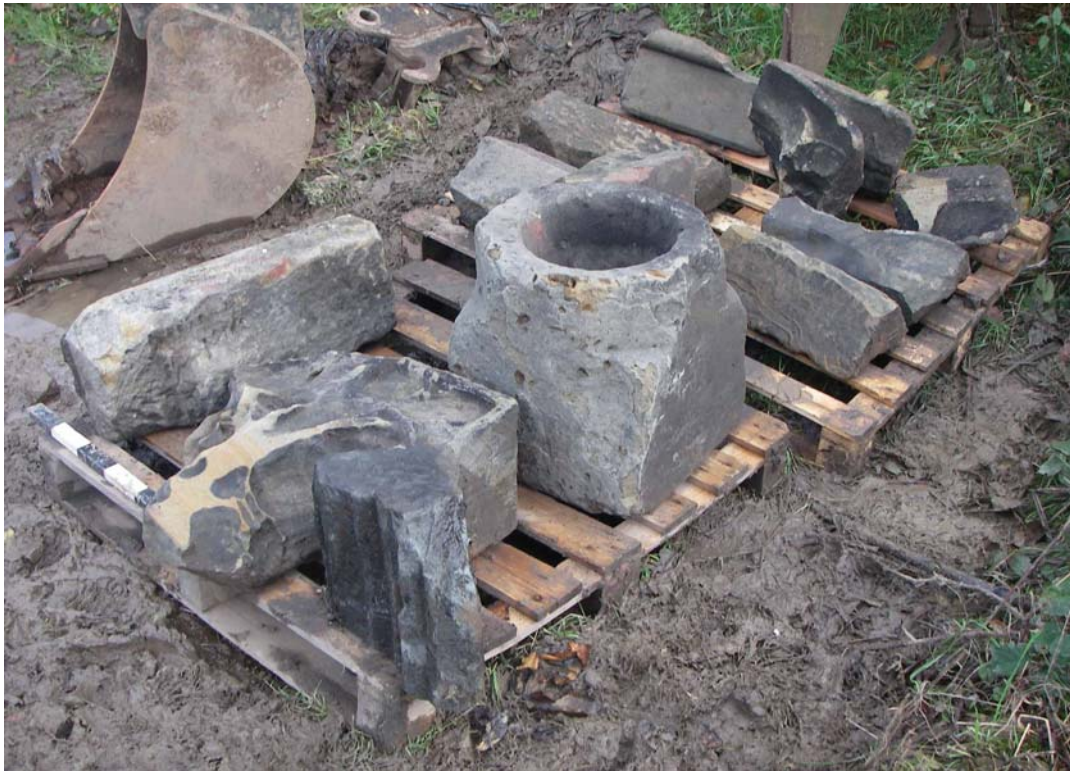
Plate 3. Selected architectural stonework

washer. If of architectural or historic value, they were recorded photographically using both 35mm black and white film and colour digital photography (Plate 3). If the stonework appeared to be of diagnostic value to the former hall or bridge, measured scale (1:10) drawings were produced of descriptive views of the stonework (Figs 5 and 6). Any plain ashlar masonry or rubble stonework was examined but not recorded.

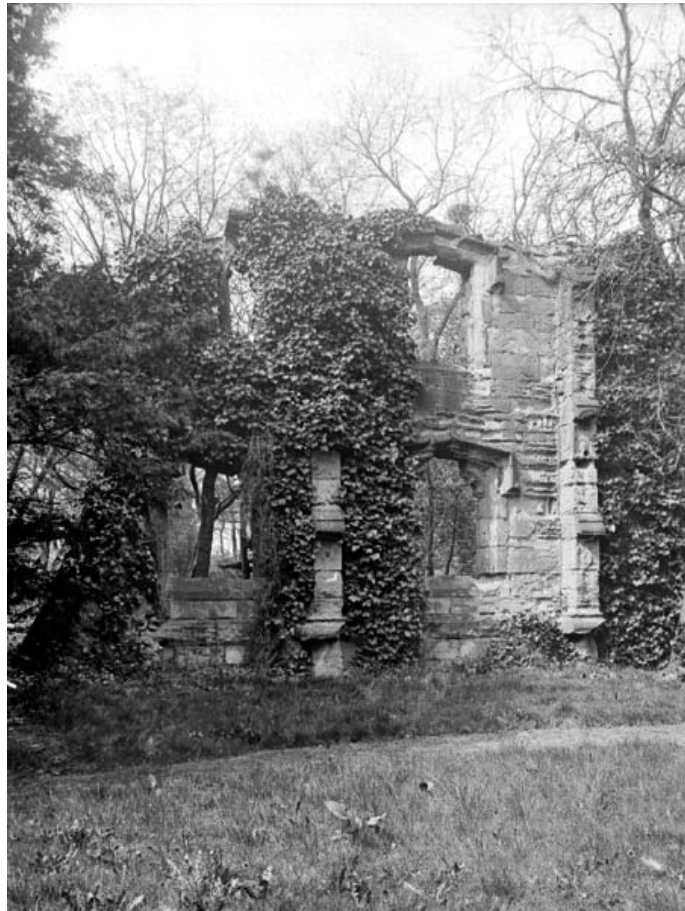
Plate 16. Stone-built phase of the Hall, with moulded window tracery, hood mould and reveals. The moulded stonework could be a match to some of the recorded stone work (see Cat. Nos 2, 3 and 11)

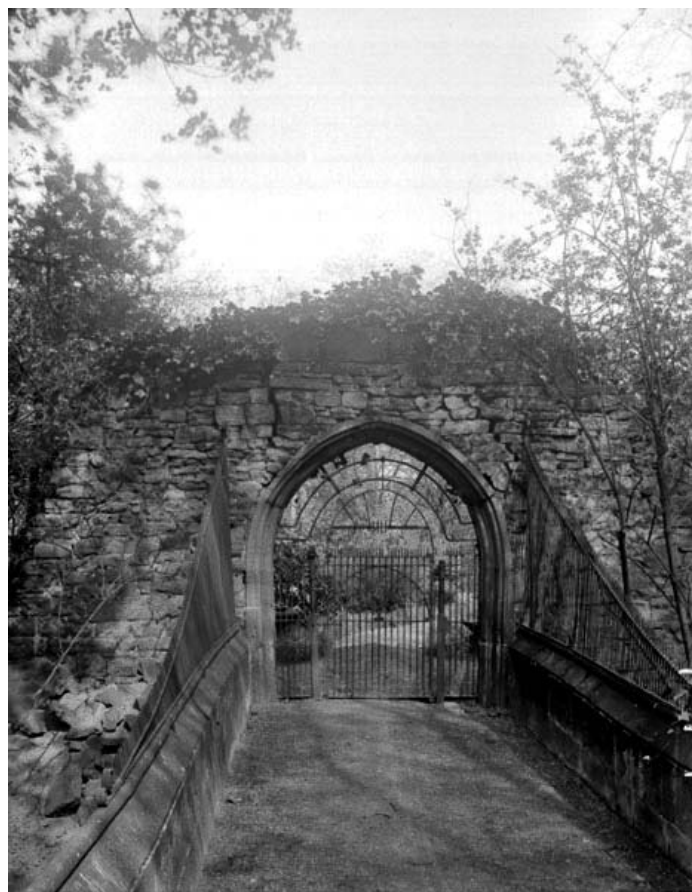
Plate 17. The Victorian bridge and gateway. The moulded parapet coping and arch appear to match some of the recorded stonework (See Cat. Nos 1 and 6)
