**Land off Barnsley Road  
Wath-upon-Dearne  
Rotherham  
South Yorkshire**

*Archaeological Evaluation*

*Report No. 1489*

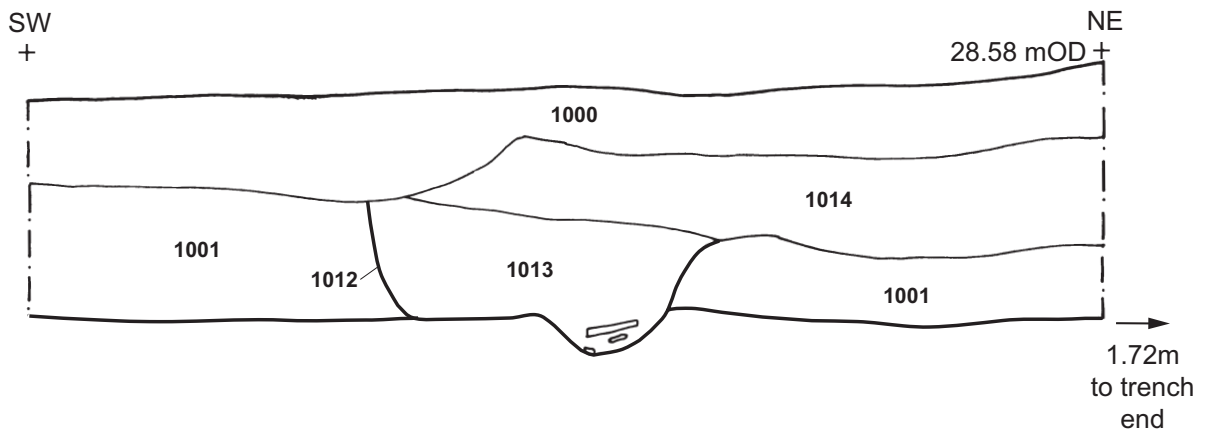
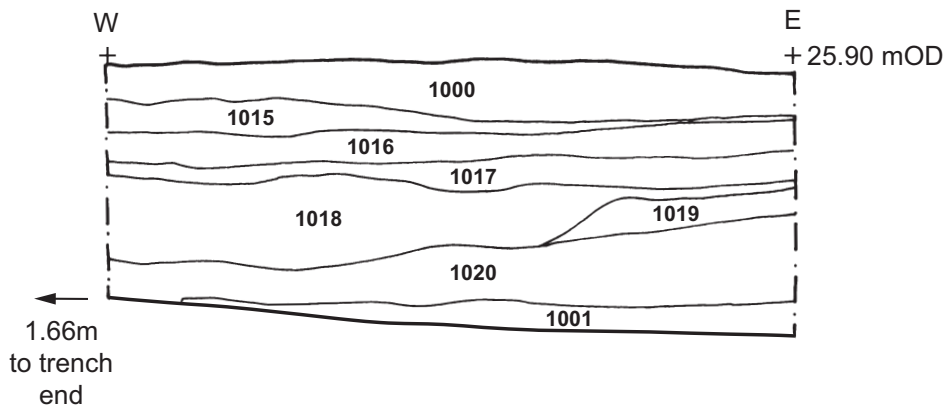
Fig. 3. Sample sections from Trenches 1 and 2

- 4.1.1 Trench 1 was located to establish the presence/absence of outbuildings associated with the medieval manor. The size of this trench was reduced to 12.5m in length and 1.5m in width due to limited space and the close proximity of a wall, tree and tarmac area. The trench was excavated to a maximum depth of 0.53m revealing a layer of topsoil (1000), overlaying subsoil (1001) that was above the friable silty sand natural. A shallow gully (1012), cutting the subsoil was located towards the north-east end of the trench. This feature was 0.33m wide and 0.13m deep and was filled by a single grey deposit (1013) that contained pieces of fragmented mortar. This gully and the area to the east were sealed by re-deposited natural (1014). This linear feature was interpreted as a relatively recent field drain or boundary ditch.

- 4.2.1 The presence of service manholes, trees and a path meant that the size of this trench was reduced to 7.5m by 1.5m. At a maximum depth of 0.8m the trench revealed several layers of modern overburden, including layers of hardcore, building material, made ground and concrete (1015, 1016, 1017, 1018, 1020), which overlay truncated subsoil (1001). These modern layers overlay the silty clay natural. No archaeological features were observed.

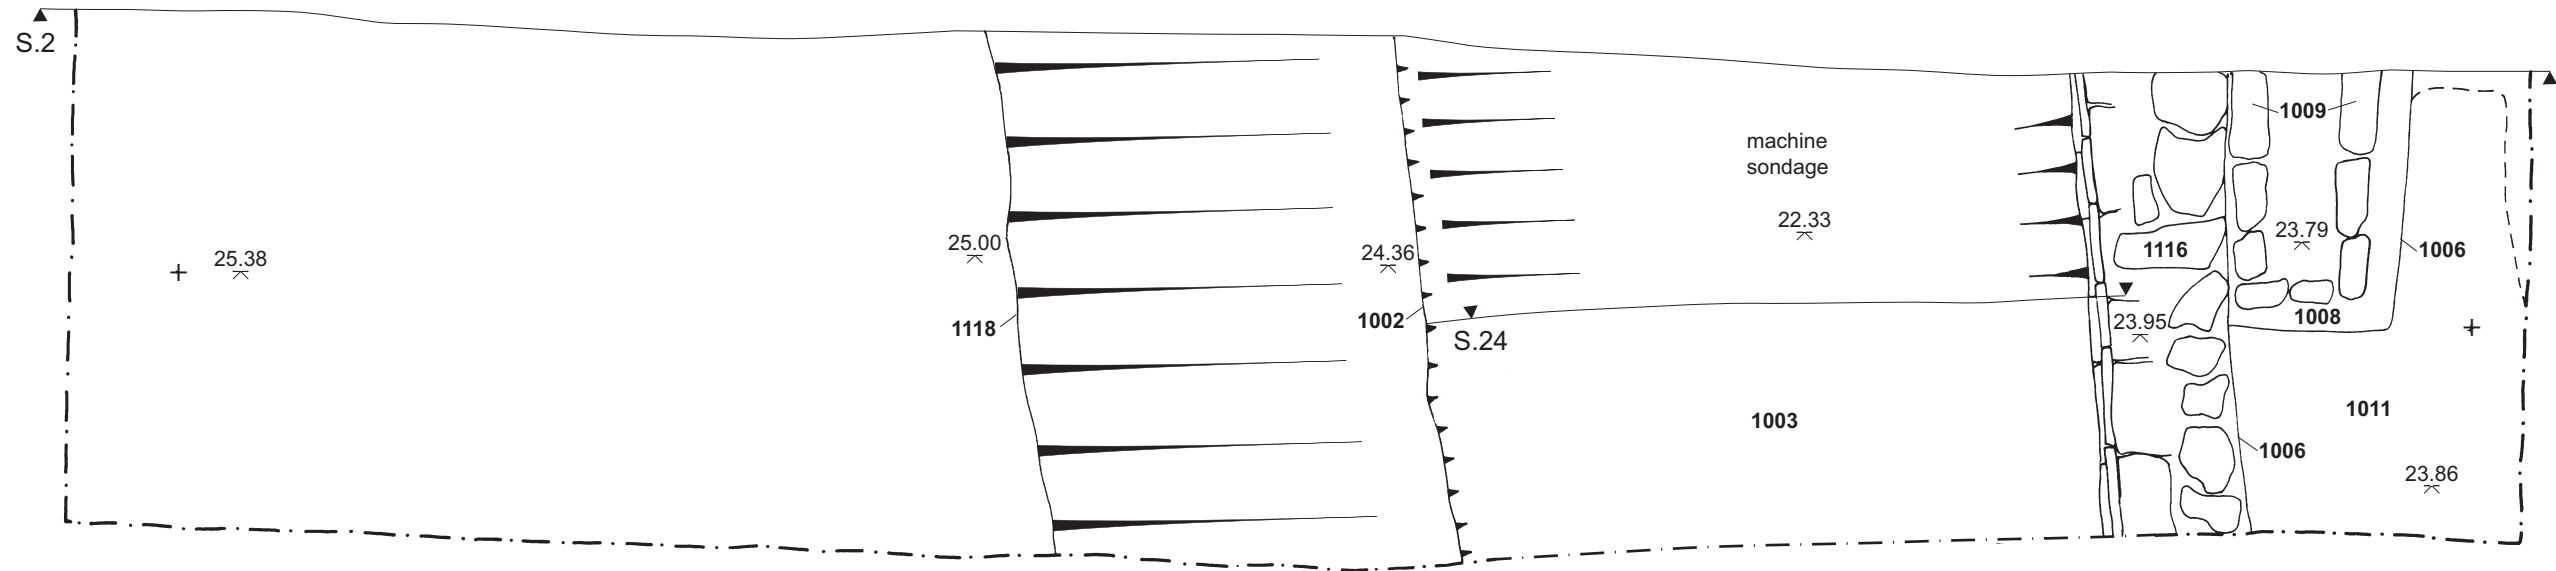
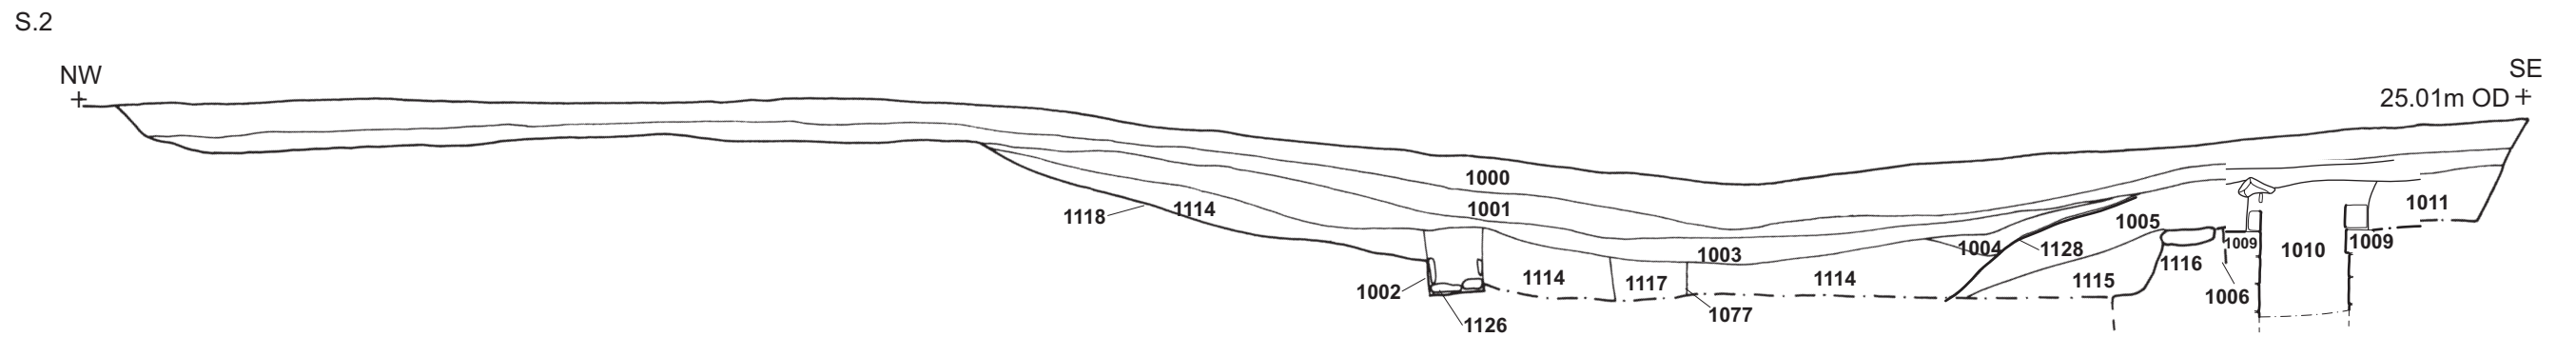
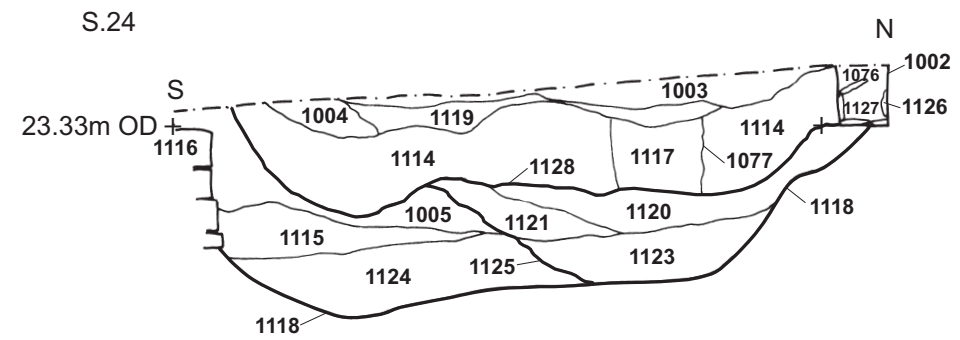
Fig. 4. Features in Trench 3

Orientated from north-west to south-east Trench 3 was 20m in length and 4m in width and was positioned at right angles across the depression caused by the northern edge of the infilled moat in order to characterise the moat and establish the presence of potential outbuildings associated with the former manor house. Due to the depth of the feature the trench had to be stepped for health and safety reasons. Following consultation with the monitoring archaeologist from the SYAS the lower moat fills were judiciously removed in spits by machine under direct archaeological control.

The trench revealed the northern bank of the moat aligned from north-east to south-west, sloping steeply down to the south. The 'bank' appeared to have

been created by modifying the natural slope to form this more accentuated side of the moat. The original slope may have marked the edge of the flood plain for the nearby stream. The edge of the bank may have been steepened and the lower reaches flattened out to form part of the central island. The excavation revealed that the original moat feature had been re-cut on two other occasions.

- 4.3.1 Originally the moat was dug as a large U-shaped ditch (1118), which measured approximately 10m in width and 2.4m in depth. Filling this feature were three deposits. The primary fill (1124) consisted of a dark grey sandy-silt deposit that showed evidence of waterlogging (see Section 6). The secondary fill (1115) consisted of a dark brown silt deposit with frequent sandstone fragments and large sandstone blocks. A large wall (1116), constructed from large un-bonded sandstone squared blocks, was located on the internal (south) side of the moat with a face to the north (Plate 1). This wall survived to a maximum total height of approximately 1.0m, in four courses and measured 1.0m in width. The upper levels of the wall had been previously removed. The upper moat fill (1005) overlay deposit 1115 and was characterised by a large amount of angular sandstone fragments mixed with a brown clay-silt, and containing fragments of late medieval pottery (See Section 5). The first visible re-cut (1125) of the moat cut deposit 1115.

- 4.3.2 Ditch cut 1125 represents a re-cut of the original moat (1118). This second moat ditch also had a U-shaped profile with a flat base and was cut through the original moat infill deposits to the same basal level. At 3.66m in width and 0.78m in depth ditch 1125 was filled with three deposits. The primary fill (1123) consisted of a uniform waterlogged dark grey peaty silt deposit that contained a fragment of medieval pottery, an iron object (nail?) and a wooden object (see Sections 5 and 6). Overlaying this was an orange brown silt deposit (1121) containing a substantial amount of small and medium sandstone fragments, and above this fill 1120 consisted of a light grey silty-clay material with occasional small sandstone fragments.

- 4.3.3 The second re-cut resulted in another U-shaped flat-based ditch (1128), 4.98m in width and 0.90m in depth, filled by four deposits. The primary fill 1114 consisted of a yellow-brown clay-silt deposit with occasional angular sandstone fragments. The upper layers (1003, 1004 and 1119) consisted of sandy silt layers with moderate to frequent sandstone fragments that represent the final infilling of the moat.

- 4.3.4 Cutting the primary fill (1114) were two linear drains, 1077 and 1002, aligned from east to west. Both had vertical edges with a flat base. Feature 1002 was 0.40m in width and 0.50m in depth and was lined with sandstone slabs (1126), whereas drain 1077 (0.60m in width) was filled by a stony deposit (1117) with a brown silty-clay matrix.

- 4.3.5 Layer 1004 overlay layer 1114 and consisted of a mixed layer of small yellow-grey-brown silty-clay deposit with small occasional pebbles. This layer was more prominent towards the southern part of the ditch. A deposit of a dark grey-brown silty-sand (1119) with occasional sandstone fragments overlay 1004 and drain 1077. The upper layer 1003 was characterised by a mid brown clay-silt with occasional sandstone fragments, which also contained animal bones and sherds of medieval and post-medieval pottery (see Section 5).

4.3.6 A stone built rectangular structure, located immediately to the south-east of the moat revetment (1116), consisted of three courses of squared sandstone ashlar blocks faced internally (1009, Plate 2). The rectangular structure continued into the trench section and was only partially excavated to a depth of 0.75m due to the unstable rubble fill (1010). The south part of the structure (1009) was butted by a rubble deposit (1011) characterised by a large amount of sandstone fragments mixed with grey-brown silt. This deposit and the structure were overlain by subsoil and topsoil (1001 and 1000).

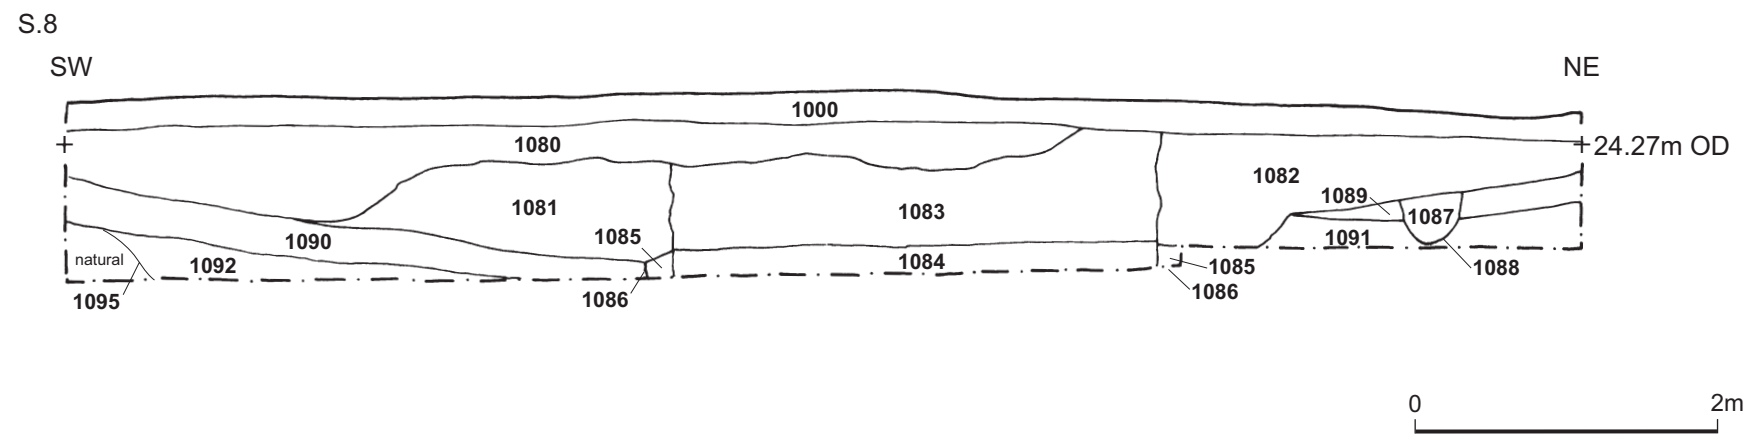
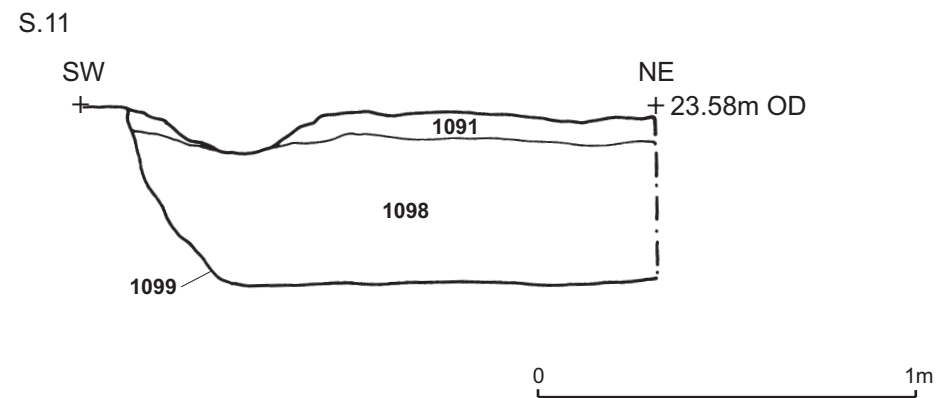
Fig. 5. Features in Trench 4

4.4.2 The concrete base 1084 had apparently been located in the depression of the medieval moat, cutting a layer of buried topsoil (1089, 1090) at a depth of approximately 1m below ground level. A possible pit (1088) 0.40m in width and 0.30m in depth filled by a yellow-brown silty-clay (1087) with sandstone fragments was located towards the east end of the trench, and was observed cutting the buried topsoil (1089). This buried topsoil layer (1089/1090) overlay the remains of two of the upper layers of the in-filled moat (1095). These consisted of a grey-brown sandy-silt deposit (1092) with occasional fragmented sandstone blocks, and a black sandy silt deposit (1089) with occasional small gravel fragments. These deposits were only partly excavated. The moat ditch (1095) was orientated north-west to south-east and was 5.8m in width and formalised by an internal stone built revetment wall (1096). At 0.6m in width the wall was constructed from un-bonded roughly hewn or unshaped sandstone blocks, and was exposed for a length of 3m. The top of the wall had been historically truncated.

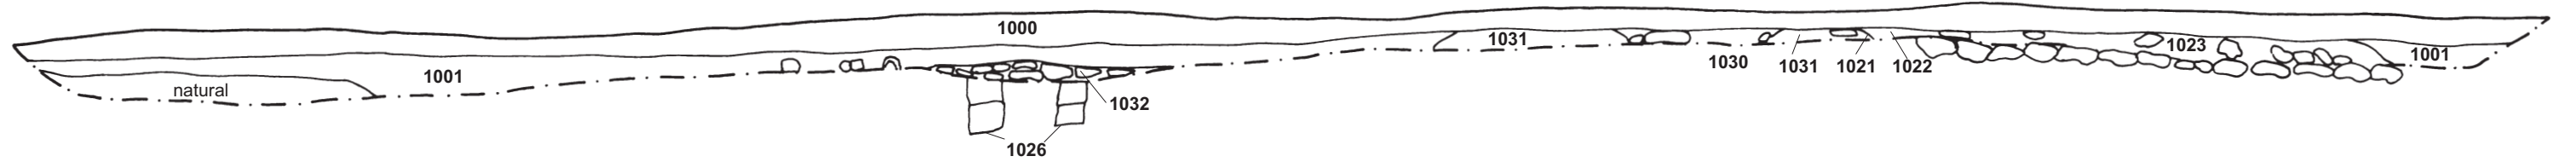
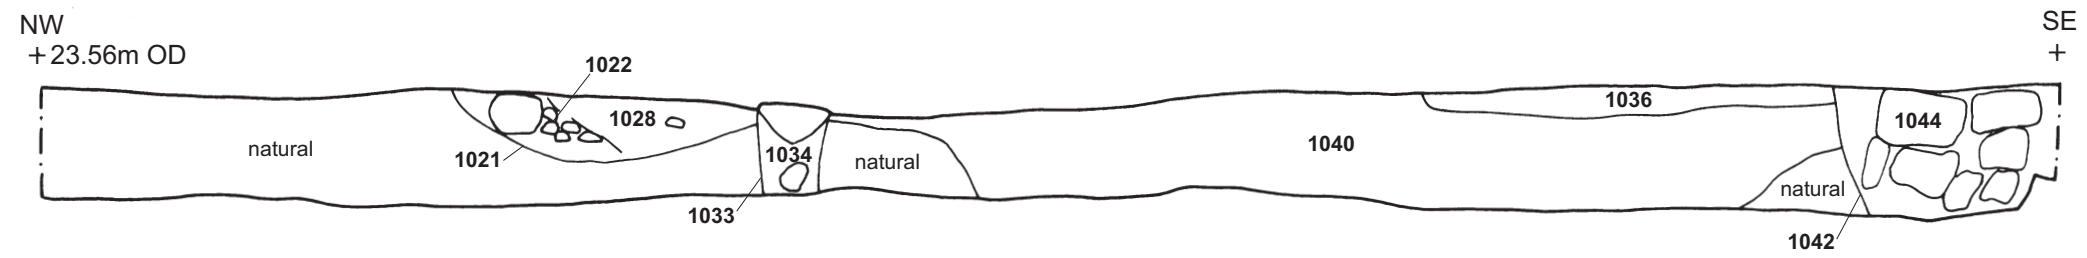
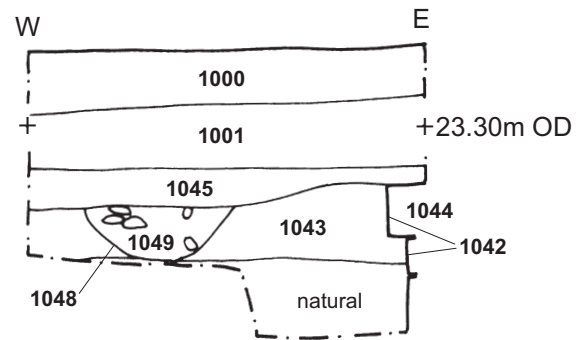
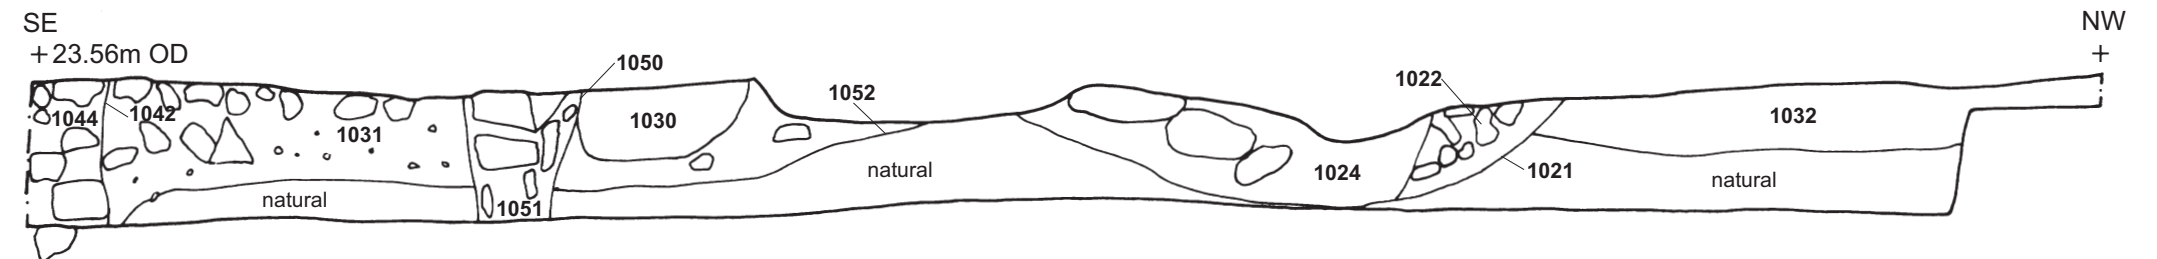
Fig. 6. Features in Trench 5

- 4.5.4 The corner of another substantial wall (1044), 1.25m in width, was present at the eastern end of the trench. This wall was of similar construction to wall 1024, and they are interpreted as the foundations of the external walls to a former building.

- 4.5.5 Wall 1041 was 0.75m in width and 1.50m in length and was aligned north-west to south-east. It was observed abutting Wall 1044, and appeared to form an internal partition to the former building. Wall 1041 appeared to form a later addition to the north-west of Wall 1044, although upon excavation this relationship was unclear and both walls may have formed the same phase. Immediately west of 1041, a small area of possible cobbled floor (1038) was identified. This consisted of a fragmentary layer of apparently deliberately laid sandstone fragments, although little survived to advance interpretation.

- 4.5.7 Artefactual material associated with the features in this trench was limited, thus hindering dating, and the majority of dateable finds derived from unstratified deposits or were recovered during cleaning. The wall foundation structures survive at a depth of between 0.25m and 0.4m below ground level largely directly below the topsoil.

- 8.3 The foundation stonewalls revealed in Trench 5 probably formed part of the former medieval manor or vicarage. Two possible phases have been suggested, although the precise chronology remains unclear, and the lack of finds material from sound contexts has not aided interpretation. The wall foundations are most likely to represent part of the 11<sup>th</sup> or 12<sup>th</sup> century manor buildings with later, probably 14<sup>th</sup> or 15<sup>th</sup> century, additions. The building foundation remains within Trench 5 continued beyond the limits of the trench to the north-west and south-east suggesting the high potential for similar remains to survive elsewhere on the moat island. This notion is also supported by a concentration of geophysical anomalies in this area (Webb 2005) that are likely to represent the remains of similar building foundations.

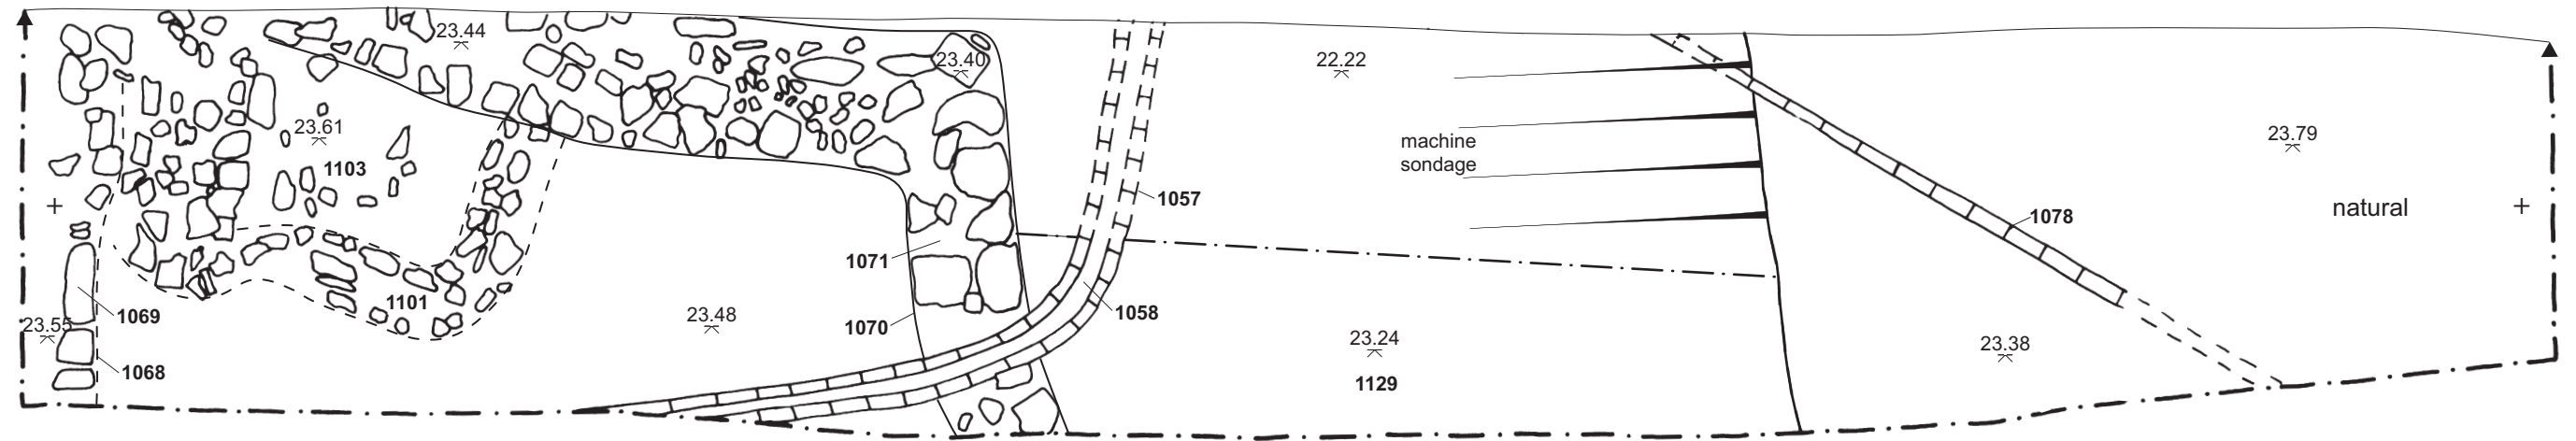
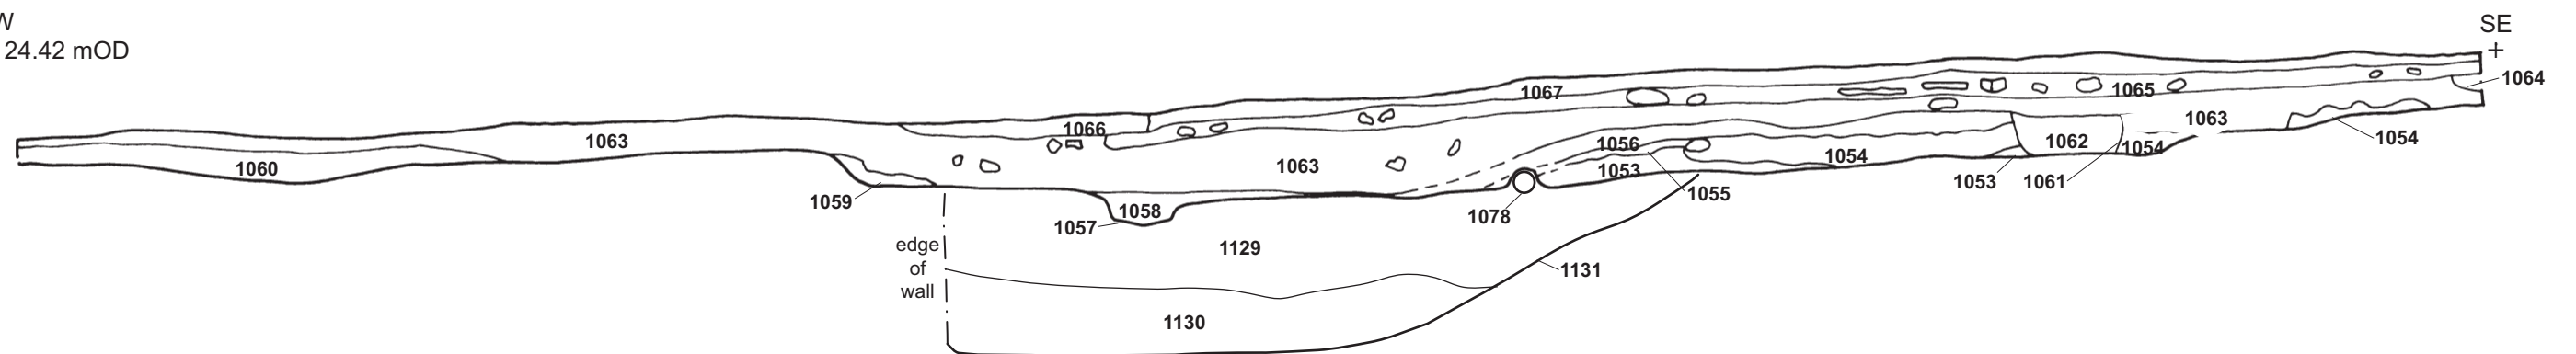
Fig. 7. Features in Trench 6

- 4.6.3 Eight modern rubble deposits overlay the upper fills of the moat. The upper most of these recent layers consisted of an orange sandy deposit (1066) and a dark-brown sandy-clay layer (1067). These overlay a layer of rubble (1065) that contained a substantial quantity of broken bricks, sandstone fragments mixed with a loose yellow-brown sandy mortar. Layer 1065 overlay a very dark brown sandy-clay deposit (1063) with a substantial amount of rubble and fragmented bricks that was present along the full length of the trench. Interpreted as made ground this deposit was observed overlaying three thin layers of dark brown sandy-clay mixed with occasional sandstone fragments (1054, 1055 and 1056) in the south of the trench. Layer 1063 also overlay a further thin deposit (1060) of brown sandy-clay towards the north-west end of the trench.

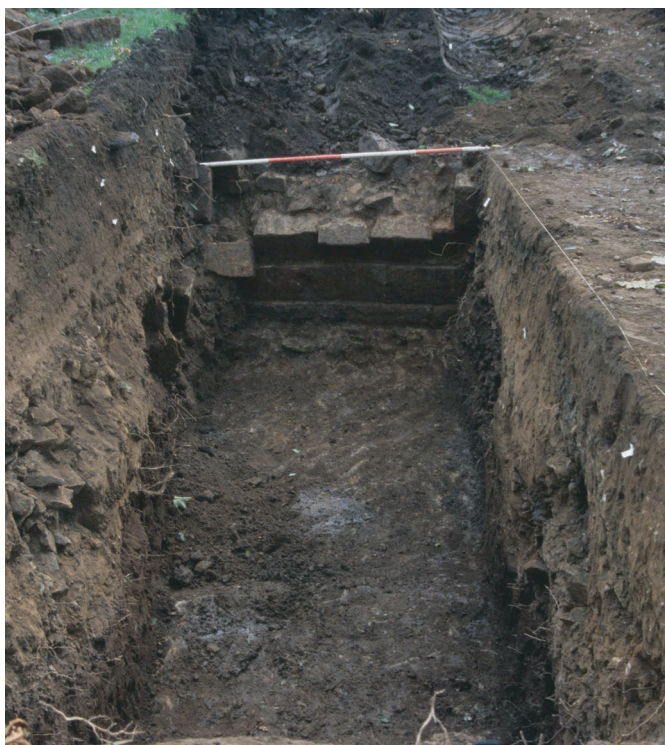
*Plate 1. Trench 3, view of moat retaining wall (1116) in machine excavated sondage, looking south-east*

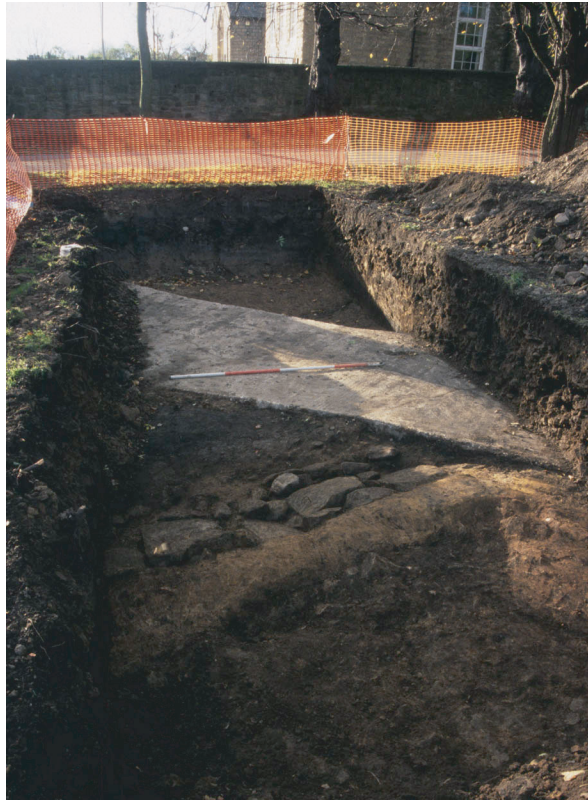
*Plate 3. Trench 4, moat retaining wall (1096) visible in the foreground, and the concrete base (1084), looking south-west*

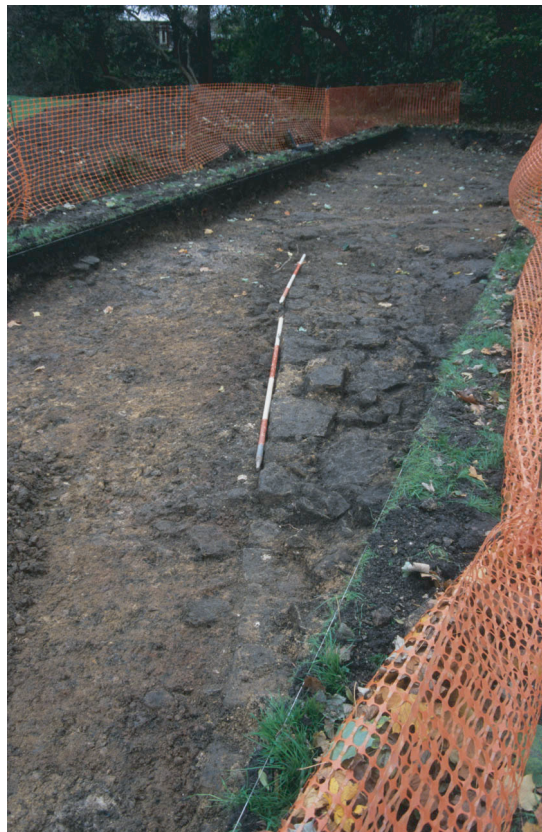
*Plate 4. Trench 5, general view building wall (1024), looking north-east*

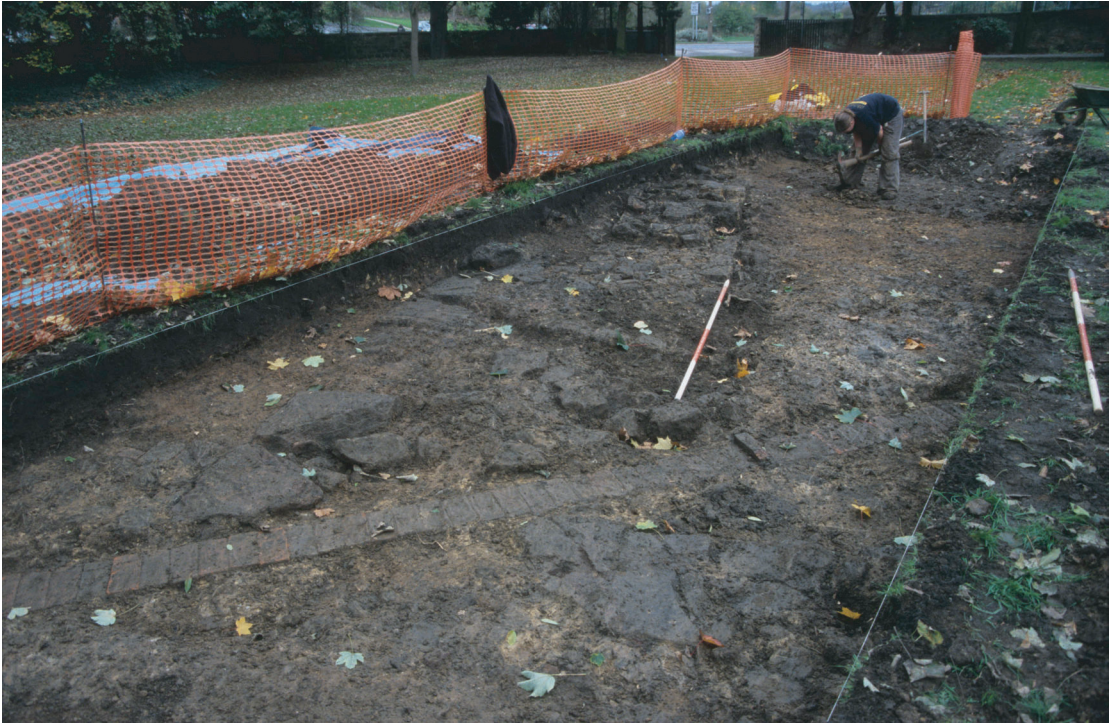
*Plate 4. Trench 5, General view of trench towards Wall 1024 and 1030 with Drain 1026 in foreground before excavation, looking south-west*

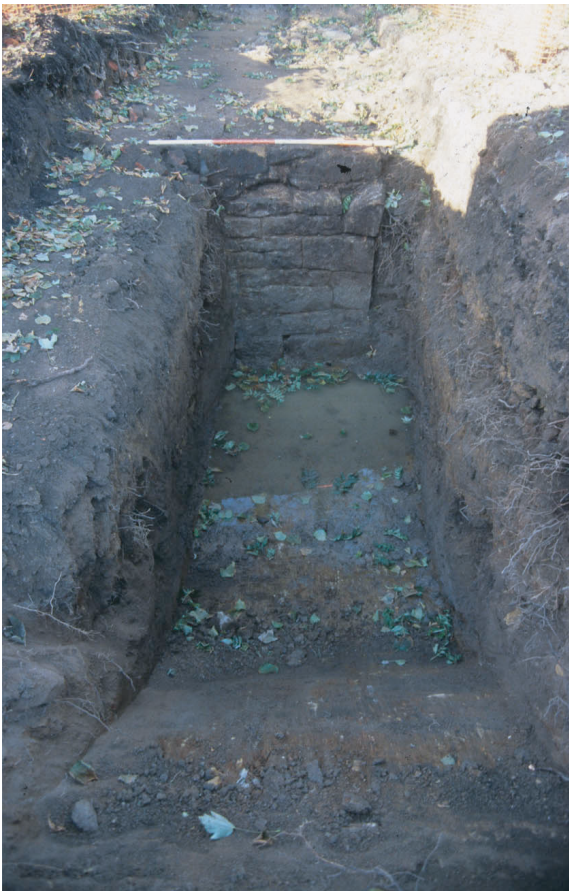
*Plate 5. Trench 6, view of moat retaining wall (1071) in machine excavated sondage with the corner visible to the right, looking north-west*
