Cooper Gallery

Church Street, Barnsley

Archaeological Watching Brief

Report no. 2773

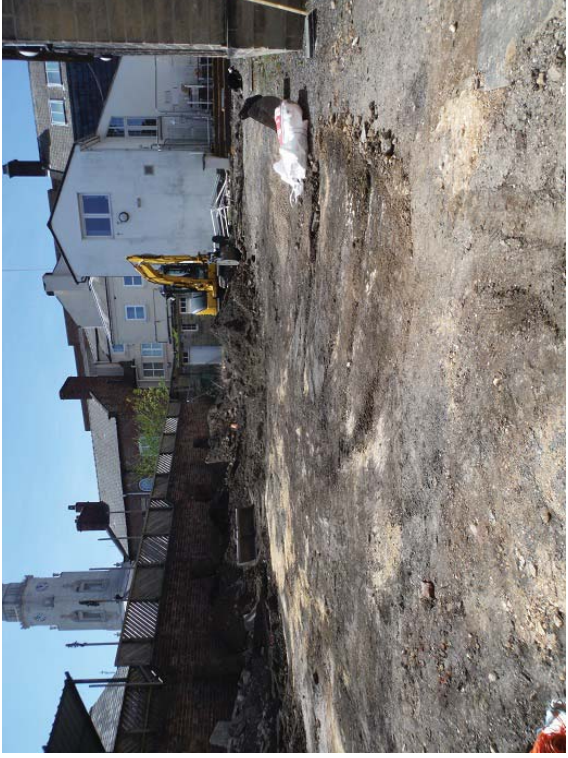
Plate 1. General view of the site looking west

The Cooper Gallery is located on the east side of Church Street, to the south-east of the church, in the centre of Barnsley (NGR SE 3443 0663). The site occupies raised ground (at about 120m OD), above the River Dearne, which lies 300m to the north-east. The site was used most recently as a car parking area to the rear of the gallery (Plate 1).

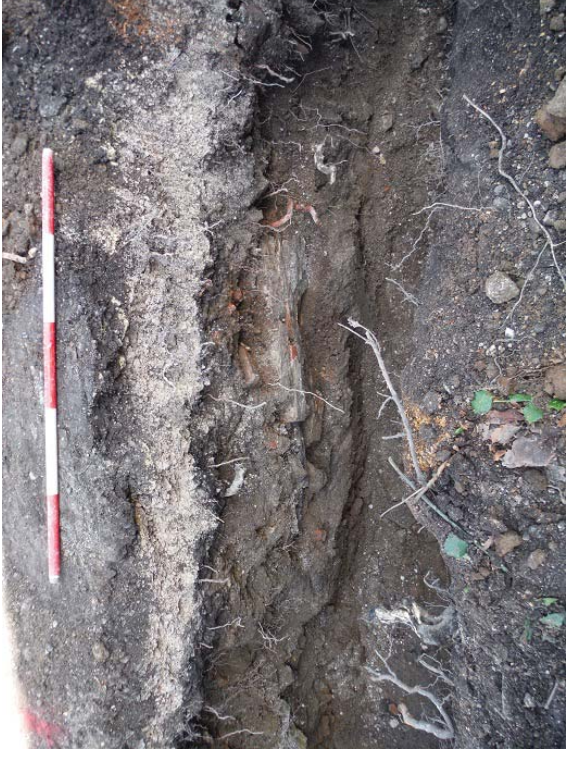
Plate 2. Possible in-situ wall and floor in drainage trench section looking north

A thick deposit of made ground was encountered at the surface across the whole site (100). This comprised a complex series of demolition layers spread over the site, with occasional thinner, compact layers of crushed mortar or stone, resembling yard surfaces. The deposit also varied considerably in depth, from 0.38m at the eastern edge of the site to 1.2m along the western edge. Deposit (100) was difficult to understand in detail due to the constraints of working around the deep trench, though the layer was made up of deposits over a long period as both hand-made and modern bricks and 20th-century glass and plastic were present. Large amounts of rubble and bricks were present within the made ground layer suggesting the presence of substantial demolished structures nearby. Only along the southern edge of the site were possible in-situ walls and floors observed (see Plate 2). Here four courses of handmade bricks, bonded with lime mortar were observed with small sections of stone paving slabs seen at the same level as the lowest course.

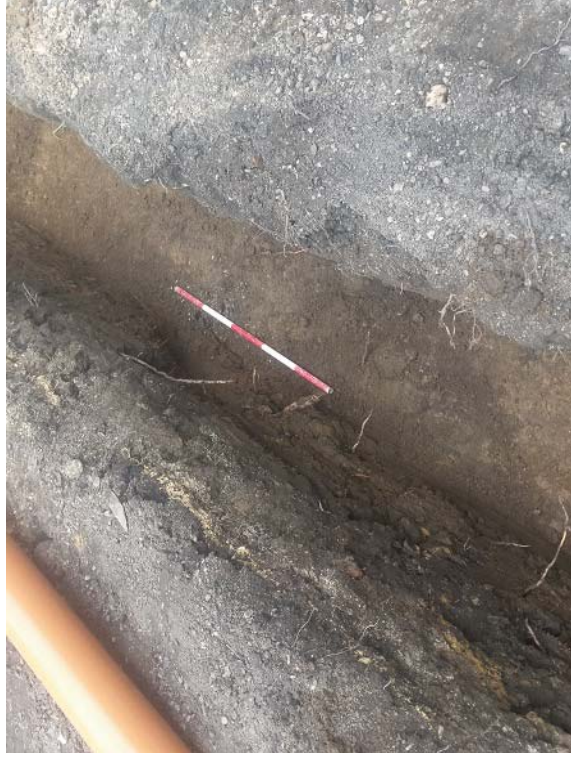
Plate 3. Possible pit [104] in base of drainage trench looking north-west

A possible pit [104] was seen at the eastern edge of the site, 1.25m below the surface, in the base of the drainage trench (Plate 3). The feature cut into the natural and was sealed by the subsoil. The pit appeared to have a rounded shape and extended beyond both edges of the drainage trench and was at least 2.88m in length. The feature was filled with a dark brown

sandy-clay with occasional greenish patches, possibly indicating cess deposits. Due to the depth of the trench it was not possible to excavate the feature any further, though it was possible to take a soil sample and recover several sherds of pottery dating to the medieval or possibly early post-medieval period. The feature may be a refuse pit associated with the medieval buildings that would have fronted onto Church Street.

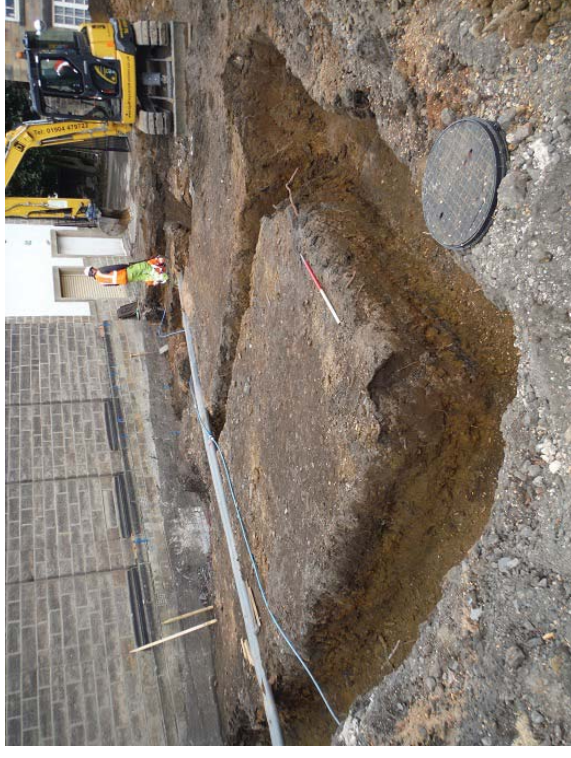
Plate 4. Excavation of foundation trenches looking north-east

Further groundworks were monitored at a later date, involving the reduction of the ground level by around 0.4m across the whole site, and foundation trenches were then excavated to a depth of around 0.6m (Plate 4). The same sequence of made ground deposits were seen above buried topsoil and subsoil and no further features were seen. No trace of feature [104] was seen in the foundation trench.
