Imphal Barracks

Fulford, York

Archaeological Evaluation

Report no. 2792

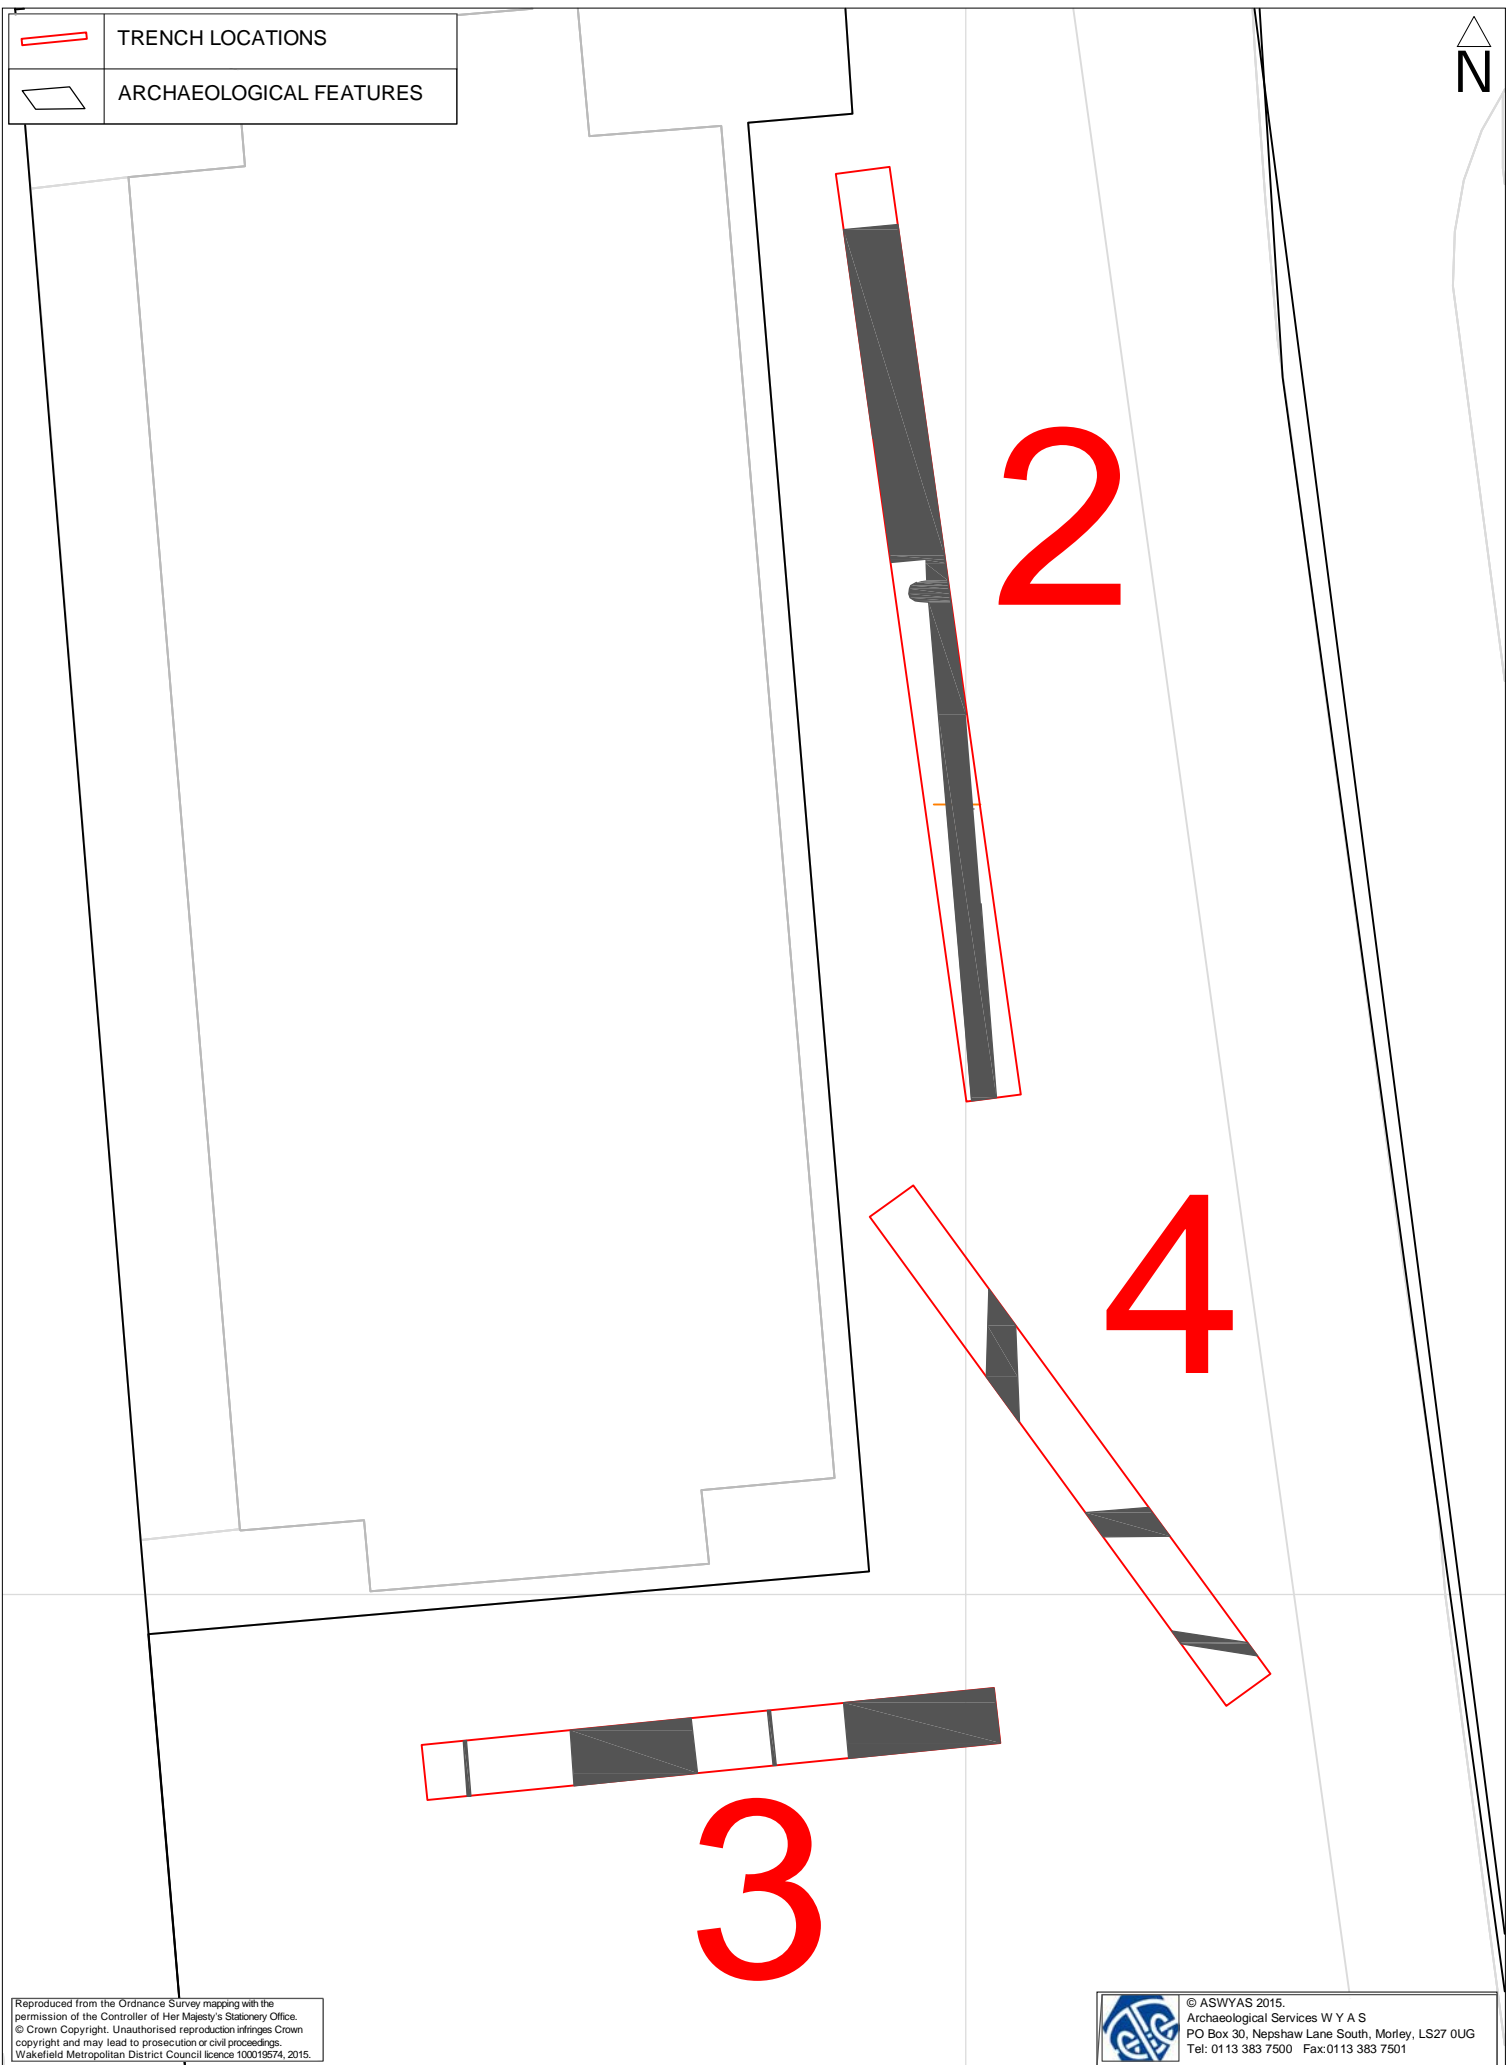
Fig. 3. Plan of archaeological features (1:250 @ A4)

Trench 2, 3 and 4 (Fig. 3)

This group of trenches were placed around the recently demolished remains of a nuclear bunker. They were arranged to target the small areas which did not contain known services, in between the bunker's deep foundations, large trees and a car park which was still in use. All the trenches were excavated through a thin layer of re-laid topsoil up to 0.15m thick and a layer of crushed concrete up to 0.50m thick. The concrete originates from the recently demolished deep bunker foundations. Beneath this was a heavily disturbed layer of buried topsoil and subsoil between 0.30m and 0.55m thick containing frequent brick and concrete fragments. At the base of each trench, natural deposits of sandy yellow or light brown sandy-clay were encountered.

Trench 4 exposed the continuation of the same service trench found in Trench 2, which was not investigated further (Fig. 3). A second feature with a similar fill and size was identified 1.50m to the south-east with an east to west alignment (Fig. 6). Investigations showed the edges to be near vertical but further investigation was halted due to the depth of the trench, already at 1.30m, and the feature rapidly filled with groundwater. Despite these limitations, it appears likely that the feature represents another service trench. A third linear feature [404] ran across the trench towards its south-eastern end, on an east-west alignment. Excavation showed this gully had a shallow U-shaped profile, measuring 0.57m wide and 0.13m deep. Its fill (403) was a mid-grey sandy-clay containing occasional flecks of charcoal. The soil sample from fill 403 also contains rare fragments of wood charcoal, but these were of insufficient size to be identified to genus. No finds were recovered, however, so the possibility remains that this feature pre-dates the barracks.

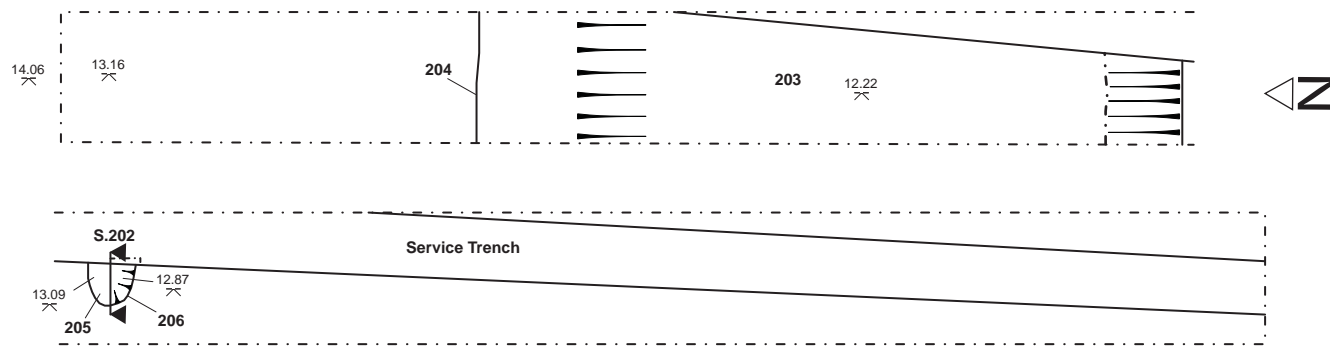
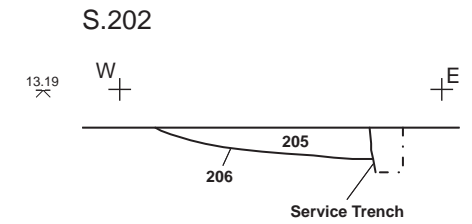
Fig. 4. Trench 2 plan and section

Trench 2 contained several features which were cut into the natural and sealed by the buried topsoil. A service trench ran along most of the trench at a slight angle to it. This was marked on the site's service plan and was not investigated further. The service cut a large feature [204] at the northern end of the trench (Fig. 4). The feature was excavated by machine to the maximum safe depth of 1.80m which did not expose its base. The feature's northern side was not excavated due to suspected asbestos near the surface. The material was covered and not disturbed further. The feature had a total exposed width of 12m and a depth of at least 0.95m and was filled with a mixed backfill (203) of dark and mid-brown silty-sand and clayey-sand containing frequent brick and concrete fragments. This material is likely to relate to the recent clearance of the site.

A shallow pit [206] was located in the centre of the Trench 2. This was cut by the service pipe, and predates both the services and the modern rubbish dump. Pit [206] measured 0.60m wide and its truncated length was 0.56m, with a depth of 0.09m and it had an oval shape. It was filled with a dark brownish-grey clayey-sand with patches of light brown clay (205). The feature contained occasional charcoal and clinker and two sherds of probable 19th or 20th-century flowerpot.

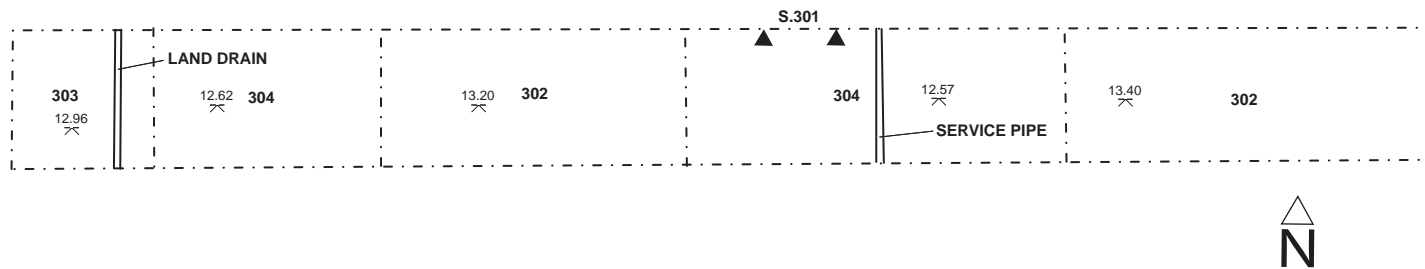
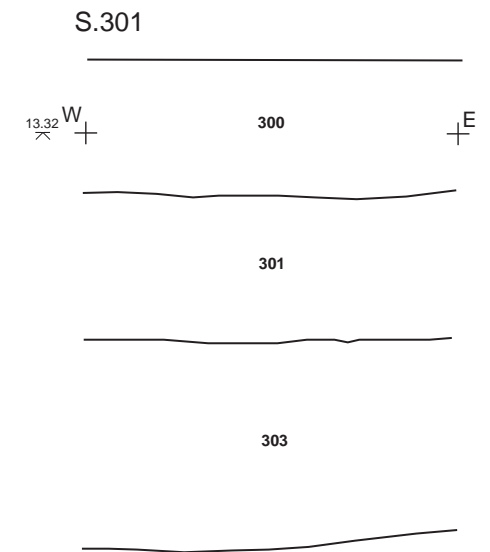
Fig. 5. Trench 3 plan and section

Trench 3 was not excavated to its full extent at its western limits due to live services. In addition, due to the presence of reinforced concrete footings, excavation was halted at around 0.30m in depth at the eastern end and centre of the trench (Fig. 5). The origin of the concrete footings is uncertain, but they are likely to be of modern date and related to the military occupation of the barracks. Despite the Nevertheless natural deposits were reached in between the concrete and services at a depth of 1.35m, through a similar sequence of crushed concrete and buried soil. No archaeological remains were identified.

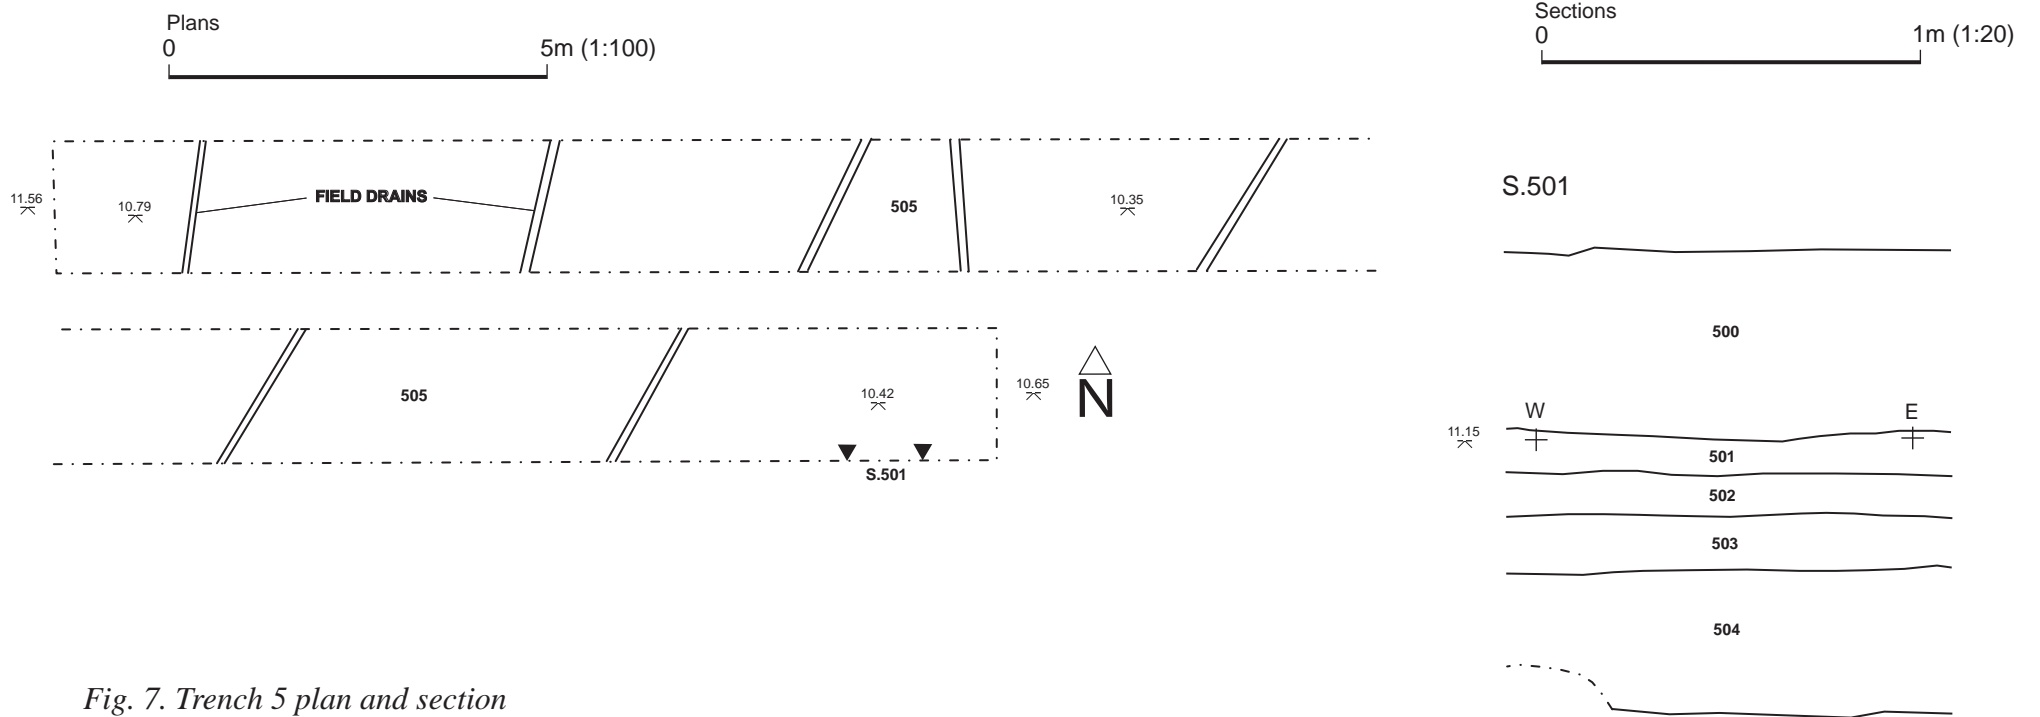
Fig. 7. Trench 5 plan and section

A total of seven field drains containing ceramic pipes ran across Trench 5 (Fig. 7) and a cable ran across Trench 6 (Fig. 8) but no other features were seen to cut the natural which comprised light brownish-yellow sandy-clays.

In Trench 5, the made ground consisted of a 0.10-0.12m thick, black layer of burnt material (501) above an unstructured layer of brick rubble (502) around 0.10m thick. The bricks appear to be from the demolition of a structure and are of 19th or 20th-century date, although no Ordnance Survey (OS) maps show any structure in the immediate vicinity. Either the bricks represent an early 19th-century structure that was demolished before the time of the first OS mapping in the mid-19th century, or more likely the bricks were introduced to the area when a later 19th or 20th-century building was demolished nearby. The brick deposit sealed a thin mid-grey silty-clay (503), around 0.15m thick, the origin of which is unclear. This overlay a buried subsoil (504) which sealed natural sandy clay deposits (505).

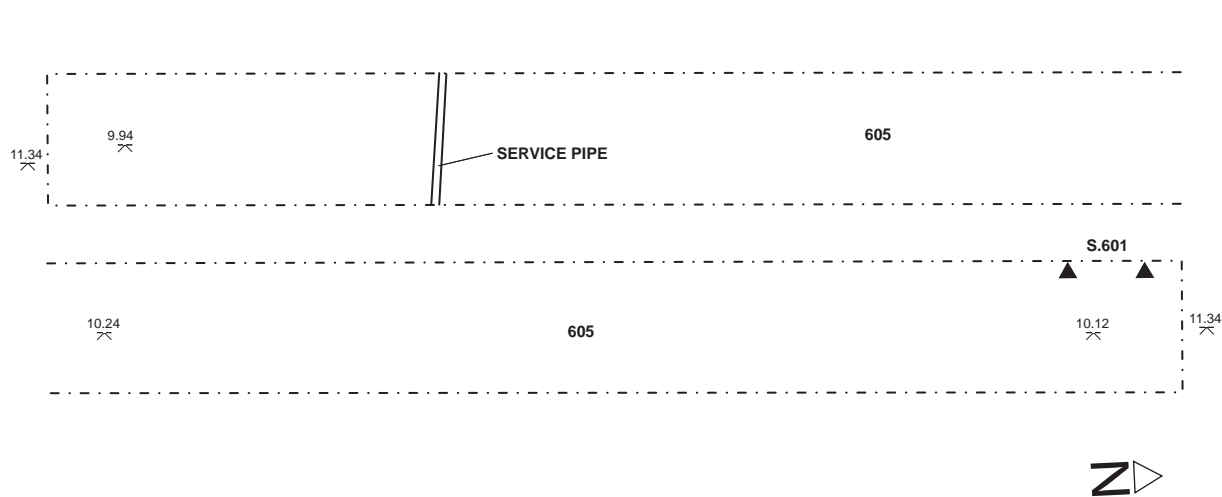
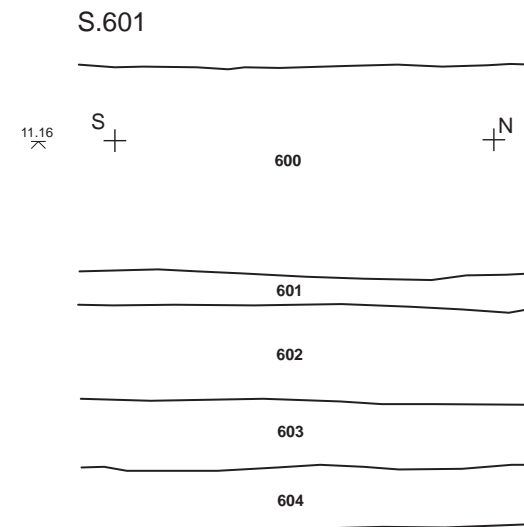
Fig. 8. Trench 6 plan and section

In Trench 6, the made ground consisted of a thin layer of crushed mortar or possibly concrete with white glazed tile and fragments of toilet bowl (601) around 0.10m thick. This overlay a dark layer of burnt material (602), around 0.30m thick, which was similar to that seen in Trench 5. Beneath the made ground in both trenches, dark grey and mid-yellowish-brown silty-clays were observed, which are likely to be buried topsoil and subsoil deposits, measuring between 0.30m-0.45m in depth. The layer was more homogenous in Trench 5 (504) with a clearer separation of topsoil (603) and subsoil (604) apparent in Trench 6.

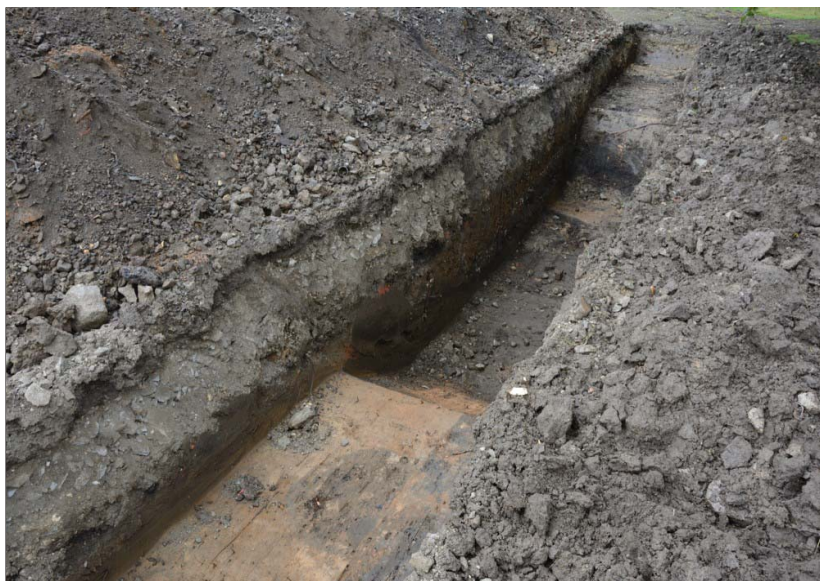
Plate 1. Feature 204, looking north-west

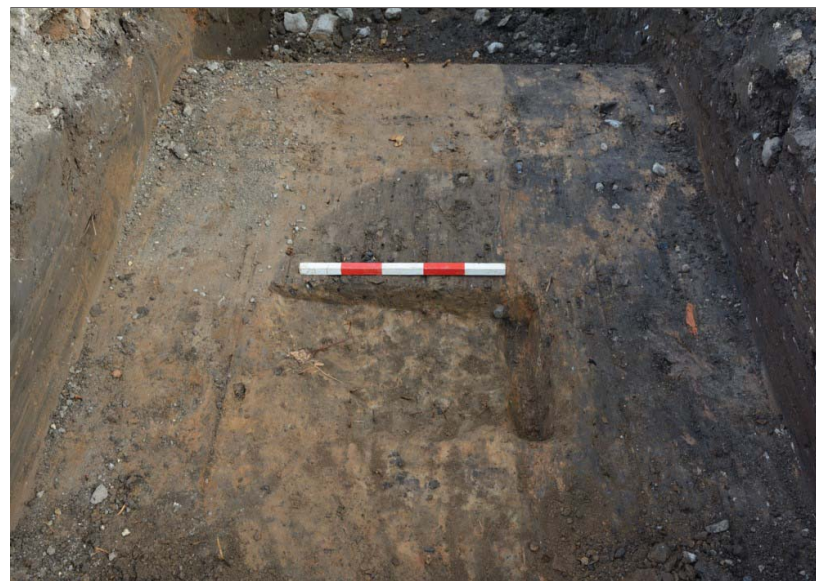
Two sherds of pottery from the fill (205) of pit [204] are of the same type. The details are summarised below.

- One rim sherd (1g) in a fine red fabric; the rim is small and clubbed but the bulge is entirely external, consistent with the vessel being a flowerpot of late 19th or 20th-century date.
- One body sherd in a fine red fabric (2g); undecorated but with fine striations internally and externally. The sherd is probably from a very similar vessel to that represented by the rim and is most likely to be a flowerpot of late 19th or early 20th-century date.

Two fragments of clinker, weighing 14g, were recovered from the fill (205) of pit 204. They represent fused residues from an unidentified coal-fired furnace or fire.

Plate 2. South-facing section of post-medieval pit 206

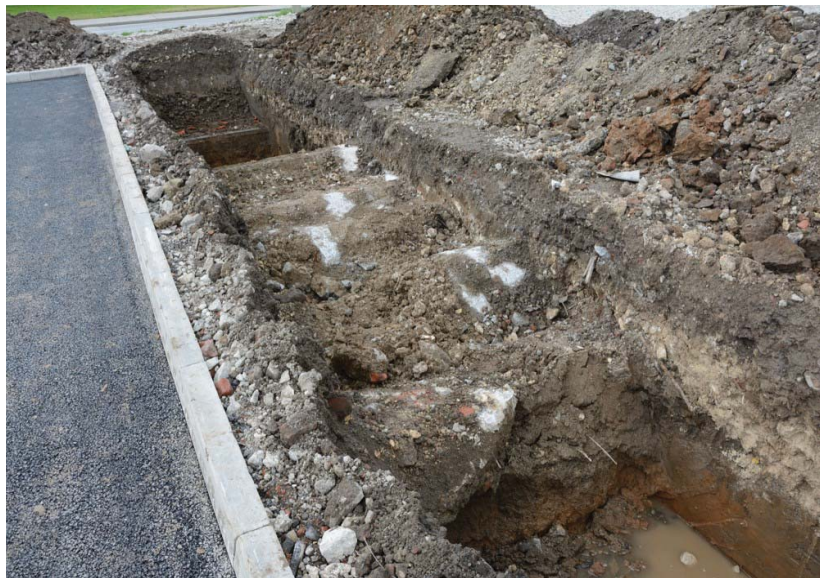
Plate 3. Concrete footings in Trench 3, looking north-west

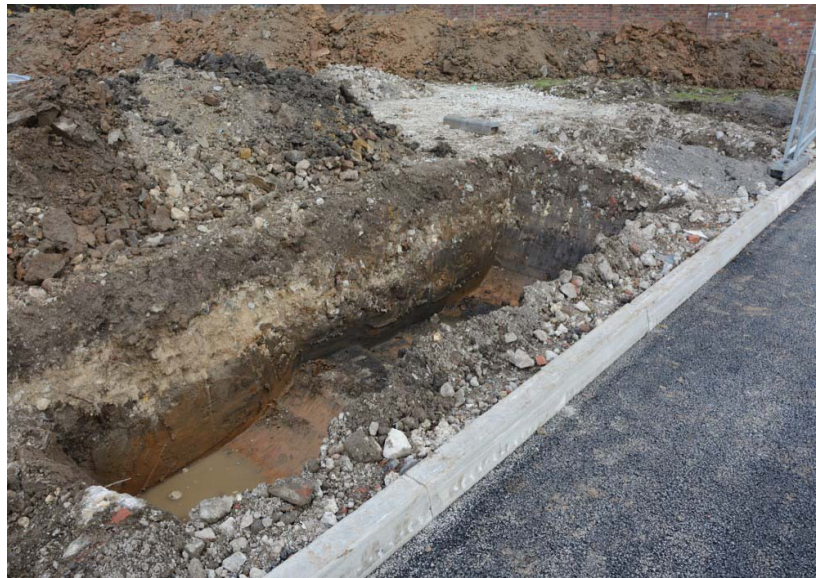
Plate 4. Eastern end of Trench 3, looking north-east

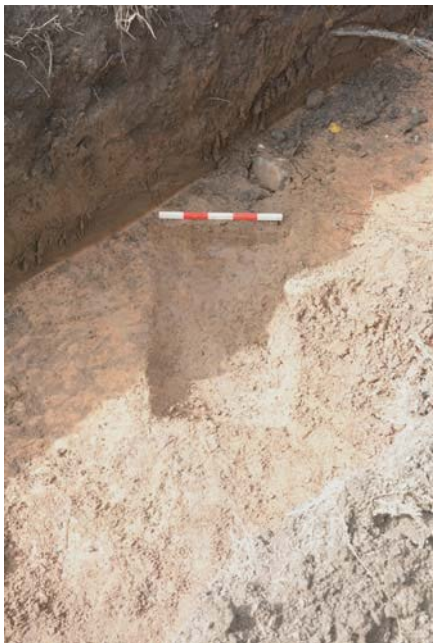
One bulk environmental sample from the fill (403) of gully [404] was processed by ASWYAS using a Siraf-style water flotation system (French 1971), a 300 micron sieve and a 1mm mesh. The flot was dried before examination under a low power binocular microscope typically at x10 magnification. The retent was sorted by eye, and scanned with a magnet in order to retrieve any hammerscale.

The flot contains no charred cereals, chaff or weed seeds, but small undiagnostic fragments of wood charcoal are present. Modern plant material, including rootlets were noted. The retent contained no artefacts, ecofacts or hammerscale and has been discarded. The flot will be retained as part of the site archive, but no further analysis is required.

Plate 5. East-facing section of gully 404

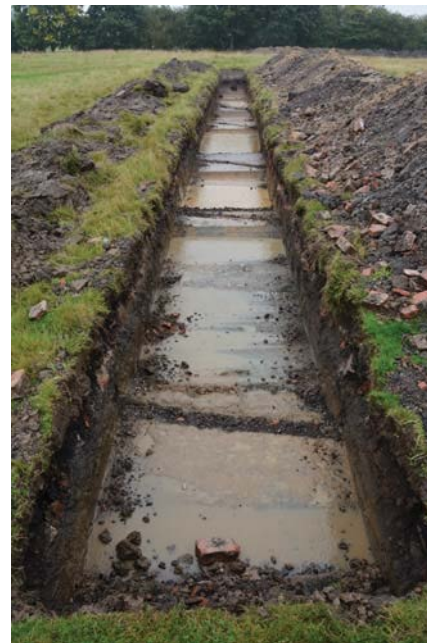
Plate 6. Trench 5, looking east

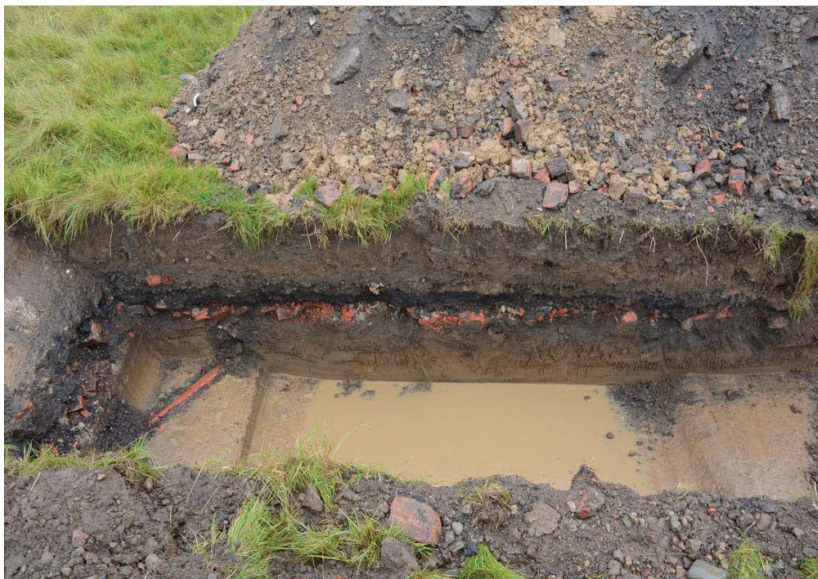
Plate 7. North-facing sample section of Trench 5
