**Broadway Centre
Bradford
West Yorkshire**

Archaeological Evaluation and Excavation

Volume 2: Figures and Appendices

Report No. 1582

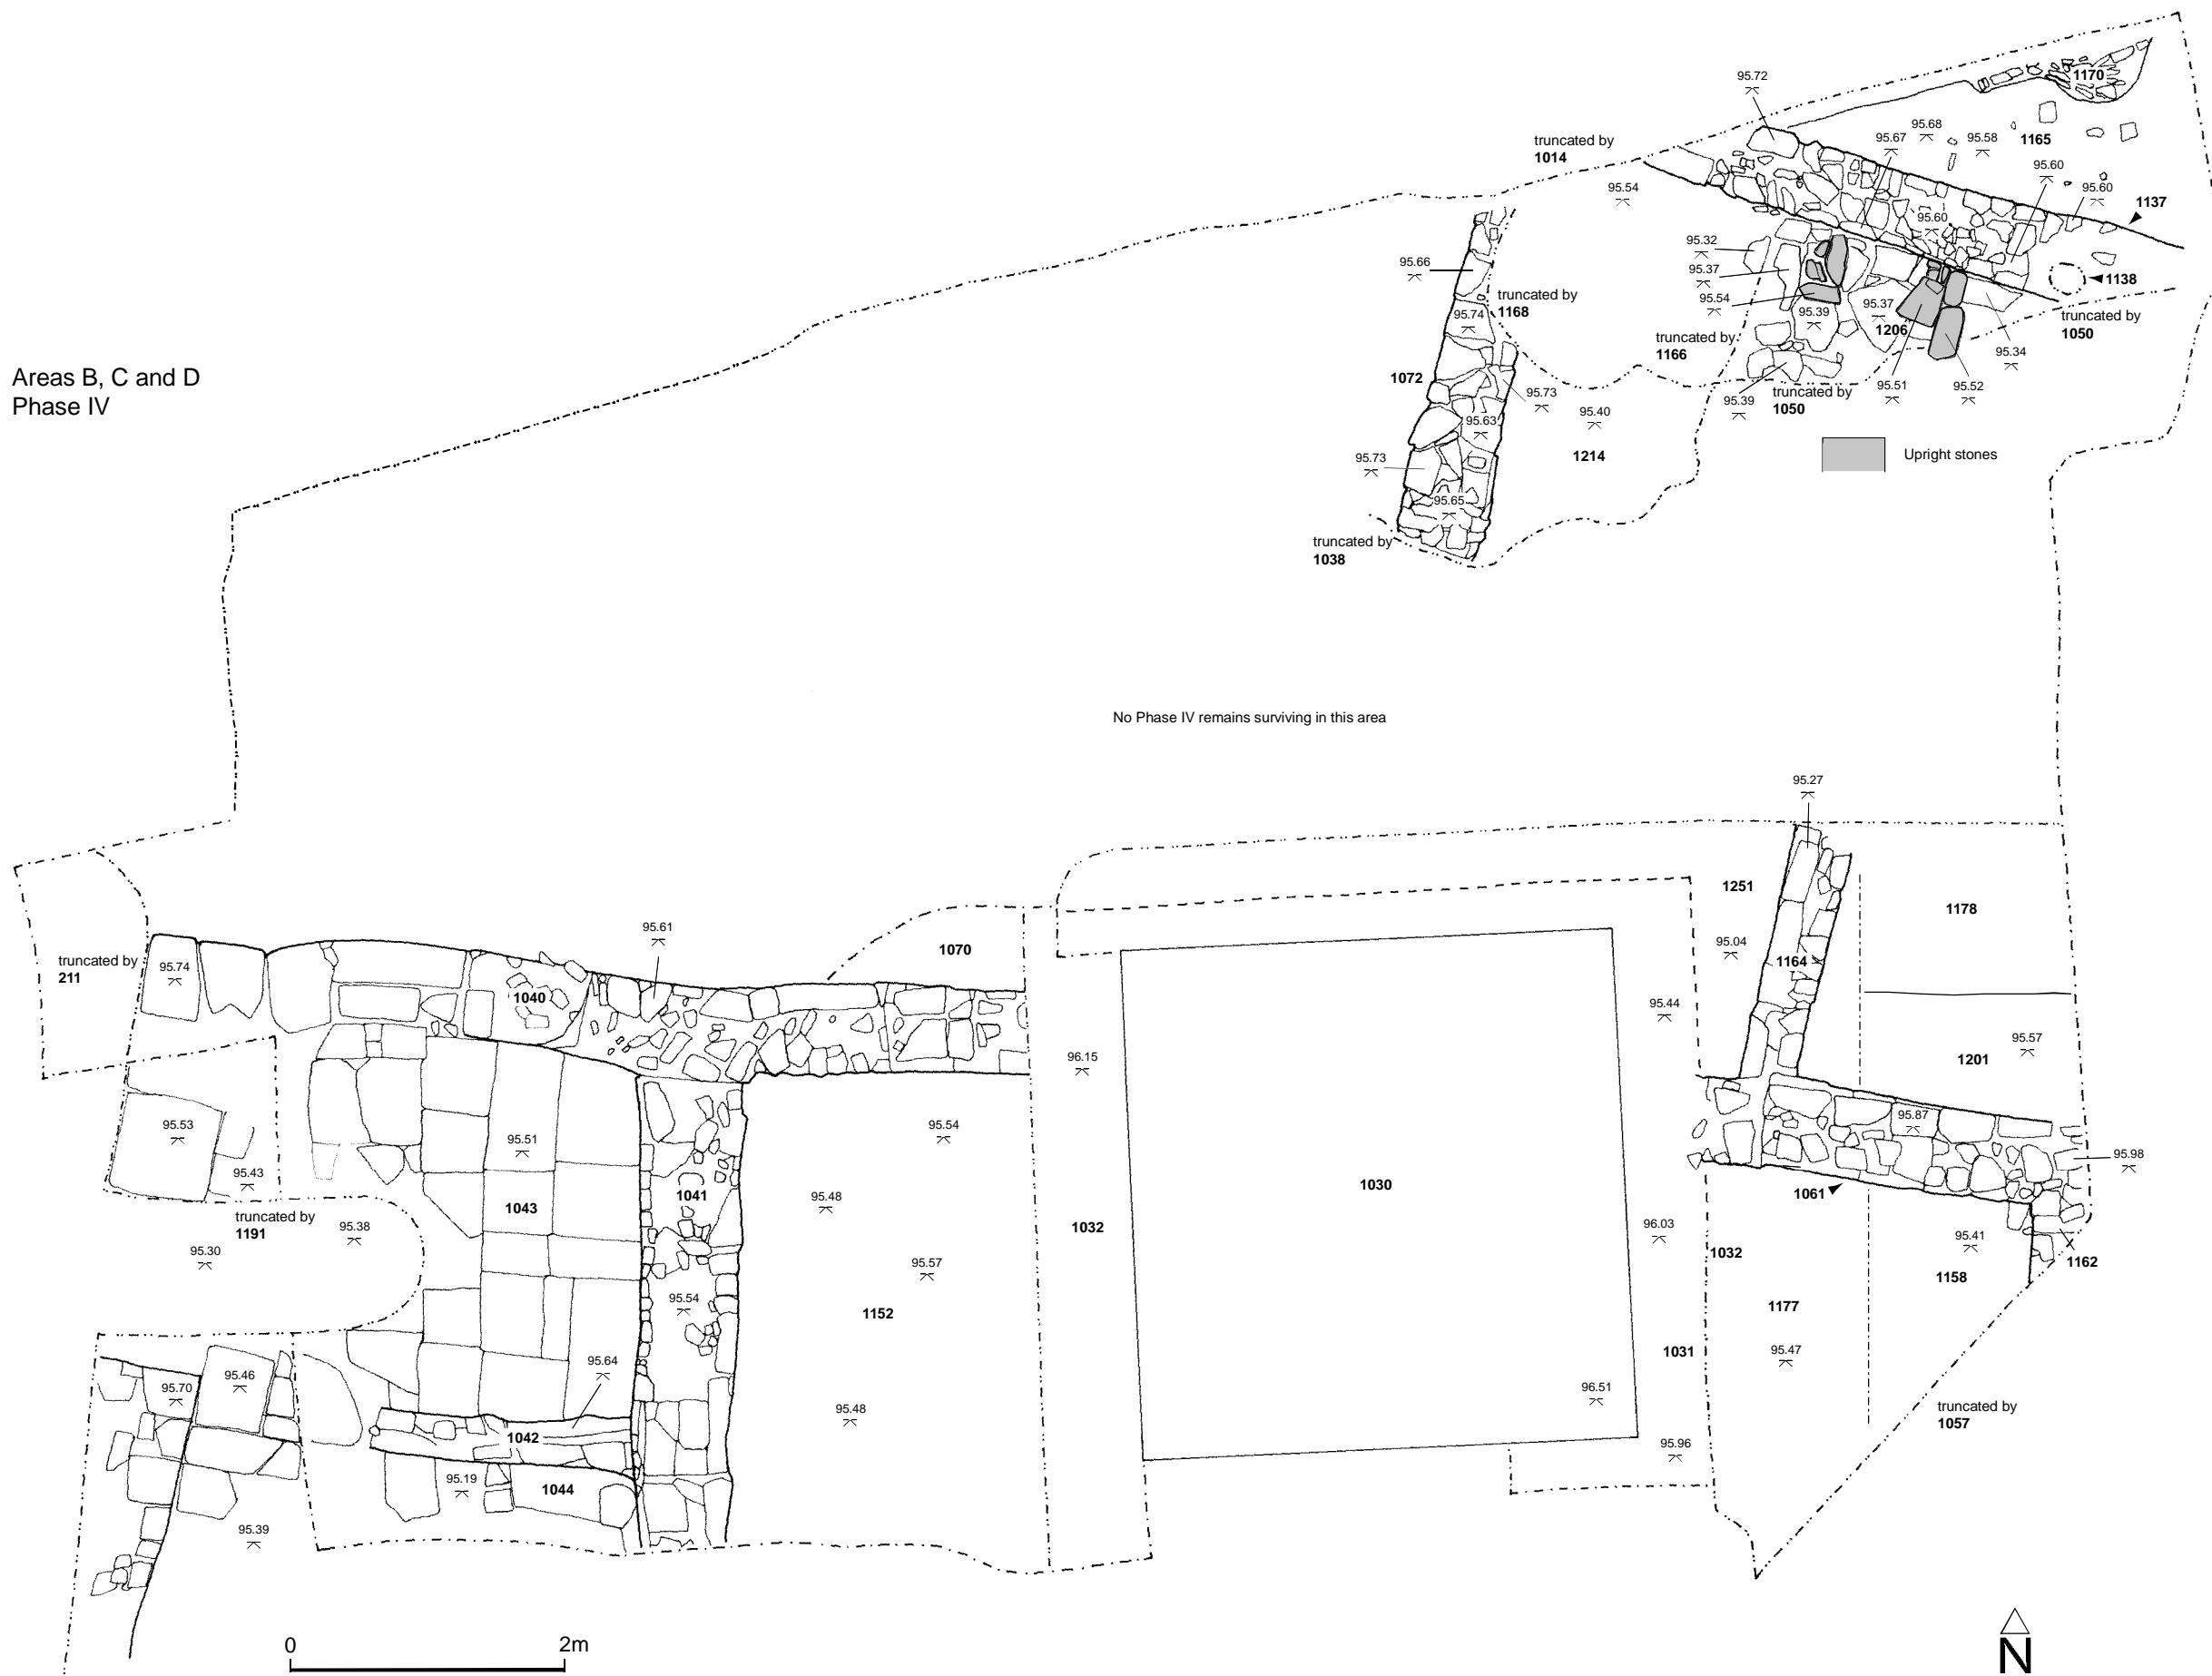
Fig. 30. Phase IV structure in Areas B, C and D.

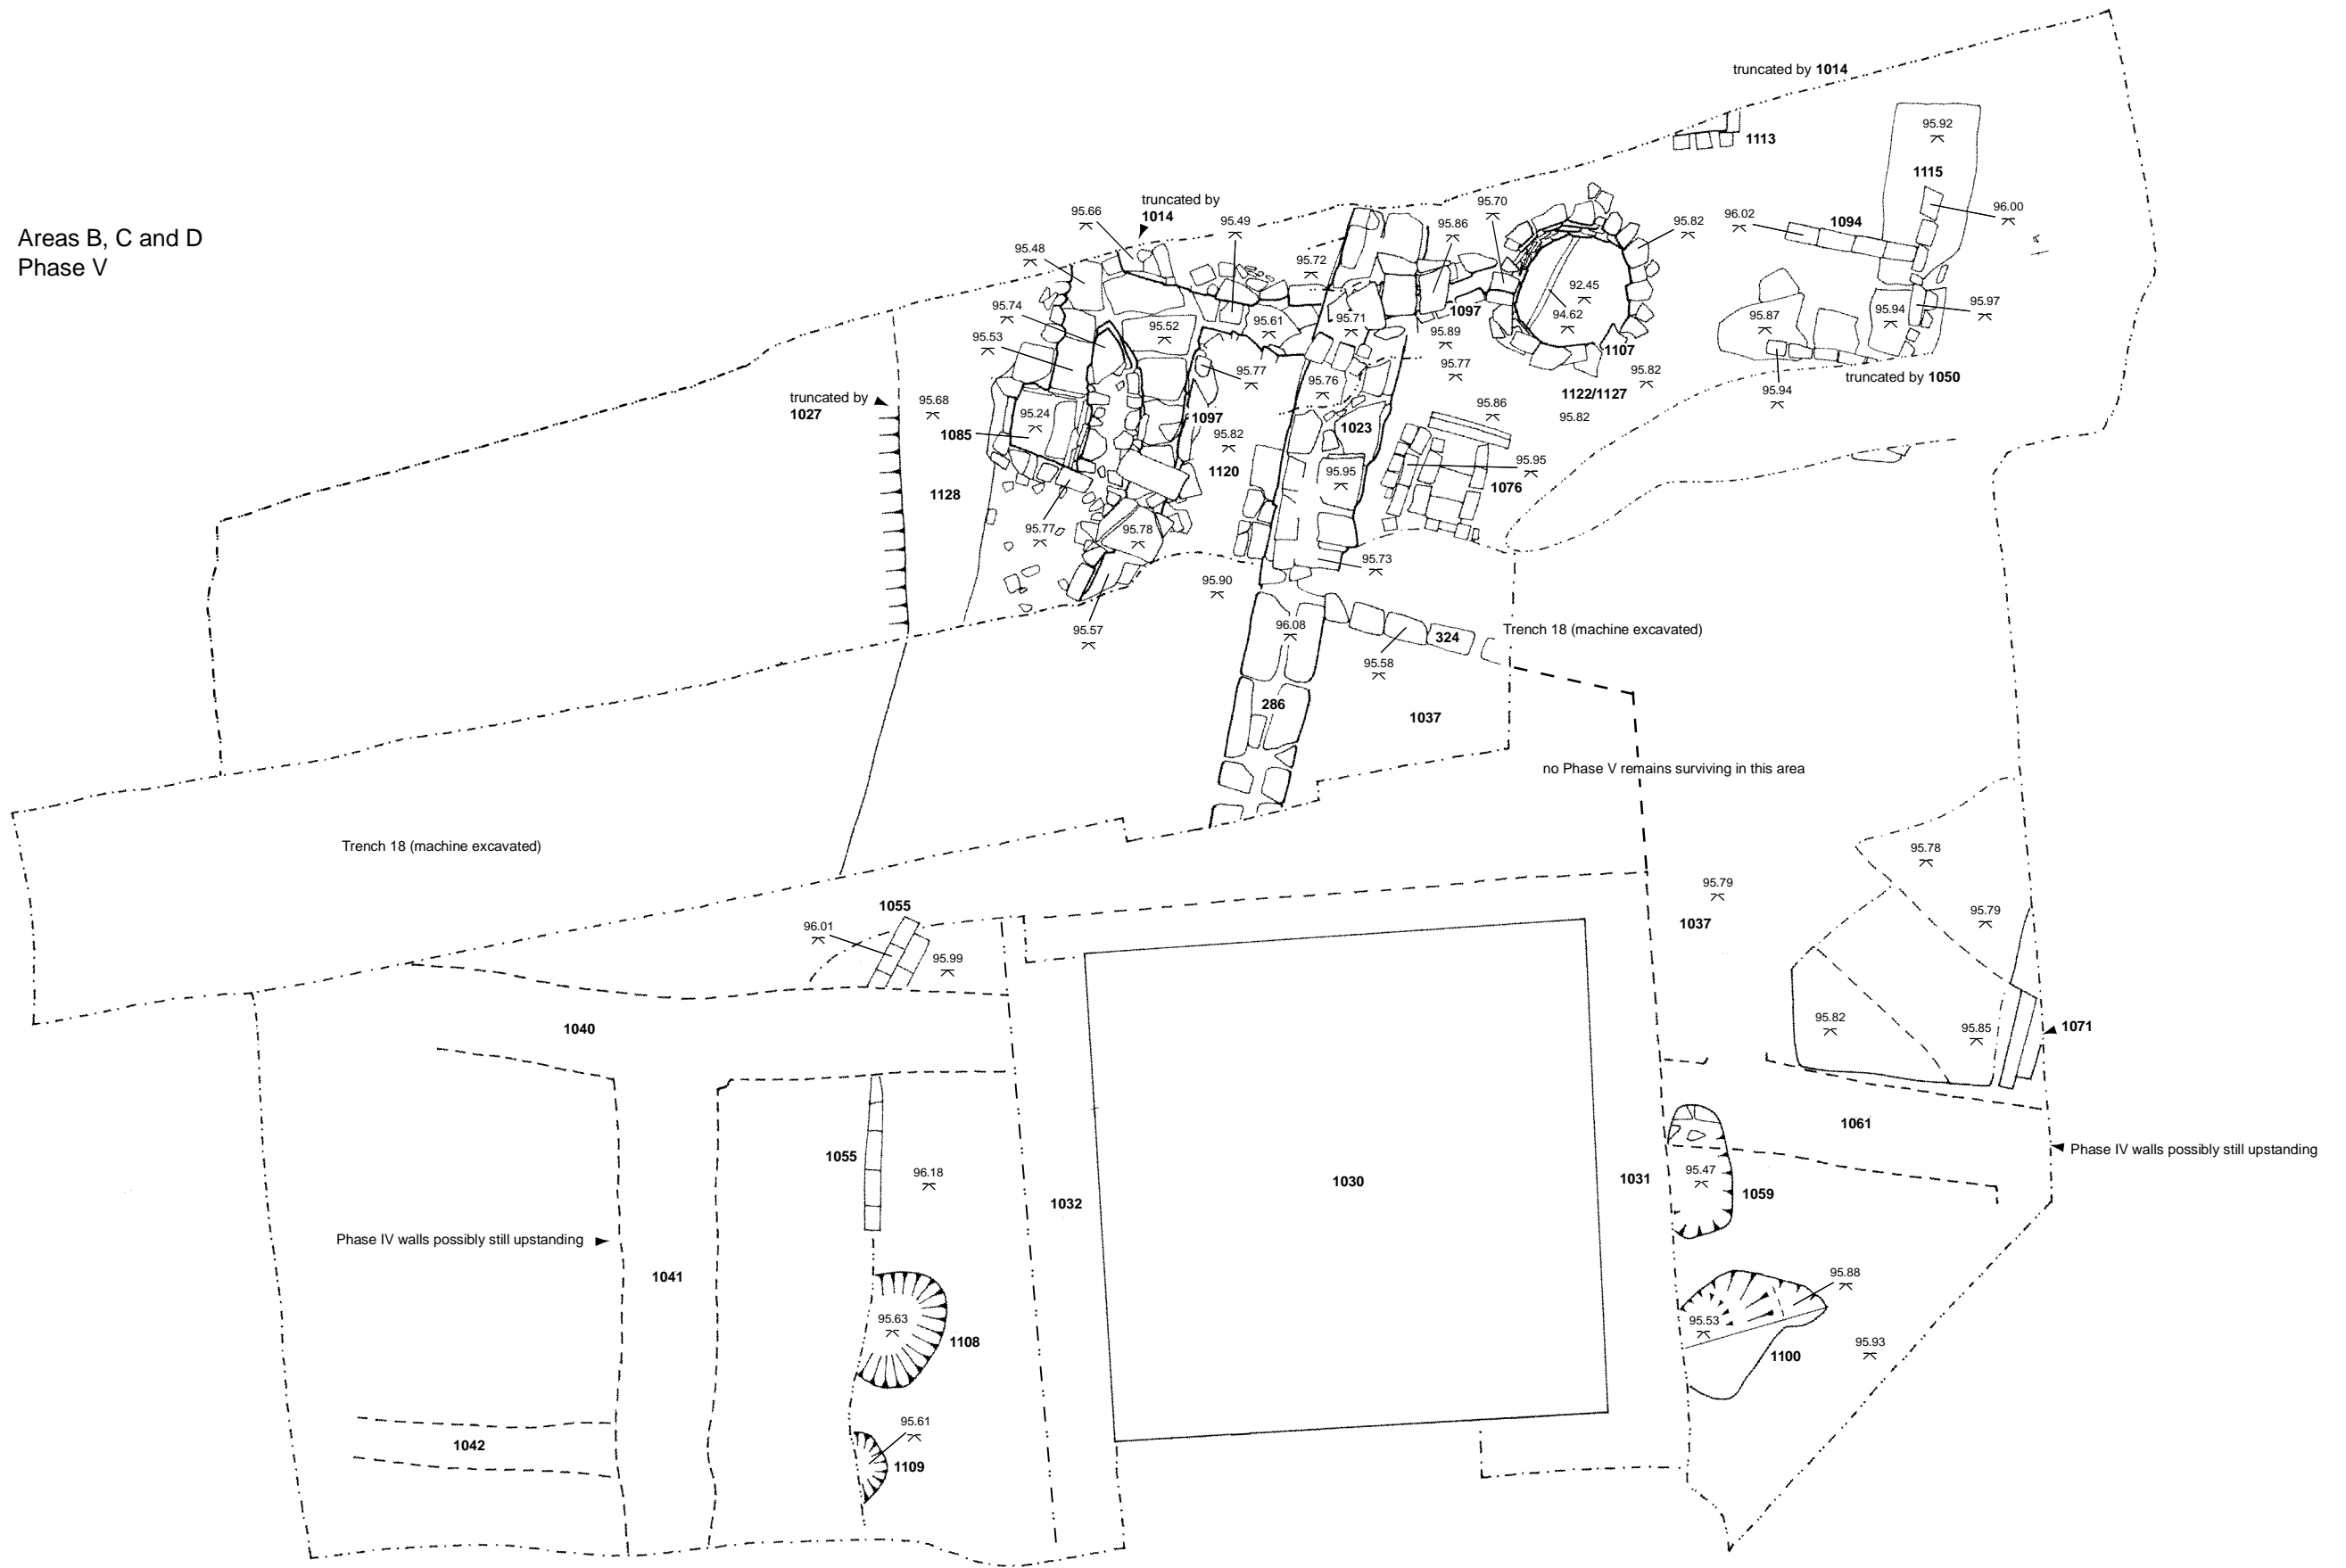
Fig. 31. Phase V structures in Areas B, C and D.

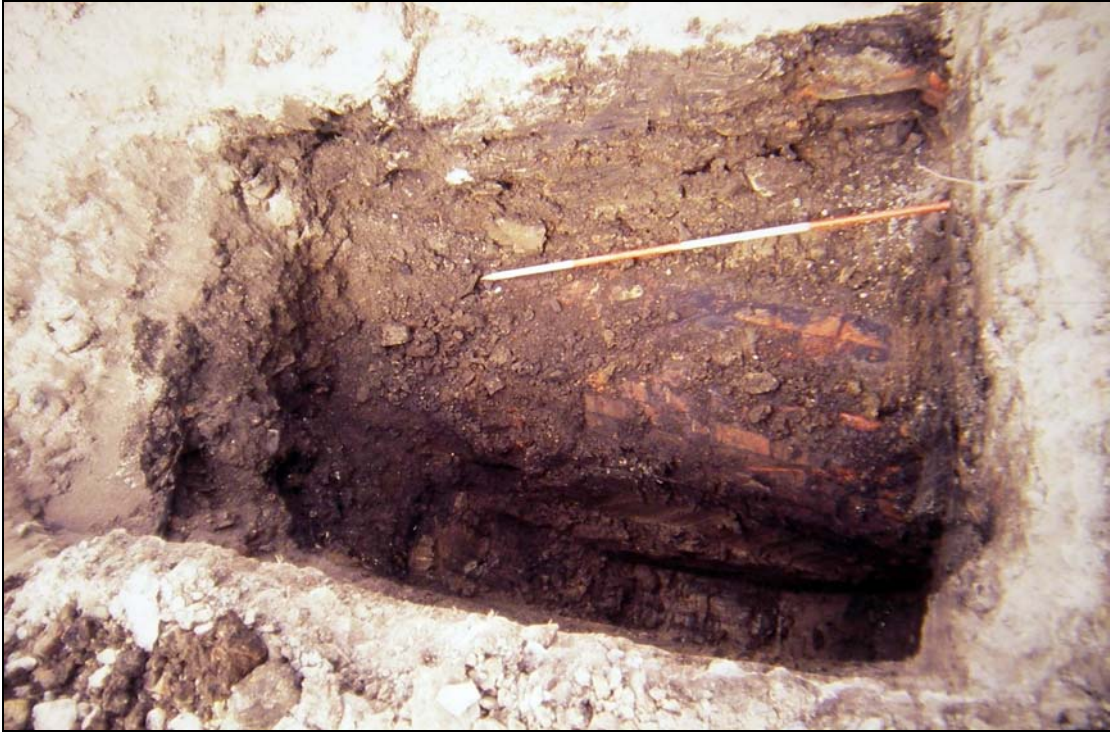
Pl. 1. 19th brick culvert in Trench 4 from the south

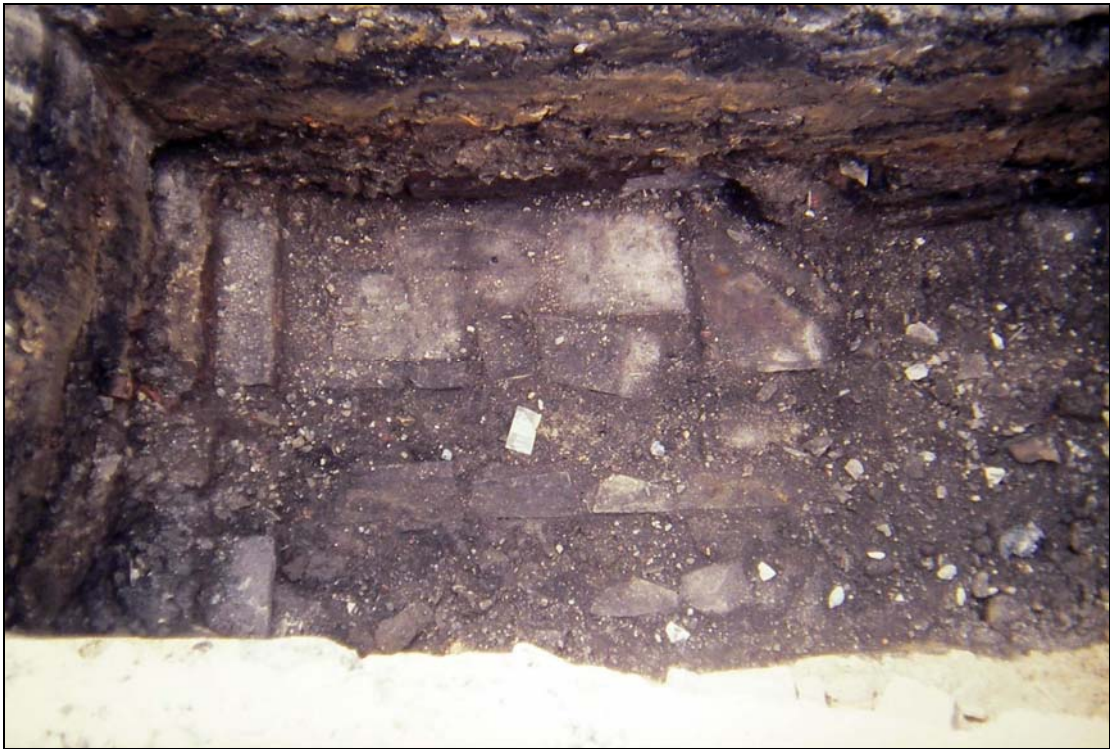
Pl. 2. Flags 101 and stone culvert 103 in Trench 9 from the south-east

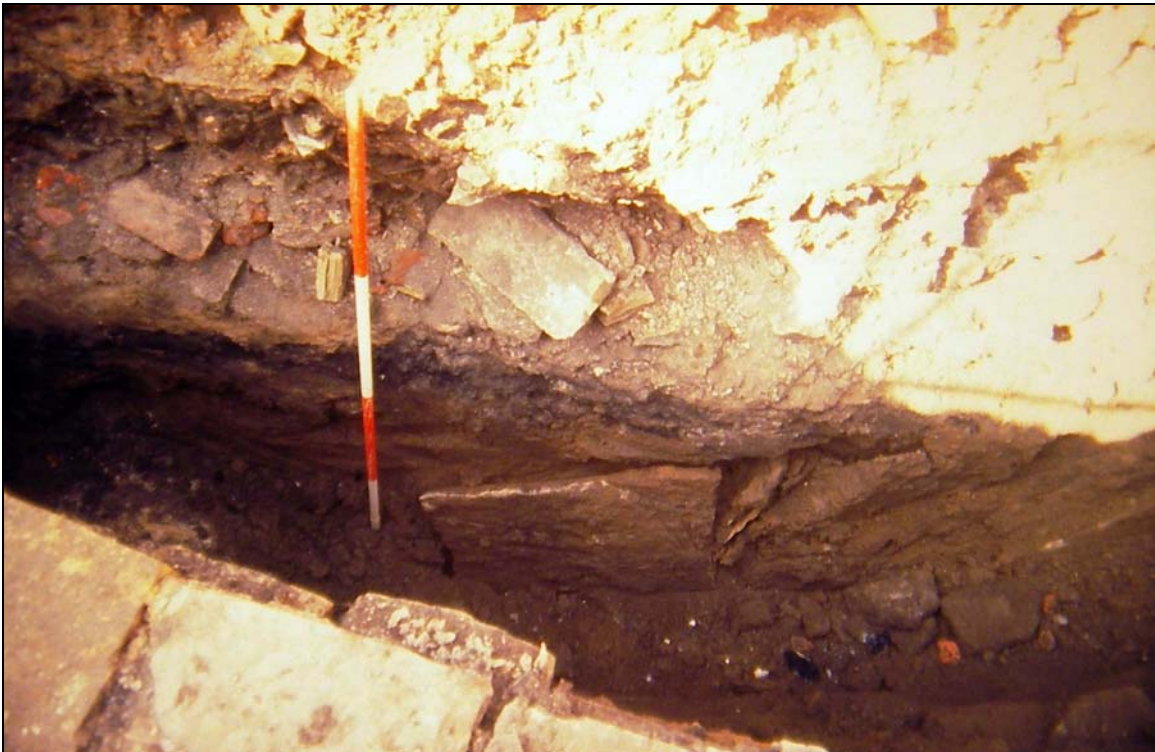
Pl. 6. Side of stone culvert 254 visible in south facing section of Trench 18

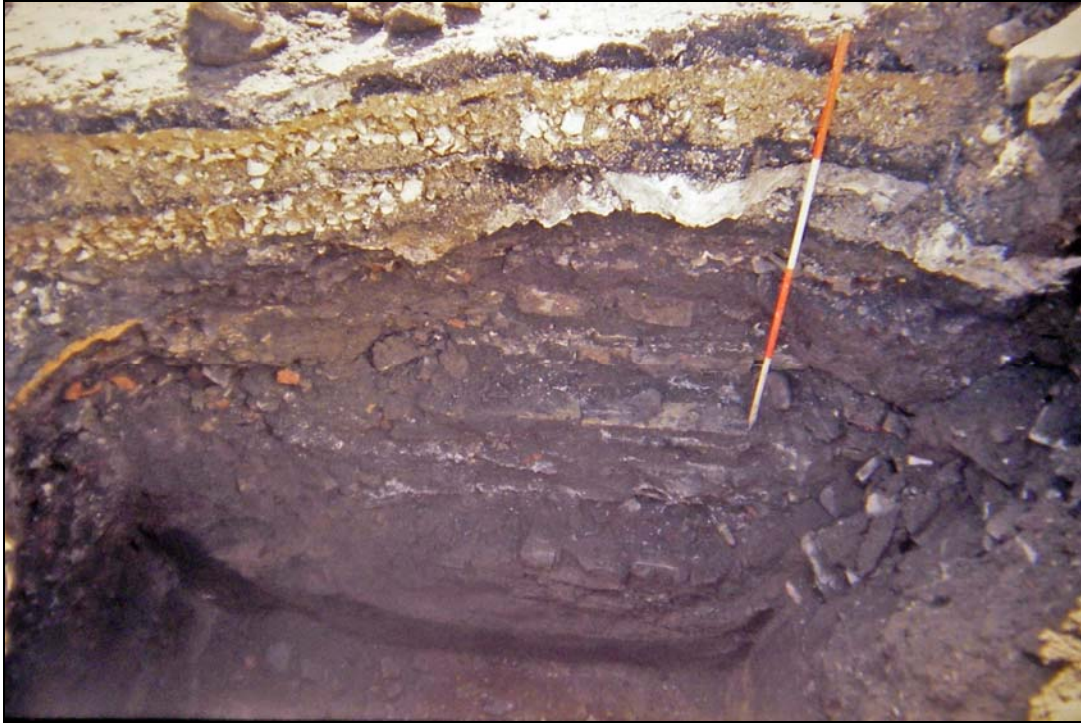
Pl. 9. 'Wall' 312 as first revealed in north facing section of Trench 18

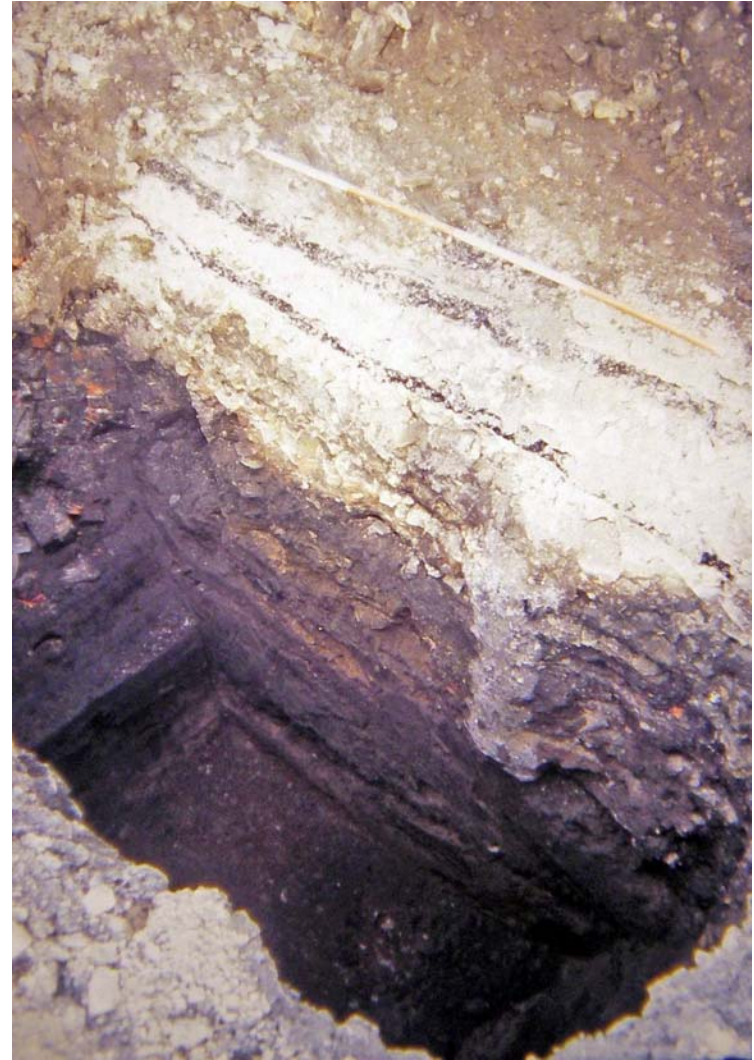
Pl. 12. South facing section of eastern end of Trench 18

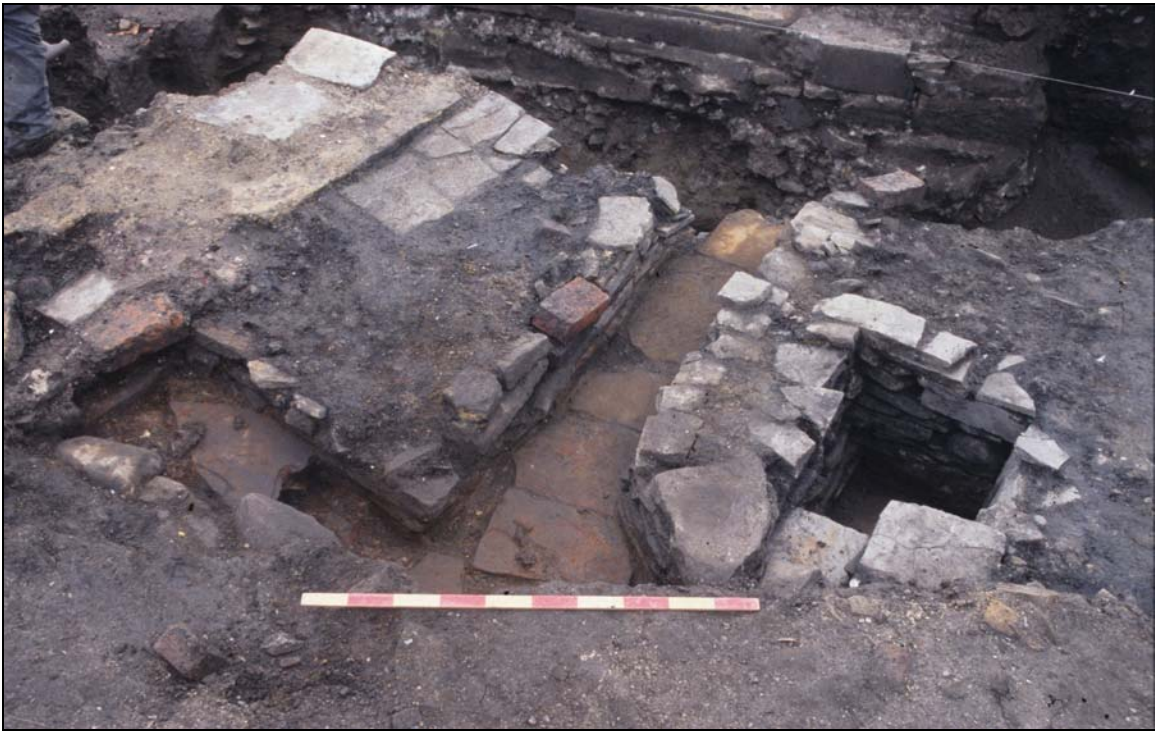
Pl. 18. Culvert 1097 and stone lined tank 1085 in Area A B1 from the north

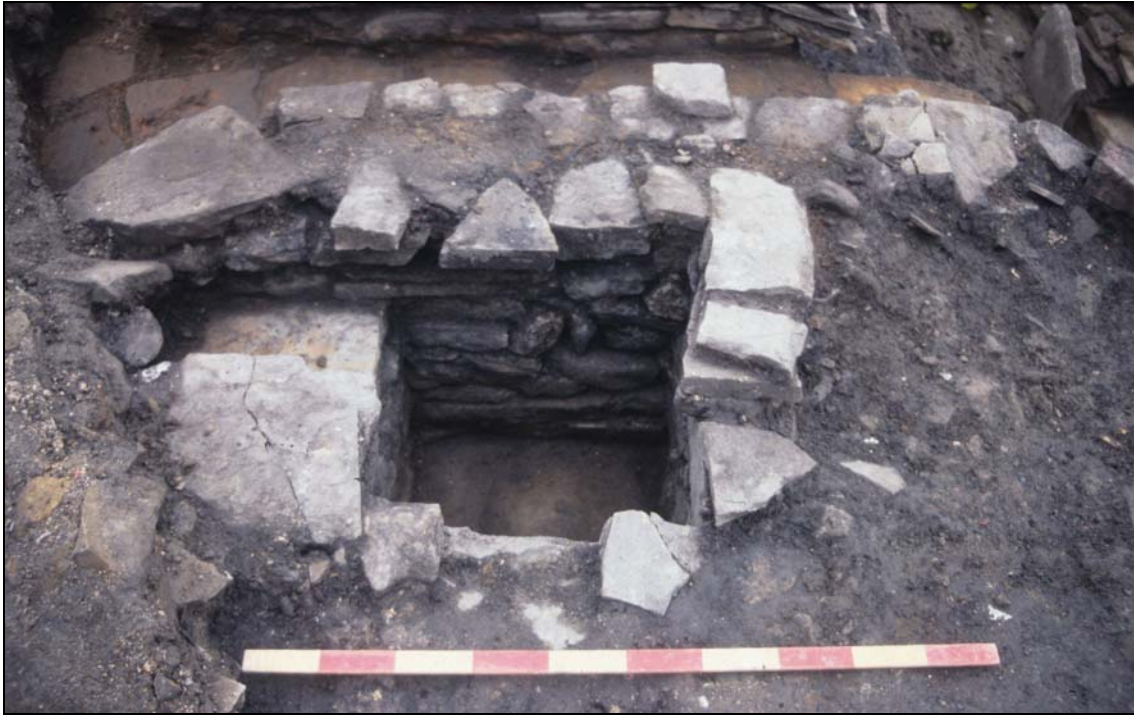
Pl. 19. Stone lined tank 1085 from the west

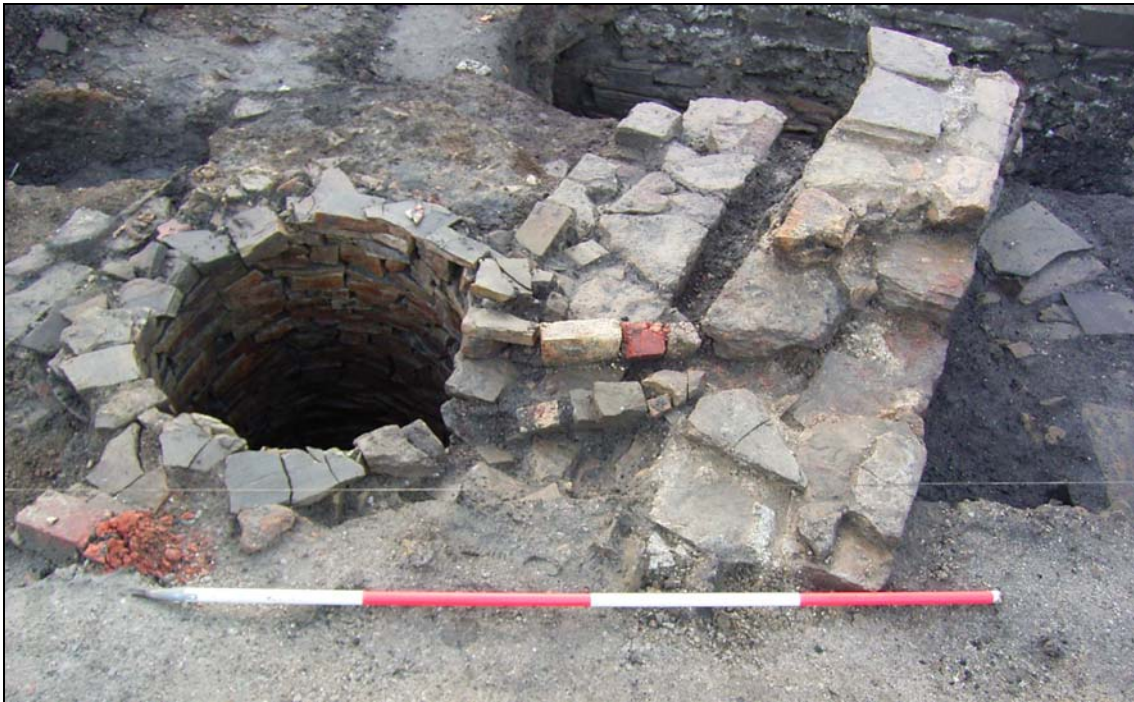
Pl. 20. South facing view of Area B showing well 1106, walls 1072 and 1023, and the top of culvert 1196. Note also channel of culvert 1097 passing through wall 1023

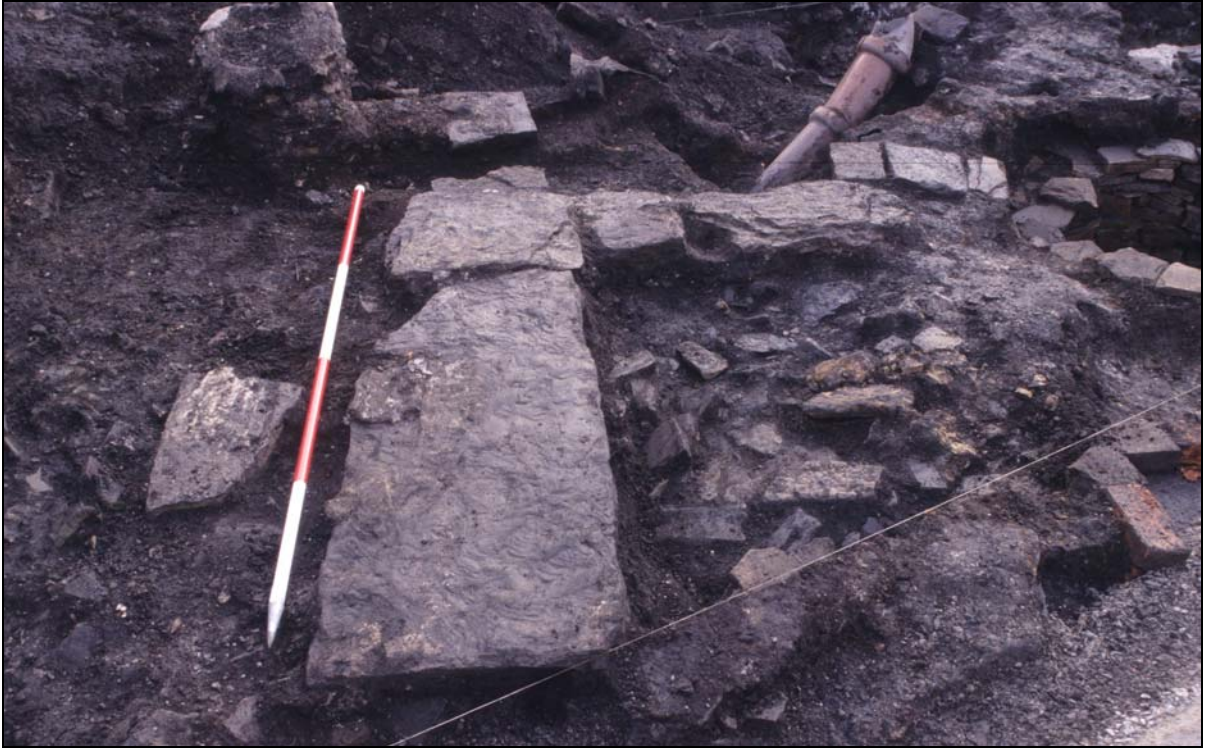
Pl. 23. Stone footings 1115 and underlying demolition layer 1122/1127 from the north-east

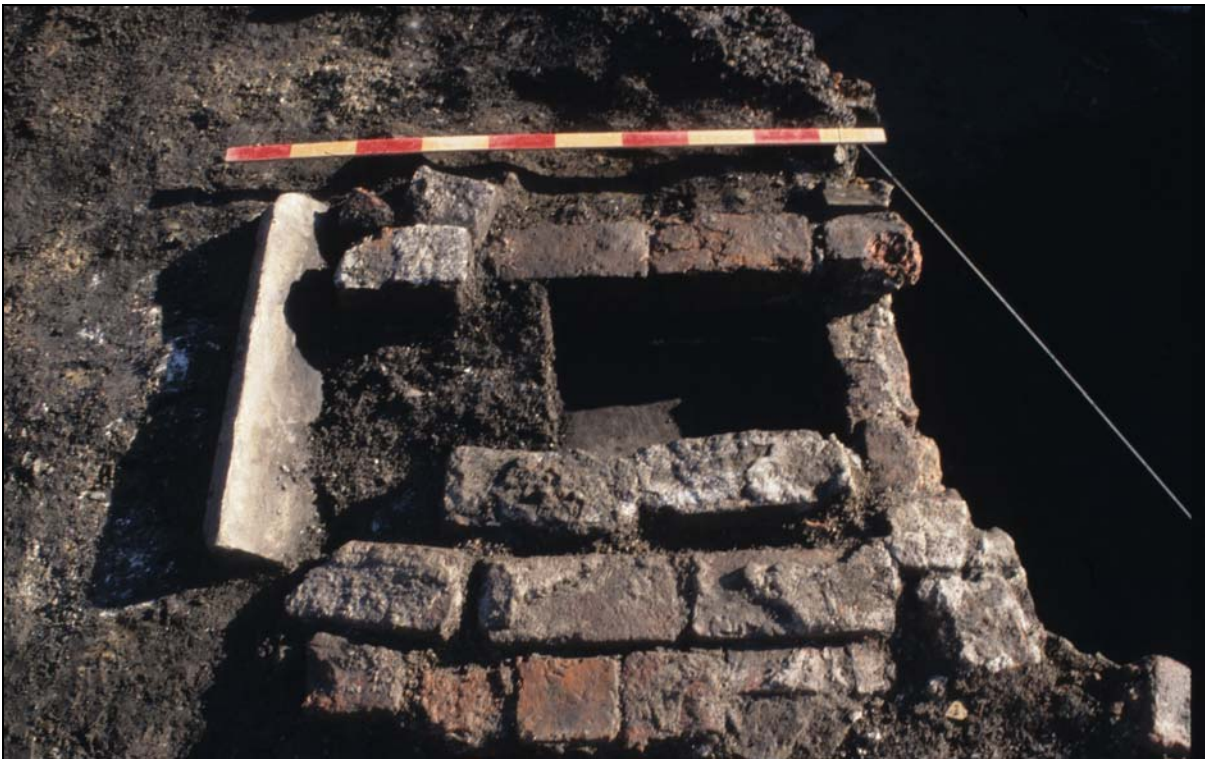
Pl. 24. Brick ash pit 1076 in Area B2 from the west

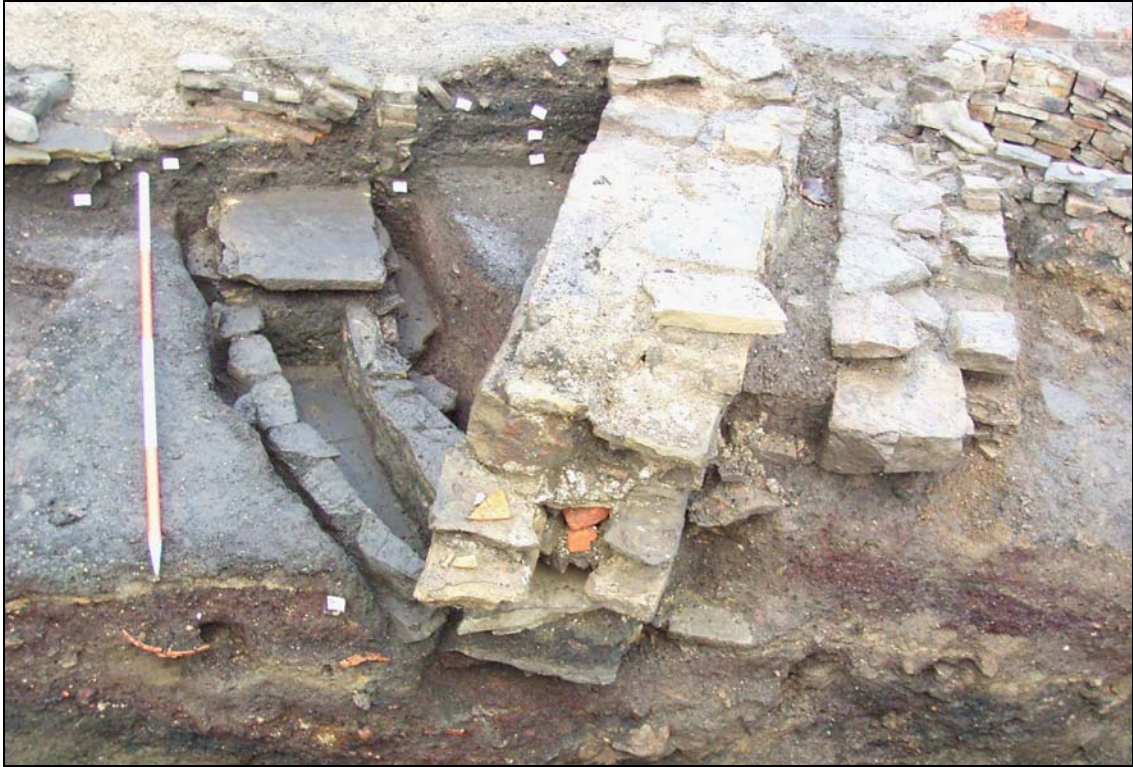
Pl. 25. Culvert 1196 and walls 1023 and 1072 in Area B from the south

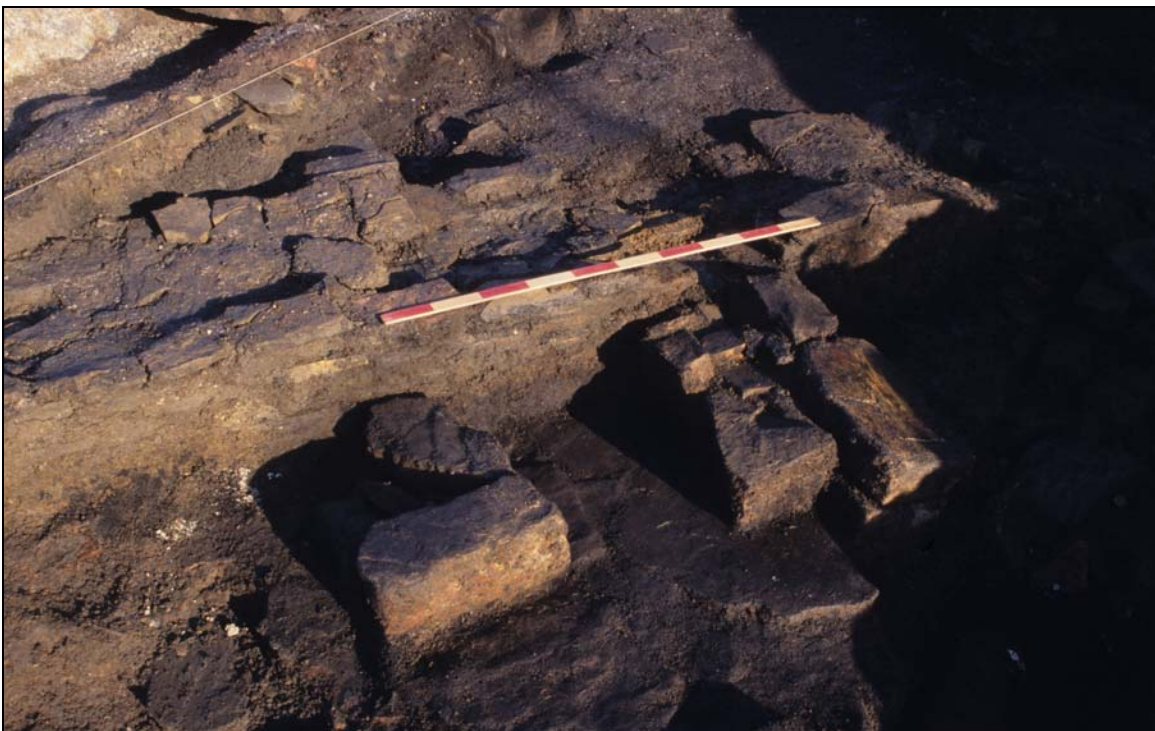
Pl. 26. Stone hearth or ash pit 1203 abutting wall 1137 in Area B2 from the south-west

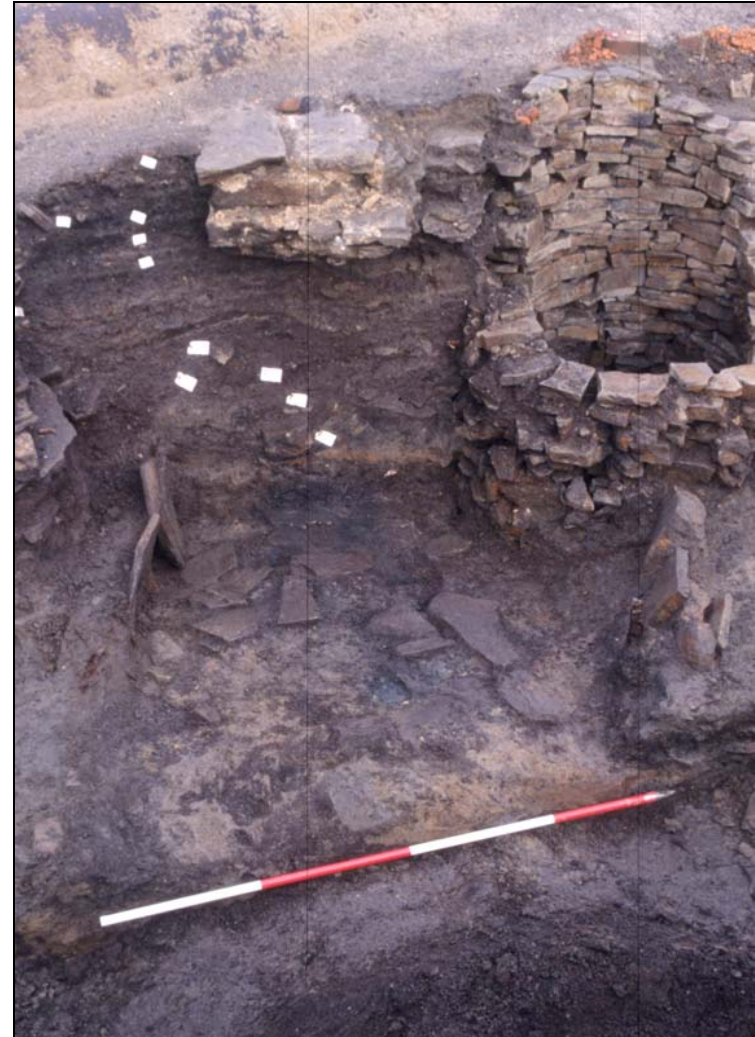
Pl. 30. Stone lining 1304 of possible leat 1303 in Area B2 from the south

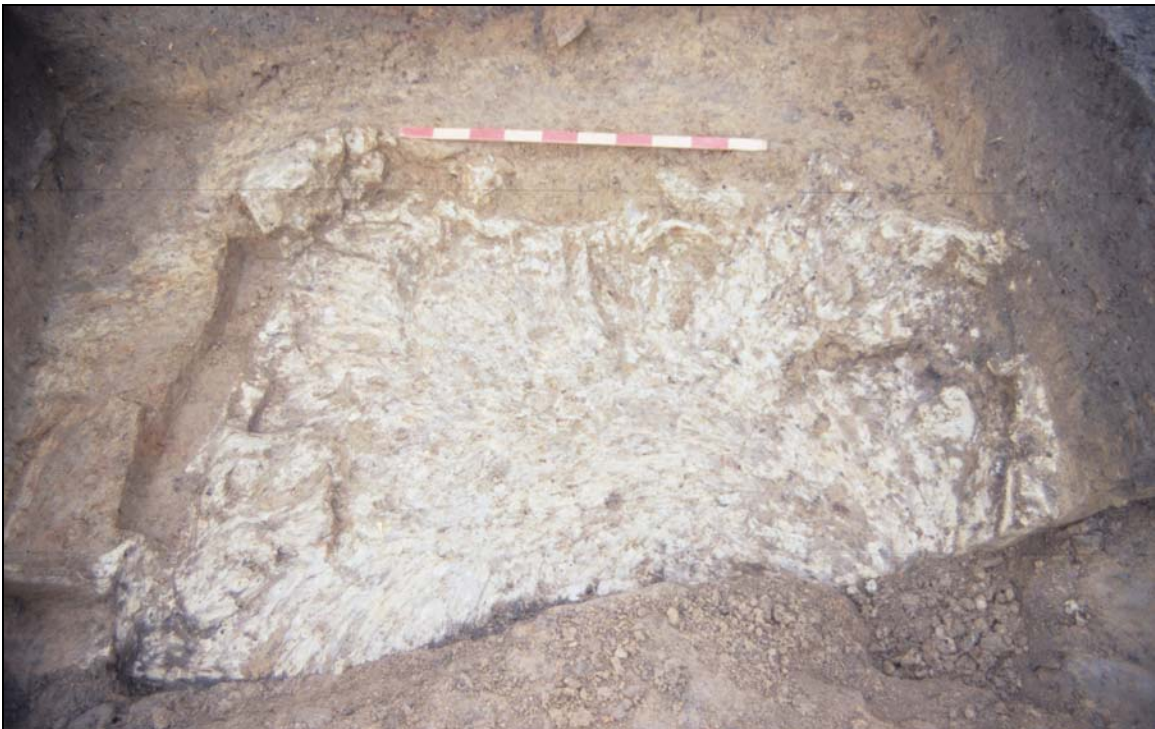
Pl. 32. Base of clay lined tanning pit 1065 in Area B1 from the south

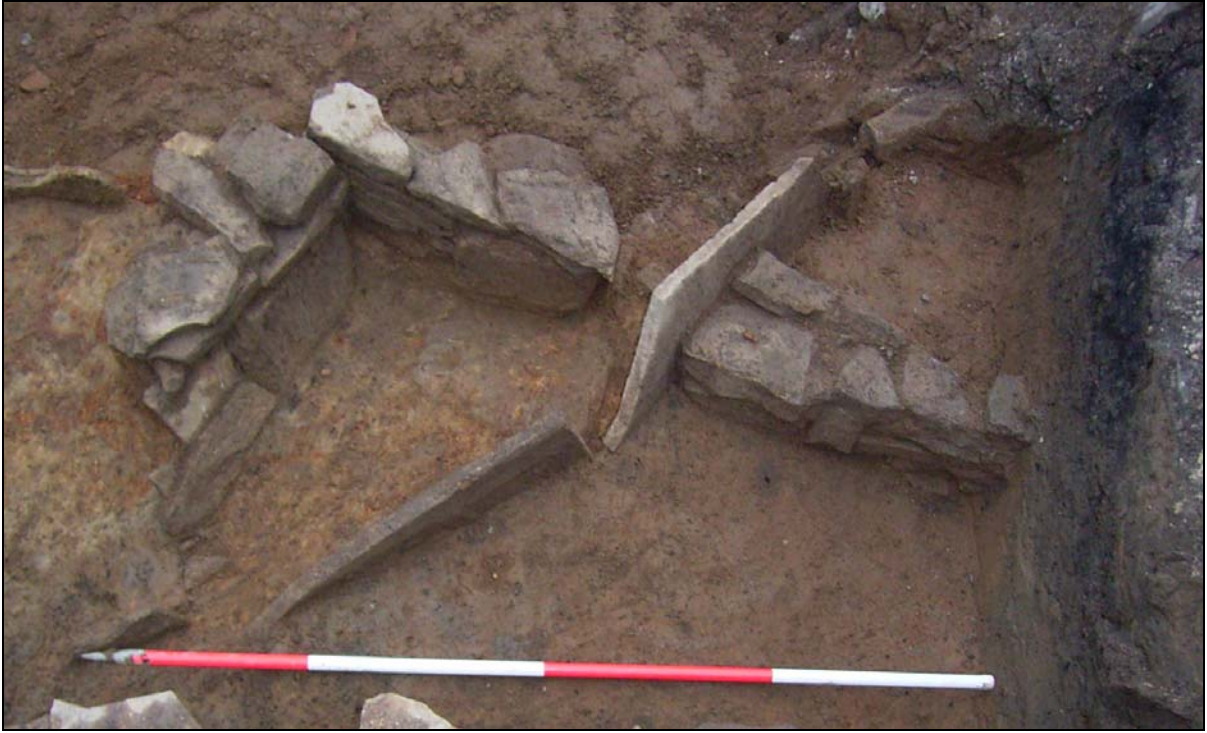
Pl. 33. Overhead view of stone water management features 1300 and 1301 in Area B1 from the north

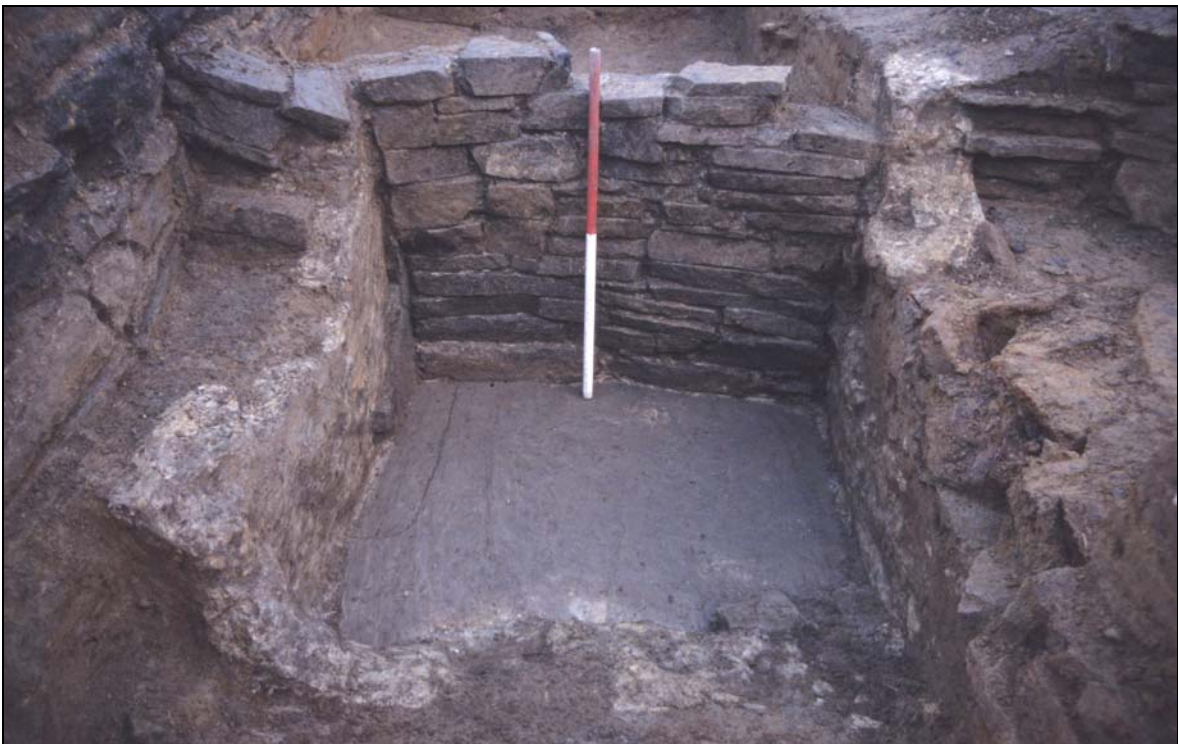
Pl. 40. Tanning pit 1325 from west showing base stone 1295 and stone lining 1242

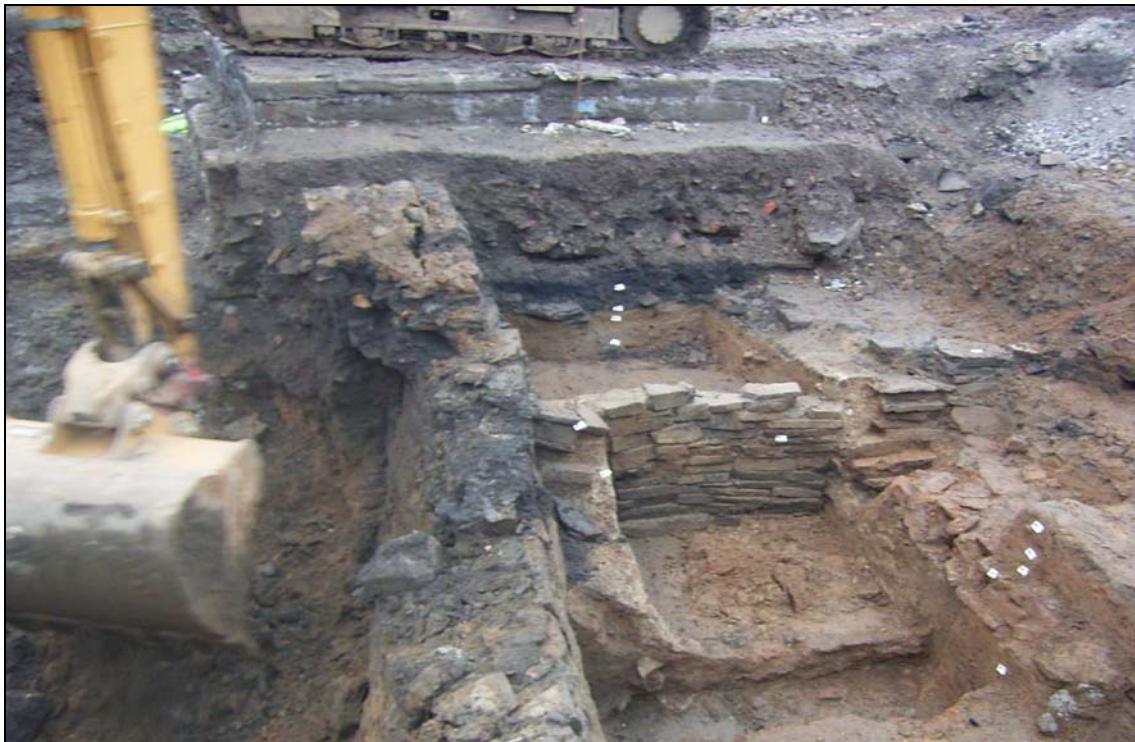
Pl. 42. Working shot from west showing Phase I wall 1321 exposed beneath wall 1040

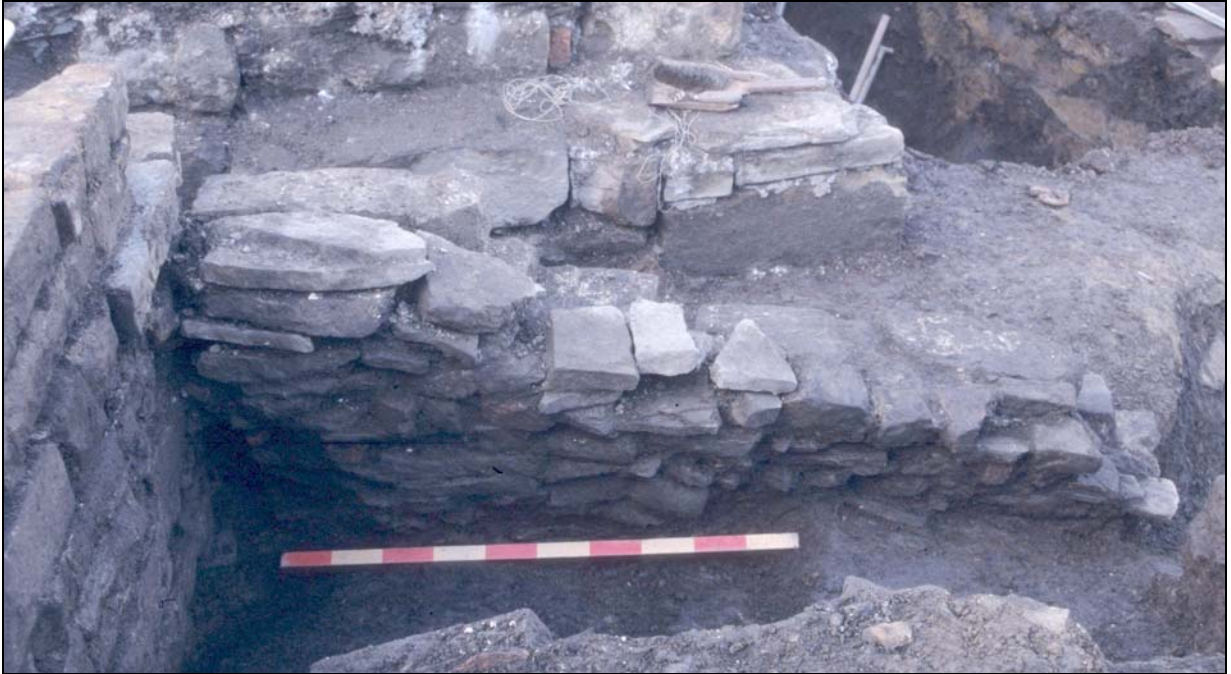
Pl. 43. Wall 1164 from east in Area D, shown abutting north side of wall 1061
