**Ironhouse Bastle,
Otterburn Training Area, Northumberland**

Archaeological Topographical Survey

March 2008

Report No. 1796

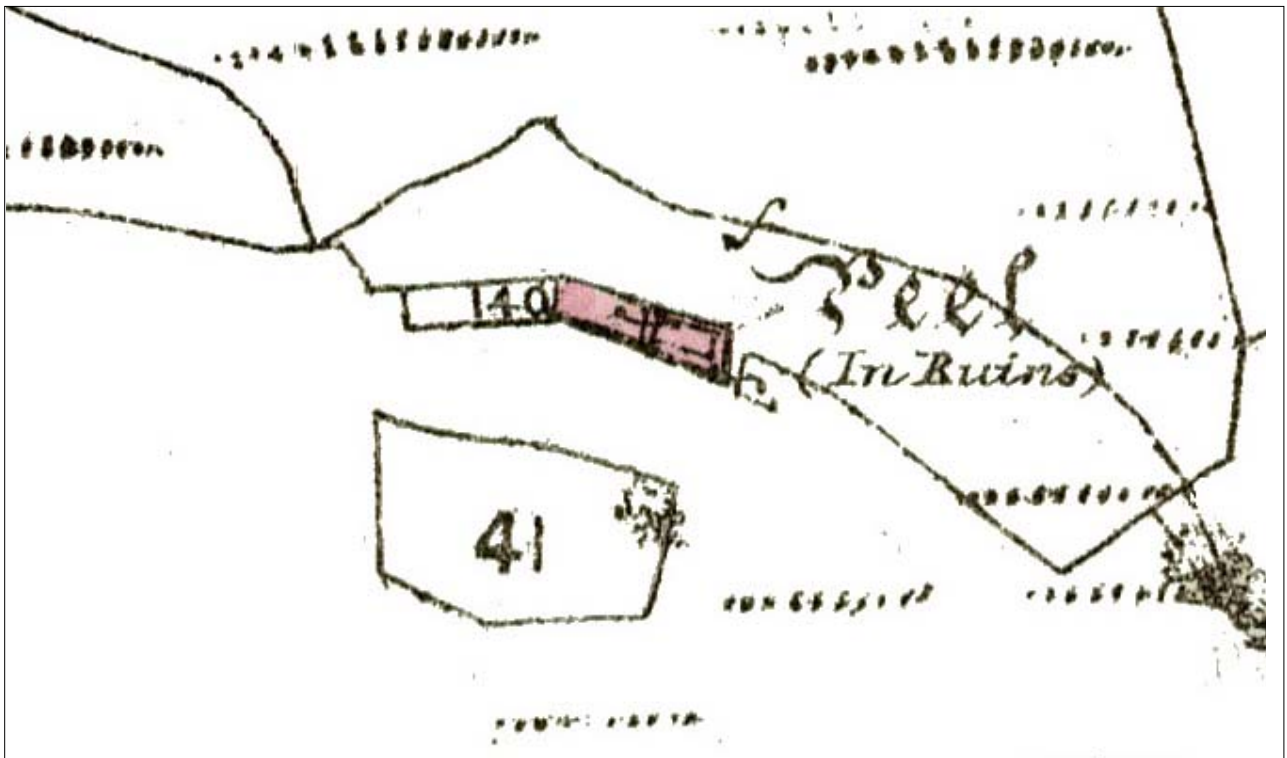
Fig. 10. Extract from the First Edition Ordnance Survey 25 inch map of 1866 (Northumberland Archives, Woodhorn)

By the 1860s it appears that Ironhouse Bastle was no longer occupied. The First Edition Ordnance Survey map, surveyed in 1863, names the site as 'Peel (In Ruins)' (Fig. 10; Ordnance Survey 1866). This depicts the bastle as a roofless structure, with another similar sized building adjoining its western side and two square enclosures to the west of this. A smaller square structure is shown at the bastle's eastern end from which runs a boundary towards the south-east, which turns north-east over Watty's Sike, and continues to the north. A large rectilinear enclosure is shown to the south of this group of structures. The First Edition Ordnance Survey map also marks 'Iron Well' to the north-west of Ironhouse (Ordnance Survey 1866).

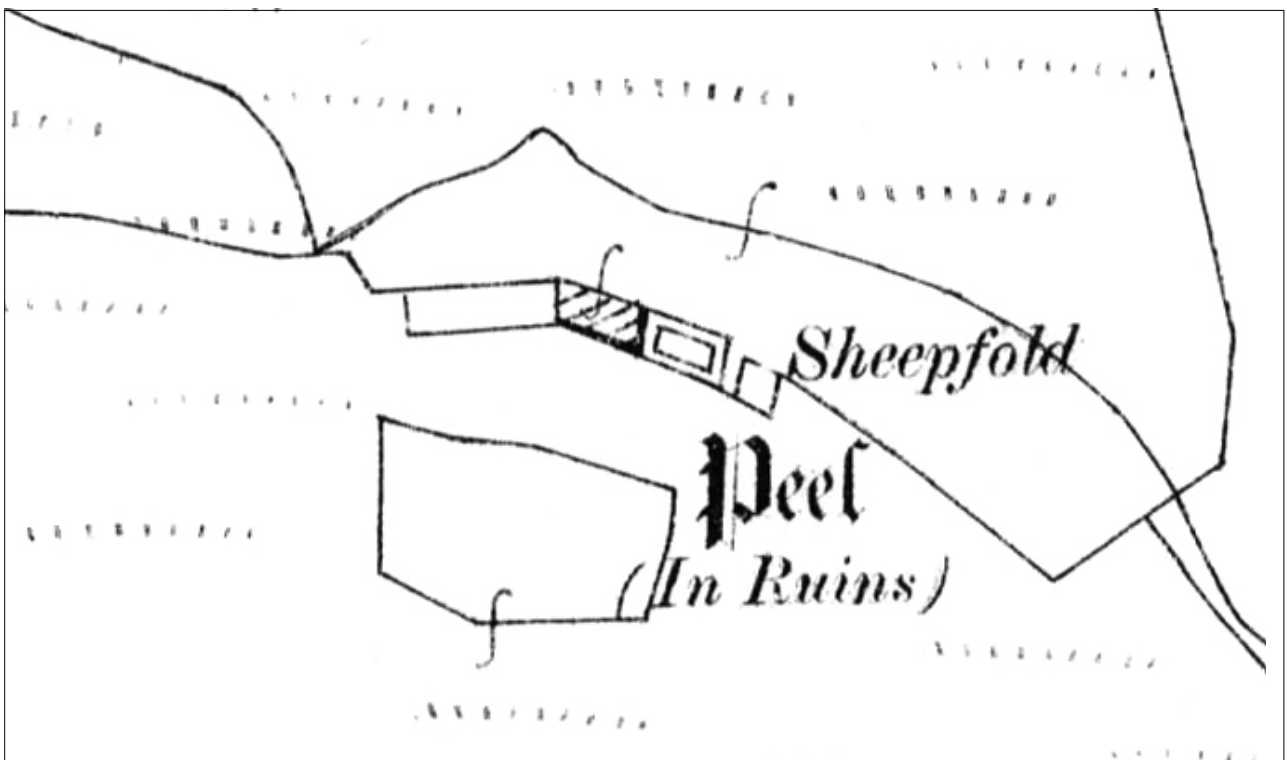
Fig. 11. Extract from the Ordnance Survey 25 inch map of 1897 (Northumberland Archives, Woodhorn)

The Second Edition Ordnance Survey map, revised in 1896, shows little change in the general plan of the structures at Ironhouse, and it is still marked as 'Peel (In Ruins)' (Fig. 11; Ordnance Survey 1897). However, it is probable that, although the bastle itself was in a ruinous state at this time, the buildings and structures on the site still served an agricultural function. Indeed, the small enclosure at the bastle's eastern end is marked as a sheepfold and the building adjacent to the western end of the bastle is still depicted as a roofed structure, and was perhaps in use as a storage barn or sheep byre.

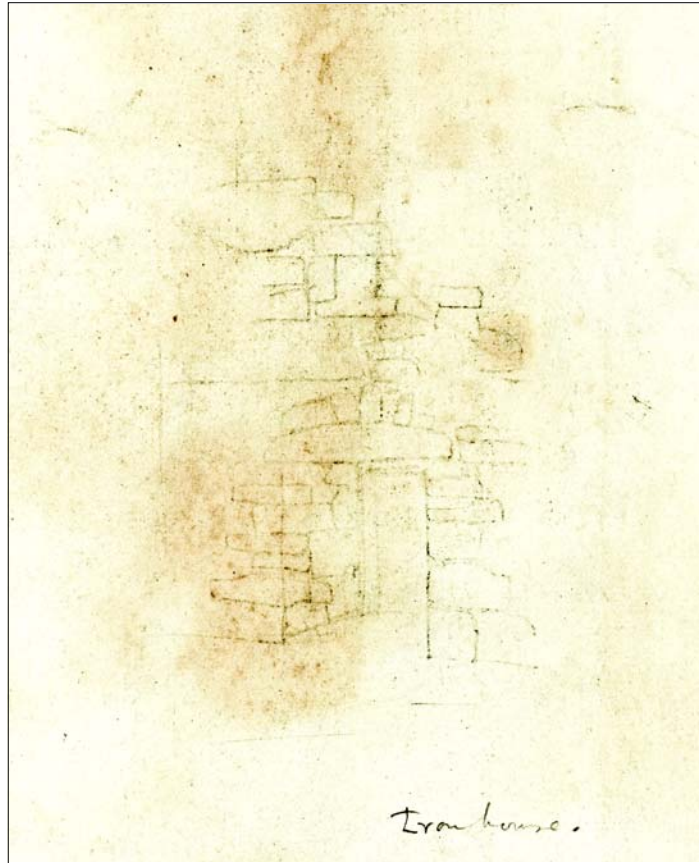
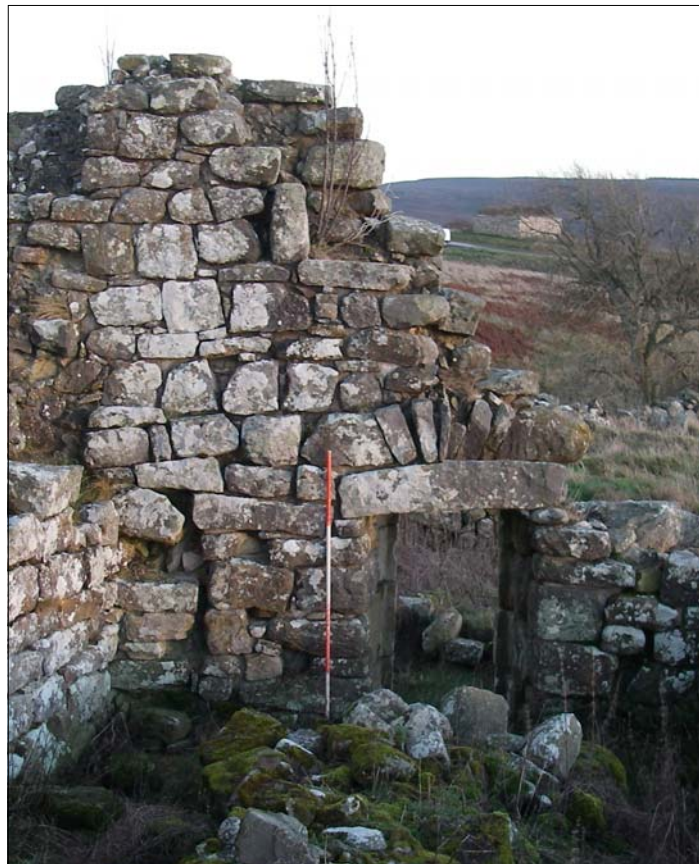
Fig. 14. Pencil sketch of the interior of the doorway of Ironhouse Bastle, held at the Northumberland archives and probably dating to the early 20th century (ref. SANT/BEQ/21/4/3/12/1). Below is a photograph of the interior of the doorway of the bastle at the time of the survey

Ryder 1990), and there appears to have been no substantial deterioration in the condition of the building from this time. The possibly early 20th-century sketch of the interior of the eastern gable-end of Ironhouse Bastle, although perhaps not completely accurate in its depiction, shows the structure in a similar state to its present condition. This suggests that there has been little deterioration to that part of the building over the course of the last century.

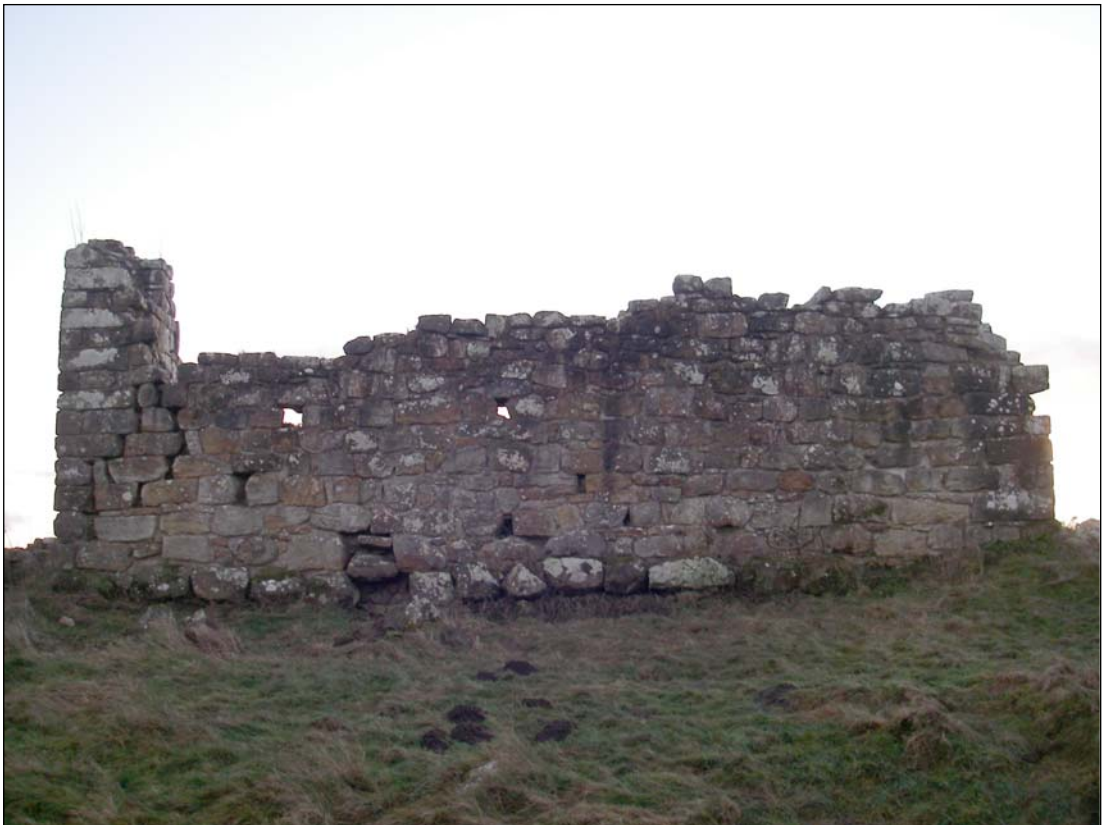
Plate 4. The northern wall of Ironhouse Bastle, looking south

this was a functional part of the building, originally forming a slit-vent or possibly a drain for the byre, or if this break was made a later date. On the northern side of the bastle one of the large foundation stones has also apparently been deliberately removed (see Plate 4).

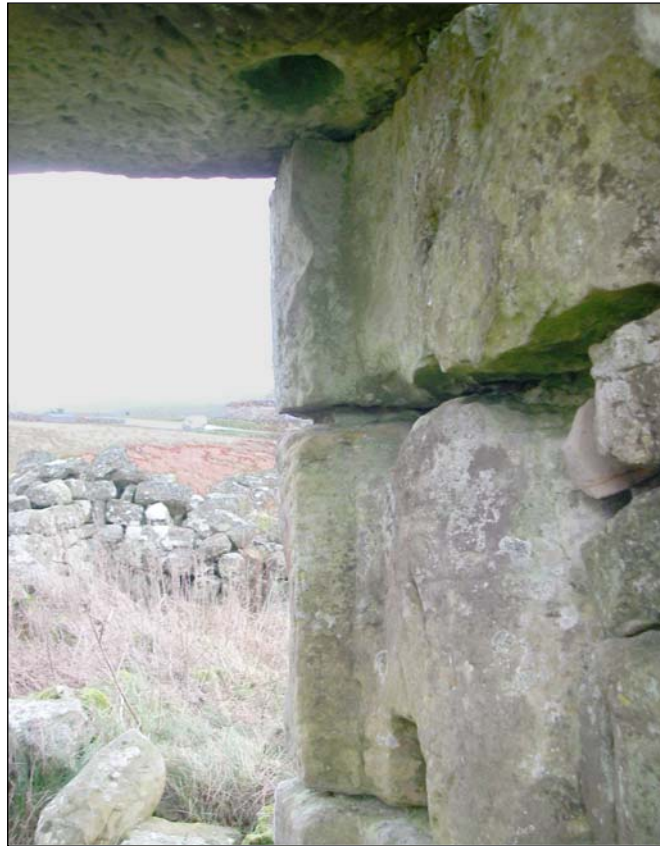
Plate 9. The interior of the southern wall of the bastle doorway with the circular depression of the harr-socket on the lintel, and the hole for the drawbar to the bottom right

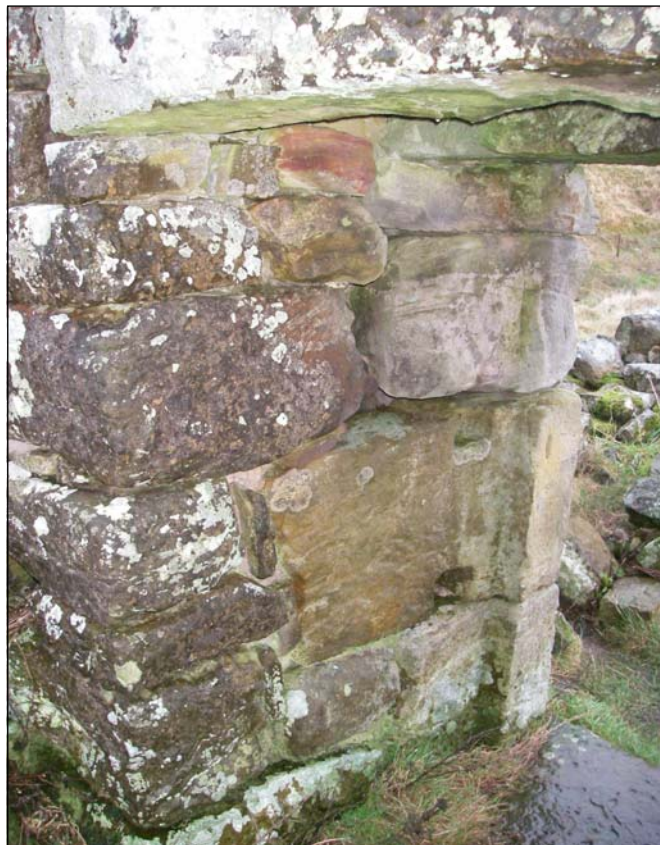
Plate 10. The interior of the northern wall of the bastle doorway, showing the tunnel for the drawbar, and below, the hole for the opposing drawbar, together with latch indentations

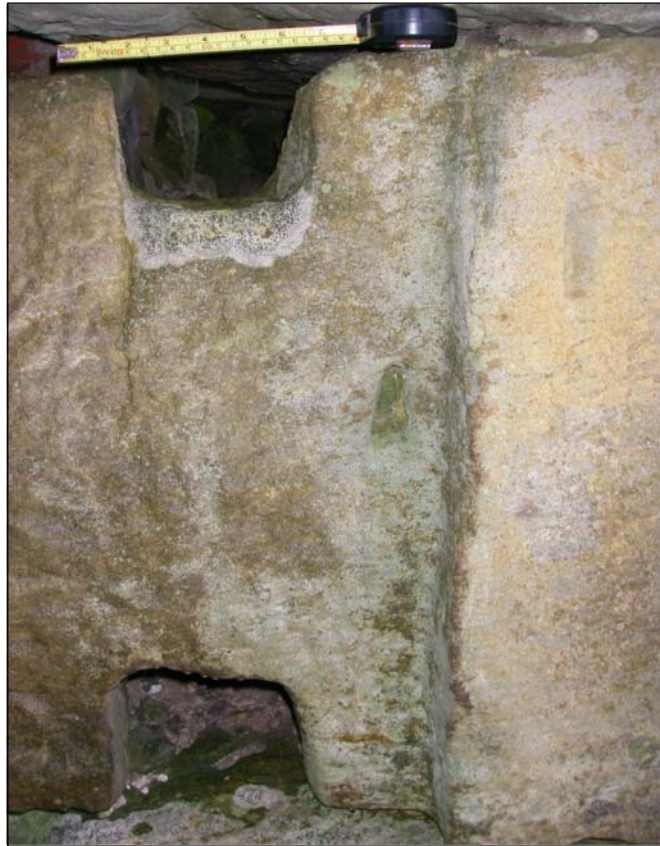
Plate 11. The drawbar tunnel on the northern wall of the bastle doorway to the top, with the hole for the drawbar from the opposing wall below

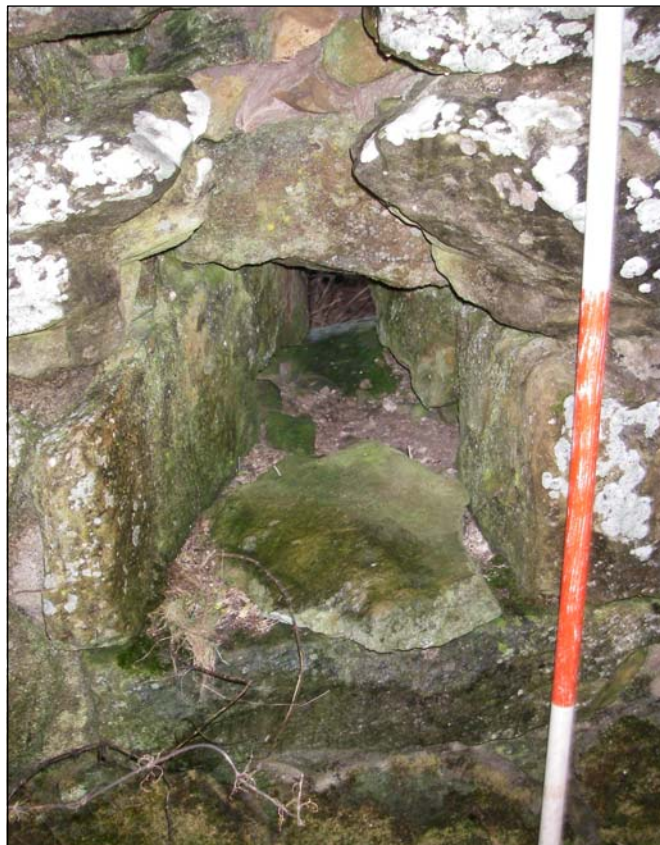
Plate 12. The interior of the slit-vent in the western gable-end wall of the bastle

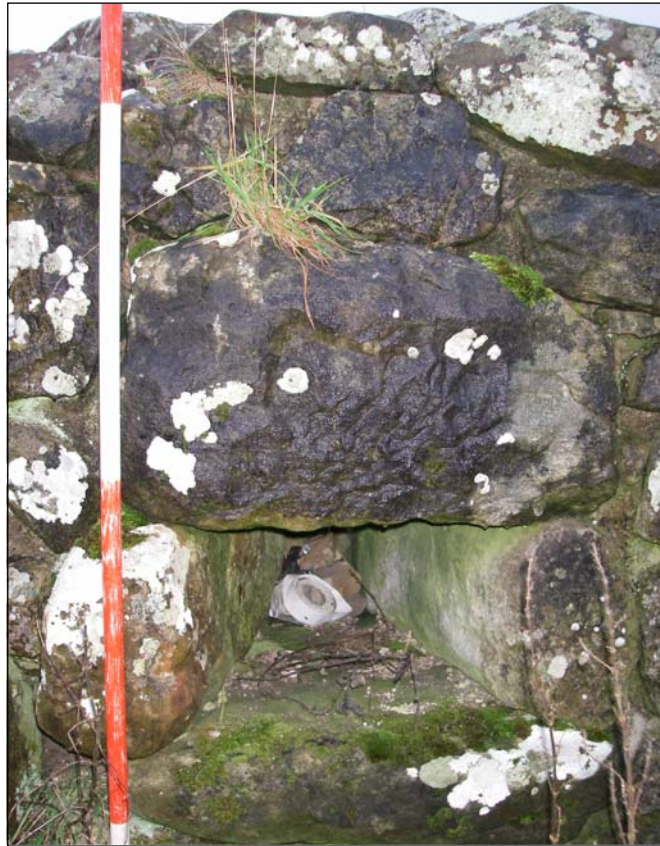
Plate 13. The interior of the slit-vent in the southern wall of the bastle

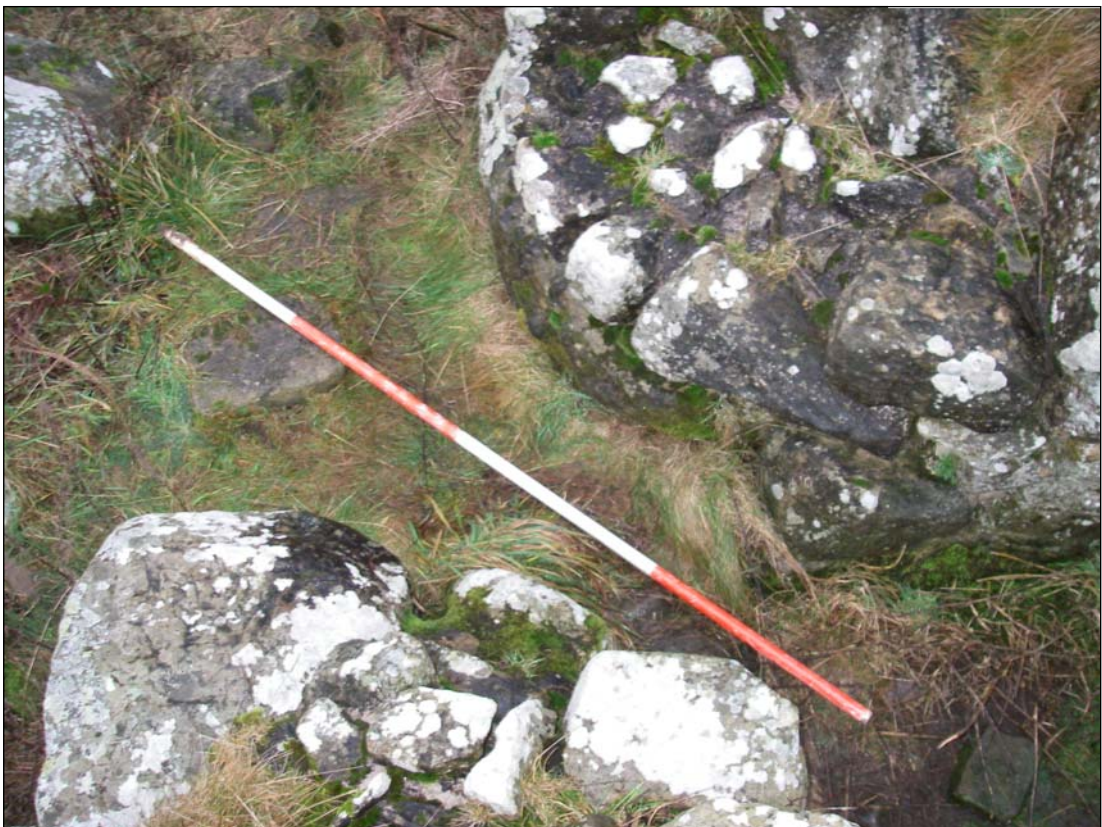
There is a break in the south-western corner of the bastle wall about 0.4m wide, where it appears that the stone work has been deliberately removed (Plate 14). It is unclear whether

Plate 14. The break in the south-western corner of the bastle wall

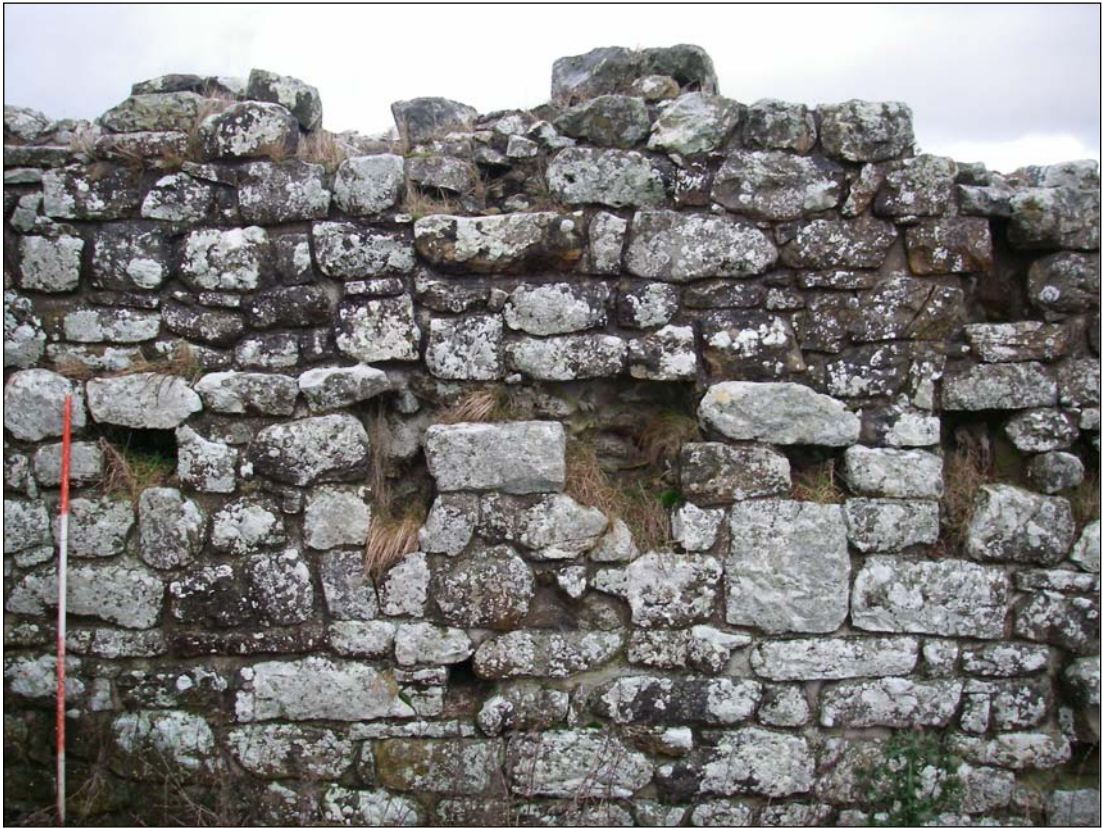
The first floor of the bastle would have been supported by a timber floor and a number of beam slots, varying in width between 0.2m to 0.3m, are visible on the internal side of the northern wall of the bastle (Plate 15). A flat stone projecting from the inside of the western wall may have supported a hearth, and an indent in the northern end of the same wall could have acted as a cupboard space (Plate 16). There is a possible triangular slit-vent in the upper part of the western gable-end wall, but no evidence of first floor windows survive.

Plate 15. The interior northern wall of the bastle, with a number of beam slots visible

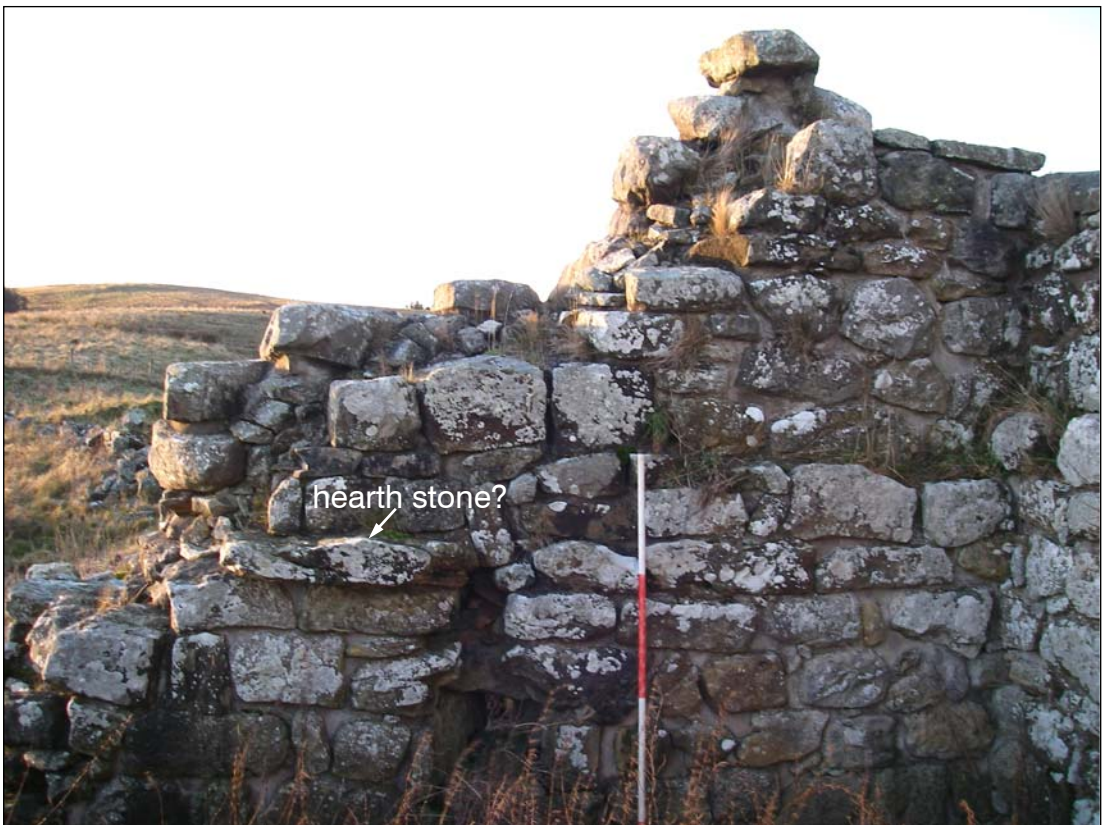
Plate 16. The interior of the western gable-end of the bastle. A projecting stone to the left may have supported a hearth, and a recess to the top right may be the remains of a cupboard space. There is a slit-vent at the centre of the base of the wall

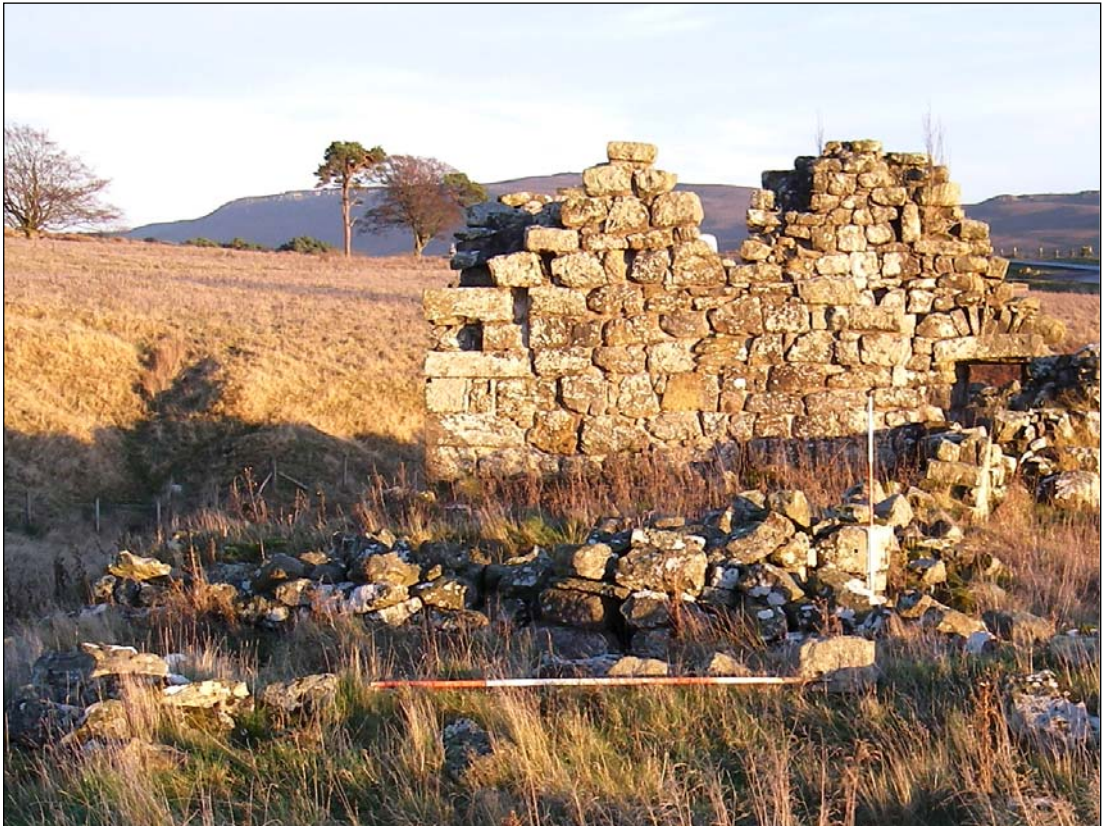
Abutting the western end of Ironhouse Bastle are the remains of a building (House 1) (see Figs 4 and 5; Plate 17). This is shown on the First Edition Ordnance Survey map of 1866 as the only roofed structure surviving on the site by that time, and was probably the latest house to be occupied at Ironhouse (see Fig. 10; Ordnance Survey 1866). House 1 measures 6m wide by 9m long, and is defined on its southern side by a wall about 0.75m wide and 1.2m high, of worked stone. It is not clear if the north-western wall, and part of the northern wall, still partially survive as they are obscured by stone building debris, although most of the northern wall is no longer visible on the ground. The remains of a blocked doorway, about 1m wide is situated in the southern wall, at the south-eastern corner of House 1, indicating different phases of use or re-use of the building (Plate 18). To the west of House 1 is a further length of wall, orientated approximately on the same alignment as House 1, but with no apparent visible structural connection to it. However, the building's depiction on the First Edition Ordnance Survey map of 1866, showing its length and relationship with the enclosure to the west, suggests that this wall formed part of at least one phase of House 1's use (see Fig. 10; Ordnance Survey 1866).

Plate 17. The remains of House 1, adjacent to the western end of Ironhouse Bastle, looking east

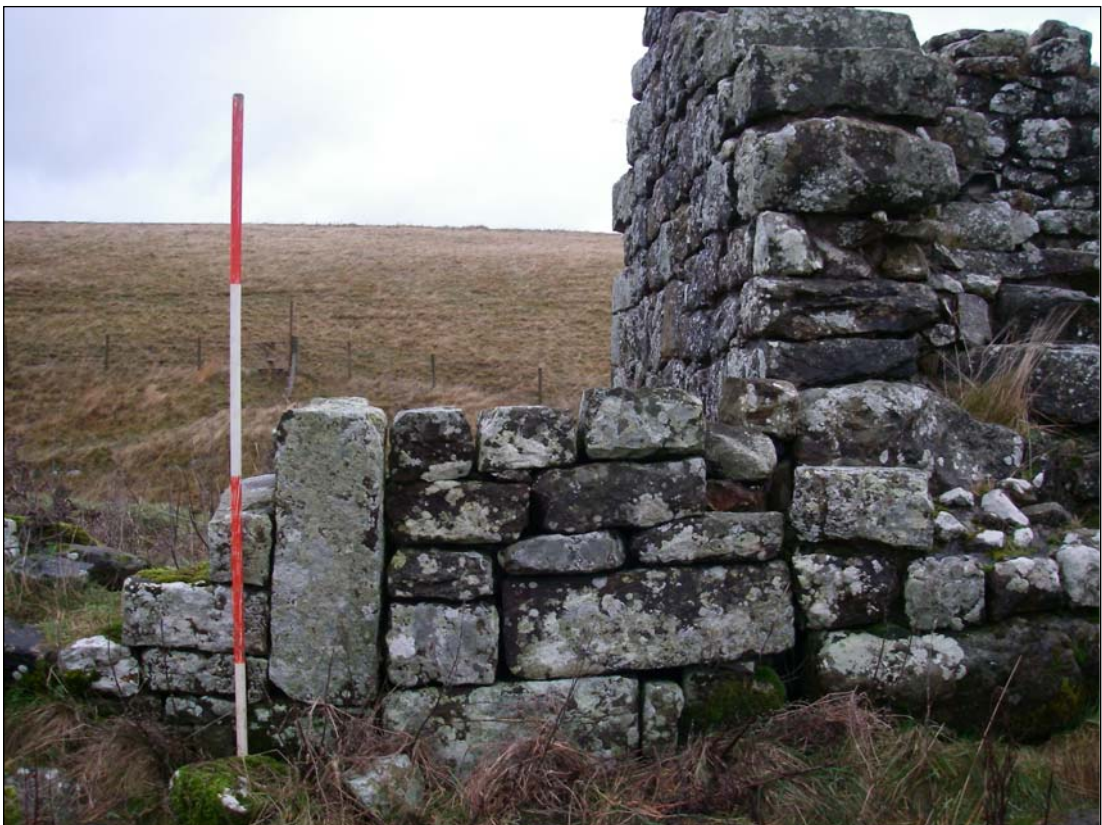
Plate 18. The blocked doorway in the southern wall of House 1, looking north

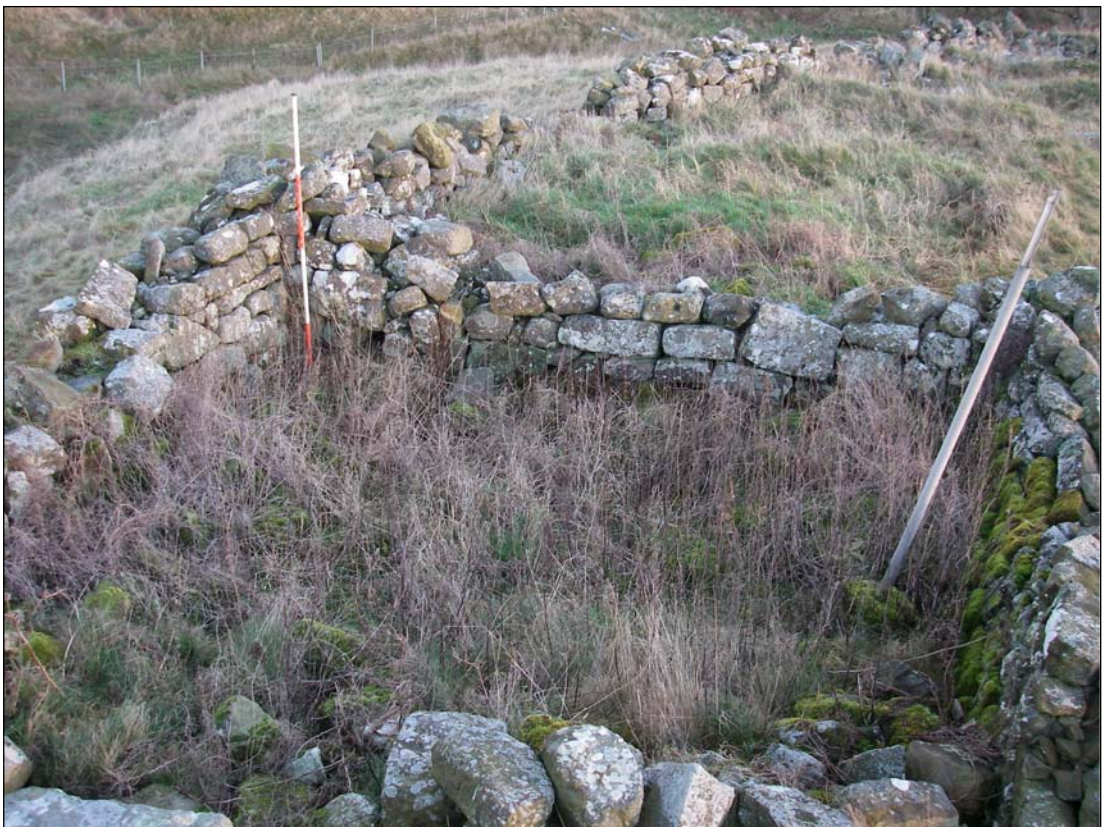
The nearest building to the bastle measures about 6.3m by 5m and is defined by stone walls surviving to a height of 1.5m (Plate 20). There is no clear wall structure surviving on its western side, although the substantial spreads of stone building debris which fill the interior may obscure further remains. This structure is shown on the First Edition Ordnance Survey map of 1866, but by 1896 was being used as a sheepfold (see Figs. 10 and 11; Ordnance Survey 1866; 1897). This may account for the height of the surviving walls which could have been rebuilt over earlier building foundations to hold the sheep. To the east of this are the remains of two further rectangular buildings, defined by turf covered walling between 1m and 1.75m wide and about 0.5m high. The westernmost is 5m wide and 6.5m long with an entrance at the south-west corner; the other measures 6.5m wide and 6.2m long, with an entrance at the south-east corner. A break at the northern end of the wall dividing the two buildings may be a doorway between the two.

Plate 20. The remains of a building or sheep pen, in the eastern building range nearest to Ironhouse Bastle, looking east

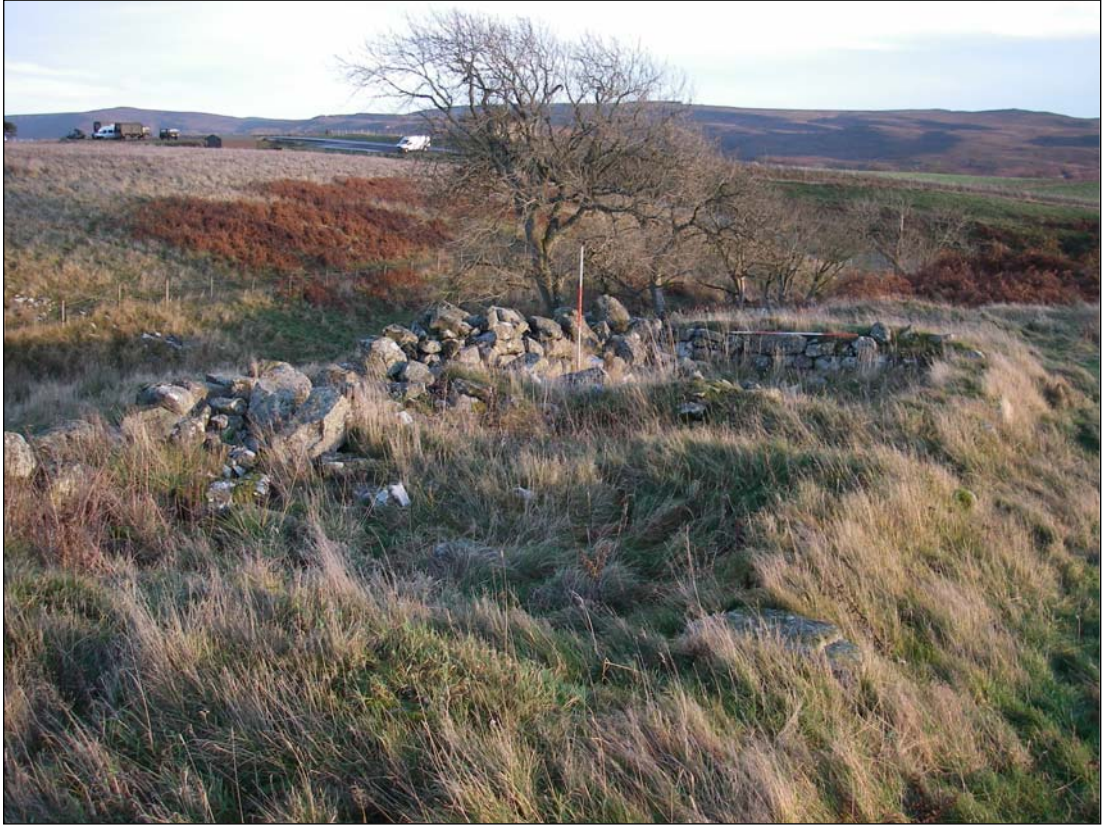
Adjacent to these appears to be a larger building, possibly the remains of a house (House 2) (Plate 21). This measures 16m by 6.5m and is divided into two rooms accessed via doorways leading off of a central corridor. The westernmost room is approximately square, measuring 4.5m by 4.4m, and the easternmost room is slightly larger, measuring 4.5m by 5.5m. The remains of the house are defined by turf covered stone walls with surviving lengths of wall structure visible in places. These are about 1m wide, and survive to a height of between 0.2m and 0.5m. The house's south-eastern wall is a right-angled continuation of the main northern wall. Stone building debris fills much of the interior of the building.

Plate 21. The remains of House 2, looking east

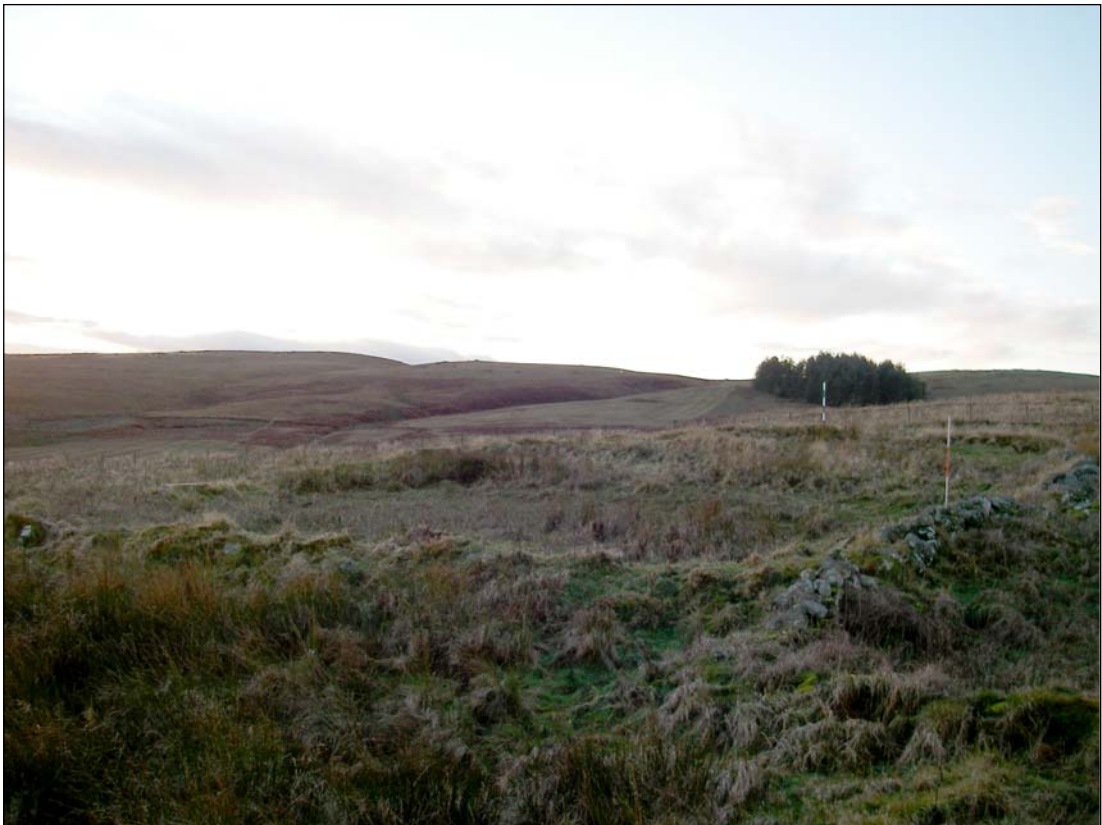
A large rectilinear enclosure (Enclosure 1), approximately 20m wide by 32m long, is situated 11m to the south of Ironhouse Bastle (see Fig. 4; Plate 22). It is defined on its western and southern sides by turf covered walls, 1.75 m wide, surviving to a height of about 1m, which are cut through by a number of later breaks. On its eastern side it is defined by a sharp eastward facing scarp about 0.5m high, with a slight back scarp visible along its northern end. The northern side of the enclosure is defined by a ruinous section of stone wall, approximately 0.5m high on the interior of the enclosure and 1.25m high on its exterior side, where the ground level is lower. Enclosure 1 appears to have an entrance on its western side, and perhaps at its north-western corner. It is shown on the First Edition Ordnance Survey map, surveyed in 1863 (see Fig. 10; Ordnance Survey 1866)

Plate 22. Enclosure 1, looking south-west

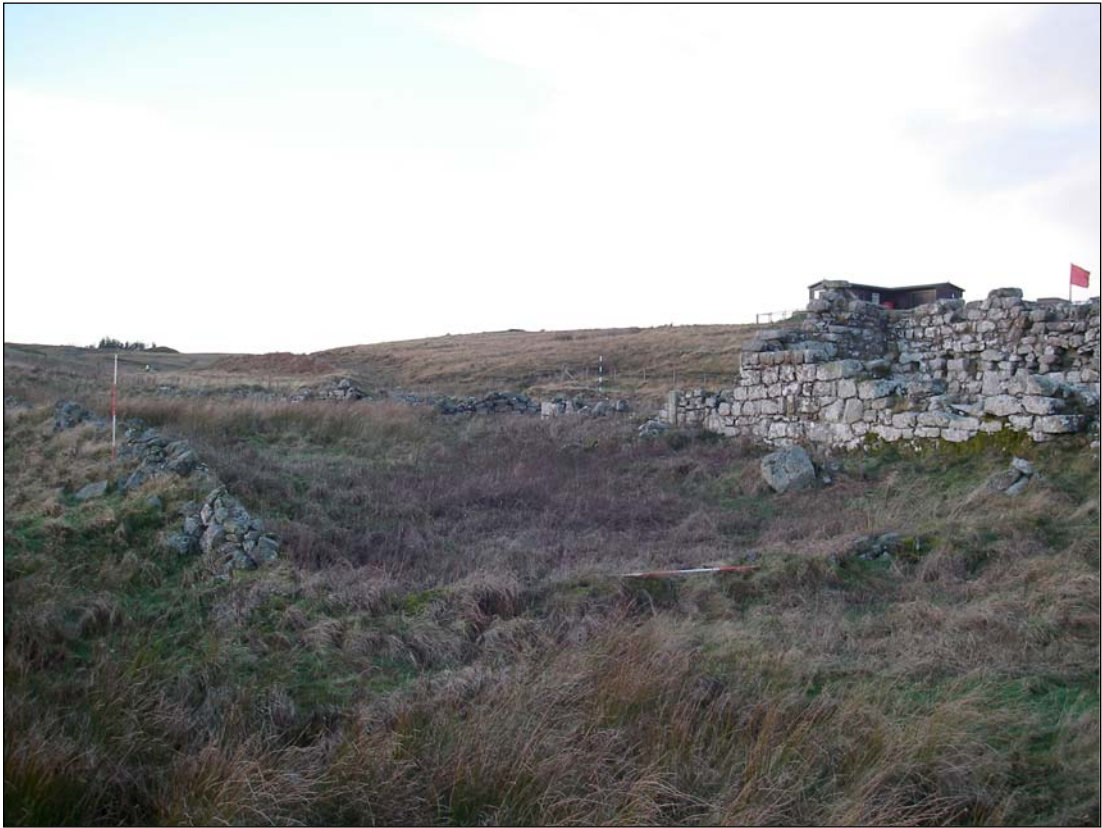
Another enclosure (Enclosure 2) is defined by the northern boundary of Enclosure 1 to the south and by a slight east-facing scarp and stone spread to the west (see Figs 4 and 5; Plate 23). On its eastern side it is defined by a length of stone wall, 1m wide and 0.8m high. The stratigraphic relationship between Enclosure 1 and Enclosure 2 is unclear, although the western wall of Enclosure 2 appears to abut the north-eastern corner of Enclosure 1. This length of wall is of a different construction to the northern boundary of Enclosure 1, suggesting it is a later addition. The eastern and western boundaries of Enclosure 2 are also not marked on the Ordnance Survey mapping until the early 1920s (see Fig. 12; Ordnance Survey 1922).

Plate 23. Enclosure 2, looking north-west

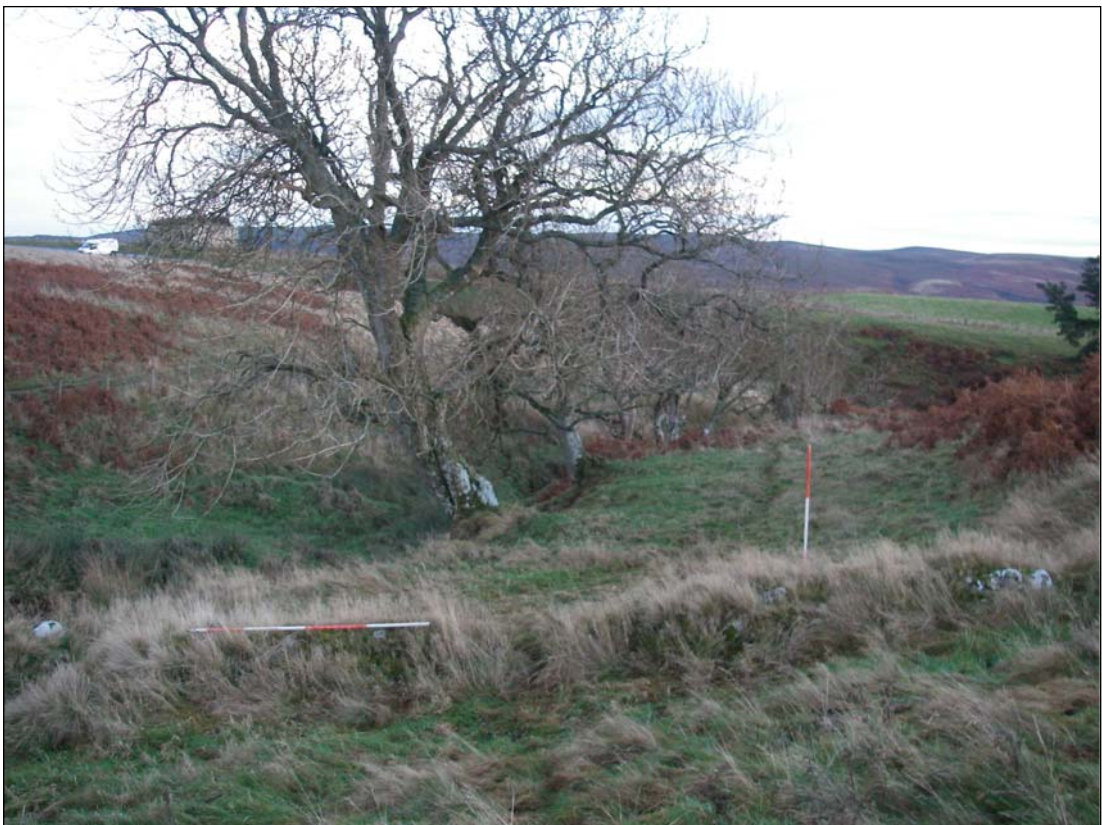
Another enclosure is situated on a terrace of lower ground on the valley side (Enclosure 4) (see Fig. 4; Plate 24). It is defined on its southern side by an artificially steepened scarp, between 1m and 1.5m high, and on its northern side by a steep natural slope descending north-eastwards to Watty's Syke. At its south-eastern end Enclosure 4 is defined by a substantial length of bank, about 1.5m high on its southern side, 4.5m wide and 8m long. The north-western side of Enclosure 4 is defined by another small section of bank which sits above a slight scarp between the lower ground of Enclosure 4 and the higher ground to the north-west.

Plate 24. Enclosure 4, looking south-east, with Watty's Sike to the left

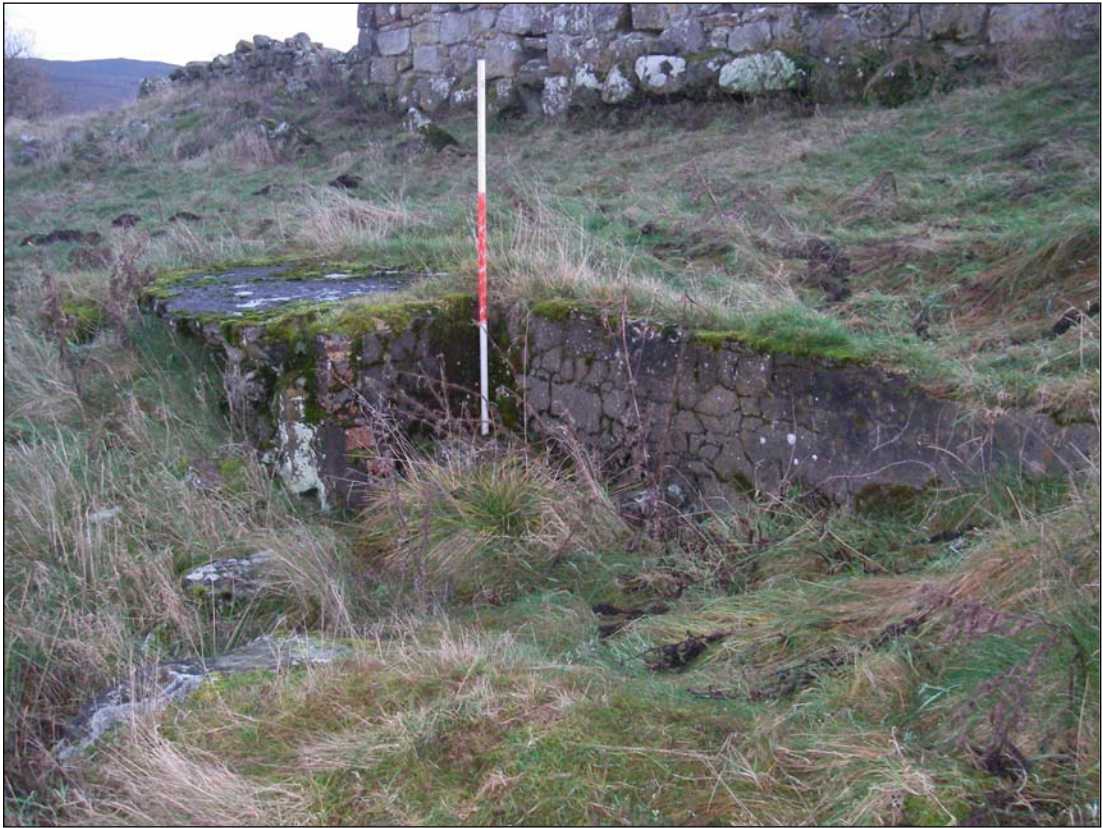
The remains of a probable 20th-century sheep-dip are situated 8m to the north-west of Ironhouse Bastle. This comprises a rectangular tank, 1m wide and 3m long, constructed of brick and concrete, with a ramp at its western end, and with two areas of concrete hard-standing adjacent to it (see Figs. 4 and 5; Plate 25).

Plate 25. The remains of a modern sheep-dip to the north of Ironhouse Bastle, looking south-east
