Manor House Farm
Micklefield
West Yorkshire

Archaeological Evaluation

Report no. 3001
August 2017

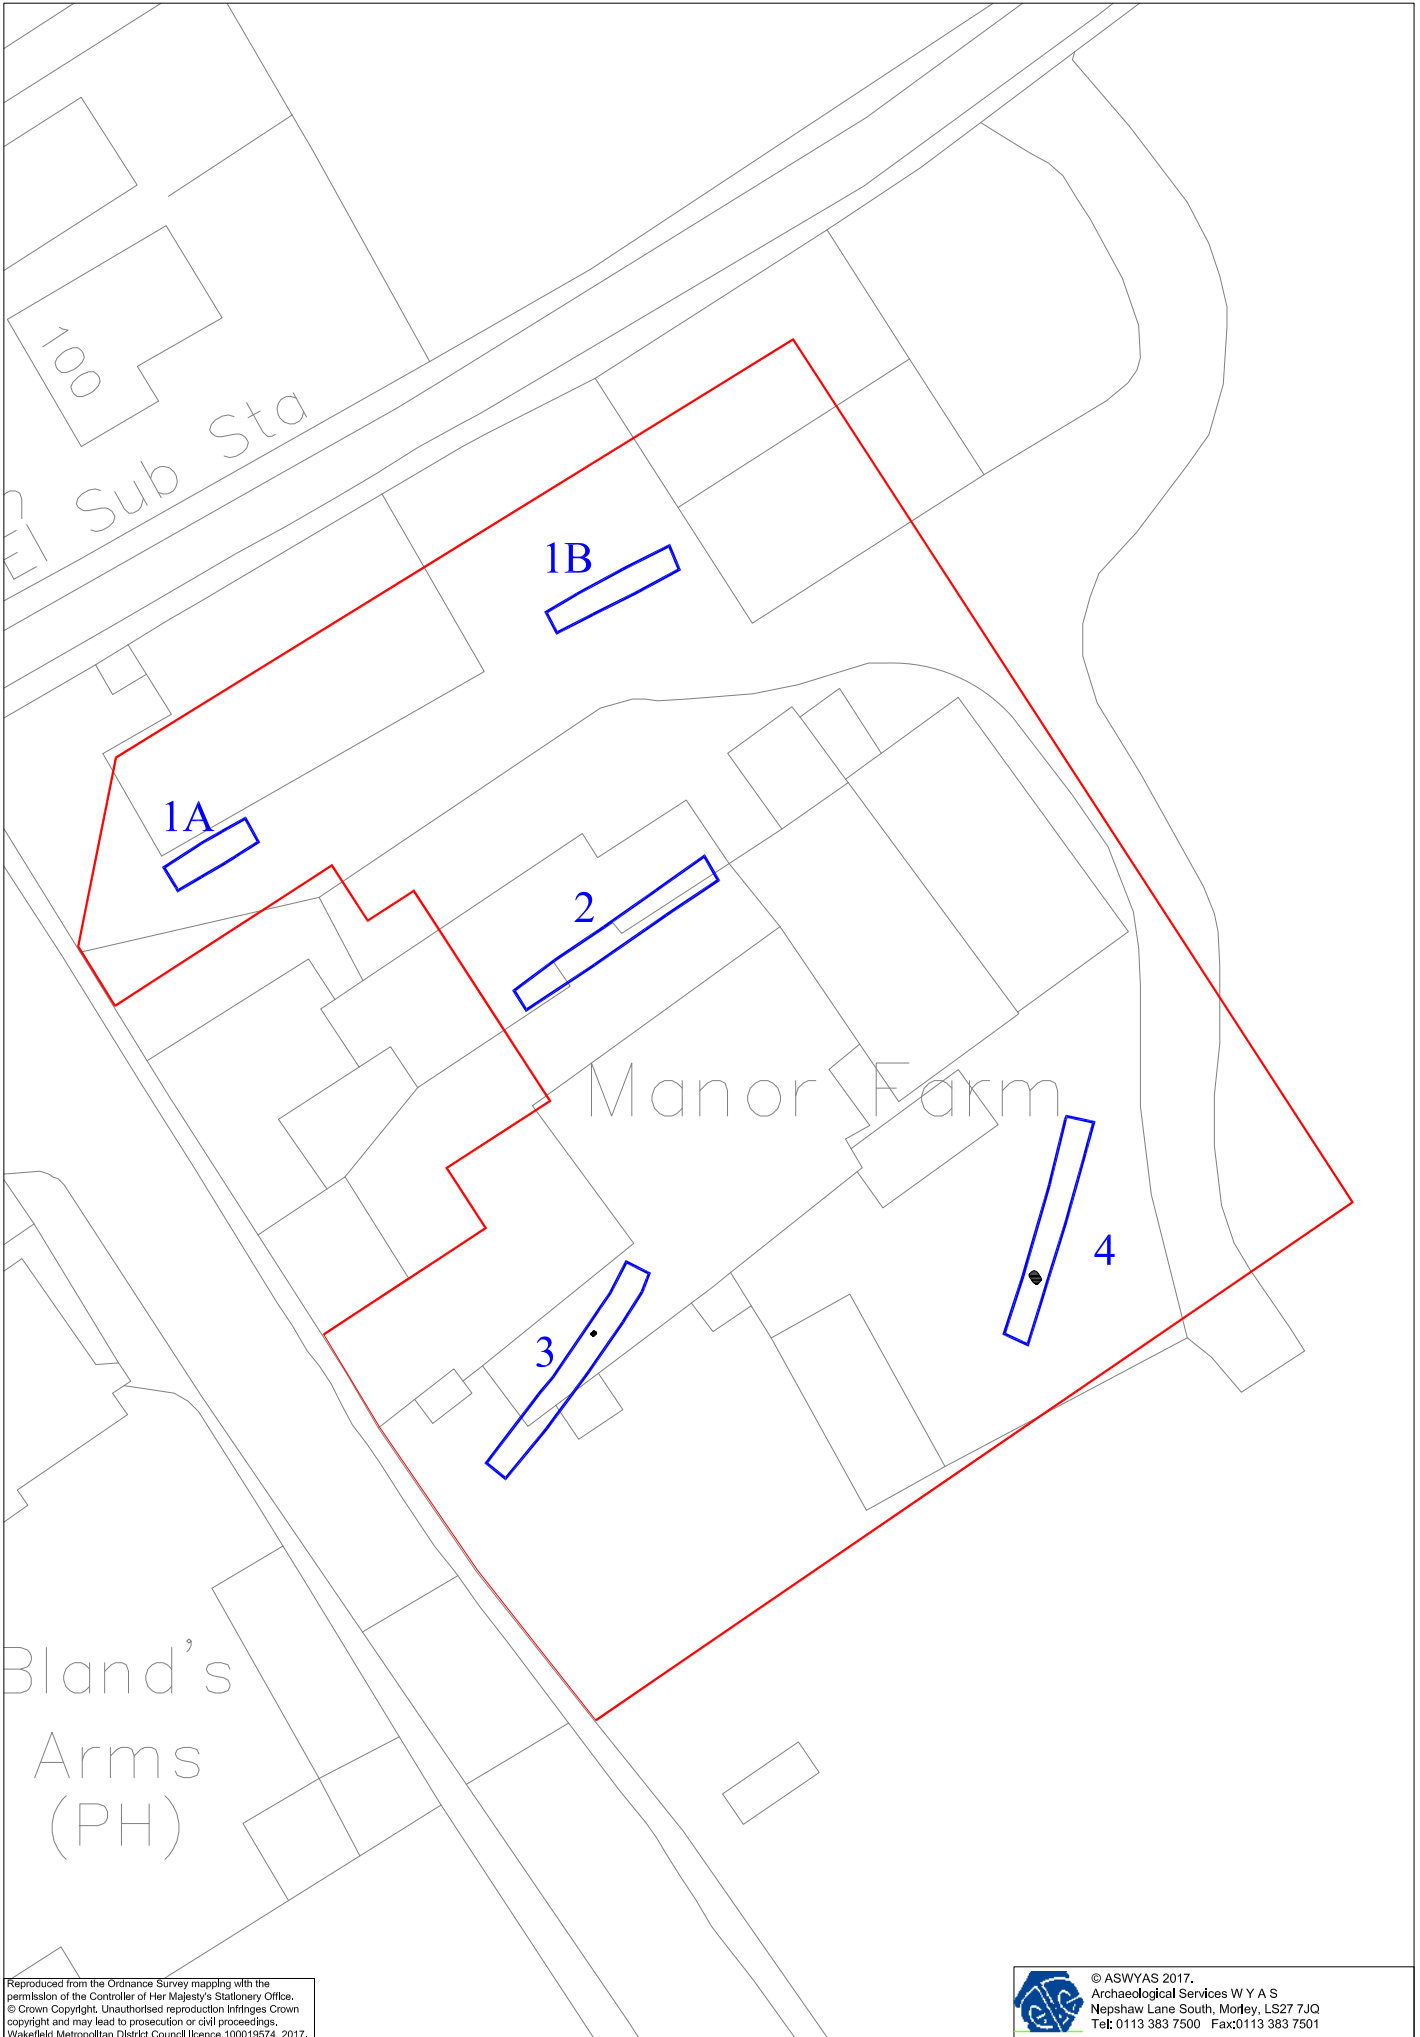
Fig.2. Site plan showing location of trenches and excavated features (1:500 @ A4)

Trench locations are shown in Fig. 2 and the results of each trench are recorded in Appendix 3. A description of each trench in which archaeology was encountered is given below, with further details about the depths and descriptions of individual deposits provided in Appendix 3. Trenches devoid of archaeology (Trenches 1-2; Plates 1-2) are not discussed further but their details are tabulated in Appendix 3.

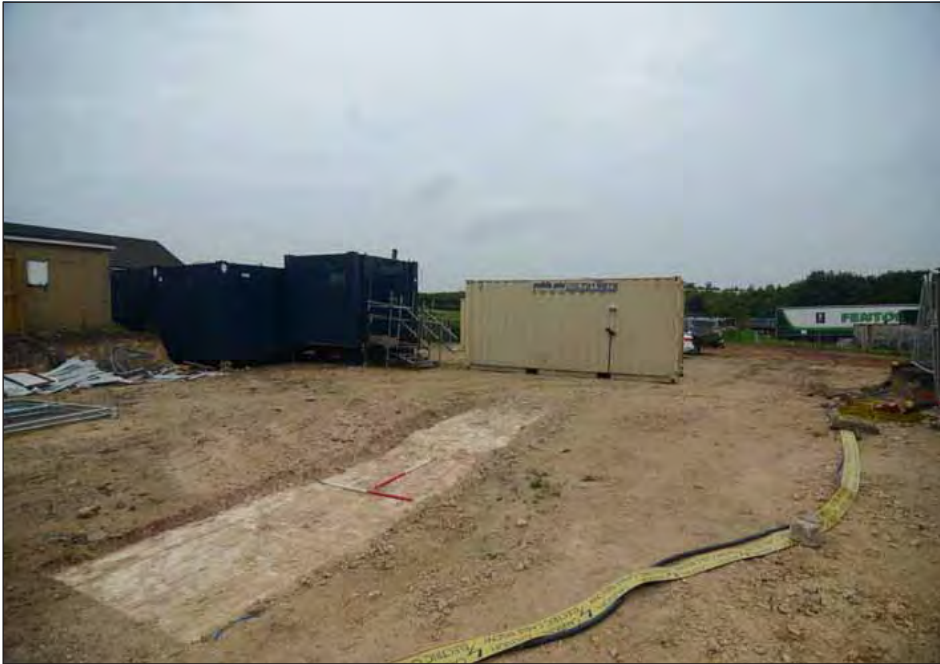
Plate 1. General view of Trench 1A, looking north

General Description				Orientation	SW-NE
Trench 1 had to be split into two sections as the site compound covered part of the planned location of the trench. Trench 1A was excavated through around 0.10m of demolition material and no cut features were observed. Trench 1B was excavated through c.0.10m of demolition material and around 0.10m of mid-orangey-brown sandy-clay subsoil in the centre of the trench. No archaeology was observed.				Average Depth (m)	0.10
				Width (m)	2.00
				Length (m)	1A – 6.10 1B – 8.90
Contexts					
Context	Type	Length (m)	Width (m)	Depth (m)	Description
100	Layer	-	-	0.10	Demolition material and disturbed limestone bedrock
101	Layer	-	-	0.10	Subsoil – mid-orangey-brown sandy-clay
102	Layer	-	-	-	Natural – weathered limestone bedrock

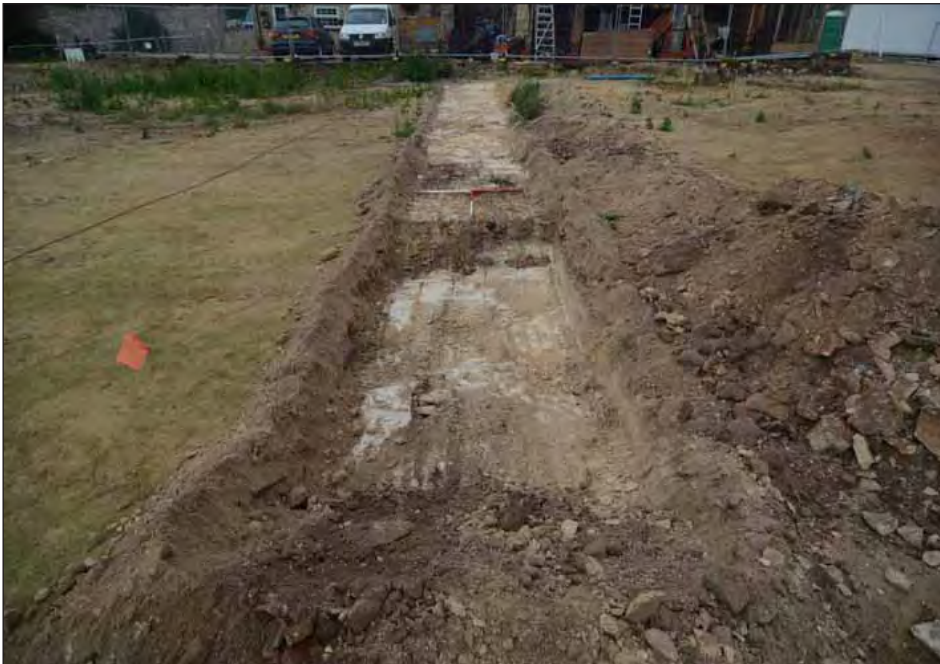
Plate 2. Trench 2, looking south-west

General Description				Orientation	SW-NE
Trench 2 was excavated through c. 0.10m of demolition material. At the north-eastern end a deeper deposit of similar demolition material lay in a 0.30m deep hollow and was excavated by machine.				Average Depth (m)	0.10 – 0.30
				Width (m)	2.00
				Length (m)	15.00
Contexts					
Context	Type	Length (m)	Width (m)	Depth (m)	Description
200	Layer	-	-	0.30	Demolition material, mostly lying in hollow 7.50m wide at north-eastern end of the trench
201	Layer	-	-	-	Natural – weathered limestone bedrock

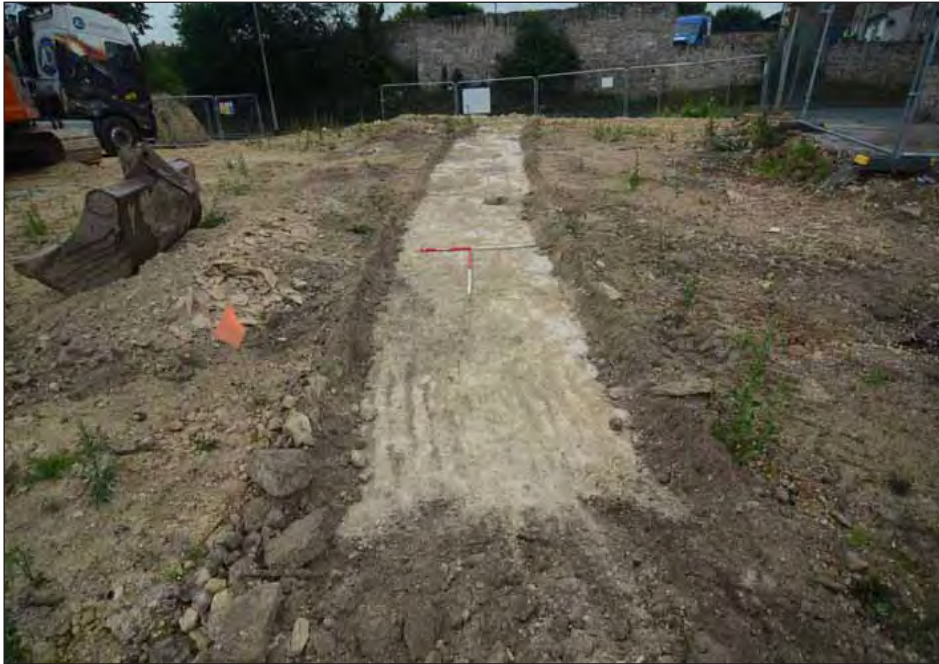
Plate 3. Trench 3, looking south-west

Trench 3 was moved a short distance to the north-west from its planned location to avoid the ramped access to site. The trench was excavated to a depth of 0.05m-0.10m through modern demolition material (301). One feature was observed cutting the bedrock. A small pit or post-hole (303) measured 0.37m long, 0.28m wide and 0.11m deep and had a sub-rectangular shape, steep sides and a flat base. It was backfilled with a mix of limestone, brick and slate fragments (302), suggesting a modern date. The feature is likely to relate to the recently demolished farm.

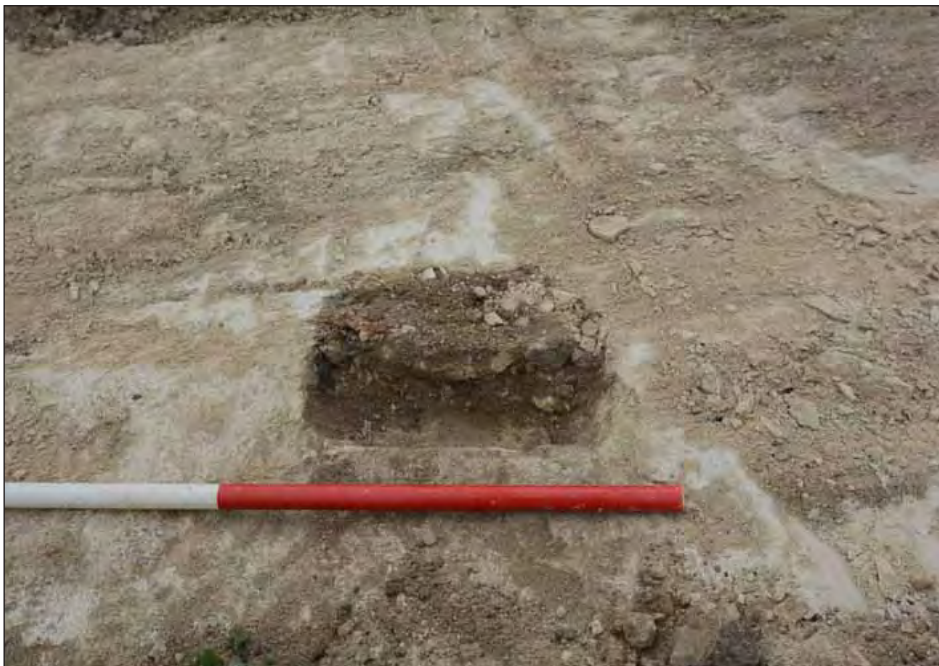
Plate 4. Pit or post-hole 303, looking south

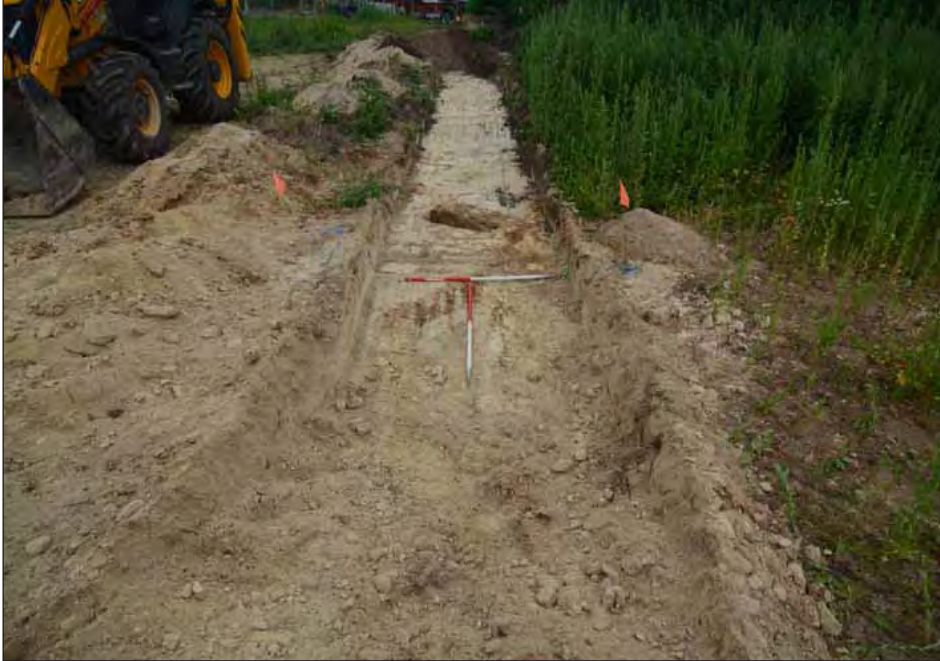
Plate 5. Trench 4, looking north

Trench 4 was excavated in an area which was comparatively undisturbed, with historic mapping suggesting it lay within open ground beyond the farm buildings. Much of the trench was excavated through a dark blackish-grey sandy-silt topsoil (400) measuring between 0.20 and 0.40m in depth, onto natural geology (409). One cut feature was observed. Pit 408 measured 0.91m long, 0.63m wide and 0.21m deep, with near vertical sides, a flat base and a sub-rectangular shape. It was filled by a series of deposits (401-407) consisting of orangey and greyish-brown sandy-silts and redeposited limestone, suggesting backfilling of the pit from the western side. The uppermost fill (401) contained finds of a post-medieval or modern date: a clay pipe stem and a sherd of white-glazed pottery. The lowest fill (407) contained a large number animal bones packed into the western end, representing a dog burial, and a single sherd of grey stoneware pottery.

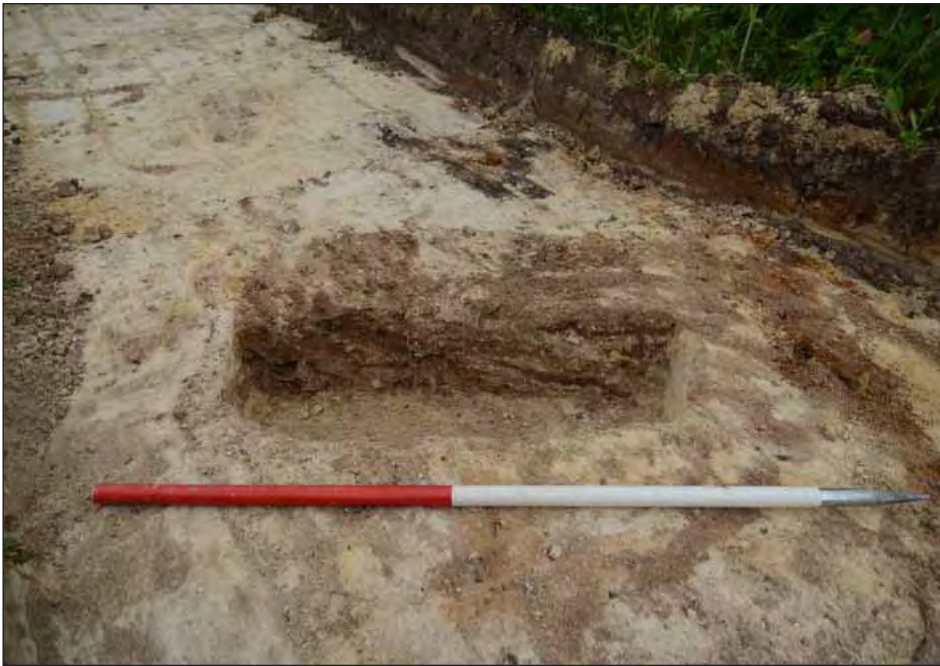
Approximately 75 bones representing the majority of a dog skeleton were recovered from fill 407 of pit 408. The animal was an adult, but there is very little wear on the teeth indicating

Plate 6. Pit 408, looking north-east

The evaluation was successful in investigating the potential for archaeological features or deposits to survive on the site. Trenches 1-3 were in heavily disturbed ground, having been the site of several agricultural buildings and associated driveways. Trench 2 contained a deeper deposit of demolition material, almost certainly relating to the recent demolition of these structures. In Trench 3, one feature was identified cutting into the bedrock. This probably was related to the agricultural structures that once stood here and is not considered to be archaeologically significant. In contrast, Trench 4 was excavated in an area that was relatively undisturbed by either the construction or the demolition and clearing of the agricultural buildings. The pottery and clay pipe recovered from the only feature identified within the trench indicate a relatively recent date. The presence of a dog skeleton suggests that this pit was excavated specifically for the animal's disposal.
