St Oswald's Church

Archaeological Watching Brief

Report no. 3141
June 2018

St Oswald's Church
Church Lane, Collingham
West Yorkshire
Archaeological Watching Brief

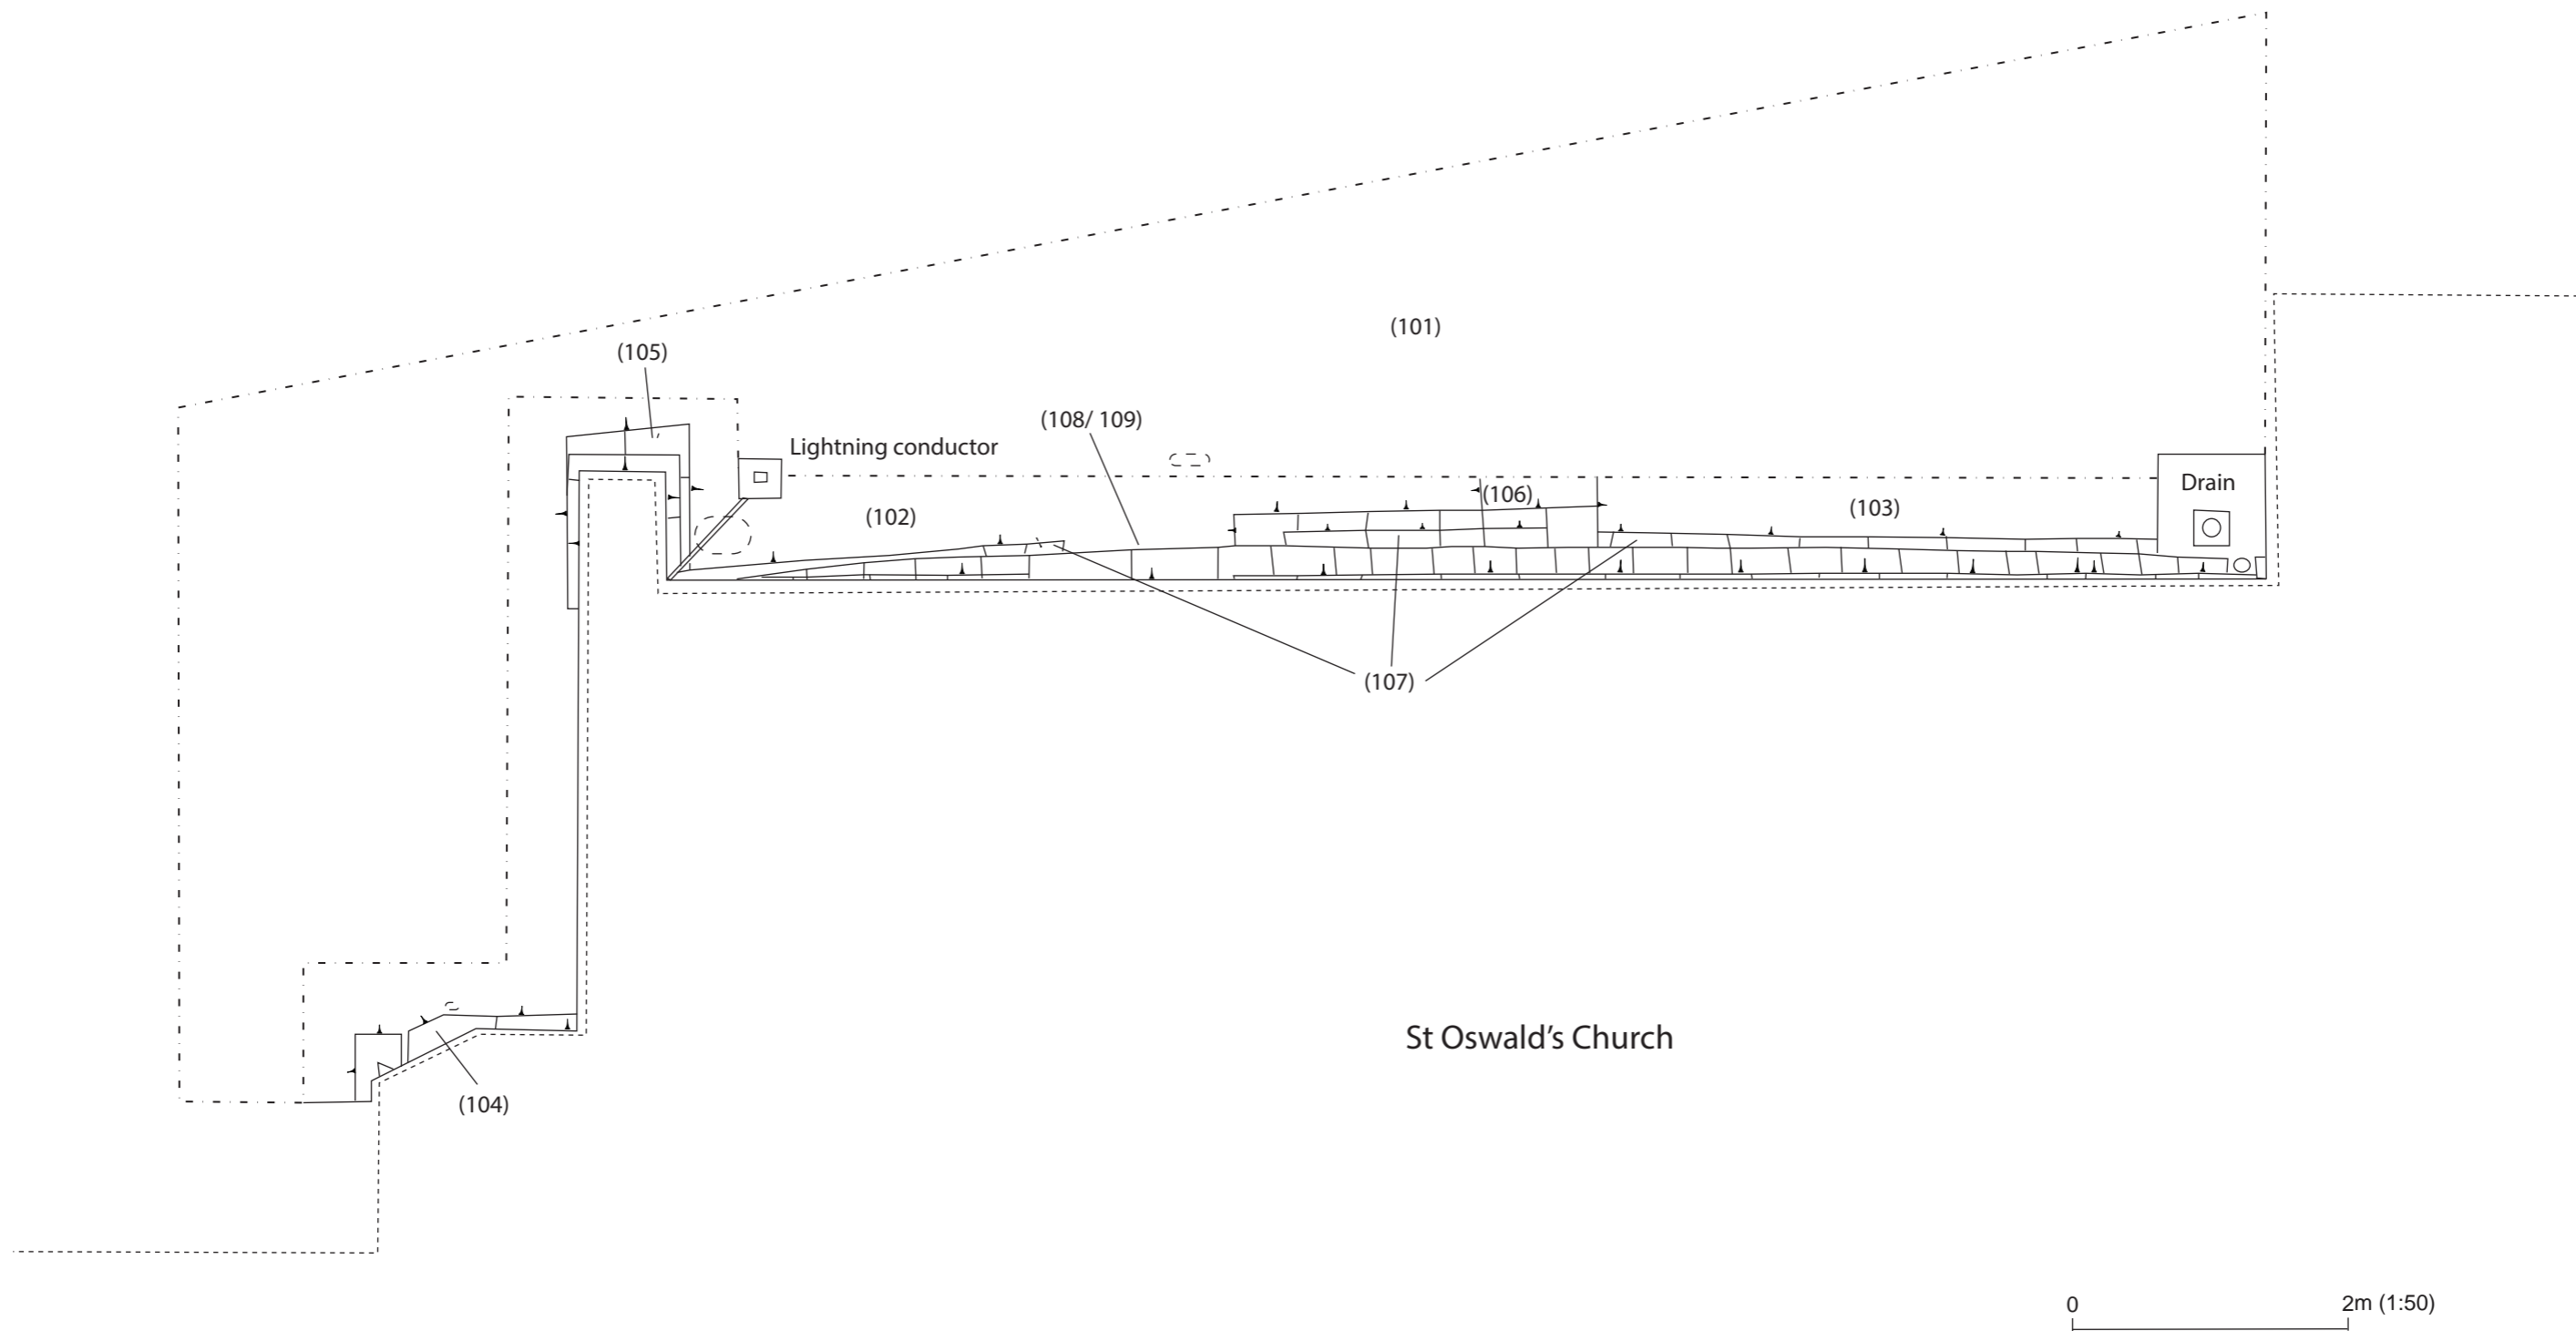
Fig. 3. Site plan (1:50 @ A3)

The results of monitoring the topsoil strip and excavation of the drainage trench are summarised below by context. Excavation took place on the north-west extent of the north aisle of St Oswald's Church. A topsoil strip was undertaken across the entire area, identified in Fig. 1. The drain trench was then excavated around the western and northern extent of the

church building and was 0.5m wide and 0.5m deep. The length of the drainage trench was approximately 21m. The contexts and features described below are illustrated in Fig. 3.

Context 108 (Plate 13) was a single threshold stone incorporated within the lowest level of foundation wall Context 107. The stone measured 1 by 0.2m and was 0.2m deep. Context 108 is overlain by a rubble infill (Context 109) and the dressed and chamfered skirting found along the lower facia of the north aisle wall. The chamfered dressing around the church foundation means that neither Context 108 or 109 are displayed within Fig. 3, however, the positions of both are indicated.

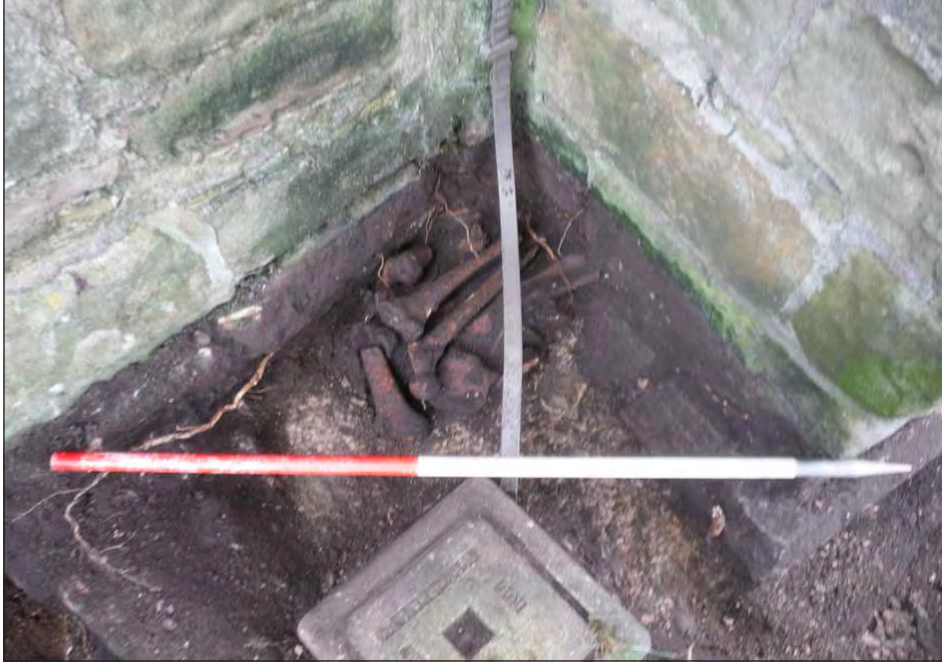
Plate 3. Disarticulated remains within Context 101, facing south-west

Context 100 was a dark grey-brown silt topsoil which covered the entire excavated area in depths between 0.1 and 0.35m. The deepest extent of the deposit was located around the edge of the church building. The topsoil had very few inclusions apart from around the area of the church building where a heavy concentration of rounded river cobbles was located at its deepest extent. The remains of two sets of disarticulated skeletal remains were found within Context 100. Packed in a sub-rectangular fashion, against the corner formed by the north-western buttress, and located immediately under the lightning conductor, at a depth of 0.03 to 0.32m, were the partial skeletal remains of at least four individuals (Plates 3-4). The skeletal remains excavated were predominately of lower long limbs – femur, fibula and tibia – but also included a mandible, ribs, two pelvic fragments, humerus, radius and ulnas.

Approximately 3.8m west of these remains and 0.75m from the north wall, a second set of disarticulated skeletal remains were located within the topsoil overlying the aforementioned river cobbles (Plate 5). These remains consisted of the lower long limb bones laid on top of each other in a general east-west orientation at a depth between 0.11 to 0.29m.

The disarticulated skeletal material found along the edge of the church within Context 100 represent remains that had been previously disturbed and reinterred. The present pathway, which borders the northern limit of excavation, was constructed in the 1980s (Earle, pers. comm.). Considering the shallow depths of both sets of remains, it is likely that this disarticulated skeletal material was disturbed and reburied during the construction of the pathway. Likewise, the single vertebrae found within Context 101 was probably disturbed during earlier building activities within the churchyard.

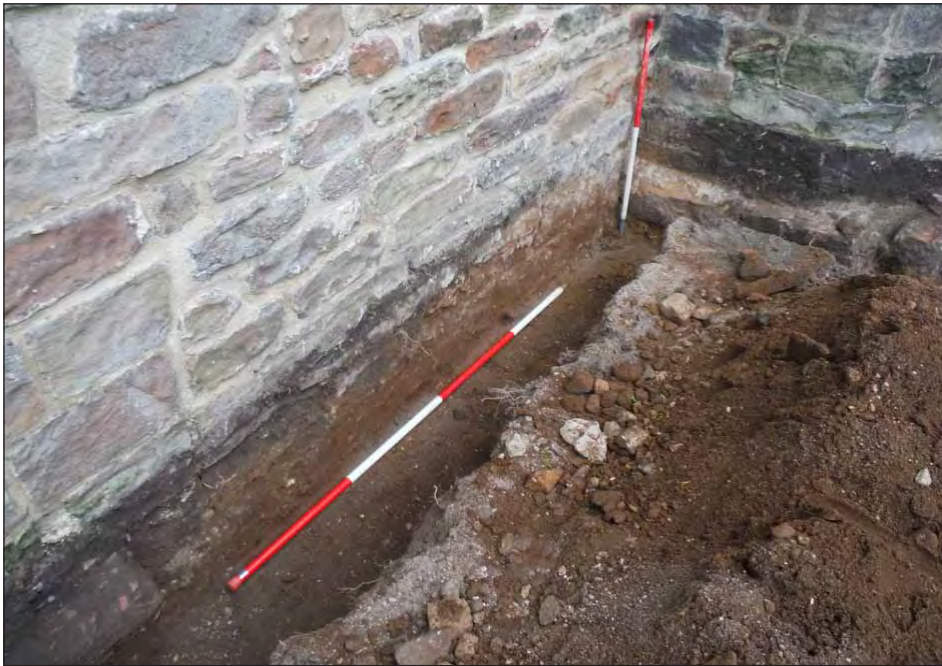
Plate 6. Context 102, facing south-east

Context 102 (Plate 6) was a mid-red brown sandy clay located along the western and northern walls at the deepest extent of the excavation. The building foundations for the north aisle rested on this substrate. The excavation did not fully establish the depth of Context 102. No finds were found within Context 102.

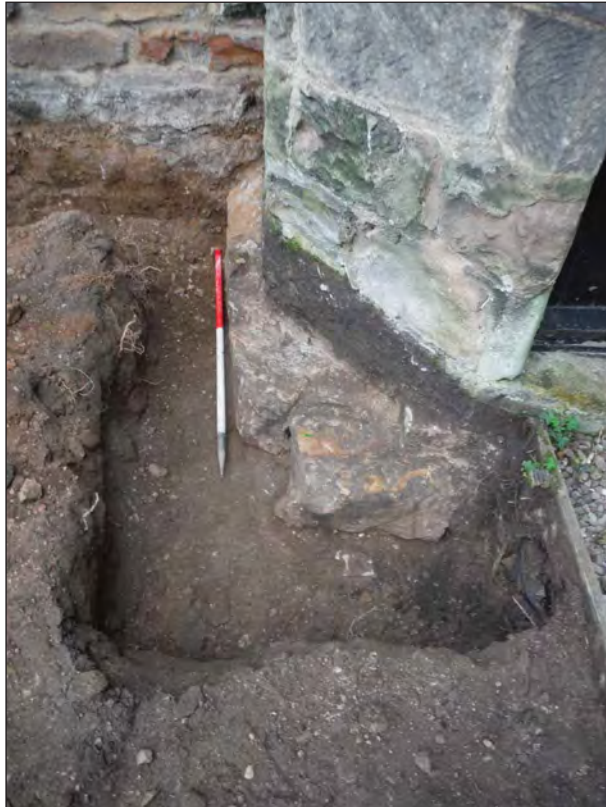
Plate 7. Context 104, facing east

Context 104 was a sub-octagonal foundation wall located to the south-western extent of the excavated area (Plate 7). This foundation supports the 16th-century tower located on the western façade of St Oswald's Church. The foundation was constructed of a single layer of large sub-rectangular sandstones 0.4m deep. The dimensions of the foundation uncovered

were approximately 1.8 by 0.5m. The foundation was stepped out from the wall of the tower above by 0.25m. The foundation stones rested on Context 102. Context 104 butted the western flat-faced façade of the north aisle.

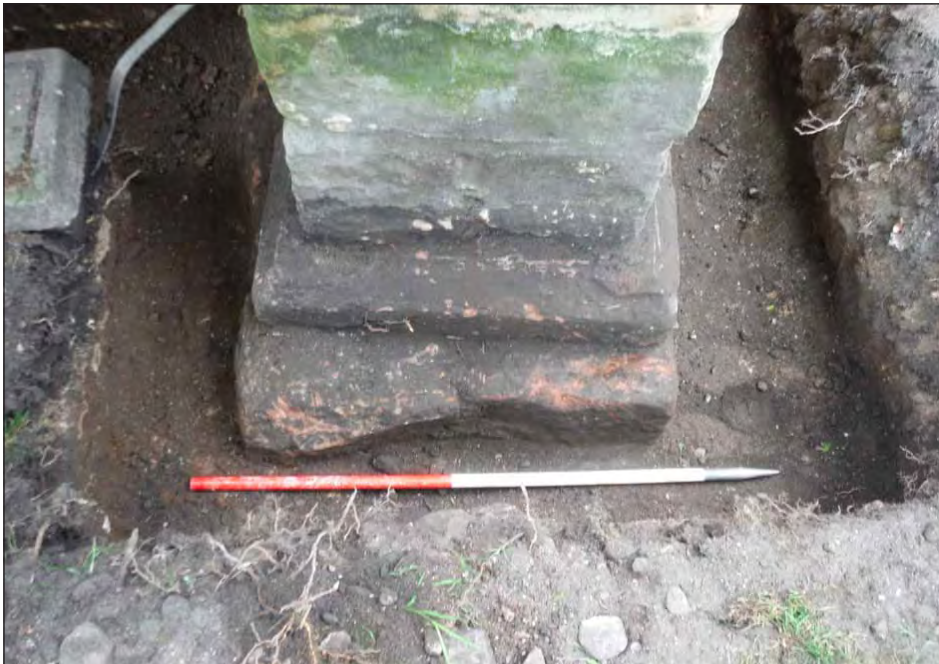
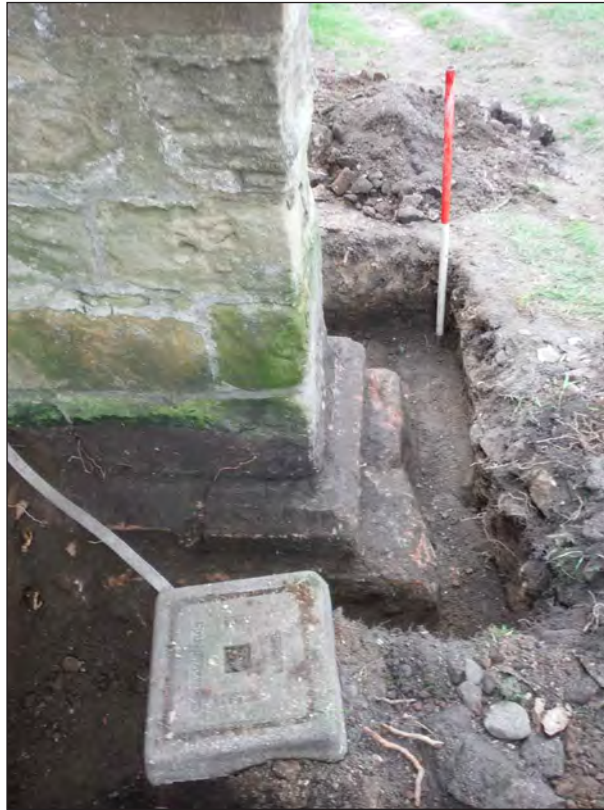
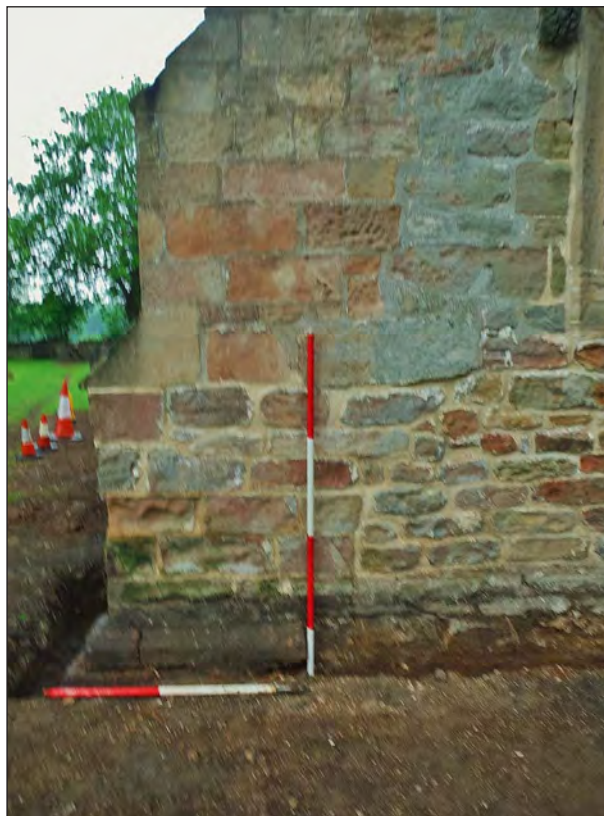
Context 105 was a stepped buttress foundation found at the north-west corner of St Oswald's Church (Plates 8-10). The foundation was constructed of large red sandstones and measured 1.25 by 0.85m. The foundation construction was at least 0.45m deep. The full extent of the foundation descended below the 0.5m depth of excavation. The top stone on the two stone step had a chamfered face while the lower stones were sub-rectangular and not as finely worked. Context 105 supports an extant buttress found on the north-west corner of the north aisle and butts the north-west corner of the north aisle.

The possible buttress foundation Context 106 was similar in design to Context 105 which supports an extant buttress. The north aisle was constructed around 1200 AD and the facia has been remodelled on several occasions. Evidence from the facia above Context 106 (Plate 12) suggests that a buttress was attached to the wall here during earlier times. The foundations recorded in Contexts 105 and 106 were constructed exclusively with red sandstone. This material is also found occasionally within the lower foundation of Context 107, while the majority of the church is built from locally procured yellow sandstone. Both buttresses examined appeared as later additions to the north aisle (Plate 10). Context 106 truncates the foundation wall (Context 107) and it is likely that these were added as part of the reconfiguration of the north aisle facia during the Georgian period.

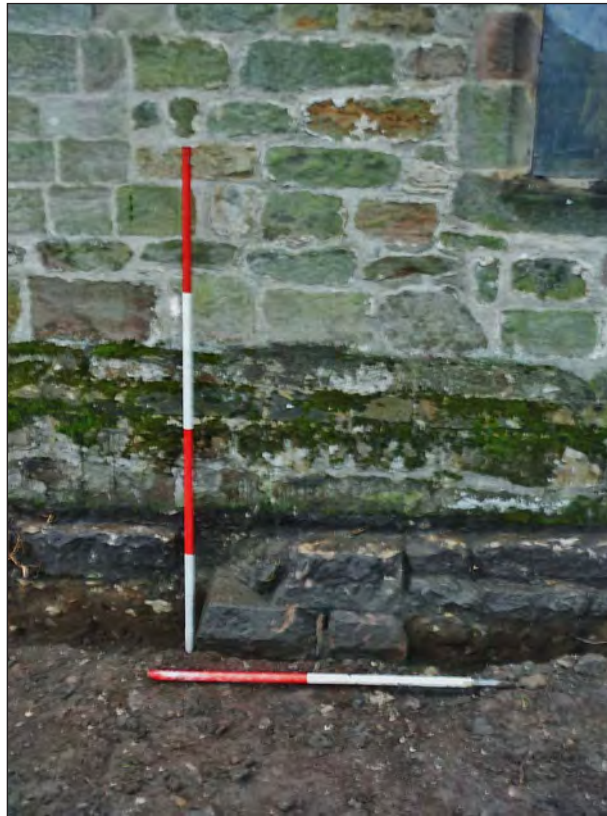
Plate 11. Contexts 106, 107 and north wall, facing south

Context 106 (Plates 11) was similar in design to Context 105 and was found below the centre of the north face of the Church. Again, large red sub-rectangular sandstones provided the stepped and chamfered foundation. Context 106 appeared to truncate church foundation wall Context 107 which displayed robbed stone directly east of Context 106. No extant buttress is present above the recorded foundation. The total dimensions of the foundation and their true relationship to the surrounding walls of the north aisle were not viewed within the excavated area. Context 106 divided the clay substrates of Contexts 102 and 103.

The position of the foundation described in Context 106 is not centred between the extant corner buttresses found to the east and west extents of the north aisle. The threshold stone (Context 108) located within the lower level of the foundation wall (Context 107) suggests a probable earlier entrance on the north facia of the church which may explain the slight off-centre positioning of any further buttress that previously extended above Context 106. Again, the wall above this area shows evidence of later alterations highlighted by the inclusion of a single and large exceptional stone above the foundation wall (Plate 14).

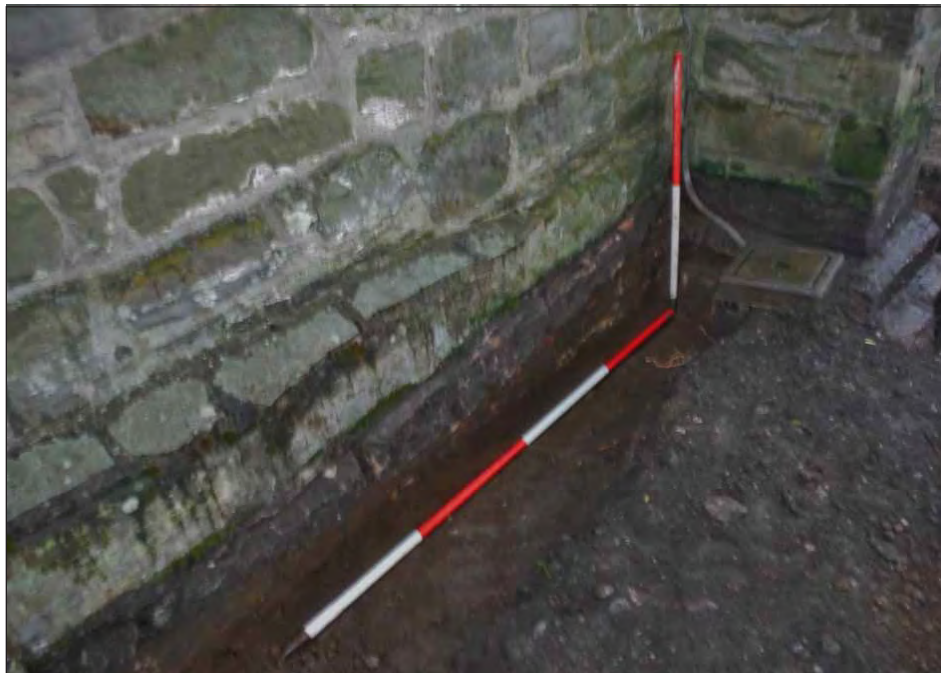
Plate 12. Context 107, facing south-west

Context 107 (Plate 12) represents the foundation wall which extends the full length of the north face of St Oswald's Church. It is constructed of large yellow sub-rectangular, roughly dressed sandstones. The stones used in these foundations are larger and not as finely worked as the extant stone work displayed above present ground level. Red sandstones have also been incorporated towards the western extent at the lowest level. Context 107 supports the dressed and chamfered skirting found on the northern façade of the church above present ground level. The foundation wall was approximately 0.4m deep and comprised a double layer of stones with an overlapping bond. The upper limit was located approximately 0.05m below present ground level and the lower limit found embedded into the clay substrate at a depth of 0.5m in. The upper stones protruded out from the dressed façade of the north wall by around 0.1 to 0.25m. To the western extent the upper stones were flush with the church wall while the lower foundation stones were stepped back approximately 0.1m below. Context 107 is partially truncated to the eastern extent by a later metal vent and red brick repair, in the centre of the wall by buttress foundation Context 106 and to the western extent by a single threshold stone Context 108.

The foundation wall (Context 107) was irregular along the course of the north aisle's northern facia, with areas where the foundation extended out from the building edge and areas where the lower stones were stepped inwards (Plate 13). The western wall was flat-faced from top to base and while not fully excavated to the lowest extent of the foundations appeared to be of a single construction with less remodelling than the northern facia. At least three periods of construction, associated with the north aisle, have been identified.

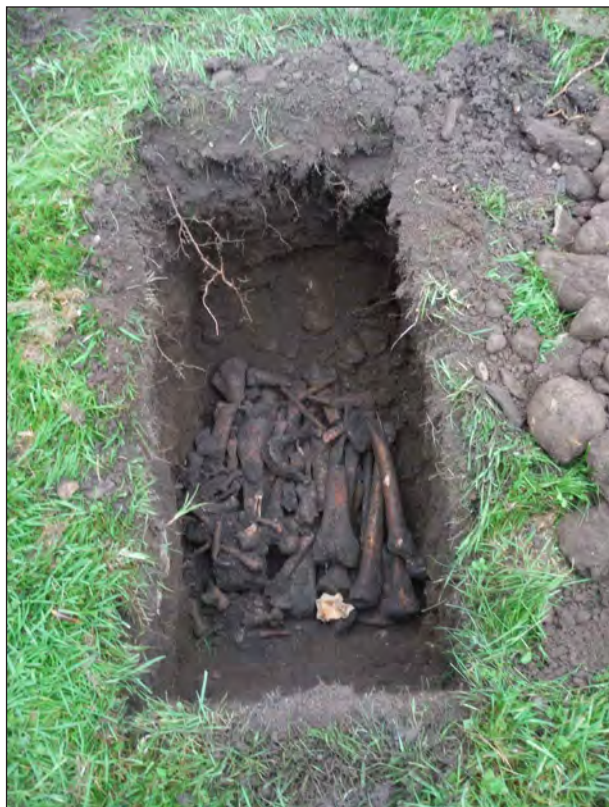
Plate 14. Reinternment of disarticulated human remains, facing west

The disarticulated skeletal remains recovered during excavation were stored within St Oswald's Church, and in line with the WSI, were subsequently reinterred within the graveyard (Plate 15) on Wednesday 30th May 2018 during a short service conducted by the Reverend Sylvia Earle.
