**All Saints' Church
Harewood House
West Yorkshire**

Archaeological Watching Brief

May 2011

Report No. 2220

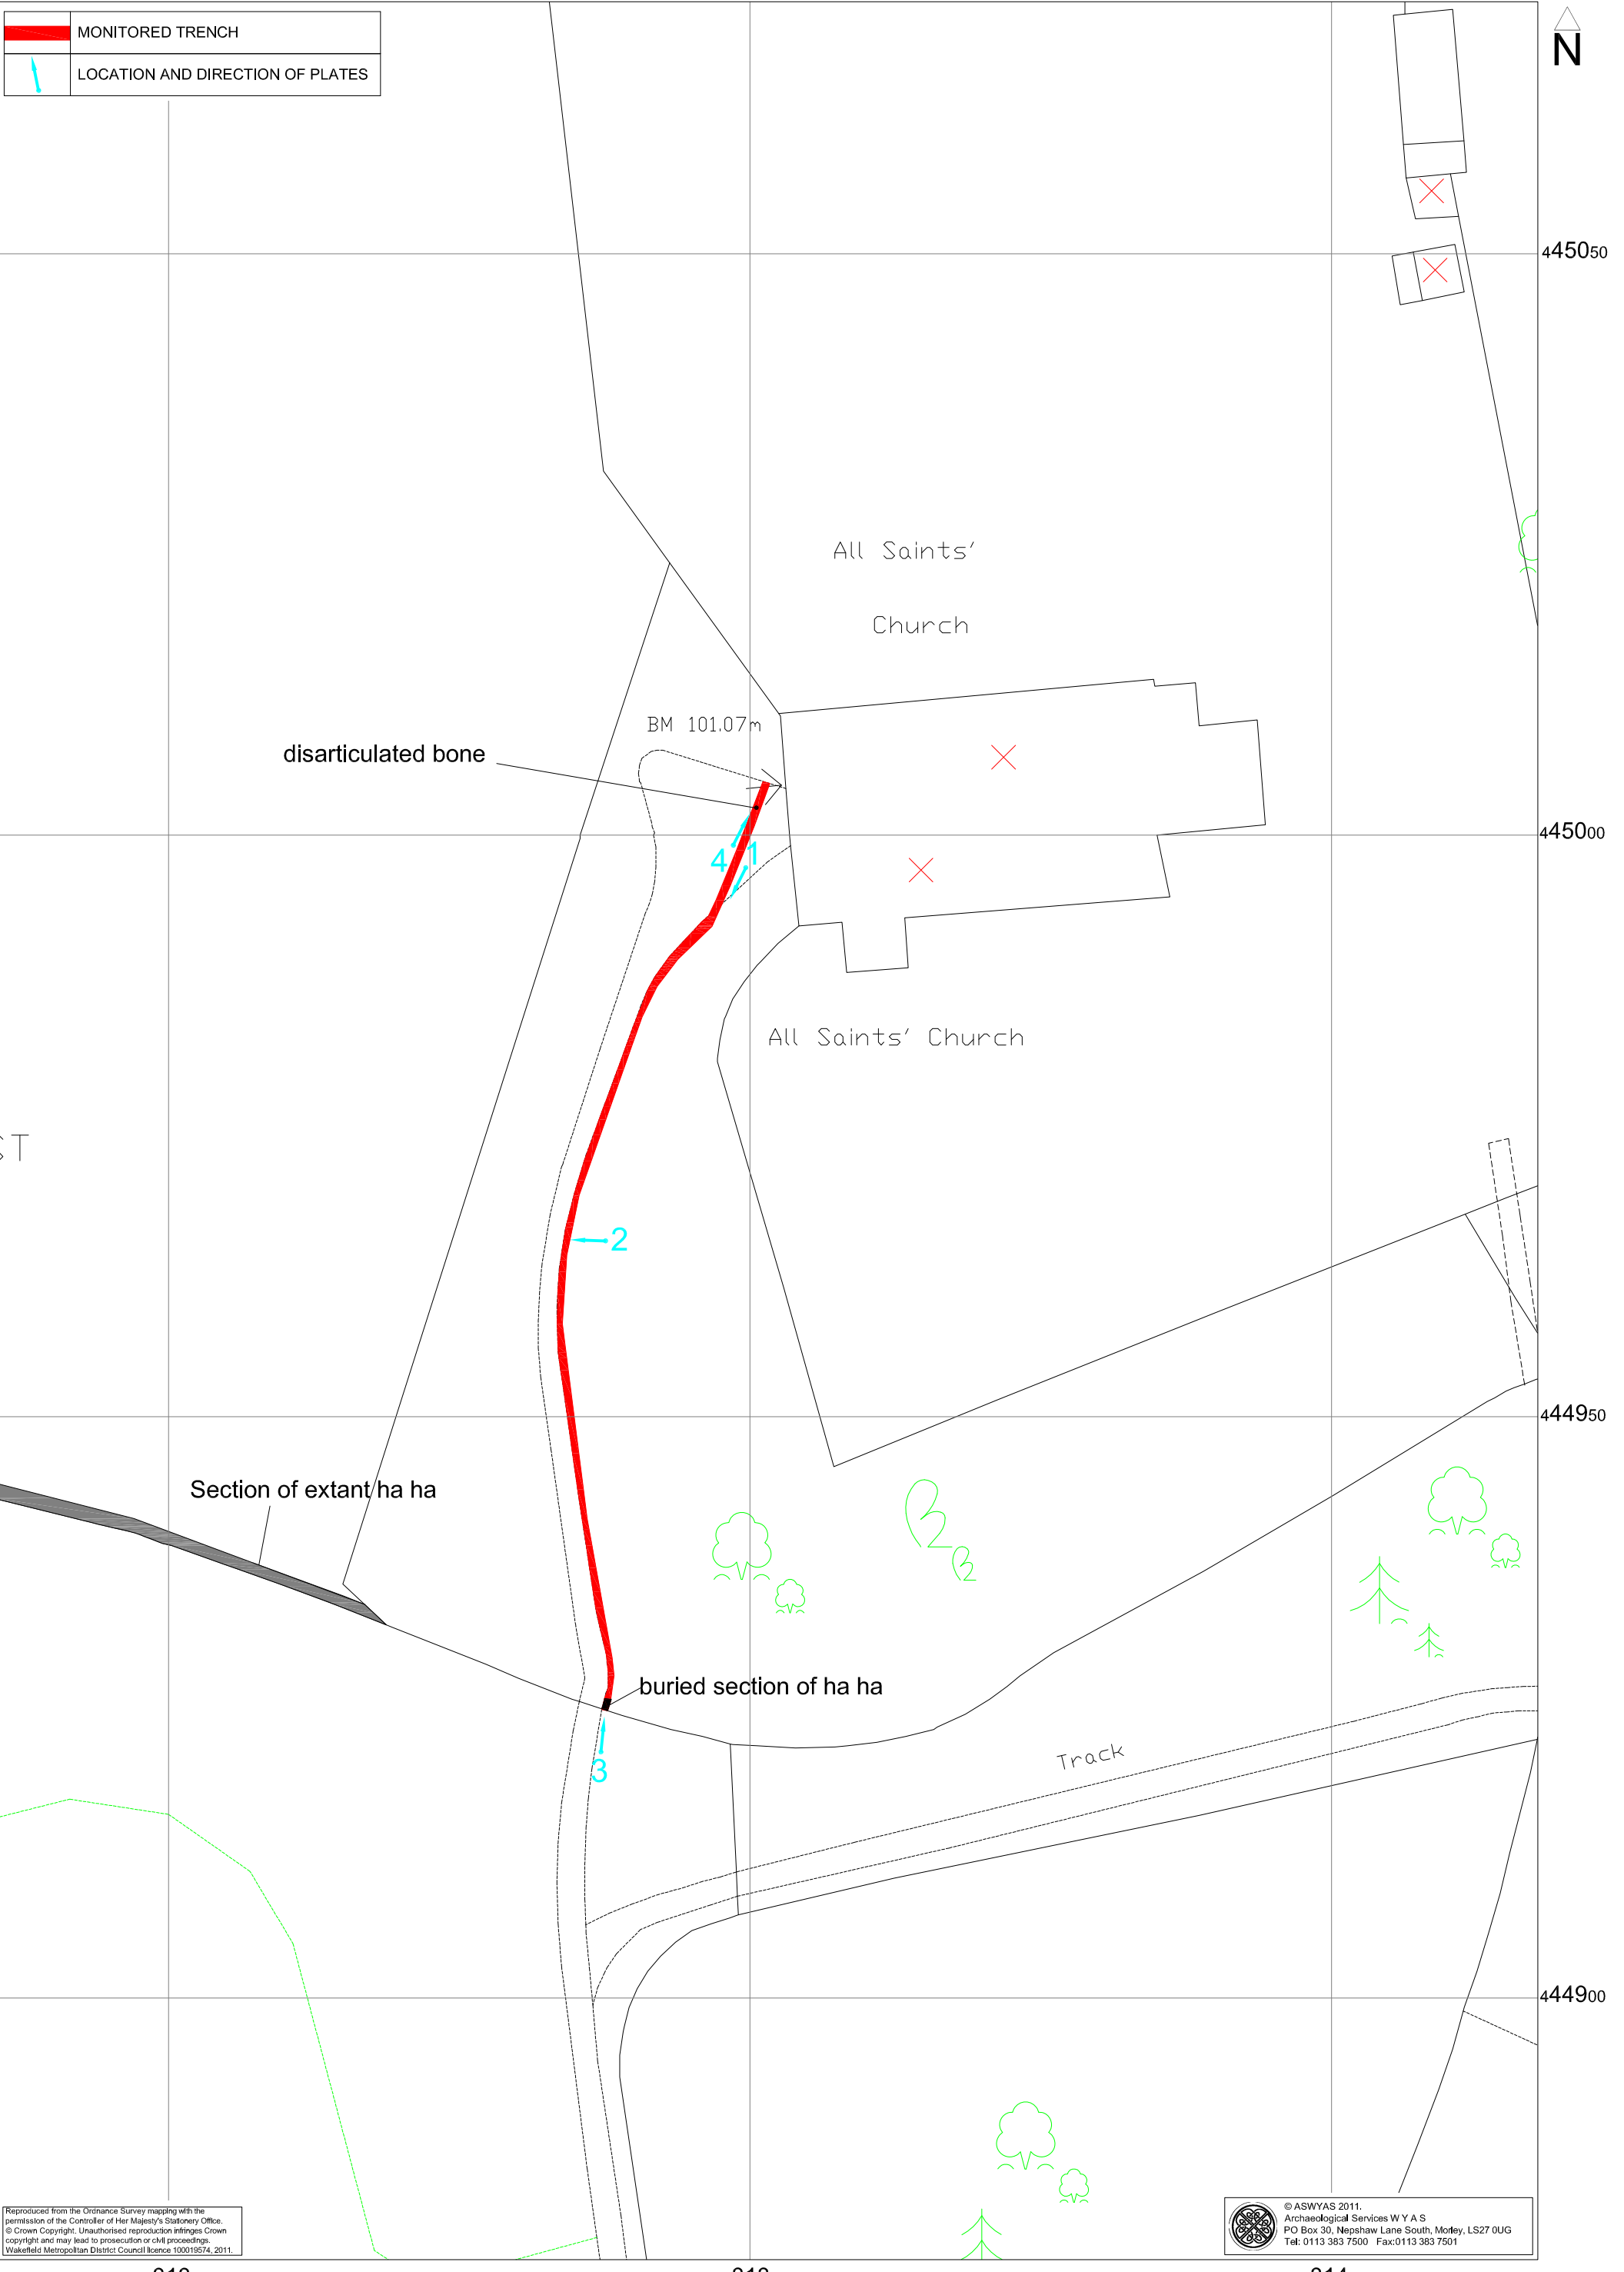
Fig. 2. Detailed site location showing monitored trench (1:500 @ A3)

A single trench was excavated using a small mini-excavator following the main path up to the church from the grounds of Harewood House (Fig 2; Plate 1). The trench was excavated along the eastern side of this path slightly under the cover of yew trees. The trench was 86m in length, 0.45m wide and between 0.5m and 0.6m deep.

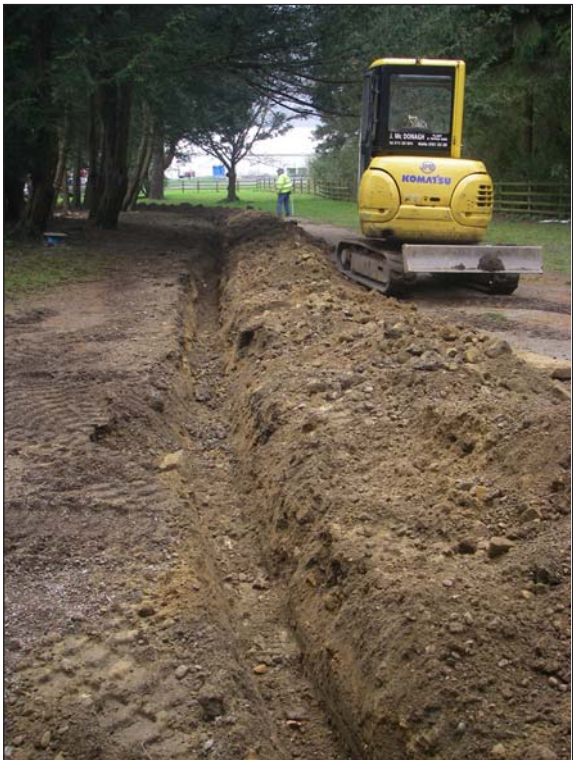
Plate 1. Excavated service trench, looking south-west

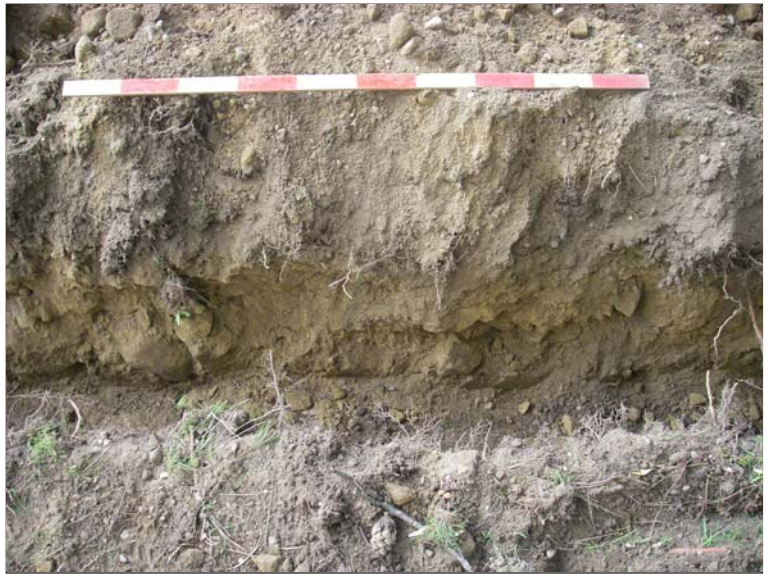
The stratigraphy comprised topsoil (100), 0.25m in depth, overlying subsoil (101) which varied between 0.2m and 0.35m in depth with the natural deposits comprising sandstone (Plate 2). The topsoil was 0.25m deep, with the subsoil varying between 0.2m and 0.35m in depth.

Plate 2. Central part of trench, showing general section of trench, looking west

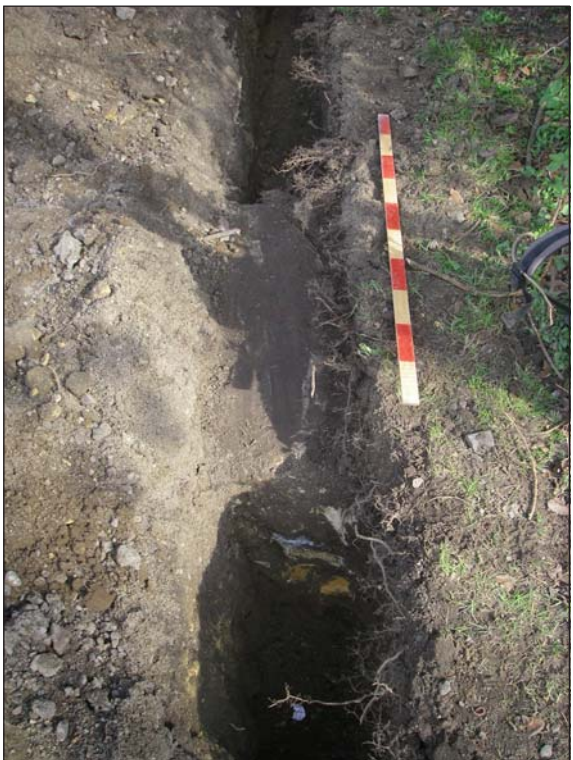
Towards the southern end of the trench, near the present gateway, a buried section of the ha-ha wall was uncovered (see Plate 3)(103). Extant sections survive approximately 20m to the west. The wall was 0.92m wide and at least 0.44m deep – its full depth was not exposed. The wall was made up of large sandstone blocks bonded with lime mortar.

Plate 3. Exposed ha ha 103, looking north

A short length of ha-ha was also exposed at the southern end of the trench. This is clearly part of the same feature which survives 20m to the west. The section of ha-ha exposed appears to have been in filled and covered suggesting that the path to the church did not always follow its present course.

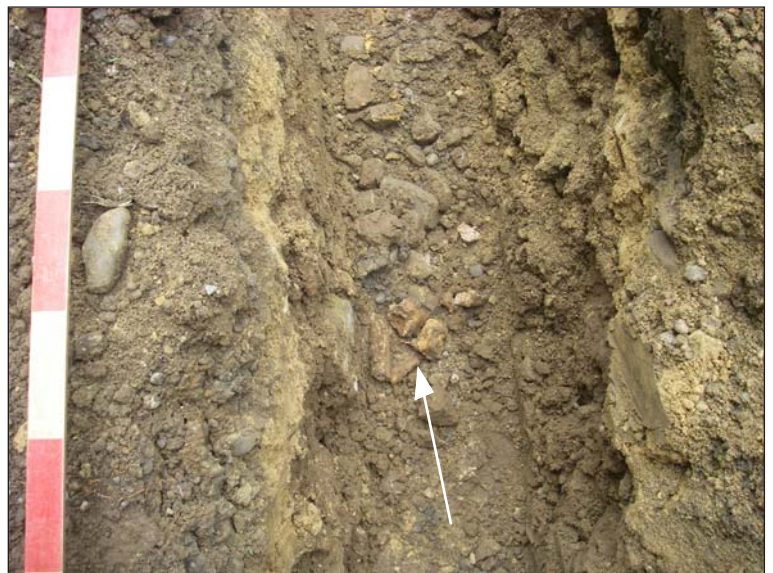
In the base of the northern part of the trench, immediately outside the western door to the church, a small group of disarticulated human bone was observed in the base of the trench (see Plate 4). As no further excavation was required below the level at which the bone was exposed the remains were photographed and covered, leaving them *in situ*. No grave cuts were observed. The bones appeared to be human ankle bones. The excavations in the northern 10m of the trench did not reach natural deposits with only topsoil and path make up 0.25m deep and subsoil 0.35m+ deep being recorded.

Plate 4. Exposed disarticulated bone in base of trench, looking north-east

The watching brief on the service trench uncovered a small amount of disarticulated human bone just outside the western door of the church. As the natural deposits were not exposed in this section of the trench it was impossible to determine whether there were any grave cuts. The presence of disarticulated bone does, however, suggest that graves may well extend to the west of the church and may not therefore be confined within the present graveyard. With the long history of the church dating back from at least the 10th century this would not be surprising.
