**Generator House, Brodsworth Hall,
Doncaster, South Yorkshire**

Archaeological Building Recording

Report No. 1948

April 2009

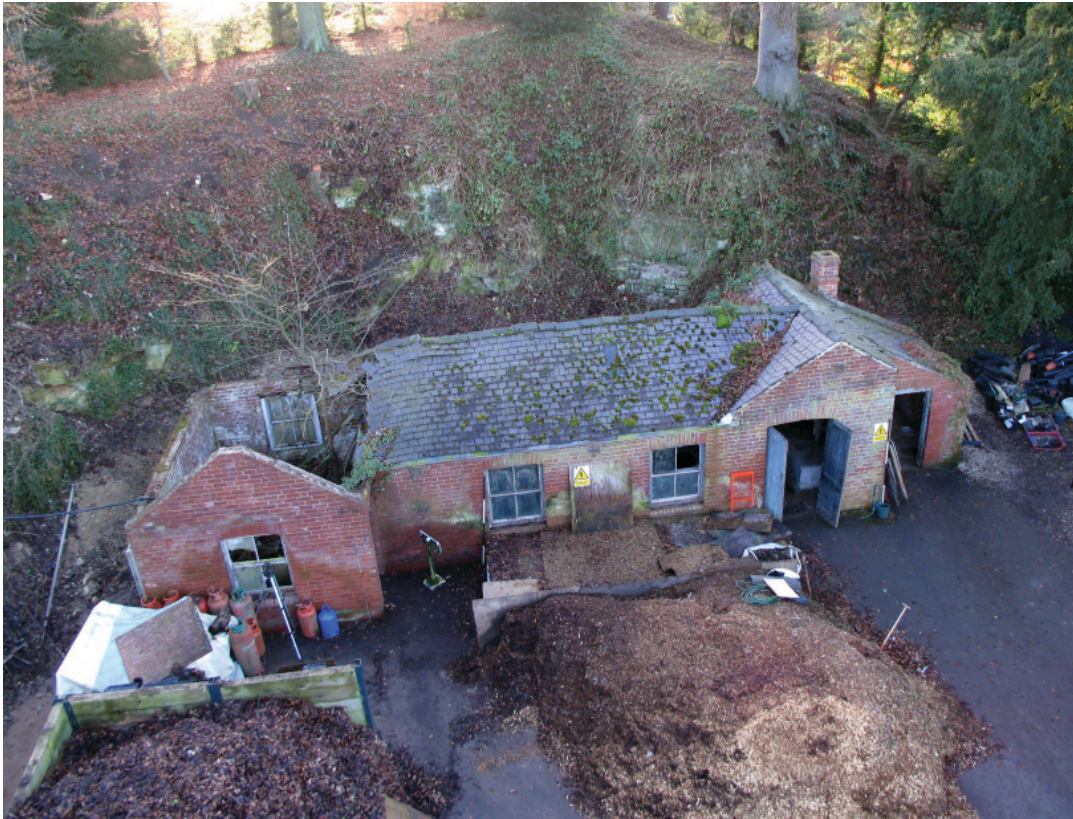
Photograph 1 Film 09D009_3387_0015 Direction SW

General elevated view showing the slate roof covering

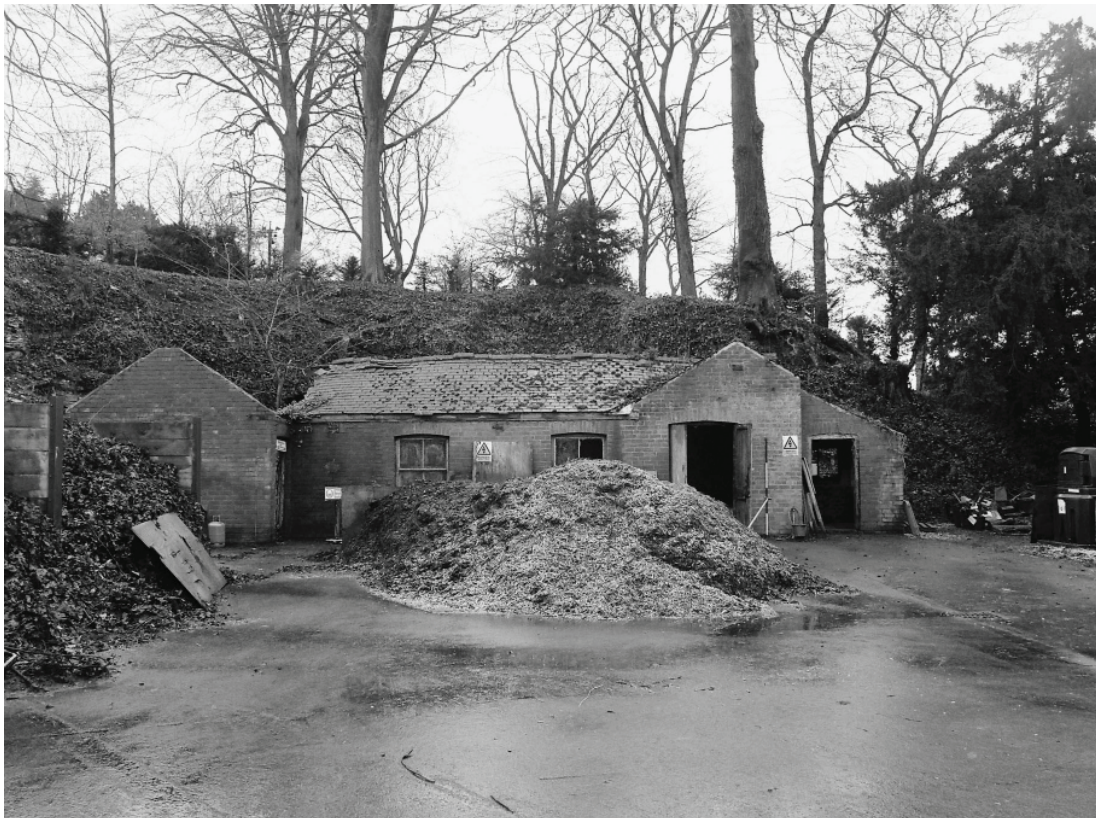
Photograph 2 Film 2_11 Direction SW

North-east elevation with the quarry face in the background

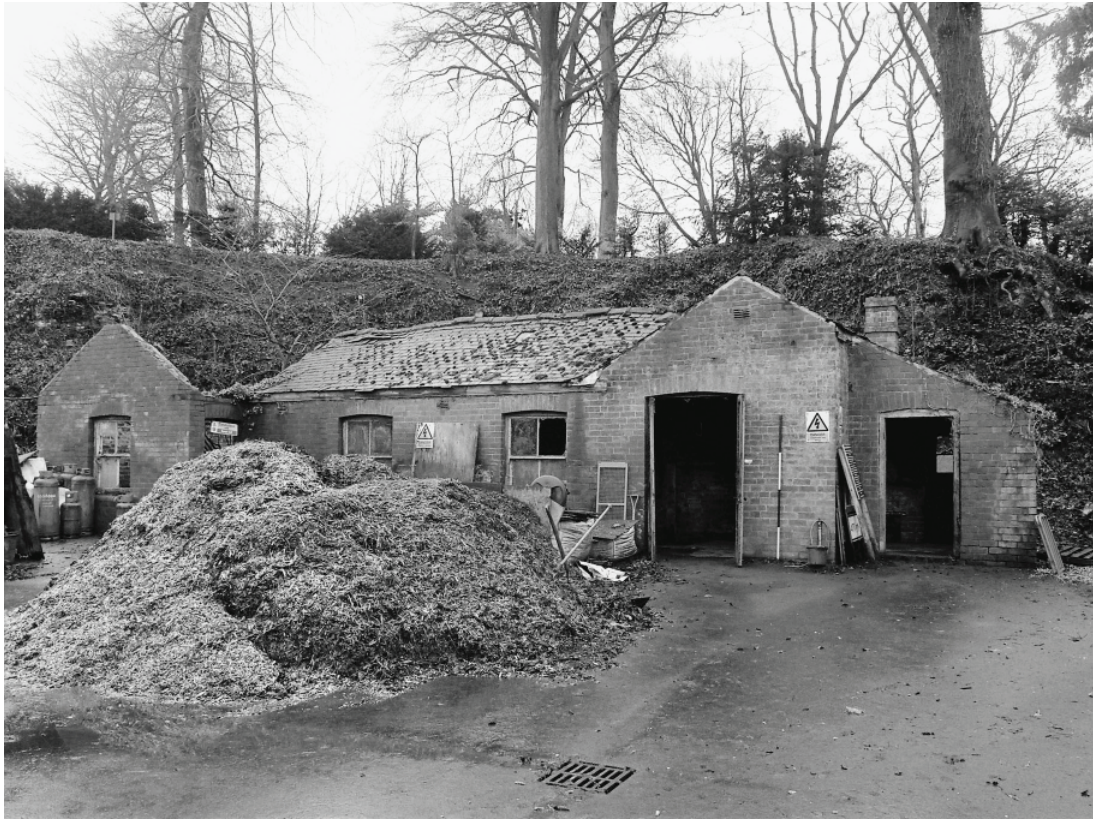
Photograph 3 Film 2_9 Direction SW

North-east elevation with the quarry face in the background

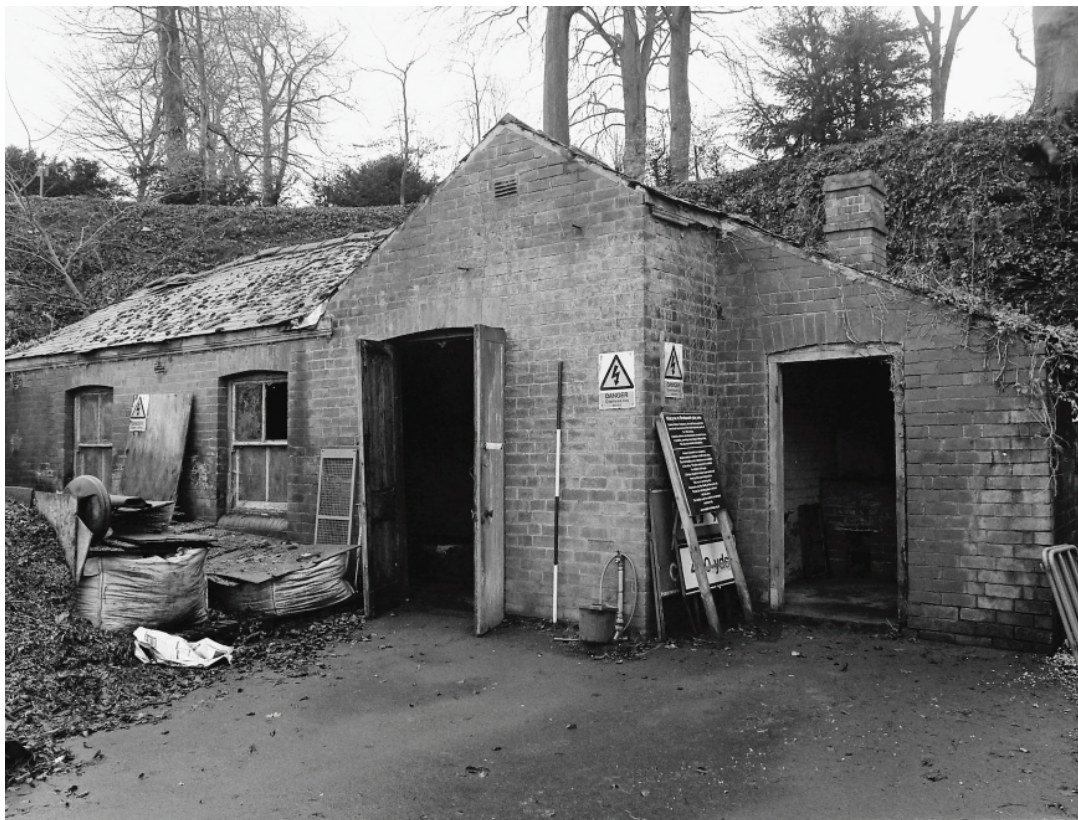
Photograph 4 Film 2_12 Direction S

North-east elevation showing the washroom to the right containing the enamelled sink and the corner set-pot

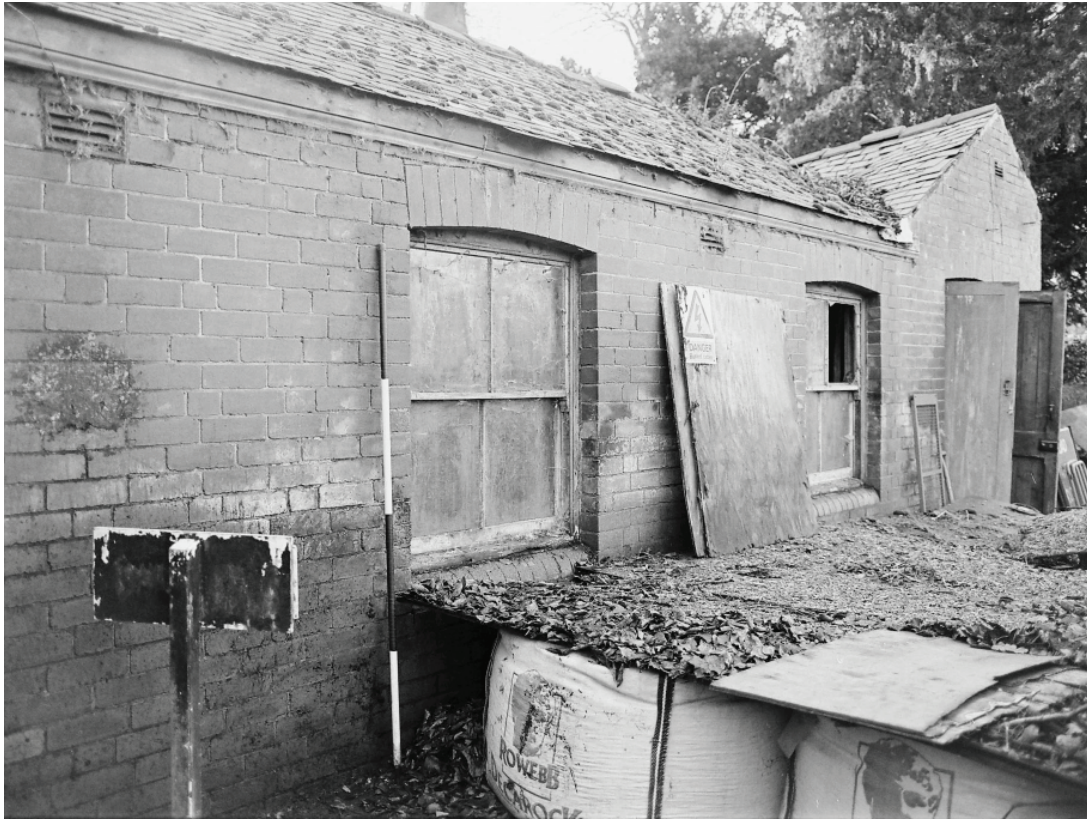
Photograph 5 Film 4_7 Direction W

North-east elevation showing the window openings with rounded brick sills, above is a moulded wooden eaves board

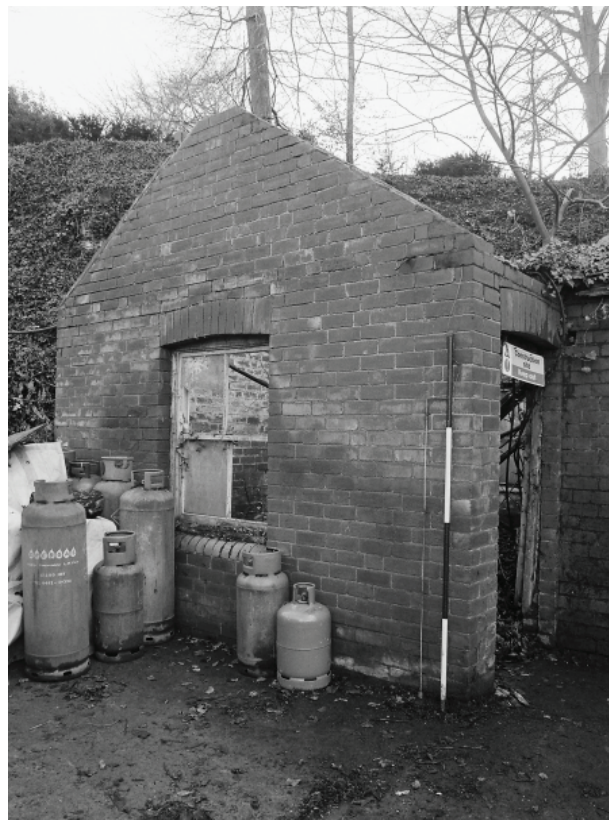
Photograph 6 Film 4_5 Direction S
Room No:e1

North-east facing gable showing a segmental-arched window opening with a rounded brick sill. The window opening has a wooden two-over-two vertical sliding sash frame

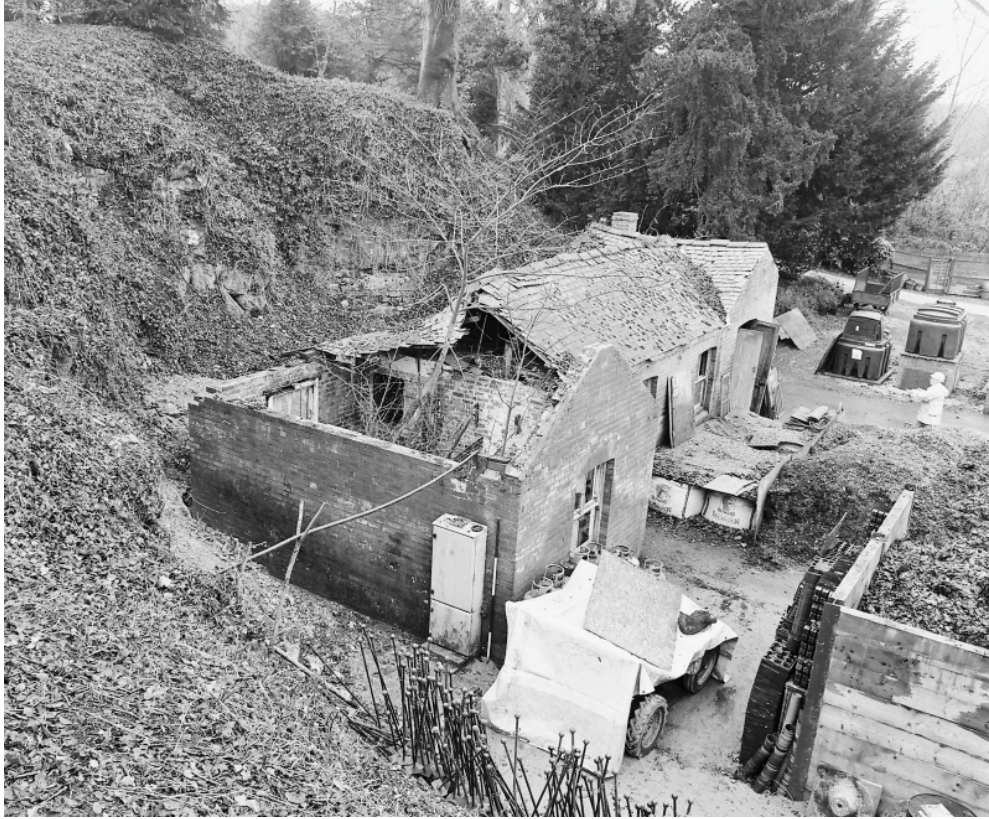
Photograph 7 Film 3_8 Direction W

General view from the east showing the building set against the quarry face

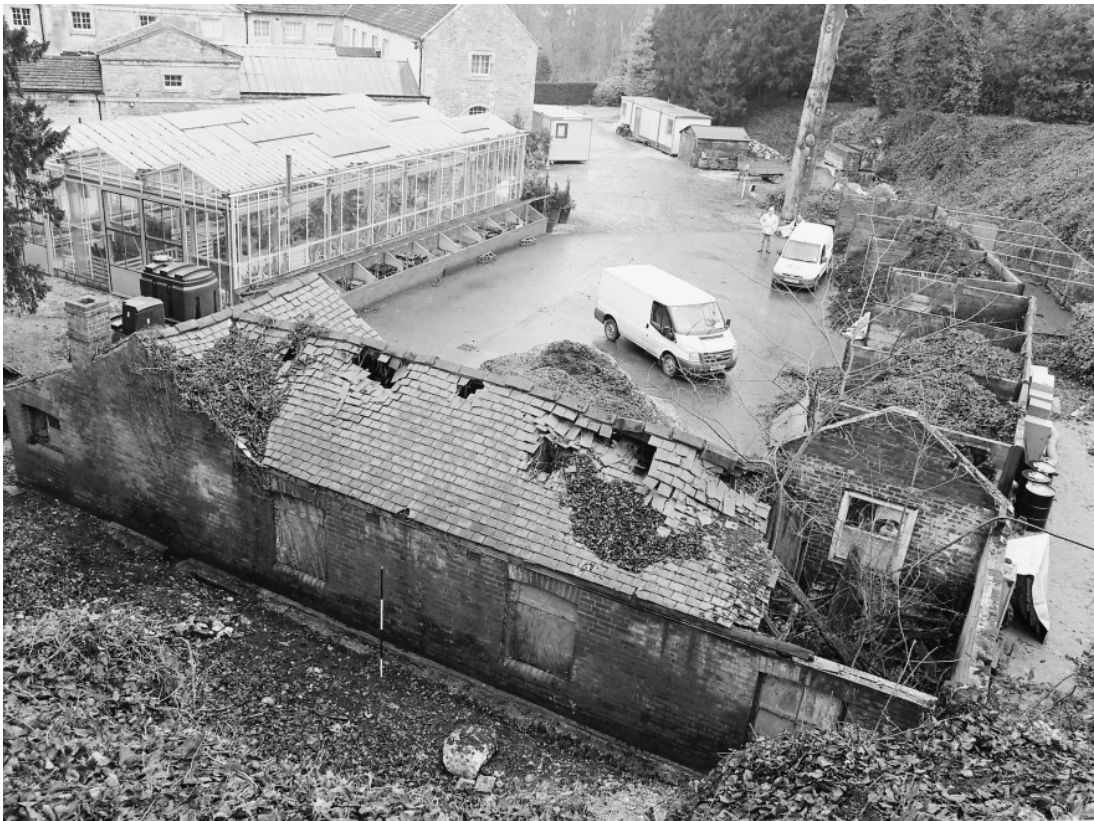
Photograph 8 Film 3_6 Direction N

General view showing the building with stable block to the north

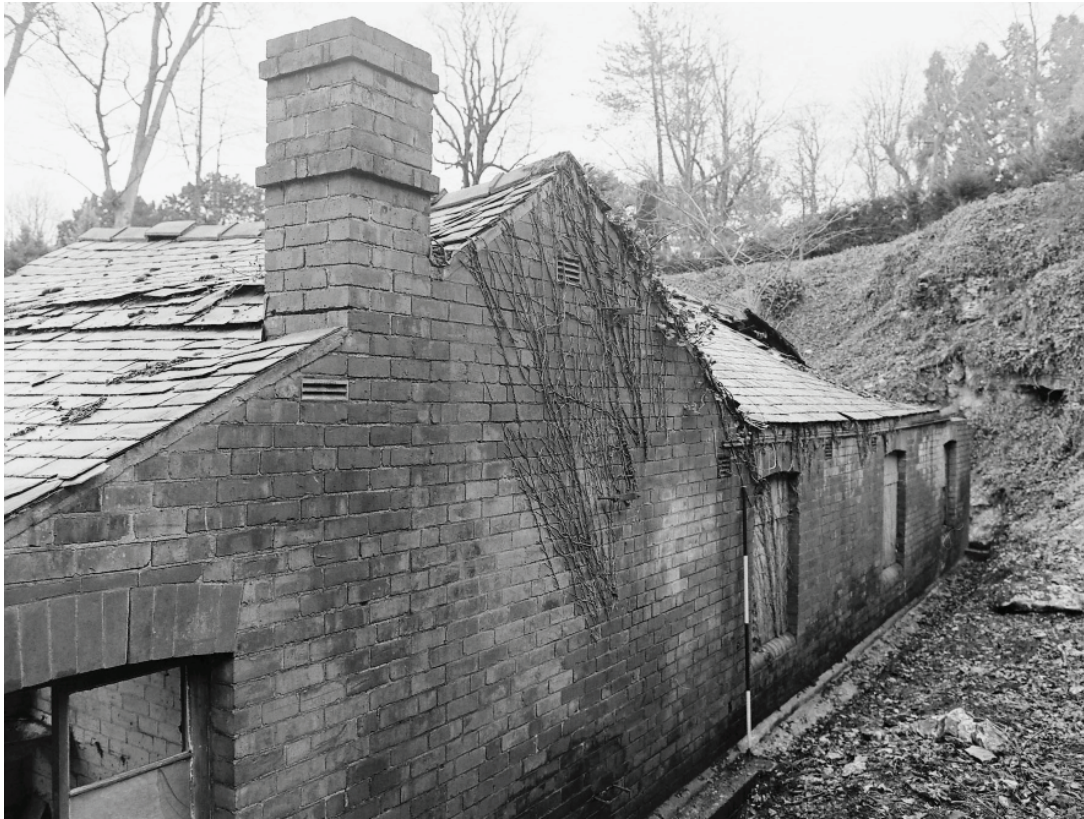
Photograph 9 Film 2_17 Direction E

South-west elevation showing the chimney stack from the corner set-pot in the washroom

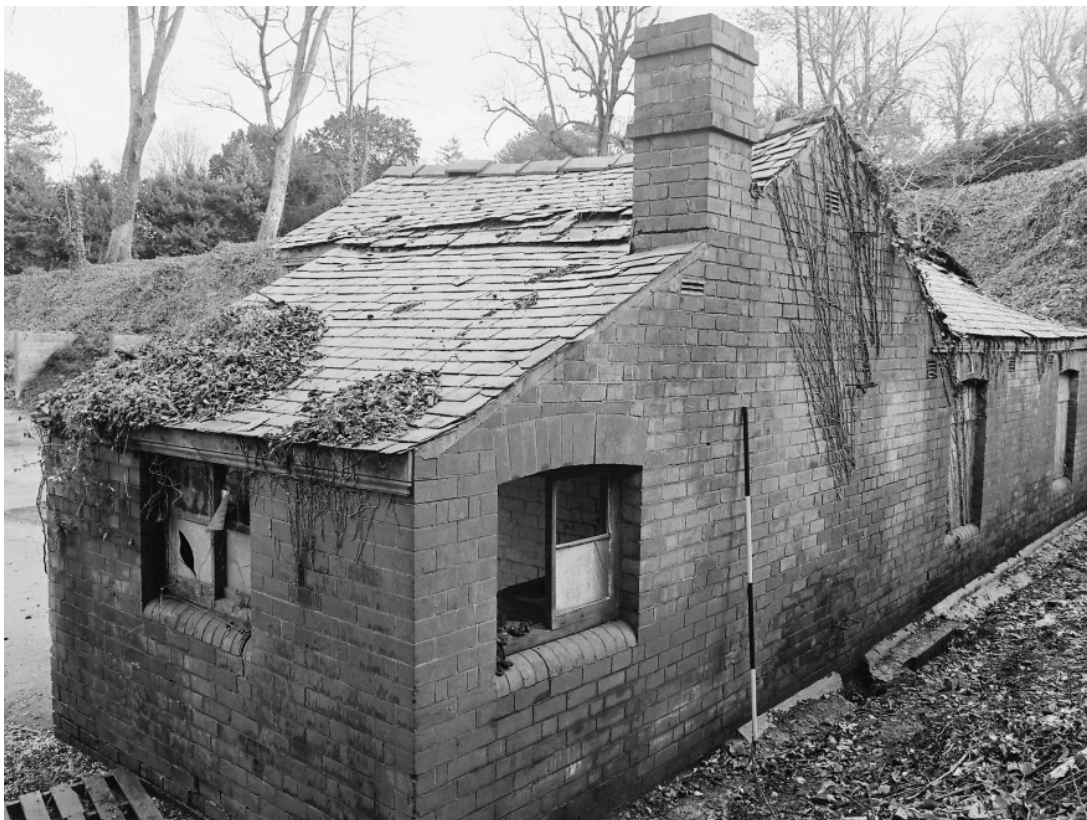
Photograph 10 Film 3_1 Direction E

View showing the window openings in the north-west and south-west elevations of the washroom

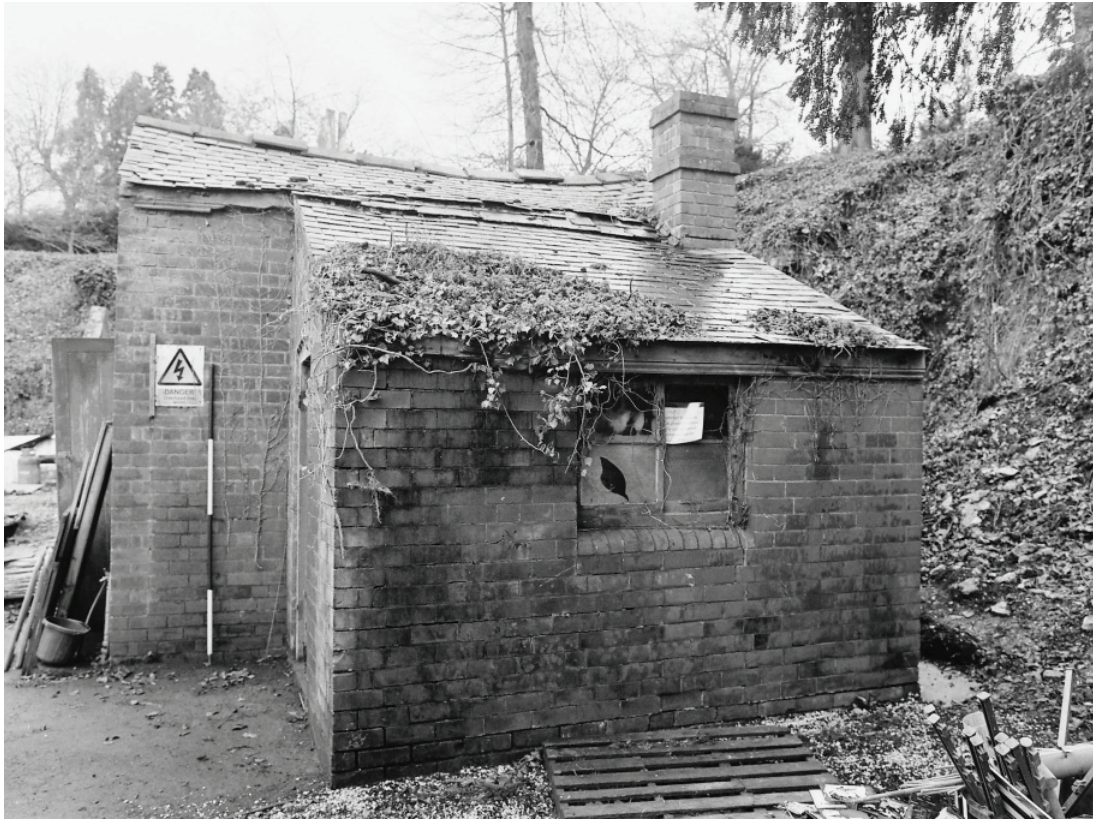
Photograph 11 Film 2_15 Direction SE

North-west elevation showing the window opening with a rounded brick sill. The wooden window frame is a two-over-two vertical sliding sash

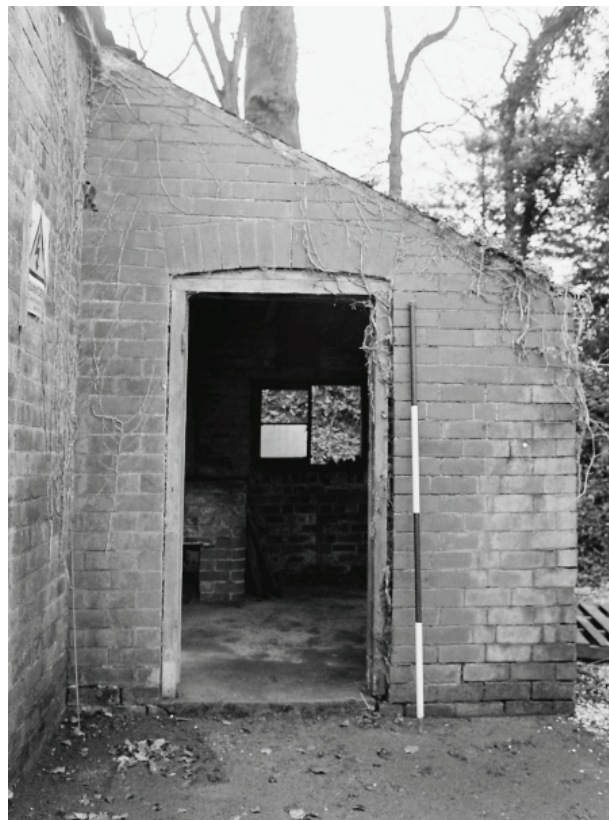
Photograph 12 Film 2_14 Direction SW

Segmental-arched door with wooden frame in the north elevation of the washroom

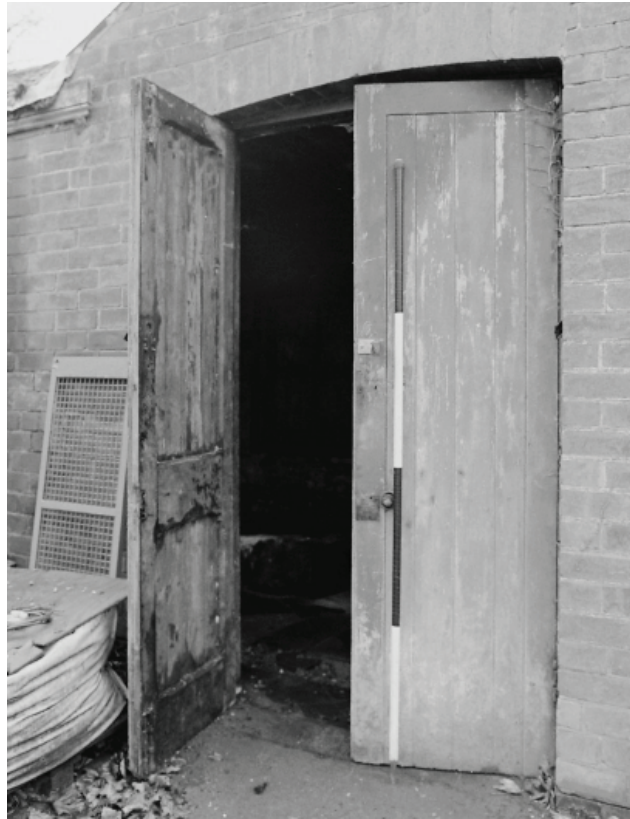
Photograph 13 Film 2_13 Direction SW

Wooden double doors with large internal chamfered midrail in the north-east wall

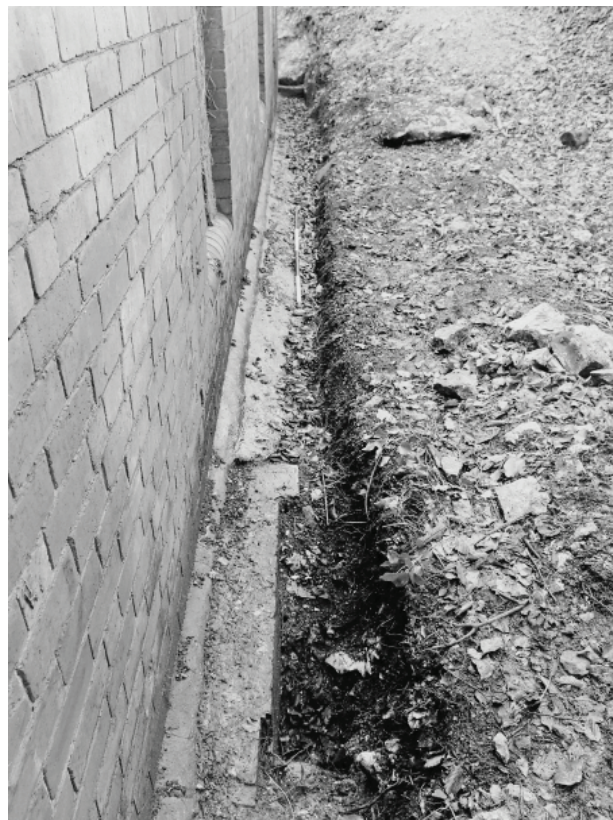
Photograph 14 Film 3_2 Direction SE

Drainage channel against the south-west wall

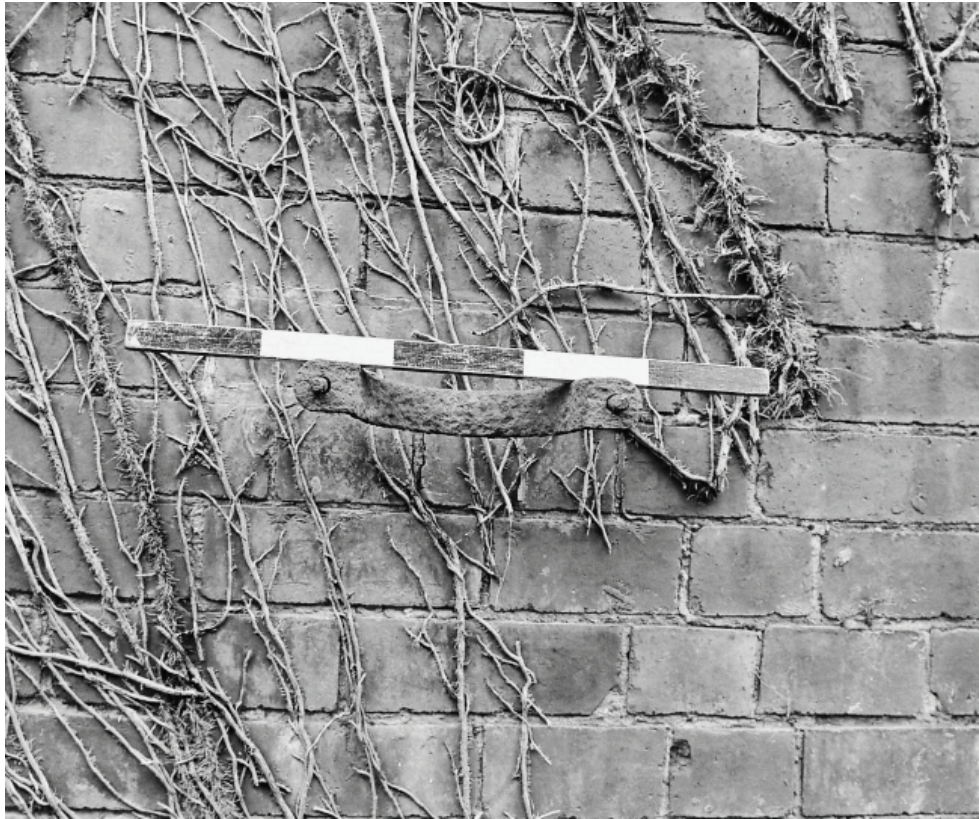
Photograph 15 Film 3_5 Direction NE

Wrought-iron strap for a fall pipe in the south-west elevation

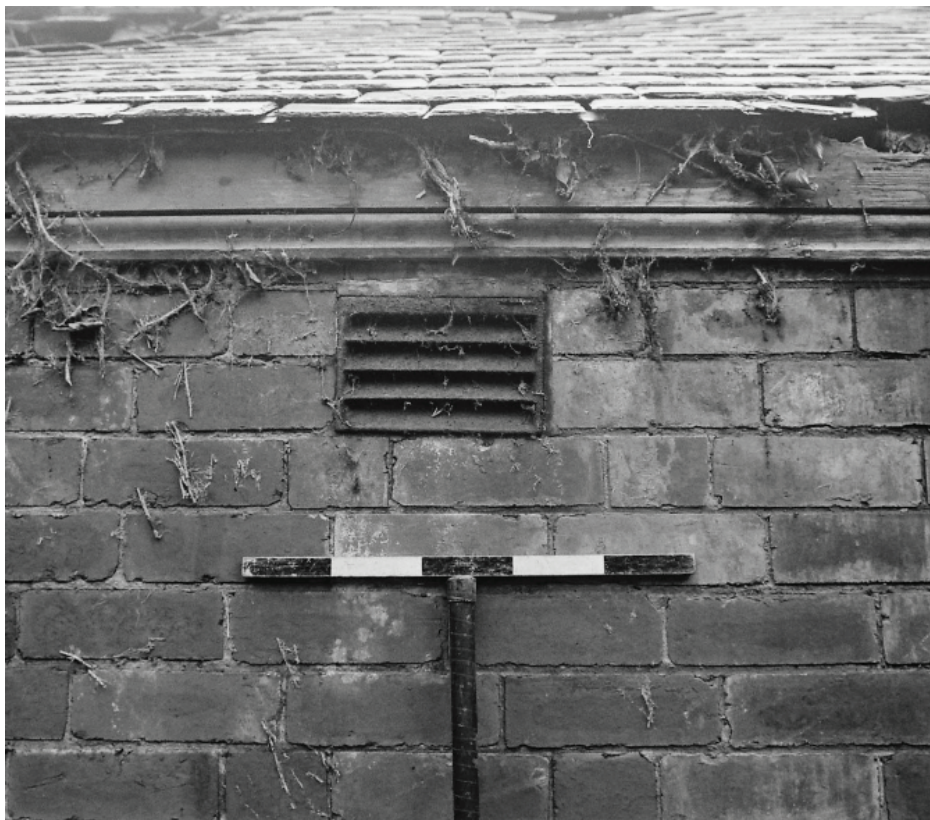
Photograph 16 Film 3_4 Direction NE

Ventilator grille below a section of moulded wooden eaves board in the south-west elevation

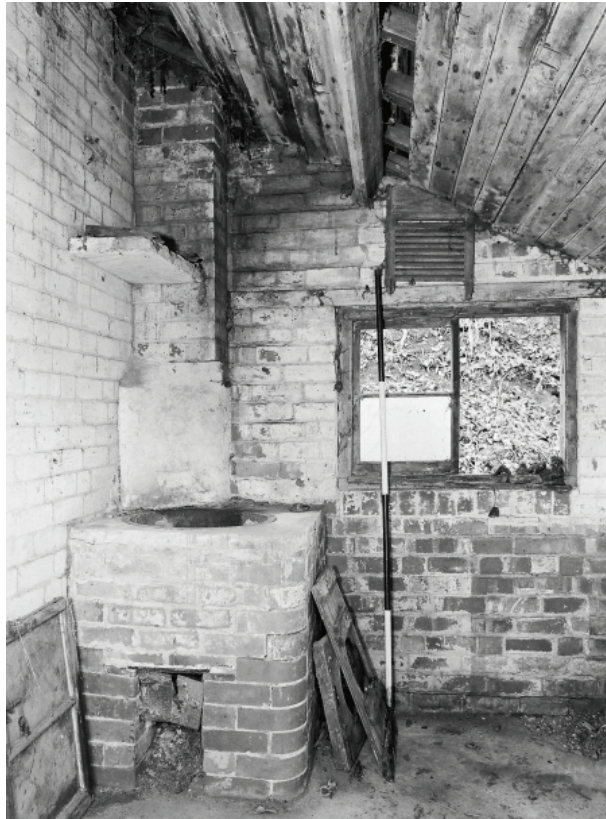
Photograph 17 Film 1_15 Direction SW

Brick fireplace with stone cap into which is set a cast-iron pot. The fire is vented through the chimney stack in the corner

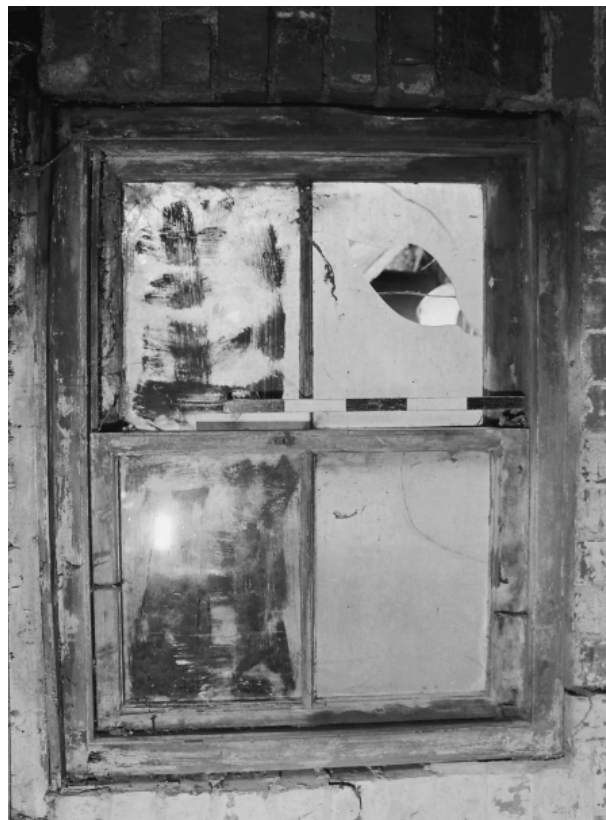
Photograph 18 Film 1_17 Direction NW

Two-over-two vertical sliding sash window in the north-west wall of the washroom

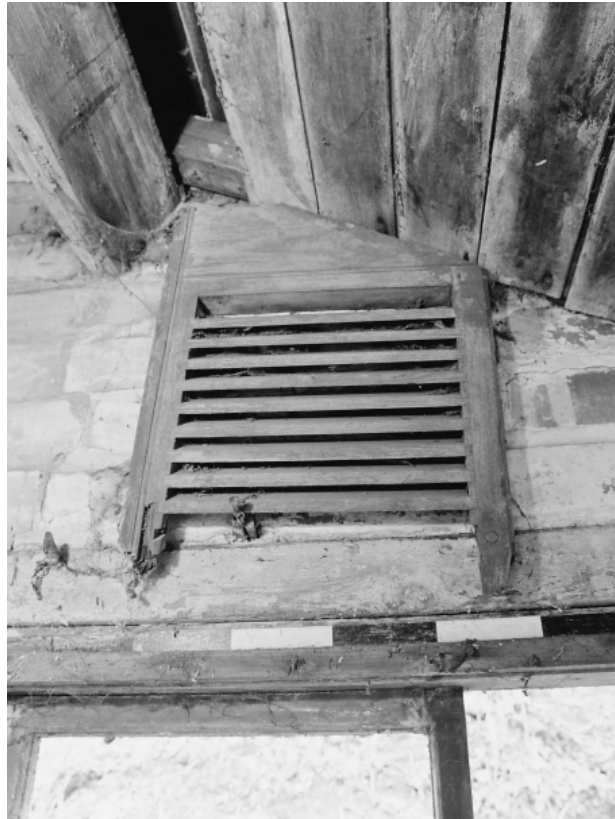
Photograph 19 Film 4_4 Direction SW
Room No:n1

Part of a louvered ventilated wooden frame, which appears to have been cut and attached to the wall to prop the matchboard above

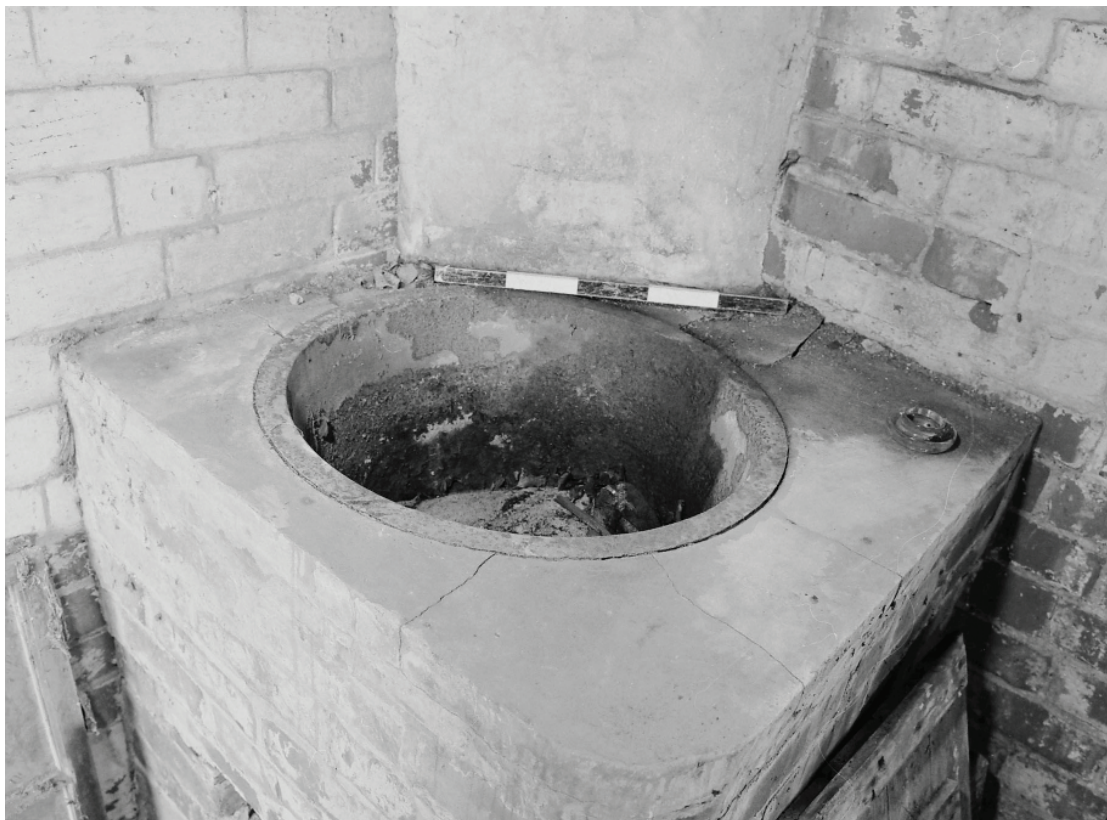
Photograph 20 Film 1_18 Direction SW

Detail showing the cast-iron set-pot in the south corner of the washroom

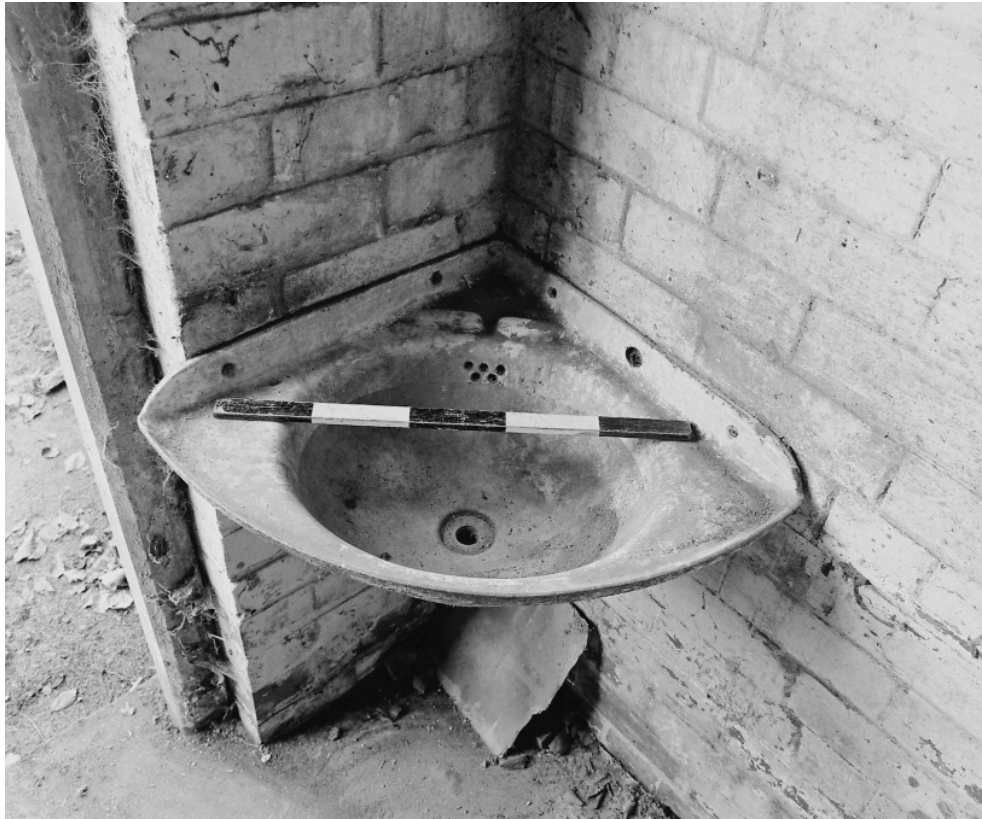
Photograph 21 Film 4_1 Direction E

Enamelled cast-iron sink in the washroom

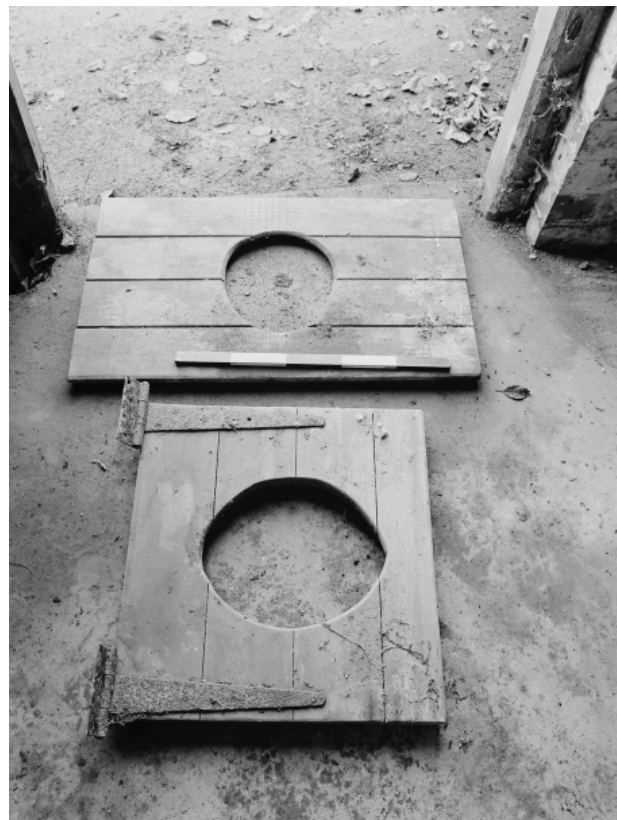
Photograph 22 Film 4_2 Direction NE
Room No:w1

Wooden toilet seat from an earthen closet, also a softwood board with metal strap hinges which has a larger diameter hole. These were found in the washroom during survey but not in situ

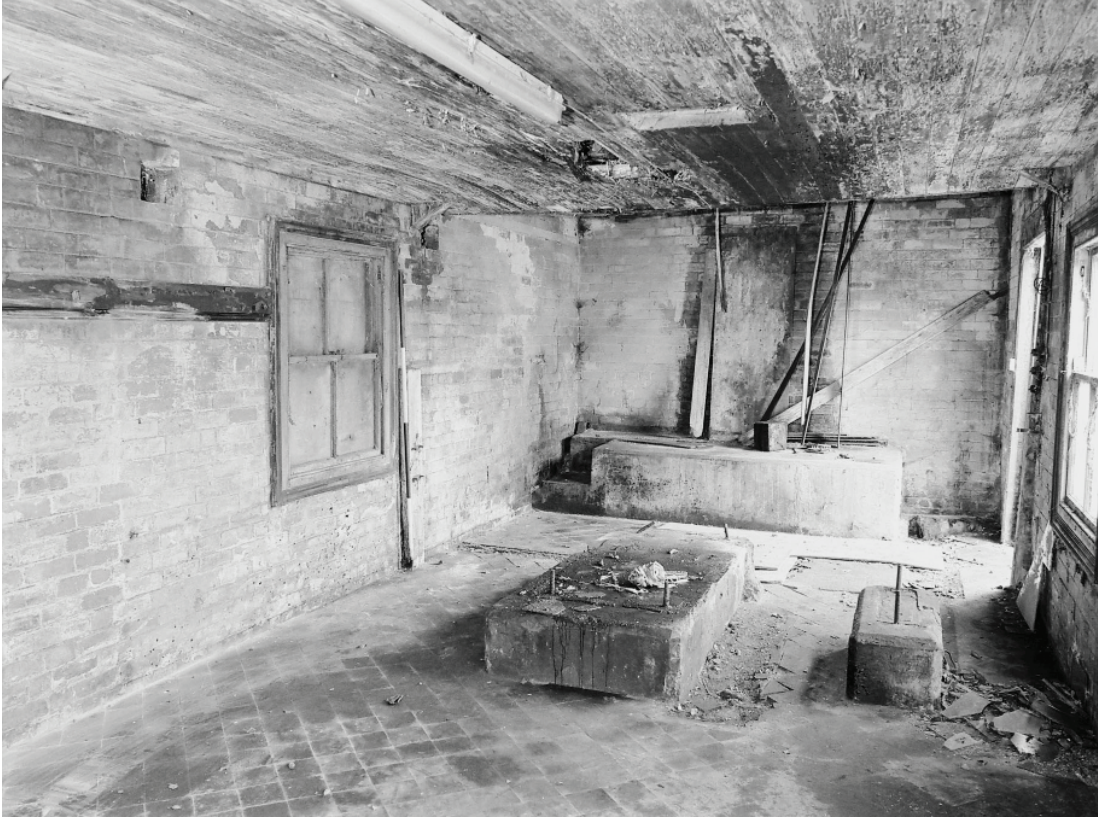
Photograph 23 Film 3_10 Direction NW

General view from the south-east end showing the large concrete block against the north-west wall

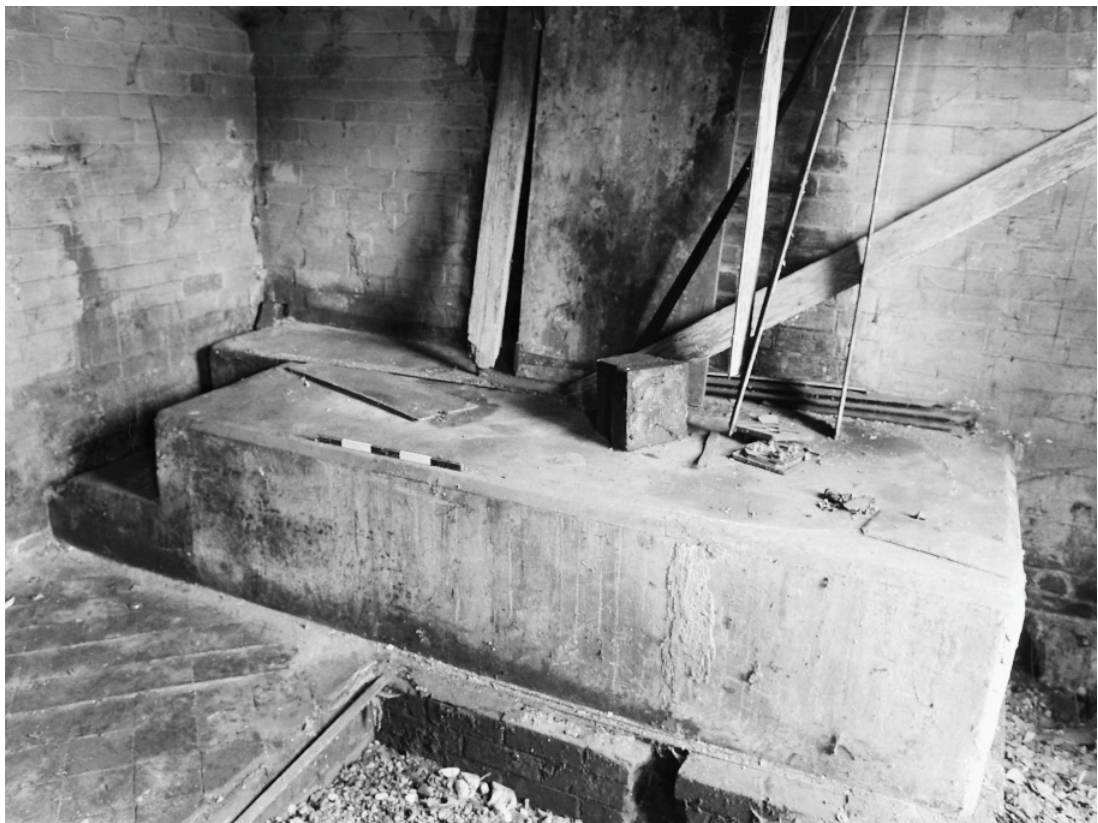
Photograph 24 Film 1_11 Direction NW

Stepped concrete mounting block at the north-west end showing no obvious bolting positions

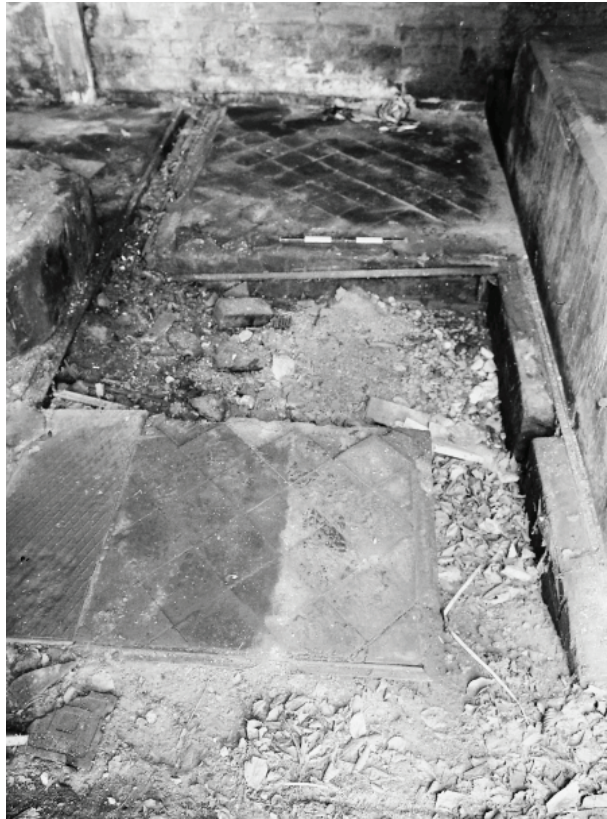
Photograph 25 Film 3_18 Direction SW

Recess in the floor, near the entrance door to the generator room

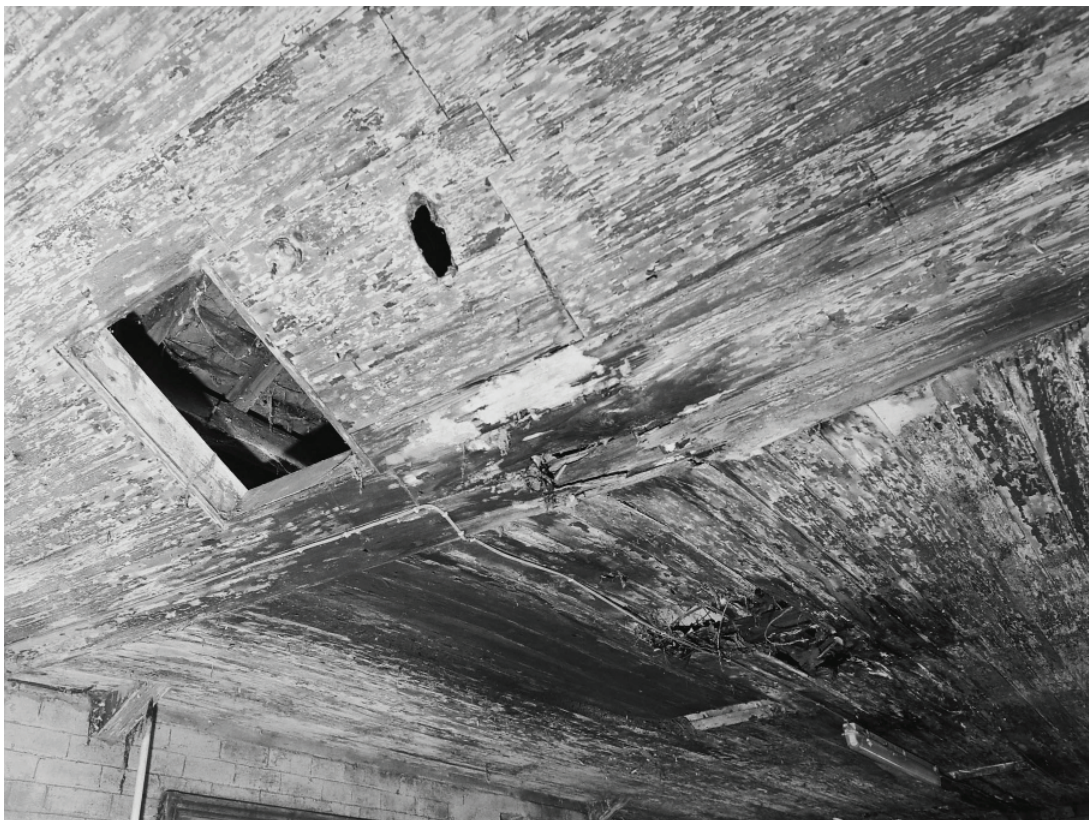
Photograph 26 Film 1_12 Direction NE

The roof over the main generator room is under drawn by softwood matchboarding, this is angled upwards at the north-west end to accommodate machinery mounted on a large concrete block

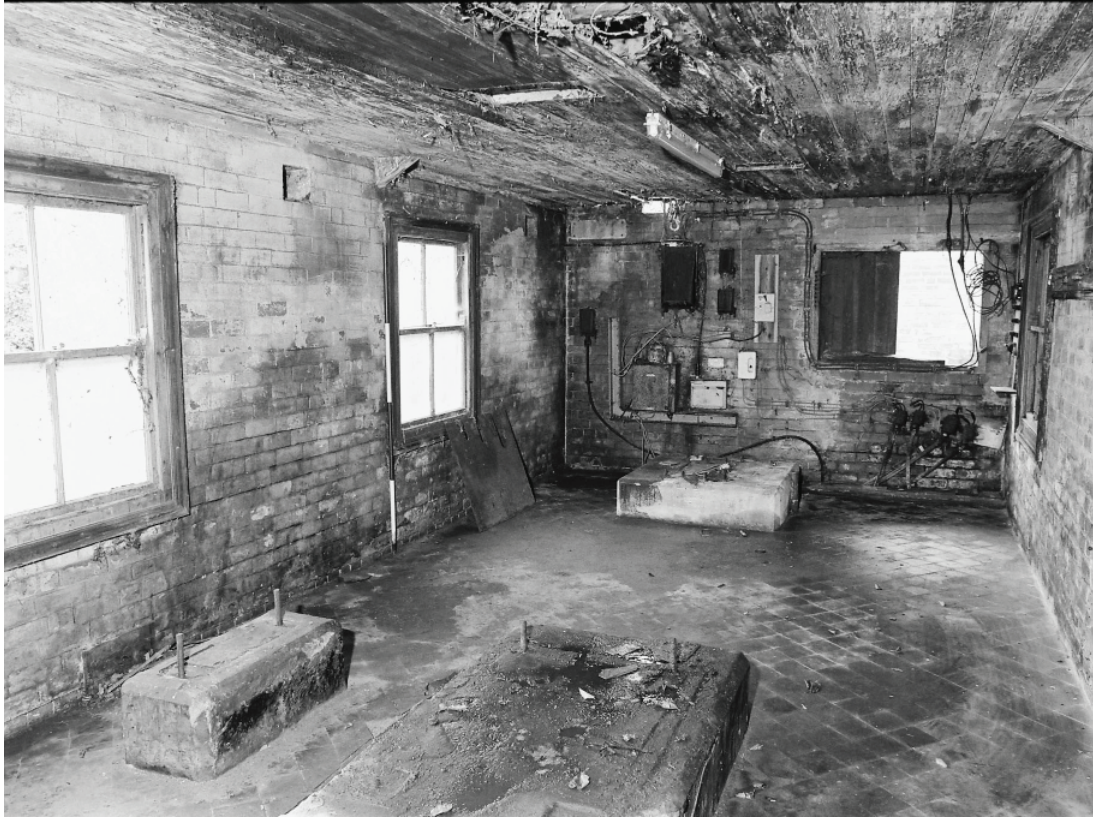
Photograph 27 Film 3_11 Direction SE

General view from the north-west end showing the concrete mounting blocks and the diamond-set ceramic floor covering in the generator room

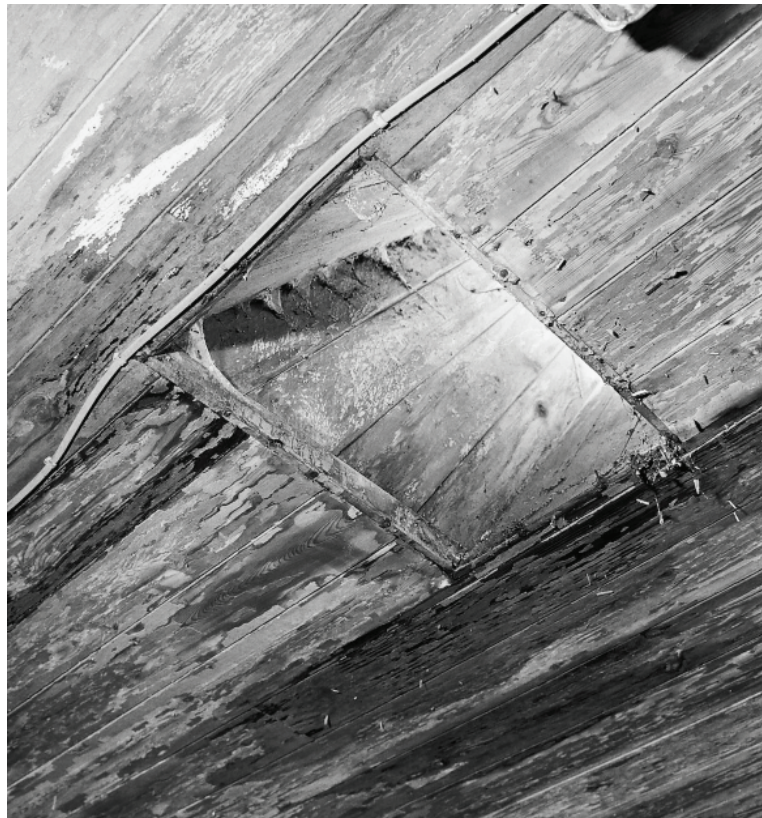
Photograph 28 Film 1_9 Direction SE

Wooden-lined ventilator shaft in the ceiling over the main generator room

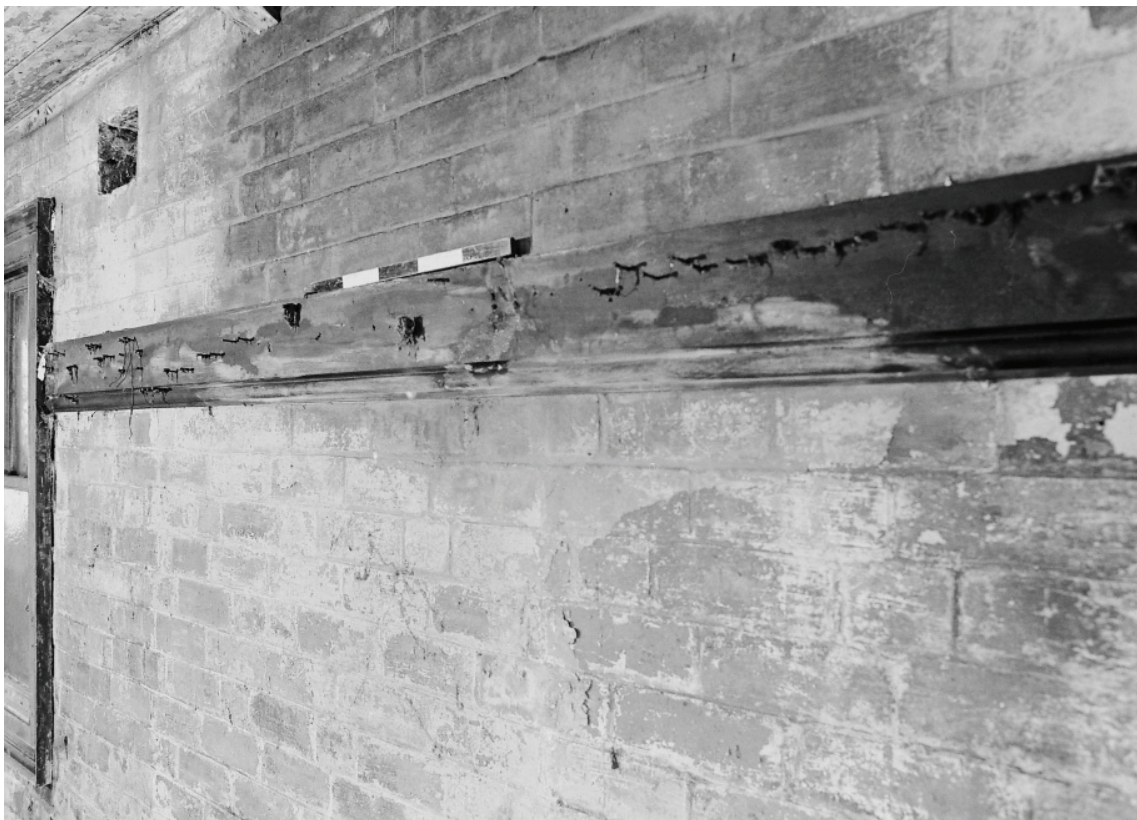
Photograph 30 Film 3_14 Direction S

Wall-mounted, moulded softwood board with nail hangers fixed to the south-west wall
