**Generator House, Brodsworth Hall,
Doncaster, South Yorkshire**

Archaeological Building Recording

Report No. 1948

April 2009

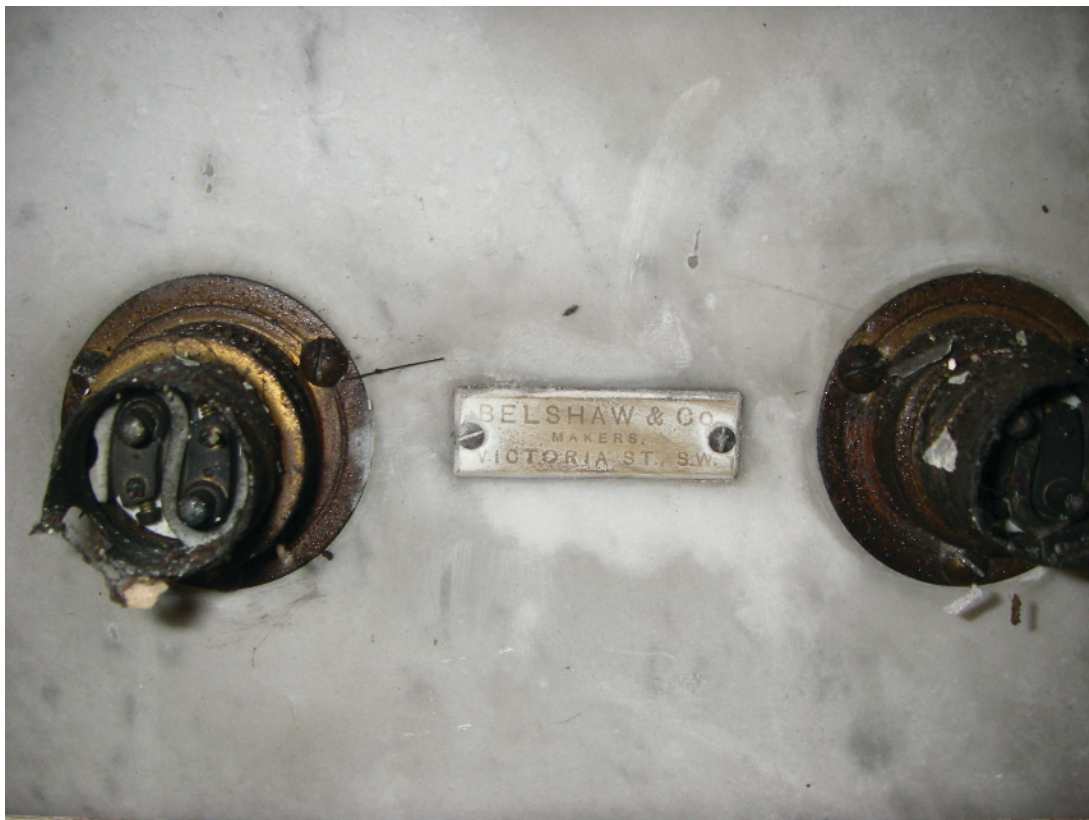
Photograph 32 Film 09D009_3387_0035 Direction SW

Detail of the manufacturer's plate on the switchboard panel

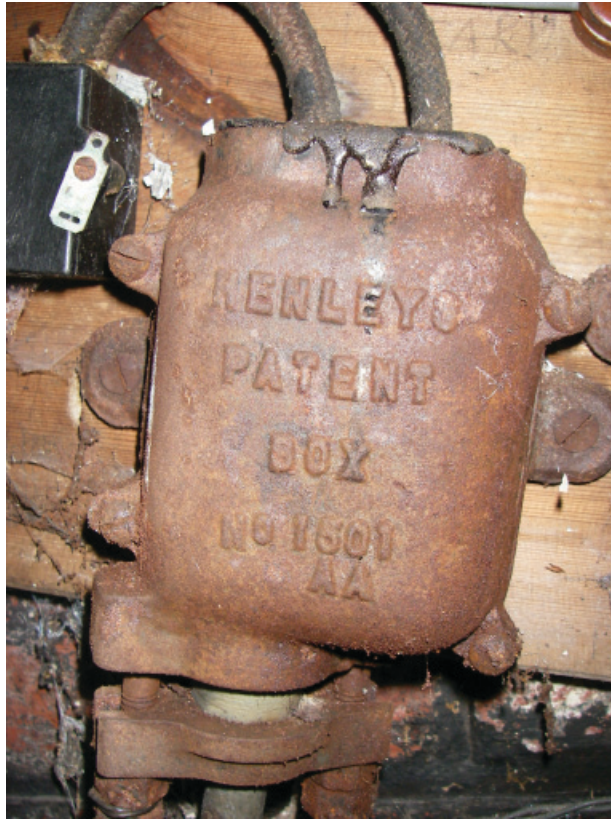
Photograph 35 Film 09D009_3387_0036 Direction SE

Detail of one of the metal boxes with the patent no.1501AA

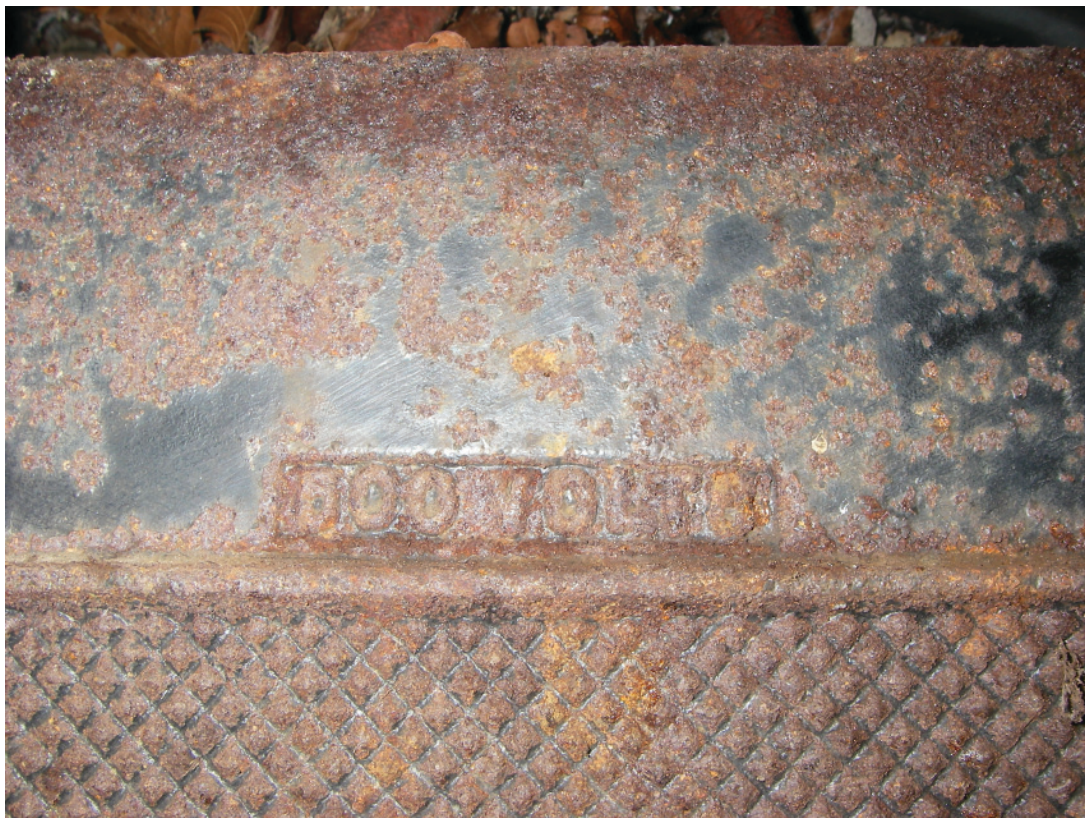
Photograph 39 Film 09D009_3387_0037 Direction SE

Detail of the casting at the top of the wall-mounted transformer box

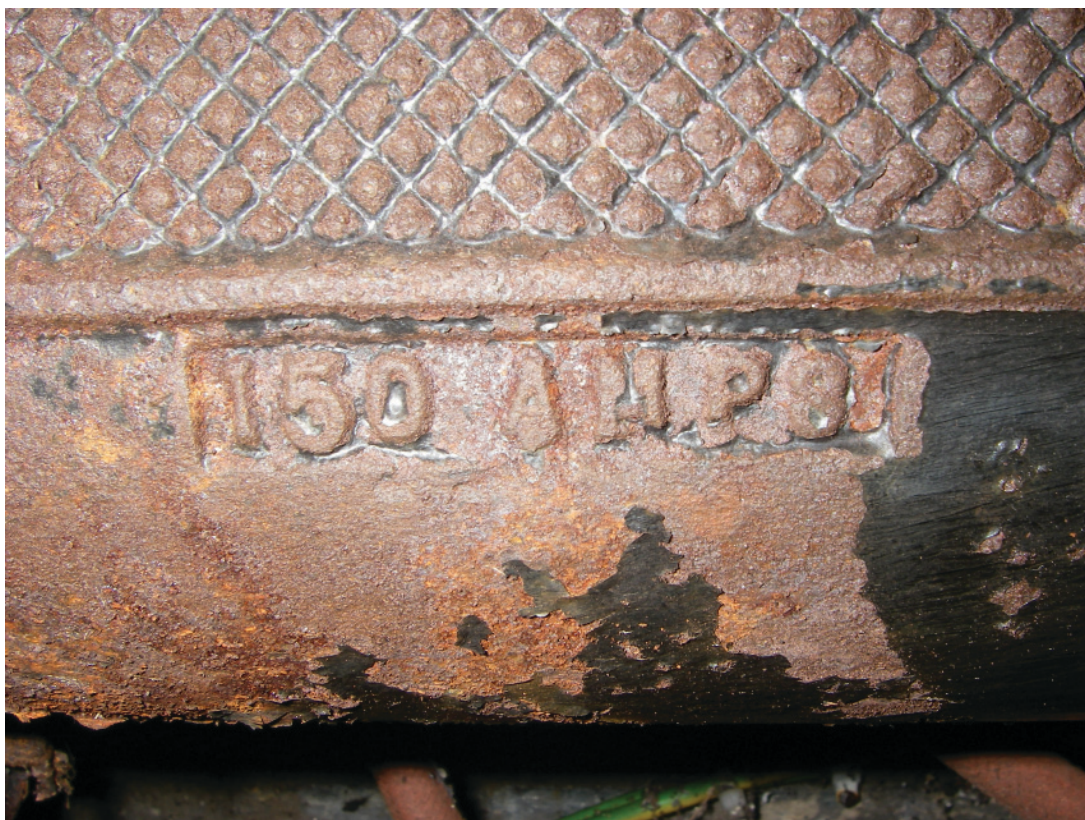
Photograph 40 Film 09D009_3387_0038 Direction SE

Detail of the casting at the bottom of the wall-mounted transformer box

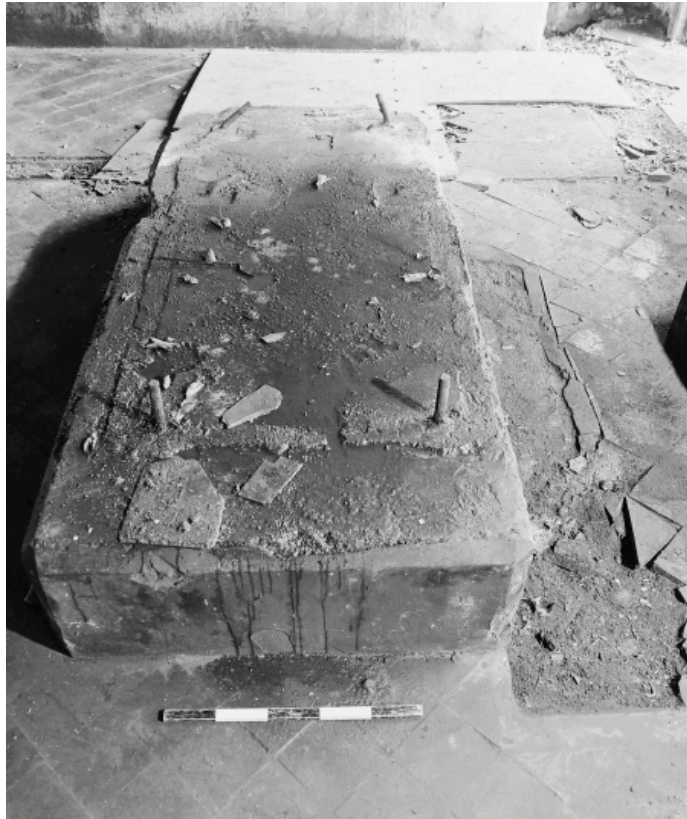
Photograph 41 Film 3_15 Direction NW

Concrete mounting block showing six bolting positions

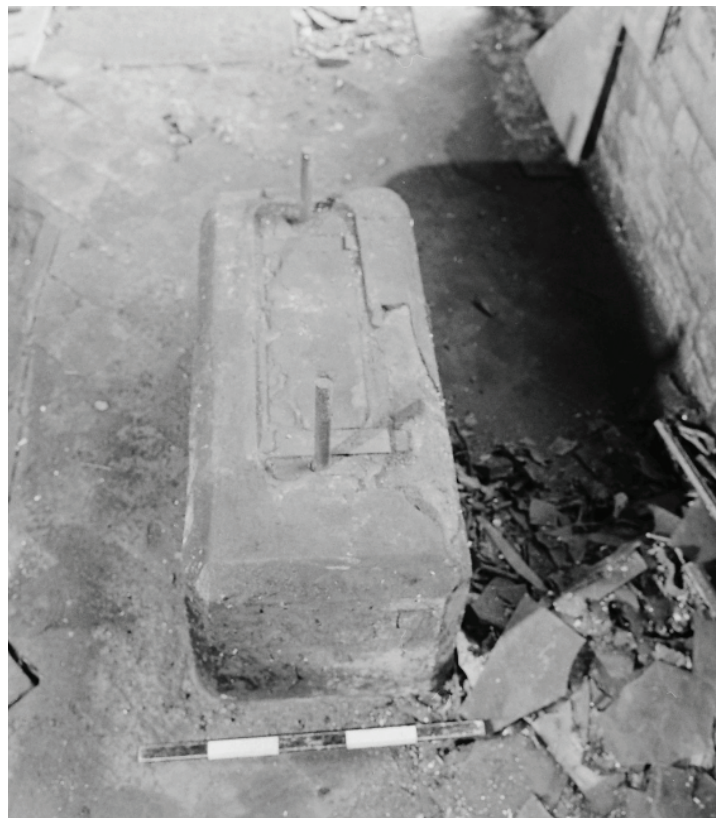
Photograph 42 Film 3_17 Direction NW

Concrete mounting block showing two bolting positions

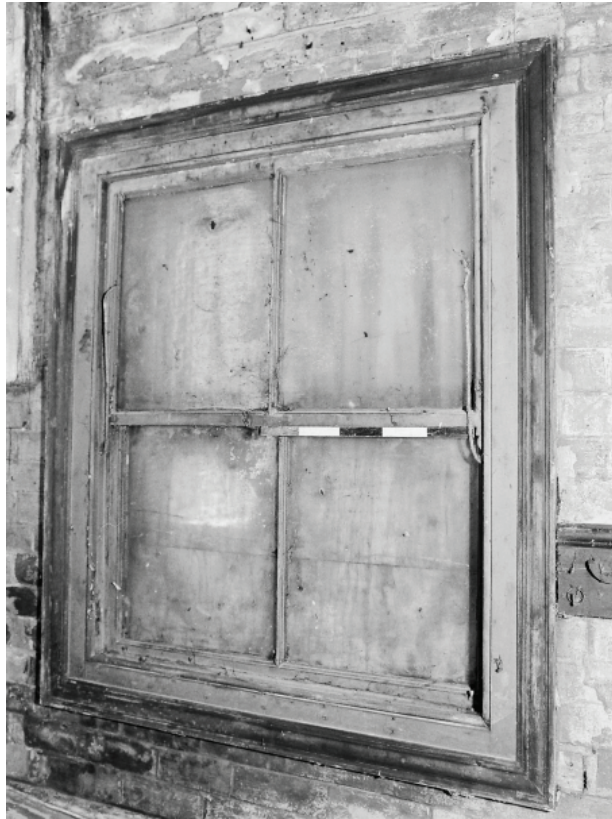
Photograph 43 Film 3_13 Direction W

Two-over-two vertical sliding sash window in the south-west wall

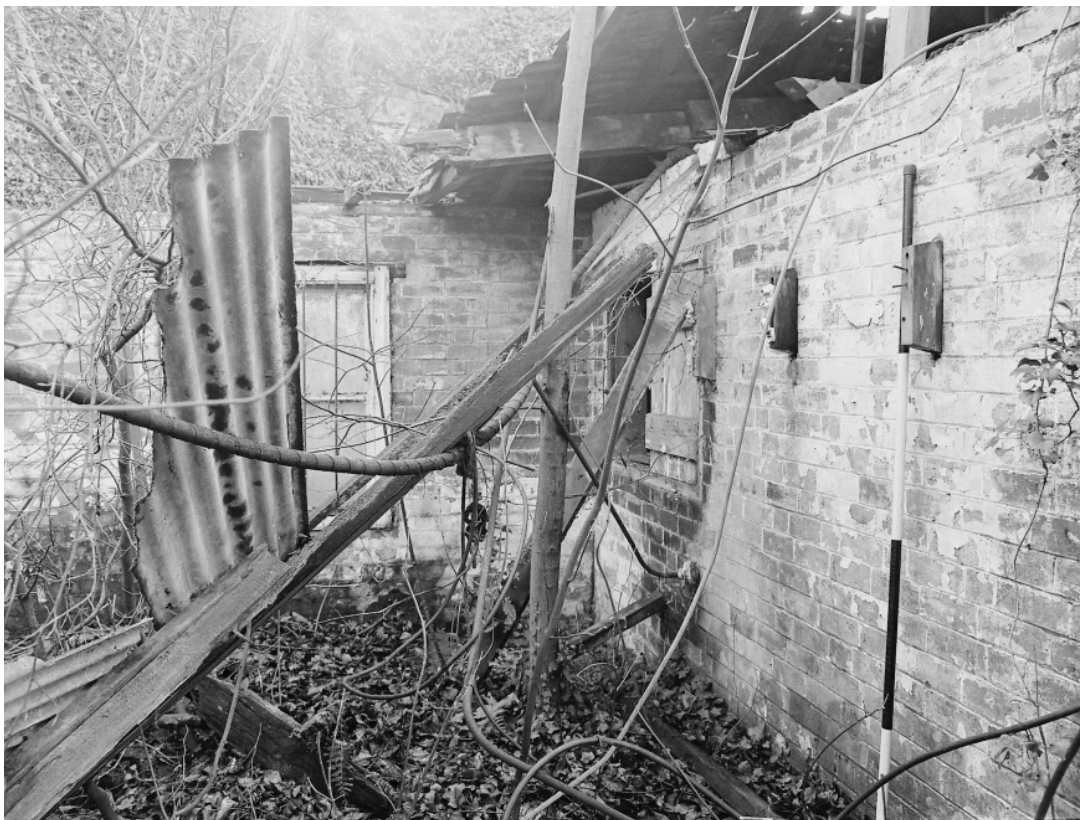
Photograph 44 Film 4_6 Direction W

General view into the room at the south-east end of the building
