**23, Fishergate
York**

Archaeological Monitoring of Geotechnical Boreholes

February 2010

Report No. 2023

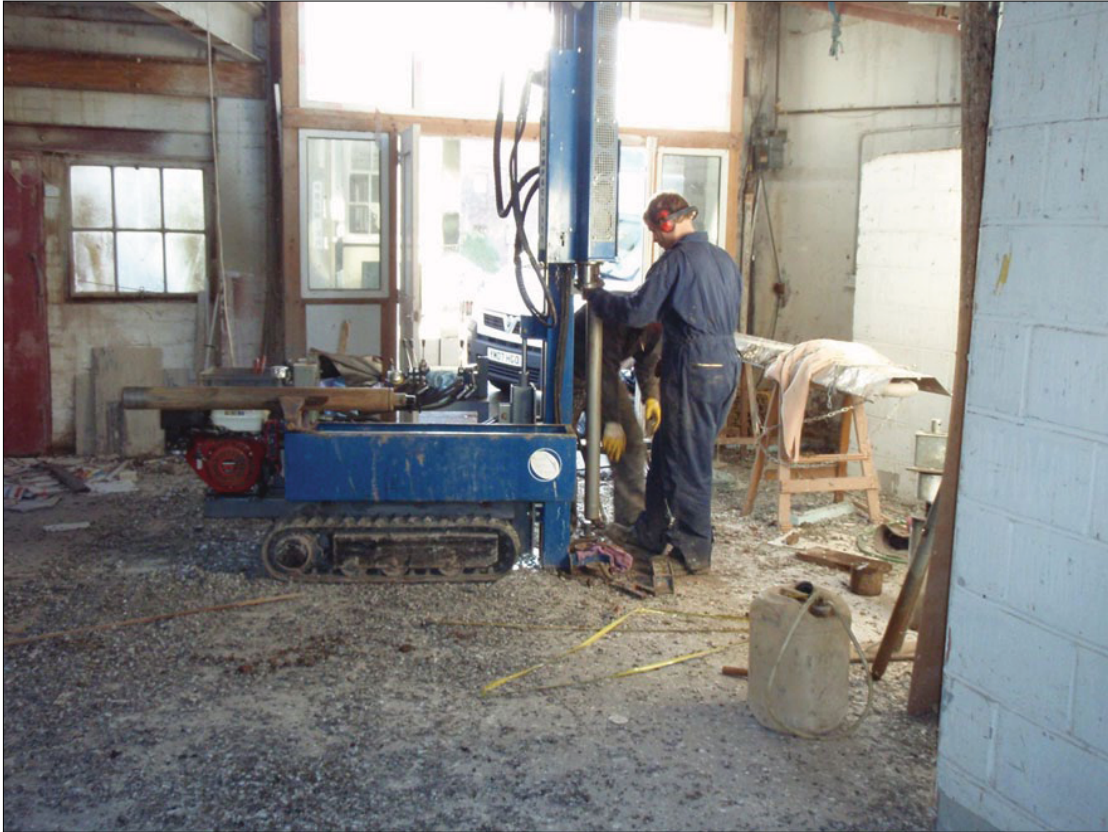
Plate 1: General working shot; drilling BH3

All drilling was carried out using a compact drilling rig (see Plate 1). The location of the boreholes were determined by the Senior Geo-Environmental Engineer from Opus Joynes Pike in consultation with the monitoring archaeologist with the aim of providing a representative sample of the deposits across the full width of the site (see Fig. 2).

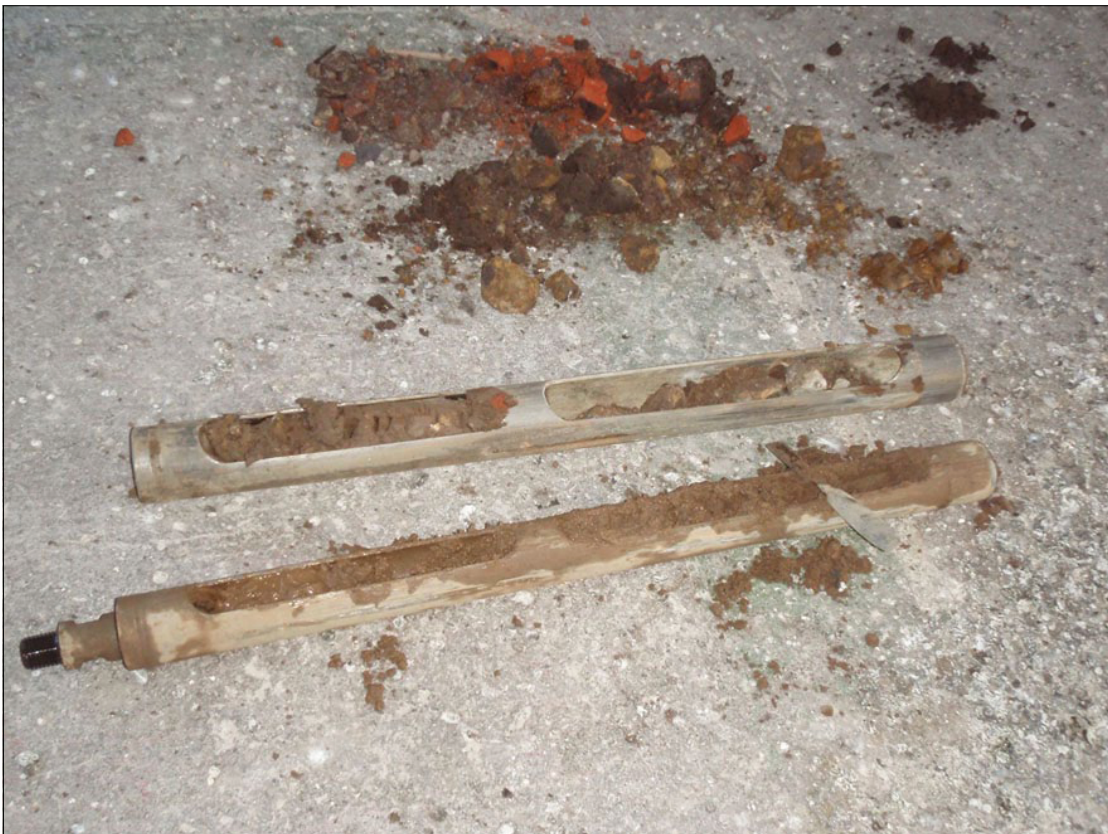
Plate 2: Cores from BH3

Each of the boreholes revealed a similar sequence of deposits (Geotechnical Record sheets BH1-5) although with differing depths of material recorded in each core. Beneath the concrete floor surface (0.25m thick) was a layer of made ground that varied in depth between approximately 1m, in BH1 on the eastern side of the building, and 1.5m in BH3 and BH4 on the western side. This deposit was very black in colour and contained abundant brick fragments. This deposit is interpreted as demolition material or made ground from previous phases of construction. In BH2 and BH4 this made ground deposit could be sub-divided as it contained lenses with less brick inclusions at deeper levels.

Underlying this deposit was a greyish silty clay deposit between 0.2m and 0.85m in depth. This deposit was recorded by the geotechnical survey to be the start of the natural levels but flecks of charcoal were noted in this layer in the cores from BH4 and BH5. This charcoal may have been intrusive and its presence may be as a consequence of the coring method. No archaeological material was recovered, and it was not possible to identify any stratified archaeological remains within this layer. The deposit was, however, noticeably different from

the obviously natural gravel deposit recorded immediately below. This layer was encountered at 1.25m below current ground level in BH1 and 2.5m below current ground level in BH3.
