Hut 34, Thurns Head Quarry, Whitworth

A Photographic Building Survey

By J.M. Trippier Archaeological and Surveying Consultancy

<u>An Archaeological Recording and Monitoring Programme at</u> <u>Hut 34,Thurns Head Quarry, Whitworth, Lancashire</u>

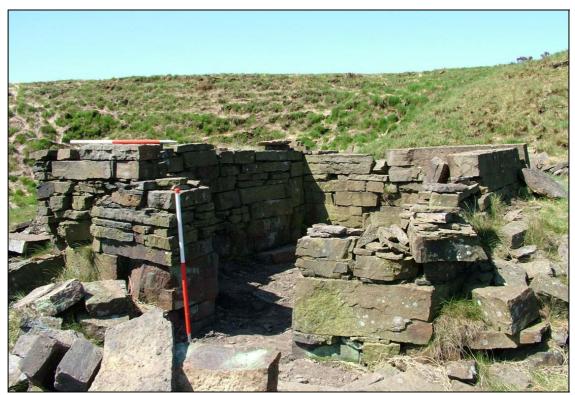
Plate 7: Hut 34 from South East after Clearance

- 6.1 Some further conservation work is required on this structure beyond the clearing away of loose stones and rubble that has already taken place. In particular the south-east corner is largely made up of stone that now lie awry especially in the upper courses. It is recommended that these stones be straightened up and re-laid. On first sight the structure appears to have been of dry stone construction. However this survey revealed that the stonework was probably bonded with clay. It is not unusual for the clay to be used to bed irregular stones and for it to leach away in wet conditions leaving the appearance of dry-stone (Brunskill 1987, 38). It is for consideration whether clay should now be used again in the rebuilding process or whether dry-stone will suffice. The latter would be acceptable archaeologically as it does in fact reflect the leaching that has taken place and is, in any event, a non-intrusive method of reconstruction.
