# 13-15 Great Underbank, Stockport, SK1 1LF

## An Archaeological Building Record

January 2012

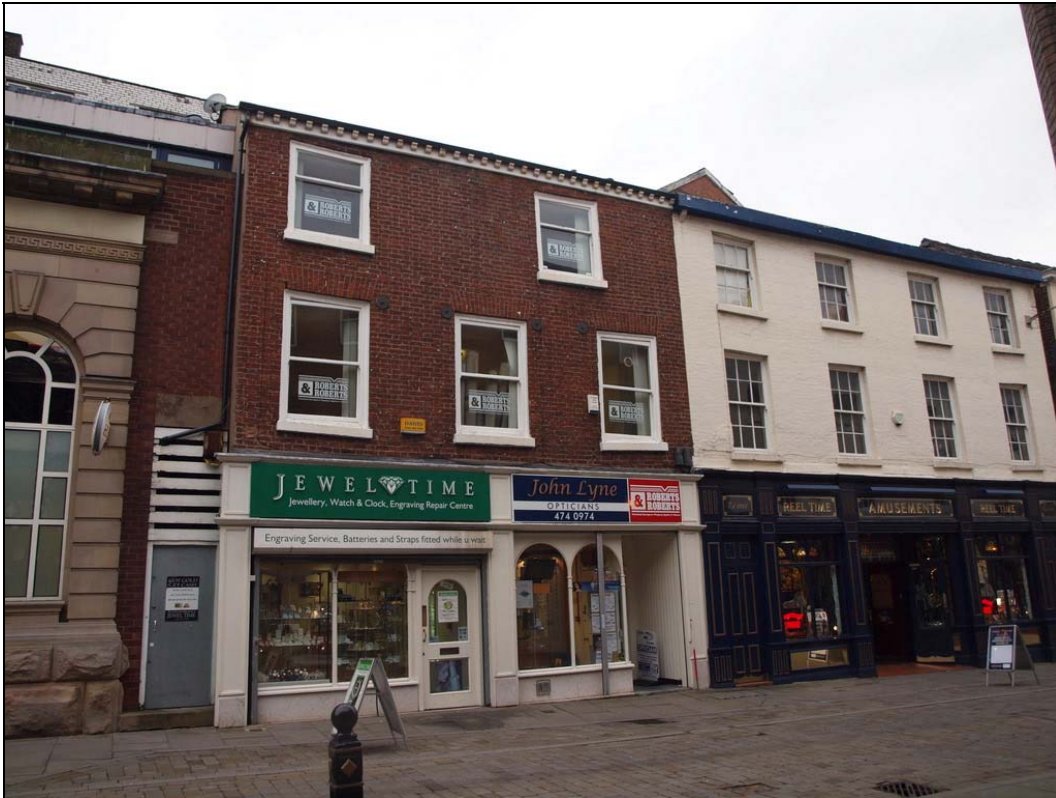
Plate 1: Exterior of property and flanking buildings fronting Great Underbank

7.2 **Western Elevation** (Plate 1). This elevation comprises the front of the building. The ground floor is converted into two shop windows with two separate modern entrances and shop windows. At the southern end is a small porch with a modern door leading directly into a staircase to the first floor. At first floor level the face is wirecut brick in Flemish bond with three large timber framed sash windows, with nibs. The cills are sandstone and the lintels splayed brick soldiers. At second floor level is a matching pair of windows, although without the lintels, and the face continues to be of brick in the Flemish bond.

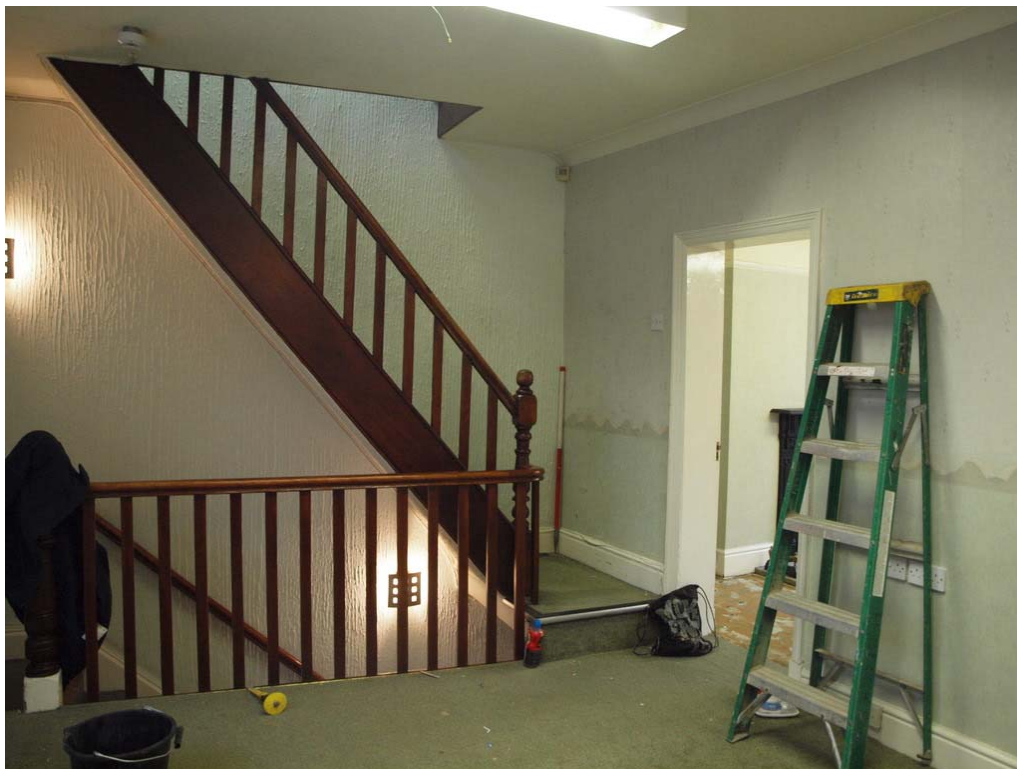
Plate 2: Room 1 looking south towards staircase

7.3 **Room 1** (Plates 2 & 3). The room is accessed via the modern timber staircase which runs up from west to east at the southern end of the room. An identical staircase runs above it giving access to the second floor. Floor is timber and the walls plaster and paper over brick, with the exception of the northern wall which is a modern stud insertion. The ceiling is plastered. Two large square windows lie in the east wall each fitted with a timber frame of 6 lights. The northern stud wall overlaps the northern window. A personnel doorway in the west end of the north wall leads into room 3 and a similar doorway in the south end of the west wall leads into room 2. Both have moulded timber surrounds and are hung with a modern timber doors.

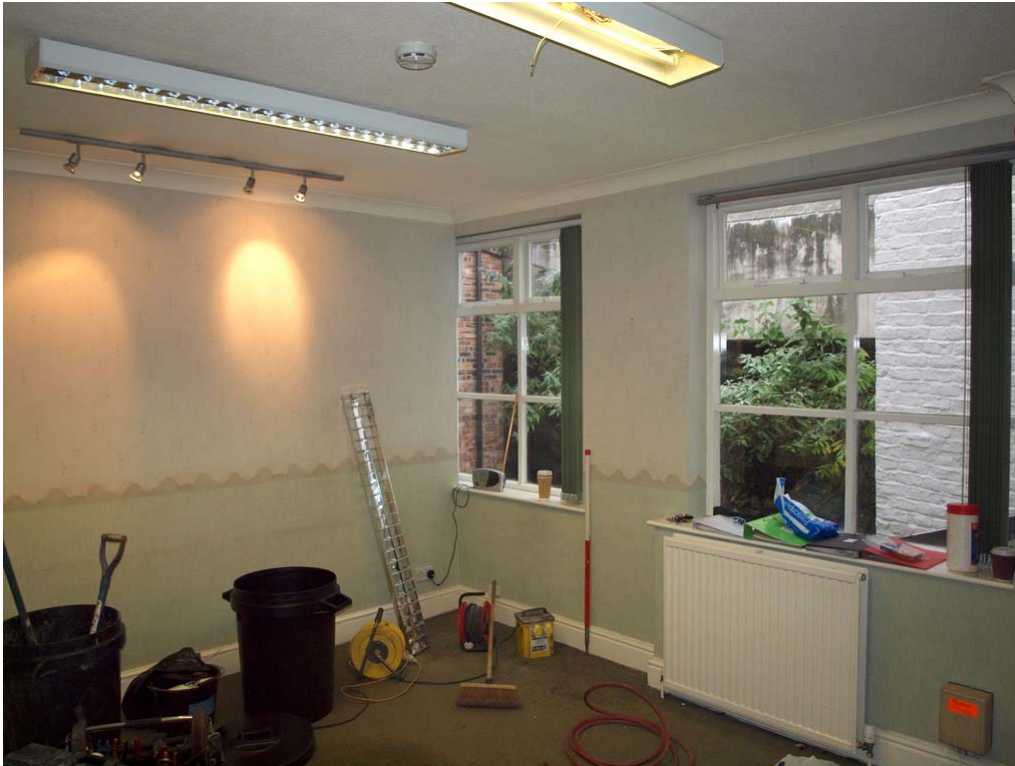
Plate 3: Room 1 looking north-east towards rear of property

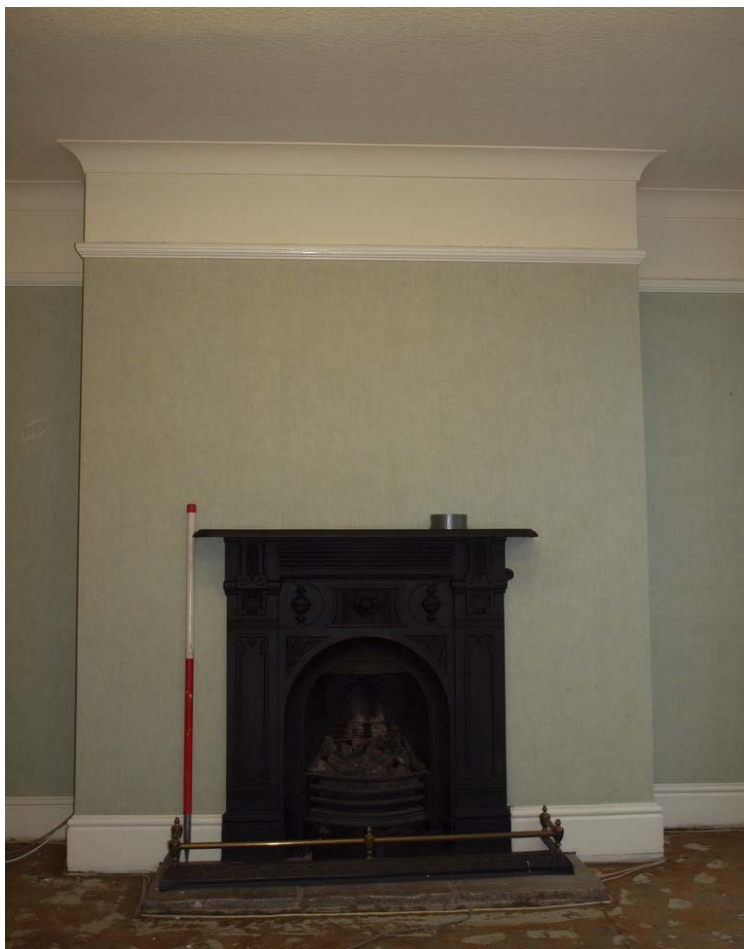
Plate 5: Detail of fireplace in Room 2

- 7.4 **Room 2** (Plates 4 - 7). This room is accessed via a personnel doorway in the southern end of the east wall. The room has both a moulded timber picture rail and skirting running around the room (Plate 7), as well as a plaster cornice. Three large portrait windows line the west wall, each fitted with timber sash frames, with nibs. In the centre of the south wall is a chimney breast with a carved timber fireplace. The floor is timber and the walls are plaster over brick. A personnel doorway in the north end of the east wall leads into room 3. This has a moulded timber surround and a modern door.

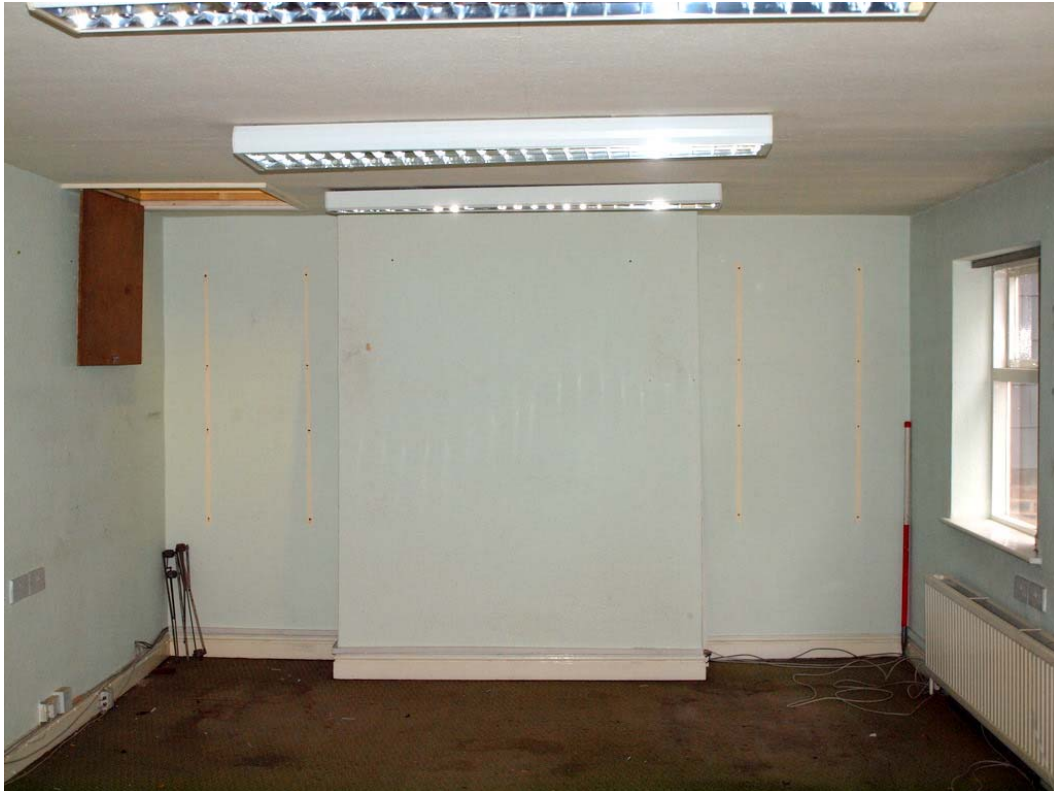
Plate 9: Chimney breast in room 4 looking north-east

- 7.6 **Room 4** (Plates 9 & 10). The room is accessed from room 1 via the modern timber staircase running from west to east at the southern end of the room. The walls are paper and plaster over brick, the ceiling plastered and the floor is timber. A moulded timber skirting runs around the room. A chimney breast lies in the centre of the north wall. Three timber framed portrait windows lie along the east wall. Two doorways lie in the western wall, either side of centre. Both have moulded timber surrounds and are hung with modern timber doors. A small hatch is located in the ceiling towards the northwest corner, giving access to the attic (Plate 9)

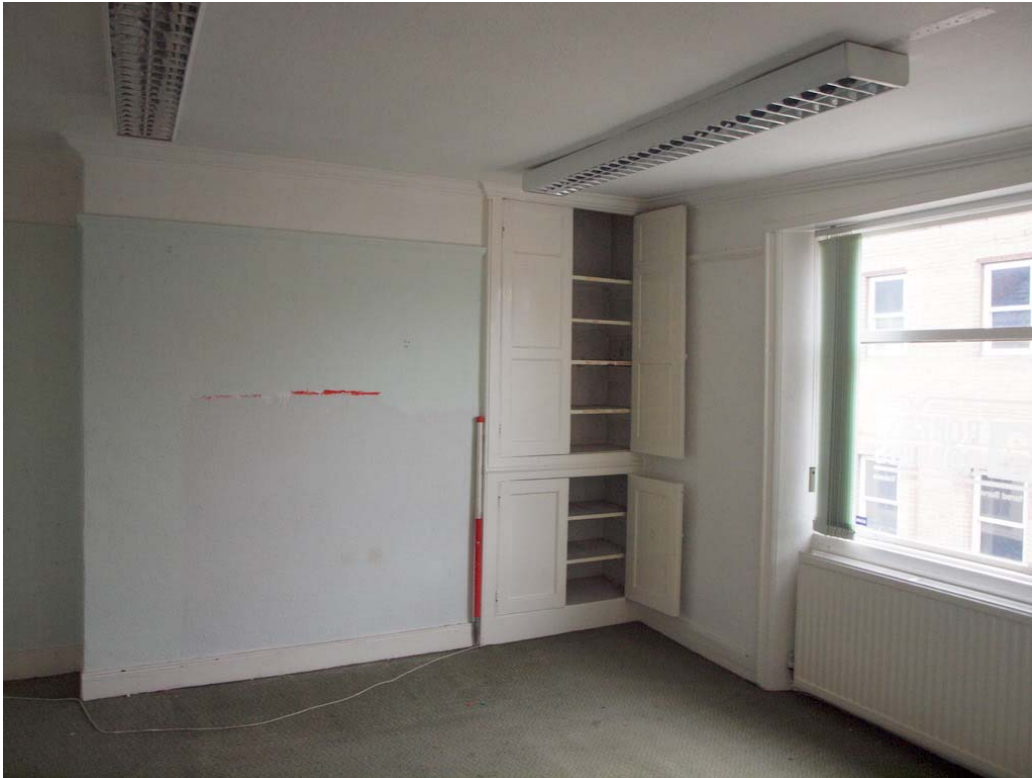
Plate 11: Room 5 looking south towards chimney breast and cupboard

- 7.7 **Room 5** (Plates 11 – 13). The room is accessed via the doorway at the north end of the east wall from room 4. The floor is timber and the walls paper and plaster over brick, with the exception of the northern stud wall. The ceiling is plastered. A chimney breast lies in the south wall with a cupboard built onto the western side. This was hung with timber panelled doors and timber shelves (Plate 12). The room has a moulded timber skirting, picture rail and cornice running around the room (Plates 14 & 15). A large timber framed sash window lies in the centre of the west wall. A doorway at the east end of the north wall leads through to room 6.

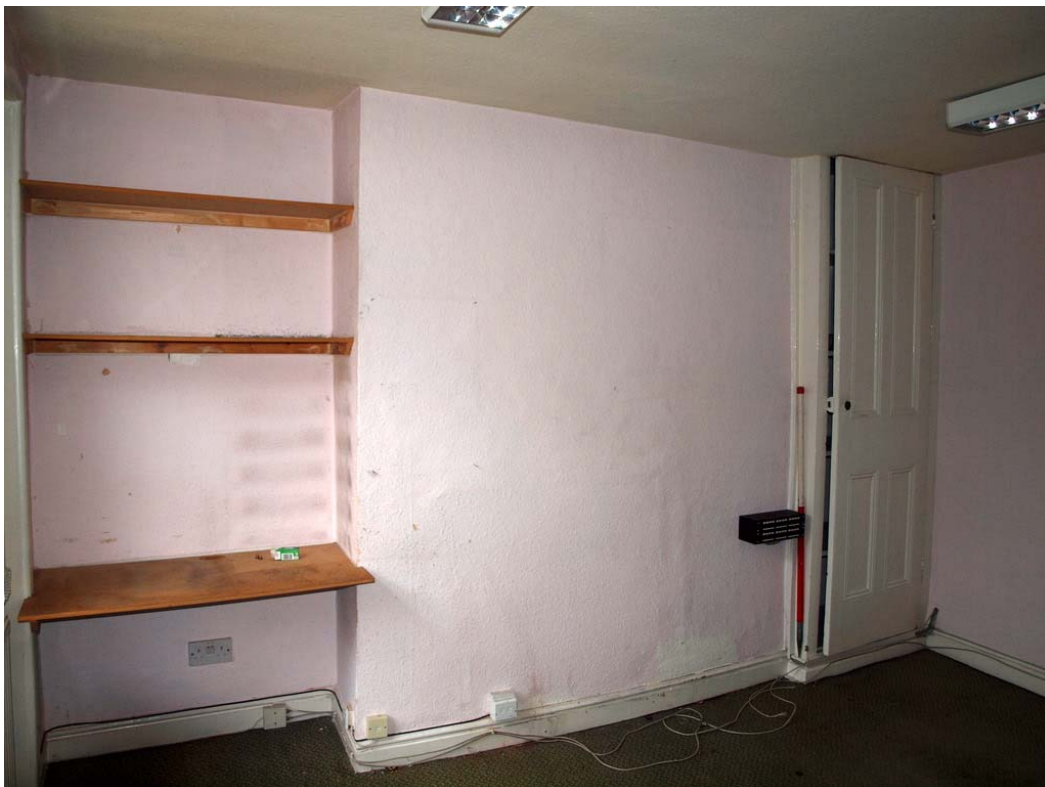
Plate 16: Room 6 looking north-east towards chimney breast and cupboard

- 7.8 **Room 6** (Plates 16 – 18). The room is accessed from room 5 via a personnel doorway in the east end of the south wall and from room 4 via a personnel doorway at the south end of the west wall, Both doorways are hung with panelled doors. The floor is timber, the ceiling plastered and the walls paper and plaster over brick, with the exception of the southern stud wall. A large timber framed sash window lies at the north end of the west wall (Plate 19). As with all of the sash windows the jambs reach the floor and are chamfered, with timber panelling. A chimney breast lies in the centre of the north wall with a built in cupboard to the east. This has a timber panelled door and timber shelves inside. Shelves have also been fitted to the western side of the chimney breast.

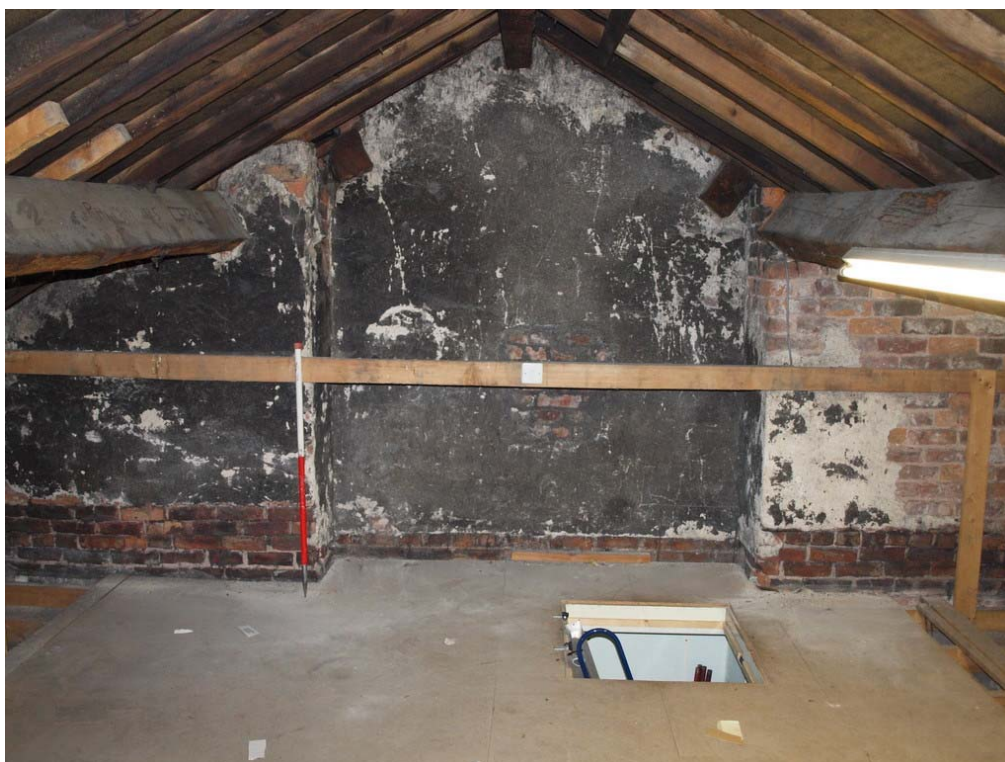
Plate 20: Attic looking north east showing chimney breasts to be removed

- 7.10 (Plates 20 - 23). The room is accessed from room 4 via a hatch in the floor at the northern end of the attic. The roof is supported by machine cut timber truss in the centre of the roof space running east – west. The northern half of the attic has been boarded, but the southern end is open to the timber joists. The walls of the northern and southern gables have been rendered, as have the chimney breasts. There are four chimney breasts in total, two in the north wall and two in the south.

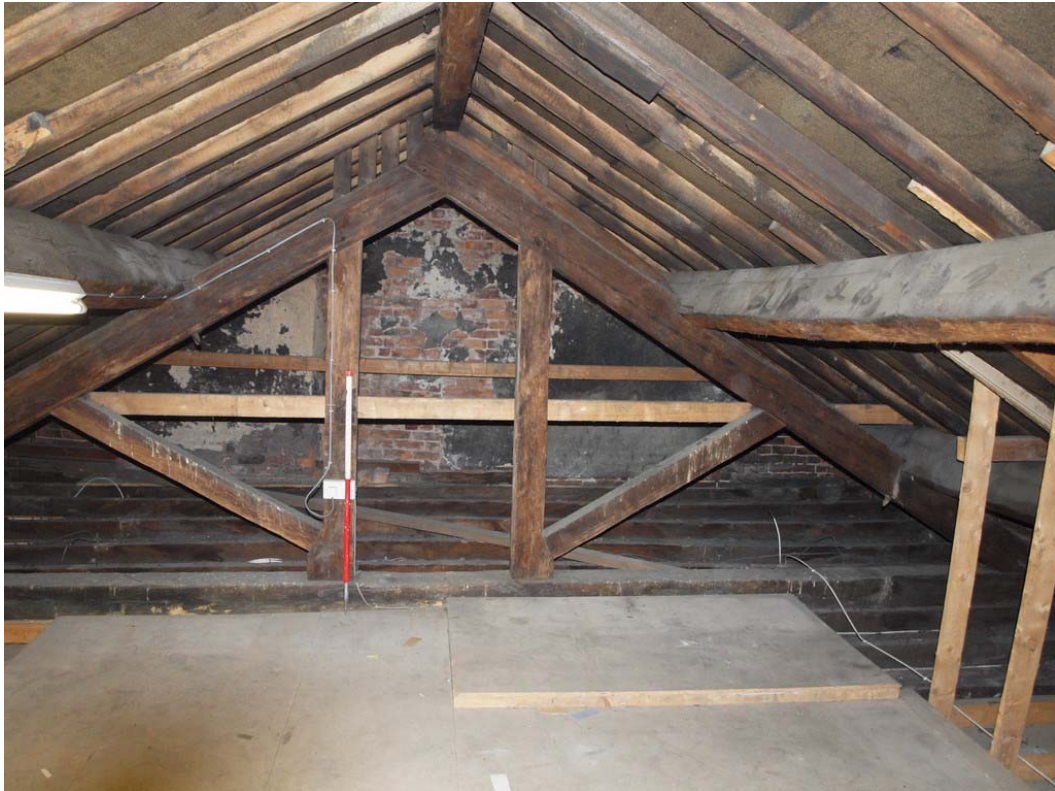
Plate 23: Southern end of attic showing roof truss

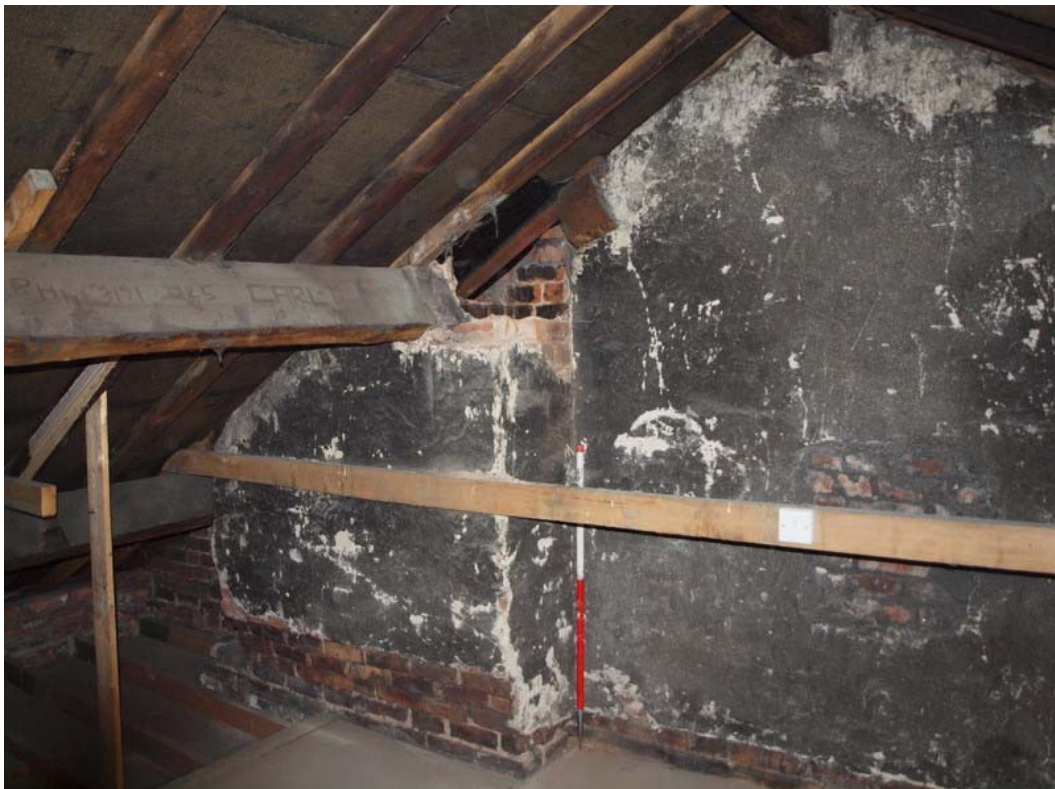
Plate 24: Western chimney breast showing it supporting purlin

- 8.1 The chimney breasts were successfully removed from the attic and second floors. Those in the attic were found to support the modern timber purlins (Plates 24 & 25). This caused work to halt as metal shoes had to be manufactured to hold and support the purlins before the chimney breasts could be removed further. Removal showed 4 separate vertical flues in each chimney (Plates 26 – 28).

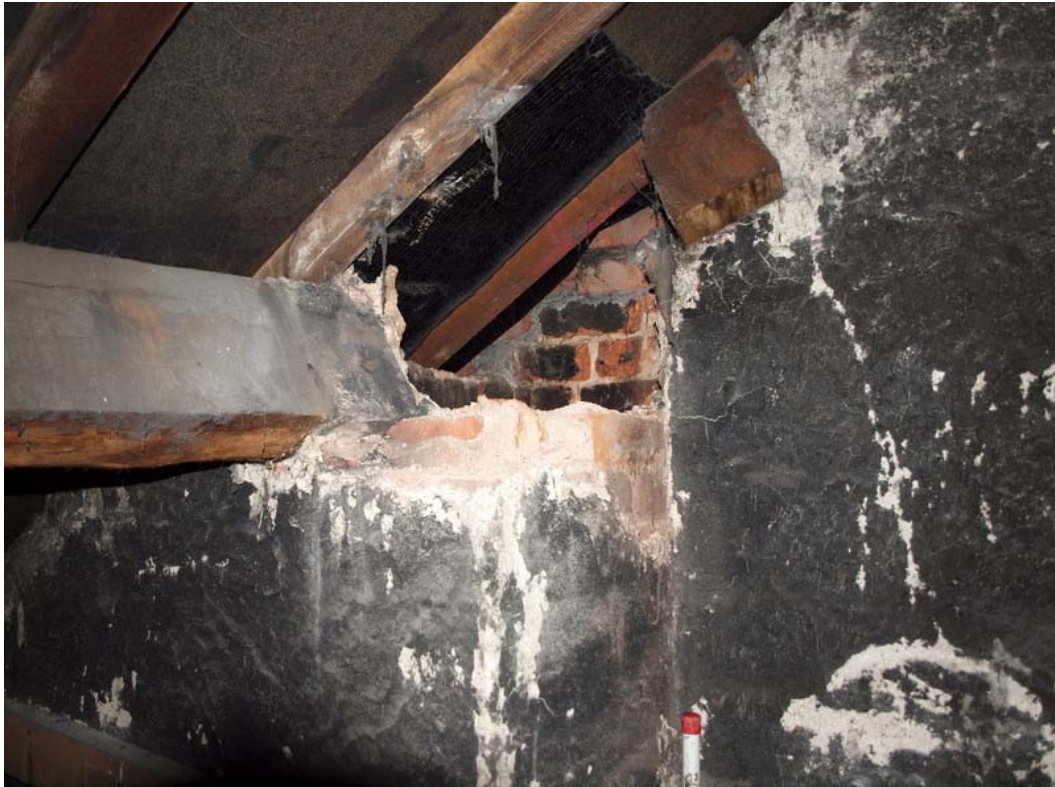
Plate 25: Detail of western chimney breast showing it supporting purlin

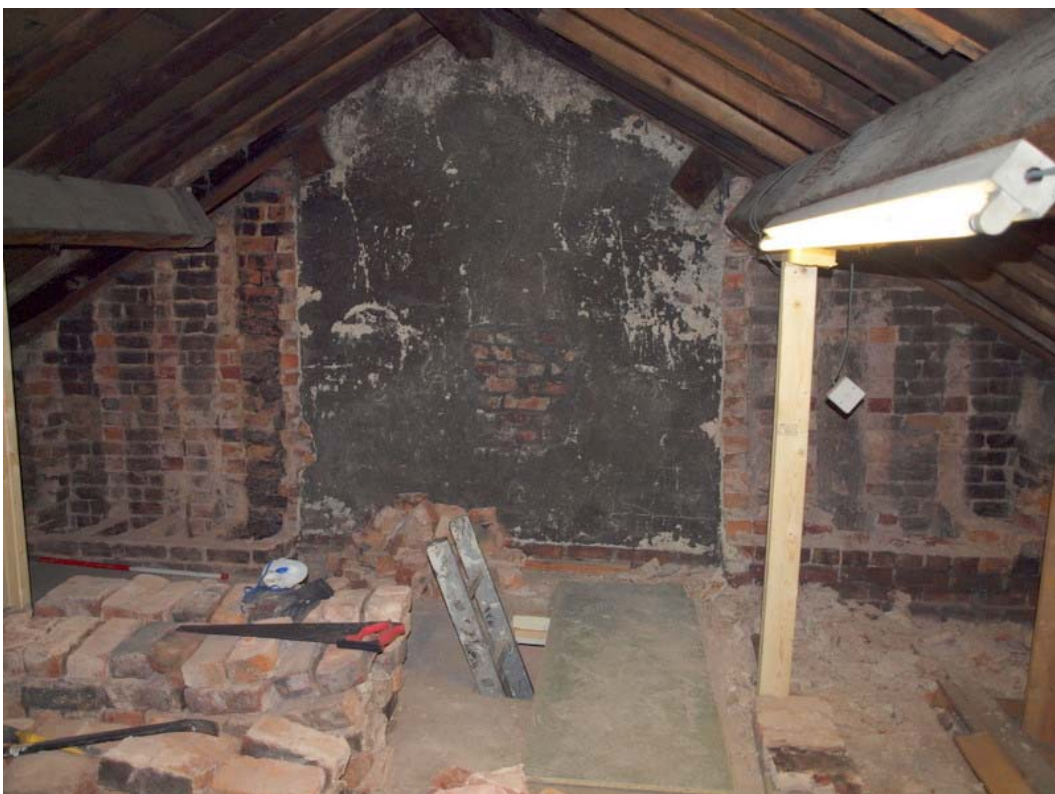
Plate 26: Attic after removal of both chimney breasts

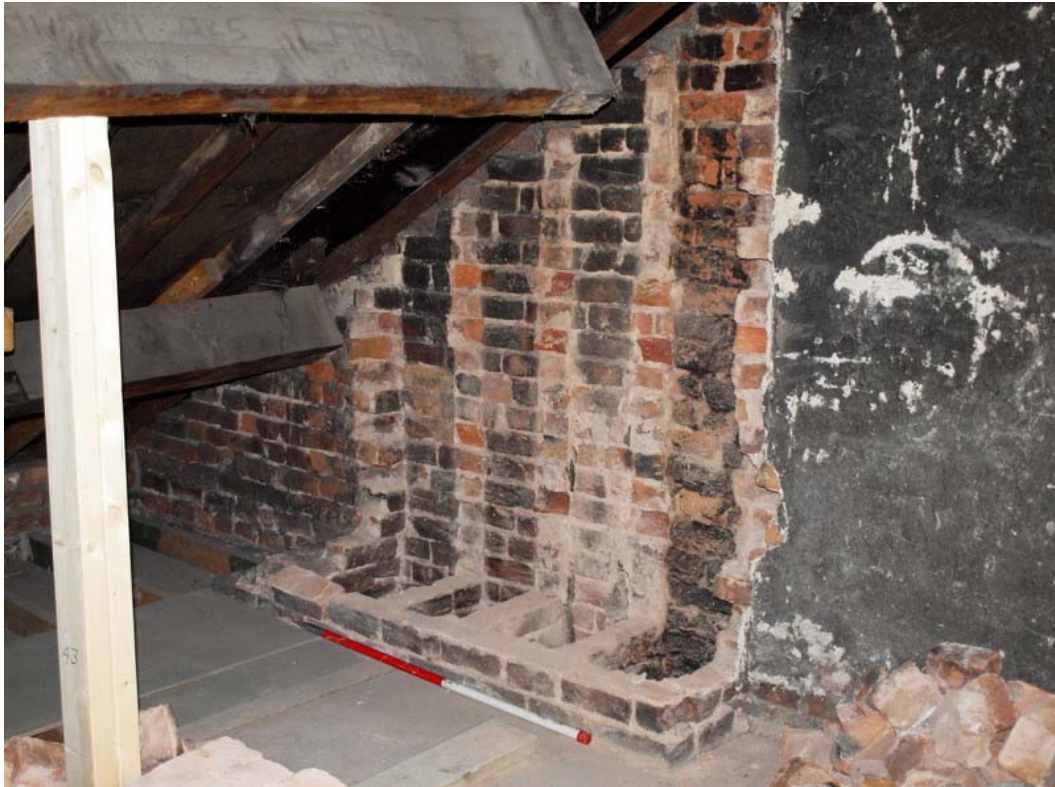
Plate 27: Western chimney breast after removal

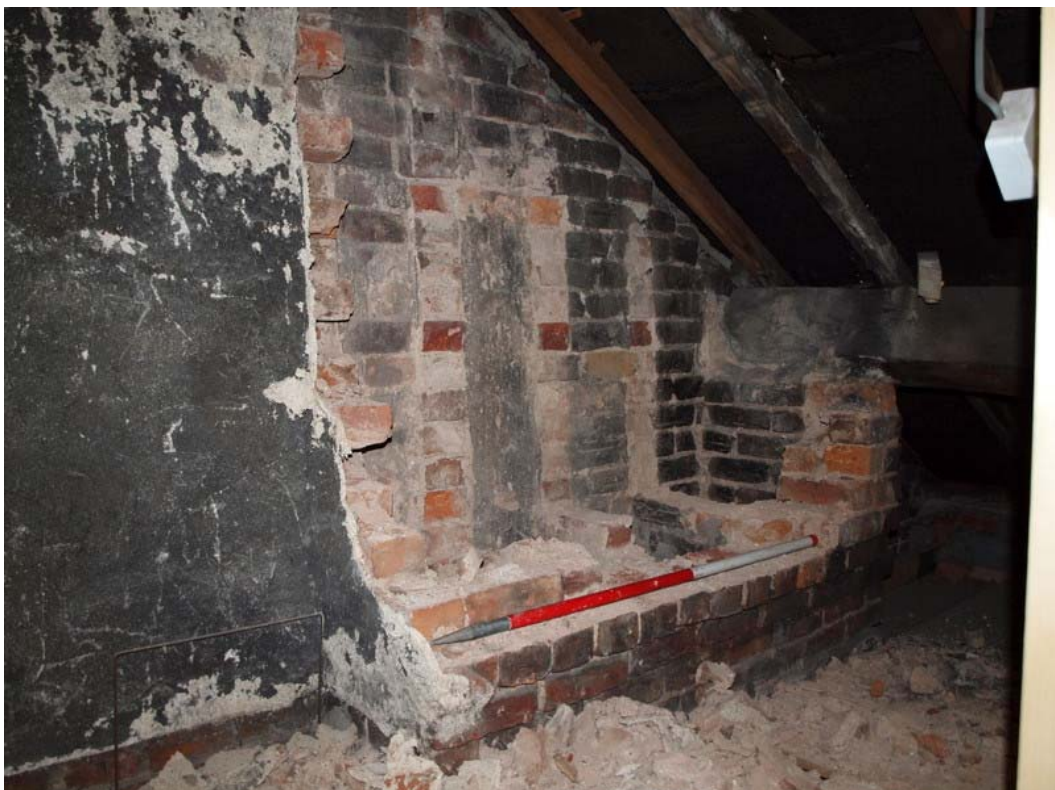
Plate 28: Eastern chimney breast after removal

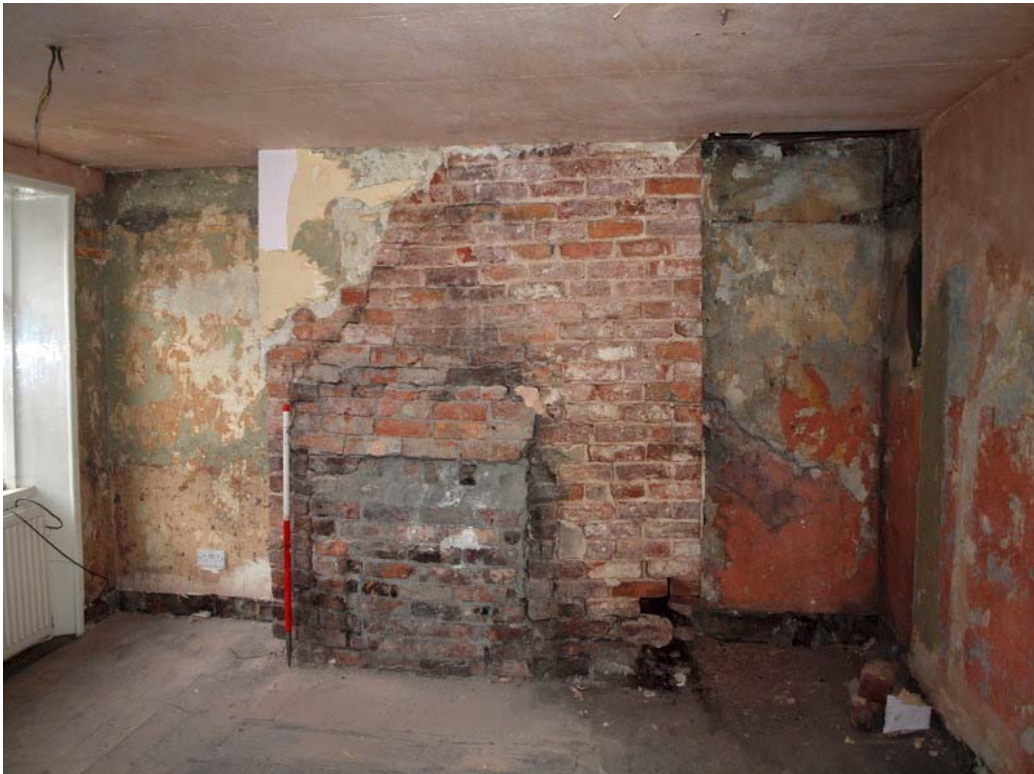
Plate 29: Chimney breast in room 6 after uncovering blocked fireplace

- 8.2 The western chimney breast, at second floor level, appeared to be bulging slightly once stripped back to the brick. This also revealed a blocked fireplace in the western side (Plate 29). During the demolition of this breast it collapsed under the internal weight of a large amount of brick rubble (Plate 30). Further, a cast iron pipe was found in the eastern side of the chimney breast (Plate 31). The four flues were vertical on the eastern side with the two to the west curving upwards to the east (Plates 32 & 33).

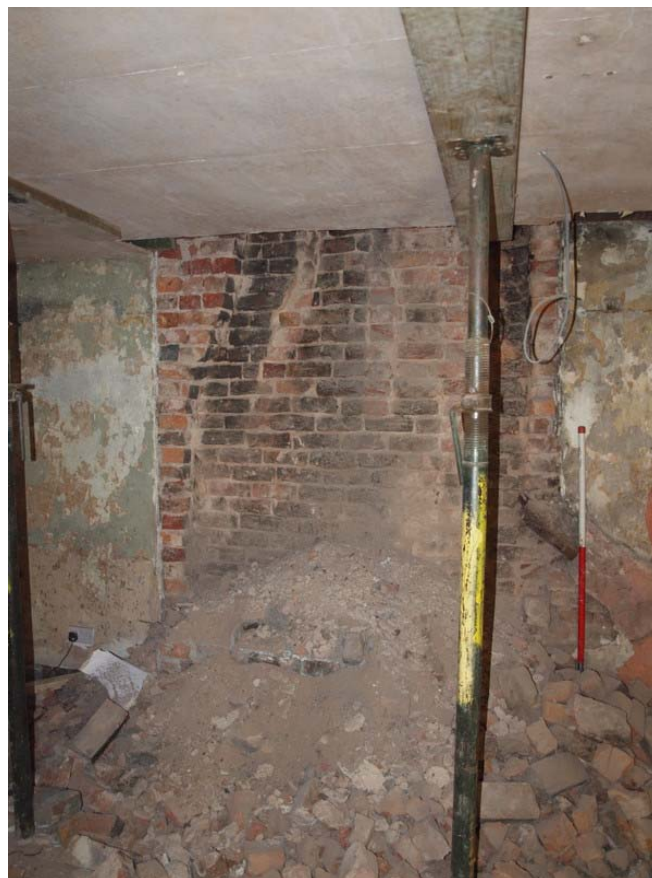
Plate 30: Chimney breast in room 6 after collapse

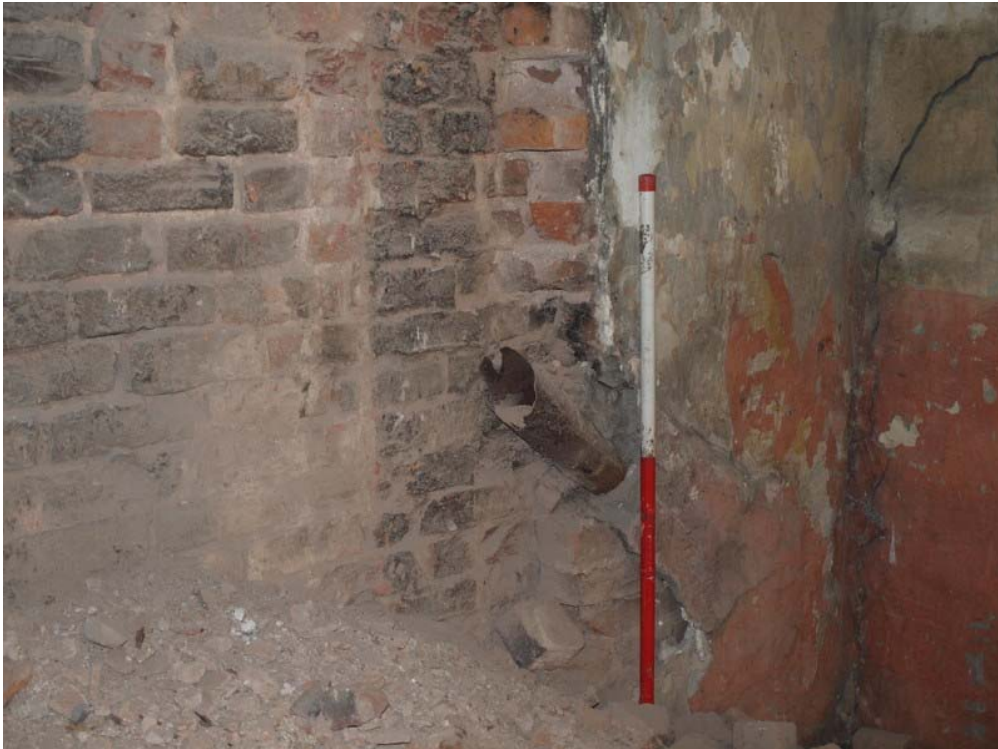
Plate 31: Detail of metal pipe in chimney breast in room 6

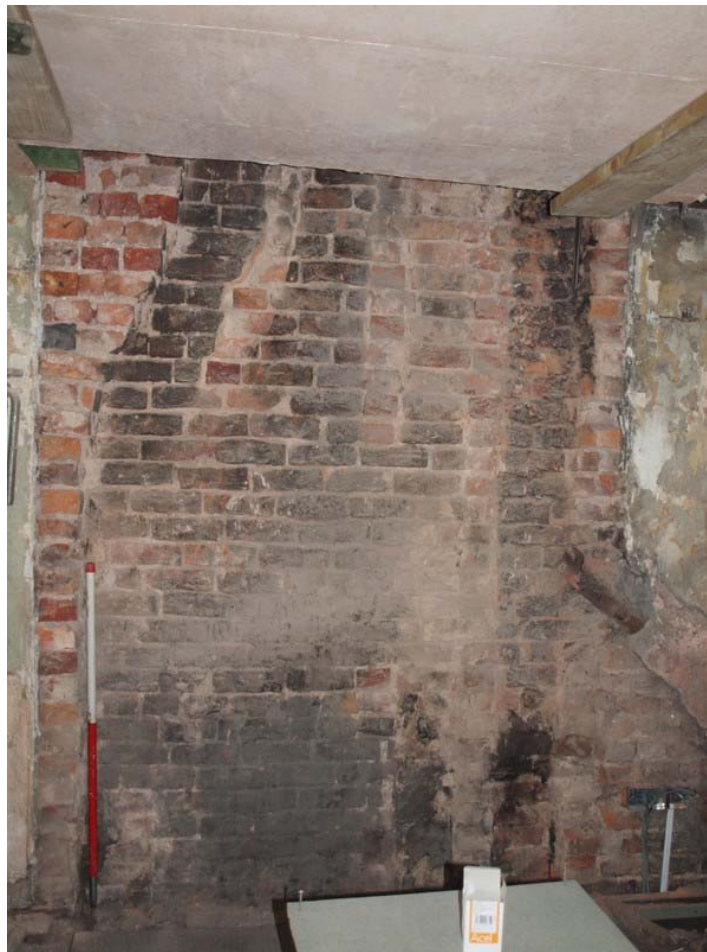
Plate 32: Chimney breast in room 6 after removal of rubble

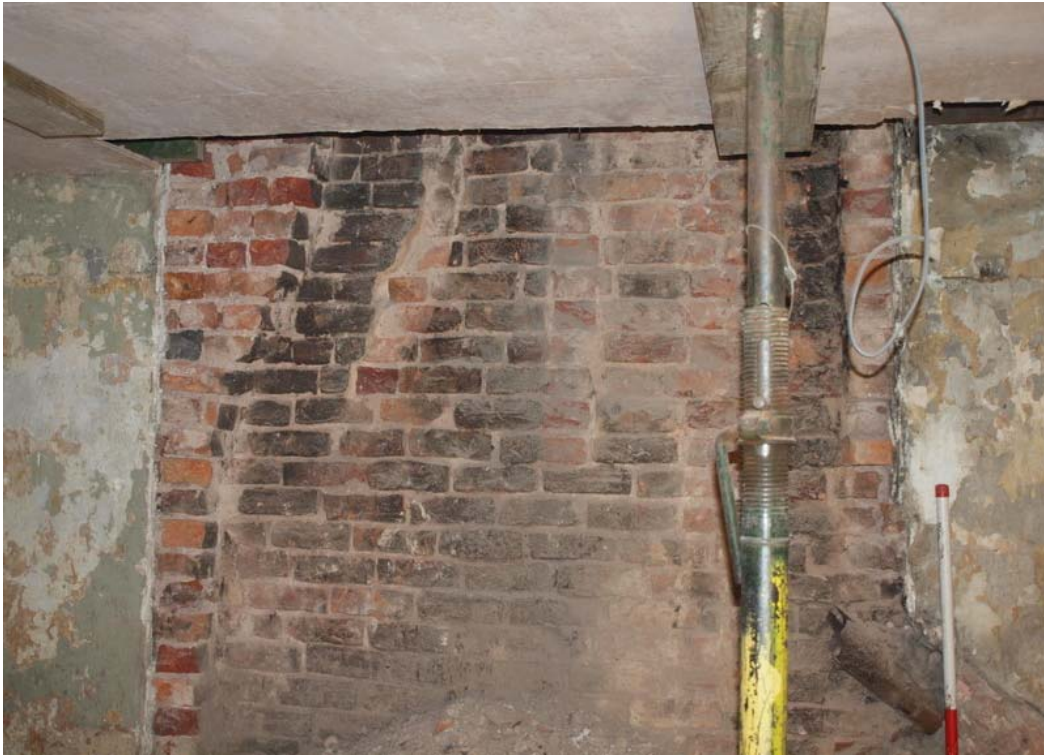
Plate 33: Detail of flue curve in room 6

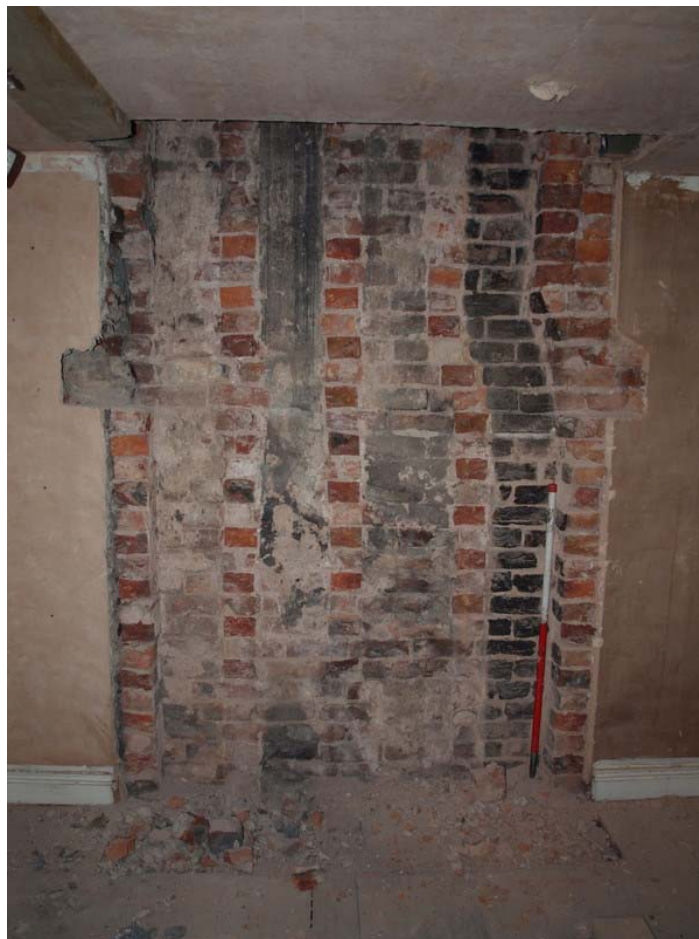
Plate 34: Room 4 after removal of chimney breast

- 8.3 The eastern chimney breast was removed without issue. It revealed four vertical flues, with those on the east curving upwards to the west (Plate 34).
