Wellstyle Farm, Lumb Lane, Ashton-under-Lyne

An Archaeological Building Survey

By J.M. Trippier Archaeological and Surveying Consultancy

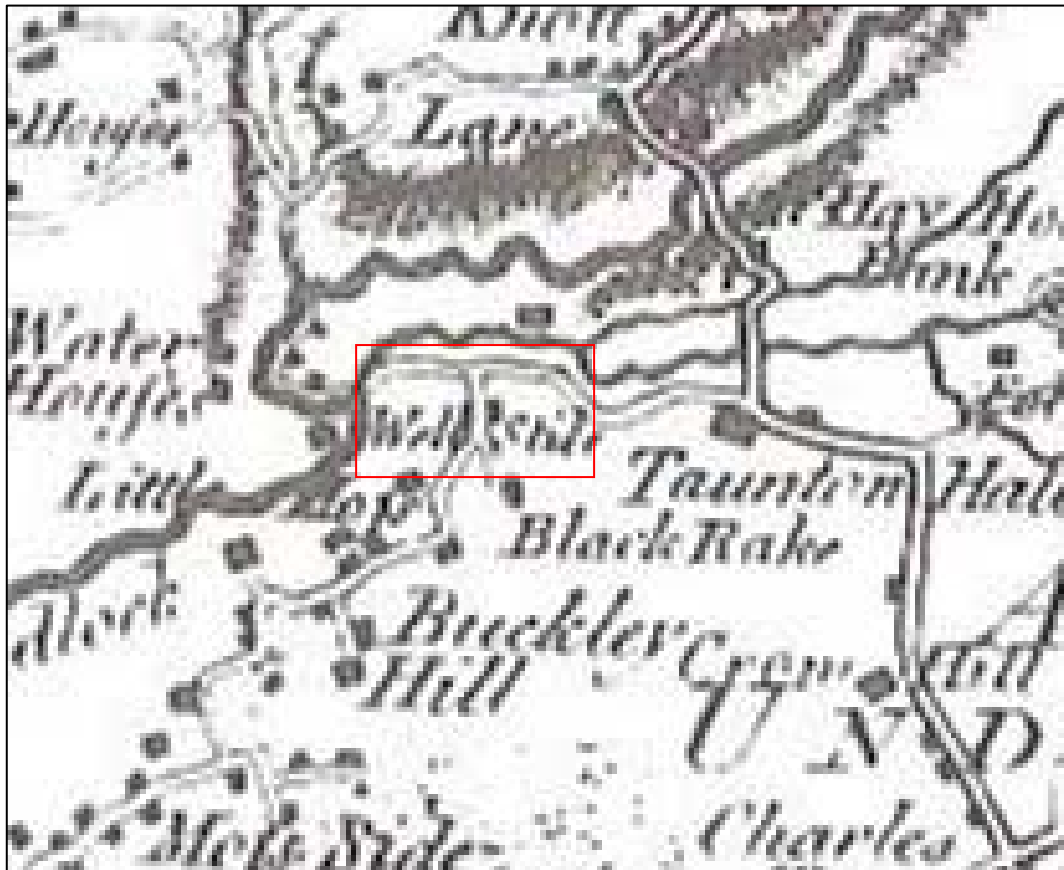
Figure 2: Detail of Yates' 1786 Map of Lancashire magnified 400%

5.4 Yates' map of 1786 (figs 1 & 2 of Appendix 2) shows the farm, with Lumb Lane running through the centre, bisecting the property. This road was originally the lane running through the farmyard, but subsequently became a main through road. Four buildings can be seen, with the two on the west possibly being the subject buildings. This bisection appears to have been around this time as after this several families start to be listed at the premises and by the mid 19th century the farm was owned by two separate people. One half belonged to Nathaniel Howard Esq., Mayor of the Manor in 1835 and the other half belonging to Mr Barlow, an attorney.

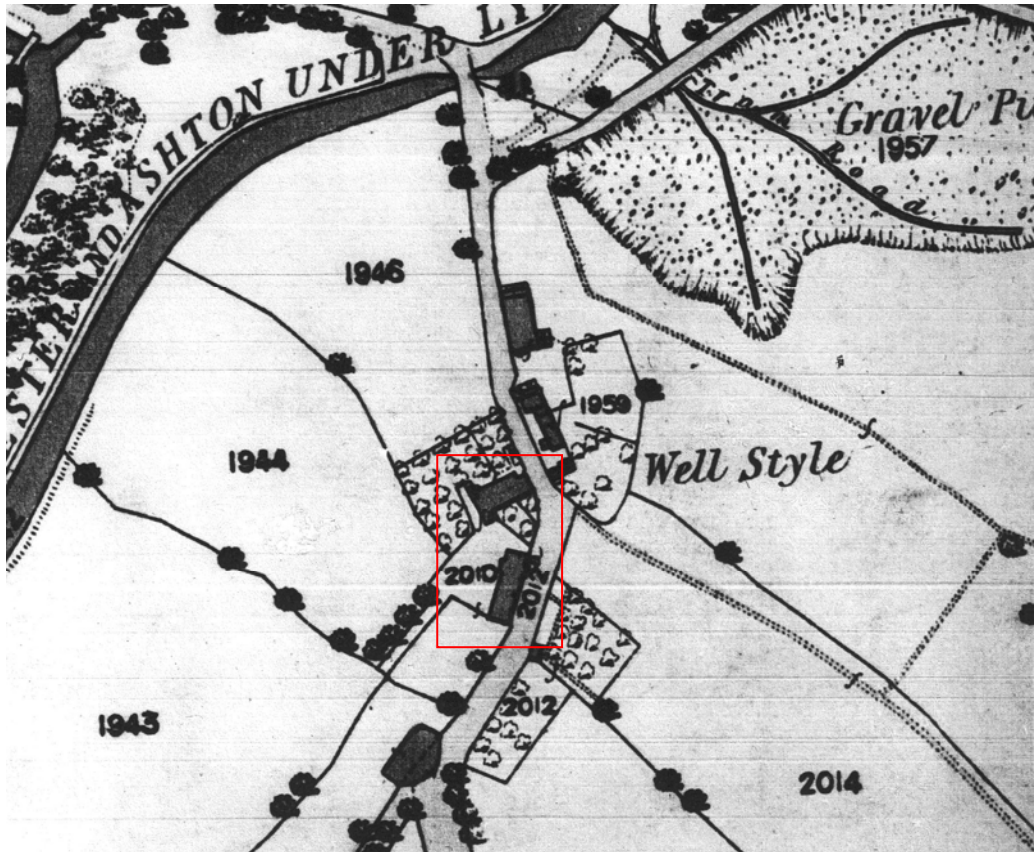
Figure 3: 1863 OS map 1:2,500 Lancashire sheet 105.2

- 5.7 The OS map for 1863 (Fig 3 of Appendix 2) shows 5 buildings on the Wellstyle farm complex. The southernmost is the barn, which may or may not have been occupied. It is shown as a rectangle, with the porches above the barn doors also being visible. The centremost building on the west side of the road, however, is shown to be composed of several small units, and may have been divided into two properties. The house is shown as larger at this time than at present, with a wing to the west creating a ‘T’ shape. The well is not shown.

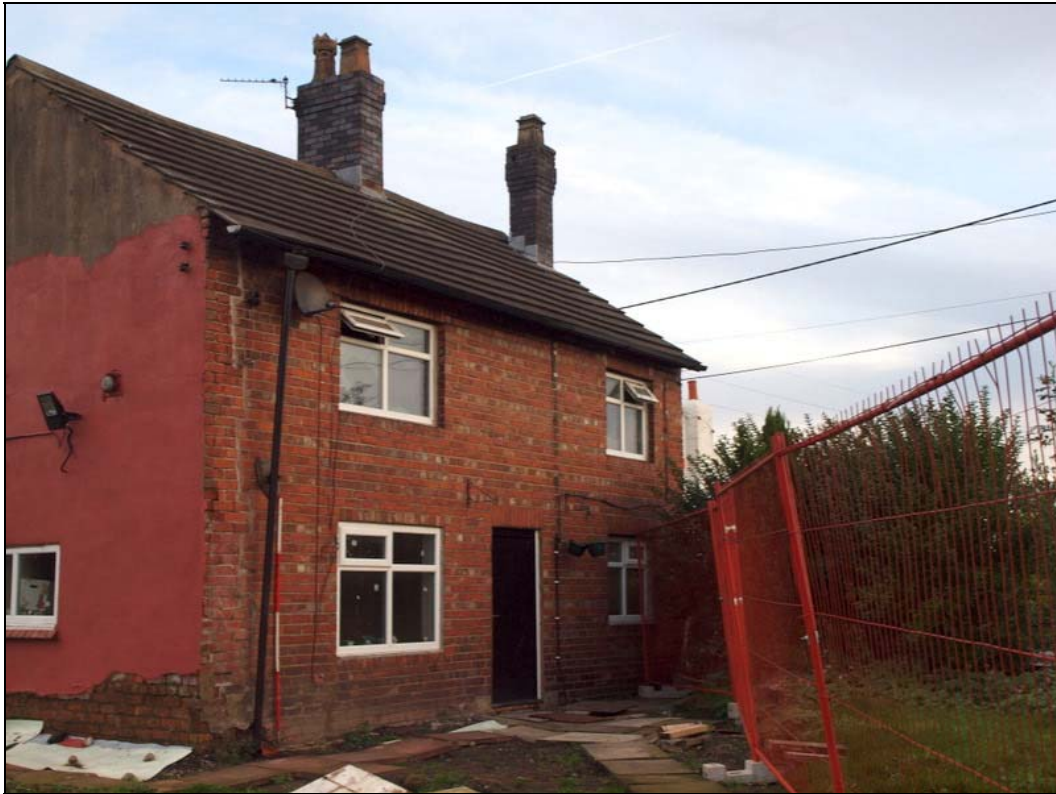
Plate 1: South elevation of cottage

- 6.2 **South Elevation** (Plate 1). This elevation forms the main front of the house. It is constructed of modern brick in English Garden Wall bond (3:1). A timber framed personnel doorway is in the centre at ground floor level, hung with a timber door. Either side of this, at ground floor level are square windows, with modern uPVC frames fitted. These are mirrored above at first floor.

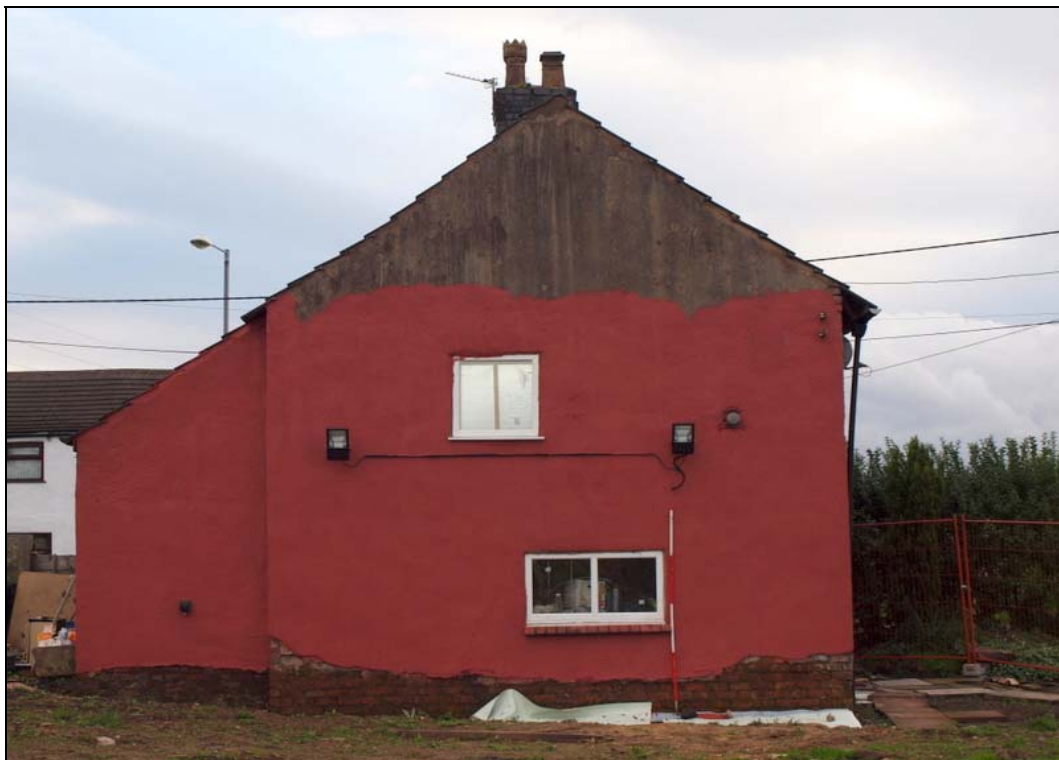
Plate 2: West elevation of cottage

- 6.3 **West Elevation** (Plate 2). This face comprises the gable end of the house with the side of single story extension. The face is rendered and painted red, although where this has decayed at the base, the brick construction is apparent. A narrow landscape window lies to the south of centre at ground floor level with a brick cill and fitted with a modern uPVC frame. At first floor level, to the north of centre, is a square window, likewise fitted with a modern frame. The extension is featureless and rendered to match.

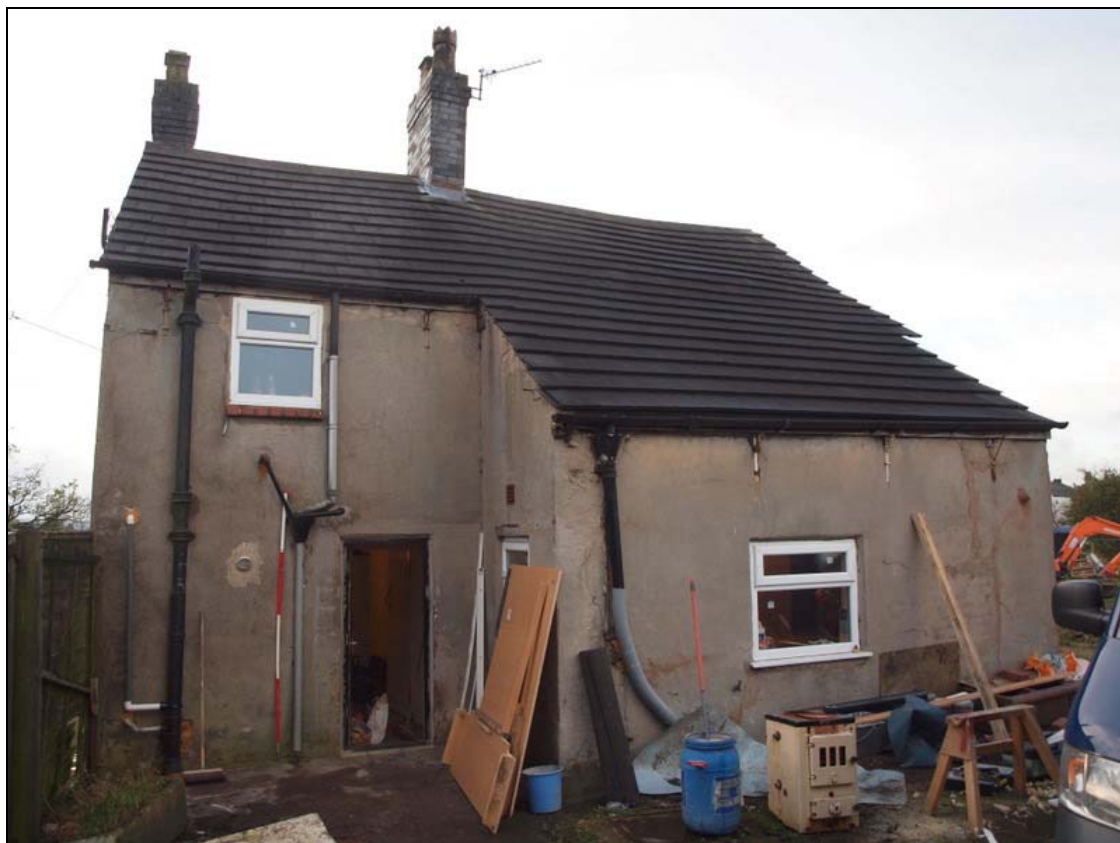
Plate 3: North elevation of cottage

- 6.4 **North Elevation** (Plate 3). This face forms the rear of the building and the front of the extension. Both are rendered with cement across the whole of the face. The extension has a single square window fitted to the east of centre, fitted with a modern uPVC frame. The face of the house to the east has a timber framed personnel doorway, hung with a timber door. Above this and to the east is a portrait window with brick cill, fitted with a modern frame.

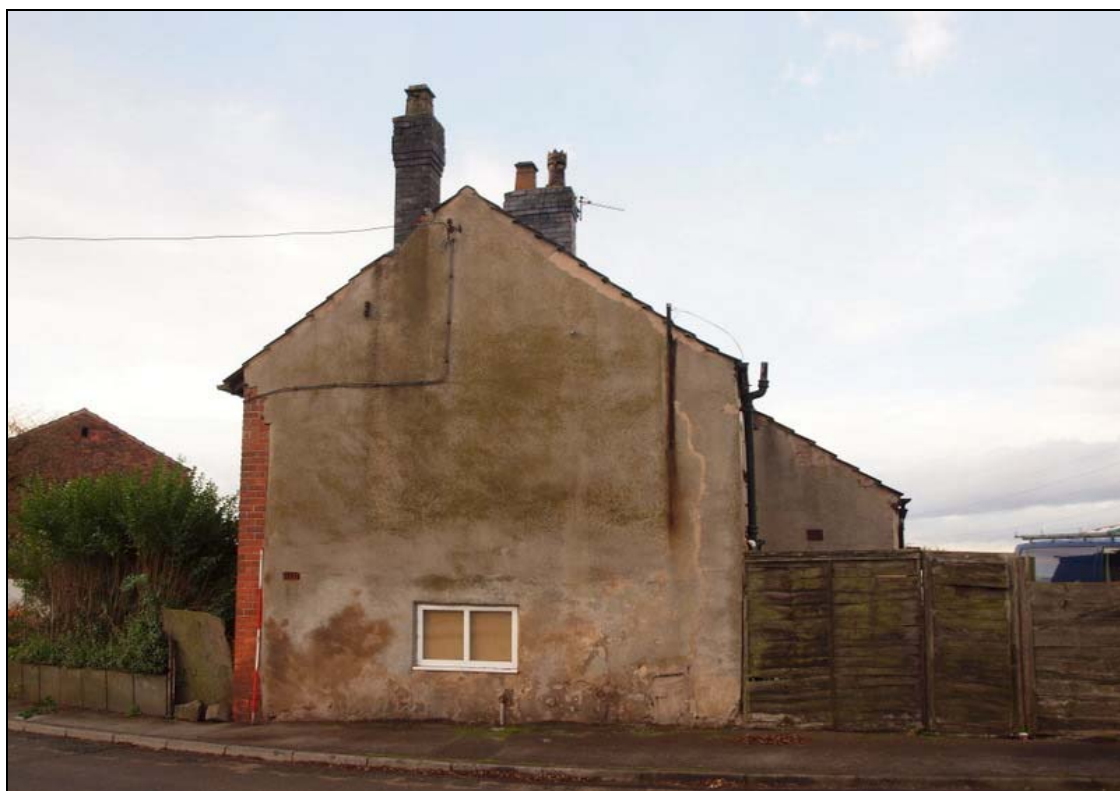
Plate 4: East elevation of cottage

- 6.5 **East Elevation** (Plate 4). This face is formed by the gable end of the house and the end of the extension to the north. Both are rendered with cement with the exception of the southern corner of the gable, where the bricks are visible. The rest of the face is featureless, with the exception of a landscape window located in the centre of the ground floor, fitted with a modern uPVC frame. A single chimney stack rises from the gable, on the southern side of the ridge. This is constructed in dark brown brick, in contrast to the red of the house. A single ceramic square pot tops it. The extension has a square window fitted with a modern uPVC window in the centre.

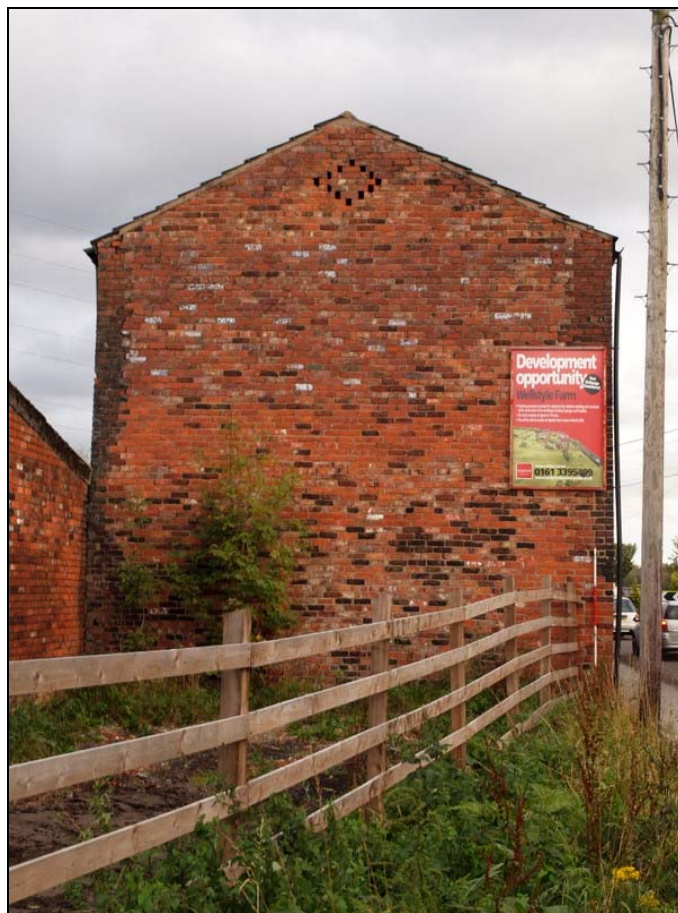
Plate 5: South elevation of barn

- 6.6 **South Elevation** (Plate 5). This elevation forms gable end of the barn and is of brick construction. The bond is English Garden Wall, although there is no consistency in the ratio of stretchers to headers. The face is featureless other than for vent holes near the apex.
- 6.7 **West Elevation** (Plate 6). This elevation comprises one of the long sides of the barn. It is constructed in a dark red brick in English Garden Wall bond (5:1),

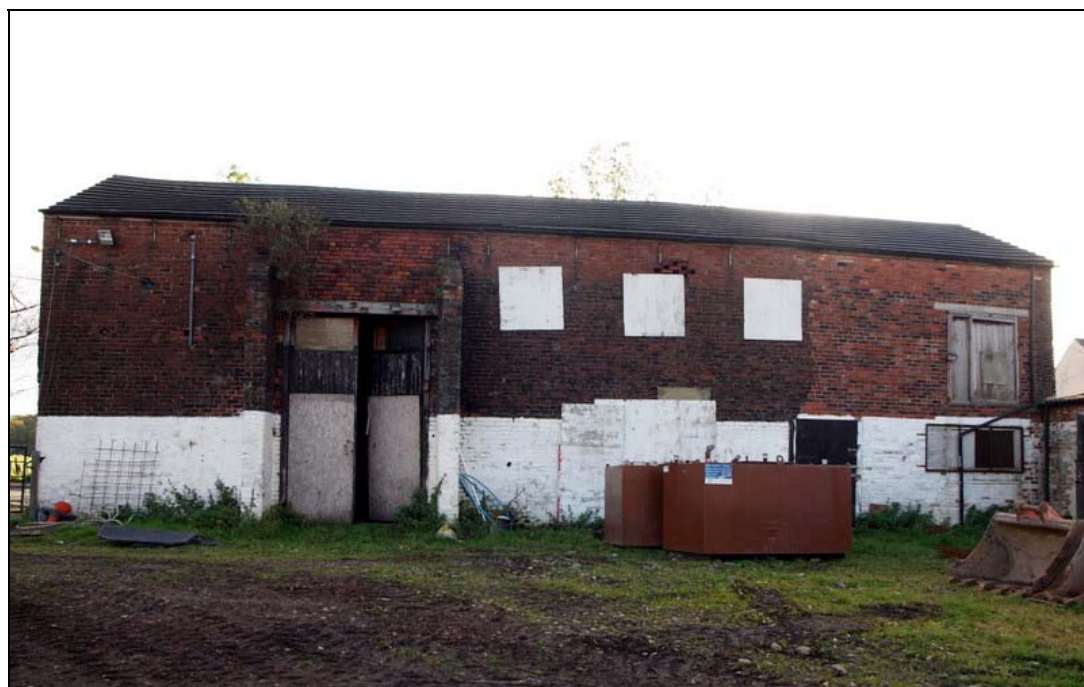
Plate 6: West elevation of barn

whitewashed at ground floor level. At the northern end is a large timber framed barn door with modern timber lintel and two timber doors hung. This is flanked by brick 'cheeks' projecting outwards on either side. To the south of this at ground floor level is a blocked window, the sandstone cill of which is still visible. Running above this, at first floor level, are three blockings, presumed to be windows, although no trace was visible. South of this at ground floor level is a timber framed cattle doorway, hung with a modern timber door. South of this again is a timber framed landscape window fitted with a timber frame and iron grate. It has a sandstone lintel. Directly above this is a timber framed taking in doorway, hung with a timber door and likewise has a sandstone lintel.

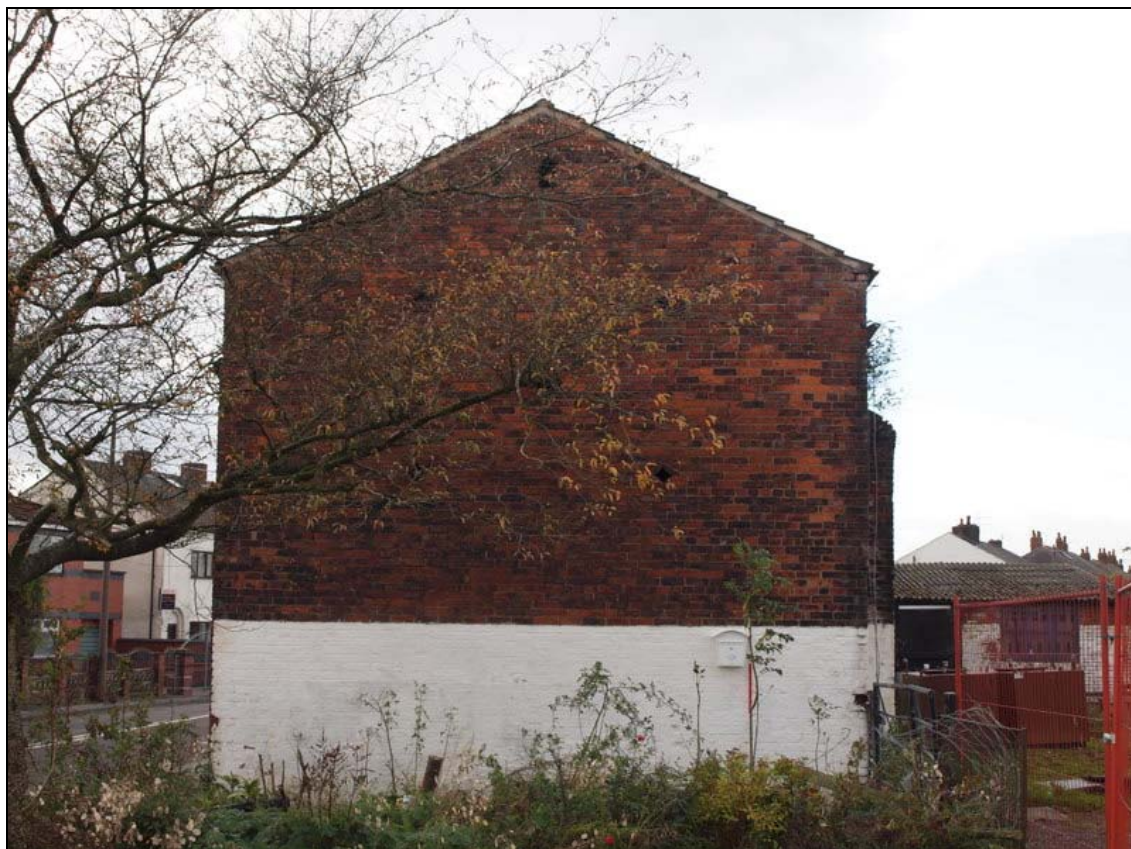
Plate 7: North elevation of barn

- 6.8 **North Elevation** (Plate 7). This forms the other gable end of the barn and is of a similar construction to the west face, likewise with whitewash at ground floor level. The face is otherwise featureless save for an owl hole near the apex and two star shaped vents at first floor level, formed of bullnosed bricks.

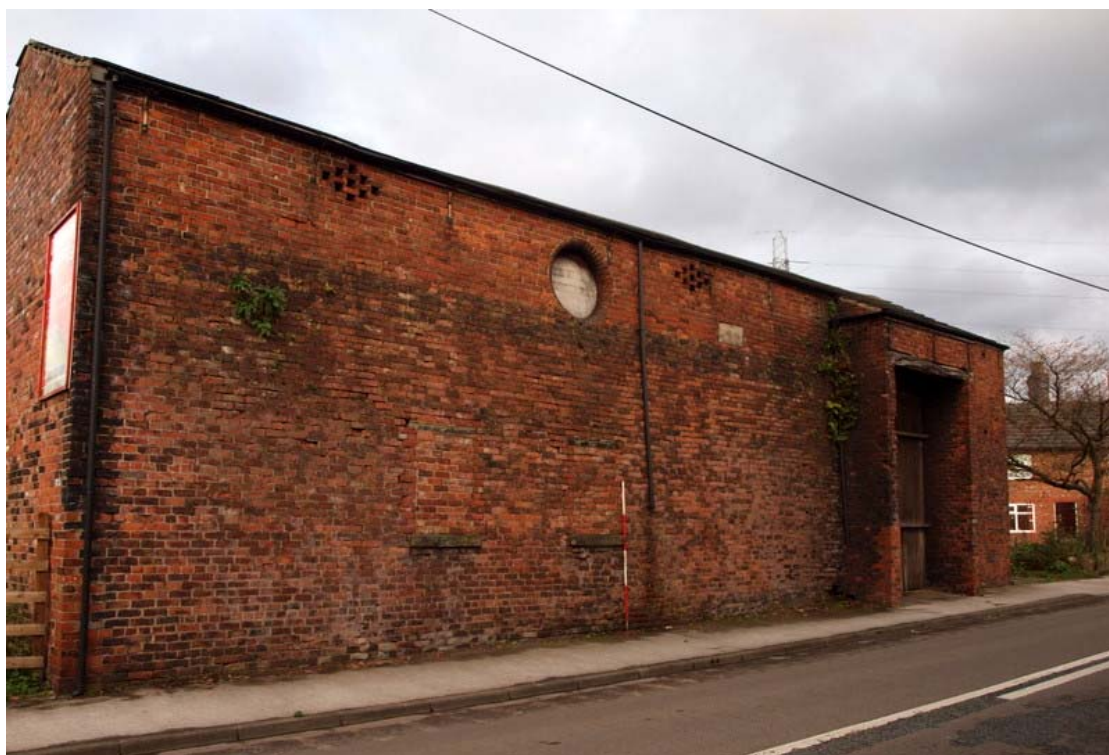
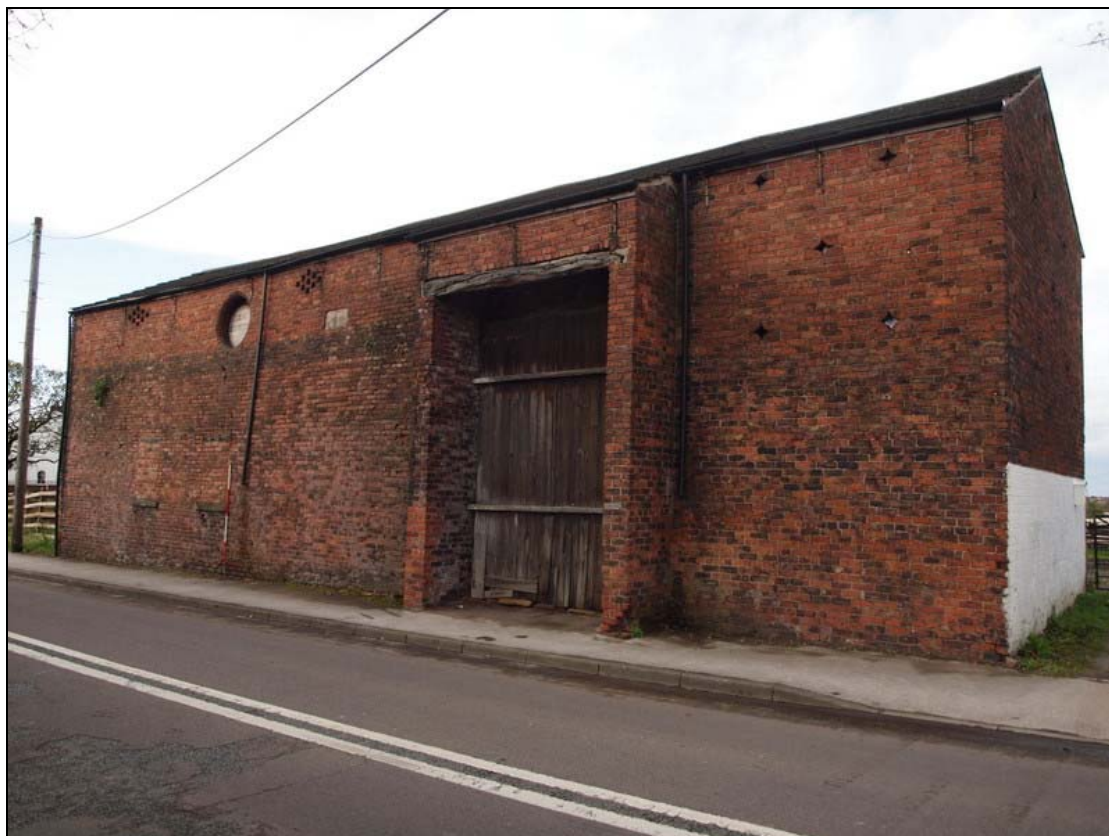
- 6.9 **East Elevation** (plates 8 & 9). This forms the long side of the barn facing the road and is of a similar construction to the west elevation. It has a matching barn doorway at the northern end, with brick 'cheeks' projecting outwards on either side. The roof extends down to create a covered porch over a timber lintel. At first floor level are five star shaped vent holes. At ground floor level to the south of the barn door are two blocked portrait windows, each with a sandstone cill and lintel. Directly above the northern most of these is a circular window, lined with bullnosed bricks. A sandstone block is located in the wall to the north of this.

Plate 8: East elevation of barn, south end

Plate 9: East elevation of barn, north end

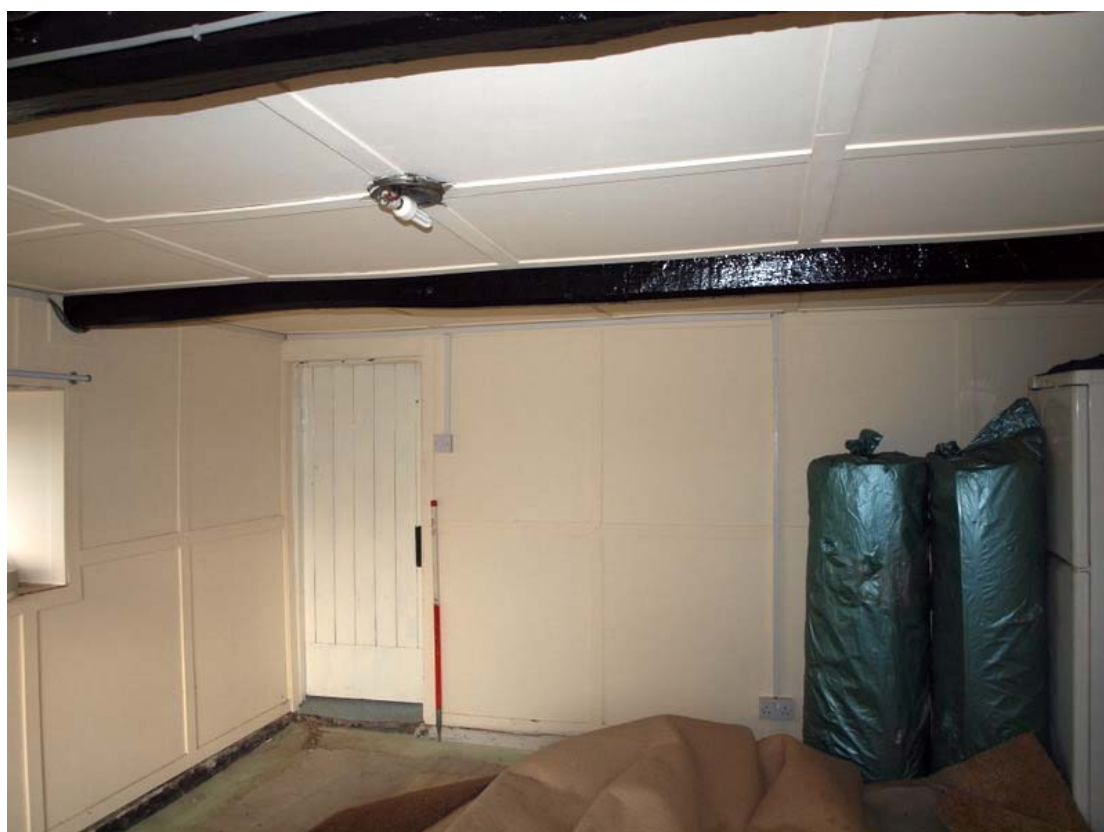
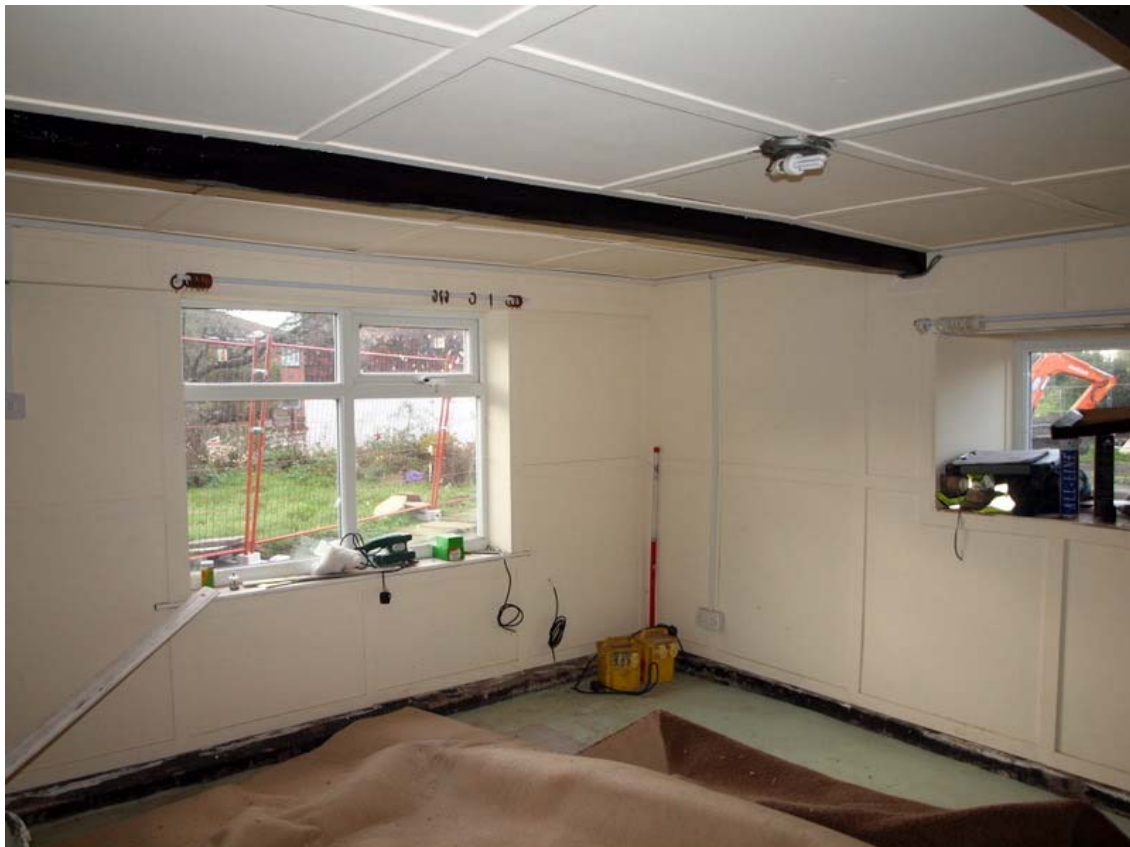
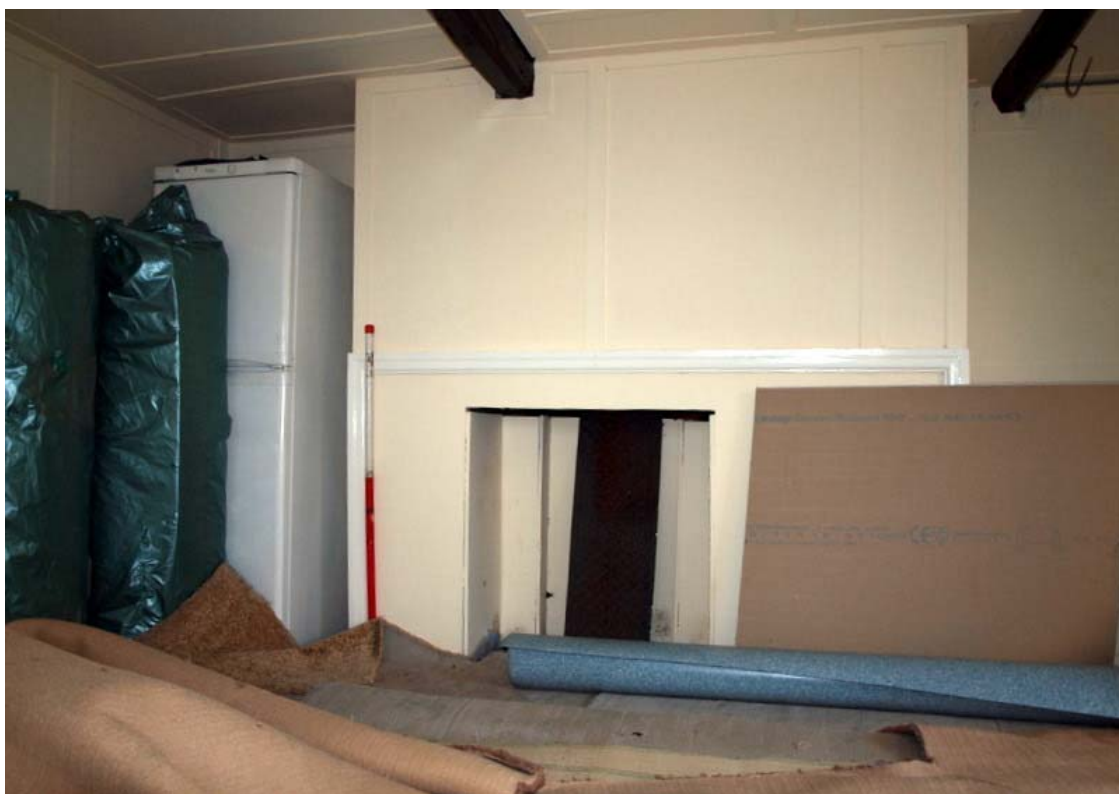
- 6.10 **Room 1** (plates 10 & 11). The room is accessed via the exterior via the front door in the eastern end of the south wall. This is timer framed with a timber batton braced door hung. To the west of this is a large landscape window fitted with a modern uPVC frame. In the centre of the west wall is a similar window, although this is much narrower. Opposite this, in the centre of the east wall is a fireplace (plate 12), with moulded timber surround. This, along with the rest of the walls, is covered with plaster board. The ceiling is likewise timber and plaster board and the floor is concrete with linoleum over it. The base of the wall in the south and west shows a very shallow stone plinth. Two hand cut timber beams span the room east – west. Two internal doorways lead out of the room, both hung with timber batten and braced doors. That in the west of the northern wall leads to room 3, with the door to room 2 located to the south of the fireplace.

Plate 10: Cottage Room 1

Plate 11: Cottage Room 1

Plate 12: Cottage Room 1 Fireplace

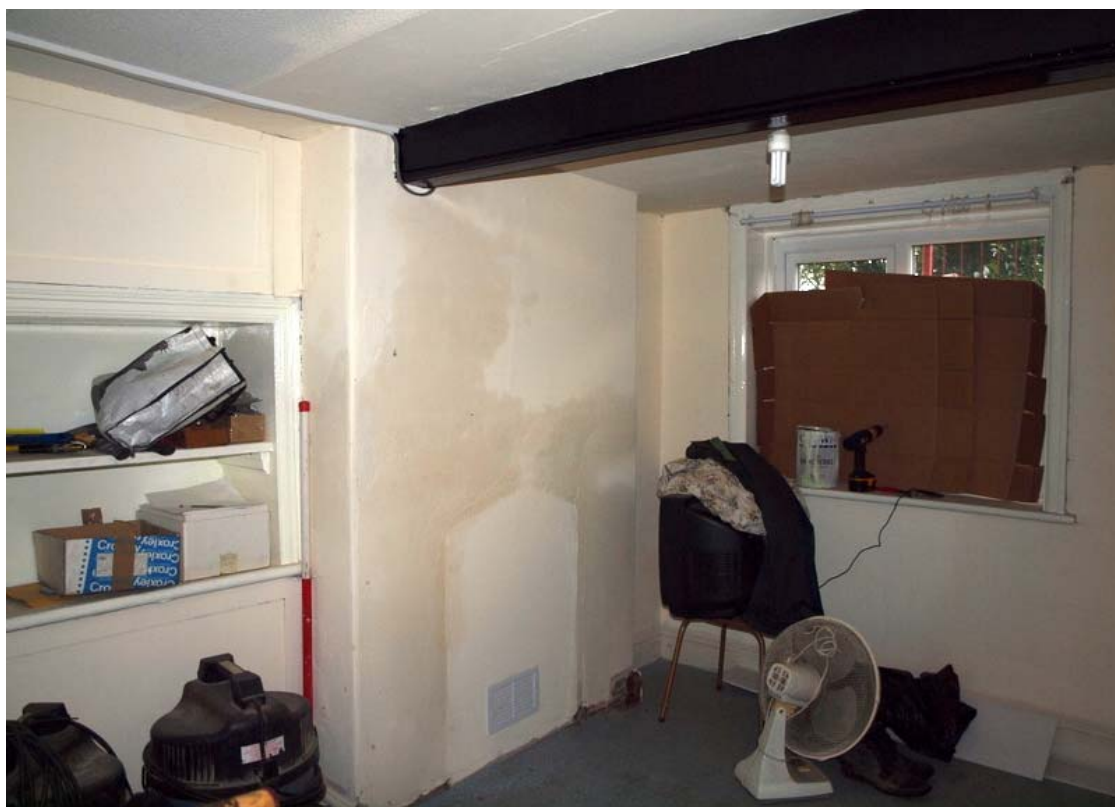
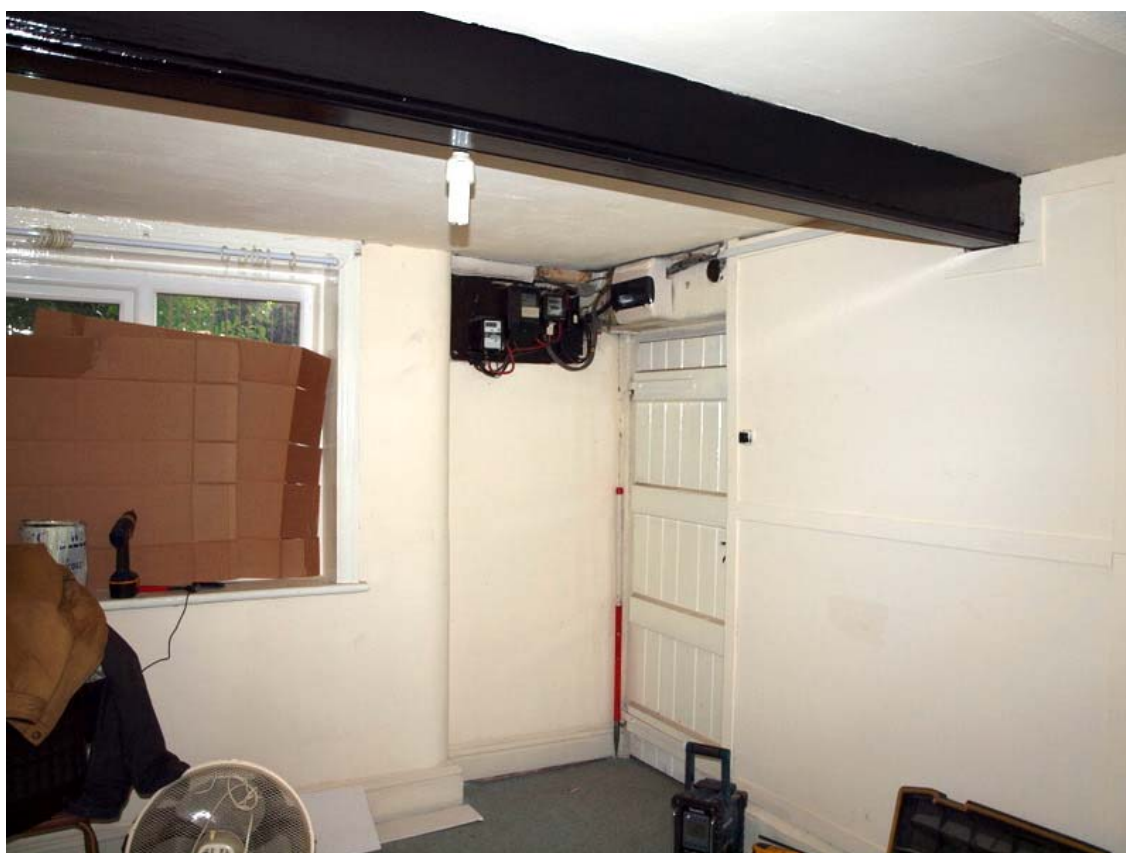
- 6.11 **Room 2** (plates 13 & 14). This room is accessed via the doorway mentioned above. It can also be accessed through a similar doorway in the western end of the north wall, via the hall. A single landscape window lies in the south wall,

fitted with a modern uPVC frame. The south wall is recessed to the west of this. The east wall has a chimney breast in the centre, the fireplace blocked up. A blocked window lies to the north of this with a moulded timber surround, now functioning as a small cupboard. The walls are plastered, although where this has fallen away at the base of the chimney breast, brick is visible. The ceiling is likewise plaster board and the floor concrete with linoleum over. A single chamfered timber beam spans the room east – west.

Plate 13: Cottage Room 2 Fireplace

Plate 14: Cottage Room 2

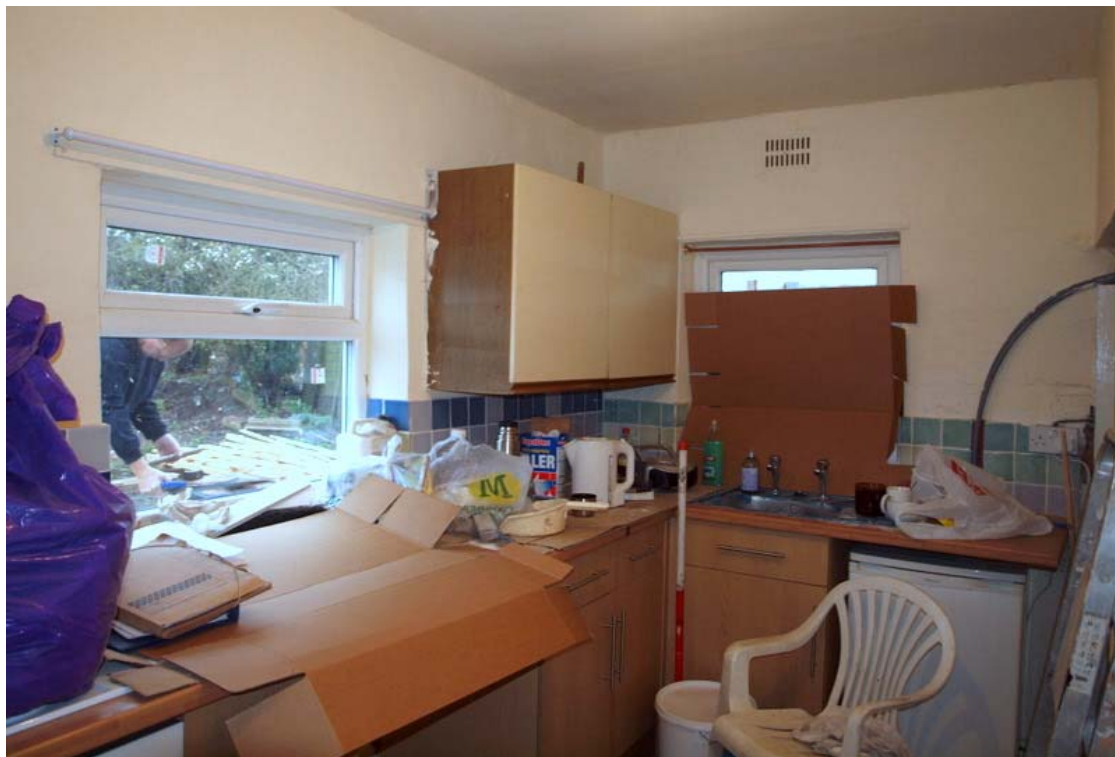
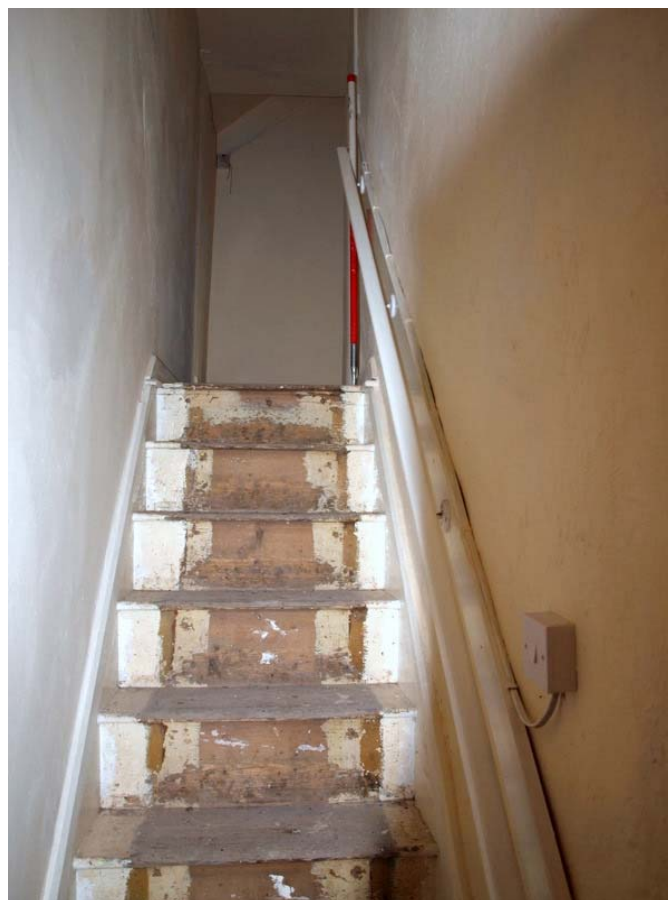
- 6.12 **Room 3** (plate 15). The room is accessed via a timber batton braced personnel doorway in the western end of the southern wall. Immediately to the west of this is the timber staircase (plate 16) to the first floor, with a simple timber handrail. Two landscape windows light the room, both fitted with modern uPVC frames. One is located in the centre of the north wall, the other in the east wall. To the south of the latter is a personnel doorway leading to the hall. The ceiling and walls have all been plastered and the floor is concrete over linoleum. The room is fitted out as a modern kitchen.

Plate 15: Cottage Room 3

Plate 16: Cottage staircase in room 3

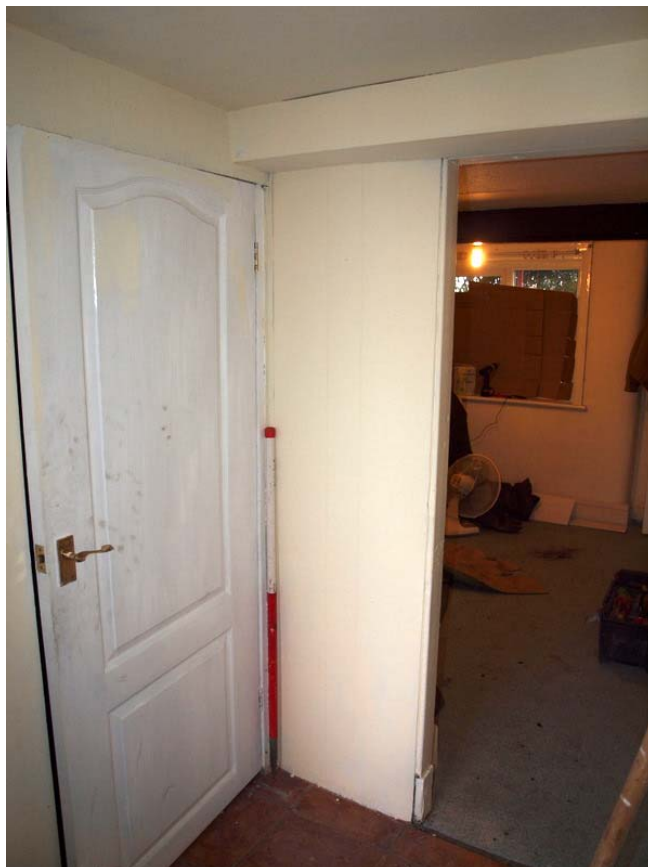
Plate 17: Hall of Cottage

- 6.1 **The Hall** (plate 17). The hall is accessed from the exterior via a timber framed personnel doorway in the north wall. The hall itself has a tiled floor and plaster boarded walls and ceiling. Three timber framed personnel doorways lead off from it to rooms 2, 3 and 4.

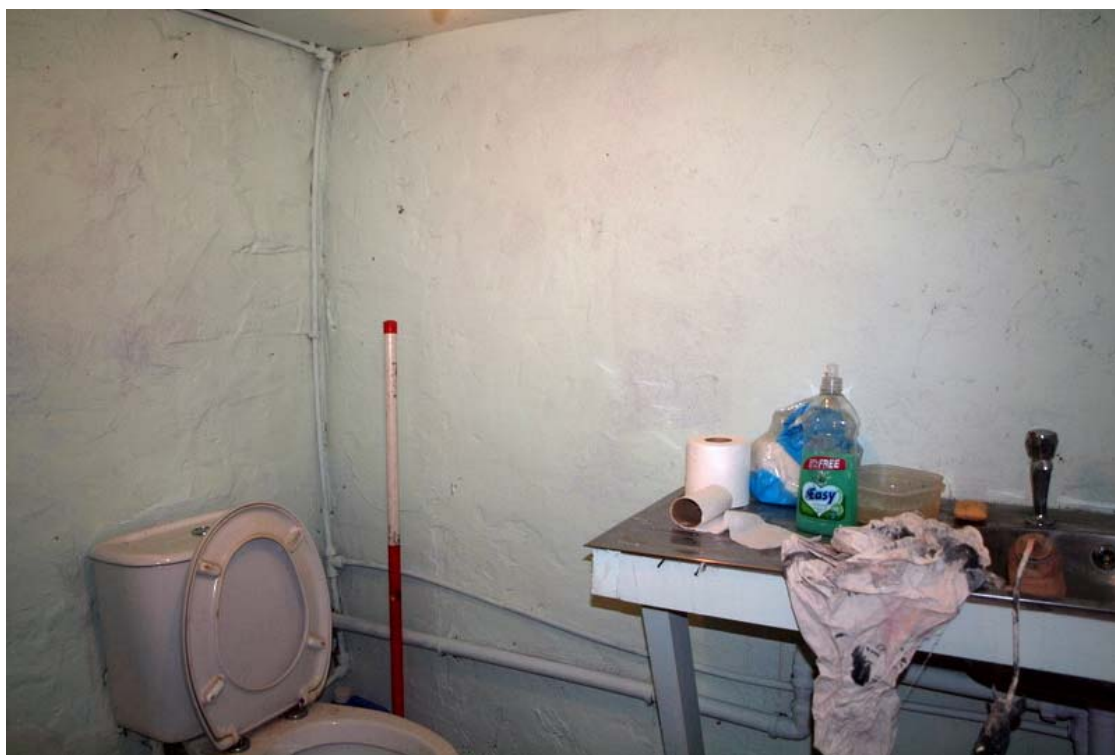
Plate 18: Cottage Room 4

- 6.15 **Room 4** (plate 18). The room is fitted out as a modern wc accessed via the modern timber door in the south end of the west wall. The walls are bare plaster and the ceiling plaster board. The floor is tiled

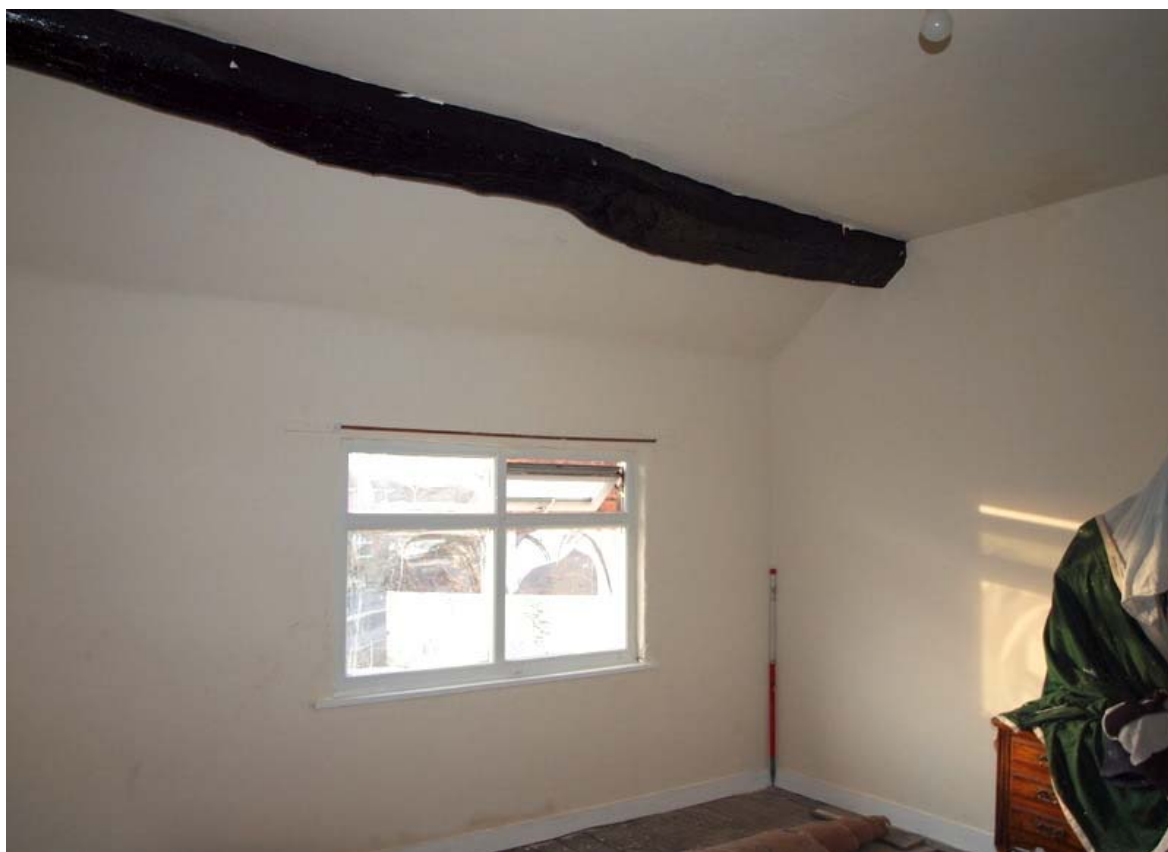
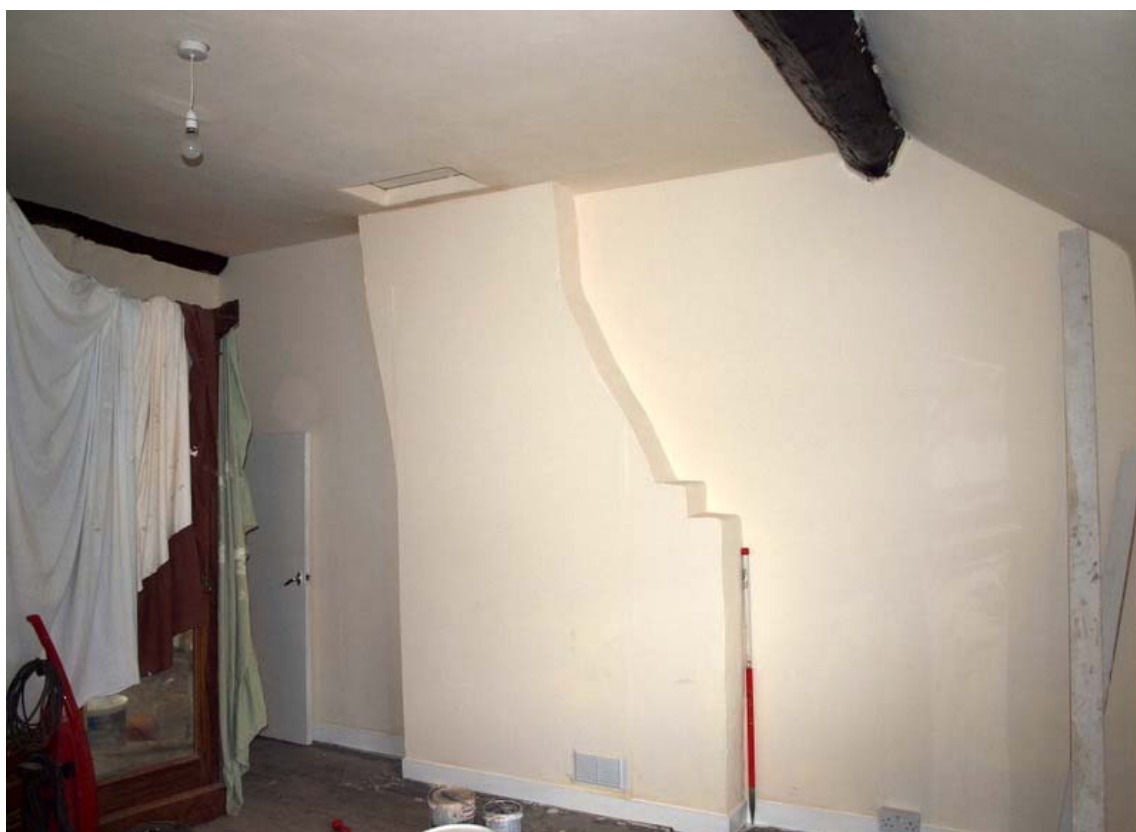
- 6.17 **Room 5** (plates 19 & 20). The room is accessed via a timber framed doorway in the east end of the north wall. A large landscape window lies in the south wall, fitted with a modern uPVC frame. In the centre of the east wall, a chimney breast runs up the wall, leaning to the north. In the west wall, at the north end is a square blocked window. The floor is timber boards and the ceiling is plastered. Two hand cut timber beams run across the room east – west, the northern of which lies on the line of the northern wall. The ceiling slopes with the pitch of the roof to the appropriate side of each of these beams.

Plate 19: Cottage Room 5

Plate 20: Chimney breast in room 5 of cottage

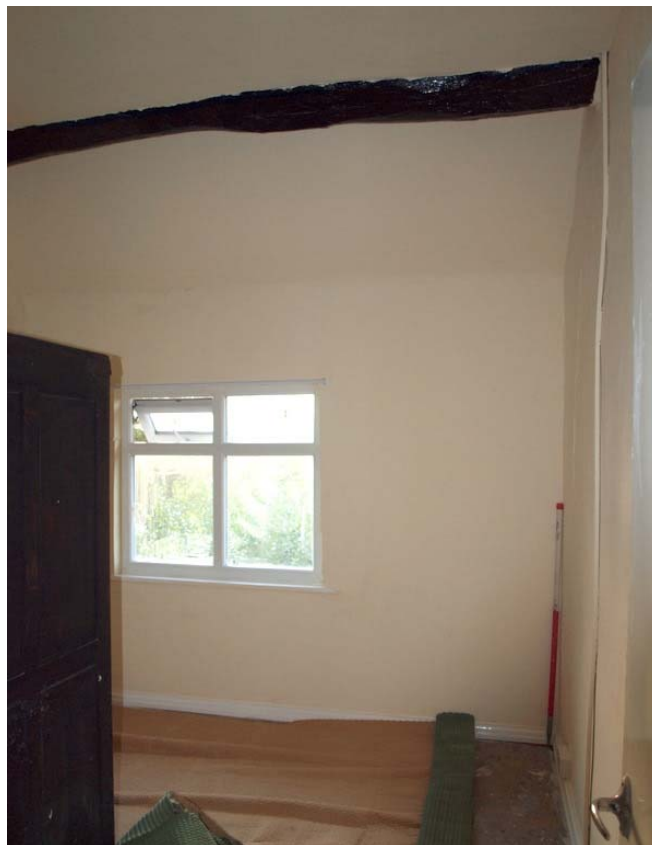
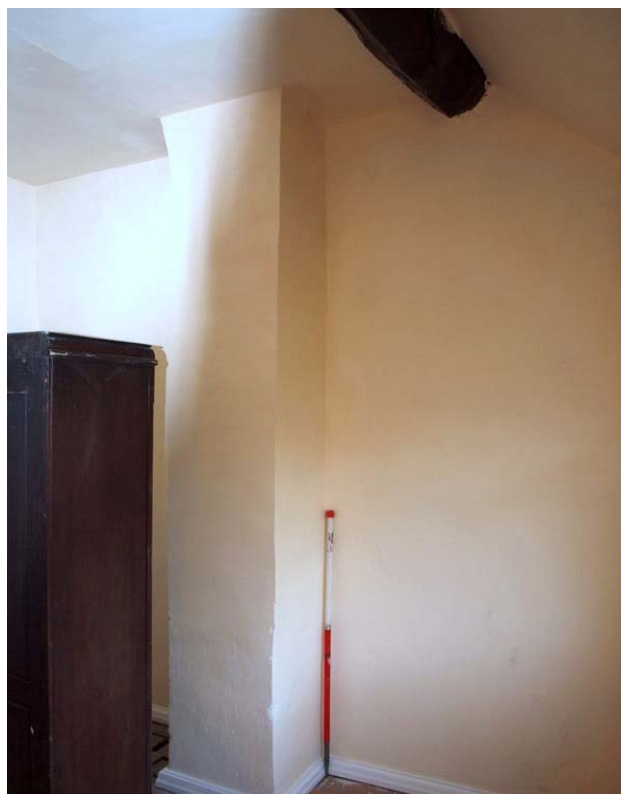
- 6.18 **Room 6** (plate 21). The room is accessed via the timber doorway in the west end of the north wall. In the southern wall is a large landscape window fitted with a modern uPVC frame. A thin chimney breast (plate 22) runs up the east

wall. The floor is timber boards and the ceiling is plastered. A single hand cut timber beam run across the room east – west. The ceiling slopes down on the south side of this, following the pitch of the roof.

Plate 21: Cottage; Room 6

Plate 22: Chimney breast in room 6 of cottage
