Wellstyle Farm, Lumb Lane, Ashton-under-Lyne

An Archaeological Building Survey

By J.M. Trippier Archaeological and Surveying Consultancy

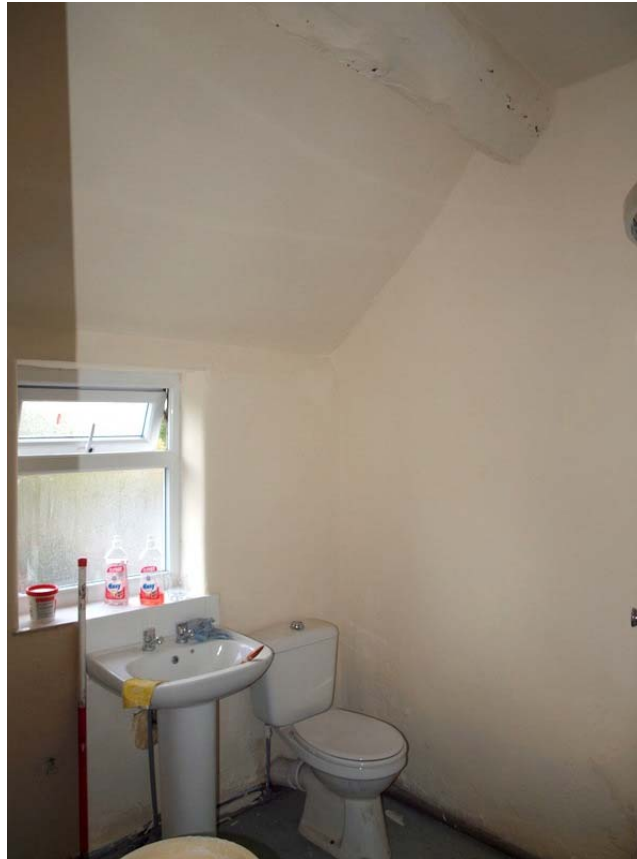
Plate 23: Cottage Room 7

- 6.19 **Room 7** (plate 23). The room is accessed via the timber doorway in the south end of the west wall. In the north wall is a square window fitted with a modern uPVC frame. The floor is linoleum over timber boards and the ceiling is plastered. A single hand cut timber beam run across the room east – west. The ceiling slopes down on the north side of this, following the pitch of the roof. The room is fitted out as a modern bathroom.

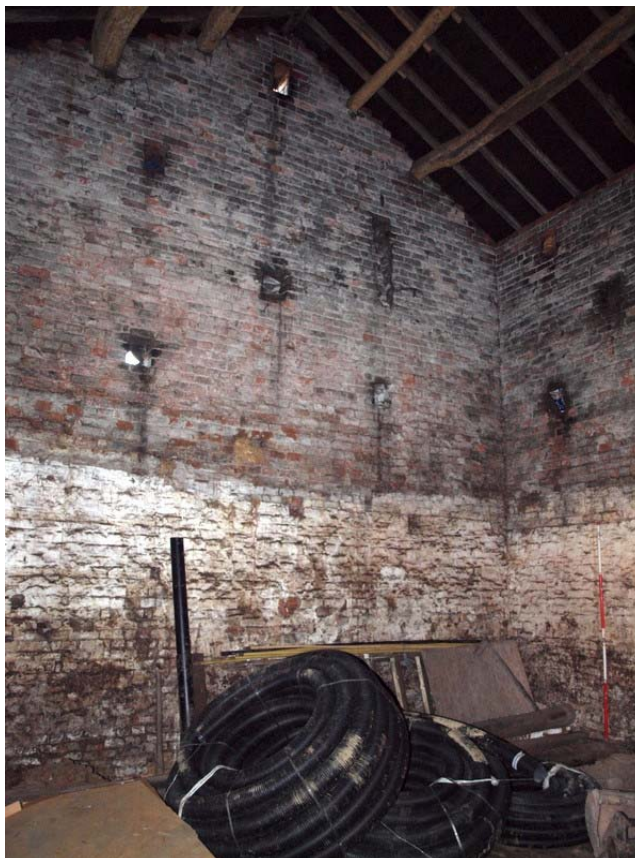
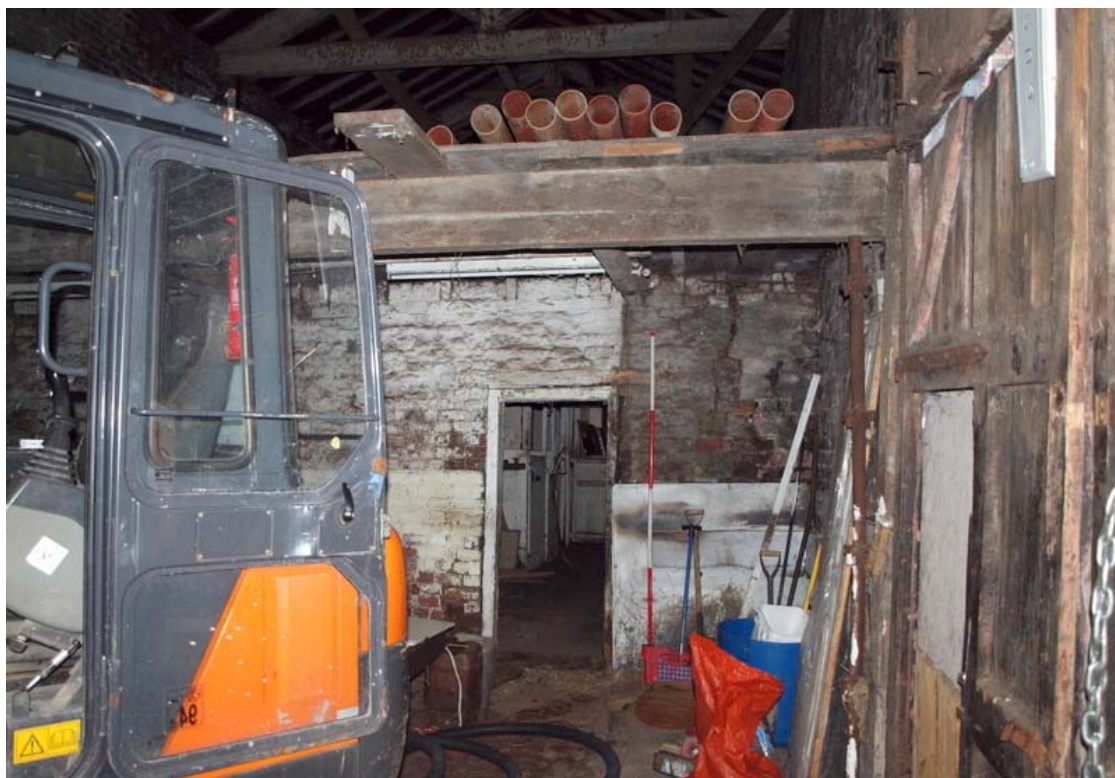
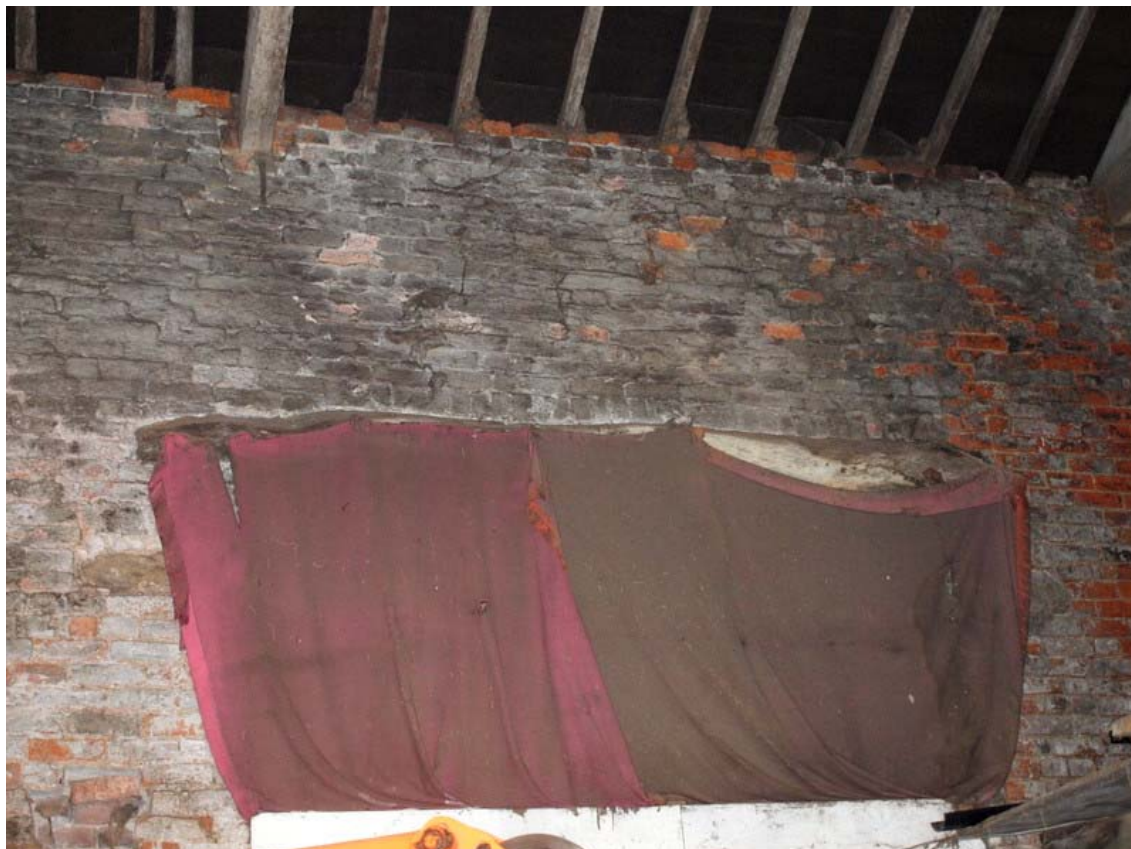
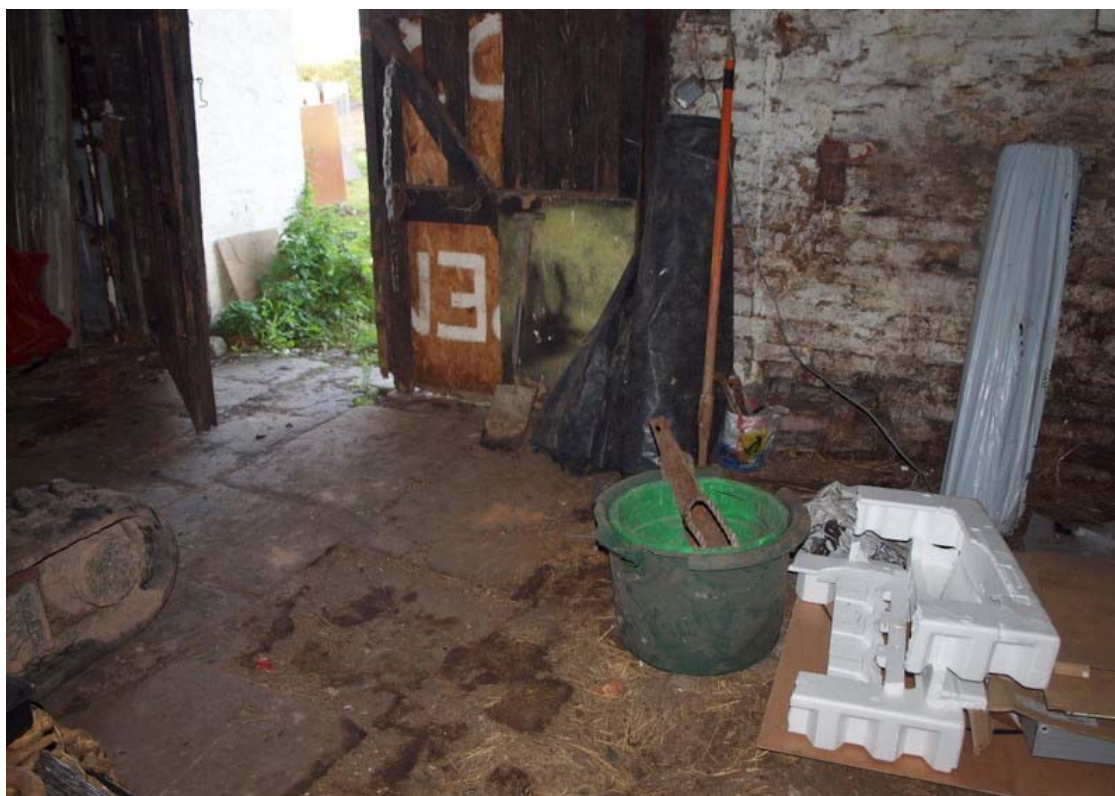
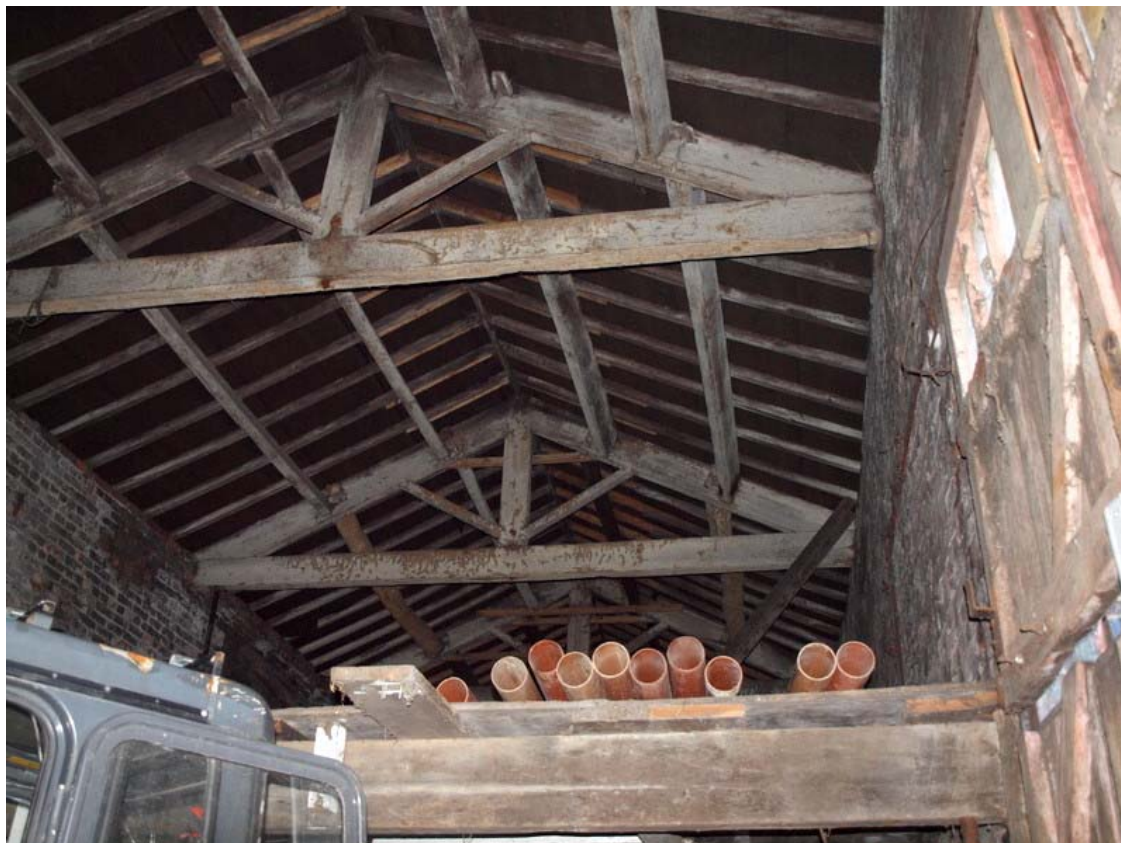
- 6.20 **Barn** (plates 24 & 25). The main area of the barn is located at the northern end and would have been accessed via either of the barn doors located in the east and west walls although the eastern one is now blocked with timber. It has a hand cut timber lintel (plate 26) whereas, and the western a machine cut timber lintel. The walls are all bare brick, whitewashed at ground floor level. The floor has a sandstone flag surface running between the two barn doors, and running south to the internal wall separating the main barn area from the stable to the south. North of the flags the surface is cobbled (plate 27). The room is open to the roof, with a first floor over the stables at the far southern end (plate 28). This is supported by a machine cut timber beam running east – west across the room. The southern internal wall has a timber framed personnel doorway at the west end leading to the stable.

- 7.4 The barn is relatively unmodified at the northern end, although the roof timbers and slates have been replaced at some point in the 20th century. The southern end of the barn, however, shows remodelling with the wall rebuilt in concrete block. The south wall has several brick pillars running up it, also suggesting that it may have been rebuilt in the past. This remodelling may have removed doorways or windows which demonstrate its function. Likewise, the drainage channel and floor in the southern end is concrete, possibly covering the original floor which may indicate its original use. Among the possibilities is that it was once intended to be lived in, as the Hulme family converted several farm buildings in the area for housing workers and the census for the 1860's records many of the farm properties being used as dwellings.

Plate 24: North end of barn

Plate 25: Internal wall in barn

Plate 26: Covered hand cut timber lintel of east barn door

Plate 27: Flag surface with cobbles to the north

Plate 28: Machine cut timber king post trusses and line of first floor

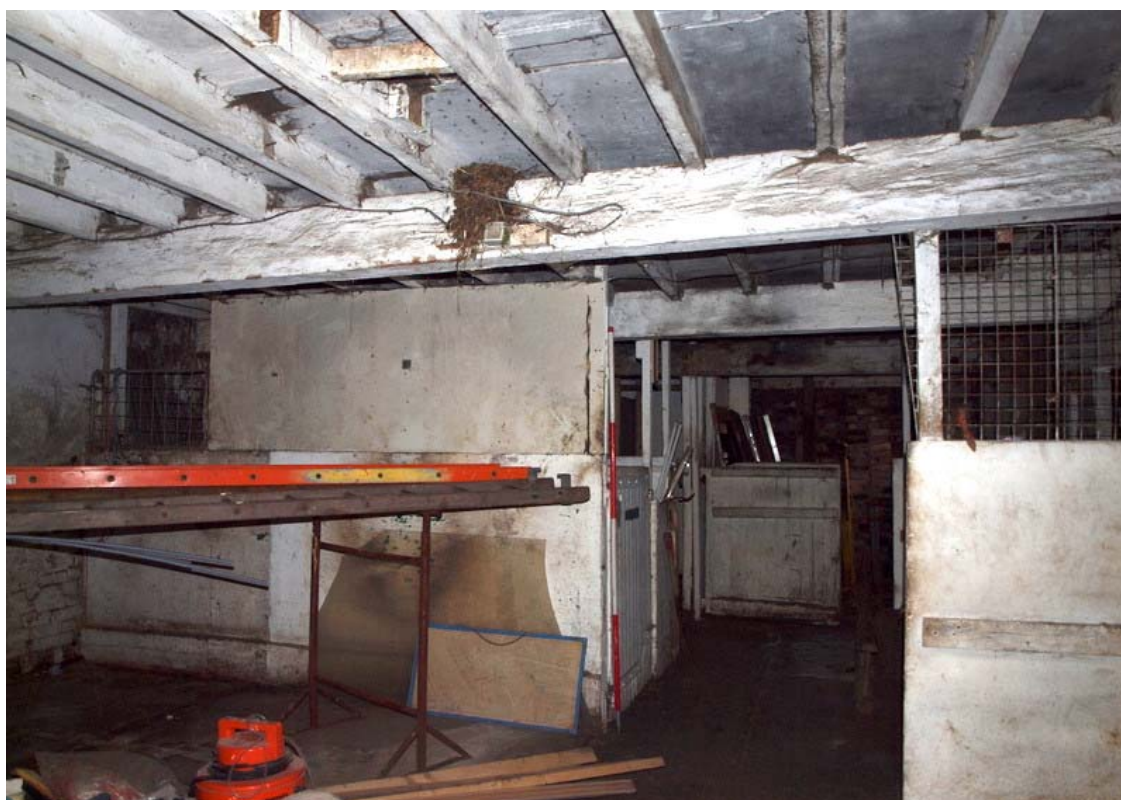
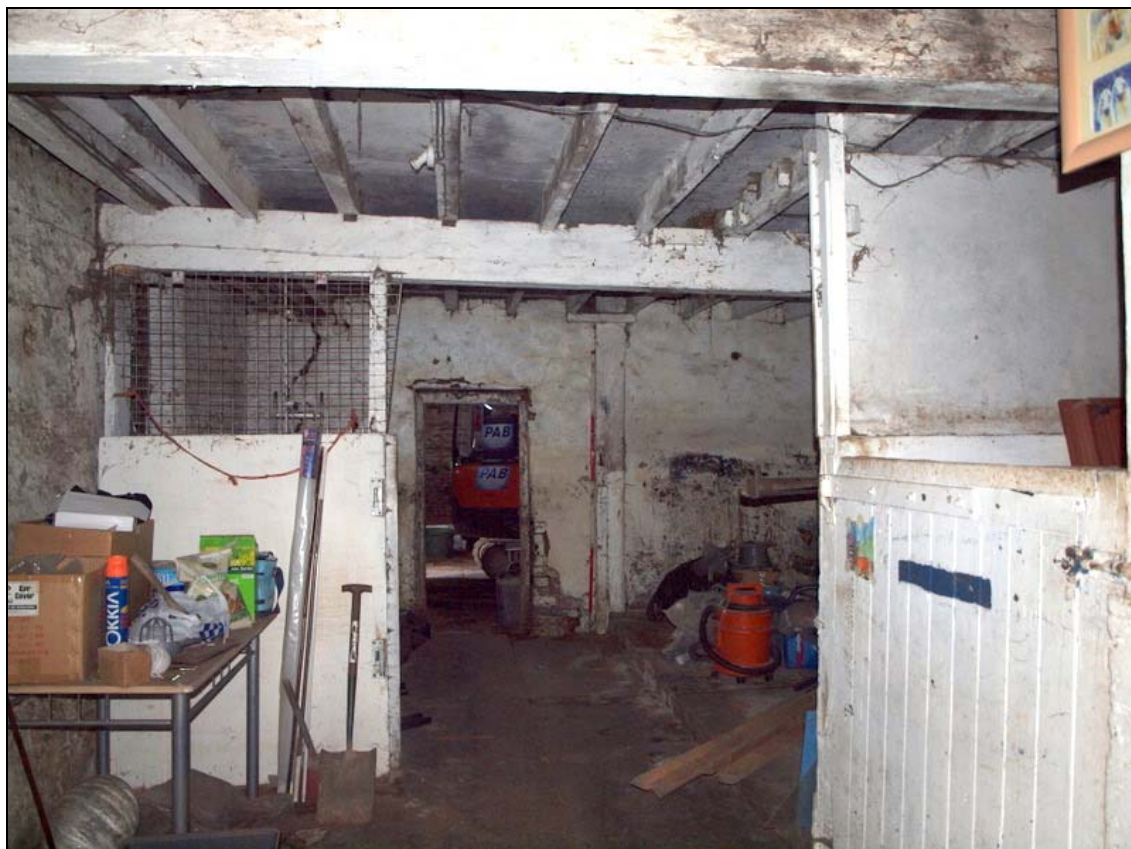
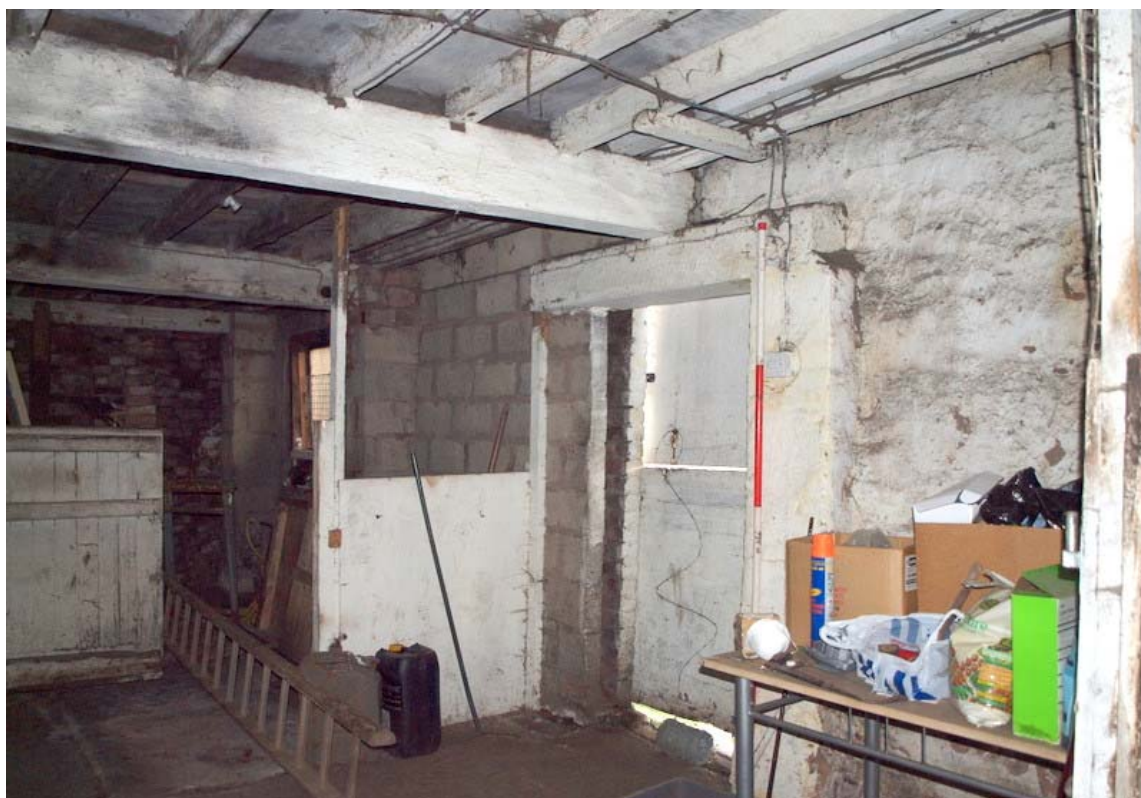
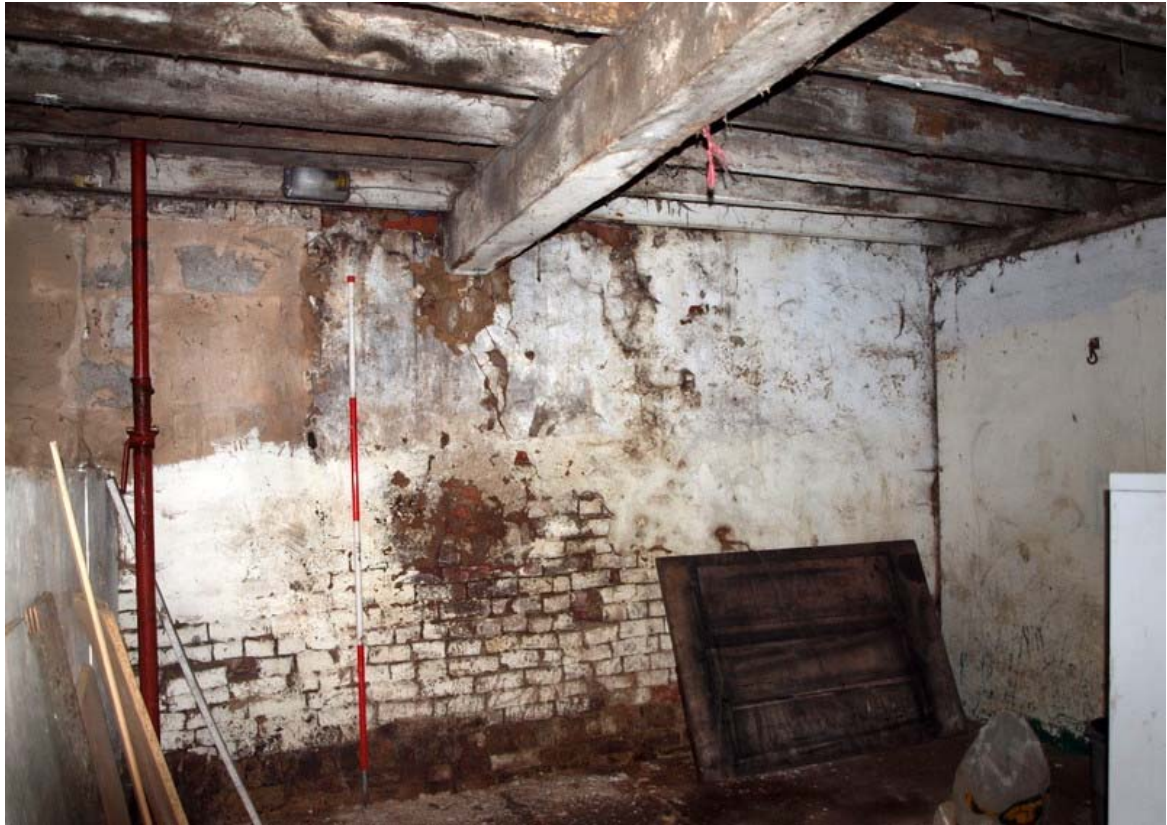
- 6.21 **Stable** (plates 29 & 30). The stable lies at the southern end of the barn. The ceiling is plywood of the floor above, supported on timber joists and east – west beams. The floor is concrete with a drainage channel running south from the personnel doorway from the barn in the internal wall. At the north end of the west wall is a blocked portrait window with a timber frame. South of this is a large cattle doorway, hung with a timber door. The northern jamb and lintel protrude from the wall (plate 31). The southern jamb is composed of concrete blocs, as is the remainder of the wall to the south. Within the concrete block wall is a landscape window fitted with a timber frame. The remaining walls are brick, whitewashed. Two timber horse boxes are located on the eastern side of the room, at the south end (plate 32). These are constructed of modern machine cut timber posts and panels. To the north of this the area is clear

Plate 29: Stable

Plate 30: Internal wall with doorway from stable to barn

Plate 31: Loading door and rebuilt concrete block wall to the south

Plate 32: Interior of horse box

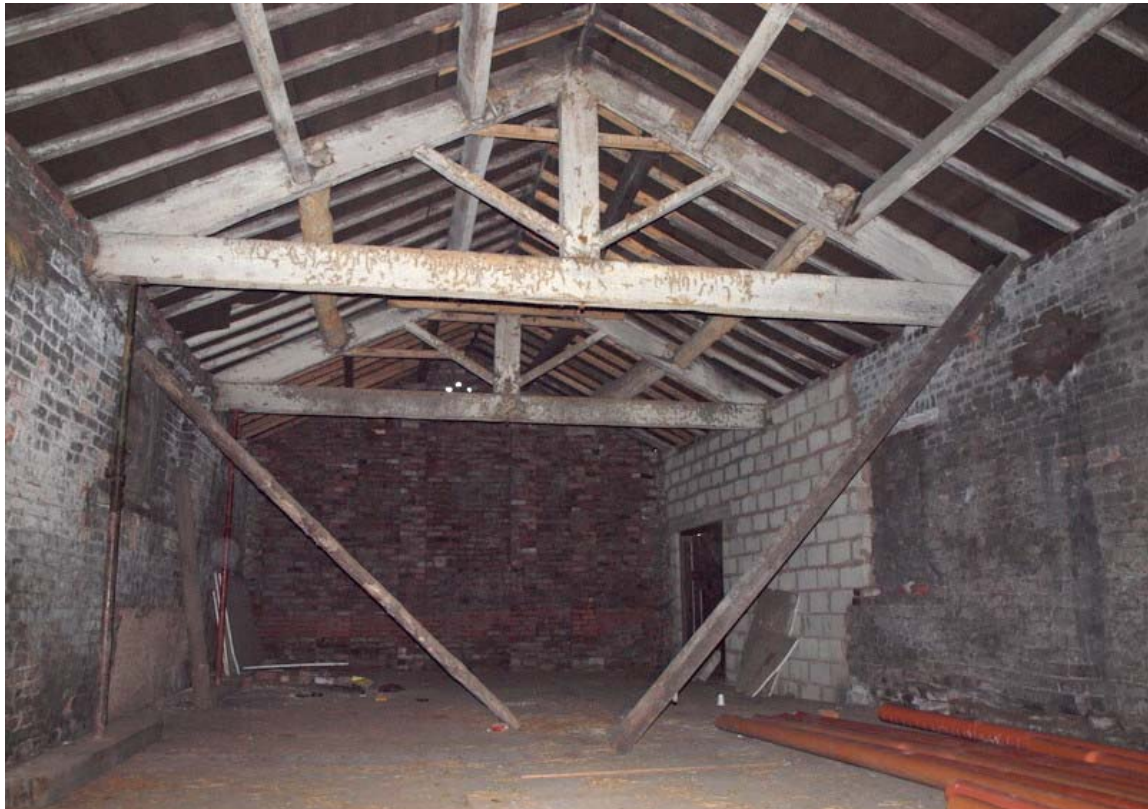
Plate 33: First floor over stable, showing king post trusses along with blocked window in west wall

- 6.22 **First floor** (plate 33). The first floor was deemed unsafe to access, thus only a visual assessment from a safe distance was achieved. The floor is plywood and the ceiling open to the rafters above. Four machine cut king post trusses support the roof. The western wall has a loading door at the southern end, hung with a timber batten braced door. As with the stable below, this section of the wall is composed of concrete blocks. To the north the wall is brick, with a blocked portrait window within it. This has a concrete lintel with brick headers above it. The eastern wall has a round eye hole, blocked with timber in the southern end.
