# **Ivy Farm Barn, Lytham Road, Moss Side, Lytham St. Annes, Lancashire**

## **An Archaeological Building Survey**

*By J.M. Trippier Archaeological and Surveying Consultancy*

**January 2010**

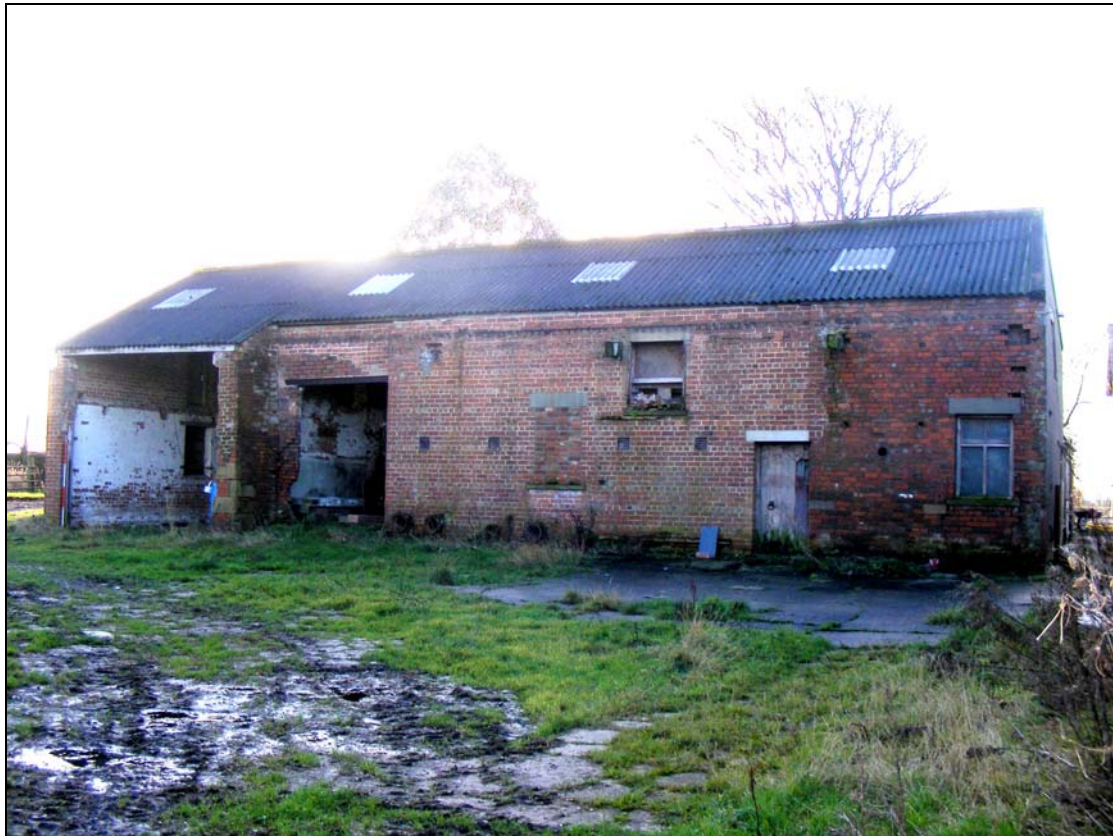
- 6.3.1 North Elevation (Plate 1) This elevation opens onto the yard and contains the only modern access into the barn although there is also a large blocked doorway in the south elevation of the western building (see para. 6.3.3 below). There are large double openings in both the eastern building and in the east bay of the western building. The former may approximate to the size of an original barn doorway although the latter, which has an RSJ lintel, may be a modern insertion. The north elevation of the eastern building merely comprises the piers on either side of eastern opening although the western pier also returns to meet the wall of the western building (**Plate 2**). The eastern pier is built of reddish machine-cut bricks whereas the western one is largely of orange hand-cut ones. The latter also contains sandstone quoins but there are no corresponding quoins on the other side of the entrance or anywhere else on the building.

Plate 1: North elevation of barn

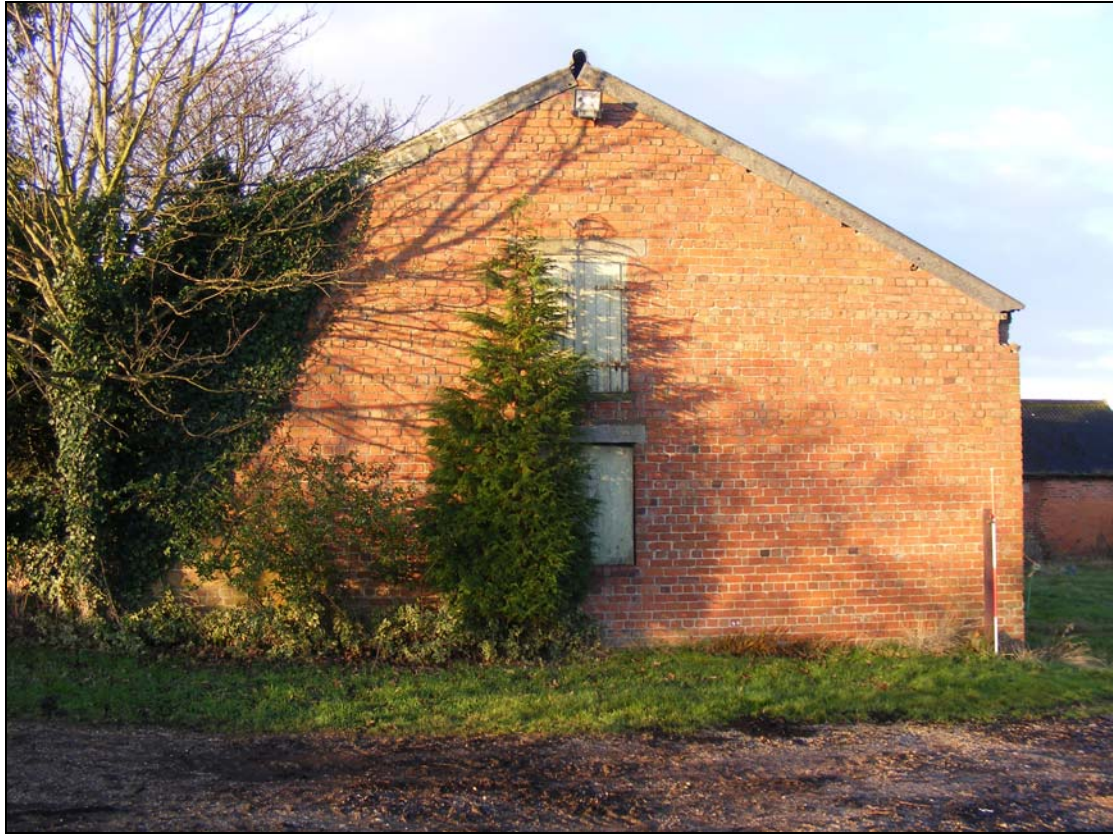
- 6.3.3 East Elevation (Plate 5). This elevation forms the gable end of the building and comprises of yellowy-orange machine cut bricks. There is a blocked window at the centre of the elevation at ground floor level with a stone lintel and brick cill. Directly above this is a wooden pitching doorway with a stone lintel and cill and timber batten doors with wrought iron hinges still in place. This elevation is otherwise featureless.

Plate 5: East elevation of barn

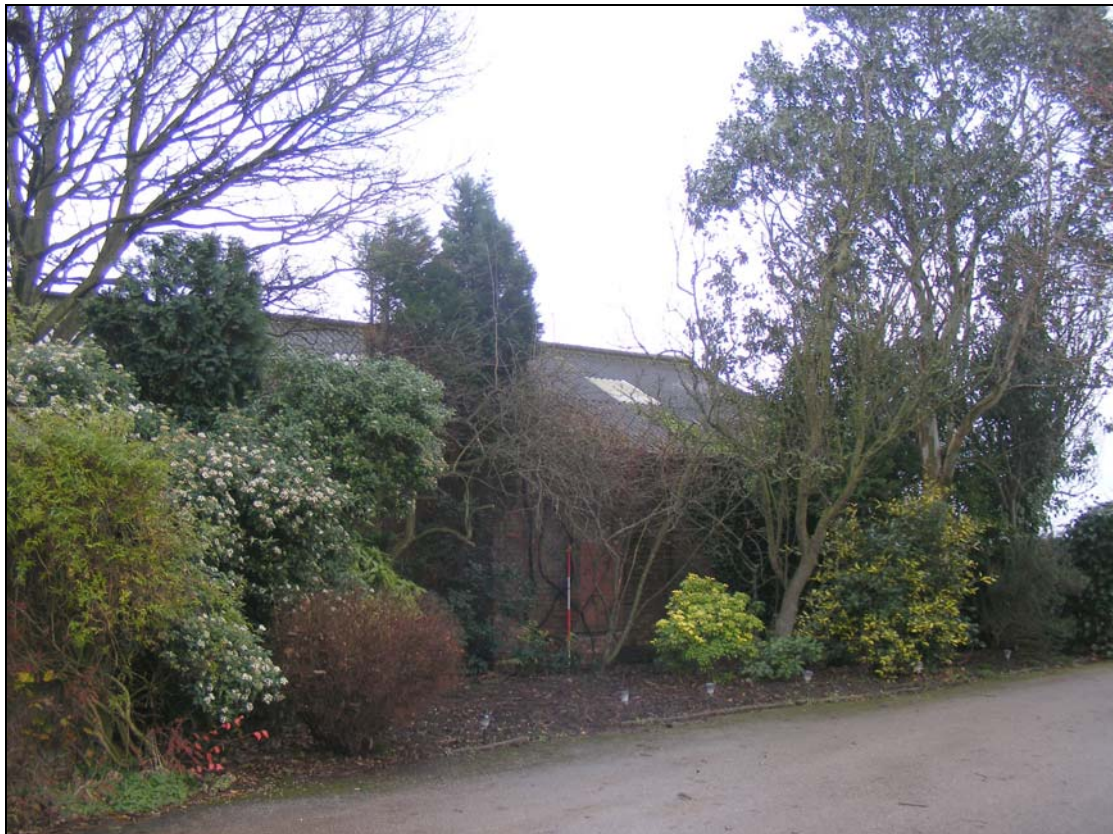
- 6.3.3 South Elevation (Plate 6). This elevation was covered in ivy and other foliage which made viewing difficult. However from what can be seen the brickwork appears to generally match that of the north elevation. At the western end of this elevation the wall is masked by the later outrigger which is also ivy covered (**Plate 7**). There are a number of blocked openings on this elevation (see **Fig. 3**). At the west end is a window masked by the outrigger (see para 6.4.3 below). To the right of the outrigger at ground floor level is a blocked window with a stone lintel and cill. To the right of this is a large blocked doorway 2m 26cm in width with a wooden lintel. To the right of the doorway is another blocked window at ground floor level with a stone lintel and cill. At this point the south elevation juts out approximately 1m, although the colour and style of brick remains the same. In the remaining section of the south elevation there are a further two blocked ground floor level windows. The first, like all the others has a stone lintel and cill but the eastern one is completely covered with ivy and other foliage and cannot be seen. However, by examining the internal wall it can be seen that this end window was approximately half the size of the others.

Plate 6: South elevation of barn

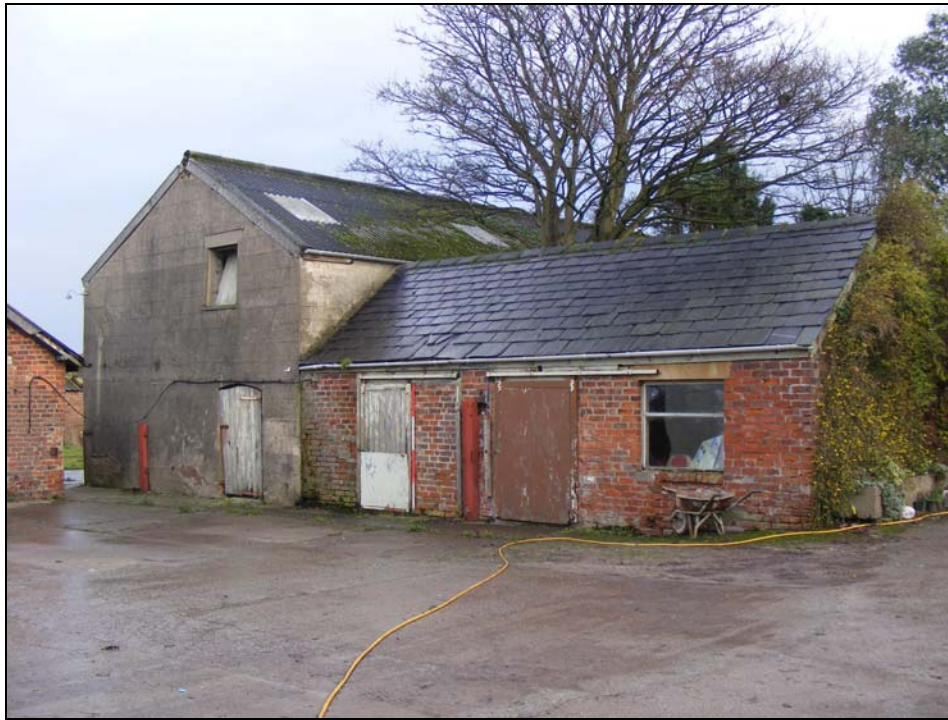
- 6.3.4 West Elevation (Plate 7). This elevation forms the gable end of the barn and the western elevation of the outrigger. The gable end of the barn is rendered and scored to give the appearance of ashlar. This continues round to meet the roof of the outrigger. There is a single timber batten door at ground floor level in the gable end and a window with a timber lintel and stone cill at first floor level.

Plate 7: West elevation of barn and south extension

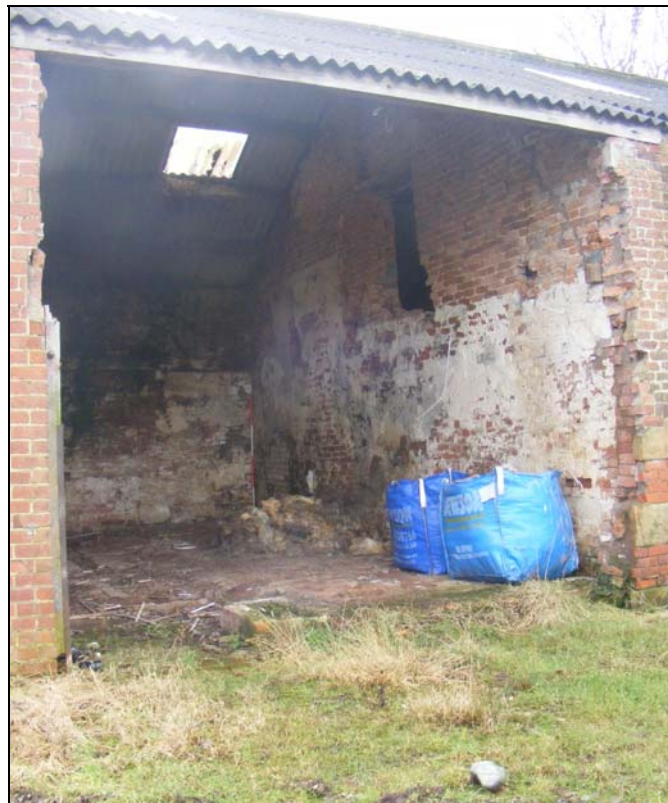
- 6.4.2 Eastern Building (Plate 8). This part of the barn is separated from its western counterpart by a partially plastered brick wall. The lower portion of the wall comprises red hand- cut bricks, whilst the upper section bricks appears to be more of an orange colour and more modern than those below. There is an open hatch at 1<sup>st</sup> floor level with a wooden lintel and an identical blocked one directly above it which is cut into by the roof timbers. Below the open hatch there are 4 equally spaced holes that would have contained timber floor joists. The lower section of this wall shows evidence of three, possibly four, stone stalls dividers running on an east-west orientation.

Plate 8: Hay store in former shippon

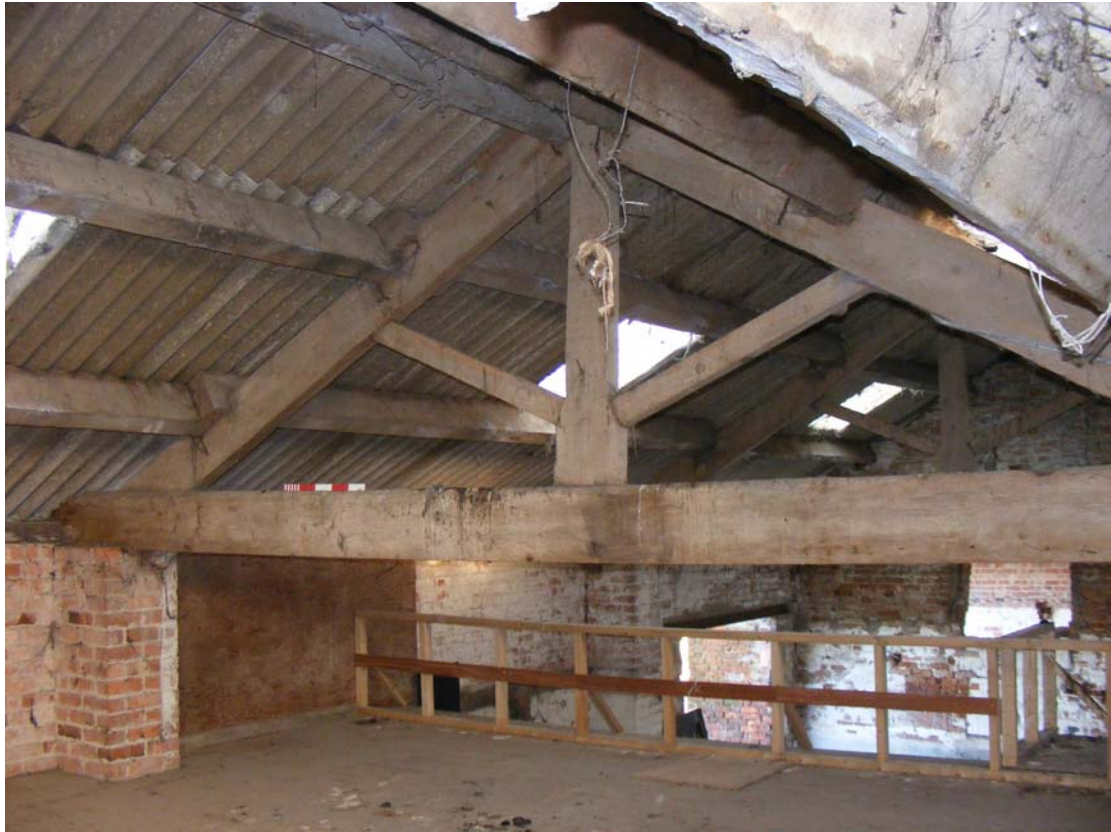
- 6.4.3 Western Building. The north wall is of reddish machine- cut brick and contains the opening used to enter this section of the barn (**Plate 9**). To the west of the opening are the four circular earthenware pipes, ventilation panels and the windows and doors described on the elevation. The east wall mimics the west wall of the east section in terms of there being an open access hatch and a blocked one above (**Plate 10**). The south wall is built of orangy-red hand cut bricks although there is some newer red machine cut material at the eastern end where there is a blocked window with a stone lintel and cill. The wall then steps in approximately 1m and contains the two further blocked windows and the large blocked door referred to on the south elevation (para. 6.3.3 above). There is a further blocked window at the western end of the barn that is now covered by the southern outrigger (**Plate 11**). The west wall also comprises orangy- red hand cut bricks, but there are covered with plaster in the lower half of the wall. There is a doorway with a window directly above it as described at para.6.3.5 above.

- 6.4.5 Two king post (**Plates 9-11**) trusses run parallel to each other and cross the barn on a north-south orientation. Below these is a timber mezzanine floor which runs from the western wall to the most eastern king post. The floor of this structure can be divided into three areas; the western bay comprises an area of square stone setts, similar to those in the eastern structure, and sloping downwards towards the north and south walls. In the centre there is an east-west channel in which the setts are laid at right angles to those of the surrounding area. The central bay is concreted and the eastern bay is of the same material but is 100mm higher.

Plate 9: King-post roof truss in barn

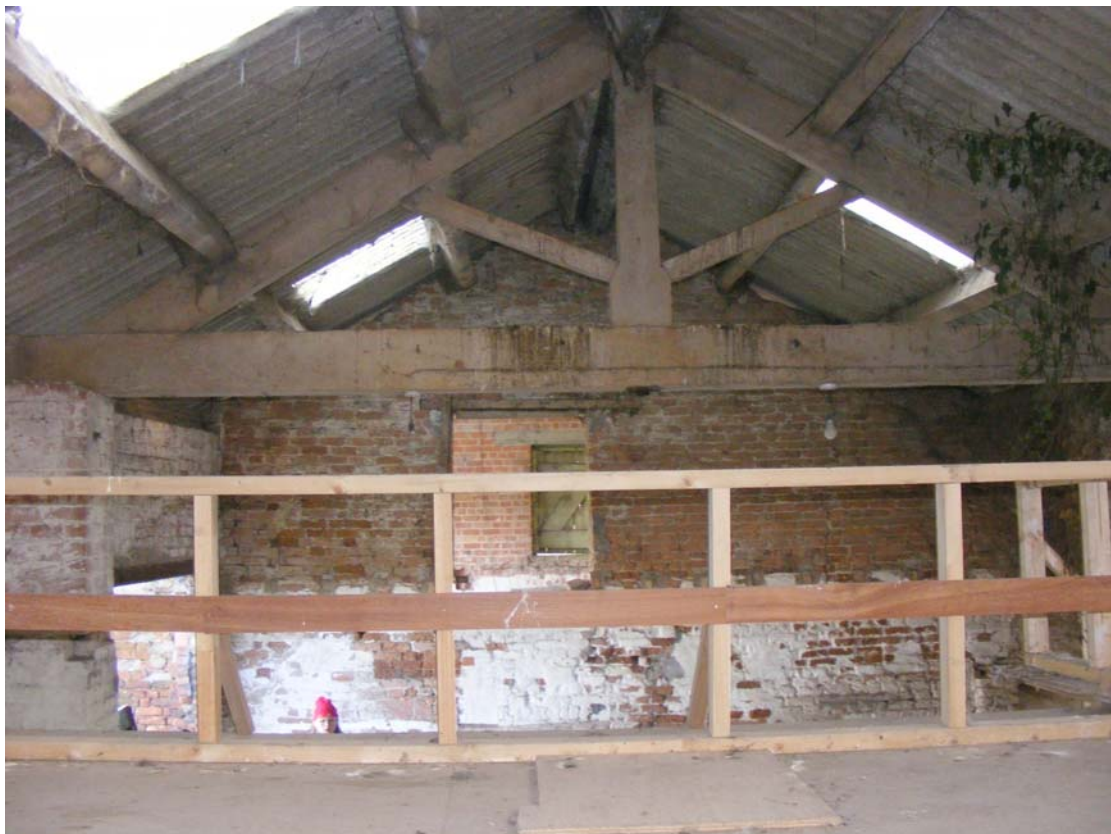
Plate 10: King-post roof truss in barn and dividing wall of barn

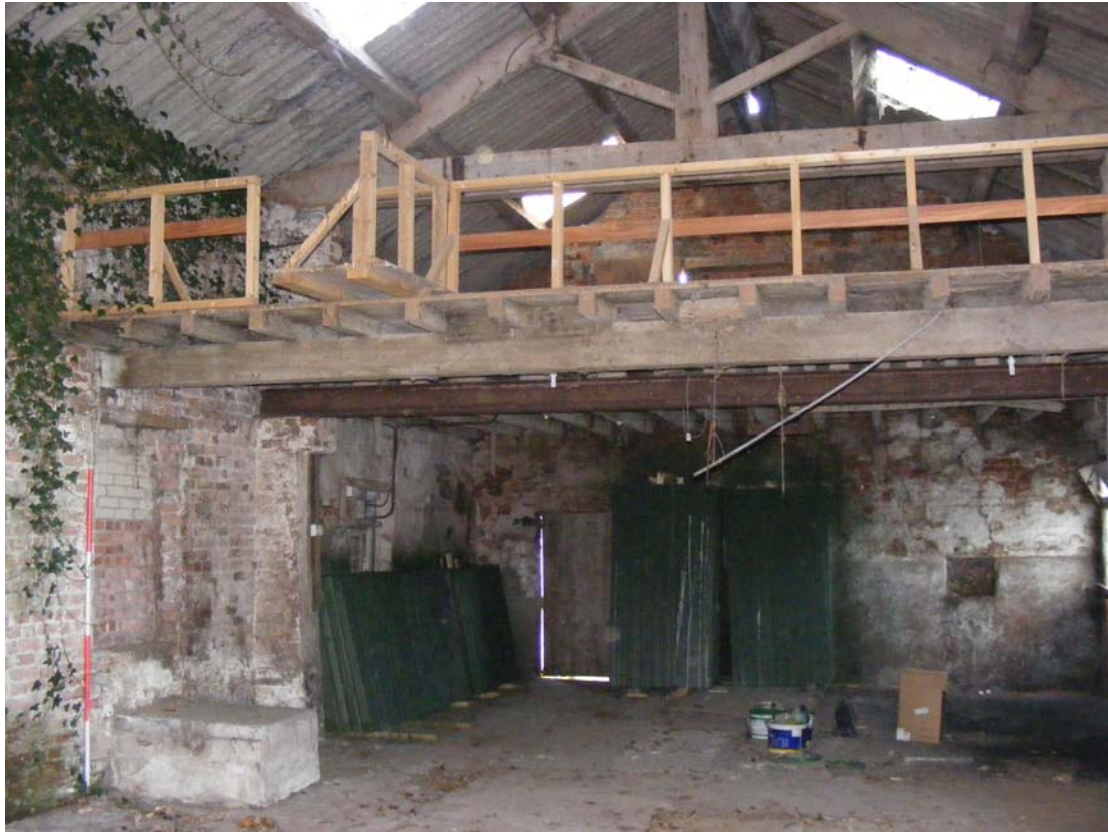
Plate 11: Interior of barn looking west

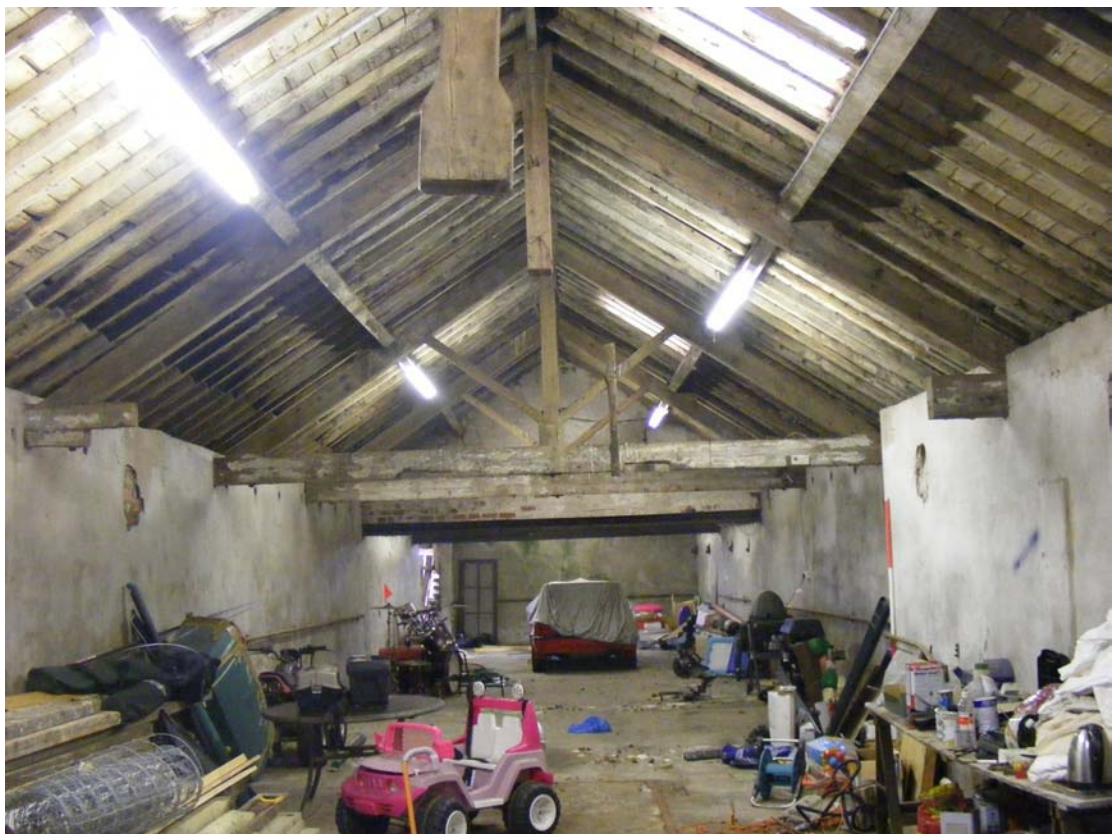
6.5.3 Internal Description (**Plate 16**). All of the walls are covered in grey plaster. The ventilation pipes are visible just below the wallplate. The east wall is stepped in 300mm for some 12m from the north end. The southern 2/3s of the building has four king post roof trusses but most of the tie beams are missing and only the 3<sup>rd</sup> one is complete. In the northern part there are two RSJs. The southerly one supports a brick dwarf wall which supports the principal rafters whilst the northern one acts as a tie beam. The floor is covered in grey concrete but two rows of red bricks 10.7m in length and 1.63m in width lead in from the south elevation down the centre of the shippon. The west row lines up with the inside edge of the blocked doorway in the south elevation suggesting that a similar doorway would have existed on the east side of the south elevation rather than the current large double door. It appears that they marked the inside edges of access passages for cattle and that there would have been a central line of boskins where they were tethered nose to nose.

Plate 16: Interior of Shippon

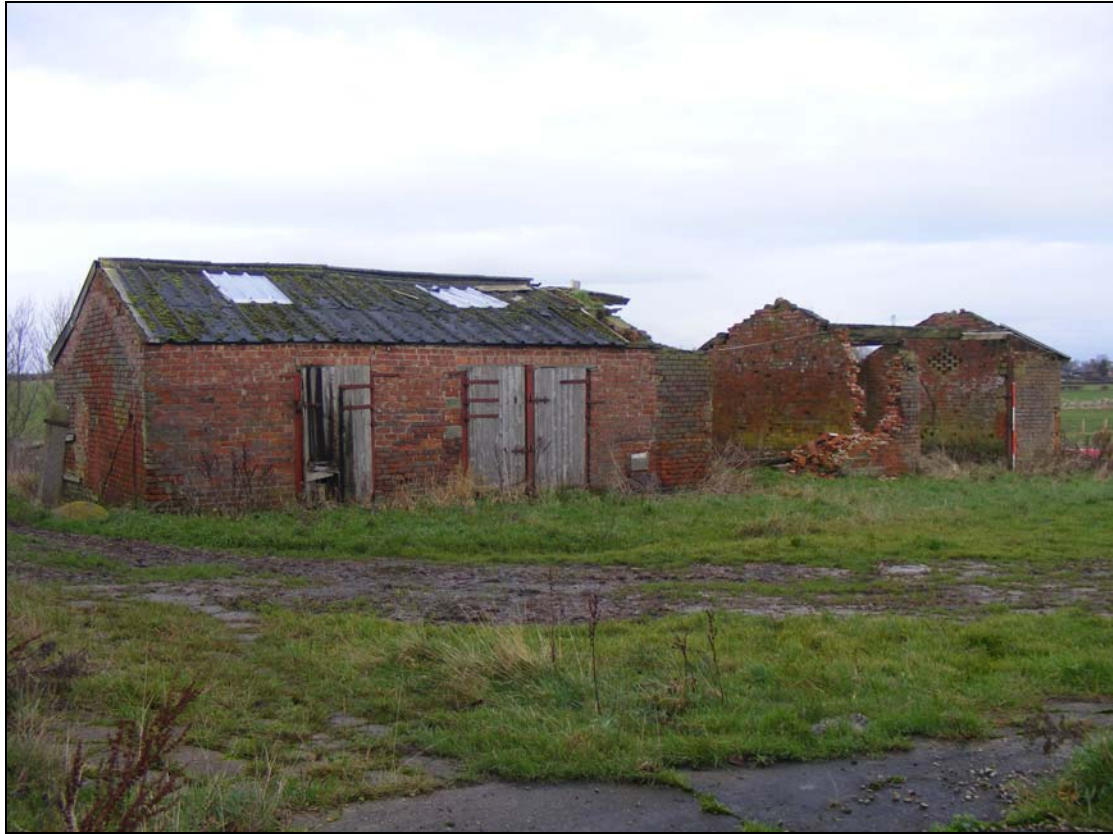
6.6.1 General Description (**Plate 17**). This range comprises a rectangular shaped single storey building constructed with orange-red handmade bricks and orientated east west. It contained five separate cells all of which appear to have been used to house various animals. There are two phases of construction; the first involved the two easternmost cells which were built between 1847 and 1893 and a later extension to the west that was constructed between 1893 and 1911. Most of the south elevation of the 1<sup>st</sup> phase has collapsed and there is no roof. The 2<sup>nd</sup> phase has a double pitched roof with a profile metal covering.

Plate 17: South elevation of animal shelters

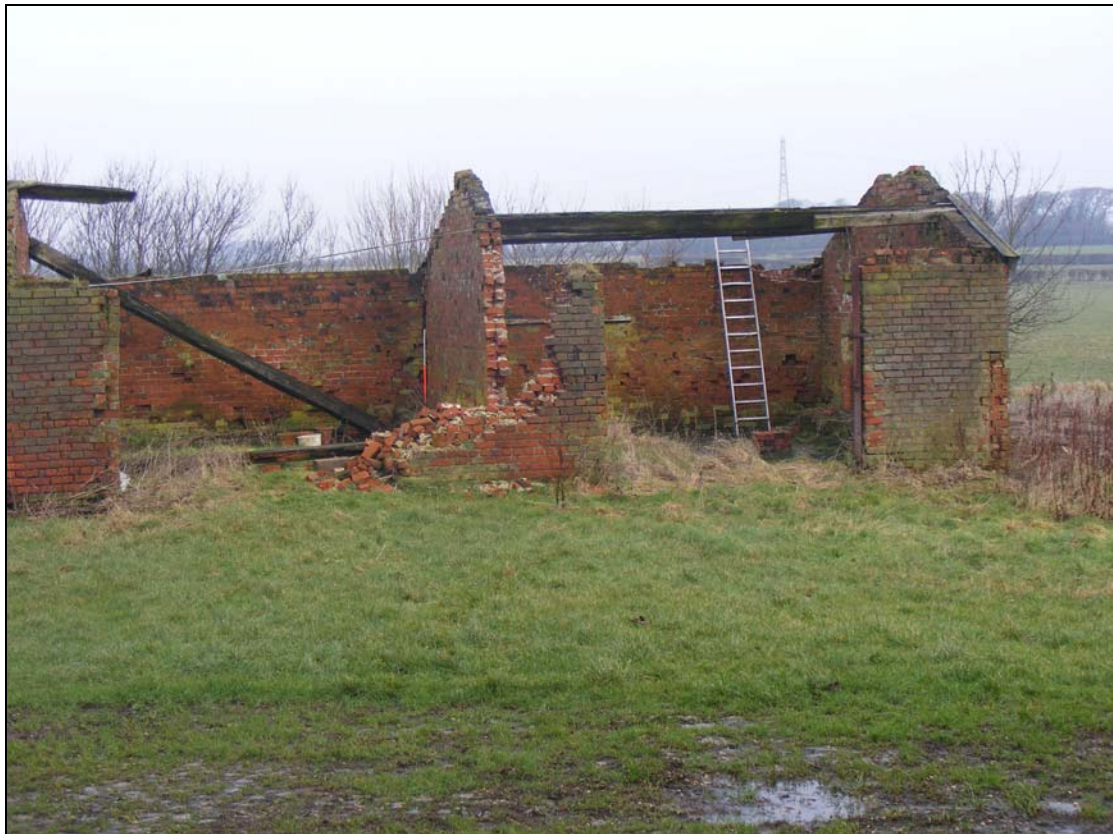
- 6.6.6 Internal Description Cells 4 and 5 (Plates 18 & 22). These are located at the eastern end of the building. The walls comprise the same brick as described in the external elevations with the floor appearing to be covered in concrete. In the east wall of Cell 5 is the diamond shaped ventilation grille described in the gable end at para. 6.6.2 above. There is no roof in situ although the remains of the roof timbers can be seen in cell 5. Both cells contain a concrete trough that runs the full length of their east walls at ground level. They are 400mm wide and rise 220mm above the ground. They each hold half an earthenware pipe.

Plate 18: East end of south elevation of animal shelters

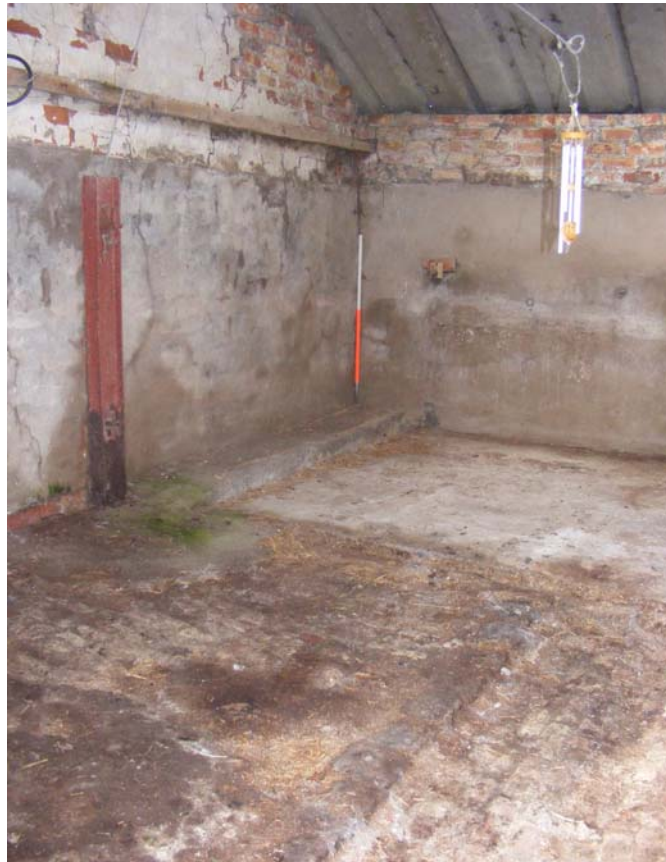
- 6.6.3 Internal Description Cell 1 (Plate 19). This is located at the western end of the building and is accessed via a full-height ledge and batten door with wrought iron hinges and latch. The walls comprise painted brick covered in grey render in places. There are the remains of a metal ring on the north wall and a steel stanchion on the west wall. In the east wall is an open hatch with a wooden lintel and cill about 1.5m above floor level. The floor can be divided into two areas; the north area comprises concrete that is 60mm higher than the rest of the floor. There is a concrete plinth, 360mm wide and 110mm deep running along the west wall until it meets the steel stanchion. To the south of the concrete the floor comprises stone setts. A 950mm wide access track runs north from the doorway and to the west of this is a depressed area which was which was probably a drainage channel. Beyond that is a slightly raised line of setts and then the main floor area which was probably a standing area for beasts and which comprises setts overlain with concrete.

Plate 19: West cell in animal shelters

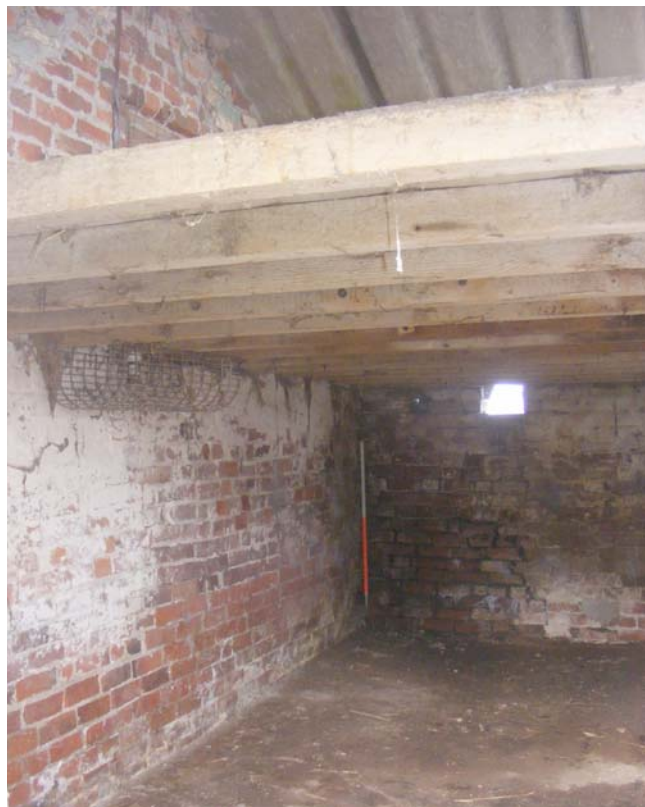
- 6.6.4 Internal Description Cell 2 (Plate 20) The walls of this cell are bare brick whilst the floor is concrete. In the north wall there is a small opening and in the east and west walls are opposing open hatches identical to that described in Cell 1. In the southwest corner is a small concrete trough 500mm by 770mm. Running across this room is a timber mezzanine floor with 13 floor joists located directly below the access hatches in the east and west walls.

Plate 20: Next to west cell in animal shelters

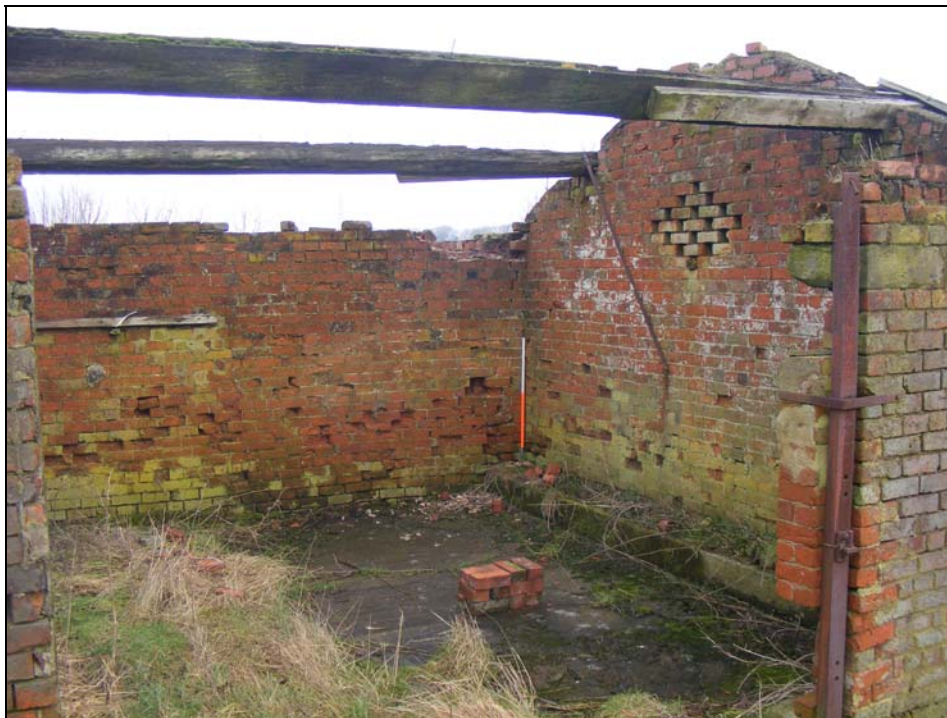
Plate 22: East cell of animal shelters
