# **Lane Ends Farm Barn, Park Road, Waterfoot**

## **An Archaeological Building Survey**

*By J.M. Trippier Archaeological and Surveying Consultancy*

**October 2009**

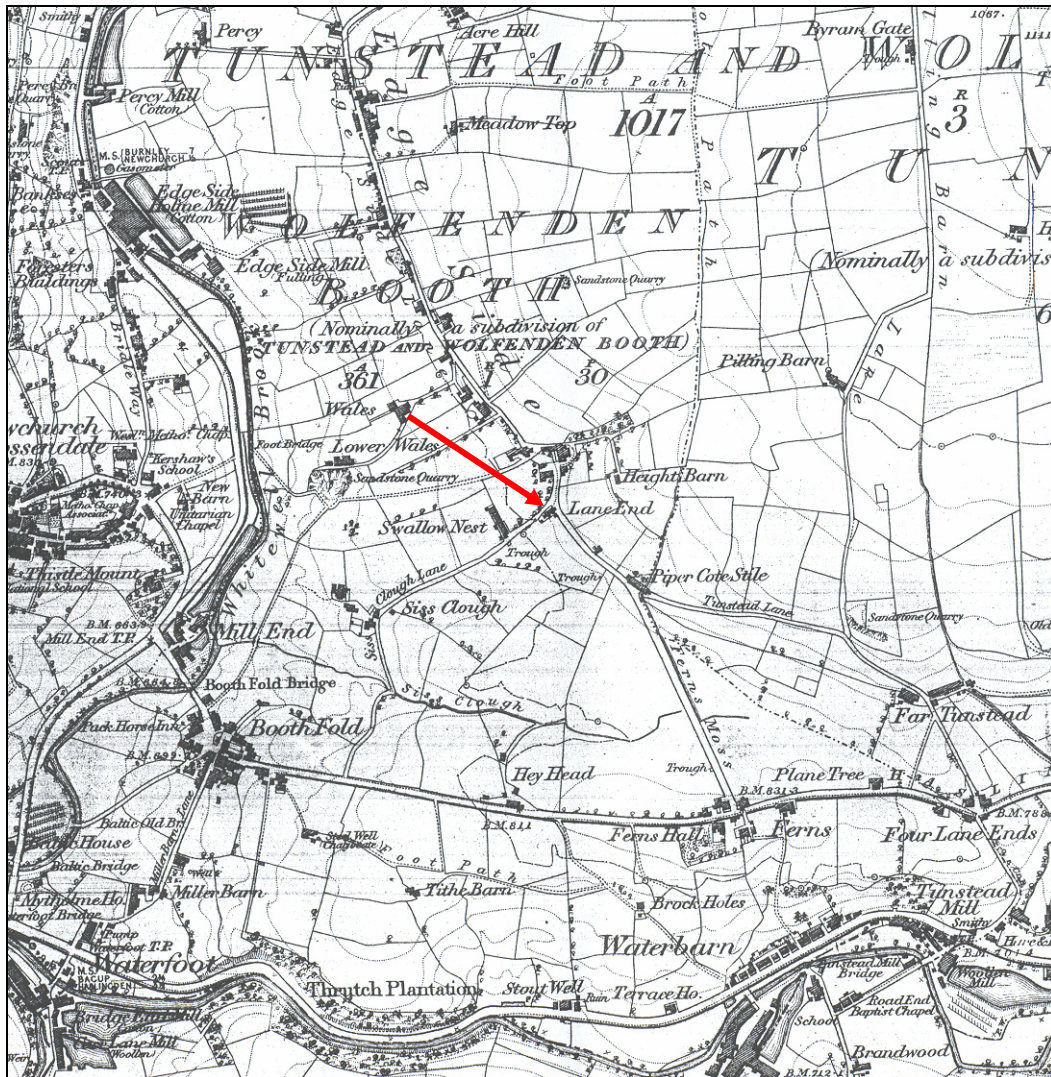
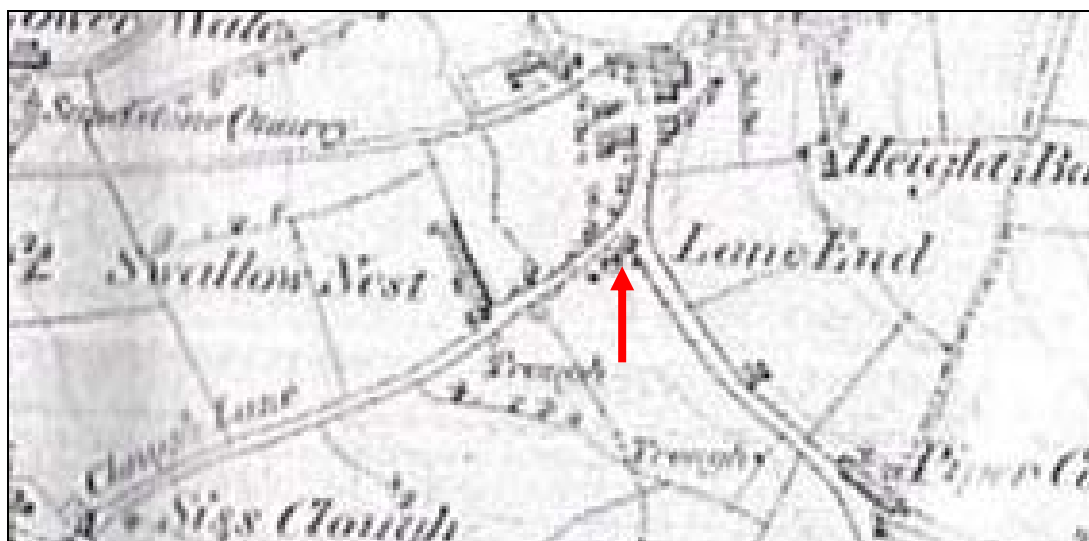
Fig. 4: OS. 6" Lancashire Sheet 72, 1844 (actual size)

- 5.8 The first definite cartographic record of Lane Ends Barn can be found on the 1844 6'' map of the area (**Fig 4**). Although, the actual physical form of the building is difficult to determine it is visible and clearly labelled. According to the 1841 census return (HO 107/509/17) two families lived at Lane Ends, with both male heads of the household being described as labourers. The first family listed is the Riley family which consisted of John and Sarah, both aged 40 and their five children, whose ages ranged from 18 to 1. Another male is recorded as living with the Riley family by the name of John Cusley, aged 12, although his relationship to the family is not clear. Unfortunately the surname of the other family recorded as living at Lanes End was not legible, although the first names were; the family comprised of a Robert and Margaret, aged 35 and 36, and their seven children, whose ages ranged from 15 to 1. The census records for the next 50 years do not list Lane Ends Farm. This could be for a variety of reasons, including the property being empty/ derelict for this period or possibly used as farm buildings but not as a residence. However by the time of the 1901 census Lane Ends Farm was occupied by one family, the Sloughfields. The family comprised of George, aged 32 and who is described as a quarryman, his wife Elizabeth aged 31, and their four children aged between 6 and 1.

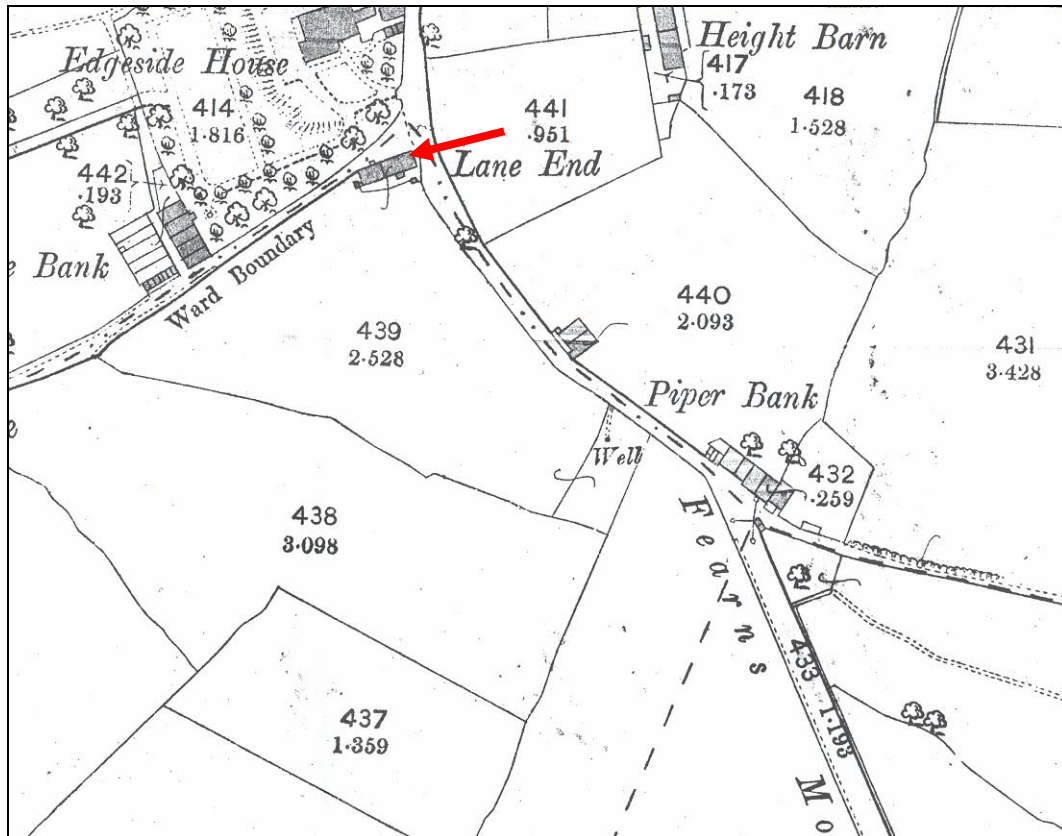
Fig. 5: OS. 25" Lancashire Sheet 72.14, 1893 (actual size)

- 5.9 By the time of the 1893 25'' map (**Fig 5**) the farmhouse and adjoining barn are clearly visible along with a couple of tiny outbuildings. The building itself is set within a medium sized field with more fields of various sizes to the south, although it is not possible to determine if these belong to the property in question or not. To the immediate west of the property lies Siss Clough and a

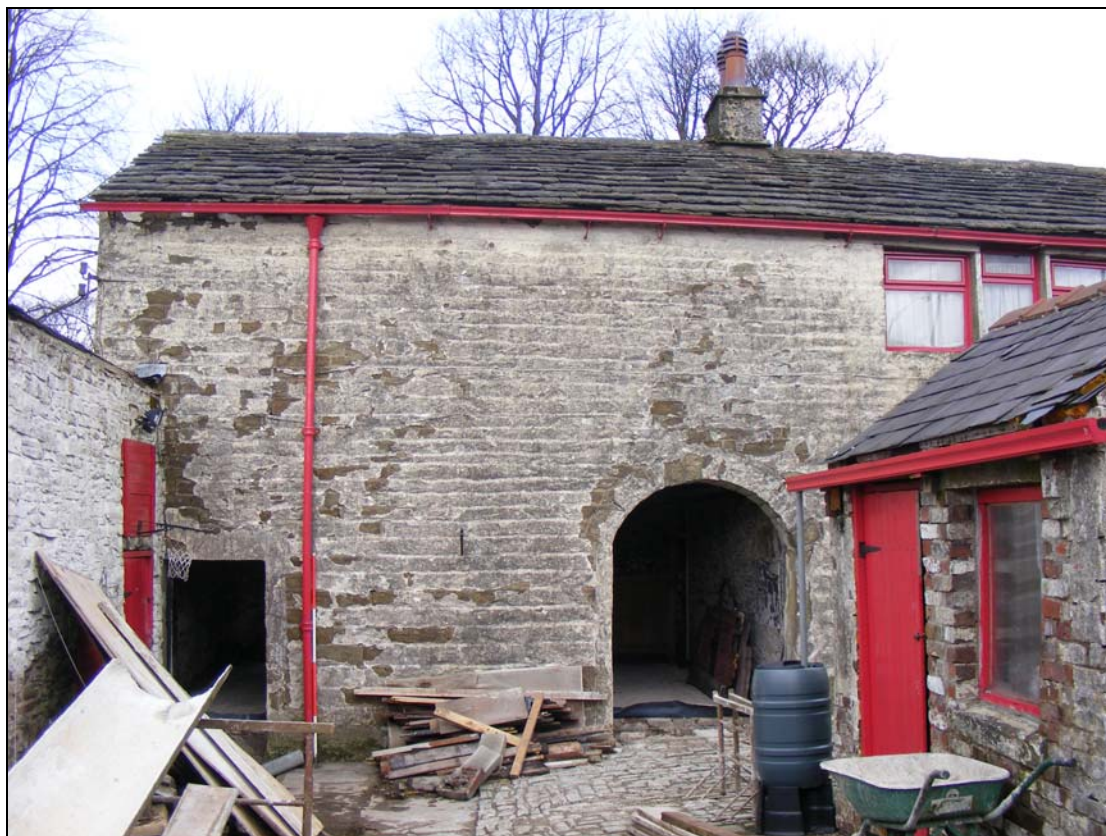
**Plate 1: South elevation of barn**

- 6.2.1 Southern Elevation (**Plate 1**). This elevation comprises the front of the building and is constructed in regularly coursed watershot sandstone blocks bonded with lime mortar re-pointed with cement in places. It is covered with a white lime render. It is characterised by two doors; a personnel door located at the west end of the face and a cart door, the eastern jamb of which is close to the dividing wall between the house and the barn. The personnel door has a sandstone surround, although no frame or door is fitted. The cart door has large sandstone jambs with a semi-circular arch of sandstone voussoirs above. The doors, which are of batten and braced red painted timber, have been removed although were still on site. The eastern door has a single light within it (**Plate 2**).

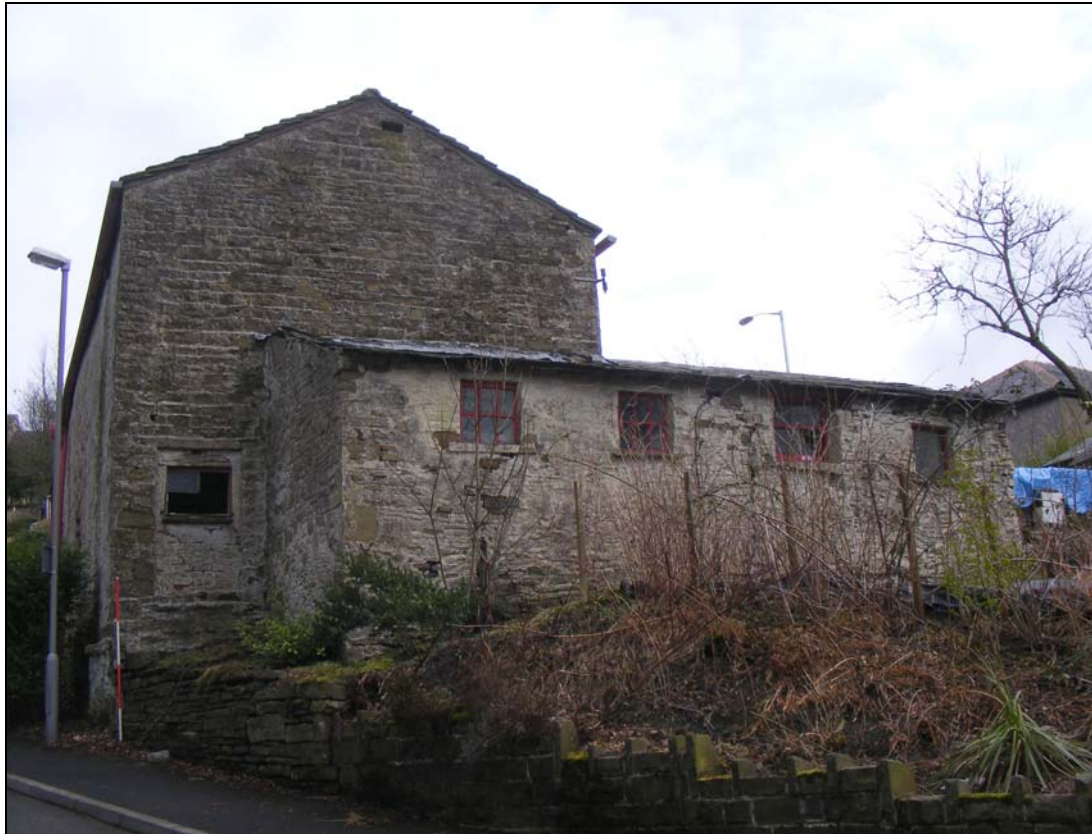
**Plate 3: West elevation of barn**

- 6.2.2 Western Elevation (**Plate 3**). This forms one of the gable ends of the building and is partially covered by the outbuilding built onto this elevation (see para.6.1.1 above). The wall is built in two different styles of construction. Within the area enclosed by the outbuilding the wall is constructed of coursed watershot sandstone blocks, the remainder being of shaped sandstone rubble, regularly coursed. The whole face is covered with a white lime render. To the

north of the outbuilding is a single blocked doorway which has subsequently been turned into a window. This has been achieved by blocking the doorway with bricks and placing a landscape window above with a timber frame and 2 lights. The 'door' is not located flush with the outside ground level, being some 70cm above this. The outside ground level is in turn a metre or so above the adjoining street level.

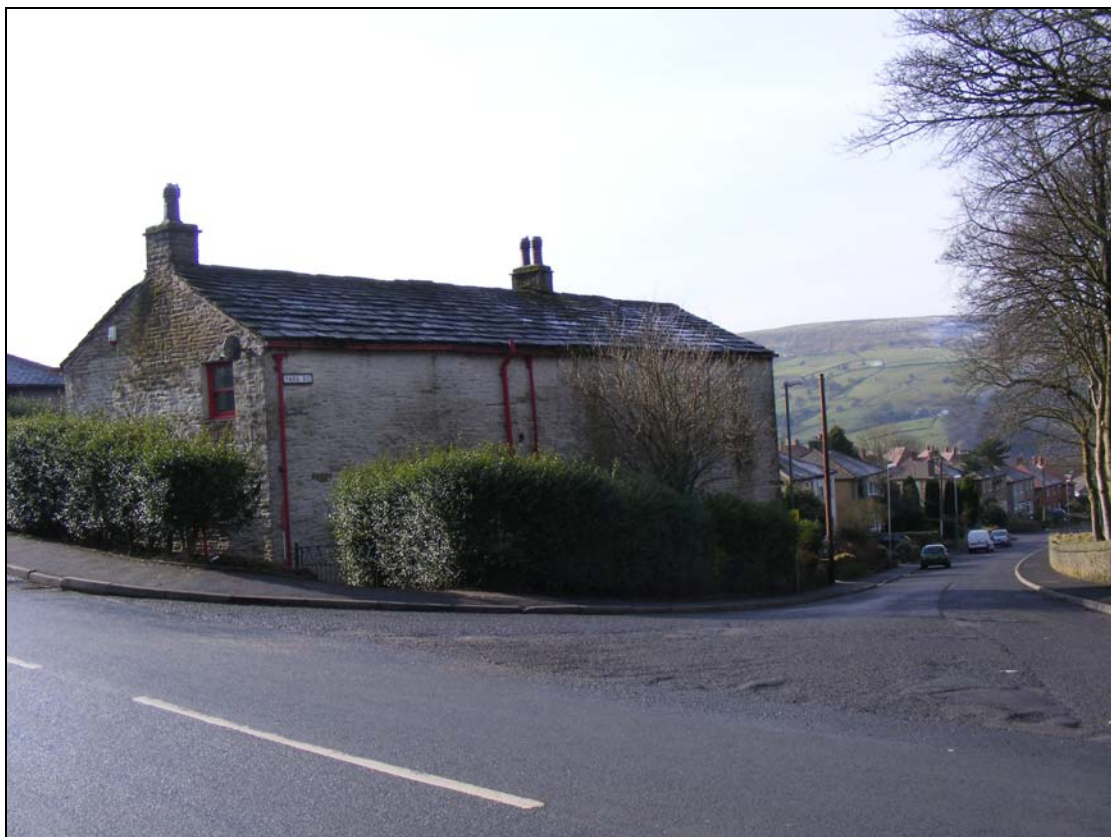
**Plate 4: East and north elevations of barn**

6.2.3 Northern Elevation (Plate 4). This elevation comprises the rear of the building, facing onto Park road. The whole face has been rendered with lime wash and has no windows or doors. The wall is constructed in a variety of ways. At the bottom, the wall is built of rough sandstone rubble, randomly coursed, up to approximately 1m. It also bulges outwards, some 20cm. Above this for 1.6m is rough sandstone rubble, but this time brought to courses. Above this again are regularly coursed watershot sandstone blocks, finally topped with regularly coursed shaped sandstone rubble. (Plate 5).

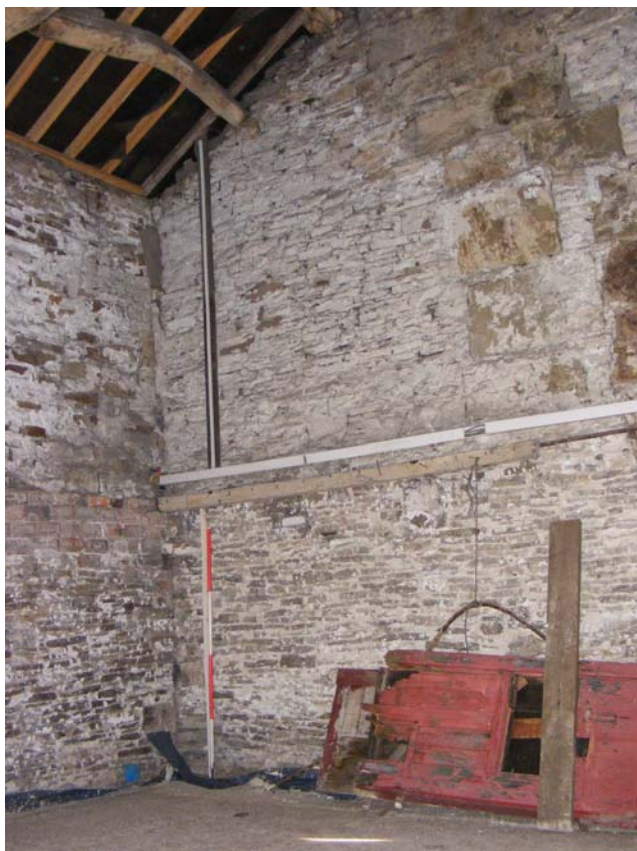
**Plate 6: North-east corner of barn**

6.3.1 The barn consists of a single space (6.40 x 5.64m) open to the underside of the roof (Plate 6). All internal walls and fittings have been removed and the floor has recently been concreted over. The owner advised that the west side of the space had been used as a shippon and that the three timber boskins, which formed four stalls in the centre of the barn, have been removed. These were available for inspection and were found to be modern but constructed in traditional style. One was photographed (Plate 7). The walls are constructed of rough rubble, occasionally brought to courses. Limewash render is still visible on most of the walls, most notably the south wall at ground floor level, and all the walls at first floor level (Plate 8).

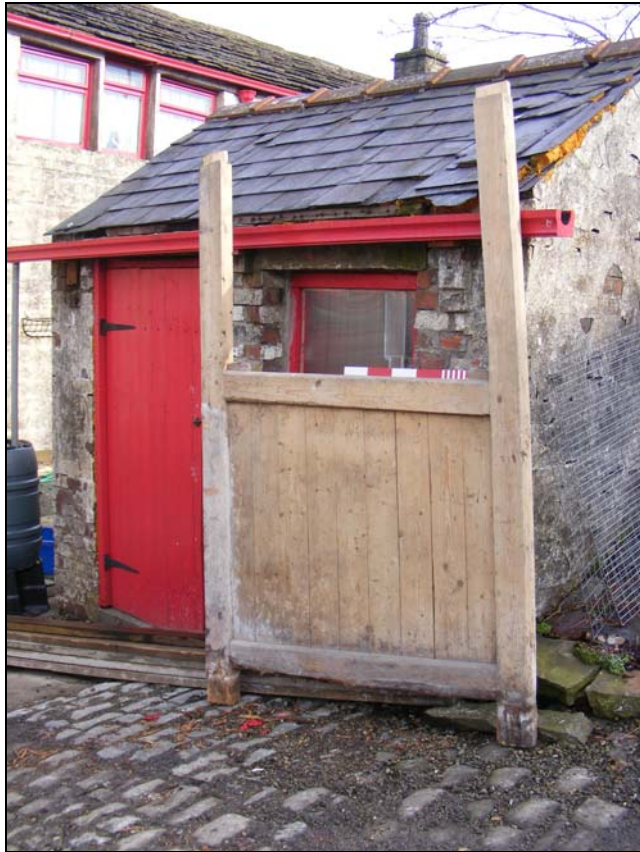
**Plate 7: Boskin removed from barn**

- 7.2 The presence of the three boskins indicates that the area below the first floor was divided into four stalls used for housing beasts. It is likely that these would have been 'doubles' allowing this shippon area to house eight beasts. The shippon would have been accessed from the door at the west end of the south wall. The floor above would have been a haystore allowing hay to be fed down to the beasts. The open area inside the large barn door would have allowed the hay wains to gain access so that the hay could be pitched onto the platform over the shippon. It seems likely that the two blocked windows in the west wall were original. The blocked doorway at the north end of the west

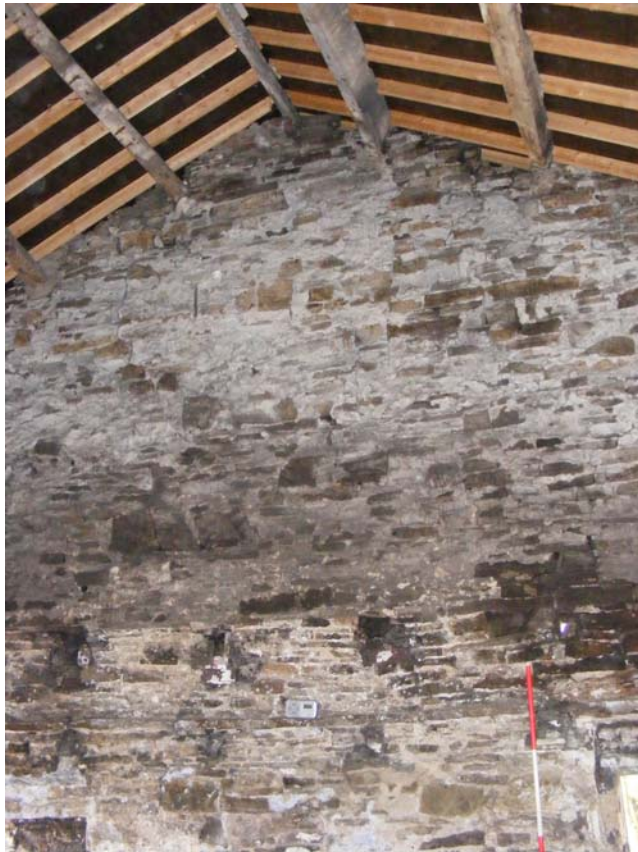
**Plate 9: East wall of barn**

6.3.2 The eastern wall, which forms the dividing wall between the house and the barn, has large sandstone blocks (700x400mm) as a part of its construction relating to the chimney flue (Plate 9-jpg002). Approximately 600mm from the southern end of east wall is an opening blocked with sandstone rubble. It is almost 1m from the ground and 0.88m wide. Given its position it is unlikely to be a window and is possibly the back of a bread oven within the house although it is not visible therein.

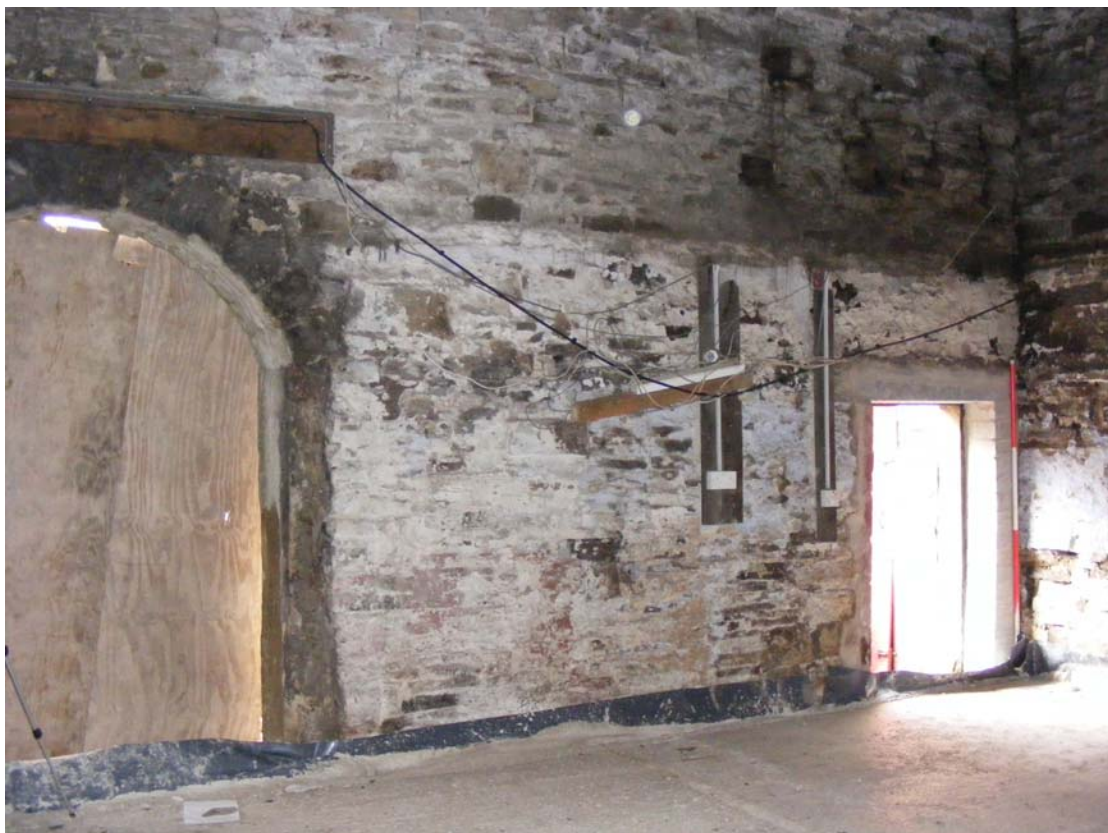
**Plate 10: West end of south wall of barn**

6.3.3 The southern wall has a cart doorway at its eastern end and a personnel doorway at its western end (Plate 10). The cart doorway has a sandstone surround and a semi-circular arch of sandstone voussoirs. Two iron hooks are present on each of the jambs where the doors were hung. The personnel doorway at the western end of this wall has bricks forming its eastern jamb and concrete blocks forming the western, with a concrete lintel above.

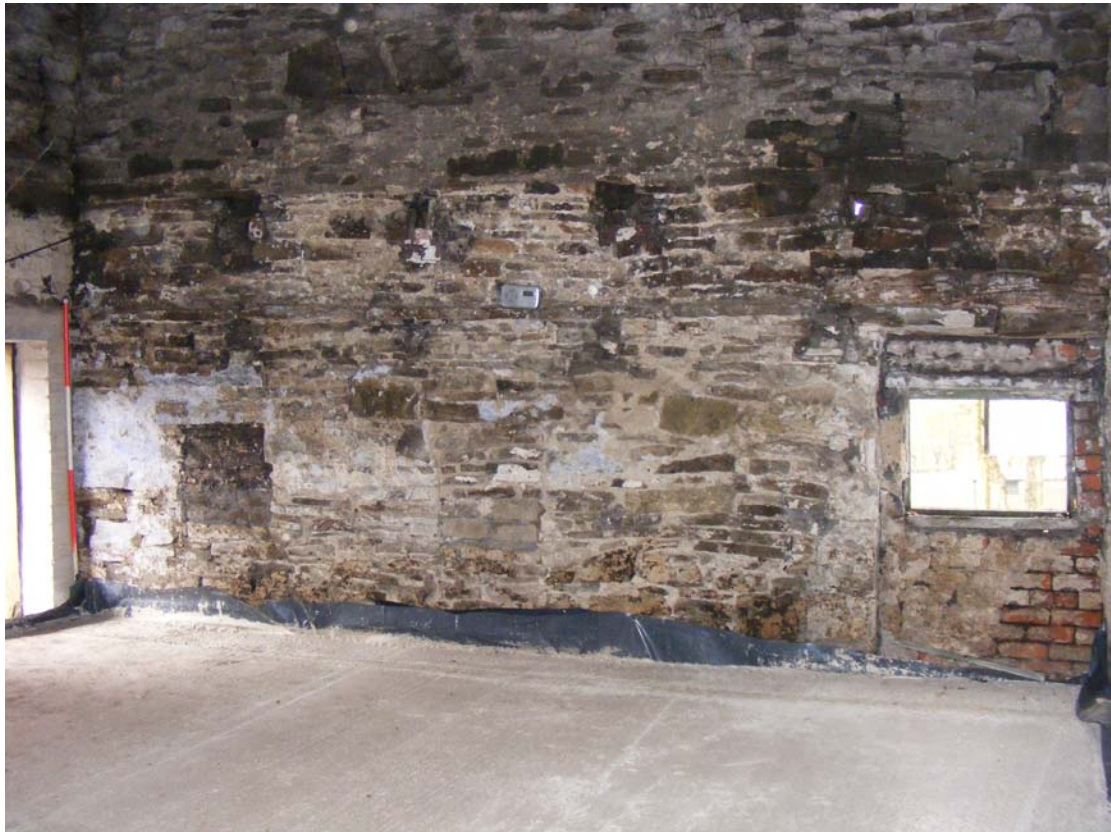
**Plate 11: Lower part of west wall of barn**

6.3.4 In the western wall are two blocked windows; one located at the southern end and the second located just to the south of centre (Plate 11). Both of these are

square with sandstone lintels and are blocked with sandstone rubble. These are not visible on the exterior. At the northern end of this wall is a blocked door, converted into a window (see para.6.2.2 above). The doorway has a sandstone lintel, with a hand cut timber lintel above that. The southern jamb is of sandstone quoins, with the northern jamb being the corner of the wall. The doorway has been blocked with brick and a timber 2 light frame inserted.

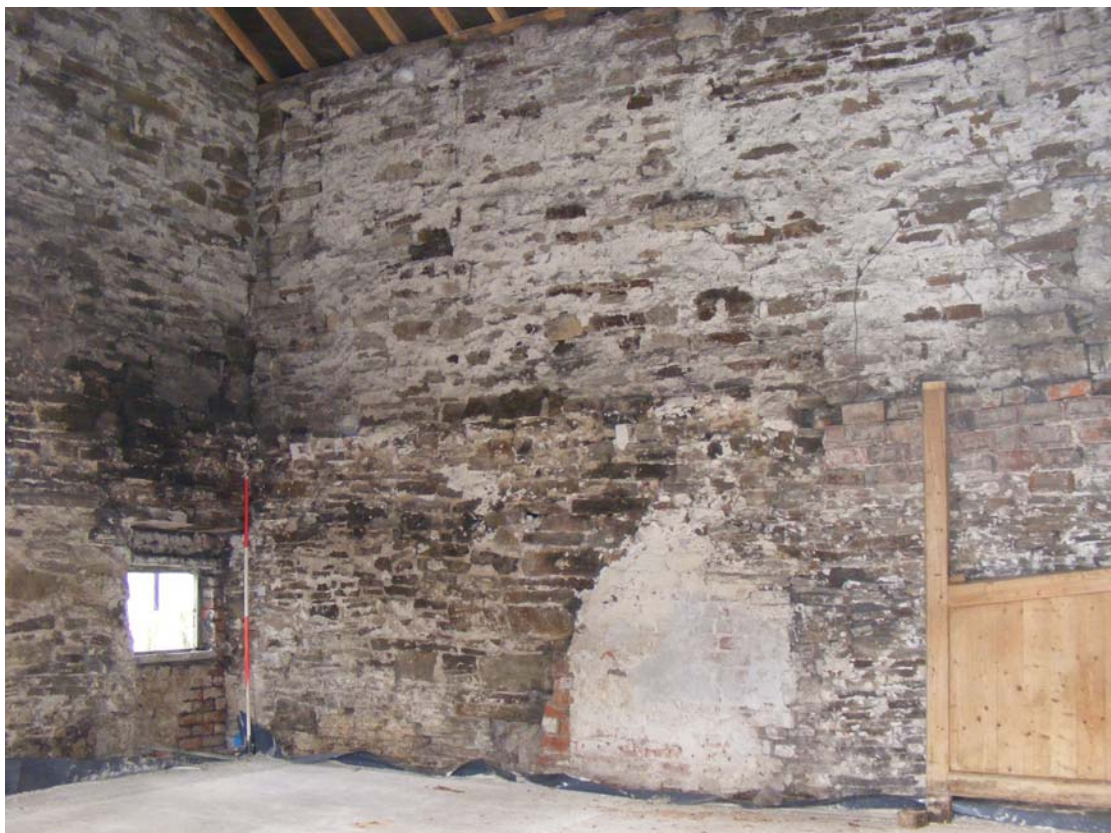
**Plate 12: North wall of barn**

- 6.3.5 A partial first floor has been removed at the western end of the building, the line which is evident on the west wall and the western end of the southern wall. This is shown as a series of timber joist holes partway up the western wall and another joist hole located in the north wall, 4m from the west wall, presumably for a cross support beam. There is also a line of through-stones along the west wall, just below the level of a line of joist holes. Other through-stones, although not forming a line, are located at first floor level on all of the walls. The north wall has brick patching near the centre of the wall, which is not apparent from the exterior (**Plate 12**).

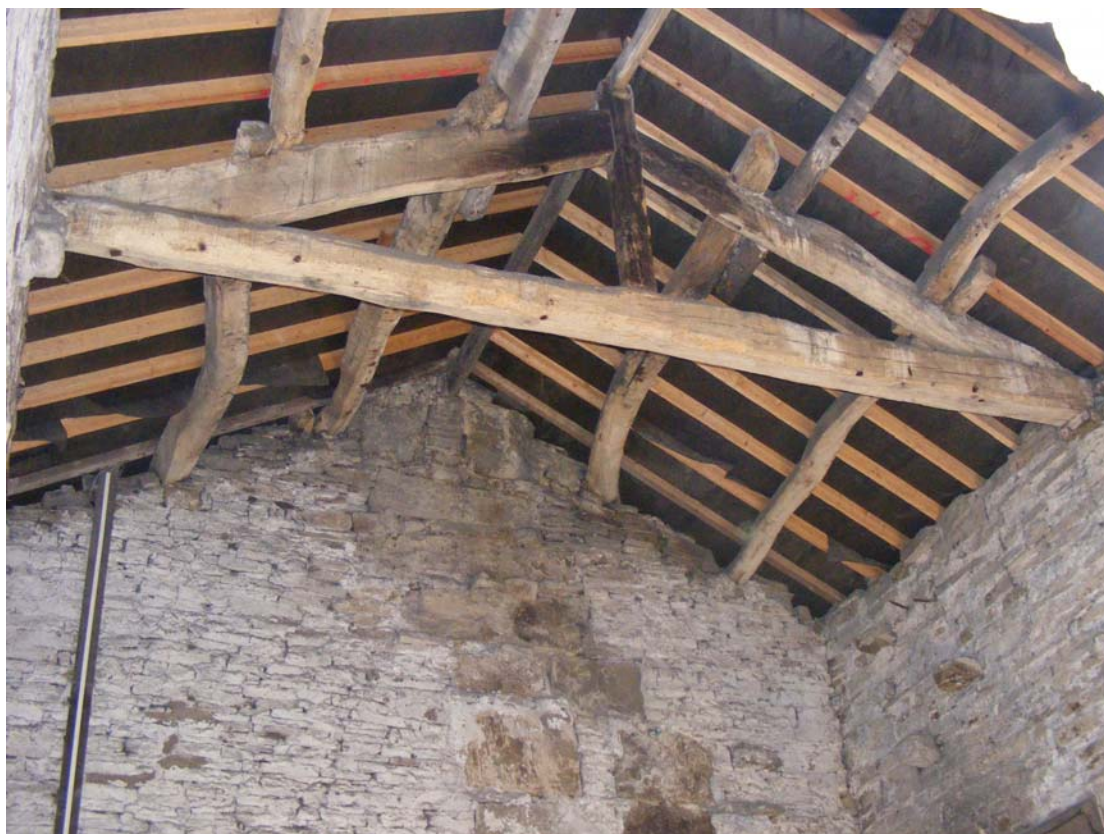
**Plate 13: Hand-cut king post roof truss with line of flue in east wall of barn  
behind Hand-cut king post roof truss**

- 6.3.6 The roof is supported by a single hand-cut timber king post truss (**Plate 13**) the tie beams of which rest on small corbels let into the tops of the walls (**Plate 14**). There are two sets of purlins under each pitch (**Plate 15**). Two were machine-cut but the others were hand-cut. Both principle rafters showed signs of reuse, with holes in the underside demonstrating earlier support (**Plate 16**) as did the purlins (**Plate 17**). The tie beam also contained an extra mortice and the tenon for the king-post itself was ill-fitting (**Plate 18**). The top of the king-post contained four peg holes for the principal rafters but these are now empty (**Plate 19**). All of the rafters have been replaced with modern machine cut timbers (**Plate 20**).
