Model Lodging House, 19 Police Street, Darwen, Lancashire

An Archaeological Building Record

by J. M. Trippier Archaeological and Surveying Consultancy

April 2014

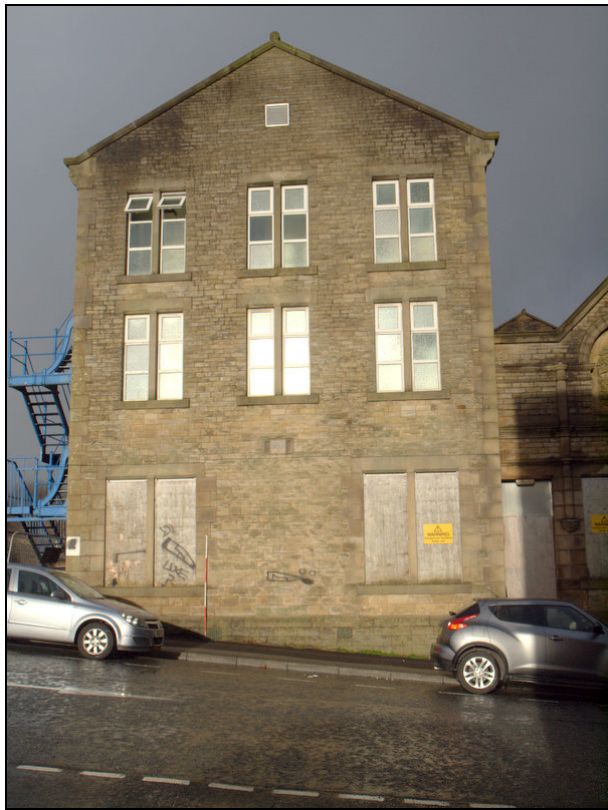
Plate 3: South gable of the west block

6.2.1 West Block. The southern face of this block (**Plate 3**), as noted is the gable and is three bays wide. Three windows line the face at first and second floor level. At ground floor level there are two windows to bays 1 and 3. These are similar to those above but slightly larger and blocked with ply. Each corner of the gable has quoins running down the length at the top is sandstone coping. A low plinth starts just above ground level and runs across the face of the gable. Due to the sloping ground to the east, the plinth gets larger towards the east. The eastern face of the block (**Plates 4 & 5**) is eight bays long with windows at first and second floor levels once again. The windows in the first (northern) bay are thinner single light windows with three light timber frames. At the southern end in bay eight are fire doors, dressed as the windows and with an iron fire escape over the face. At ground floor level are four large windows. These lie in bays 1, 3 5 and 8. These are all blocked with metal sheeting with the exception of bay 8 which shows the sandstone mullion and surround. Bay 7 contains likewise blocked doorways. At roof level two sandstone chimneys with a single pot each rise flush with the face between bays 2 and 3 and bays 5 and 6. The roof has skylights fitted on the west side and in the centre of the ridge is a small ornate iron vent, with a

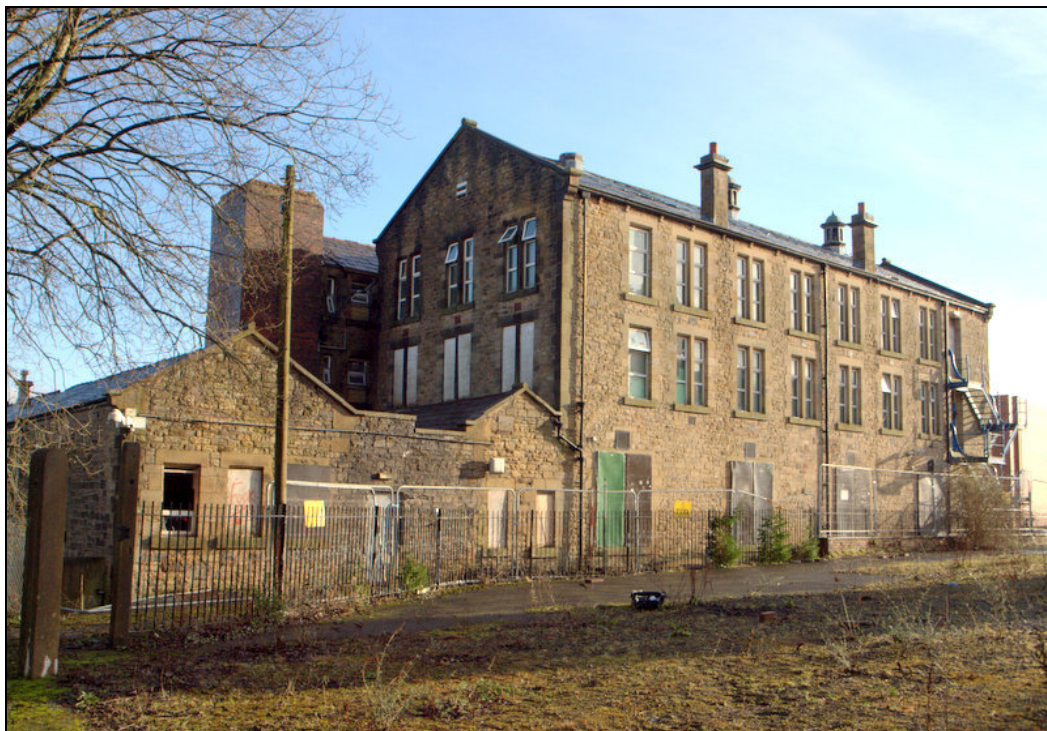
Plate 6: North and west faces of the west block

matching one towards the south. The northern gable (**Plate 6**) matches the southern, although the ground floor is masked by the northern block.

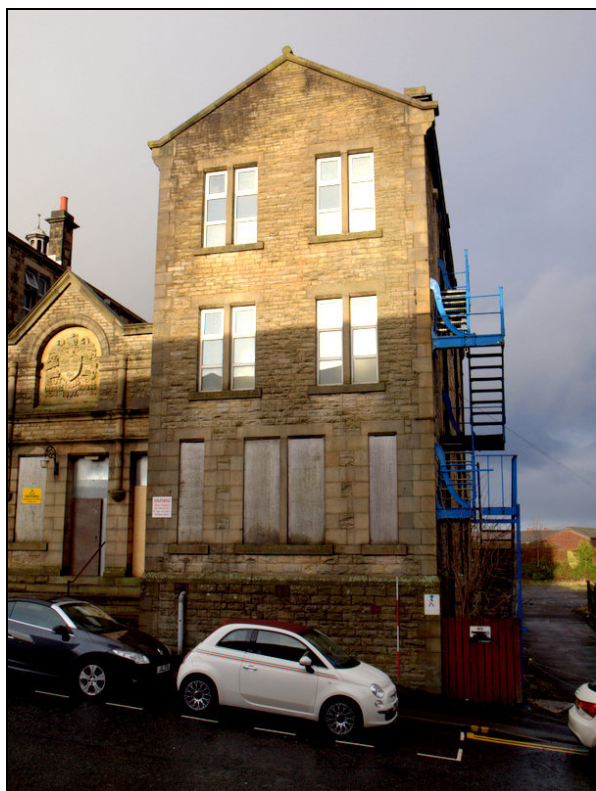
Plate 7: South gable of the east block

- 6.2.3 East Block. This block is slightly thinner than the western, being two bays wide with two windows at first and second floor level in the south gable (**Plate 7**). At ground floor level is a central window flanked on either side by a pair of thin portrait windows. Each of these is blocked with ply. As with the western block gable each corner has quoins and sandstone coping runs across the top. The plinth also continues along the face, at the same level as than on the west gable. However, due to the sloping ground level the plinth is c. 2m high at the eastern corner. The eastern face, (**Plates 8 & 9**) as with the western, is eight bays across. It also has the same arrangement of windows at first and second floor levels, with the fire doors and fire escape at the southern end. At ground floor level (which is c. 2m above the external ground surface) are 6 windows. Three of these lie in bays 3 to 5 with the fourth lying between bays 6 and 7. The northern two windows are smaller, matching those of bay eight, with one between bays 7 and 8 and the other in bay 8. All are blocked with ply. At roof level are four sandstone chimneys rising flush with the face. The first of these lies at the southern end within bay 1, with the others lying between bays 3 and 4, bays 5 and 6 and bays 7 and 8. As with the western block, the north gable (**Plate 10**) is obscured at ground floor level by the north block. Above this at first and second floor level are tall timber framed three light windows with sandstone surrounds in the centre of the face. As with the south gable, quoins run up each corner and sandstone coping along the top. Finally, a further sandstone chimney rises up on the west side.

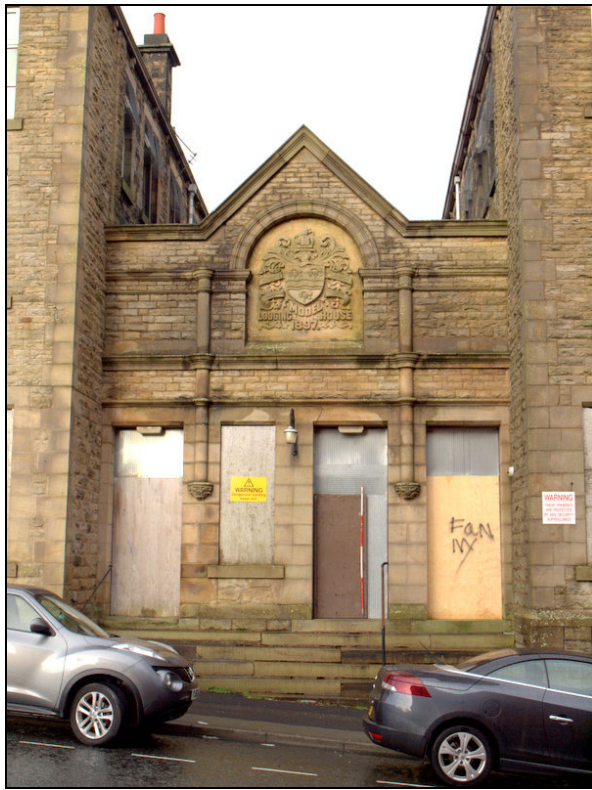
Plate 11: South face of the central atrium

- 6.2.5 Central Atrium. The southern face (**Plate 11**) of this block is slightly recessed back from those either side of it. Due to the sloping ground level a series of sandstone steps run across the face leading up to ground floor level. The face is divided into 4 bays, with blocked personnel doorways within bays 1, 3 and 4. The second bay contains a thin blocked portrait window with sandstone cill. The face is ornate, with four sandstone drip moulds running across the face. Between bays 1 and 2 and bays 3 and 4 two semi-circular sandstone columns rise up the face. The drip mouldings run across these and

the columns end level with the top mould. The columns start 2m above ground floor level and have ornate carved sandstone bases with flower design. In the centre of the face rising from the second moulding and cutting through the upper two is a carved sandstone plaque (**Plate 12**) with a crest and the words “MODEL LODGING HOUSE 1897”. The crest itself is a shield with two flowers above and a single flower below with the words “ABSQUE LABORE NIHIL” (trans. “Nothing Without Labour”) flanking. A stiff leaf design caps the crest with the image of a helmet and a man with pickaxe above. The plaque has a segmental arched moulded sandstone lintel above. The roof line has moulded sandstone coping with pediment above the centre. The northern face of the central block (**Plates 6 & 15**) is taller than the southern, matching the height of the east and west blocks. It rises up to this level at the northern end, forming a ‘T’ shaped structure to link the east and west blocks. It also protrudes further north than the others. No features are visible in this gable as the whole is butted by a large brick featureless structure. However, as the block protrudes, two bays are visible in the east and west faces at first and second floor levels. Both faces contain two small portrait windows with sandstone surrounds, at first and second floor levels. Finally, between the gables of the central block and the eastern is a matching portrait window. As noted the face is butted by a large square brick structure which appears to be a later chimney running from the basement below. It is featureless and constructed in machine made brick laid in English garden wall bond (4:1 ratio).

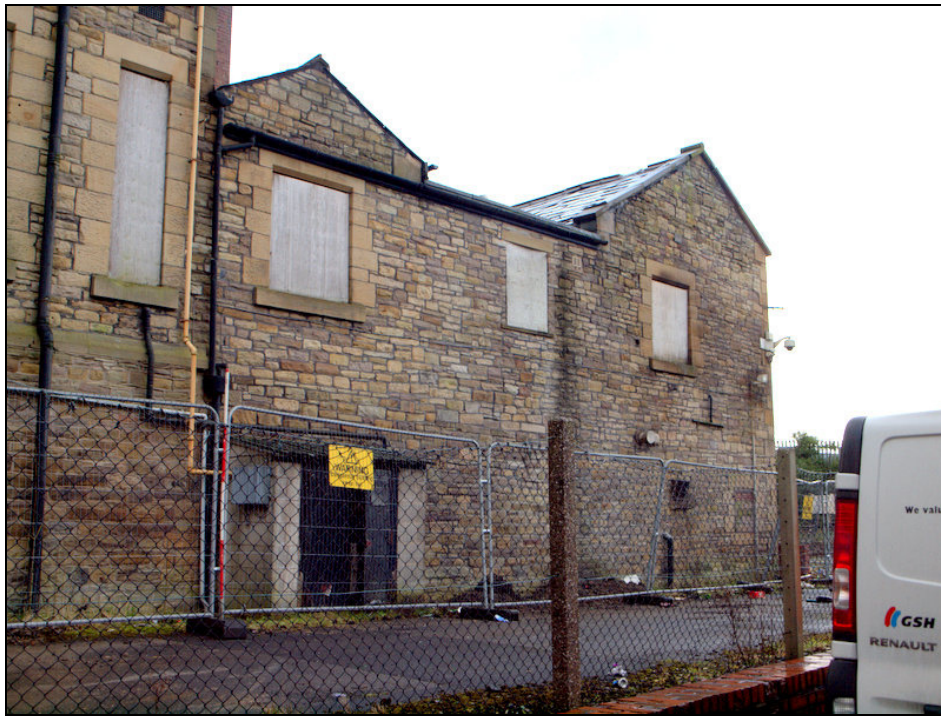
Plate 13: East elevation of the north block

- 6.2.6 North Block. The east face (**Plate 13**) of this continues along from the east face of the east block. The face has 2 gables to the north and south. At basement level the face is featureless except for a small square blocked window at the northern end and later concrete lean to at the south. At ground floor level are two large portrait windows with dressed sandstone surrounds. Between them is a smaller portrait window with sandstone lintel and thin sandstone cill. Only the northern gable has sandstone coping. The western face (**Plates 14**) is similar although only being present at ground floor level. The northern gable contains three large portrait windows with dressed sandstone surrounds and blocked with ply. The southern contains two matching, but thinner windows. Between them lies a blocked personnel doorway with sandstone lintel. Unlike the eastern face, both gables have sandstone coping. The northern face (**Plate 15**) is 9 bays long with the basement having a square blocked window at the eastern side with sandstone cill and lintel. To the west of this in bay two is a blocked loading doorway with large dressed sandstone lintel. Bay 4 also contains a blocked window, although this is blocked with sandstone and has addressed sandstone surround. The eastern side of this, however, has been obscured by the later blocking of an inserted loading bay in bay 3 running into bay 4. At ground floor level is a square blocked window with sandstone surround within bay 1

with a matching portrait window in bay 4. Bays 5, 7 and 8 also contain blocked windows, matching that of bay 1.

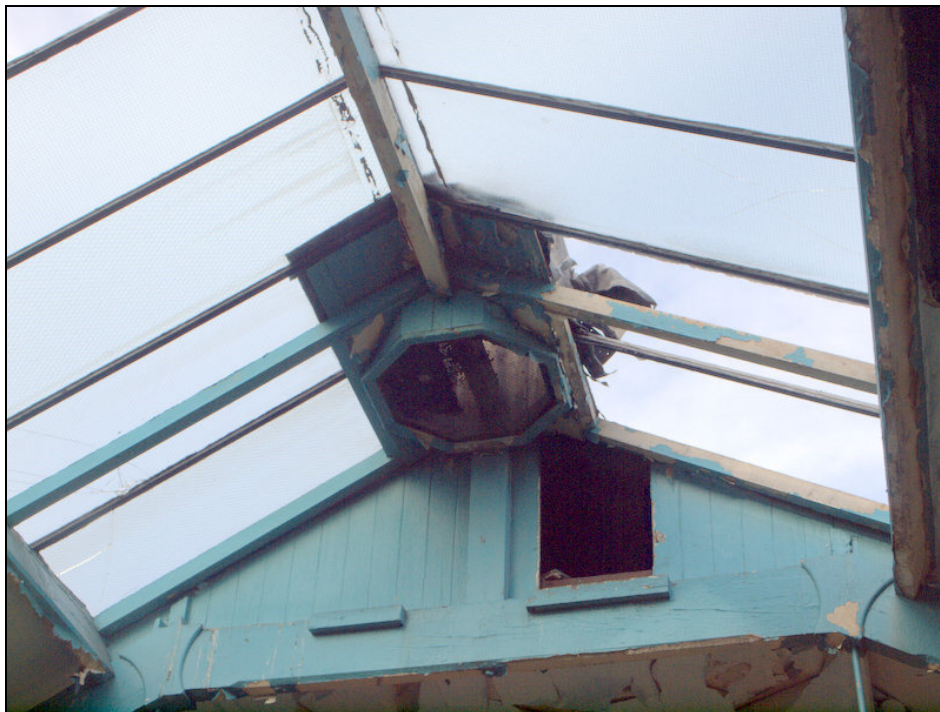
Plate 24: Attic space and vents at north end

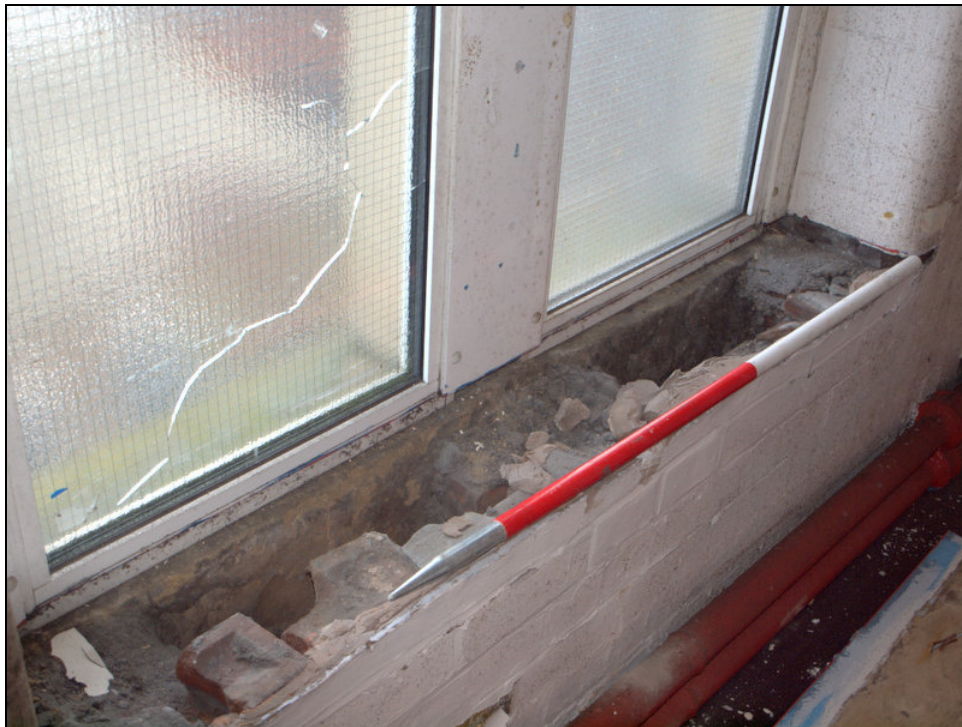
corridor is linoleum tiles whereas the rooms are carpeted and have plastered false ceilings. The windows within the rooms have timber cills although where these have been removed the wall construction is visible, showing a stone outer skin with a brick core (**Plate 25**).

Plate 25: Removed window cill showing brick construction with stone outer skin

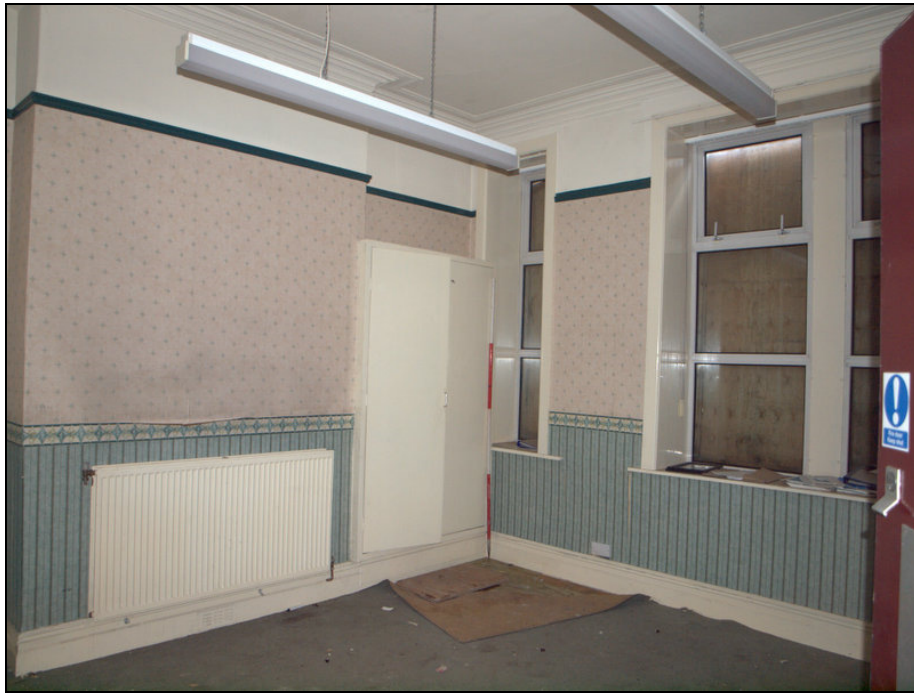
- 6.3.5 On the east side of the block, the southern room (**Plate 27**) is the largest and most ornate, having a moulded timber skirting and picture rail, as well as a cornice. The walls are plastered and papered, the ceiling plastered and the floor carpeted. A blocked fireplace lies in the east wall, although this is concealed by the modern papering and modern heating system. A wide portrait window lies in the southern wall, blocked with a thinner window to the east of it. To the north of this room is a smaller central room (**Plate 28**). This has a moulded timber skirting only. The walls and ceiling are plastered and painted and the floor carpeted. A 6 light portrait window lies in the east wall with a cast iron fireplace in the east end of the north wall. To the north of this is the northern room (**Plate 29**). This is similar to the central, having only a moulded skirting although the walls are papered. A matching window lies in the east wall and an angled cast iron fireplace lies in the southeast corner. All the doorways to these rooms have simple timber surrounds.

Plate 27: Southern room in south side of east block showing skirting, picture rail and cornice

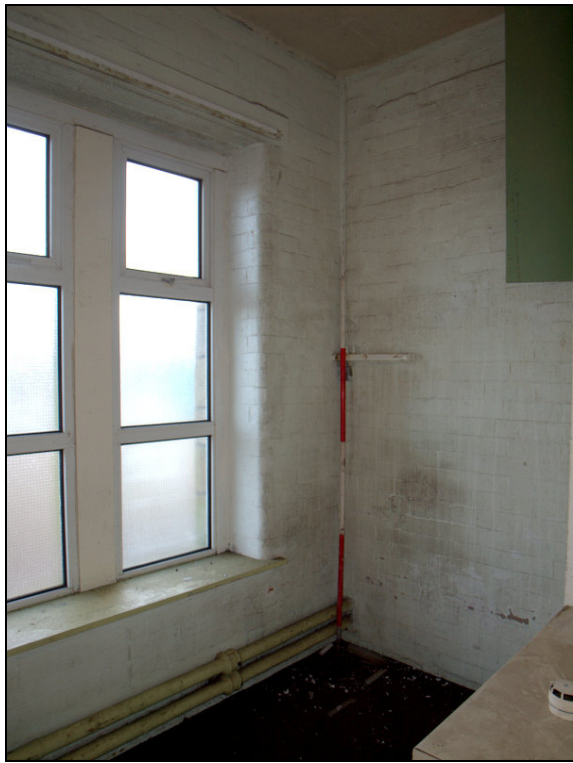
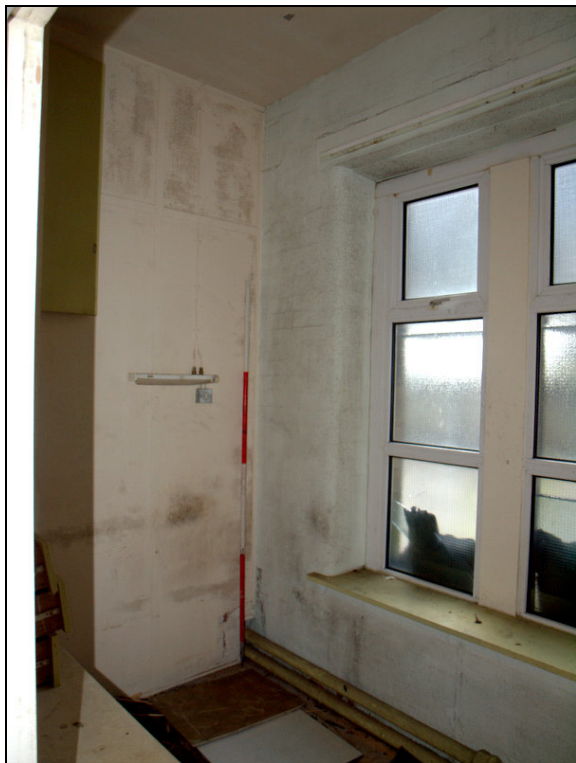
- 6.3.6 East Block First Floor. The first floor is accessed via the staircase at the north end of the central atrium. A personnel doorway leads into a corridor at the north end of the wing which then turns into a central corridor (**Plate 30**). This has timber partitioned rooms (12) at either side with an additional 2 on the southern wall and another in the northeast corner. A painted brick wall runs east – west across the centre of the room, dividing it into two areas, with a central doorway. Each of the rooms (**Plates 31 & 32**) has a small timber

personnel doorway and a two light timber framed window of 6 lights in the external walls. The ceiling is plastered and the external walls are painted bare brick. The floor of the corridor is linoleum tiles whereas the rooms are carpeted and have plastered false ceilings. At the southern end the corridor turns west and leads to the central atrium where a staircase leads down to the ground floor.

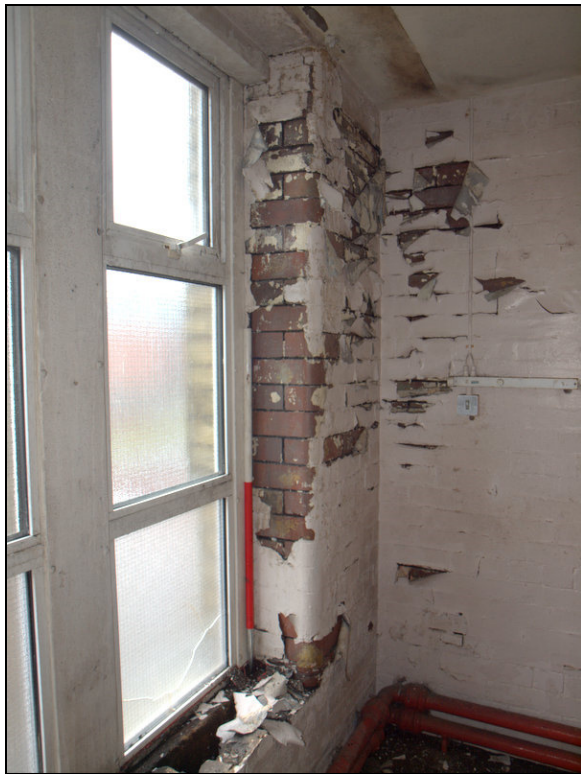
- 6.3.7 East Block Second Floor. The second floor is accessed via the staircase at the north end of the central atrium. Again, a personnel doorway leads into a corridor at the north end of the wing which then turns into a central corridor (**Plate 33**). This has timber partitioned rooms (12) at either side with an additional 2 on the southern wall. Each of the rooms has a small timber personnel doorway and a two light timber framed window of 6 lights in the external walls. The ceiling is open to the 5 king post trusses which support the plastered pitched roof. The trusses are machine cut timber with the exception of the king post itself, which is an iron rod. The floor of the corridor is linoleum tiles whereas the rooms (**Plate 34**) are carpeted and have plastered false ceilings. The walls are painted bare brick (**Plate 35**).

Plate 35: Bare brickwork where paint has peeled away

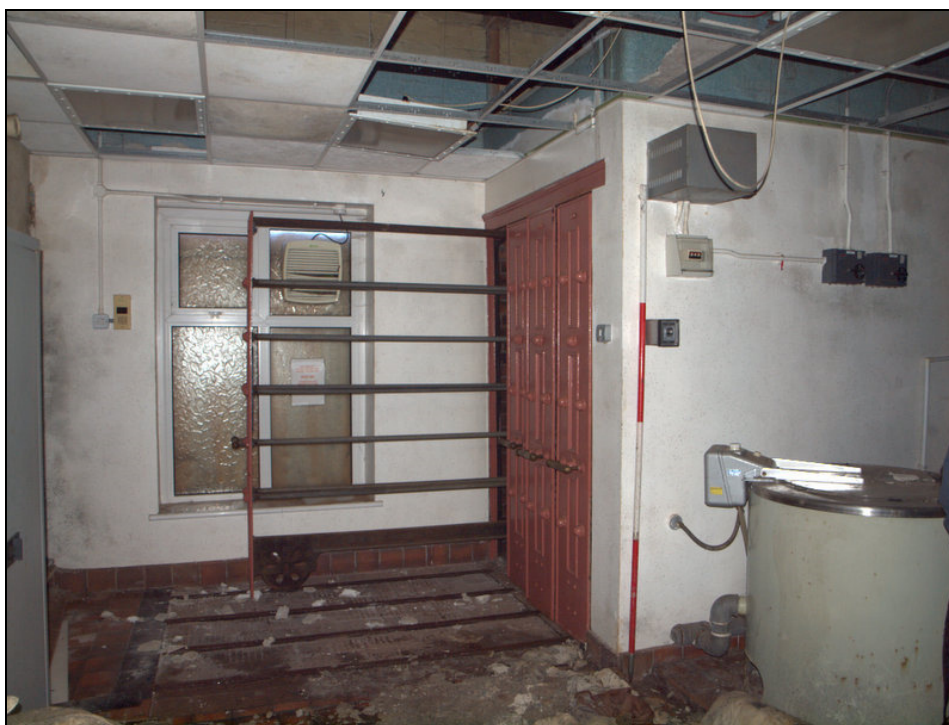
area with painted brick walls with partial modern tiling around to the west wall. The ceiling is plastered and the floor concrete. Blocked windows lie in the east and west walls. The room becomes a short corridor to the north with a small storage room on the right side. This is badly water damaged but shows the plastered walls and concrete floor. Opposite this room is the stone staircase to the basement (**Plate 44**). The walls of the basement staircase are whitewashed brick resting on whitewashed rough rubble, occasionally brought to course. A blocked portrait window lies in the west wall and a single rounded timber handrail leads down the steps to the west before turning north. To the north of the staircase the corridor opens into a laundry room (**Plate 45**). This has plastered and painted walls with a concrete floor and timber panelled ceiling. A blocked window lies at the east end of the southern wall. The northern end contains a drying cupboard with 4 tall drawers mounted on cast iron wheels running on grooves within the floor (**Plate 46**). A 4 light uPVC framed window lies in the north wall.

Plate 46: Detail of drying cupboard

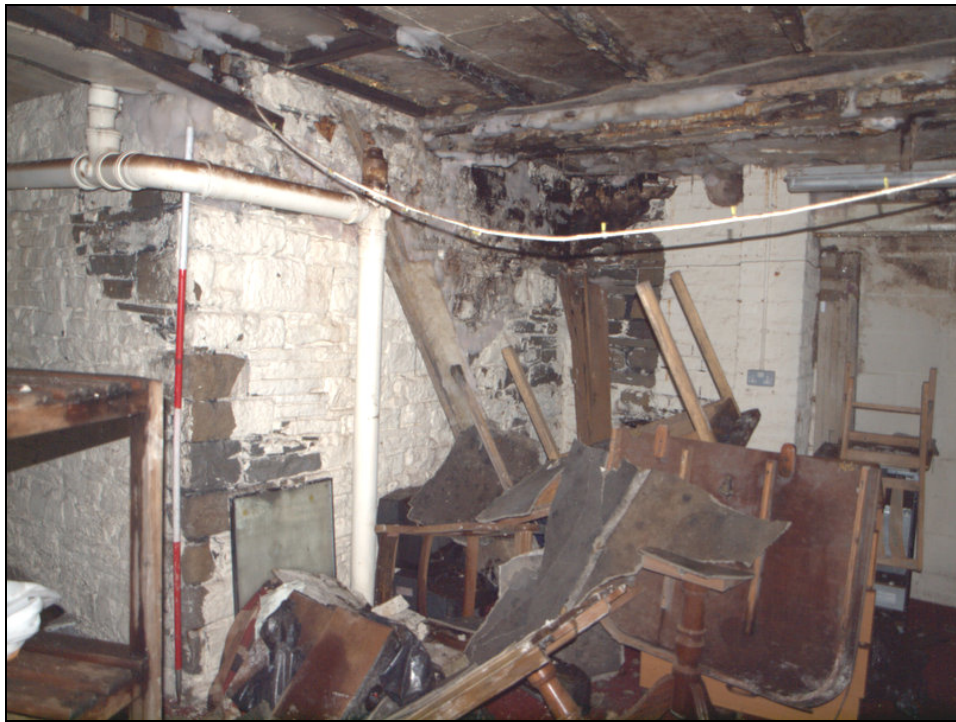
Plate 49: Basement showing stone wall construction

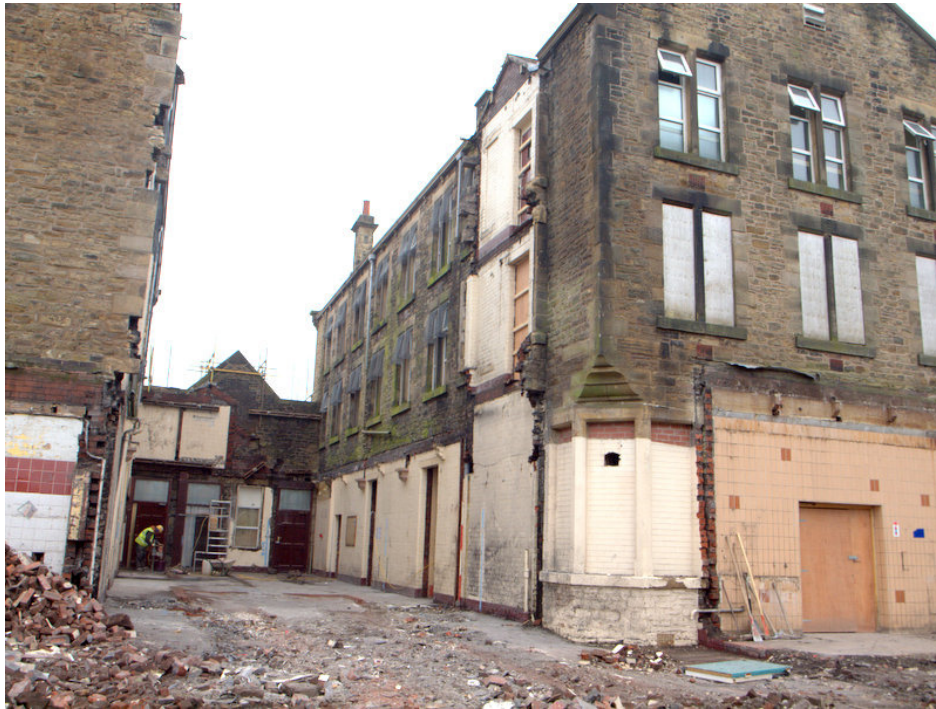
- 6.2.2 *After the removal of the central atrium the east elevation became visible (Plate 59 & 60). This showed the first and second floors to be of a random rubble construction with two light sandstone mullioned windows with dressed sandstone surrounds. The ground floor was painted brick.*

Plate 59: East elevation of west block after atrium removal

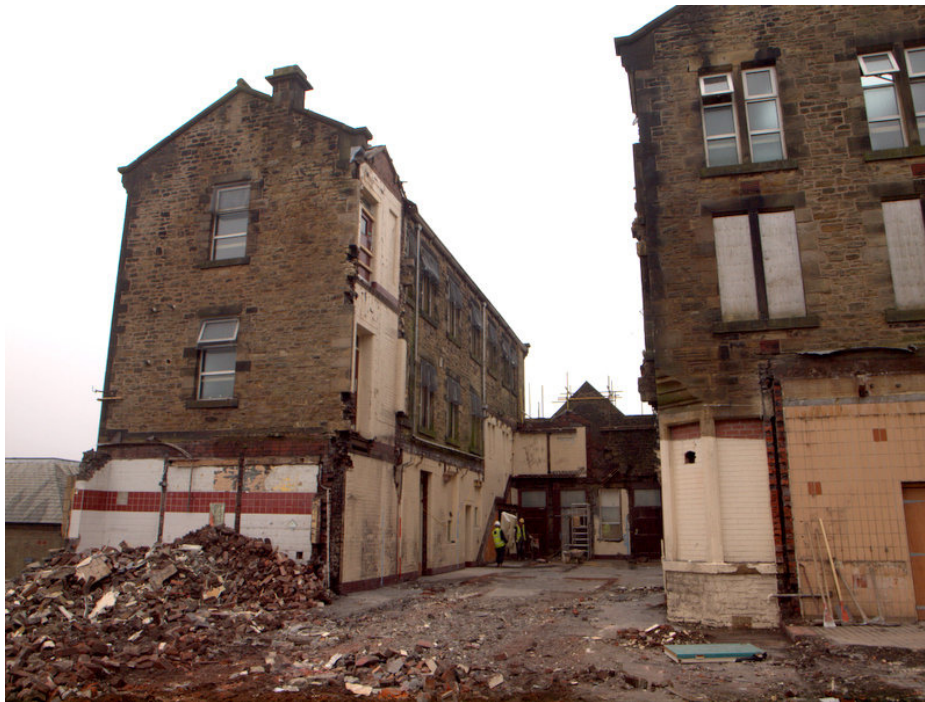
- 6.2.4 *After the removal of the central atrium the west elevation became visible (Plates 60 & 61). This showed the first and second floors to be of a random rubble construction and lined with two light sandstone mullioned windows with dressed sandstone surrounds. The ground floor was painted brick.*

Plate 60: North end of building after removal of central atrium
