Lightfoot House Farm Barn, Lightfoot Lane, Broughton, Preston

An Archaeological Building Survey

By J.M. Trippier Archaeological and Surveying Consultancy

January 2011

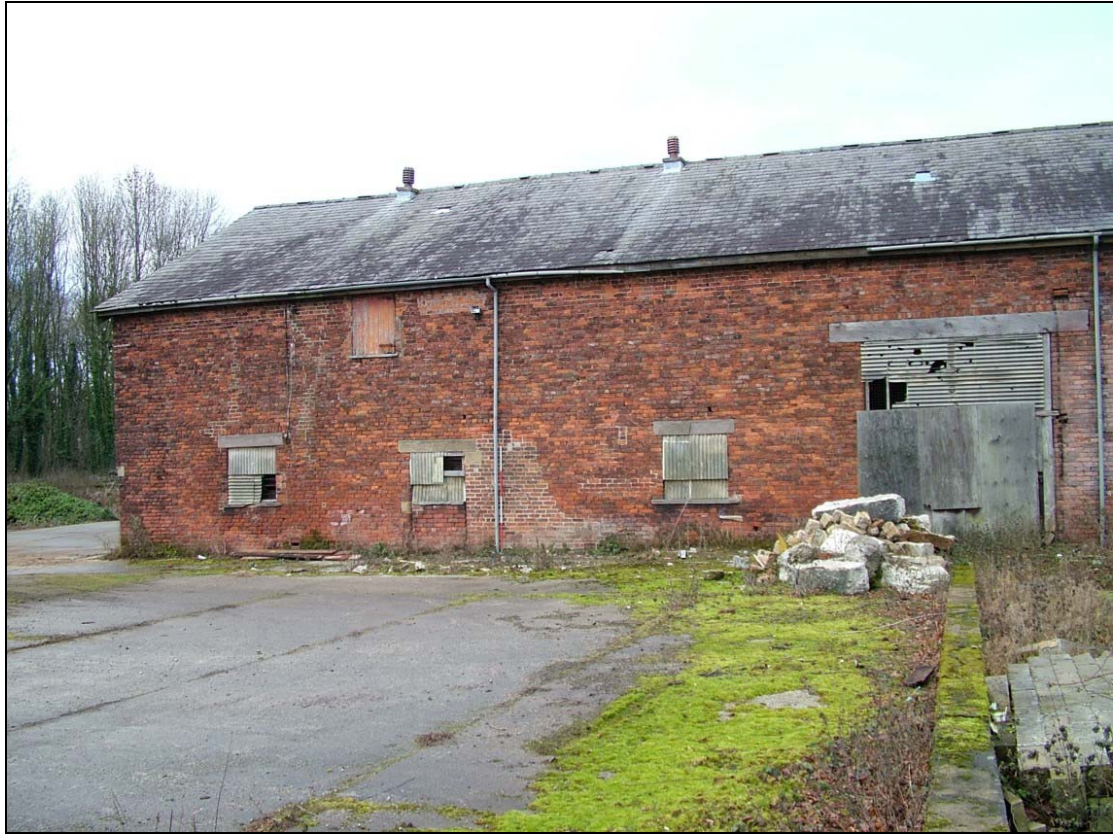
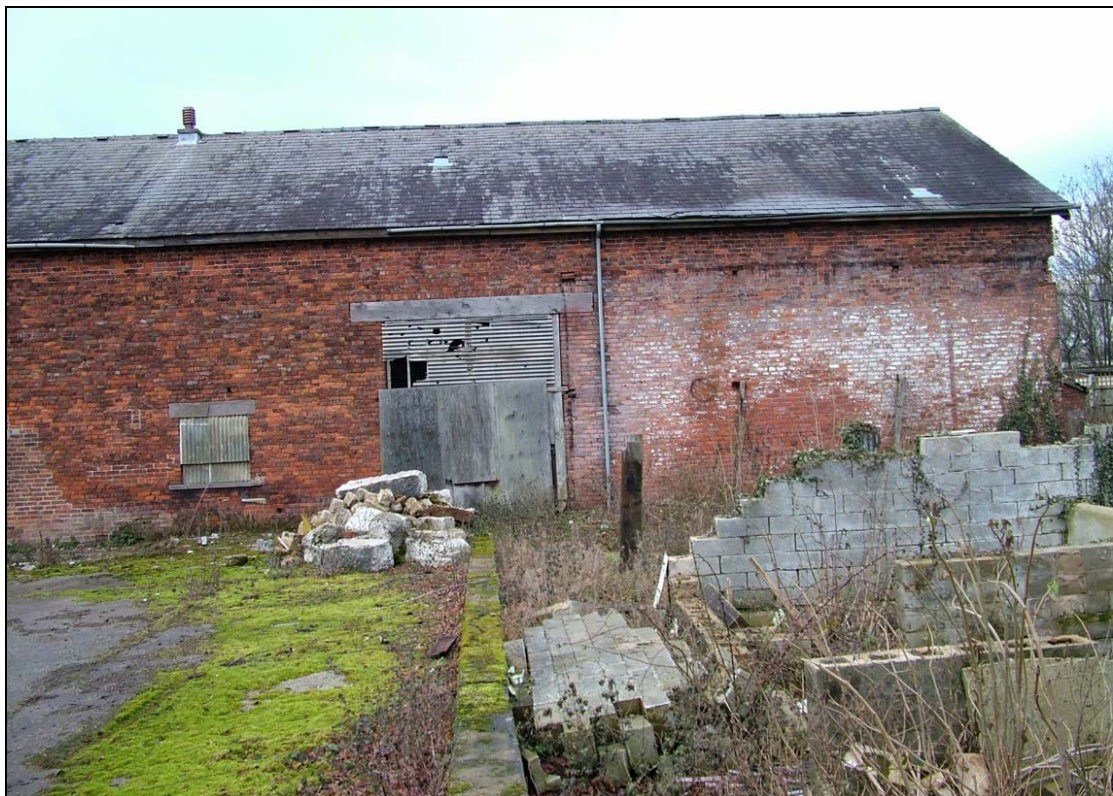
Plate 7: South elevation, west end

Plate 8: South elevation, east end

6.2.3 South elevation. This elevation comprises the rear of the main barn (Plates 7 & 8). Three windows blocked with corrugated sheeting run from the west side with a large barn door to the east of them. The windows have sandstone cills and lintels and the central window replaces a previous doorway. The barn door has a timber lintel although on this face the doorway is blocked with ply and corrugated sheeting. A window at first floor level is located between the central and western windows and is fitted with a timber shutter. The modern outshut is located to the east of the face and is featureless.

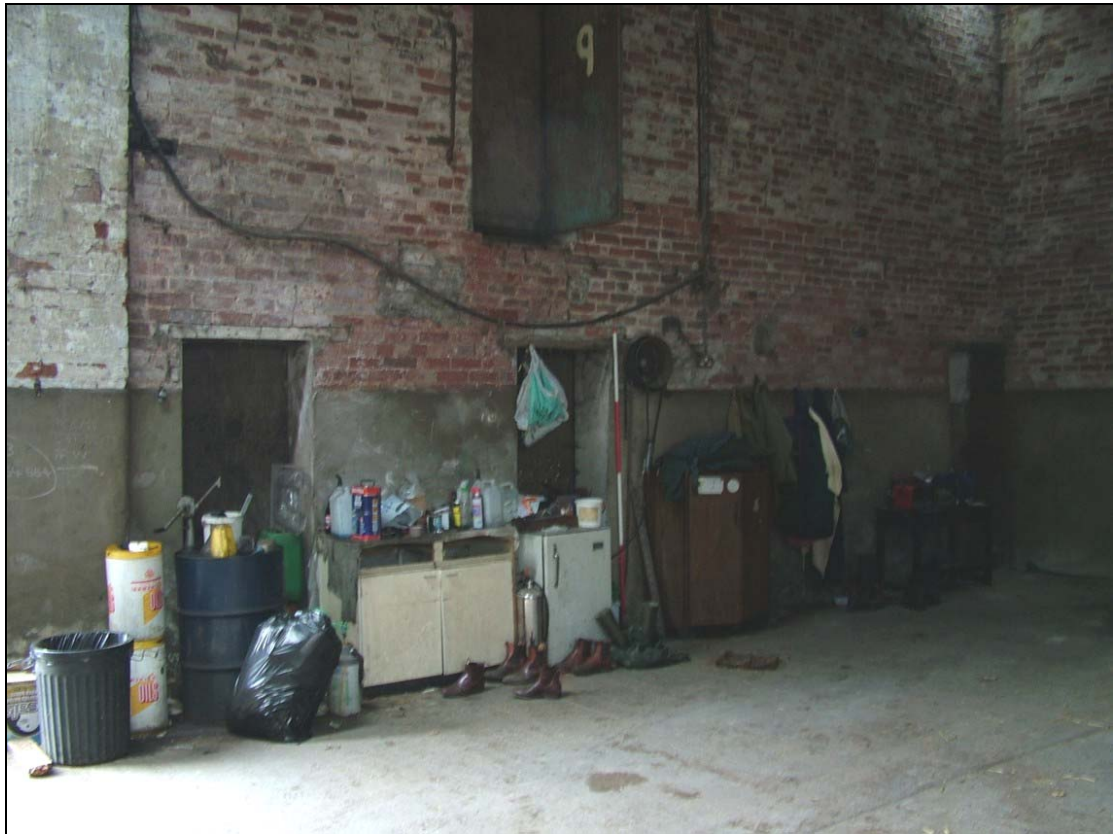
Plate 11: Main barn interior, looking north-east towards blocked doorways to milking parlour in 2nd barn

6.3.1. Main Barn. The eastern end of the barn is accessed via the large barn doorway in the north wall. The doorway has a modern metal door fitted with a timber lintel above. The walls of the barn are machine made brick with cement rendering c. 1.5m from the ground level up (Plate 11). Opposite the barn doorway, in the south wall, is a matching doorway, although this has been blocked with timber. To the east of the northern barn door is the dividing wall between the main barn and the 2nd barn. This contains three personnel doorways; the west and central ones are blocked with ply. The east one has no door fitted but leads into the storage area in the 2nd barn. All have timber lintels. At first floor level, above the central personnel door is a pitching doorway, hung with a timber door. In the internal western wall are two large cattle doorways, both with RSJ lintels (Plate 12). The southern of these has a timber gate fitted, whereas the northern is blocked with ply. The floor through the area is concrete and the ceiling is open to the rafters and two machine cut queen post trusses. At the southern end, these rest on brick pillars.

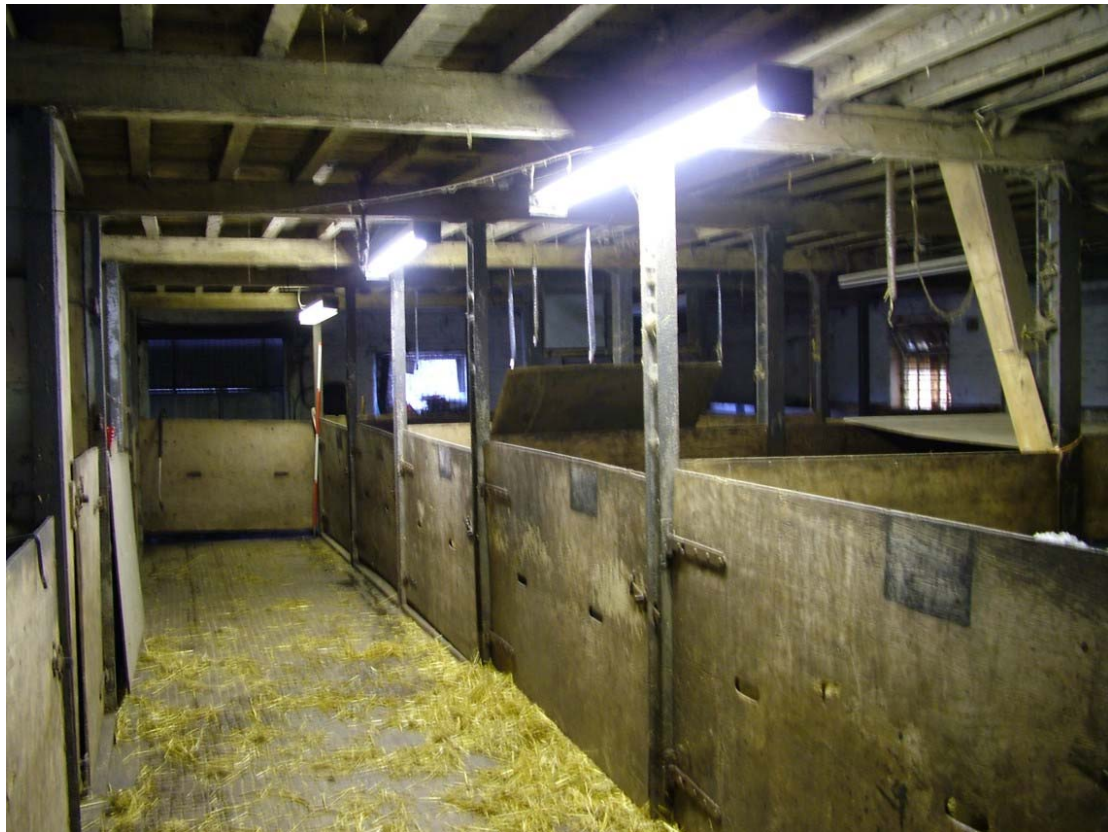
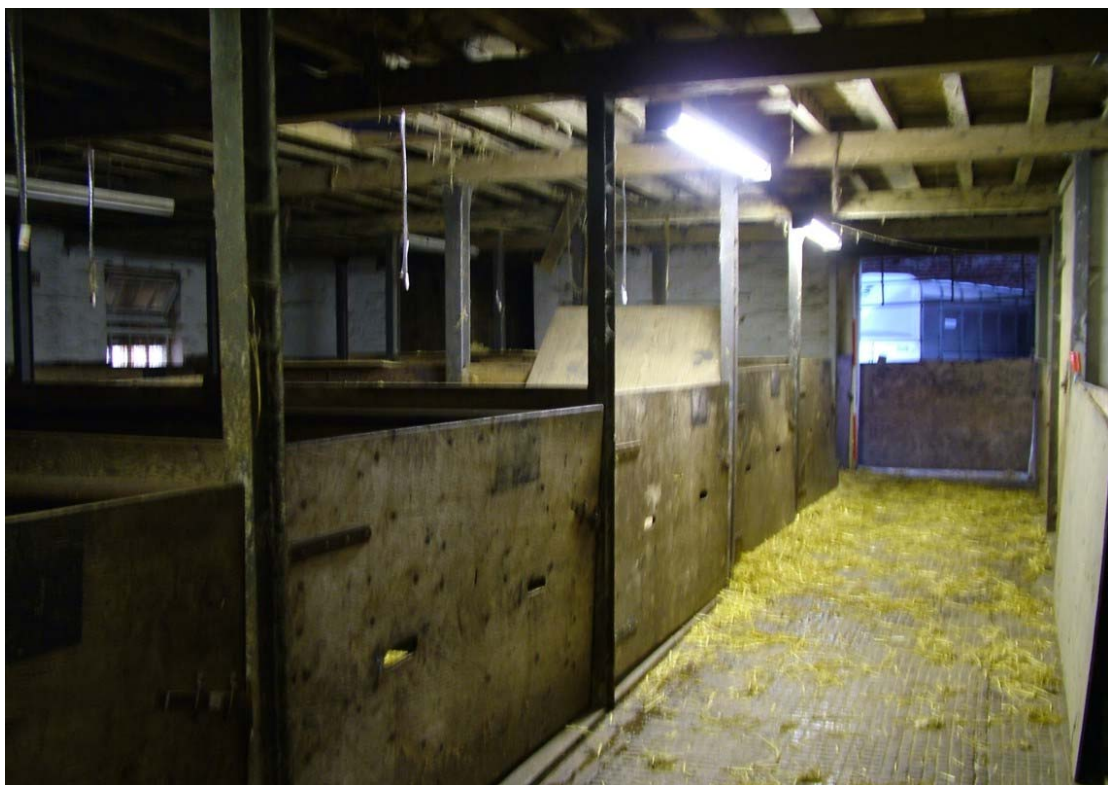
Plate 13: Main barn interior; cattle stalls looking west

Plate 14: Main barn interior; cattle stalls looking east

6.3.2 The western end of the barn (Plates 13 & 14) is accessed via the large cattle doorway in the southern end of the internal cross wall referred to at para. 6.3.1 above. The walls of this shippson area have been plastered and the floor is concrete. Two drainage channels run from east to west, from the cattle doors

in the cross wall, to the inserted cattle doorways in the west wall. The timber ceiling is supported on north – south aligned timber beams, supported by H-section steel uprights. The central area has been boarded out to form small cattle pens, with further boarding along the northern and southern walls, used as storage space. Three windows run along the north wall, each fitted with a modern timber frame, although they have been blocked with sheeting externally. This arrangement is mirrored on the south wall. The western wall has two inserted cattle doorways at the end of each of the drainage channels. Between these is a window with a modern timber frame inserted into a blocked doorway, although this is not apparent from the interior. At the extreme northern and southern ends of the western wall are two further blocked personnel doorways.

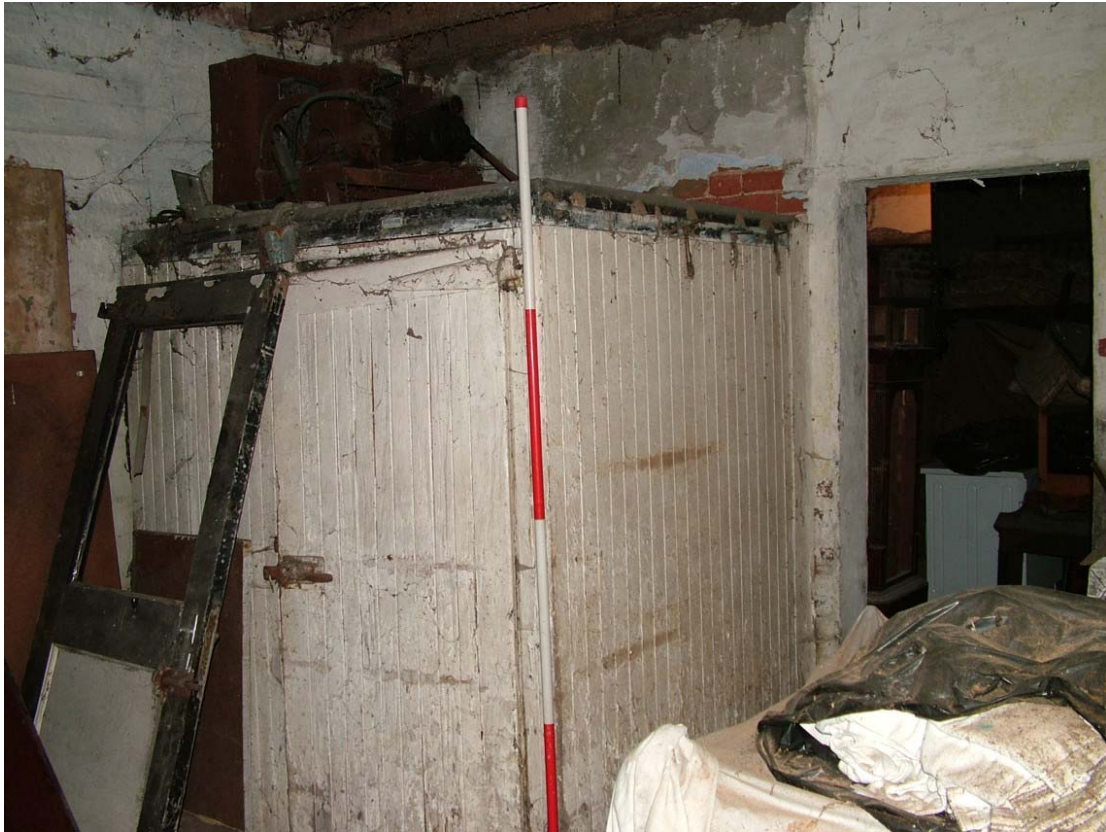
Plate 17: Northern storeroom looking south-east

- 6.3.5 This second storeroom is accessed via the aforementioned timber framed doorway and likewise has cement rendered walls, a concrete floor and a timber ceiling. A modern timber framed window is located in the east end of the north wall. This has a moulded timber cill and moulded timber surround. A doorway, blocked with ply, is in the northern end of the east wall. The wall between this door and the window has been tiled with modern white tiles to a height of c.2m. A personnel doorway into a milking parlour to the west is located in the west wall, although no door is hung. To the south of this doorway a stone bench, supported on brick pillars, runs to the south, before turning east along the south wall and terminating at the doorway to the first (south) store (see Fig.3). A square area in the south east corner of the room has been partitioned off with timber T & G boards (Plate 17).

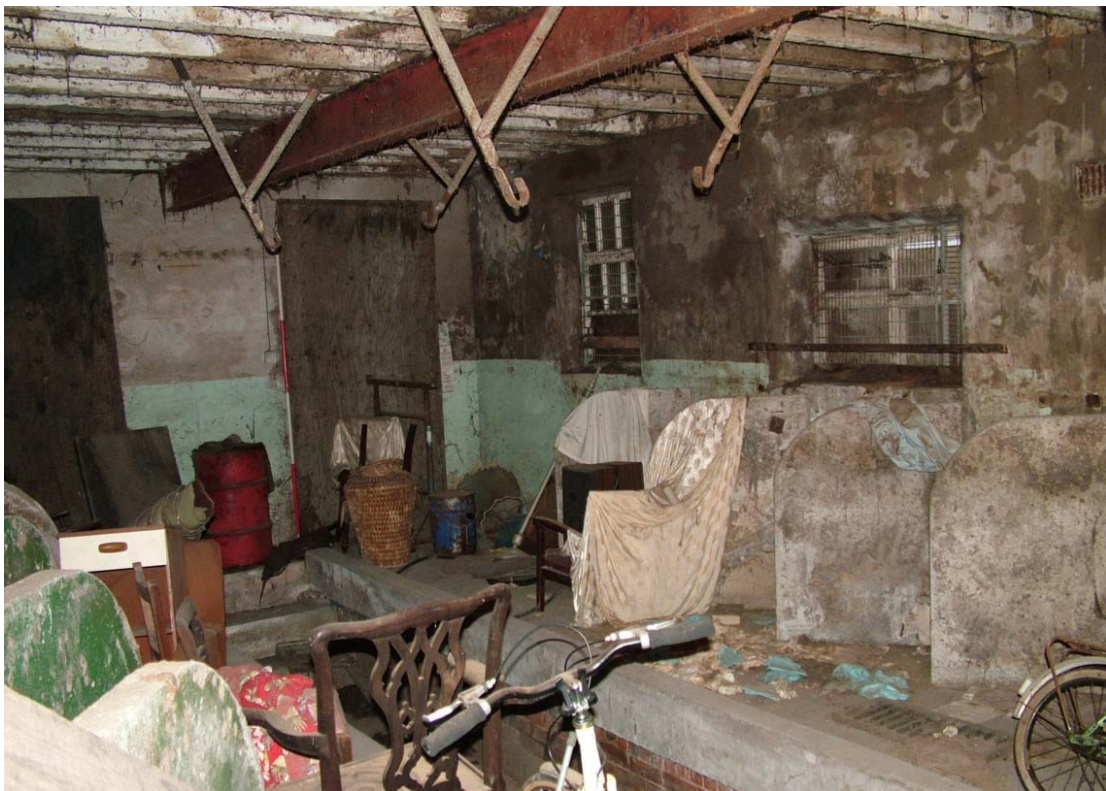
Plate 18: Milking parlour in 2nd barn looking south

- 6.3.6 The west side of the 2nd barn is the milking parlour (Plates 18 & 19). The walls of the milking parlour have been completely rendered in cement, hiding the surrounds of all the windows and doors. It is accessed from the exterior via

a doorway at the north end of the west wall. To the south of this is a landscape window blocked externally with ply. To the south again is a modern timber framed portrait window likewise blocked externally with ply. In the south wall are the two blocked personnel doors giving access to the main barn as described at para. 6.3.1 above. A doorway in the eastern wall leads into the north storeroom described above. In the north wall, slightly west of centre is a modern timber framed window. The floor is concrete and the ceiling is timber supported by an RSJ running north – south along the length of the room. A brick lined milking pit runs north – south down the centre of the room with concrete steps at either end. Flanking the pit on the west side are 6 concrete cow stalls, divided by stone boskins angled to correctly align the cows. There are 4 similar stalls on the east side. Metal hooks attached to the timber joists and used for carrying milking equipment flank the RSJ above the milking pit (Plate 18).

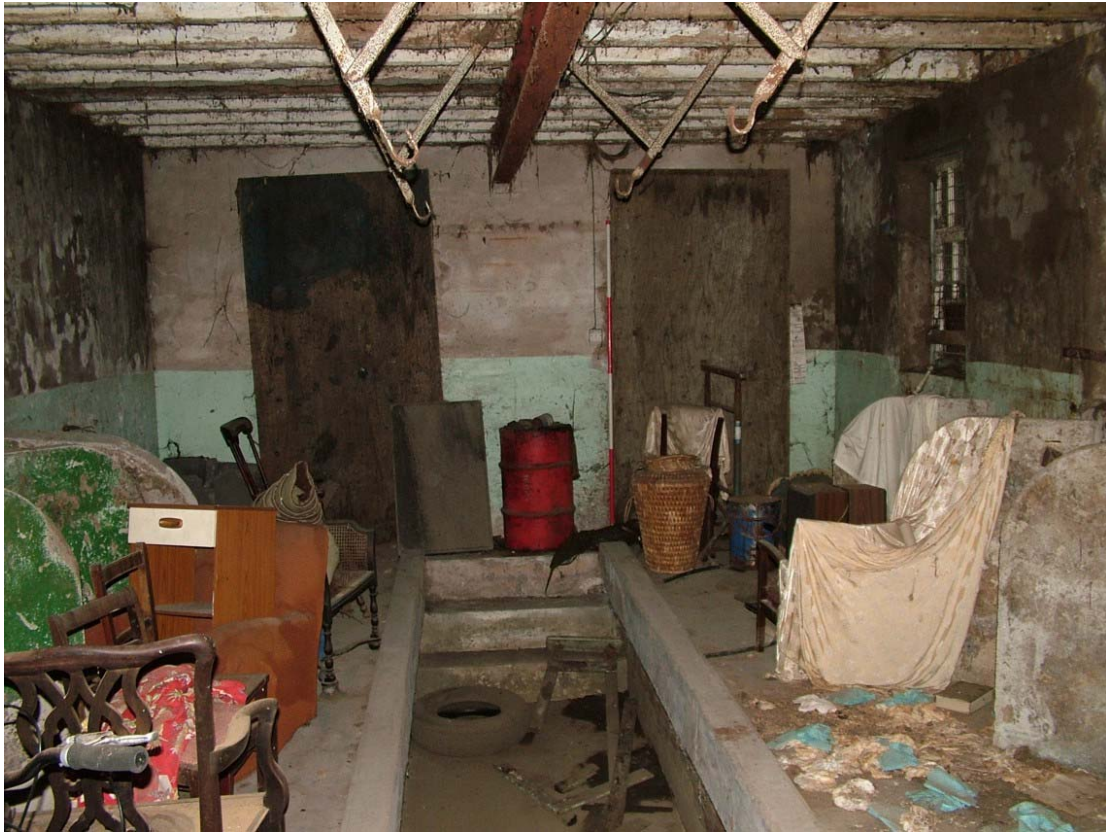
Plate 19: Milking parlour with milking pit in the centre looking south-east

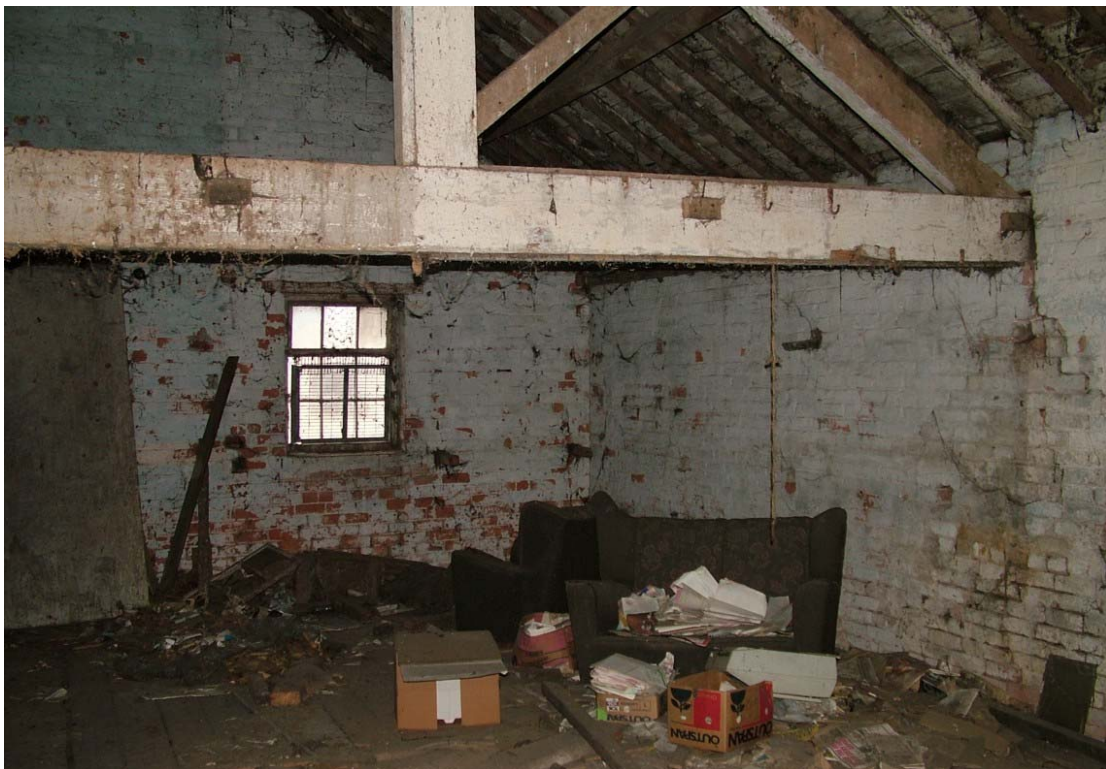
Plate 20: East room of first floor of 2nd barn looking north from stairs

- 6.3.7 The first floor of the 2nd barn is accessed via the modern timber staircase at the eastern end of the south wall in the south storeroom on the ground floor. The first floor has been divided into two areas: To the east is a single room into which the access stairs rise. It is open to the underside of the slated roof which is supported by a single machine cut queen post truss. It has a timber floor although this has decayed and is unsafe (Plate 20). A window is located in the north wall, fitted with a 9 light timber casement with a timber lintel and a concrete cill. The western side of the first floor has been converted into two modern offices separated by a stud wall. The southern room is accessed from the east room via a personnel doorway at the top of the stairs. The room has timber panelling on all the walls hiding the blocked pitching doors in the west and south walls (see Fig 4). There is a modern timber framed 2-light casement window in the west wall. A personnel doorway in the north stud wall leads to the northern office which has a modern timber framed 2-light casement window in the north wall. The surrounds of the windows in these rooms have been blocked by the modern panelling. The floor of the offices has been carpeted over the timber boards, and a plasterboard false ceiling has been inserted hiding the queen post truss from view.
