# **Hollin Hey Barn, Romney Road, Bolton**

## **An Archaeological Building Survey**

*by J. M. Trippier Archaeological and Surveying Consultancy*

**March 2010**

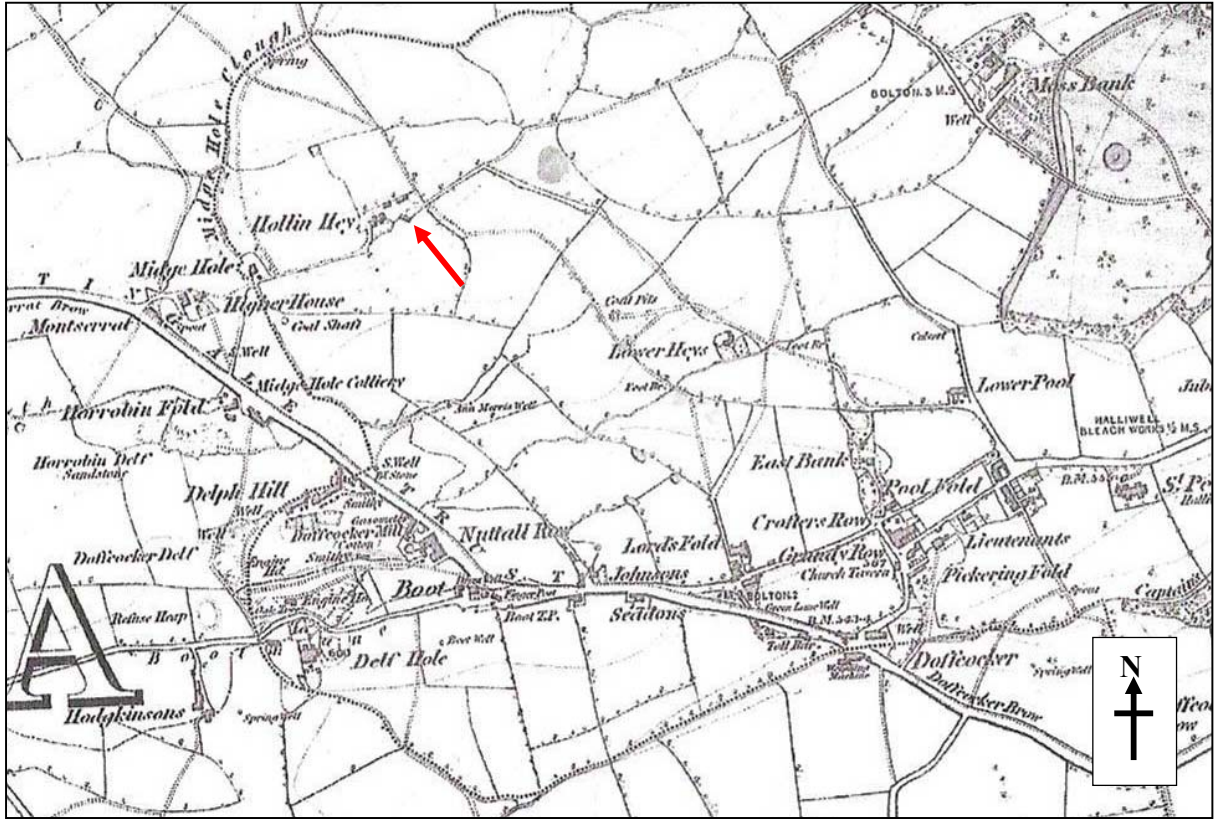
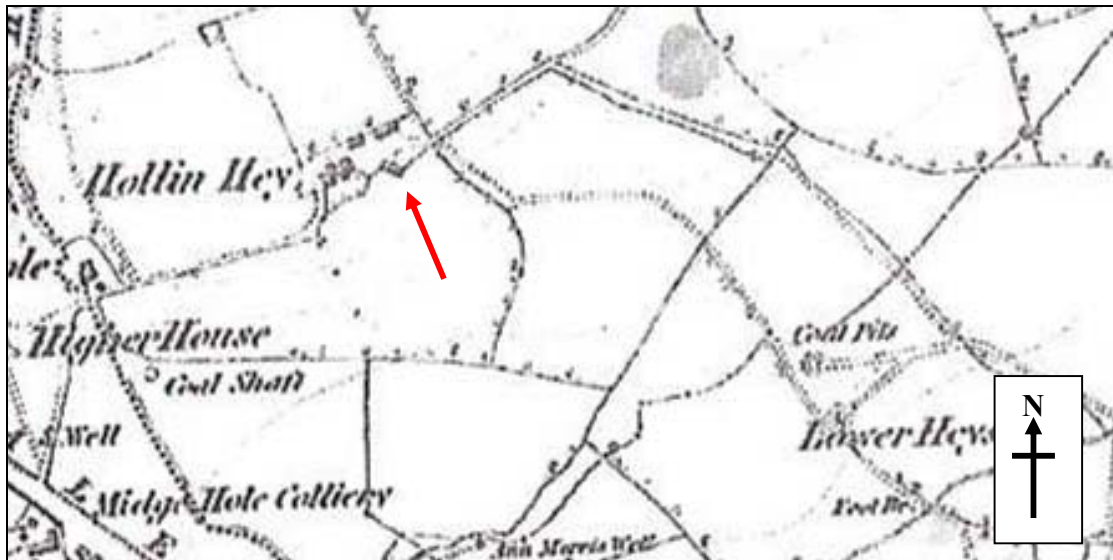
Fig 8. OS Map 1849 Scale 1:10560 –actual scale

- 7.3 The OS Map of 1849 (**Fig 8**) depicts a similar range of buildings to that outlined above although the projecting feature at the north-east corner of the subject building is not visible (this may be an accident of scale). On the OS Map of 1892 (**Fig 9**) the Barn now shows the projecting feature again but it is shallower than on the 1784 plan. However whereas the range was previously smaller than the house it is now much bigger indicating that it has been extended, possibly to its current footprint. There is also now a small free standing building to the north-east of the barn and what may be either a midden, or a building in the course of construction, to the south-east. However the large building to the north of the subject one has now gone and Hollin Hey farmhouse has what appears to be an ornamental garden surrounded by trees screening it from the barn range. This appears to be an attempt at gentrification and a distancing of the house itself from the working farm (Brunskill 1987, 106).

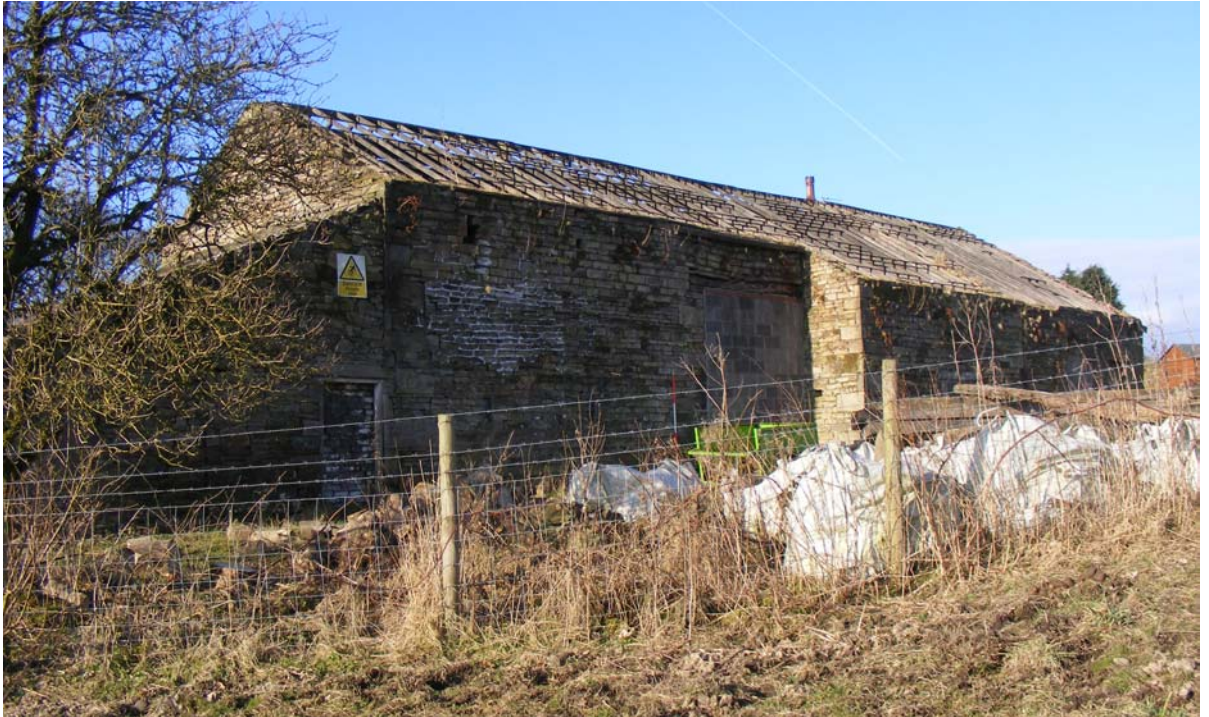
Plate 1. Barn – full view north elevation

- 6.1.1 The subject range of buildings comprises a composite structure of four elements; an original three-bay barn and extensions to the west, south and east (**Front Cover and Fig 3**). The southern extension is a shippon, with the eastern addition being an extension to this shippon and the western extension being a stable. The building is a two storey sandstone built structure, the frontage facing north (**Plate**

1). It is generally rectangular, although the north-western bay of the main barn protrudes slightly (**Plate 1**). The east and west ends comprised double gables and the southernmost of the eastern gables has been built up with brick to create a square profile (**Plate 2**). The exterior fabric of sandstone rubble is in some places shaped and regularly coursed, whereas in others it is rough and uncoursed. The whole building is in a ruinous state and the majority of the eastern wall has collapsed. The roof of the main barn comprised two double pitches running east – west, although the roof covering has been removed and only the timbers remain (**Plate 1**).

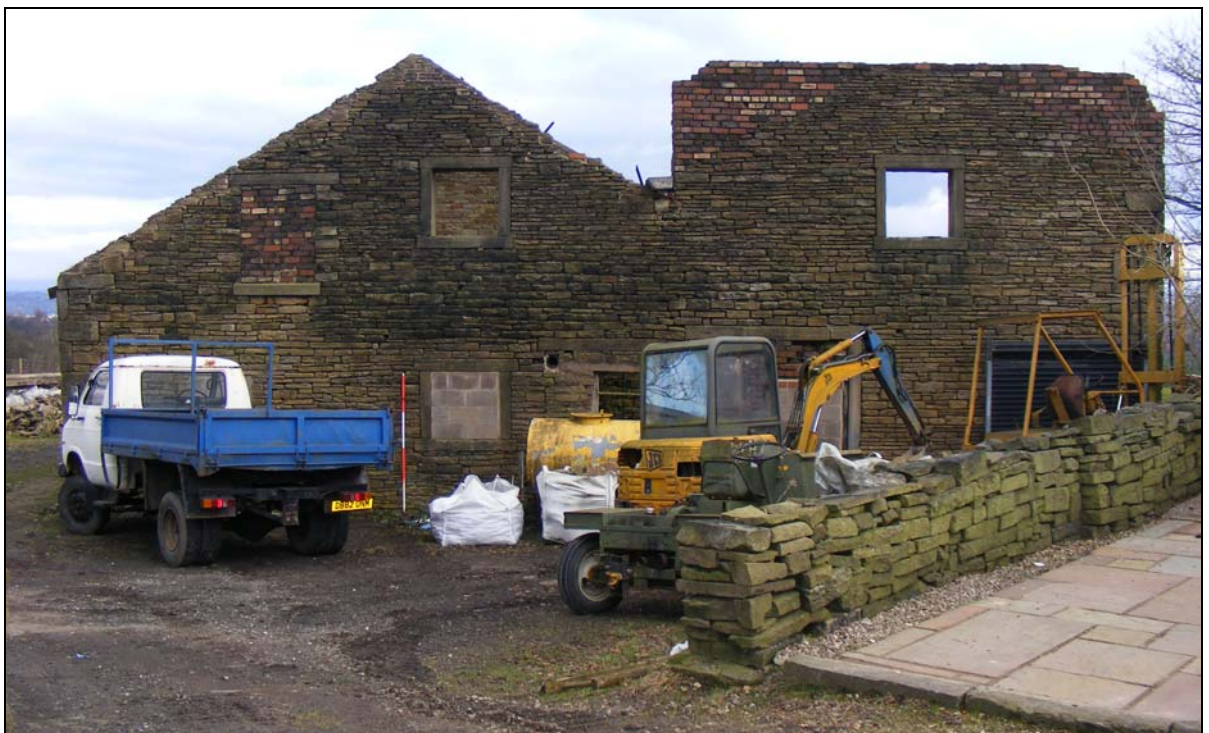
Plate 2. Barn and south shippon – west elevations

- 6.3.2 The west elevation comprises the northernmost of the double gable ends of this range of buildings (see **Plate 2** and para.6.1.1 above). It houses 3 windows at ground floor level and two at first floor level. The northern-most window at ground level is square with a sandstone lintel. To the south of this is a blocked square window with an entire sandstone surround. To the south of this again is a timber framed two light window with a sandstone surround. This is housed in a

- 6.4.3 The western elevation is a gable, built up with machine made brick to provide a flat roof (see **Plate 2**). Within this face are two doors. The northern-most is a blocked cart door with a sandstone surround. Within this is another blocked window and a blocked personnel doorway. The southern-most is likewise a cart door but fitted with a modern roller shutter. At first floor level there is a single square window with a sandstone surround.
- 6.4.4 Much of the eastern wall has been demolished and it only remains at ground floor level (**Plate 15**). What remains is constructed of roughly shaped sandstone, occasionally brought to course. Within this wall is a large personnel door at the south end and an opening at the north end both leading in from the shippon extension (see para 6.5 below).

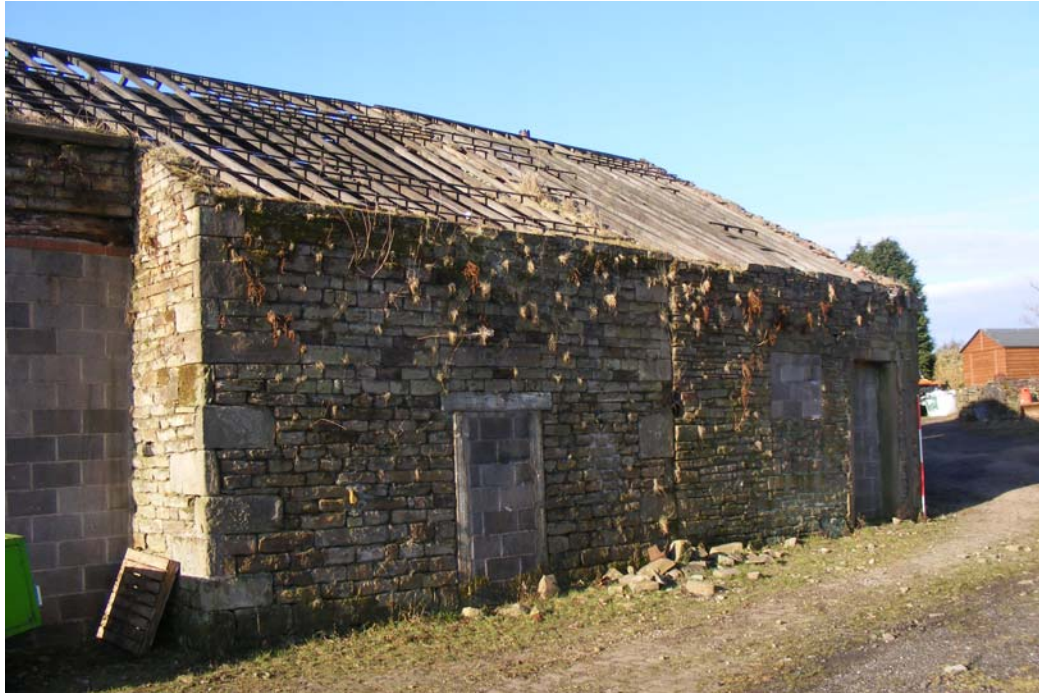
Plate 3. Barn – north elevation west end

6.2.1 This is a three bay barn with the bays being denoted by two king post roof trusses. Extensions have been built on the west (**Plate 3**) and east ends (**Plate 4**). The north elevation is constructed in shaped sandstone rubble, brought to courses. The west bay of the barn protrudes by about one metre. Each corner of the elevation, where the extensions butt against it, has large quoins as has the protruding corner of the west bay. However whereas those to the west bay were dressed those at the east end were larger and more rustic especially at the lower levels. The central bay houses a large barn door with a timber lintel and no jambs. It is now closed up with concrete blocks. The western jamb is formed by the protruding corner of the west bay. There is a blocked personnel door with a sandstone lintel and sandstone jambs in the west bay. The eastern gable of the barn, which is now partly within the east extension, is constructed in regularly coursed and shaped sandstone and has a small rectangular owl hole near the apex of the gable (**Plate 5**). The southern elevation of the barn is now located within the shippon and is constructed of shaped coursed rubble (**Plate 6**). At the western end is a personnel door with a timber frame but no door leading through to a storage area within the west bay the barn. East of this, in the wall of the central bay of the barn, is a large barn doorway. The lintel and wall above it has collapsed but the doorway has quoins and rebated jambs of dressed stone. The western gable is constructed of regularly shaped and coursed sandstone and is now within the stable.

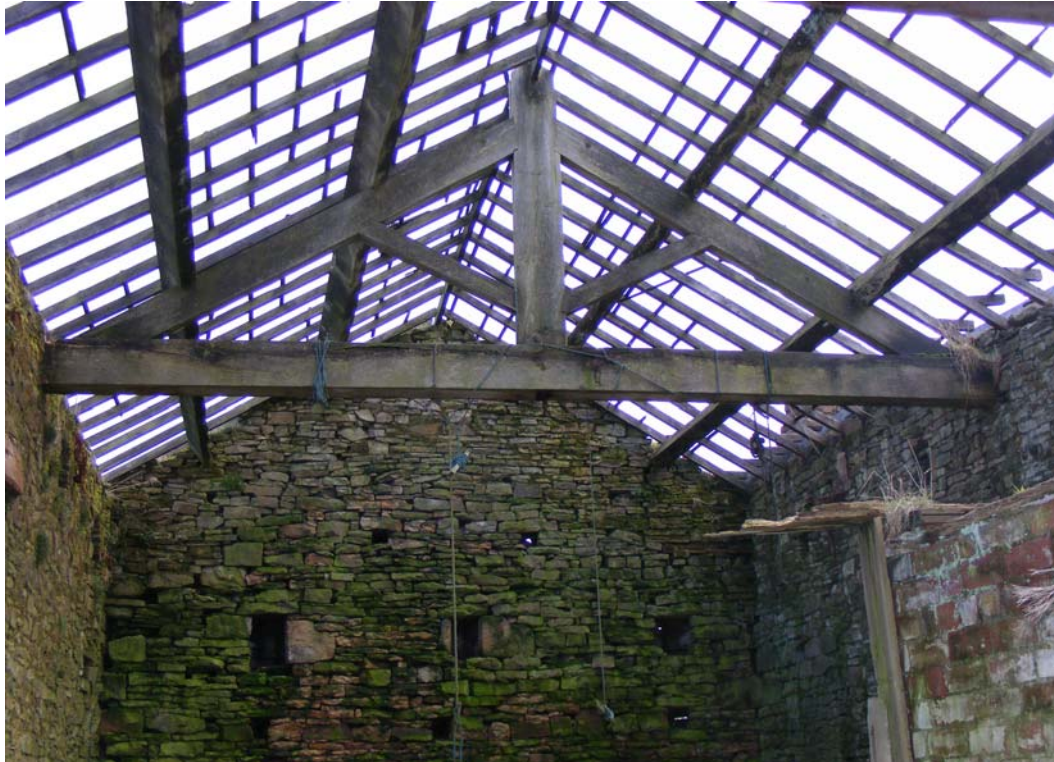
Plate 7. Barn – Internal king post roof truss

6.2.2 This comprises three bays denoted by two braced king post trusses which run north to south across the barn and support two overlapping purlins on each pitch. These in turn support the secondary rafters which are largely still in place although the roof covering has gone (**Plate 7**). All roof timbers are machine-cut and the height at the apex is c.7m. The west wall of the barn is constructed in uncoursed roughly shaped sandstone. Within the south-western corner of the barn is a storage area built of a low concrete wall with machine bricks built on top of it (**Plate 8**). The east and north walls are likewise constructed in roughly shaped sandstone, although here it is occasionally brought to courses (**Plate 9**). Within the eastern

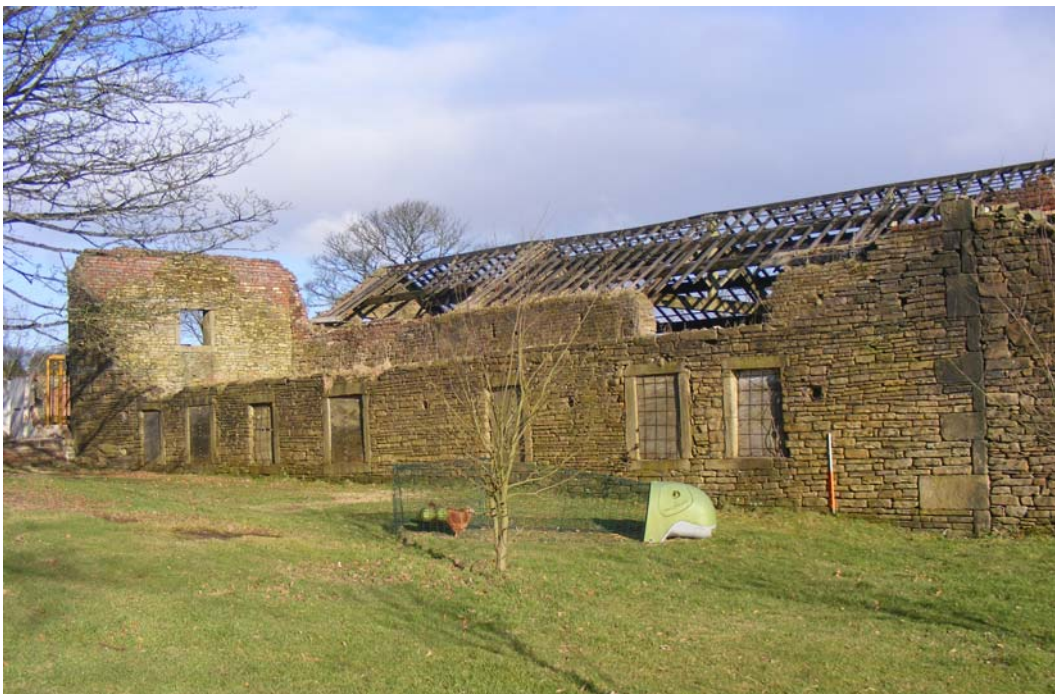
Plate 14. South shippon – south elevation with barn roof beyond

- 6.4.1 This building is built against the south walls of the main barn and the stables extension. These have been fully described at paras.6.2.1 and 6.3.2 above. The roof has collapsed and although there are joist holes in the south wall of the barn the height of the remaining east and west walls suggest that these are more likely to have been for ceiling joists or tie beams than to have marked the roof line itself (see **Plate 6**). The two beams remaining suggest that they were more likely the former.
- 6.4.2 The south elevation is constructed of shaped sandstone rubble, occasionally brought to course. Seven portrait windows line the south wall, all of which are

blocked and have sandstone cills and lintels (**Plate 14**). The first, third and fifth windows from the west all have sandstone jambs on their east side only, where as the second, fourth and sixth have both jambs of sandstone. The seventh window has a sandstone jamb on its western side, but the sandstone cill extends to the west, suggesting that the window may have been relocated slightly to the east.
