**BRINSOP HOUSE FARM BARN,
CHORLEY ROAD, WESTHOUGHTON**

An Archaeological Building Survey

by J. M. Trippier Archaeological and Surveying Consultancy

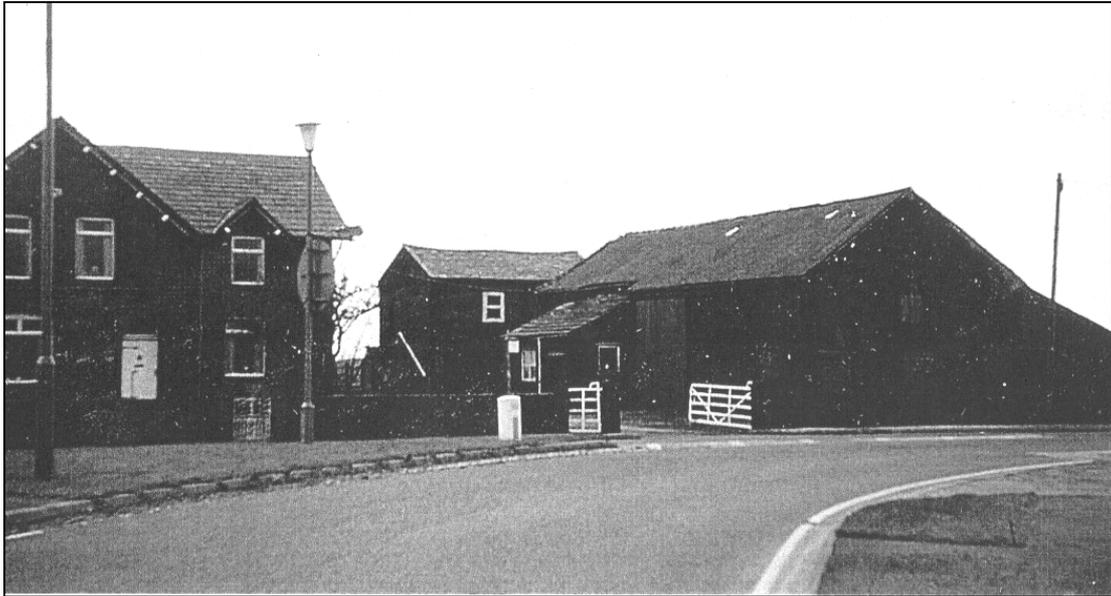
- 6.1.1 The farm lies on the southern side of Chorley road and comprises a rectangular barn aligned northeast – southwest and a smaller stable aligned northwest – southeast. The farmhouse lies to the east of the farm buildings. There is a datestone of 1870 over the doorway. The house has recently been renovated but otherwise looks little different from a photo of 1988 (see Fig.16). However its footprint does look substantially different on the 1892 OS map from the 1847 one (figs 2&3) and it may be that the date of 1870 commemorates the rebuild. The barn is constructed in handmade brick in English garden wall bond (4 stretchers to 1 header) with a single story extension to the northwest of machine-made brick in a matching bond. The roof is double pitched of corrugated metal sheeting on the northwest side and slates coated with bitumen on the other. The two-storey stable is likewise constructed in handmade brick of a similar bond. This has a double pitched roof of slate.

Plate 1: General View of Farmstead c.1988

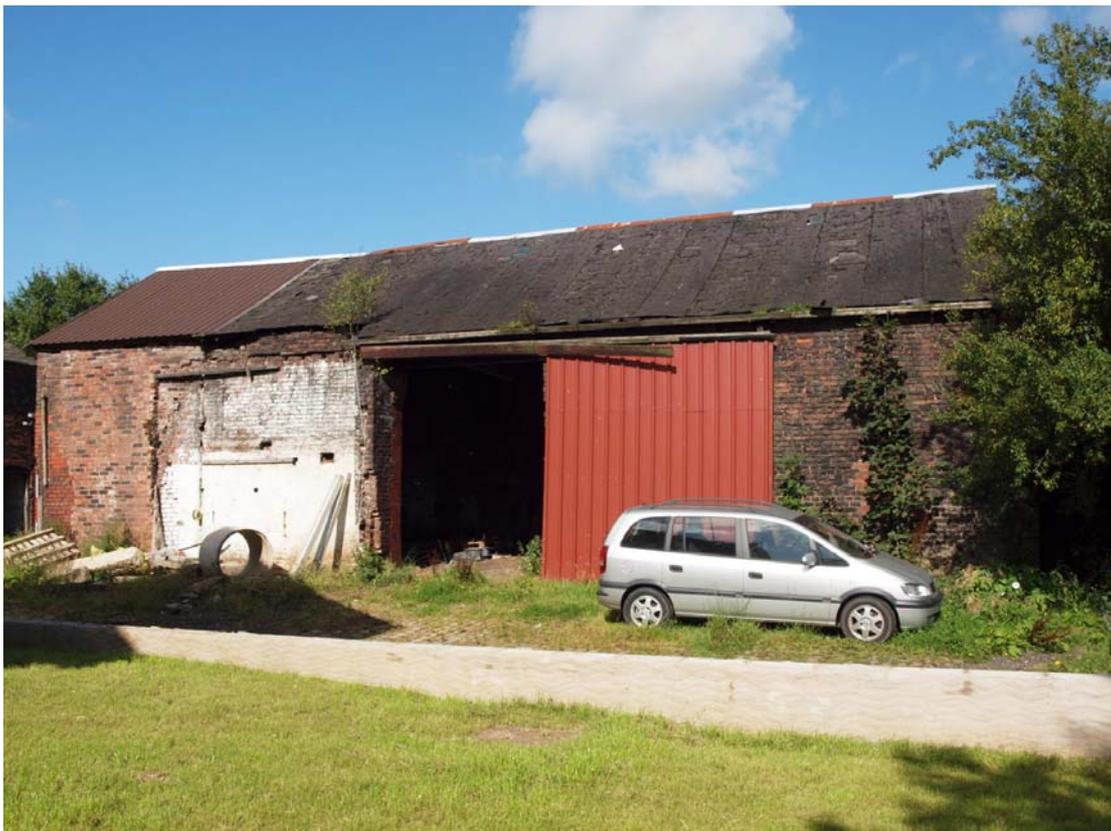
- 6.2.1 East Elevation (Plate 2). This face comprises the front of the barn and is dominated by a large barn door in the centre with a decaying timber lintel. To the north the face is whitewashed and a line of bricks shows the location of a previous outshut. A straight joint runs down the face at the southern end, badly damaged, perhaps suggesting that the southern bay was extended. To the north of the doorway are two blocked windows, the southern most square and the northern portrait.
- 6.2.2 South Elevation (Plate 3). This elevation forms the gable end of the barn and has three brick piers supporting the face, at ground floor level only. At ground floor level, at the eastern end is a large cattle doorway with RSJ lintel and

timber door hung. To the west of this is a timber framed portrait window with sandstone lintel. The area below the window has been blocked with modern brick. At first floor level there is a square window in the centre at first floor level with timber cill and lintel. Air vents arranged in a diamond pattern cover the face. The west end is the face of the extension. This is constructed in machine made brick. At the east end is a personnel doorway. This has been inserted in a larger cattle doorway as shown by the blocking to the west and the large concrete lintel above. Above this, at first floor level is a blocked window. The western end of the face holds a blocked personnel doorway.

Plate 2: Eastern elevation (front) of barn

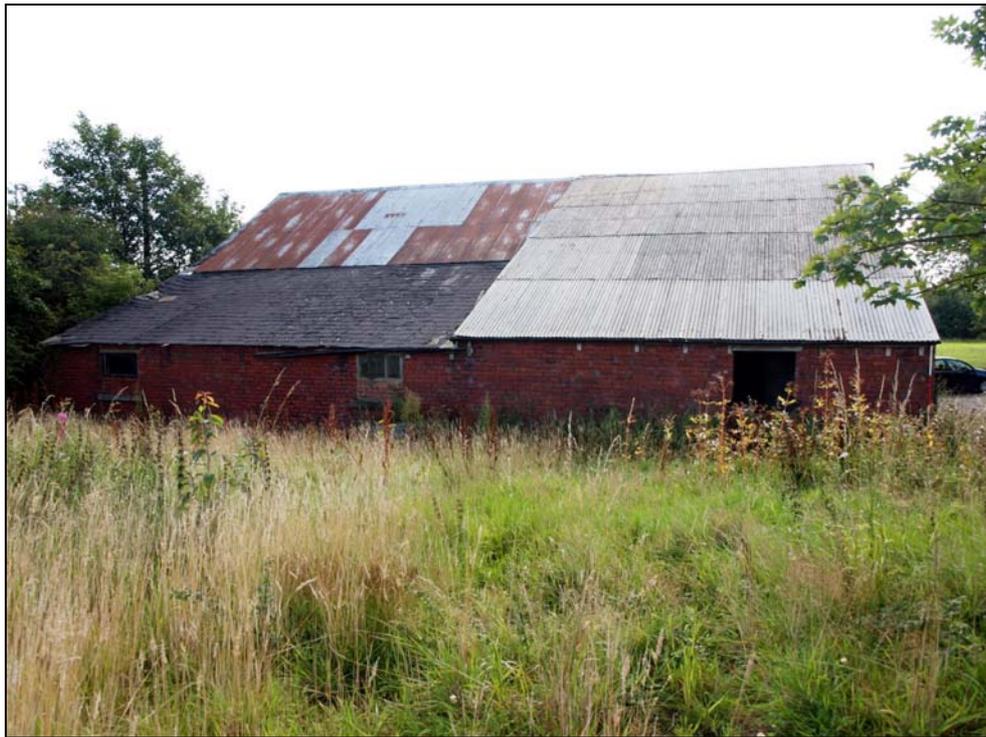
- 6.2.3 West Elevation (Plate 4). This face is the rear of the barn and is a single storey high in machine made brick. Three square windows line the face, the southern of which is square without a frame or cill. The two to the north are likewise square, but have sandstone cills. Also the lower half has been blocked, creating small landscape windows with timber frames. The roof runs down to the level with the window lintels. The roof is corrugated metal sheet. However the north end of the extension has a slate roof covered with felt.

Plate 4: Western elevation of barn

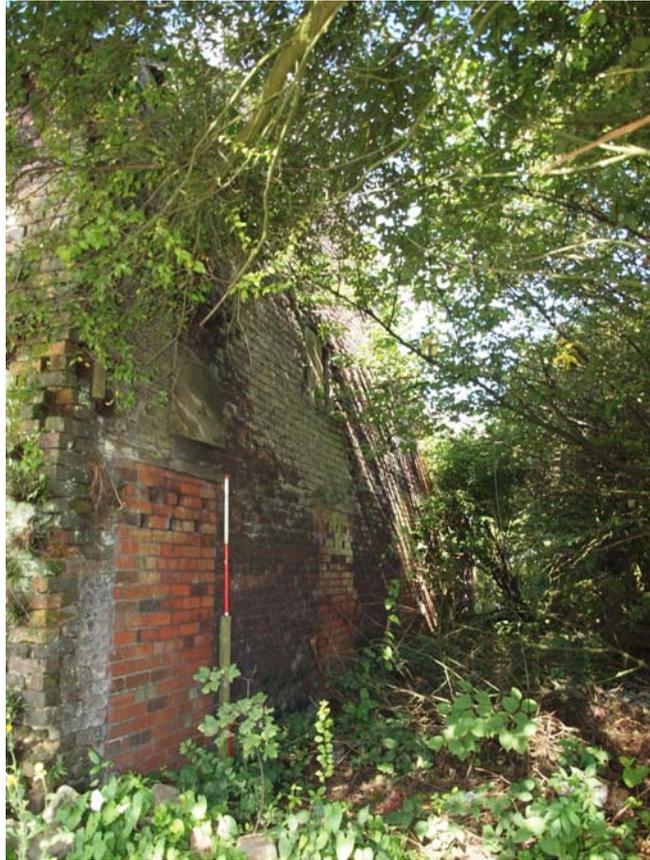
- 6.2.4 North Elevation (Plate 5). This face forms the other gable end of the building and is mostly hidden from view by several trees. Three blocked doorways line the face with two personnel doorways flanking a central cattle doorway, each with a sandstone lintel. Above the central doorway is a timber framed square window with timber shutter fitted. To the west is the face of the extension. This has a small landscape window at the eastern end with a timber lintel and a personnel doorway at the west end with a sandstone lintel and no door hung.

Plate 5: Northern elevation of barn

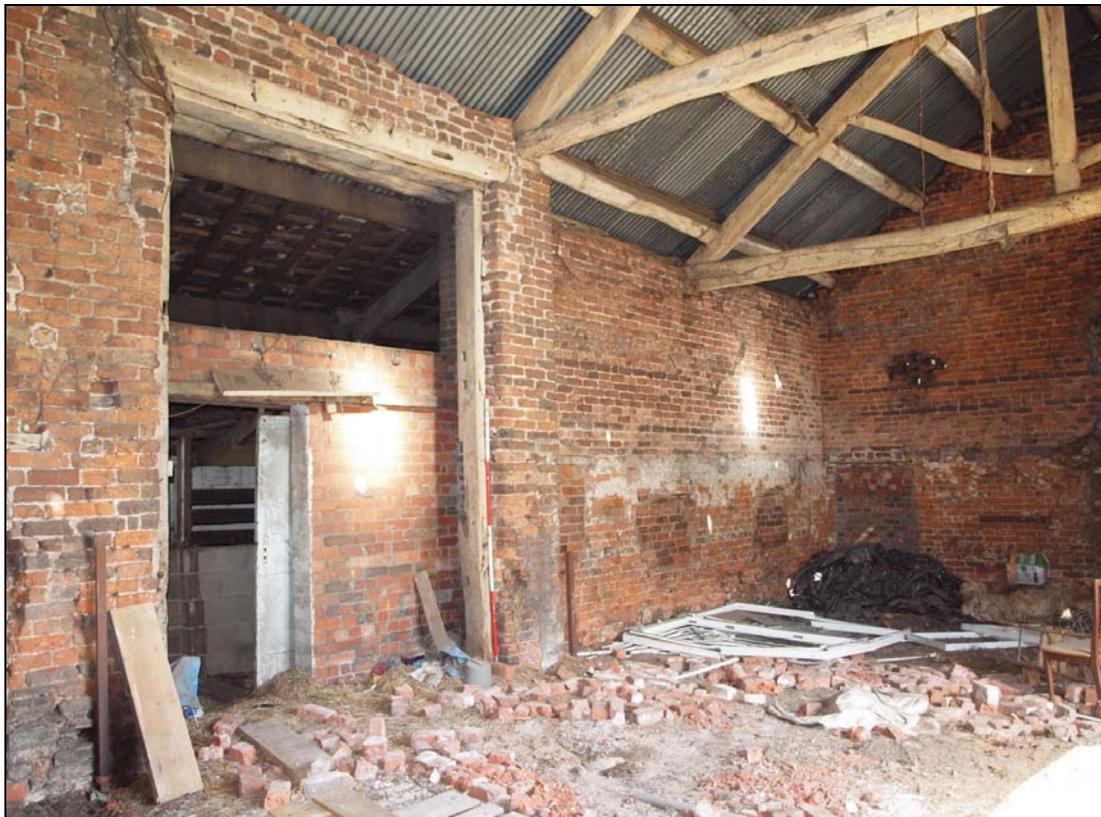
Plate 6: Barn door in west wall of barn and blocked windows to the north

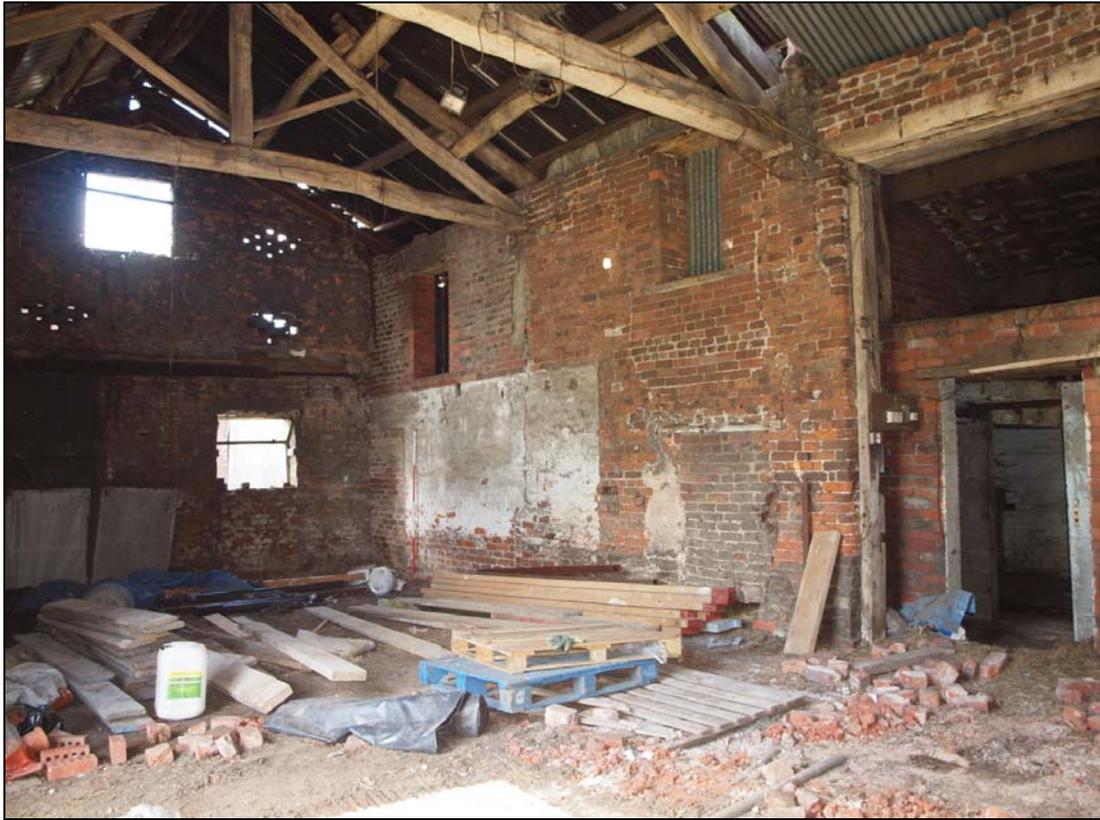
Plate 7: Blocked doorways to the south of barn door.

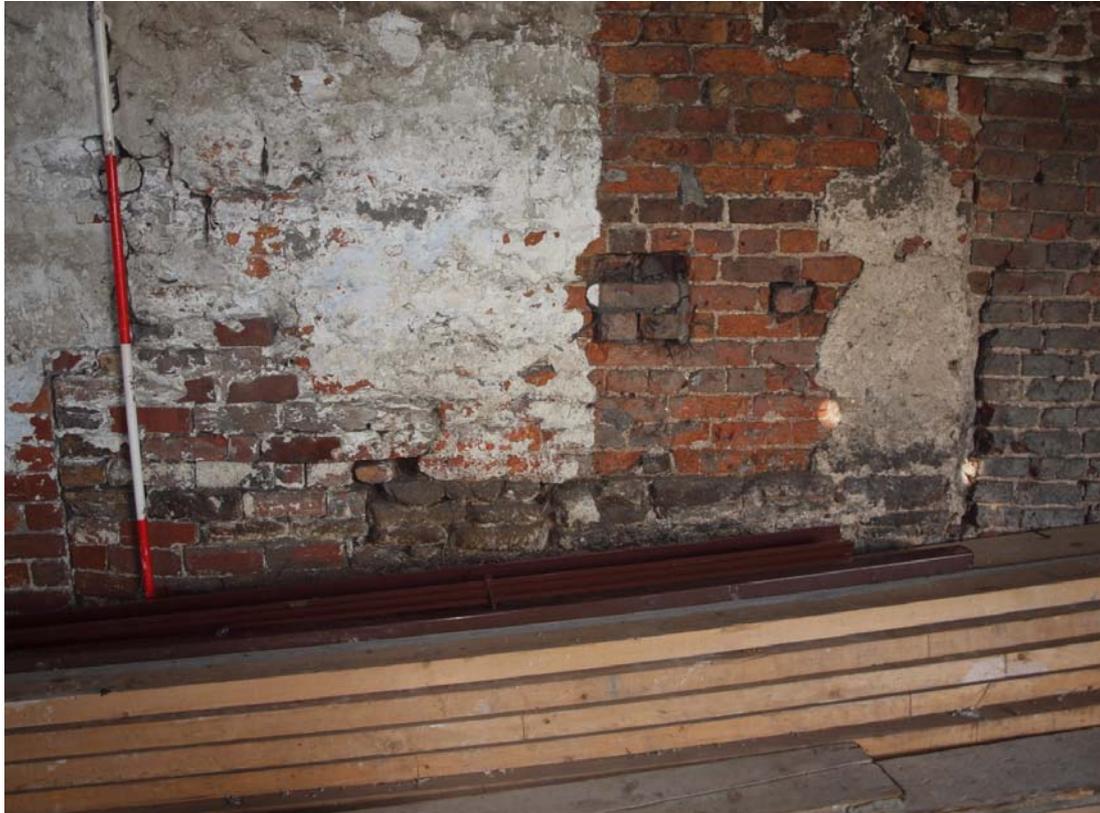
Plate 8: Area of sandstone walling in west wall of barn

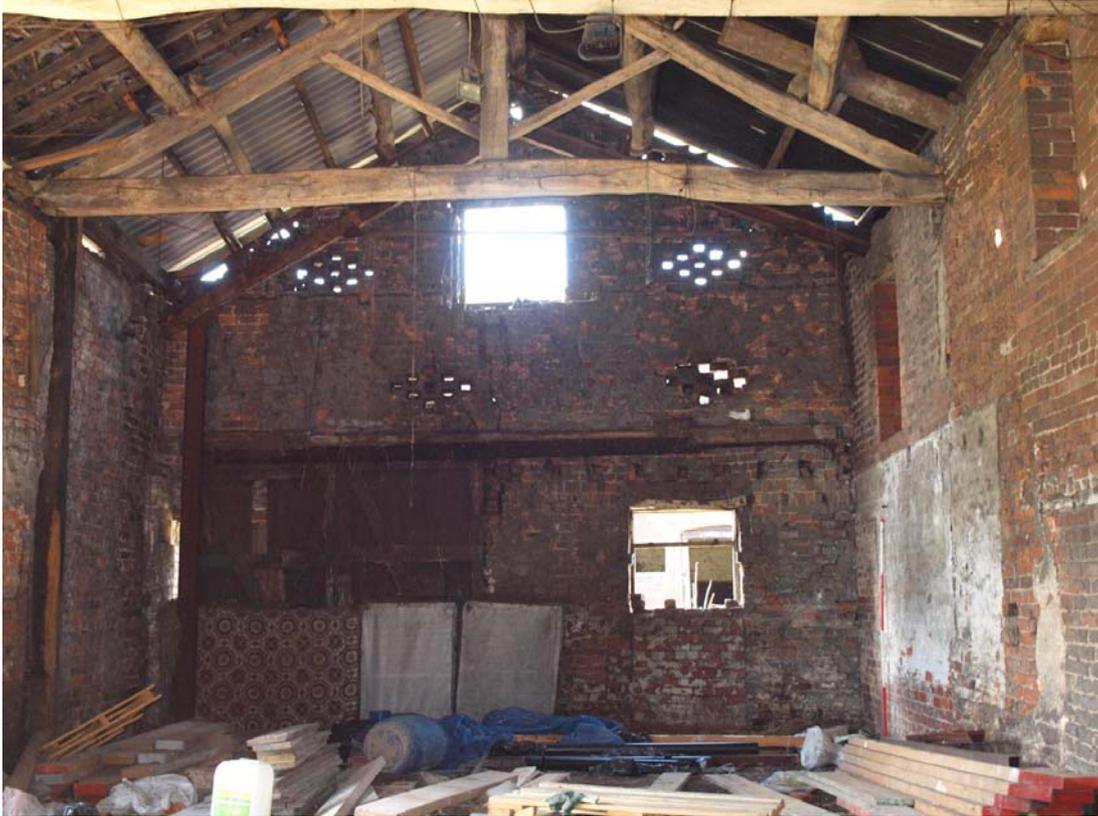
- 6.2.5 Interior - Main Barn. This comprises a single open space accessed from the exterior via a large barn door in the centre of the east wall. Directly opposite this is another barn door with a timber frame and a hand cut timber lintel above (**Plate 6**). A wall of machine made brick has been inserted behind this, with a personnel doorway set within it, leading to the shippon. To the north of this are three square blocked windows. South of the doorway are two blocked personnel doorways, one c.0.75 south of the barn door, the other at the far south end (**Plate 7**). Between these is a small area of sandstone walling, mirrored in the opposite wall (**Plate 8**). Above these at first floor level are a personnel doorway to the south and a portrait window to the north. A large doorway is located in the eastern end of the south wall with square window to the west of it, inserted in the place of a personnel door (**Plate 9**). The east wall is thinner at the south end and two timber posts stand at the southern end to give the wall support (**Plate 10**). There is a small square blocked window, just to the south of the main barn door. North of the barn door are two further square blocked windows (**Plate 11**). The north wall holds three blocked personnel doorways (**Plate 12**). The floor of the barn is earth and the ceiling is open to the metal sheet of the roof. The roof is supported by four hand-cut timber trusses (**Plate 9, 12 & 13**).

Plate 9: Southern wall of the barn showing window inserted into doorway

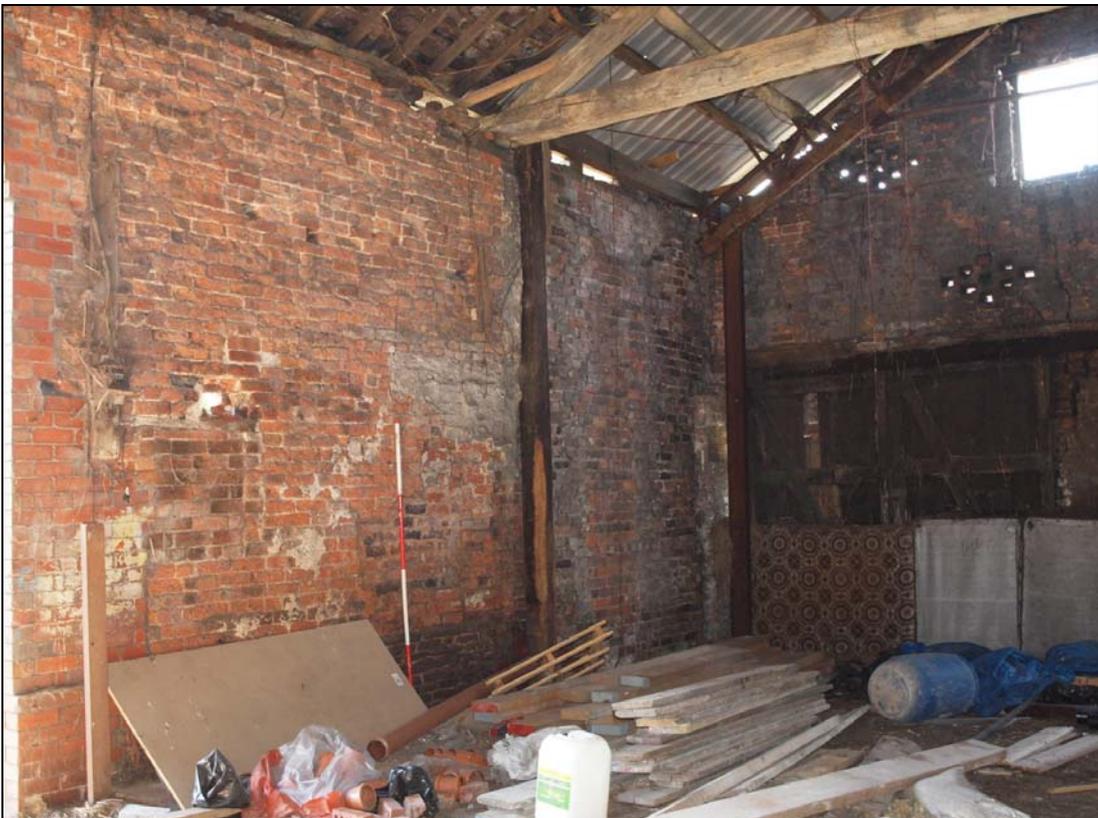
Plate 10: Southern end of east wall of barn showing timber posts.

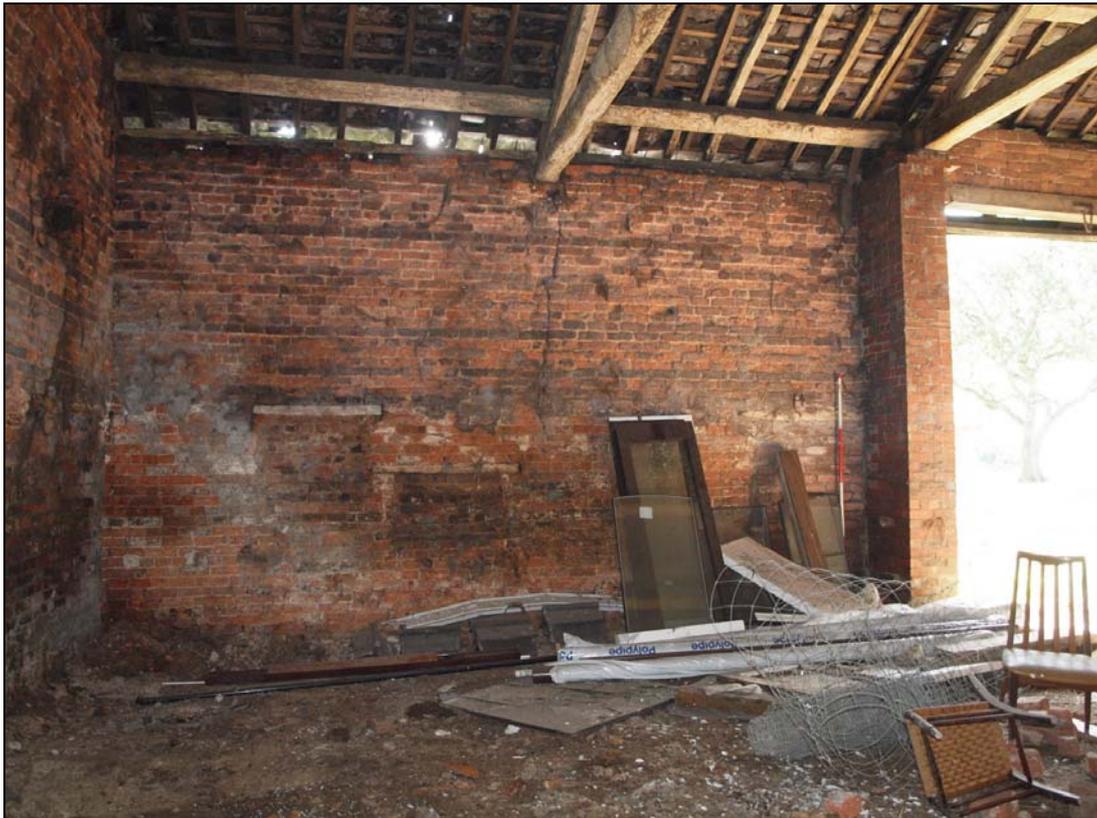
Plate 11: Blocked windows in north end of barn east wall

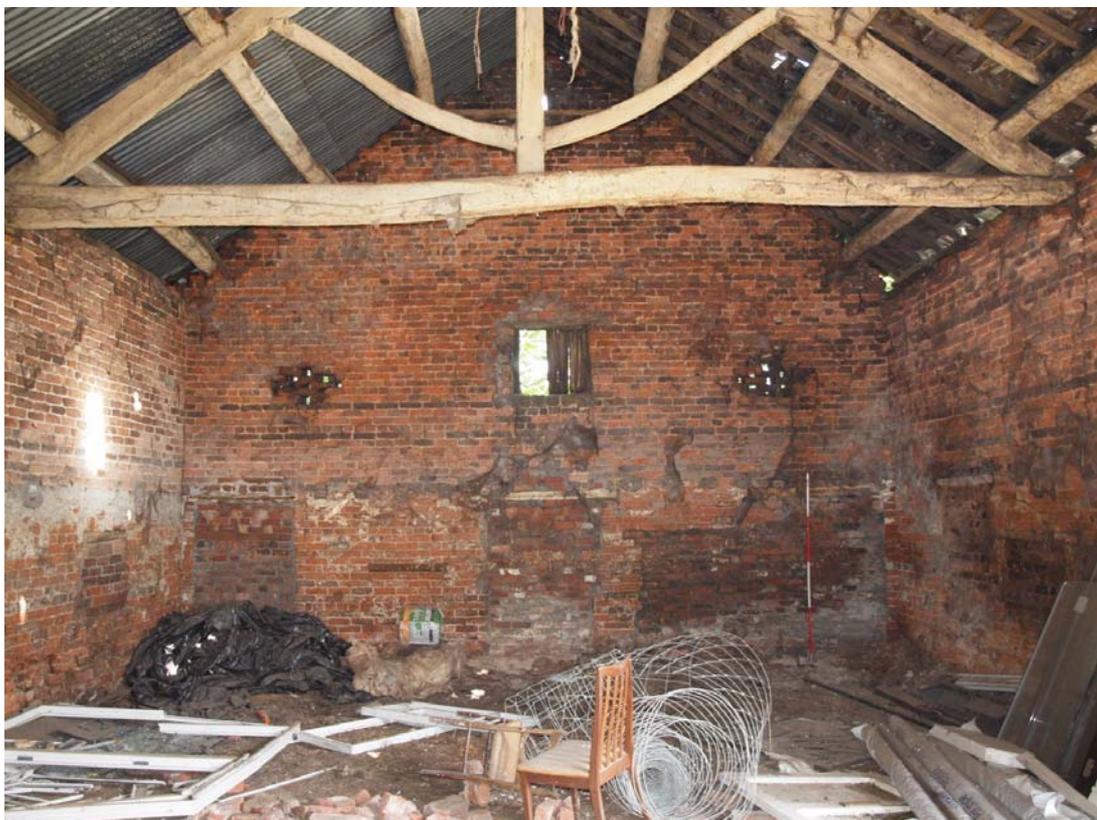
Plate 12: North wall of barn showing blocked doorways

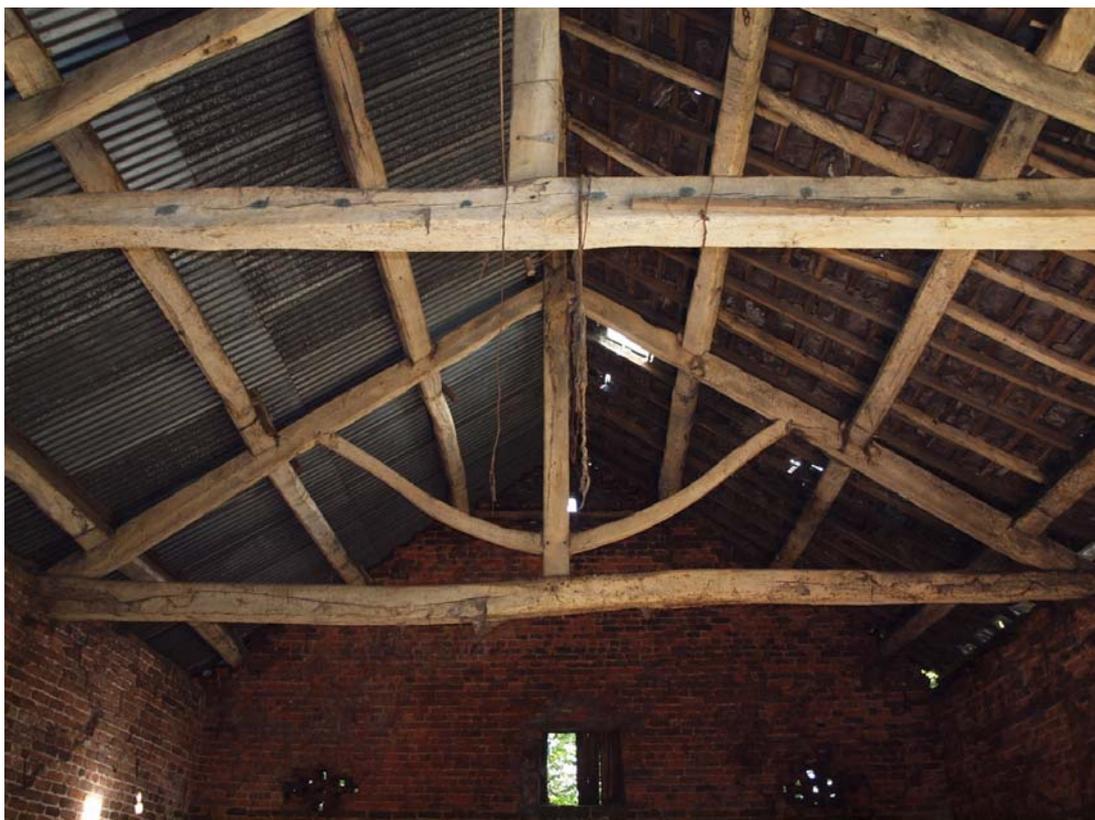
Plate 13: Hand cut timber truss in barn

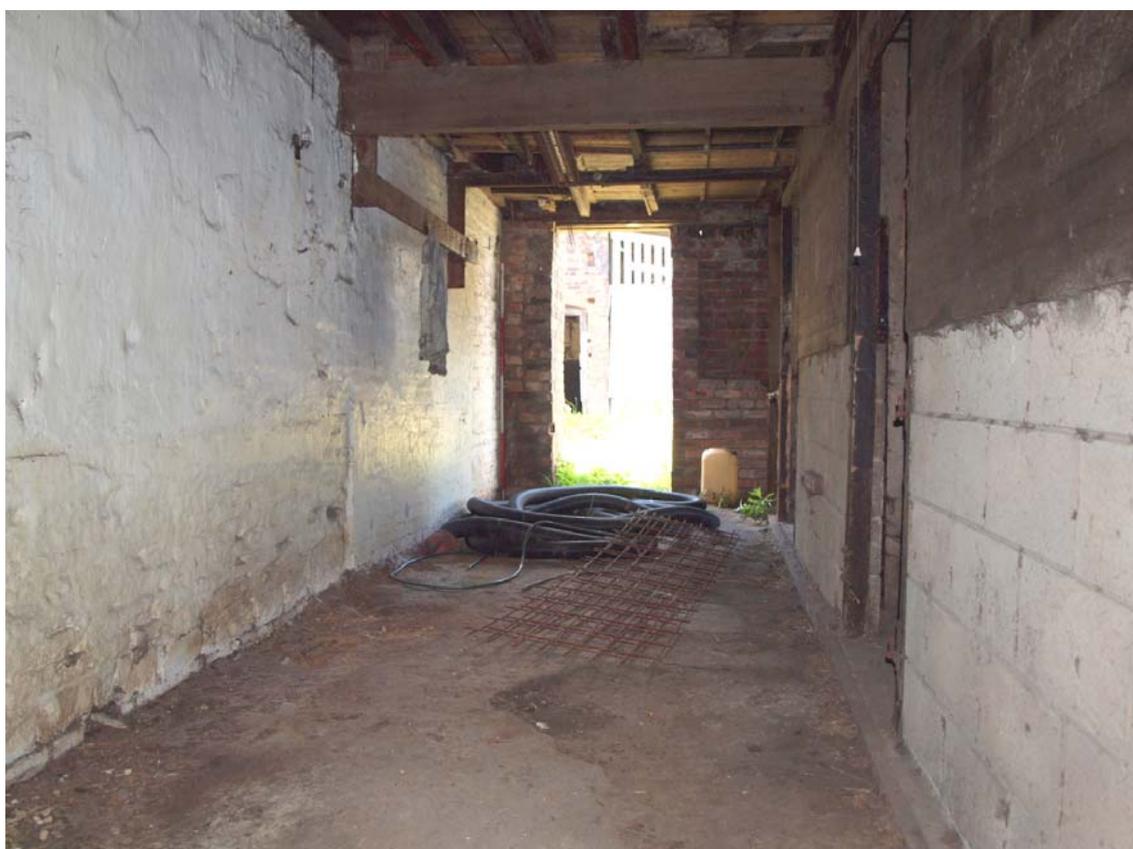
personnel doorway in the east end of the south wall. The western end of this has been blocked up, revealing it to have once been a cattle doorway (**Plate 14**). To the west of this is a blocked personnel doorway. The western wall has three windows set within it. Between these windows are two small blocked landscape windows (**Plate 15**). The northern wall has a personnel doorway at the western end of the wall with a timber lintel and a small timber framed landscape window to the east (**Plate 16**). The eastern wall has three blocked window at its northern end and a personnel doorway within a modern brick wall in the centre, leading to the main barn. South of this are two further blocked doorways. The floor over the western end of the room is a badly degraded concrete, with the floor in the boxes being concrete with a brick path running down the east side (**Plate 17**), from the blocked door at the south end to the doorway at the north. The ceiling is timber boards and for machine cut timber beams run east – west across the ceiling. A hatch in the southwest corner leads up to a low loft space.

- 7.4 The extension on the west side of the barn appears to have originally been a shippon. The blocked doorway at the eastern end of the south wall lies opposite the personnel doorway in the north wall, with what was a cattle doorway at the east end of the south wall. The cattle would thus have been brought in through this southern doorway, with a feeding passage running north – south to the west. This is further evidenced by the brick flooring in this area marking the end of the boskins and the line of the feeding passage. It is probable that the construction of this at the turn of the century also marks a change in use of the barn and the removal of the shippon area in the northern end of the barn.

Plate 14: Doorway inserted in cattle door at south end of shippon.

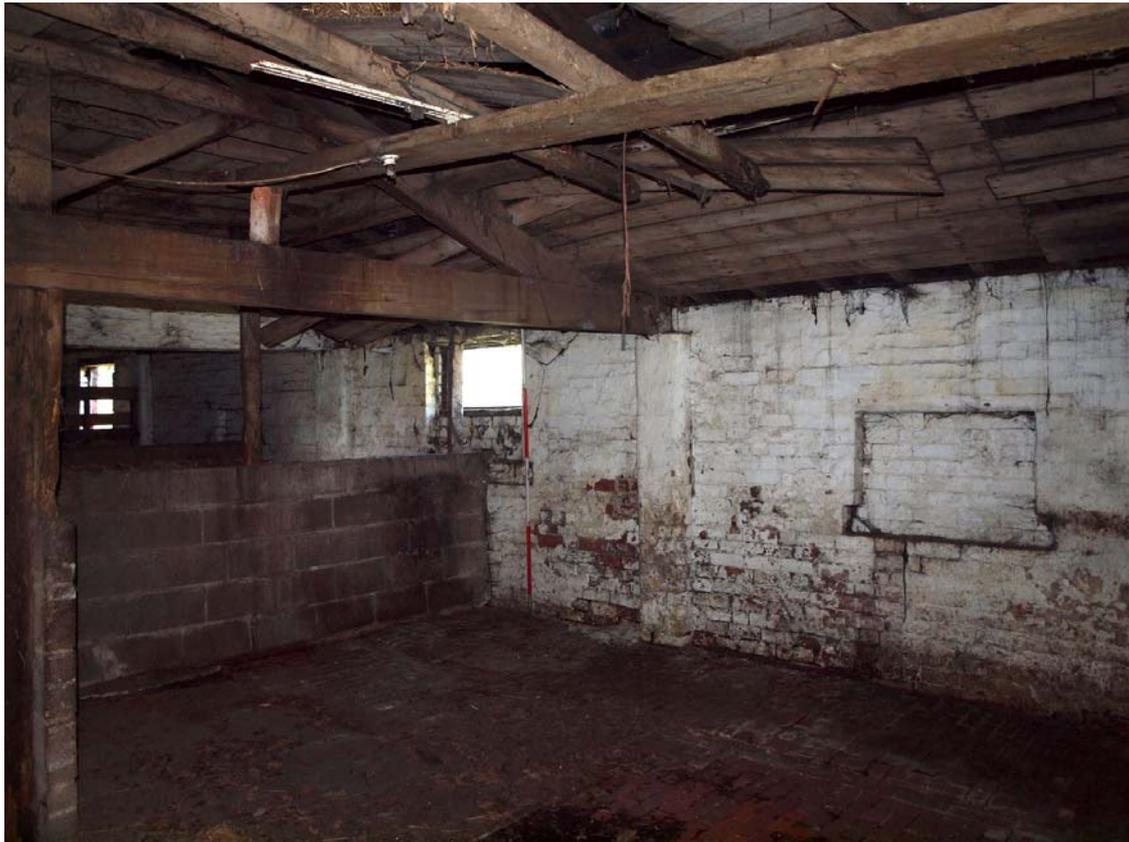
Plate 15: Blocked window in west wall of shippon

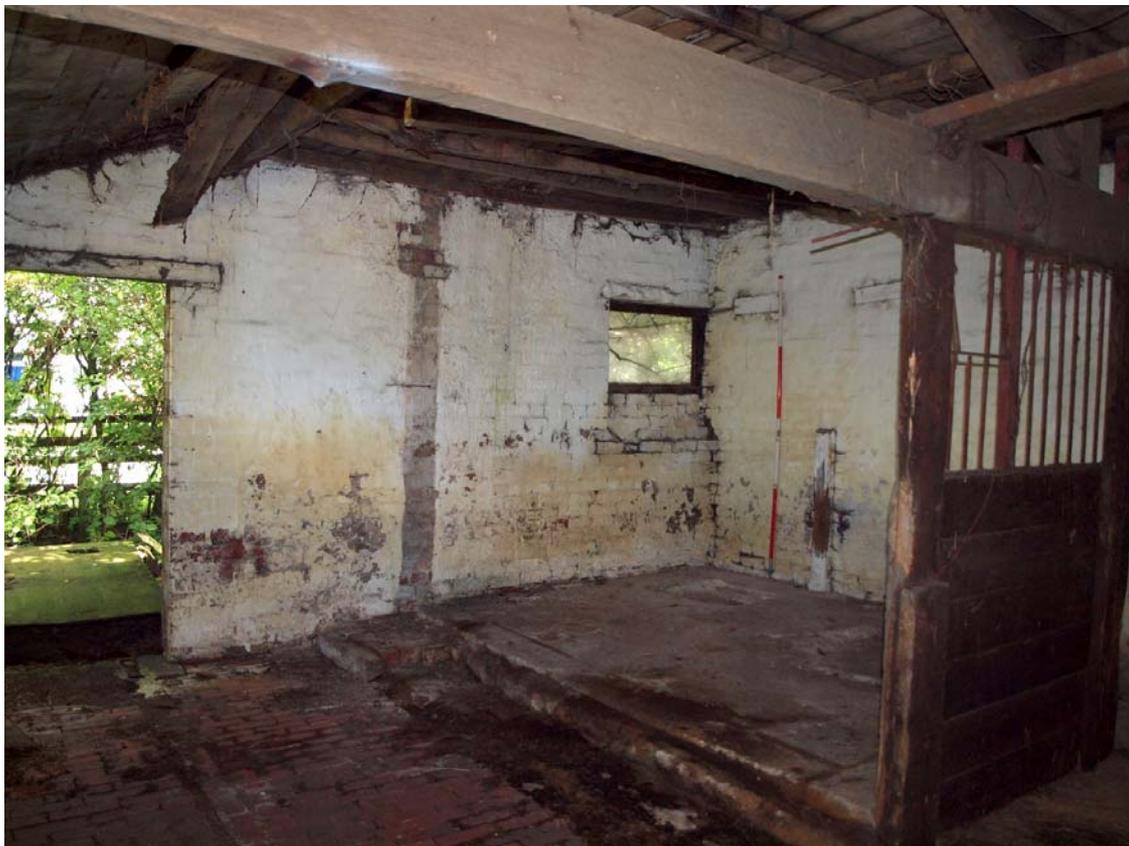
Plate 16: North wall of shippon. Note the brick and concrete areas of the floor

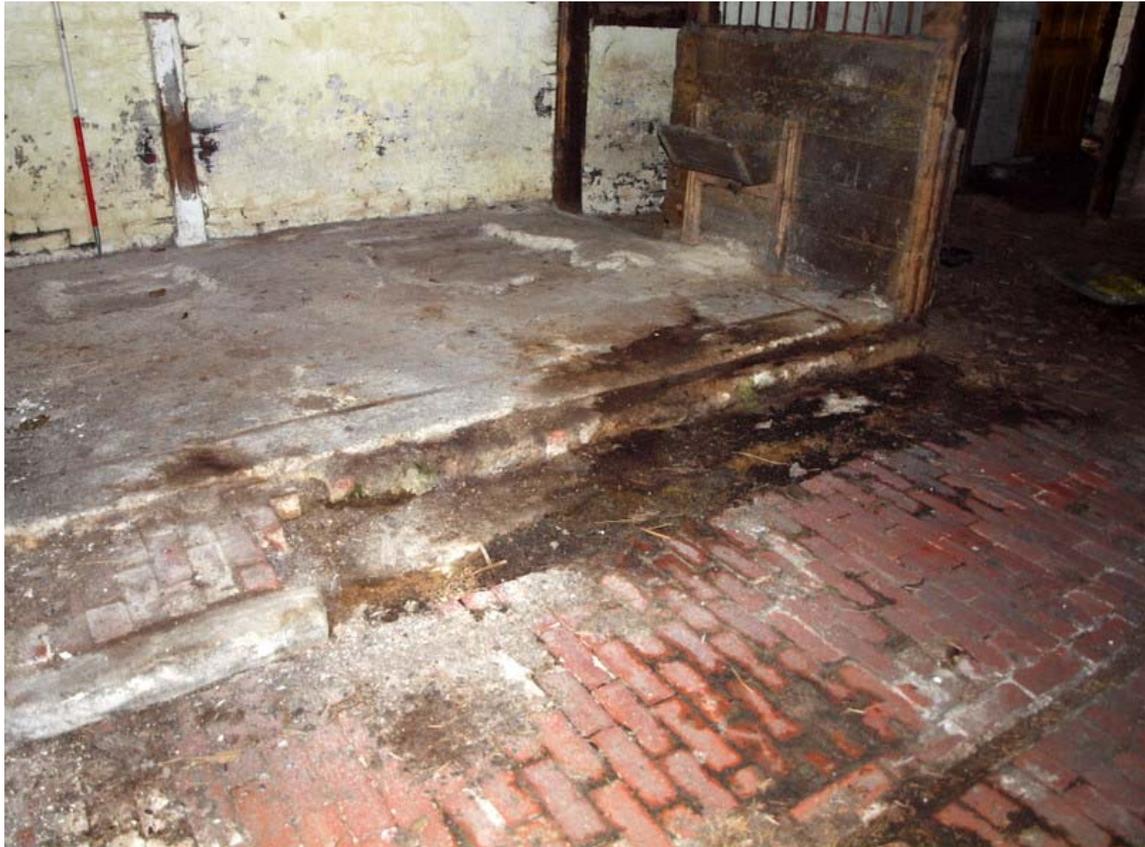
Plate 17: Brick and concrete flooring.

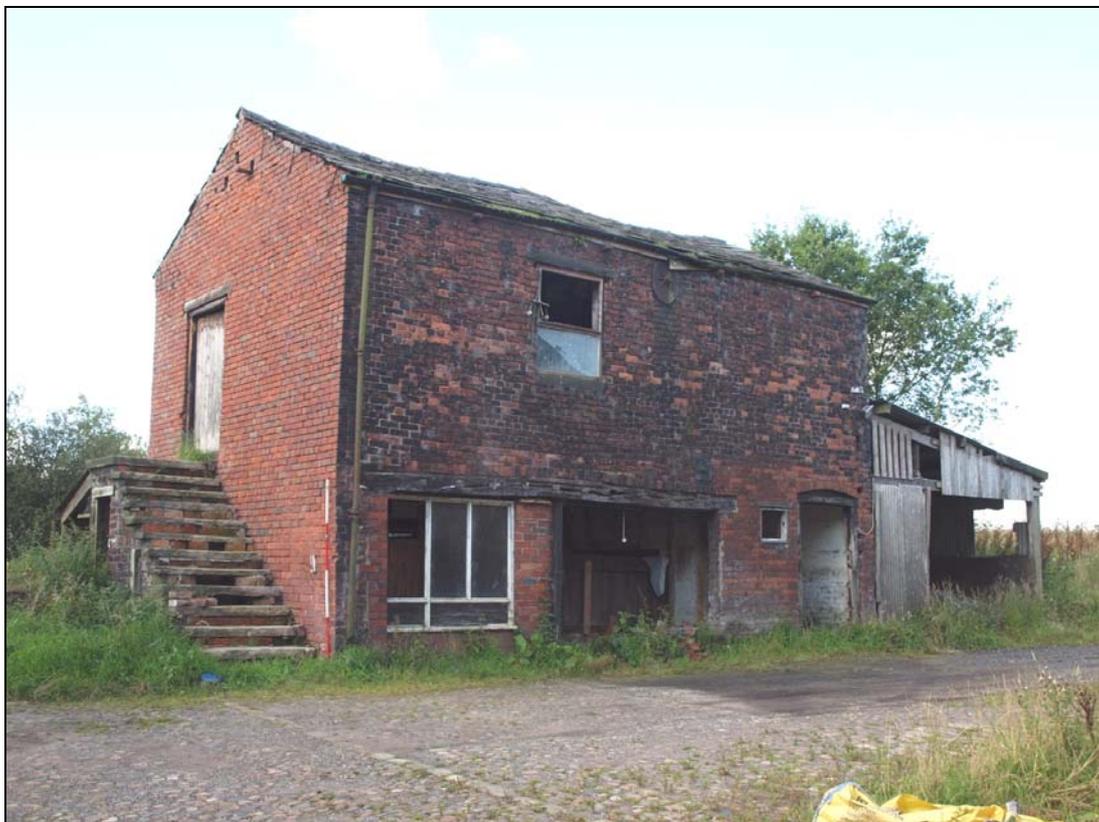
- 6.3.1 North Elevation (**Plate 18**). This face forms the front of the stable. A very long (c.5m) hand cut timber lintel runs from the east end towards the west, supported in the centre by a cast iron stanchion. A line of brick headers runs above this timber lintel. To the east of the stanchion a wall has been inserted in machine made brick with a large timber framed window within it. To the west the area is open creating a large open doorway. West of this again is a small timber framed landscape window with a timber lintel and to the west again is a timber framed personnel doorway with an arched lintel of brick headers. At first floor level, to the east of centre is a single timber framed portrait window with sandstone cill and lintel. To the west is an outshut of corrugated asbestos sheeting with a large open doorway to the west.

Plate 18: Northern elevation of stable

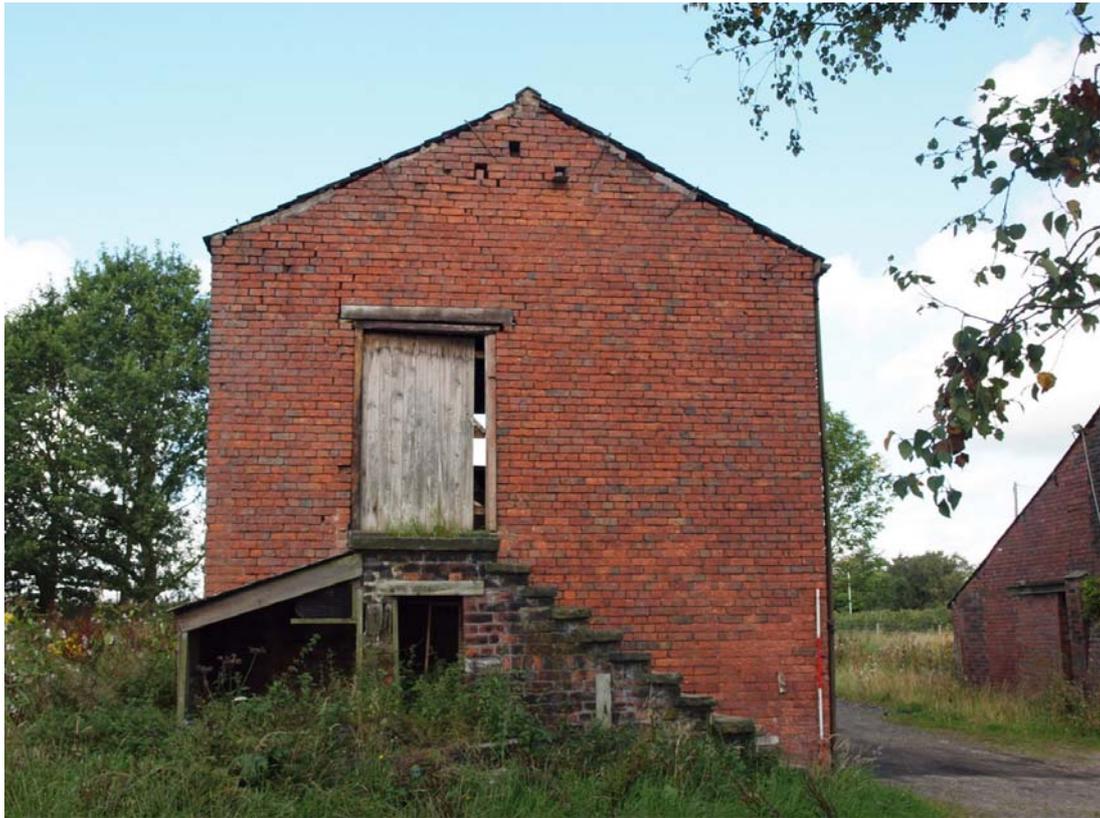
- 6.3.2 East Elevation (**Plate 19**). This face comprises the gable end of the barn with a timber framed personnel doorway slightly south of centre at first floor level. This is hung with a timber door and is accessed via a set of sandstone steps which lead up from north to south, ending at a sandstone slab landing in front of the doorway. To the south of this a small timber outshut has been added.

Plate 19: Eastern elevation of stable

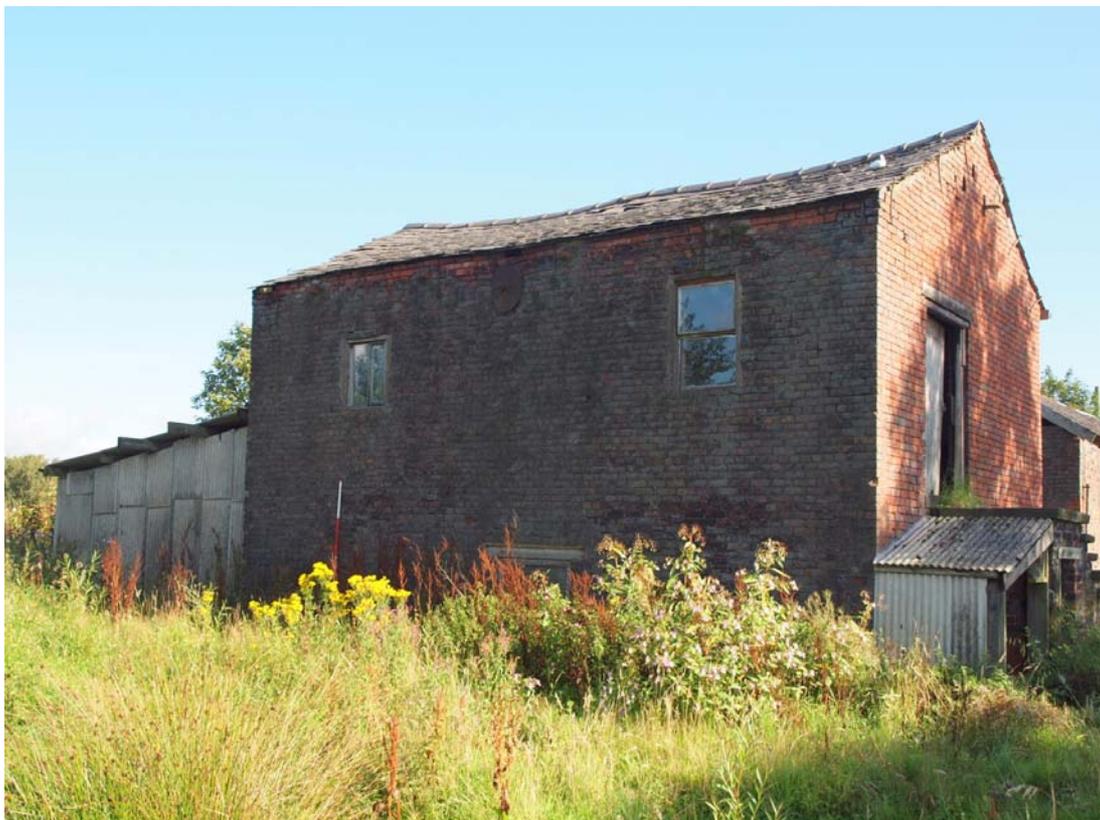
- 6.3.3 South Elevation (**Plate 20**). This elevation forms the rear of the building. At ground floor level, slightly east of centre is a small timber framed landscape window with a concrete cill. At first floor level are two portrait windows, one at the east end and one at the west. Both are timber framed with cement rendered jambs although no cills or lintels. To the west is an outshut of corrugated asbestos sheeting.

Plate 20: Southern elevation of stable

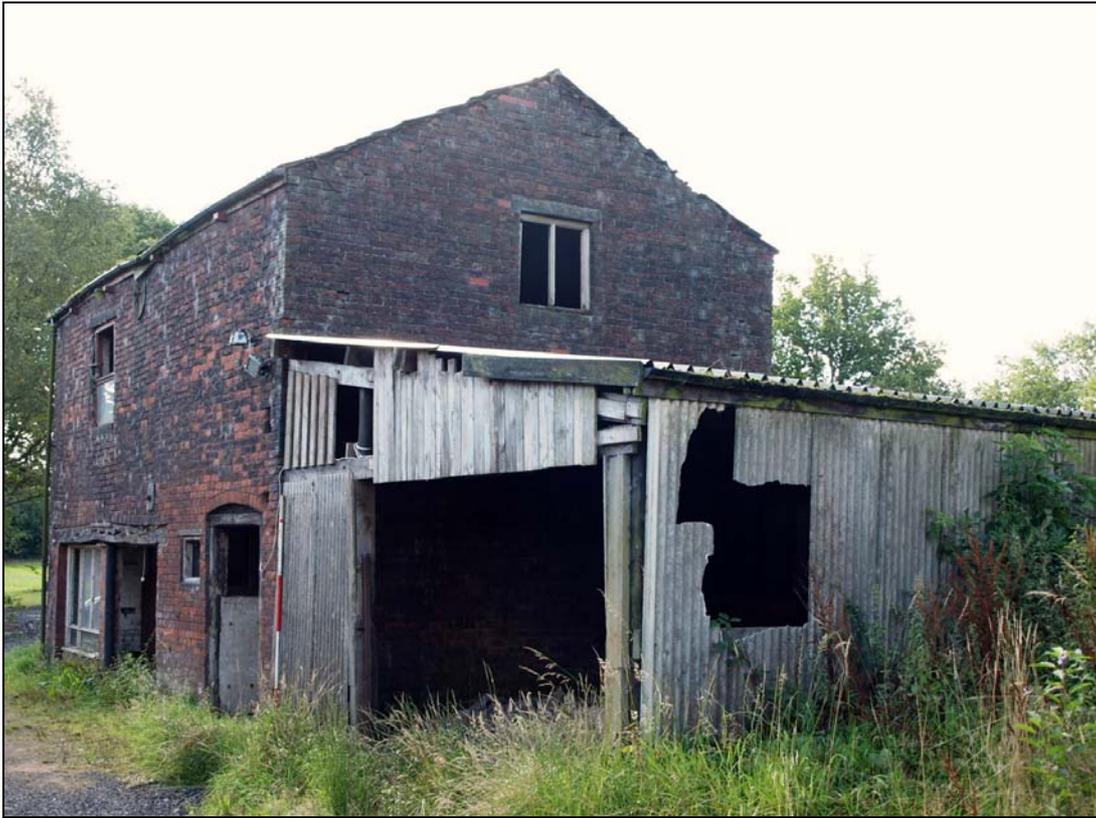
- 6.3.4 West Elevation (**Plate 21**). This face is the other gable end of the barn. A timber framed portrait window with sandstone lintel is in the centre of the first floor. The rest of the face is featureless although a single storey outshut of corrugated asbestos sheeting blocks much of it from view.

Plate 21: Western elevation of stable
