**BRINSOP HOUSE FARM BARN,
CHORLEY ROAD, WESTHOUGHTON**

An Archaeological Building Survey

by J. M. Trippier Archaeological and Surveying Consultancy

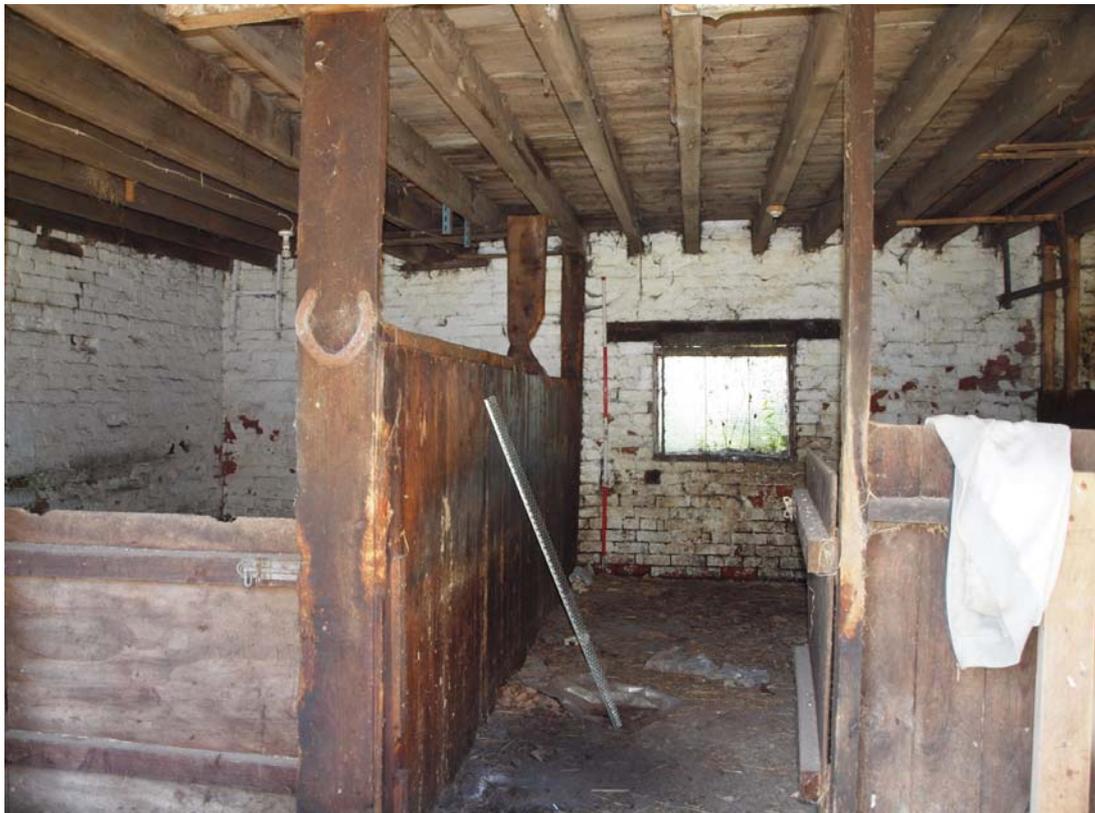
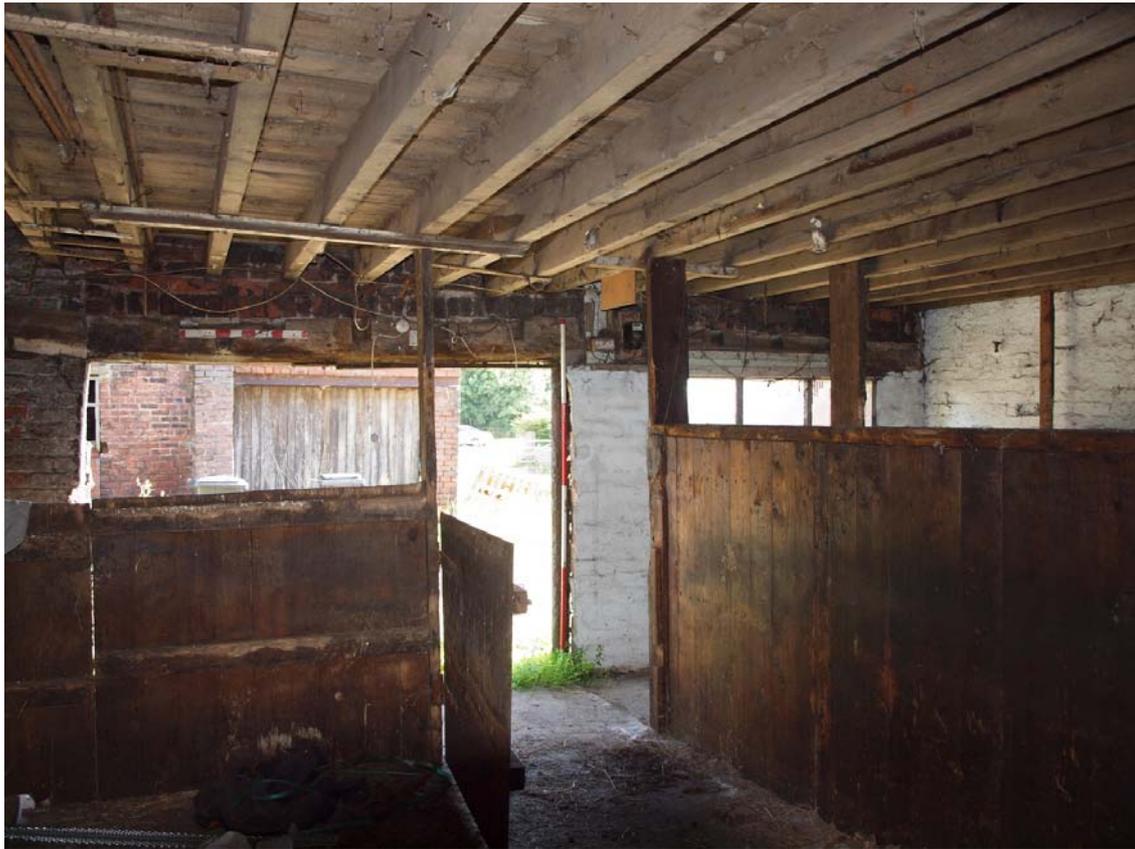
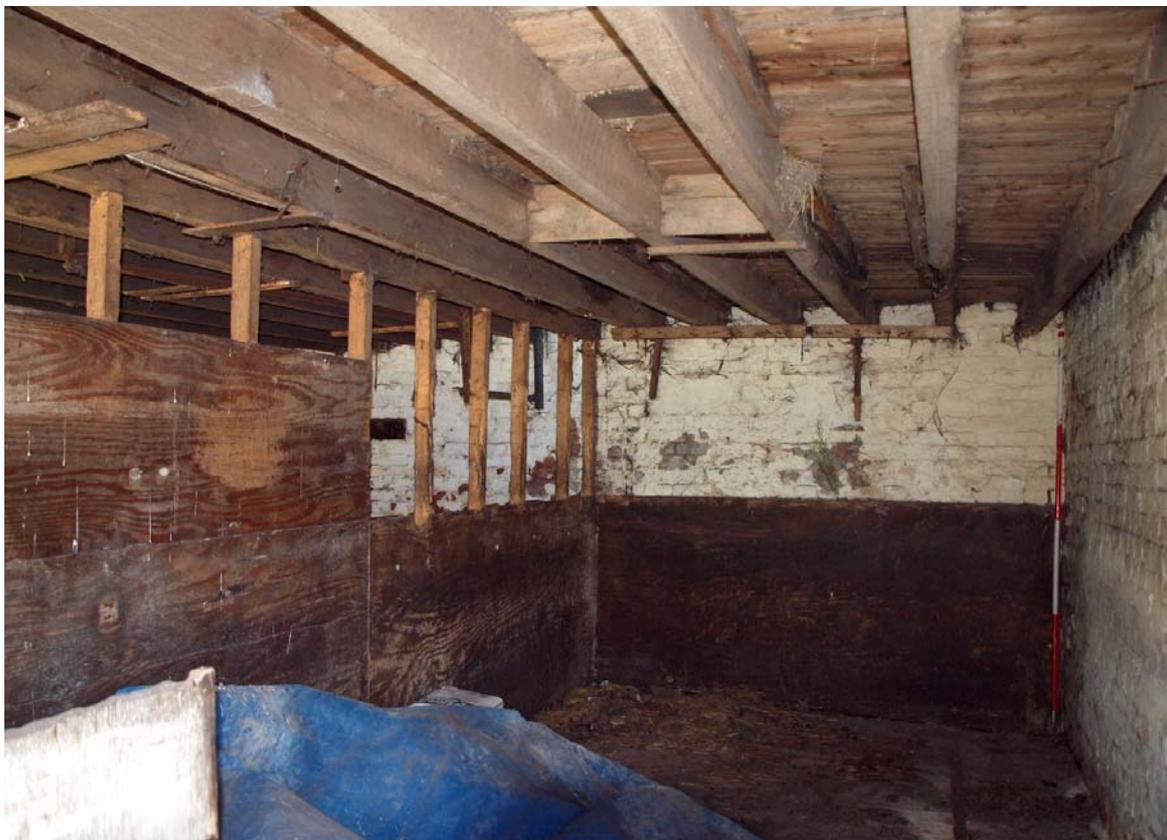
- 6.3.5 Interior - Ground Floor (Plates 22 - 24). The room is divided into three loose boxes, with the eastern and central accessed through the large opening in the north wall. The western one is accessed via the doorway in the west end of the north wall. The floor is concrete and the ceiling open to the timber boards of the floor above. The boxes are divided by low timber partitions and the central and eastern have a short walkway at the north end. This houses a large square timber framed window at the east end. A single landscape window lies west of centre in the south wall. At the eastern end of this wall the remains of a timber ladder are visible (**Plate 25**), although no evidence of a hatch remains above them. A hatch is present to the west of this however.

Plate 22: Interior of ground floor of stable; passage between east and central loose box looking south

Plate 23: Interior of ground floor of stable; central and east loose boxes looking north

Plate 24: Interior of ground floor of stable, west loose box looking south

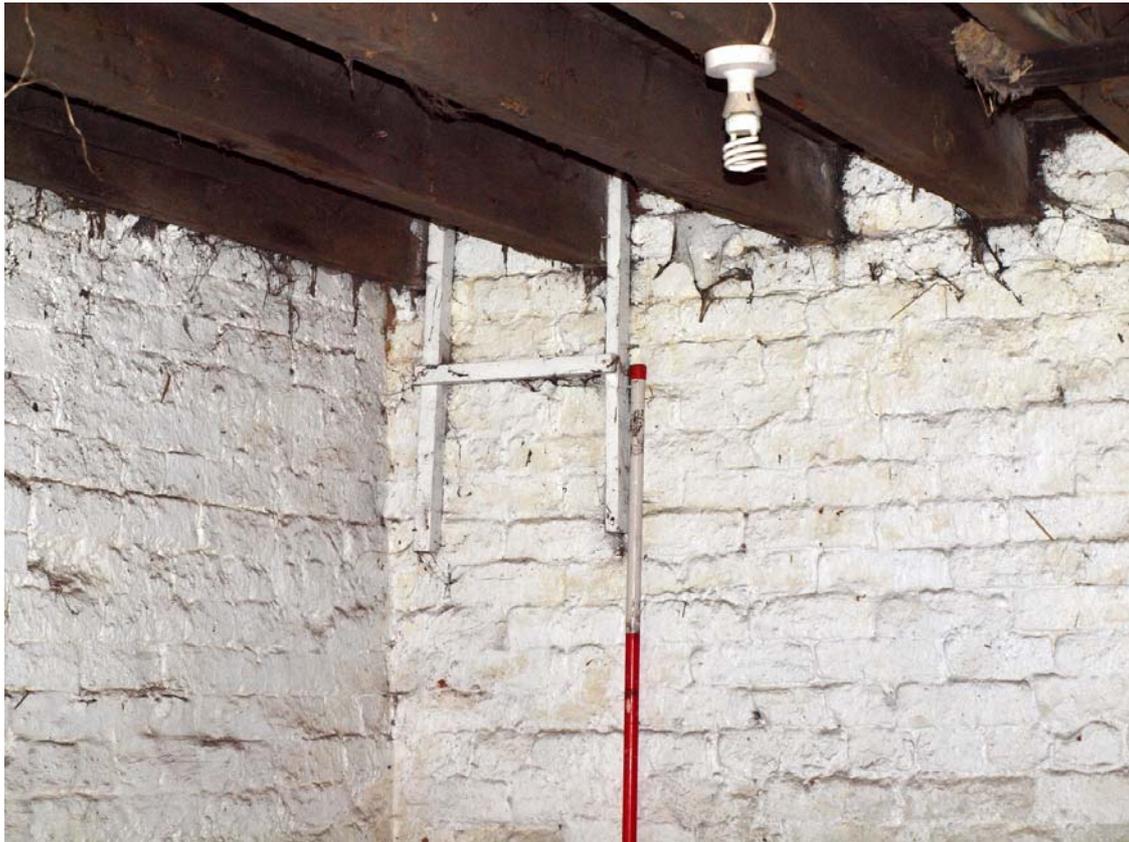
Plate 25: Remains of ladder in south- east corner of stable

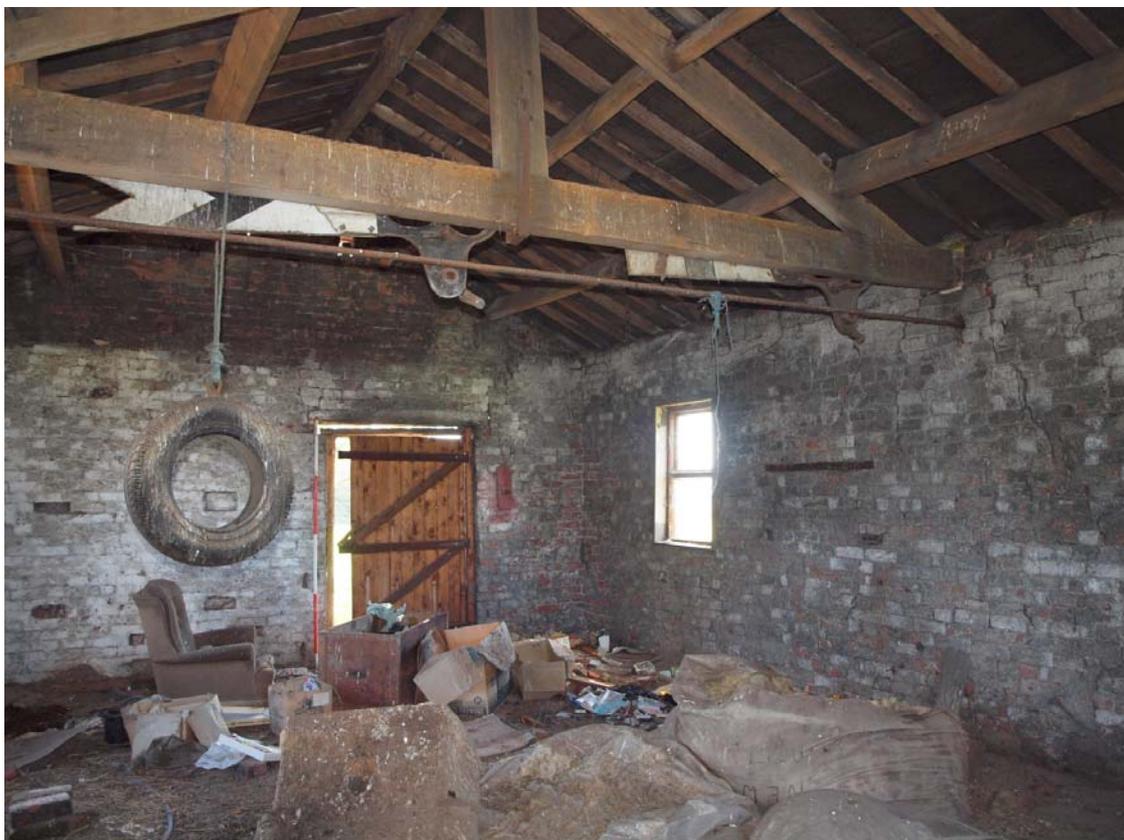
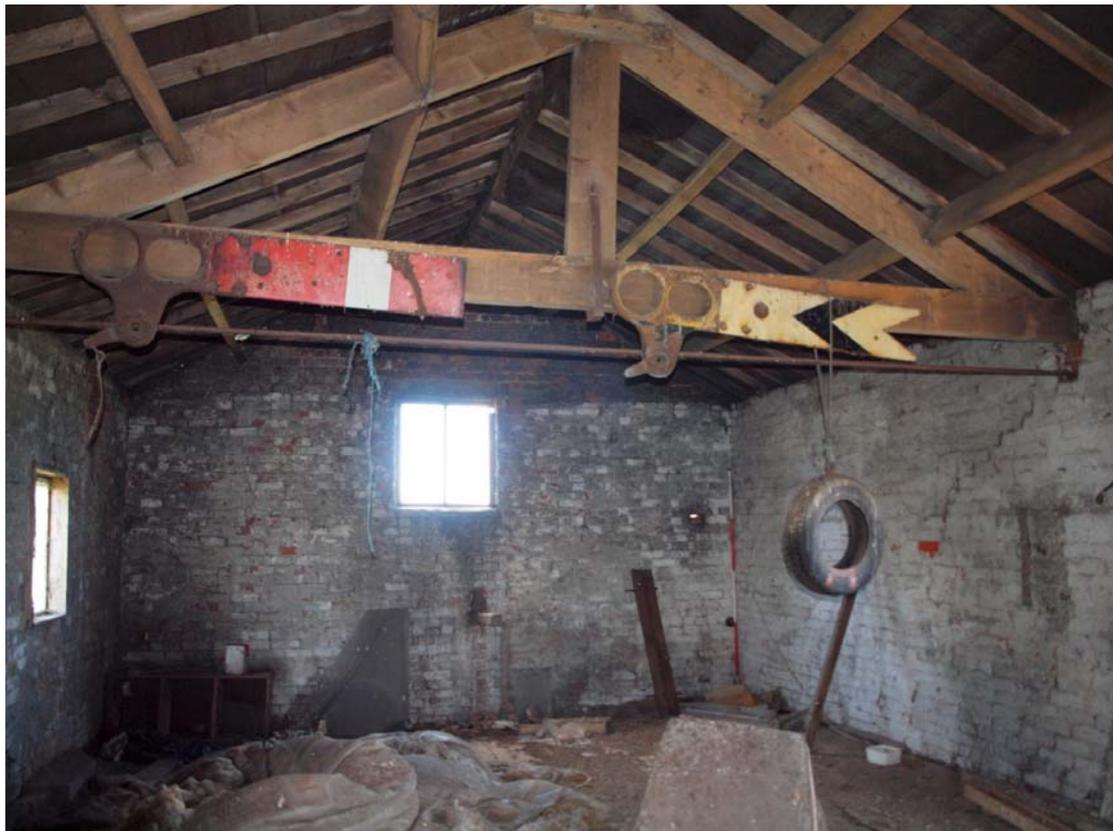
- 6.3.6 Interior - First Floor (Plates 26 – 27). The room is accessed via a personnel doorway in the east wall. Two timber framed landscape windows lie in the south wall, with another in the west wall and another at the eastern end of the north wall. The floor is timber boards and the ceiling open to the machine cut timber rafters. The roof is supported by a machine cut timber king post truss. The floor is timber boards with a small hatch in it along the south wall.

Plate 26: Stable; first floor looking east

Plate 27: Stable; first floor looking west
