**Barrack Fold Farmhouse, Arthur Lane, Ainsworth,
Bury**

An Archaeological Building Survey

By J.M. Trippier Archaeological and Surveying Consultancy

October 2011

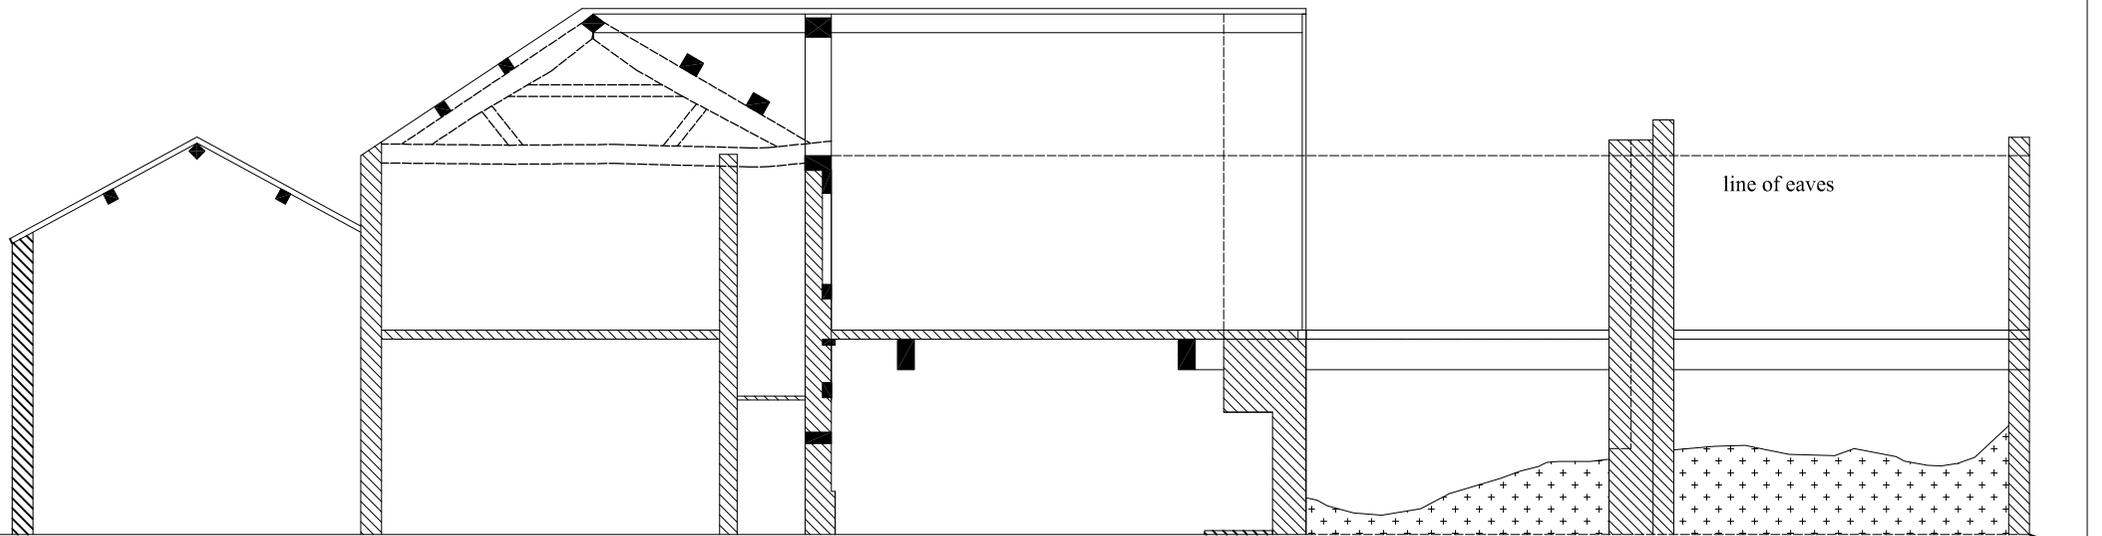
Figure Number 8. South facing section and inglenook

View of inglenook - not to scale

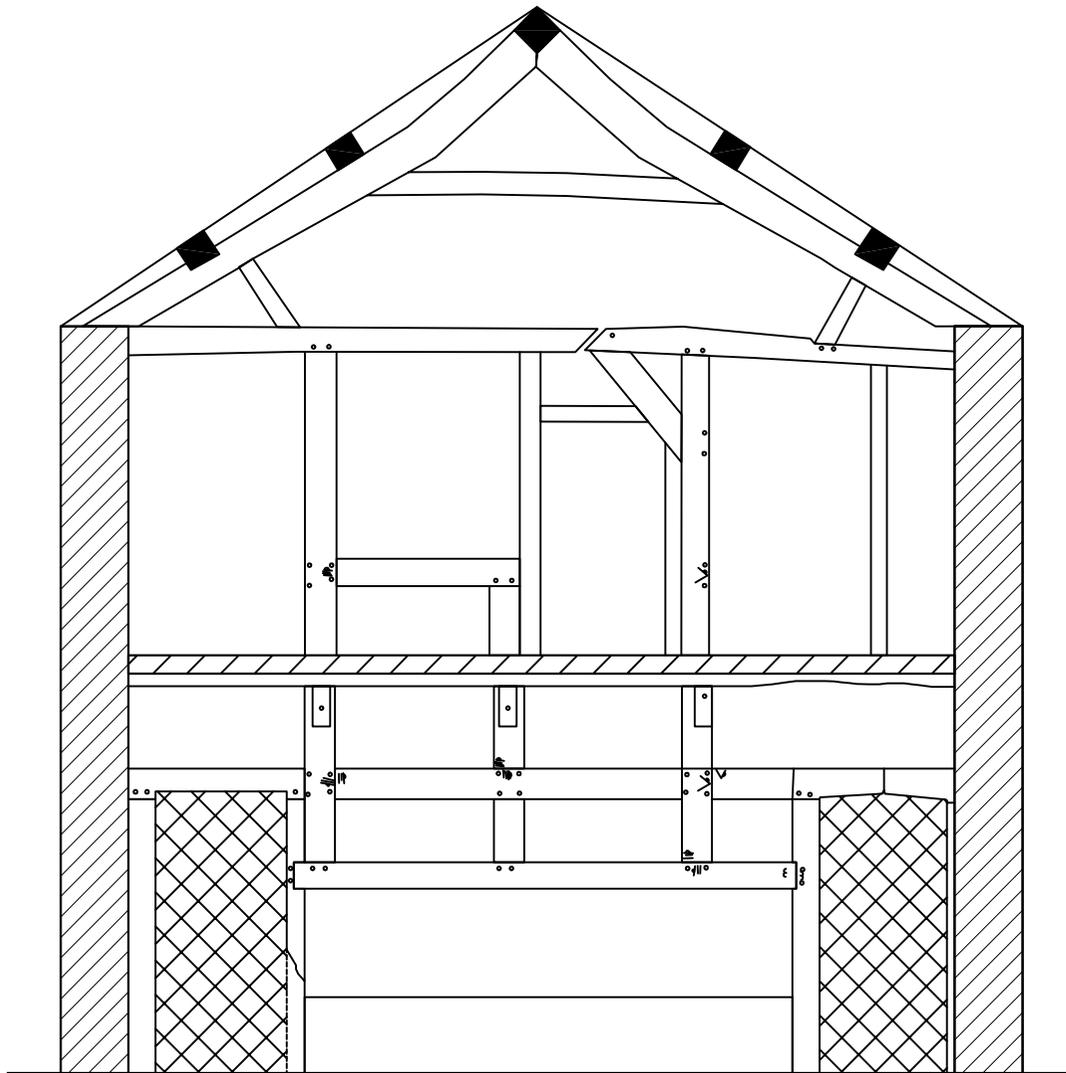
detail of timber framework and carpenters marks

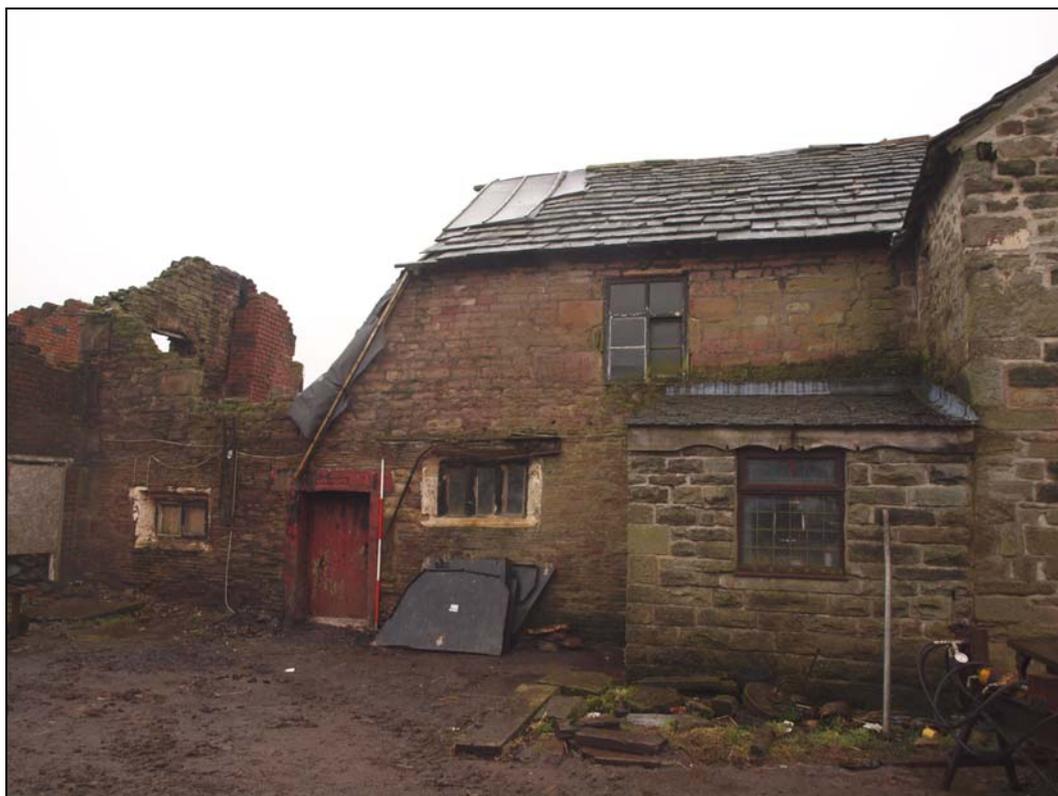
Plate 3: North elevation of dwelling

- 6.2.1 North Elevation. (Plate 3) This face comprises the front of the dwelling. At ground floor level is a wide personnel doorway with a heavy sandstone lintel and jambs. "1631 RHB" is inscribed upon the lintel (Plate 4). Flanking the doorway are two windows. The window to the east has a timber frame of two lights with a chamfered whitewashed surround (Plate 5). To the west, the window is a three light splayed sandstone mullion window, with chamfered sandstone surround (Plate 6). The stonework at ground floor level is comprised of thin rectangular stones c. 70x200mm, up to the line of the western window lintel. Above this, at first floor level, the stones are much larger c. 150x300mm, suggesting the first floor to be a later addition (Plate 7 []). The eastern end of this has collapsed due to fire damage, although quoins are visible in the eastern corner. At the western end is a 4-pane Yorkshire sash with 2 fixed lights over. A modern stone porch has been added to the western side of the face in the corner which meets the wing. This is built of shaped sandstone blocks regularly coursed with a modern top-opening timber framed window in the centre. It has a single pitched roof of welsh slate and hides a blocked personnel doorway.

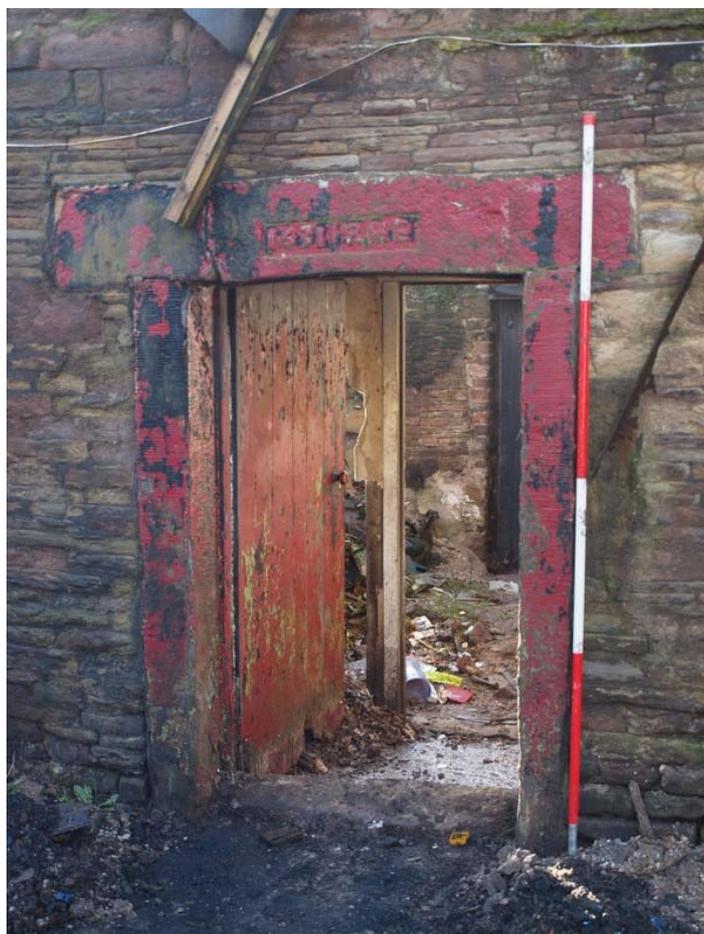
Plate 4: Front door of dwelling with date inscribed on lintel

- 7.5 Turning to the dating evidence there are two datestones. One over the north door leading to the east bay of the two unit dwelling reads “1631 RHE” whilst one over the door into the east wall of the west wing, where it protrudes northwards, reads “1601 RTH”. However neither set of initials on these datestones can be matched to the known owners and occupants of the farm. We were advised that the latter stone was found in the farmyard by the farmer and placed in its present position some years ago. Muschamp (1928-33, 22) and Bullock (Bullock 1973, 18) noted it but did not describe its location. Also the inscribed lintel in the east bay of the two unit dwelling appears to be of a different type of stone from the supporting jambs. If both have been relocated there evidential value for dating the structure is obviously severely compromised. Muschamp (*ibid*) also refers to a datestone of 1622 with an obliterated inscription but this was not located during this survey.

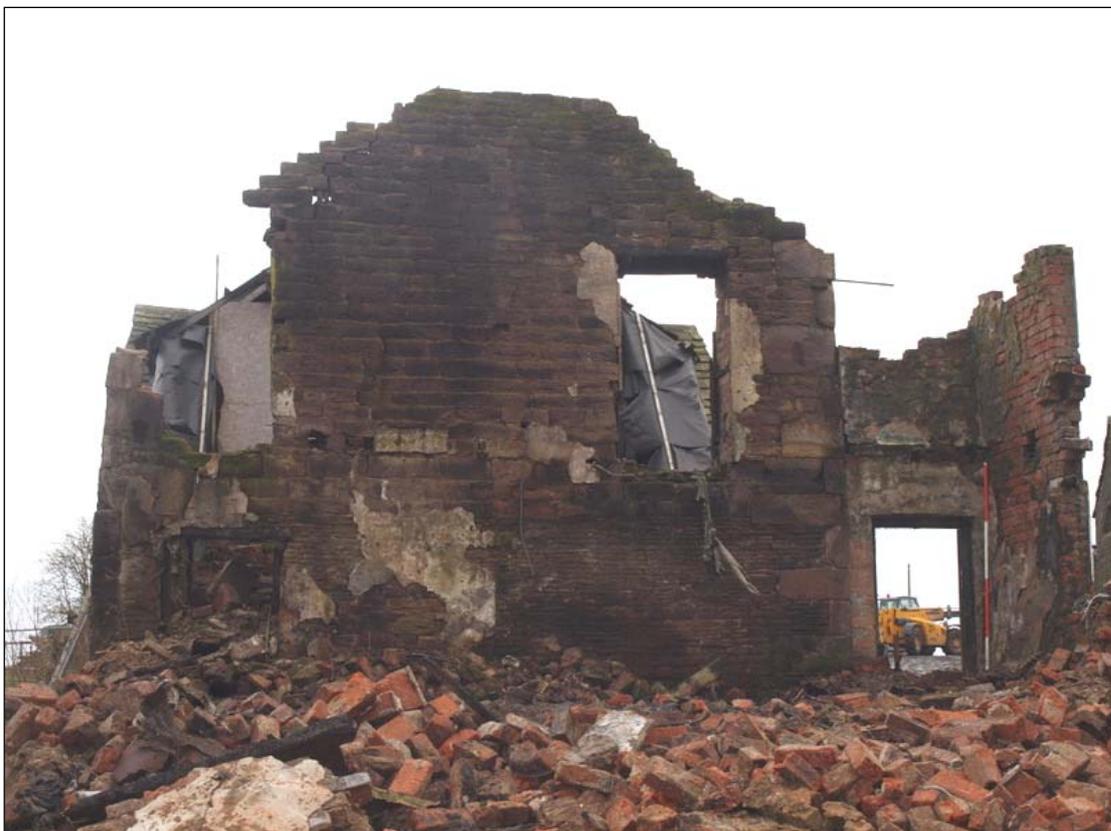
- 6.2.2 East Elevation (Plate 8). This elevation lies within the eastern brick extension and has collapsed considerably. The construction is similar to the north elevation, with smaller stone work at ground floor level and larger blocks above. A personnel doorway with a timber lintel and jambs is at the southern end at ground floor level. The wall has collapsed above it, although the straight edge of the break suggests a doorway at first floor level. At the northern end of the face is a doorway at first floor level with a sandstone lintel.

Plate 8: East wall of dwelling after demolition of eastern extension. The right-angled walls and doorway at the right-hand end were part of the extension

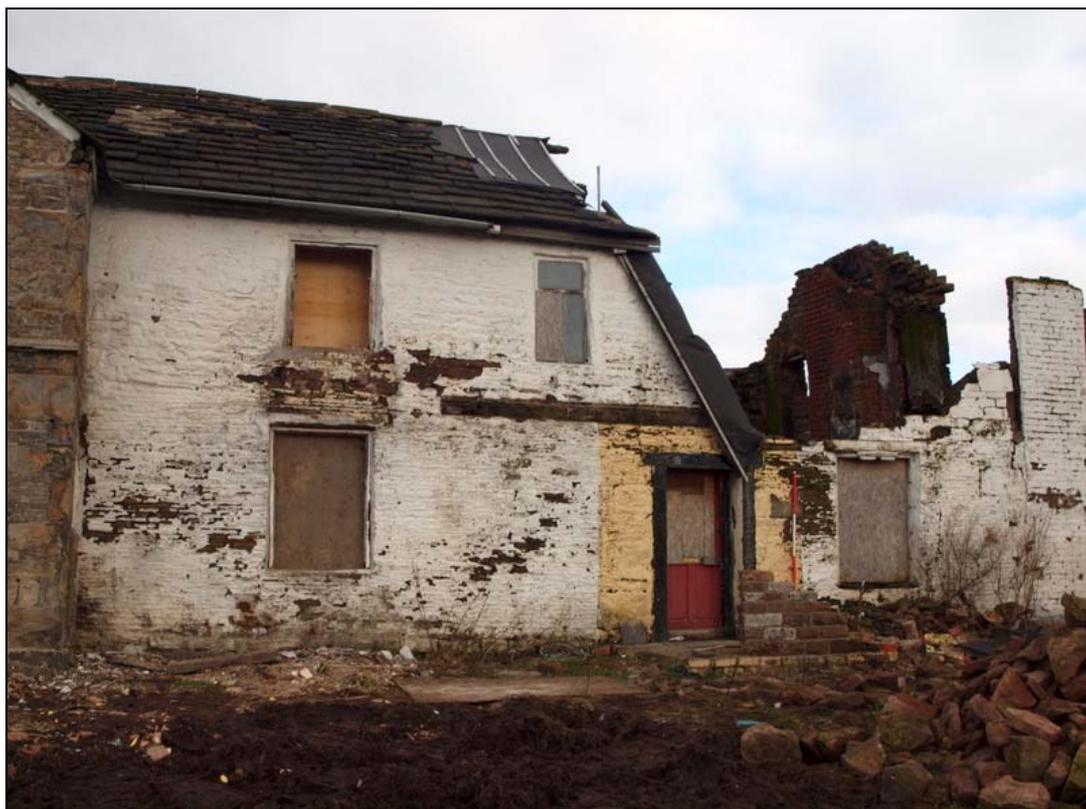
Plate 9: South elevation of the dwelling

- 6.2.3 South Elevation. (Plate 9) This face comprises the rear of the dwelling and is constructed in a similar fashion to the front, with thin stonework at ground floor level and larger blocks above with quoins in the eastern corner. This face has been whitewashed. A large personnel doorway is located slightly east of centre. It has sandstone jambs and lintel and large quoins on either side. To the east of this is a large portrait window blocked with ply and to the west of the doorway is a matching window with the frame removed. Both have sandstone lintels and cills and jambs formed by the wall. Once again, the eastern end of the first floor has been destroyed through fire damage. The western end houses two portrait windows. The westernmost matches the western window in the ground floor, albeit slightly shorter. To the east of this is a thinner timber framed two-light portrait window with sandstone jambs.

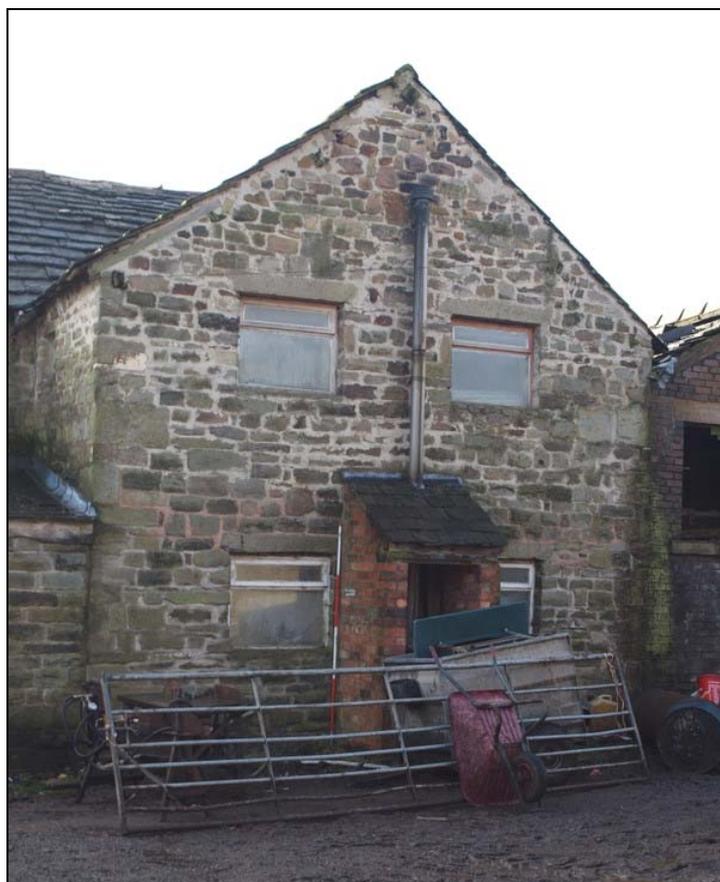
Plate 10: North elevation of west wing

- 6.3.1 North Elevation. (Plate 10) This comprises the front of the wing and is constructed in uncoursed rough sandstone rubble. A single story modern brick lean-to is in the centre of the face, flanked by a pair of two light timber framed landscape windows with sandstone lintels. These are likewise matched at first floor level.

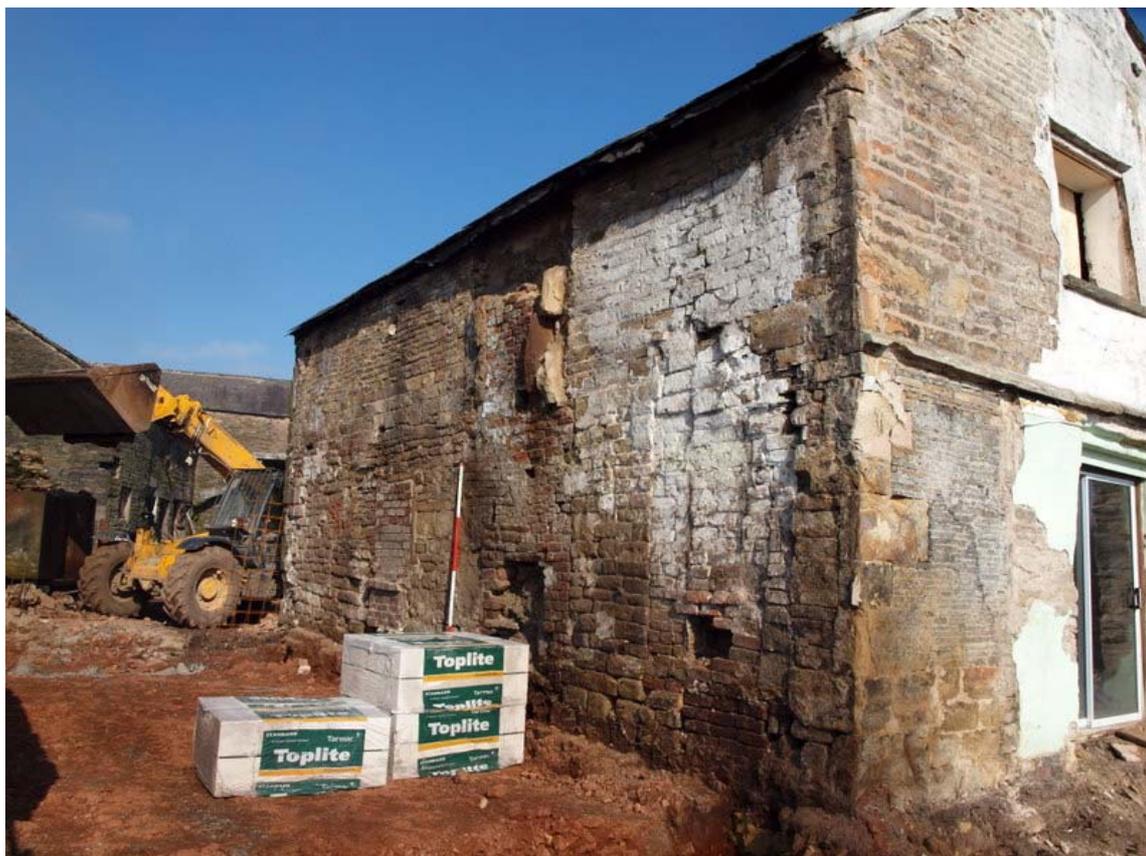
- 6.3.2 West Elevation. (Plate 11) This face is located within the western brick extension and is constructed in shaped and coursed sandstone rubble. A small blocked window is apparent in the northern end of the face with a blocked personnel doorway to the south of this. South of this again is a brick chimney stack c. 1m wide with a blocked fireplace within it. South of this again is a blocked doorway. A remaining piece of timber framing was visible at the northern end at first floor level (Plate 12), once the western brick extension had been removed.

Plate 11: West elevation of wing after removal of western extension. NB blocked windows to left of ranging rod and back of fireplace to right.

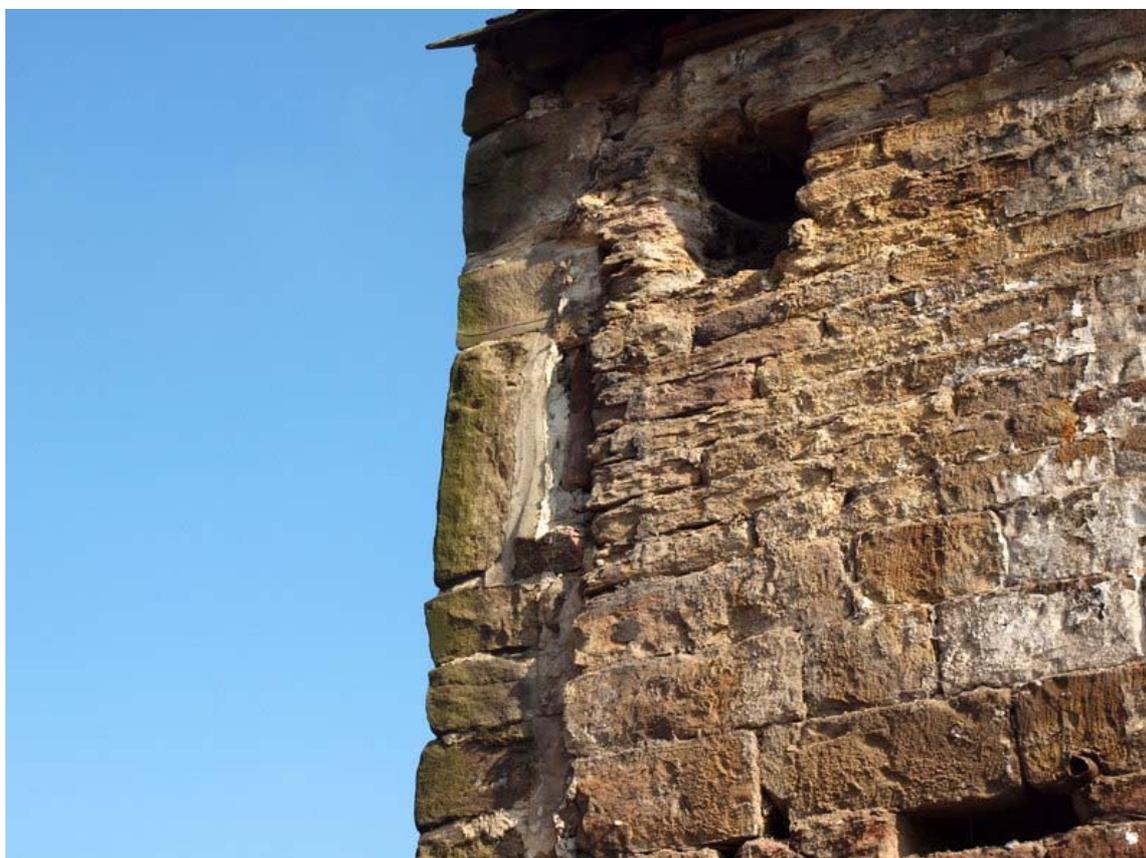
Plate 12: Remains of timber framing in north end of west wall of west wing

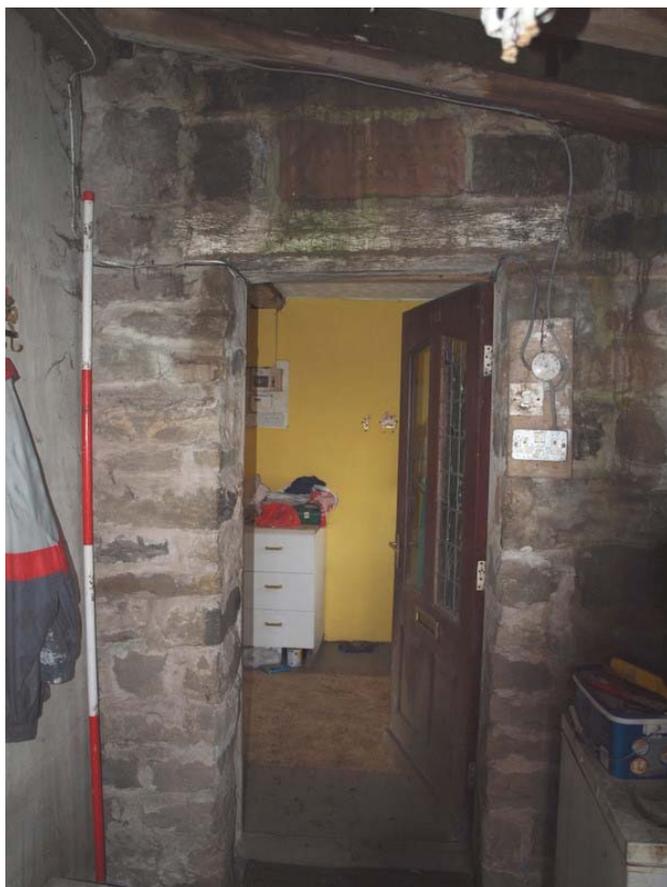
Plate 15: North end of east elevation of west wing showing doorway

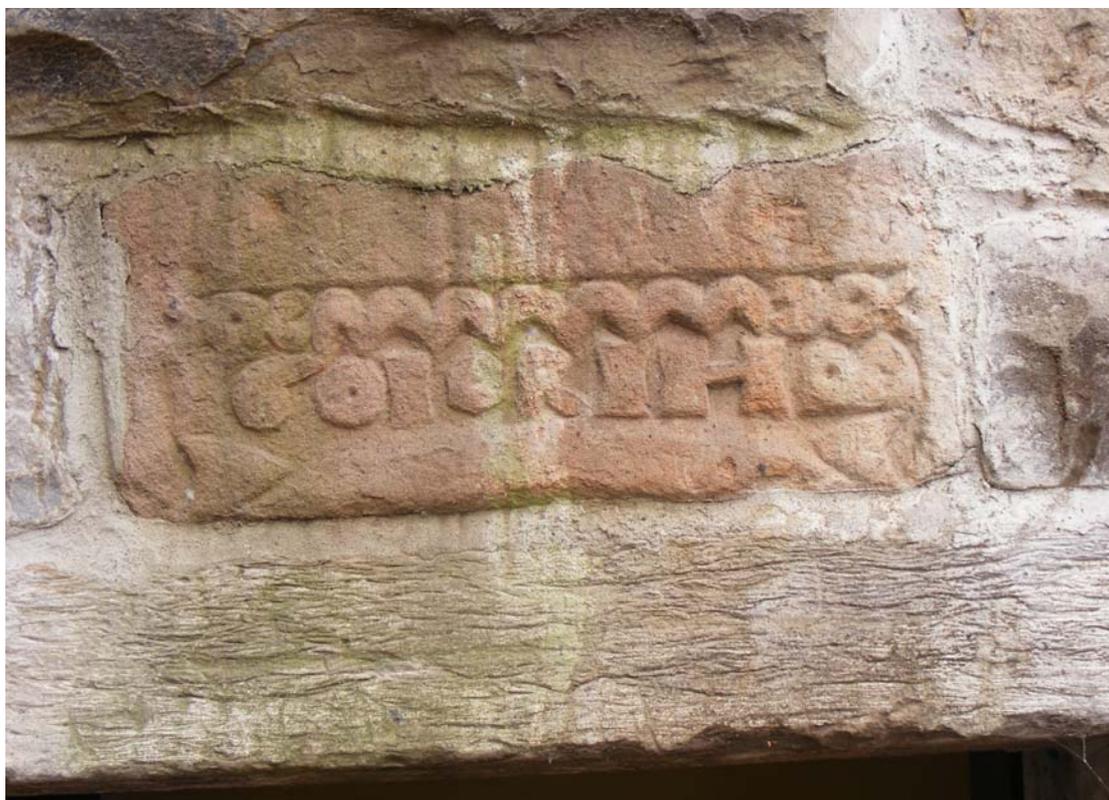
- 6.3.4 East Elevation. The majority of the face butts the central dwelling. Where it extends beyond the dwelling to the south is a small portrait window with arched sandstone lintel and sandstone jambs and cill. An upturned sandstone hood moulding is above. Above this is a thin portrait window with no surround and a two light timber frame (Plate 14 [1809]). The northern end of the face is contained within the porch at ground floor level. Here there is a personnel doorway with timber lintel and decorated sandstone block above (Plates 15 & 16) which carries the worn "1601 RTH". There are no features at first floor level.

Plate 16: Detail of inscribed sandstone block above doorway shown in Plate 15

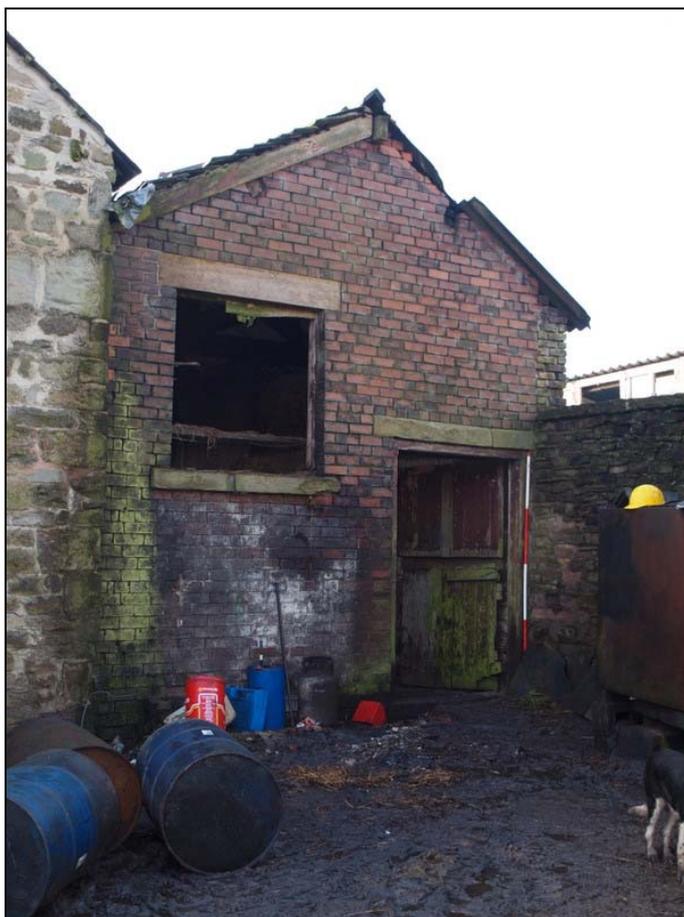
Plate 17: North elevation of western extension

- 6.4.1 North Elevation. (Plate 17) This comprises the front of the extension and is constructed in machine-made brick. A cattle doorway is located at the western end of the face with a sandstone lintel and a large window is located at the east end of the first floor. This likewise has a sandstone lintel and cill. A sandstone wall runs from the western end of the face to the north.
- 6.4.2 West Elevation. (Plate 18) This elevation is constructed of regularly coursed sandstone blocks to a height of c1.5m with hand made brick above. A square window with a timber lintel is located roughly in the centre of the face.

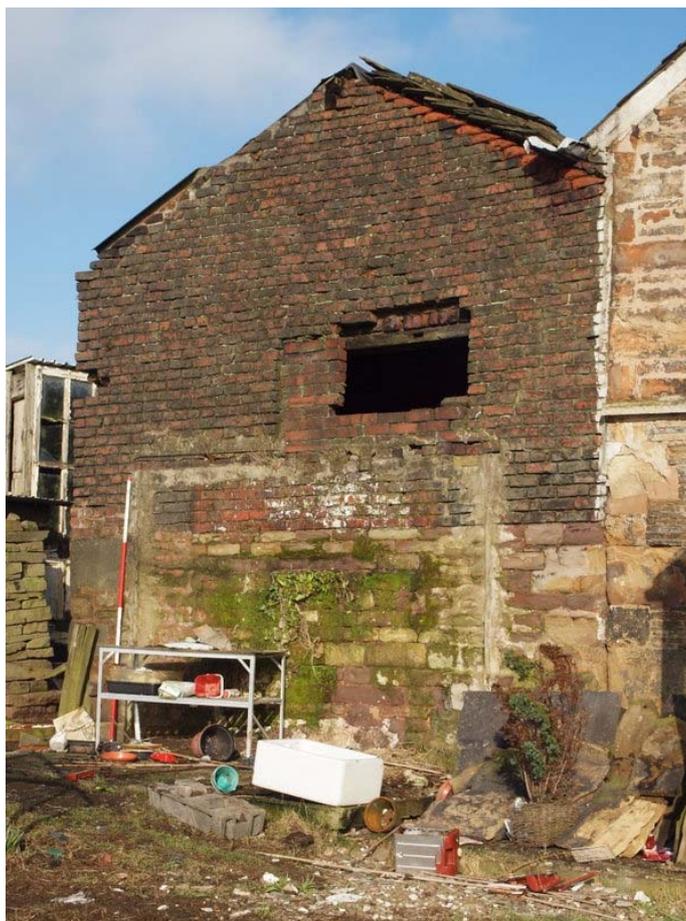
Plate 19: South elevation of western extension

6.4.3 South Elevation. (Plate 19) This face is likewise constructed of regularly coursed sandstone blocks to a height of c1.5m with hand made brick above. An area of rebuilding is evidence around a first floor landscape window with timber lintel at first floor level.

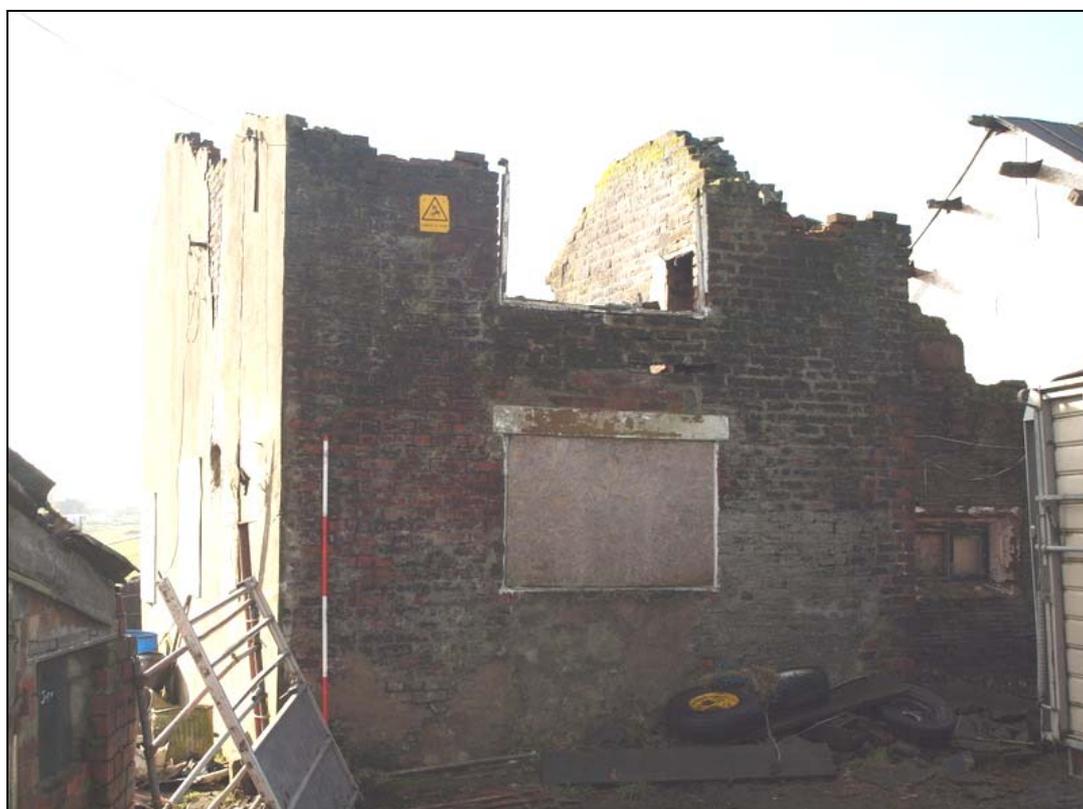
Plate 20: North elevation of eastern extension

6.5.1 North Elevation. (Plate 20) The face is constructed in hand made brick with a large landscape window in the centre of the face at ground floor level with a concrete lintel and blocked with ply. The first floor has collapsed due to fire damage, but the lower part of a matching window is still present.

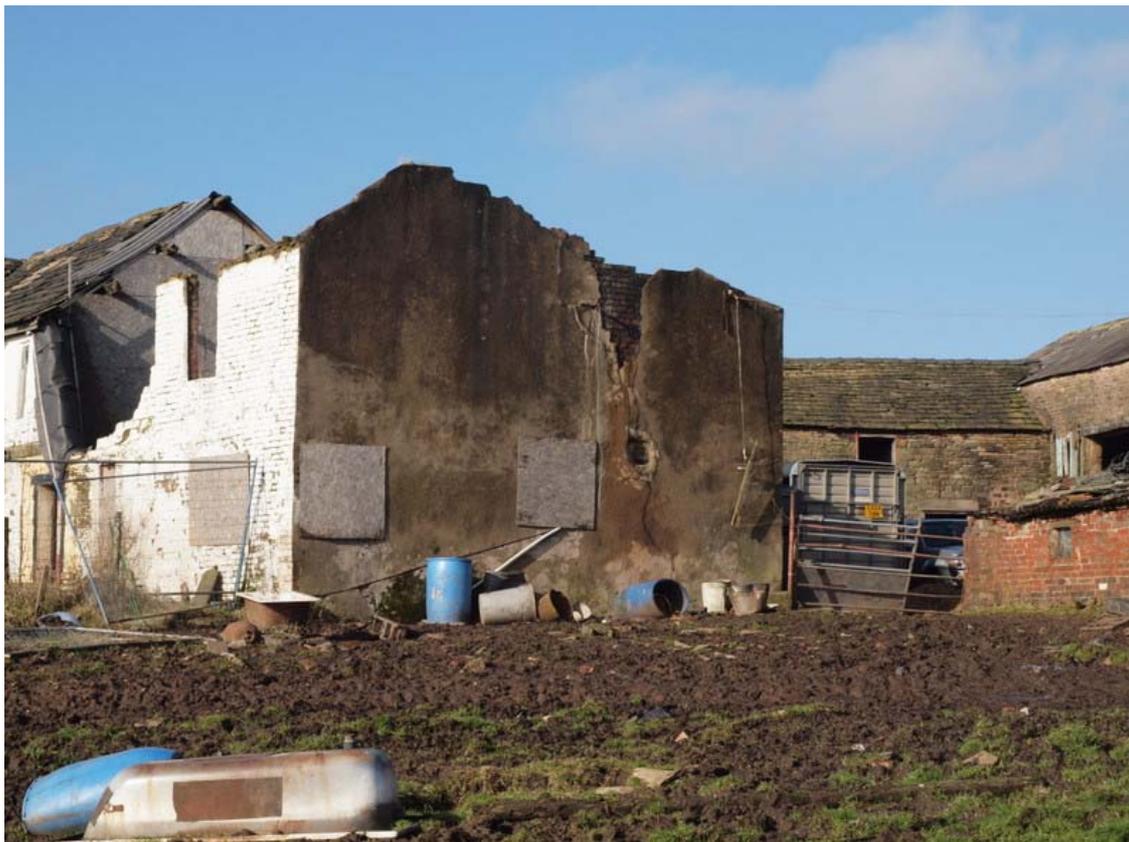
Plate 21: East elevation of eastern extension

6.5.2 East Elevation. (Plate 21) This elevation has likewise collapsed at first floor level. The face is rendered with cement although handmade bricks can be seen at first floor level where the render has fallen away. Two windows, boarded over are present at ground floor level. One is located at the southern end with the second located slightly south of centre.

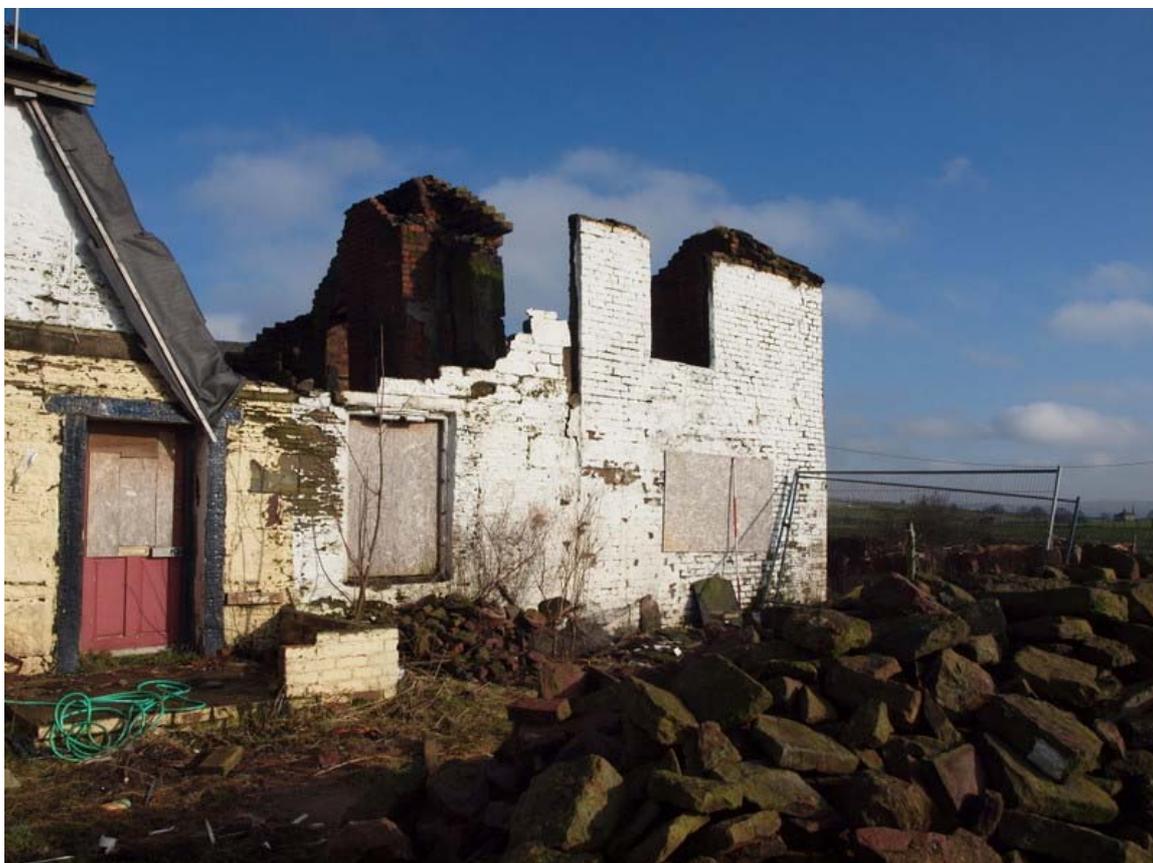
Plate 22: South elevation of eastern extension

6.5.3 South Elevation. (Plate 22) This elevation is likewise constructed of handmade brick, although the face has been whitewashed, matching the southern face of the dwelling. A window, boarded with ply, is located in the centre of the face at ground floor level. Above this, slightly west of centre are the remains of a large portrait window.

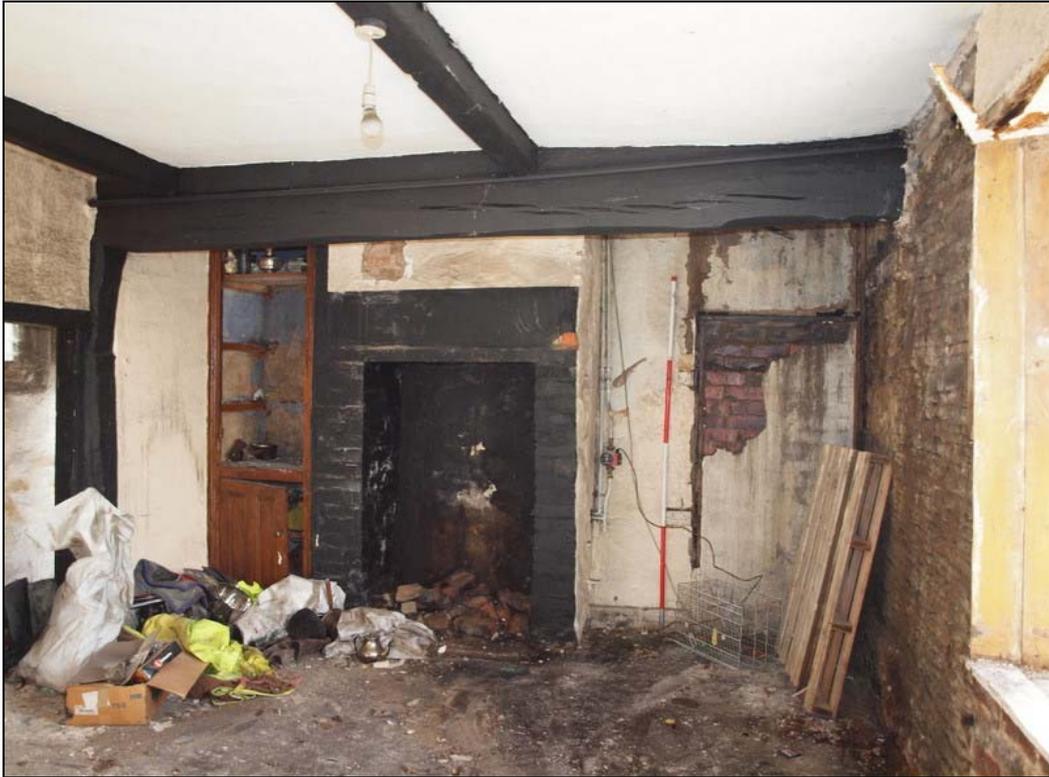
- 6.6.4 West Bay - Houseroom. As noted above the room is accessed via a doorway in the south wall of the passageway. An inglenook fireplace is located in the eastern wall (Plate 27). The fireplace itself is brick built with an iron lintel. The heck post to the north supports the bressummer beam which runs north – south in front of the fireplace (Plate 28). Another north – south beam is located at the western end of the room and two east – west beams run between them. A cupboard is located to the north of the fireplace and a blocked doorway to the south of it. The south wall is bare stonework with a blocked window in the eastern corner not visible on the exterior. A large portrait window is located to the west of this, with brick below suggesting it has been inserted. East of this again is a further blocked window.

Plate 27: Inglenook fireplace in east wall of west bay of central dwelling. Heck separating house room from mell passage is to left of fireplace

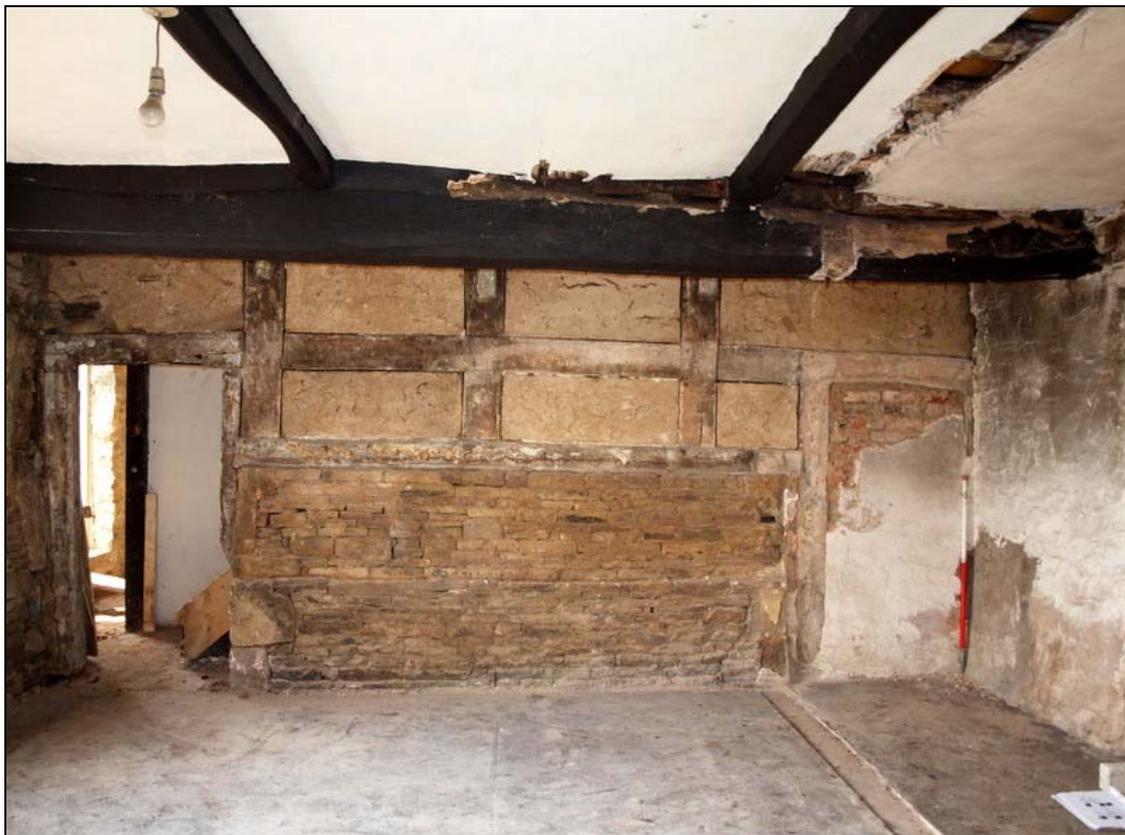
Plate 32: Uncovered timber frame with wattle and daub fill resting on sandstone wall forming west wall of west bay of dwelling

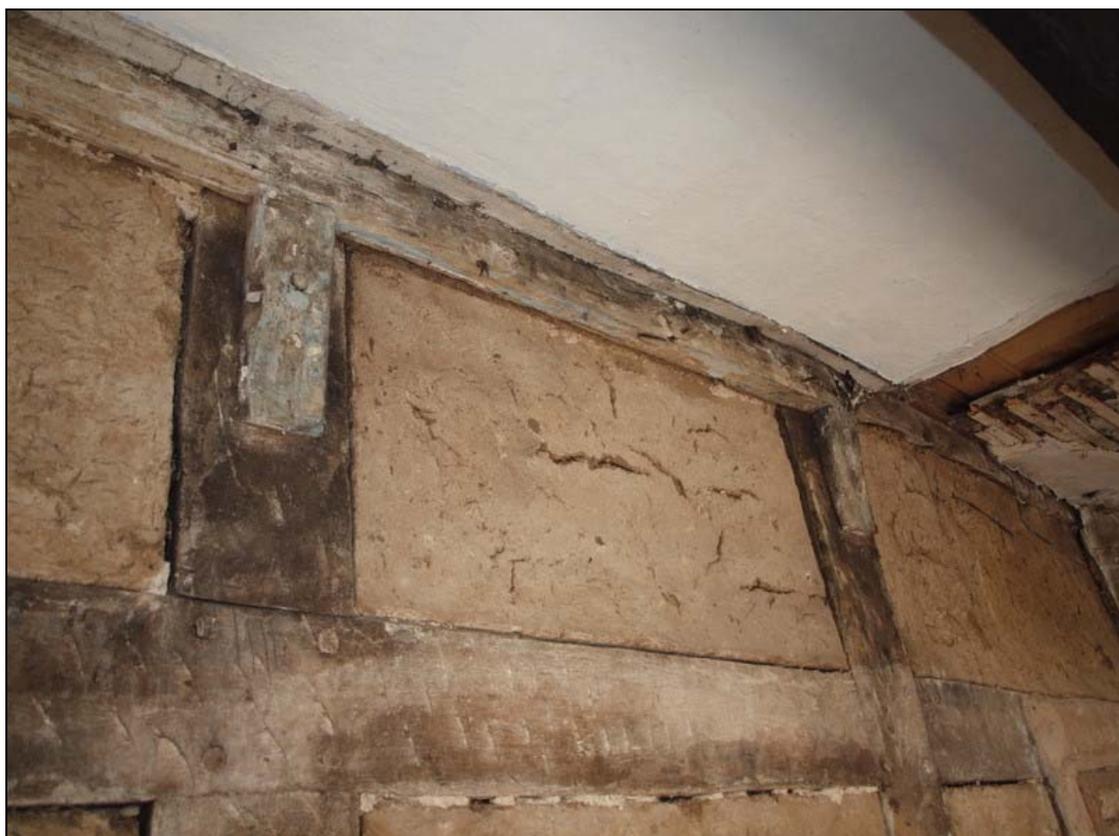
Plate 33: Detail of timber frame showing timber brackets, pegs, carpenter's marks and adze marks

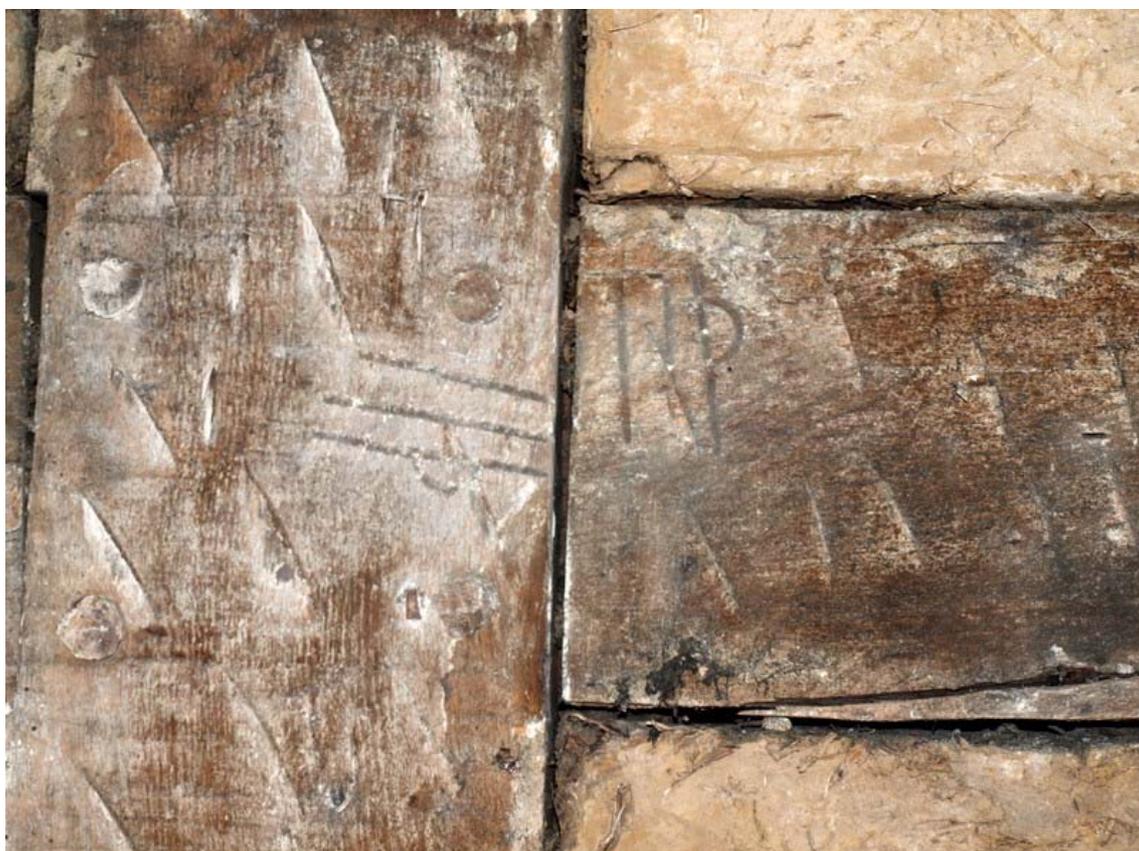
- 6.6.5 The north wall of the houseroom is the modern brick wall which separates the room from the passageway to the north (Plate 29). The west wall is constructed of sandstone blocks to a height of 1m, with a shallow plinth at the base (Plate 30). Above this the wall was papered. The paper was removed to reveal a timber frame with wattle and daub infill (Plate 32). The timber framing continues to the ceiling, where another timber beam has been fastened to the existing timbers, with timber brackets below (Plate 33). Several of the joints in the framing show carpenters marks (Plate 34). The plinth is

Plate 34: Detail of carpenter's marks on timber frame

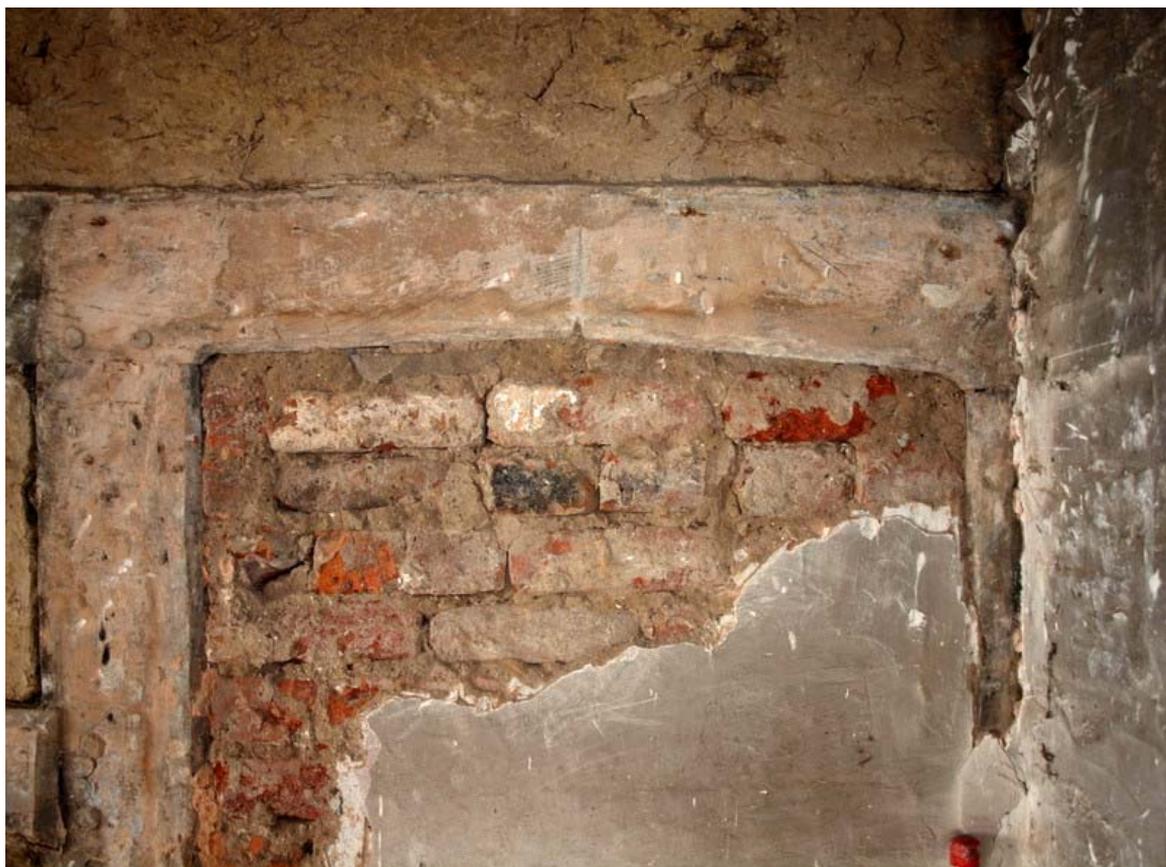
interrupted at either end by two blocked timber framed personnel doorways. The northern of these has a chamfered and cranked timber lintel (Plate 35). The floor is concrete and the ceiling is plastered.

Plate 35: Detail of lintel of north doorway in timber-framed wall

- 7.7 It is therefore necessary to rely on stylistic evidence for dating purposes. The doorway at the north end of the timber framed wall has a cranked lintel or doorhead of a type that has been dated to the late 16th century (CBA 1994, 20) which may be appropriate for the timber framed west wing. Whilst the splayed mullion windows in the north elevation of the two unit dwelling, were common from the beginning of the 15th century (Brunskill 2010, 125) it is generally held that in the Pennine regions stone buildings did not replace timber until the early to mid 17th century (Brown 1982, 198 & Smith 1987, 21) which would be an appropriate date for the addition of the two unit dwelling. The blocked window in the southern wall of the west wing, which was largely removed when the French window was inserted (see archive photos at Fig 13 and Plate 47), also appears to have splayed mullions. This suggests that the timber framed wing may have been encased in stone at about the same time that the two unit dwelling was added.

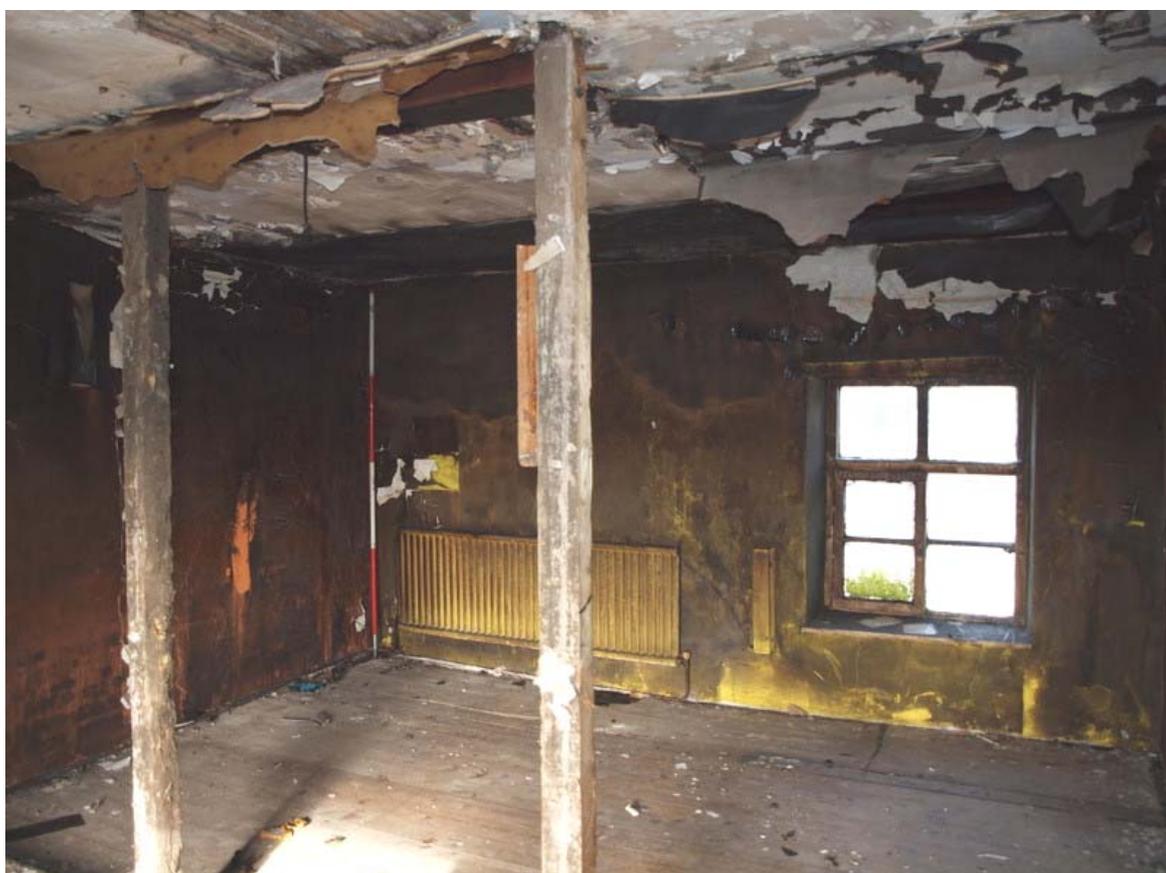
- 6.6.6 West Bay - First Floor (Plate 36). This comprises a single room which was accessed from the adjoining room in the west wing. No other staircases have been located. The room has suffered considerable fire damage and a partition wall, running east west down the centre has perished, leaving the timber studs only. The north and south walls were covered with painted plaster which was subsequently removed to reveal the underlying stonework. In the eastern end of the north wall was the 6 light timber framed casement window described externally at para, 6.2.1 above. Opposite this was a large portrait window, the frame of which had been removed. The removal of plasterboard from the west wall revealed a timber frame similar to that at ground floor level with daub still present in places but also with brick nogging (Plate 37). The vertical members are continuations of those at ground floor level and there are identical carpenter's marks on both floors (Plates 38 & 39). The floor is timber boarded and the ceiling lath and plaster. Above the ceiling are two hand cut timber trusses with tie beams (Plates 37 & 40). Timber boards have been attached to the eastern side of the western truss. The trusses support a handcut timber purlin on each side and a hand cut timber ridge pole. The east wall has collapsed and been replaced with modern temporary partitioning.

Plate 36: First floor of west bay of central dwelling looking north-west
