**Barrack Fold Farmhouse, Arthur Lane, Ainsworth,
Bury**

An Archaeological Building Survey

By J.M. Trippier Archaeological and Surveying Consultancy

October 2011

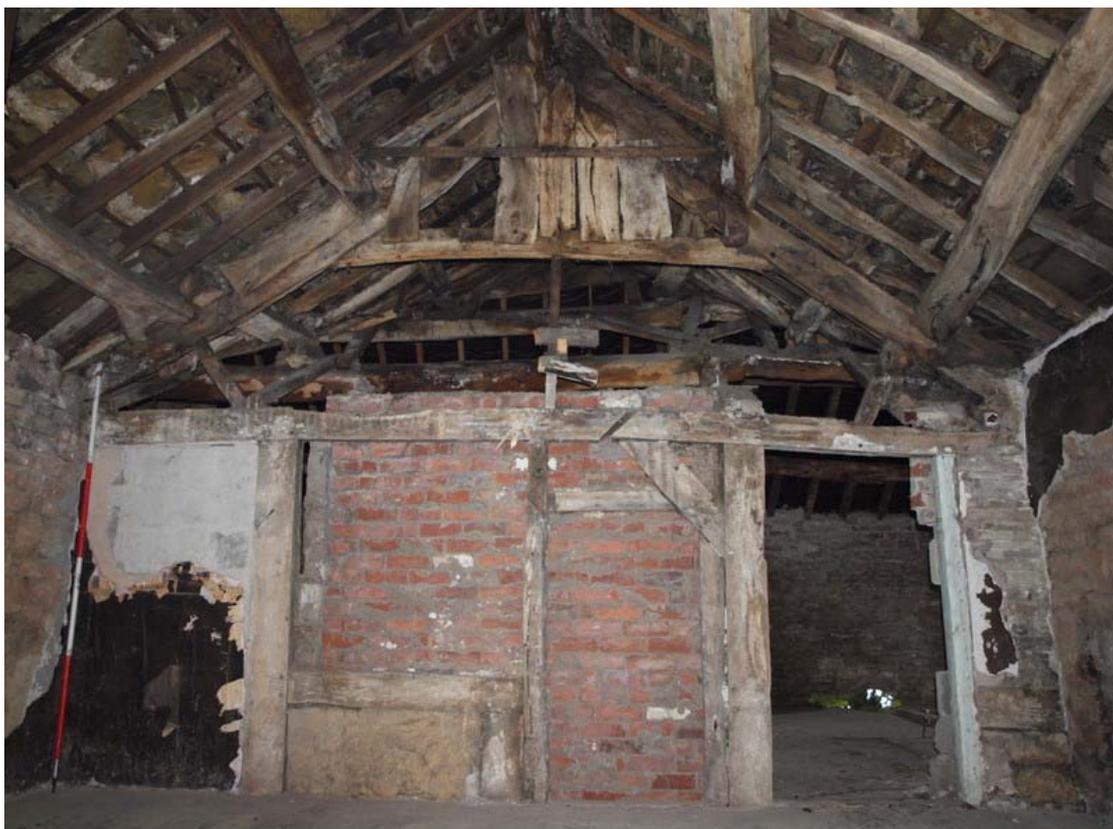
Plate 37: Timber frame in west wall of first floor of central dwelling with handcut roof timbers above

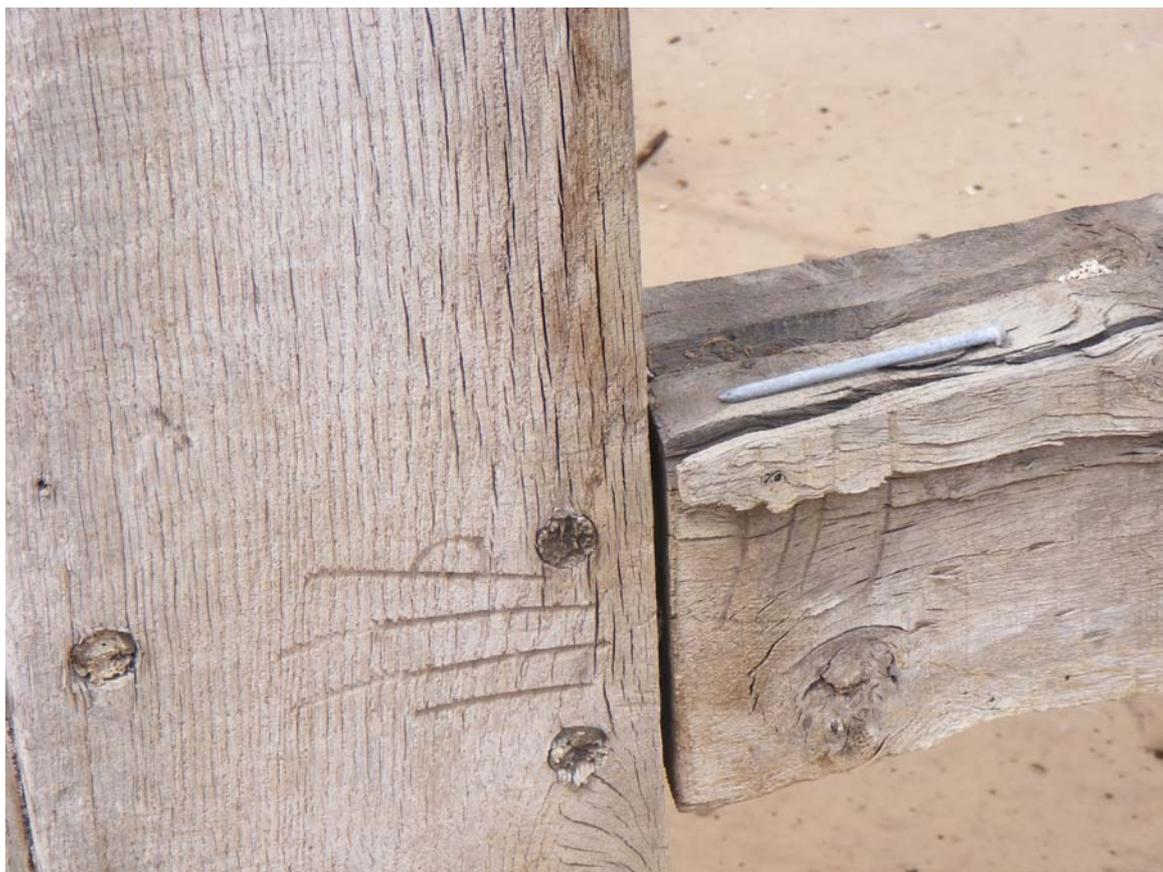
Plate 39: Carpenter's mark at first floor level matching those on ground floor (cf Plate34)

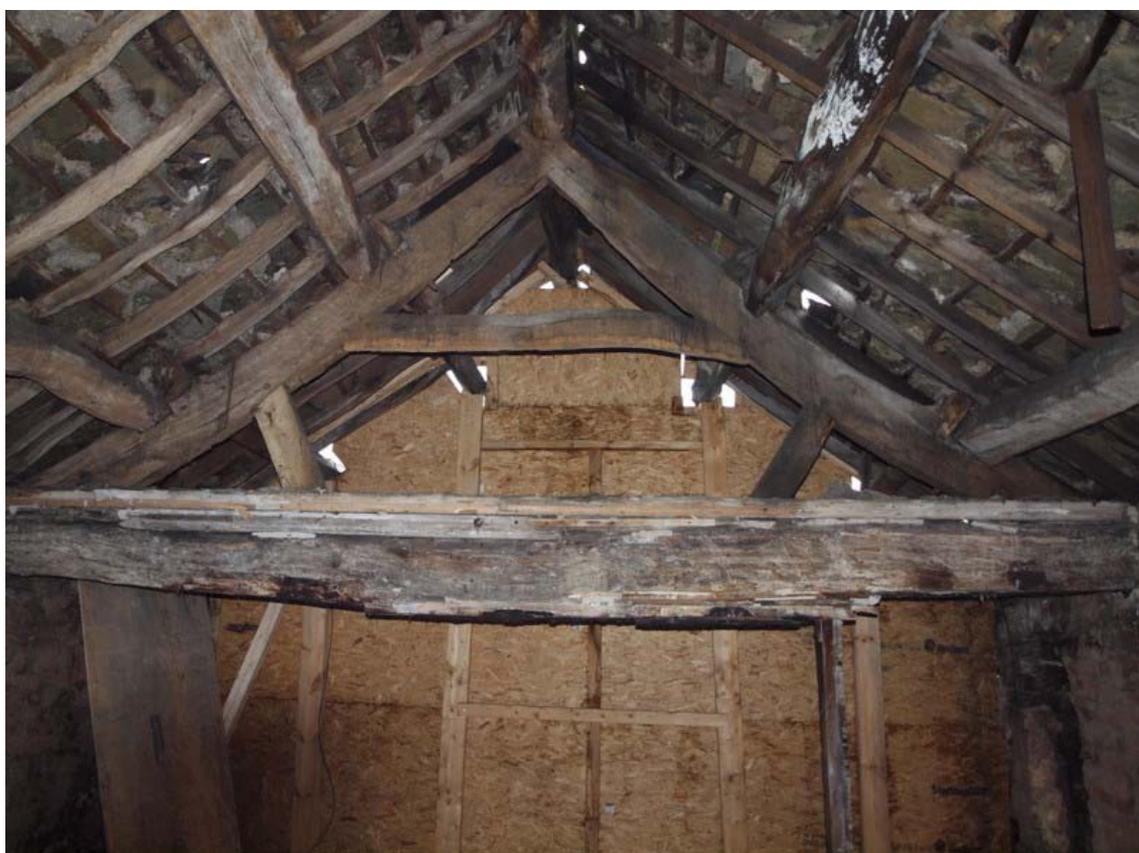
Plate 40: Handcut roof truss at east end of first floor of west bay in central dwelling

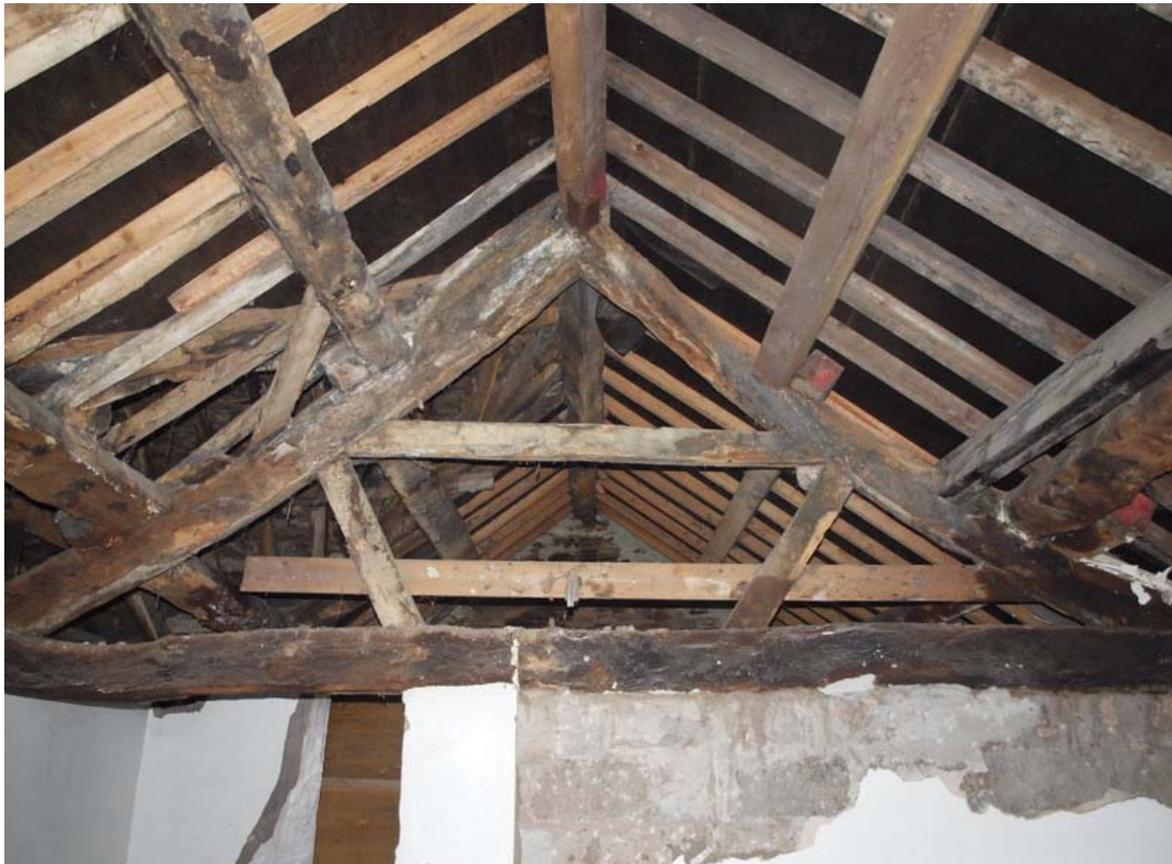
Plate 52: Exposed hand cut timber truss in west wing
