NON-TECHNICAL SUMMARY

Wyre Borough Council required an archaeological building survey of a range of agricultural buildings at New House Farm, New House Lane, Winmarleigh (NGR SD 4753 4755) prior to their conversion to residential use. The work was carried out on behalf of Maple Timber Systems by J. M. Trippier Archaeological and Surveying Consultancy. The subject buildings comprise a large threshing barn and cart-shed/granary building to which various cowhouses (shippons) have been added. The original buildings were built of good quality sandstone blocks and date from the early 19th century or possibly slightly earlier. The later buildings are a combination of stone and brick and were added in the late 19th and early 20th century. The buildings reflect changing agricultural practices from an arable or mixed economy c.1800 to a pastoral one in the late 19th century.

- 1.1 J. M. Trippier Archaeological and Surveying Consultancy was instructed by Mr J. Baines of Maple Timber Systems to carry out an archaeological building recording programme of a range of agricultural buildings at New House Farm, New House Lane, Winmarleigh (NGR SD 4753 4755) prior to their conversion to residential

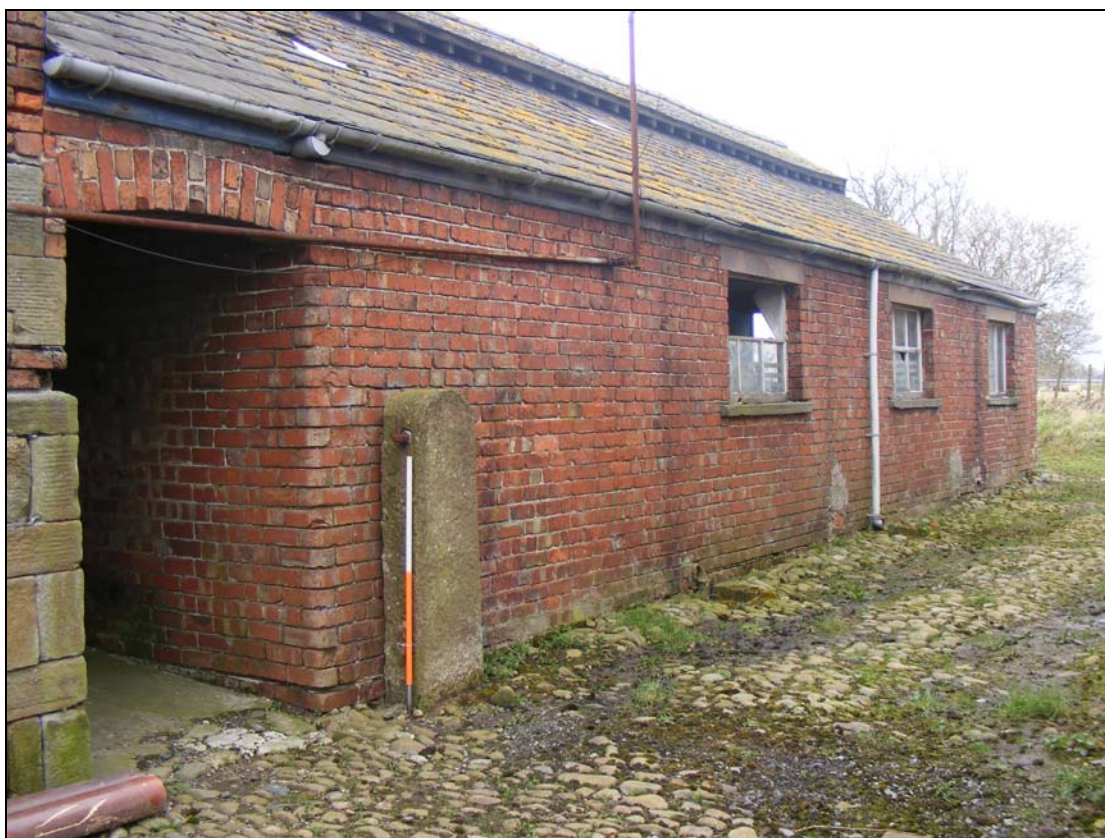
Fig 2: East Elevation of Loosebox Range

- 6.10.1 External Description (Plate 2 and Plate 29). This is a single storey building of pressed brick with a double pitched Welsh slate covered roof with a raised ridge. A passage with a brick arched lintel links this building to the north shippon block to the south (**Plate 2**). There are three windows in the east wall. They have stone slab cills and concrete lintels and are fitted with timber framed casement windows each with a lower row of three fixed lights with three bottom hung opening lights above. The west elevation is constructed of large random stone blocks with stone quoins. There are three windows in this wall with stone slab cills and lintels. They are fitted with timber framed casement windows each with two timber mullions and three fixed lights. The north and south gables each have a personnel doorway with a concrete lintel, timber frame and timber batten stable-doors.

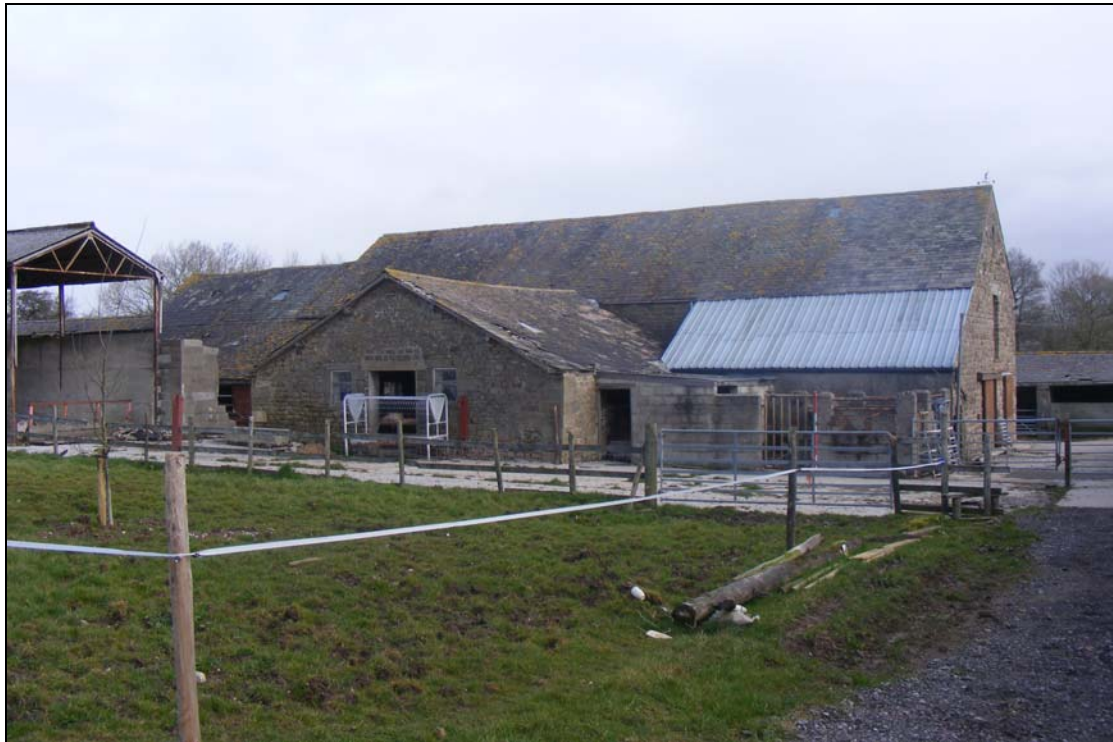
Fig 3: West Elevation of South Part of Range

- 6.7.1 External Description (Plates 3&12). It is apparent from the matching construction, most noticeable in the south elevation (**Plate 12**), that this small outshut was built at the same time as the main barn. The west wall has been covered with Portland cement rendering and the outshut now has a lean-to single pitch roof covered with plastic coated profile metal sheeting.
- 6.7.2 Internal Description. Internally the single space has been divided by a short centrally located east-west wall. It is accessed via the personnel doors at the west end of the south elevation and from the south section of the main barn. It seems likely that these rooms would have originally been used as loose boxes.

- 6.8.1 External Description (Plates 3 & 11). This single storey stone building is attached to the west face of the barn and is aligned east-west. It has a double pitched roof covered with Welsh slates. The west and south elevations are built of unevenly coursed sandstone blocks with large quoins. There is a doorway with a concrete lintel and cemented jambs in the centre of the west elevation but no door. On either side of the doorway are windows with stone surrounds. Each holds a flush timber two light casement with a transom and top hung opening light. There is a square window opening at the west end of the south elevation but no frame. The north elevation is built of regularly coursed watershot stone blocks to a height of about 1m. There is then a sandstone stringcourse above which the wall is built of pressed brick. Immediately below the eaves is a row of ceramic

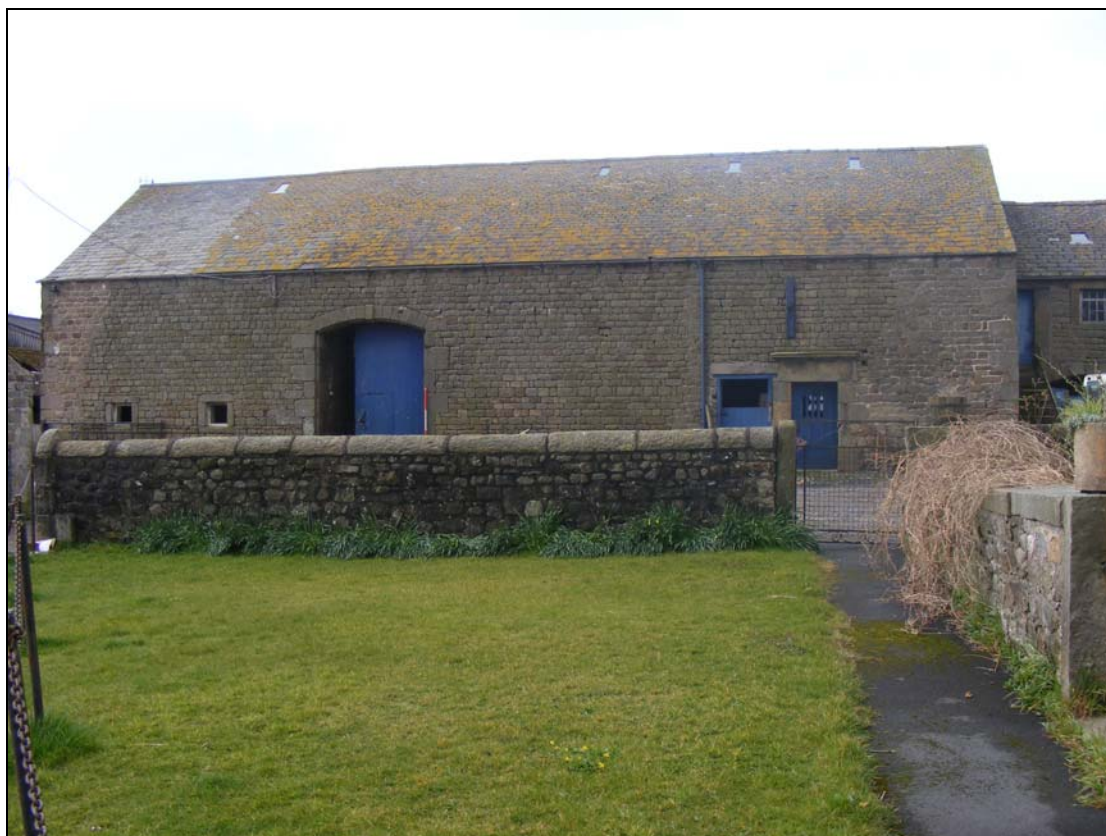
Fig 5: East Elevation of Barn

- 6.3.1 Eastern Elevation (**Plate 5**). This elevation forms the long wall of the barn which faces towards New House Lane and is the front of the building. The elevation is constructed in shaped sandstone blocks, regularly coursed. The elevation is characterised by three doors and two windows. The windows are located close together at the southern end of the elevation at ground floor level (**Plate 6**). Both windows have sandstone sills and recessed timber frames with one fixed light. A large cart door with quoin surround is located slightly south of centre (**Plate 1**). The quoins at the bottom of the door project slightly into the doorway suggesting that a slightly shorter door with a gap at the bottom was originally present. Each projection contains two vertical grooves (**Plate 7**). North of this door is a large stone trough (**Plate 8**) and two personnel doorways (**Plate 9**). The southerly of these has a doorway with a batten and brace timber stable door in a recessed timber frame. It has a stone slab lintel and jambs formed by the adjoining stonework. On the northside this is a row of large stone quoins which form the south jamb of the northernmost doorway. A row of large stone quoins laid as 'long and shortwork' form the north jamb. Together these support a massive sandstone lintel with a drip mould over. The doorway has a recessed timber frame and timber batten door with vertical light slots.

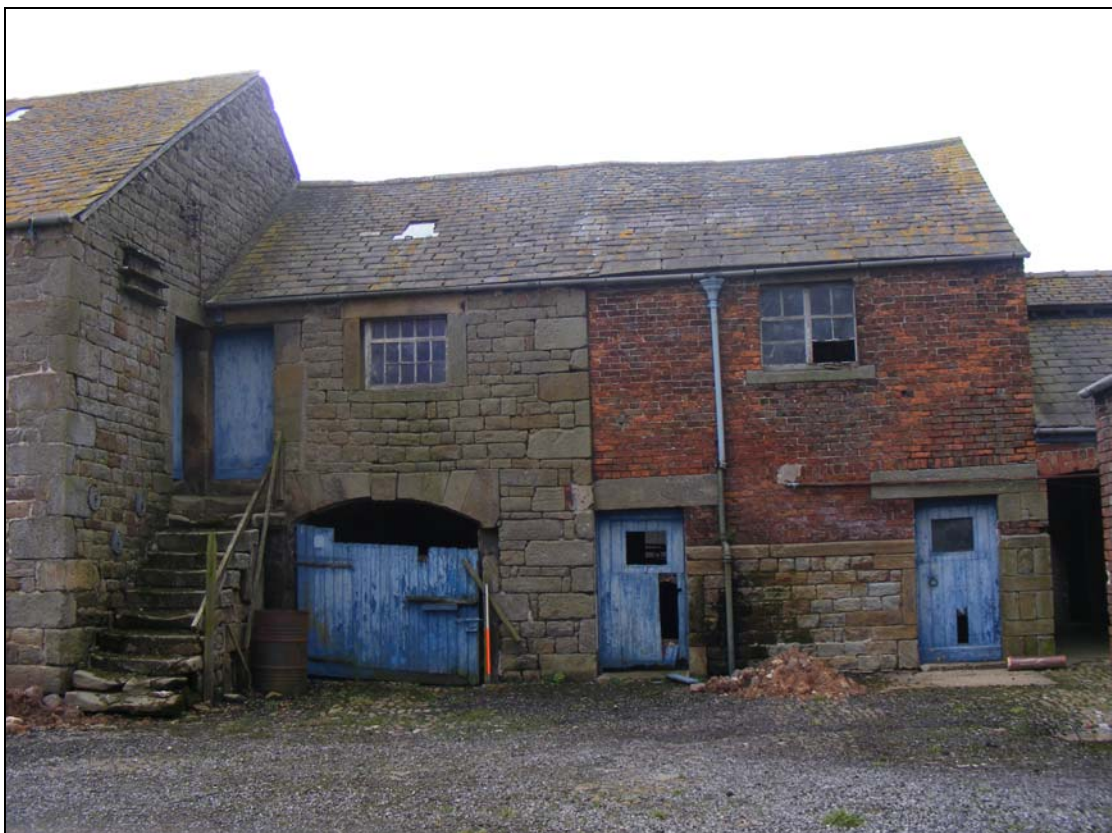
Fig 10: North Elevation of Barn and East Elevation of Cart-shed and North Shippon with Granary over

- 6.3.2 Northern Elevation (**Plate 10**). This elevation comprises one of the gable ends of the building and is constructed of regularly coursed, sandstone blocks. It is partially obscured by the adjoining two storey

cartshed building and by an external sandstone staircase rising to first floor level. At the top are two personnel doors with sandstone quoins and lintels, recessed timber frames and batten doors. One doorway leads into the first floor of the barn and the other into the first floors over the cart shed and the adjoining small shippon. There is a blocked 'letterbox' window at first floor level in the gale wall above the staircase.

6.5.1 External Description (Plate 10). This two storey building is attached to the north elevation of the barn. It is constructed of large stone quoins and coursed stone blocks similar to those of the barn. At ground level on the east elevation it has an attractive segmental arch with substantial voussoirs and a projecting keystone. This holds a poorly constructed timber batten cart door on rusted wrought iron hinges. At first floor level is a window with a stone slab cill, lintel and jambs. It is fitted with a recessed timber casement with 15 lights in three rows. The top row of lights sit above a thicker transom are top hung. The south west and north elevations now form the party walls of the adjoining buildings (see **Fig** and **Plate 4**) and are not visible from the exterior. There is a double pitched Welsh slated roof on timber battens and rafters let into the east and west elevations.

6.6.1 External Description (Plate 10). This two storey building is attached to the north elevation of the cart shed. Only the east elevation is fully visible. The north and west elevations partly so (**Plate 4**). The building is constructed of hand made brick. On the east elevation the brick work sits on a 1.25m high regularly coursed stone block wall with stone copings. There are personnel doorways at both the north and south ends of this elevation. They both have stone slab thresholds, massive stone lintels and stable style timber battened doors in recessed timber frames. Both have unglazed windows in the upper doors. Centrally placed just below the eaves is a window with a stone cill and lintel. It contains a damaged two light casement window with a timber central mullion and three panes in both lights. There is a cast iron drainpipe and rainwaterhead just north of the south doorway. The north elevation

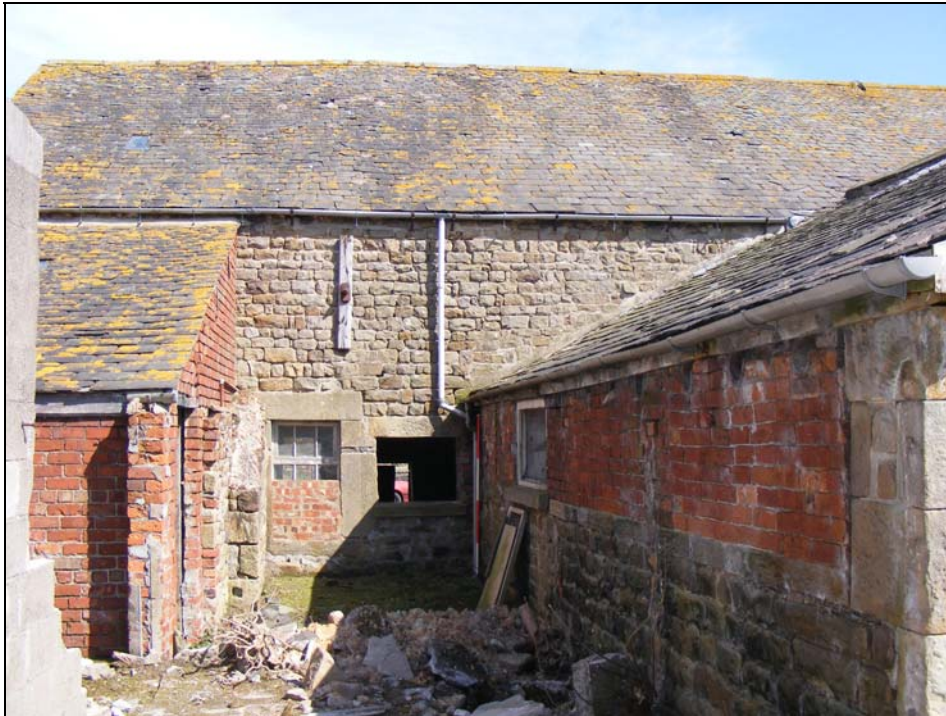
Fig 11: West Elevation of Barn between North Elevation of West Shippon and South and West Elevations of North-West Shippon

6.3.3 West Elevation (Plate 11). This elevation forms the original long west wall of the barn and is constructed of roughly shaped sandstone blocks. Only a small portion of this elevation is visible due to the erection of two shippon extensions on this face (see para.6.1.1 above). The visible portion contains two windows. Both have sandstone lintels and jambs, although the southern jamb of the southern window is constructed of machine made brick. The northern portrait window is partially blocked with machine-made brick. The visible portion shows a recessed timber frame and six lights, the top three of which can be opened. The southern window is square without a frame and the cill is rendered with concrete.

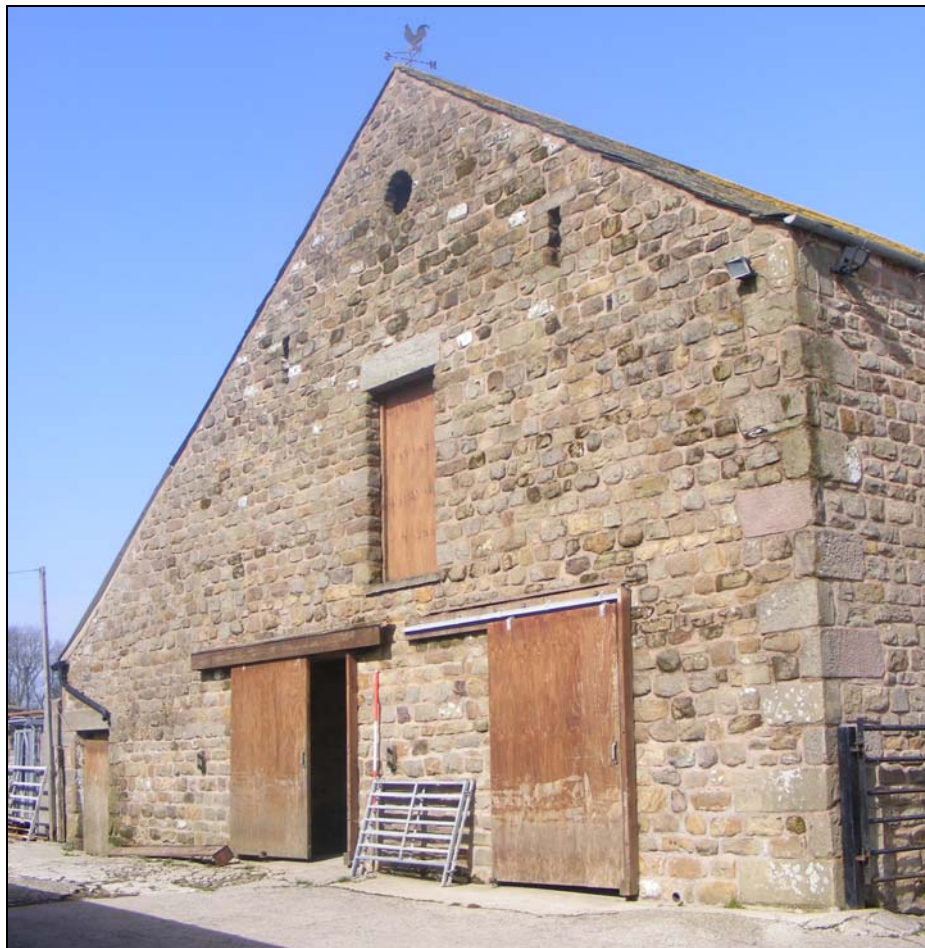
Fig 12: South Elevation of Barn

6.3.4 Southern Elevation (Plate 12). This elevation forms the other gable end of the building and is constructed of shaped sandstone, regularly coursed. The elevation is characterised by four doors, three of which are at ground level and a pitching door centrally at the first floor level. A circular 'owl hole' with a sandstone surround is located just below the apex of the roof. Two slender air vents are located below this, but above the level of the first floor pitching door. At ground level, the western doorway is a personnel door with sandstone quoins, a recessed timber frame and a modern flush panelled timber door. Both doors to the east of this are modern large timber flush panelled cattle doors on runners above. The pitching door at first floor level is boarded shut with the same sort of timber panelling used on the ground floor doors.

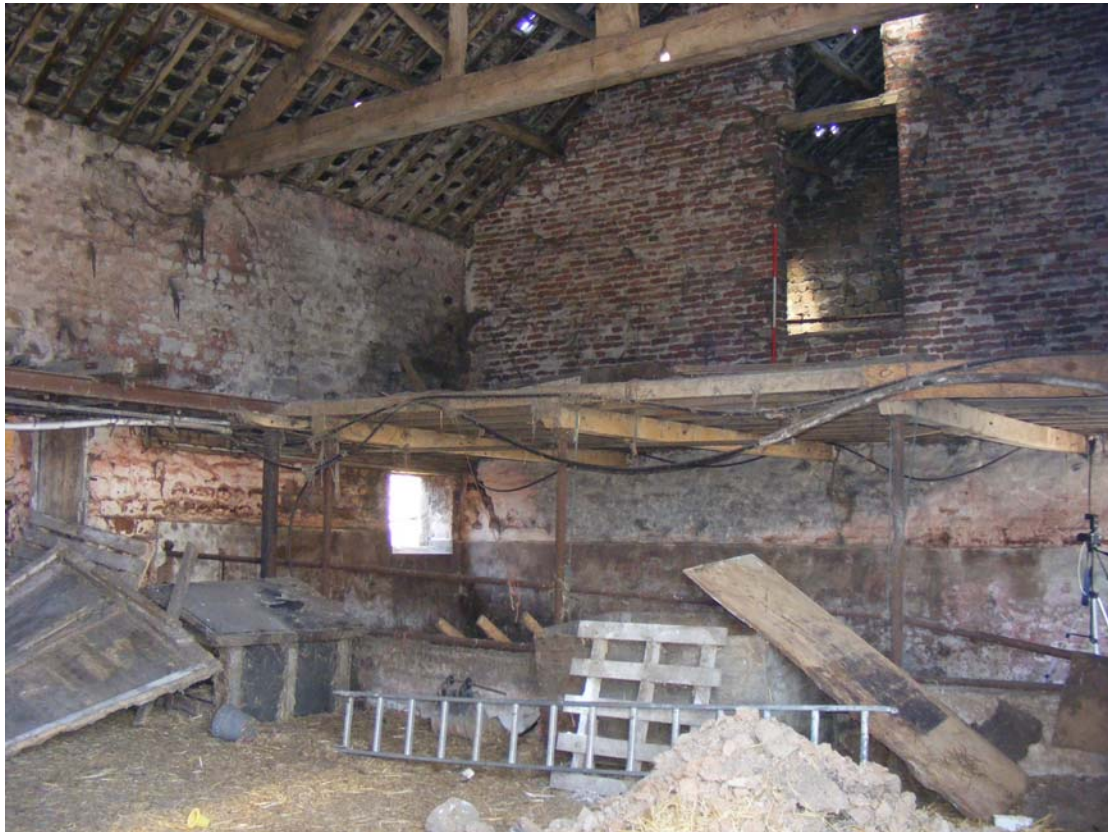
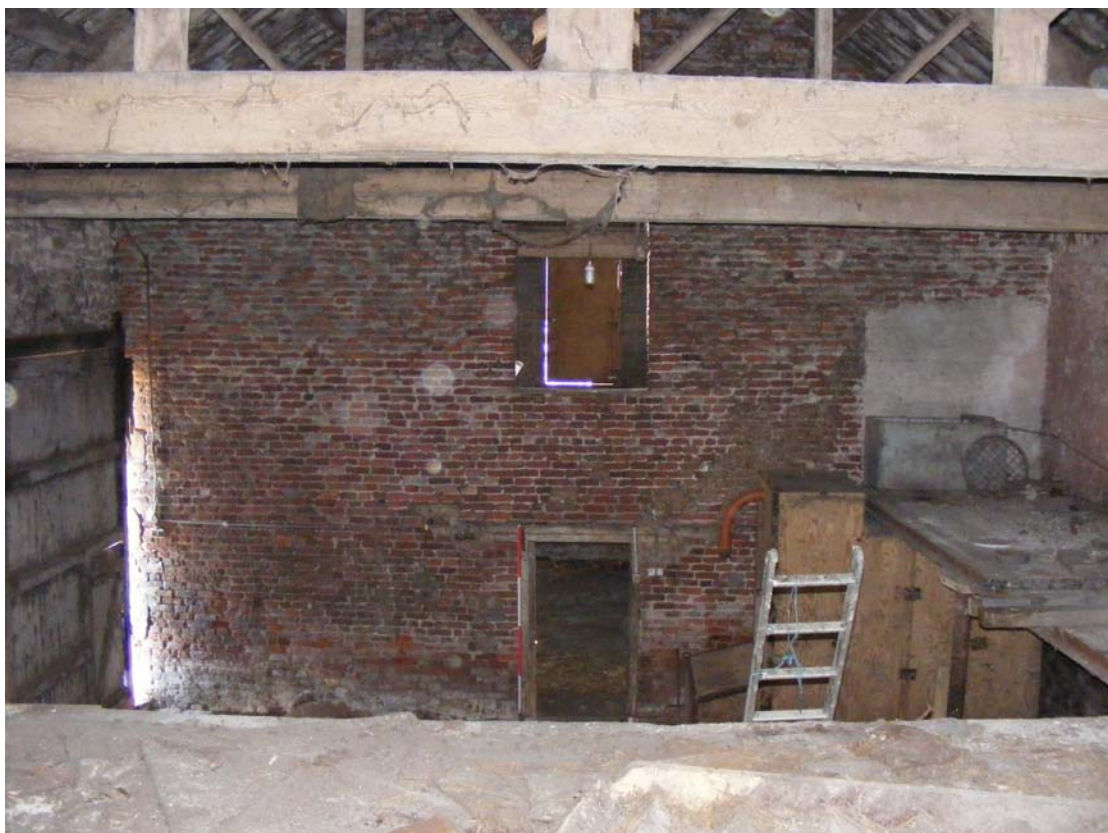
Fig 13: Interior of Central Section of Barn looking North-West from Cart Door

6.4.2 Central Section (Plates 13&14). This section is separated from the south and north sections by handmade brick walls that run east-west across the barn (see Fig. 9). The external east and west walls are made from coursed sandstone blocks. The interior is accessed from the exterior through the large timber cart door located in the southern end of the east wall. A large personnel door with a recessed timber frame is located centrally in the west wall and leads to the west shippon (see Fig. 9). In the southern end of the west wall there is evidence of a blocked doorway. Although it is obscured by

machinery in this area it is partially visible in the west shippon. The floor is concreted with a small apron of cobbles running along the east wall. The northern end of this section is separated from the main area by a concrete dwarf wall rising to a height of approximately 1m (**Plate 15**). North of this is a raised concrete platform which appears to have comprised four double stalls. Although the stalls have been removed although their footprint is still visible. The platform ends 1m from the north brick wall creating a walkway or manuring passage behind the stalls. An external personnel door is located in the northern end of the east wall granting ingress from outside to this shippon area of the central section. A small square window at the west end of the walkway, directly opposite the external door, has a brick surround and a concrete rendered cill, without a frame. A small personnel doorway with a timber frame but no door is set into the south brick wall and provides access to the ground floor of the south section of the barn.

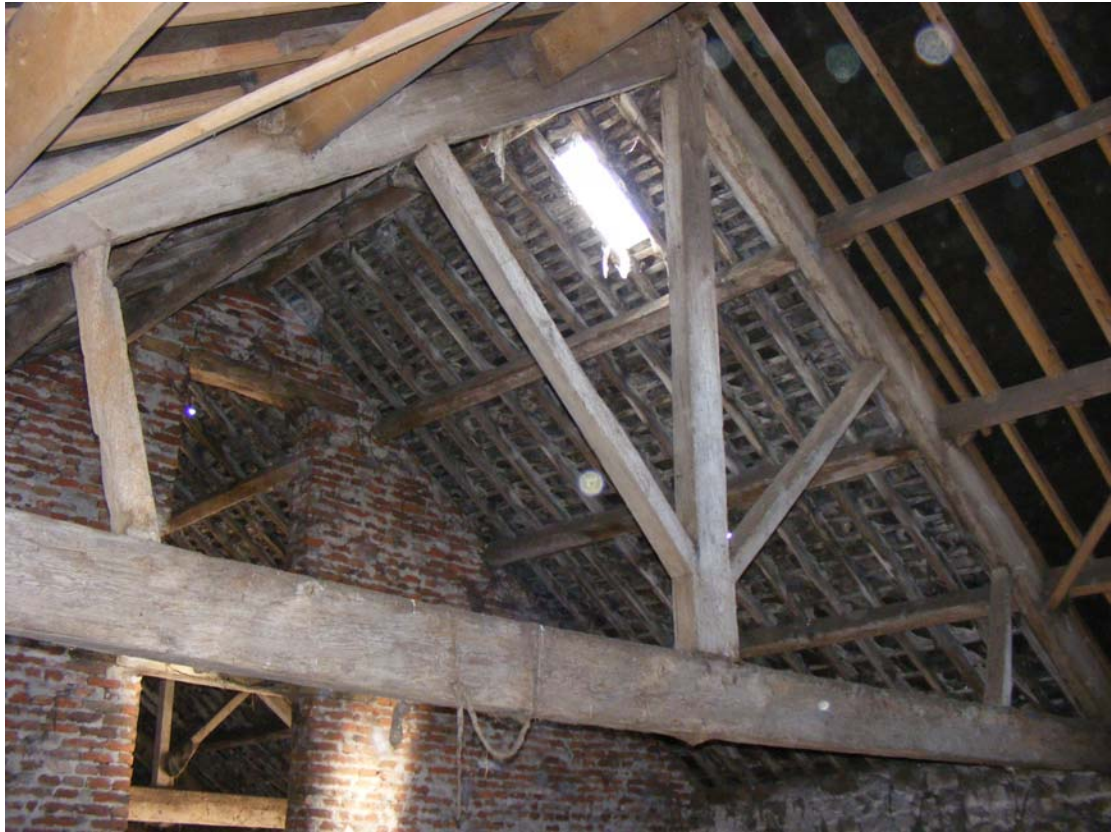
Fig 17: King-Post Roof Truss in South Section of Barn looking North-East

This leads into the western outshut. Two small windows are located in the east wall (see para 6.3.1 above). Both have sandstone cills and lintels with a recessed timber frame and a single fixed light. Another window is located at the south end of the west wall, but this has been blocked and contains no frame. The space has a partial upper floor which extends from the west wall to within 3.3m of the east wall. This comprises an RSJ running centrally east to west, and another running north to south along its the edge. These support timber joists which carry the timber floors. No staircase is present and access is by ladder. The upper floor is open to the roof which is supported by a single king post roof truss with three pairs of purlins and rafters. The king post is braced and there area pair of angled struts. All roof timbers are machine-cut. Those south of the truss are quite modern (**Plate 17**).

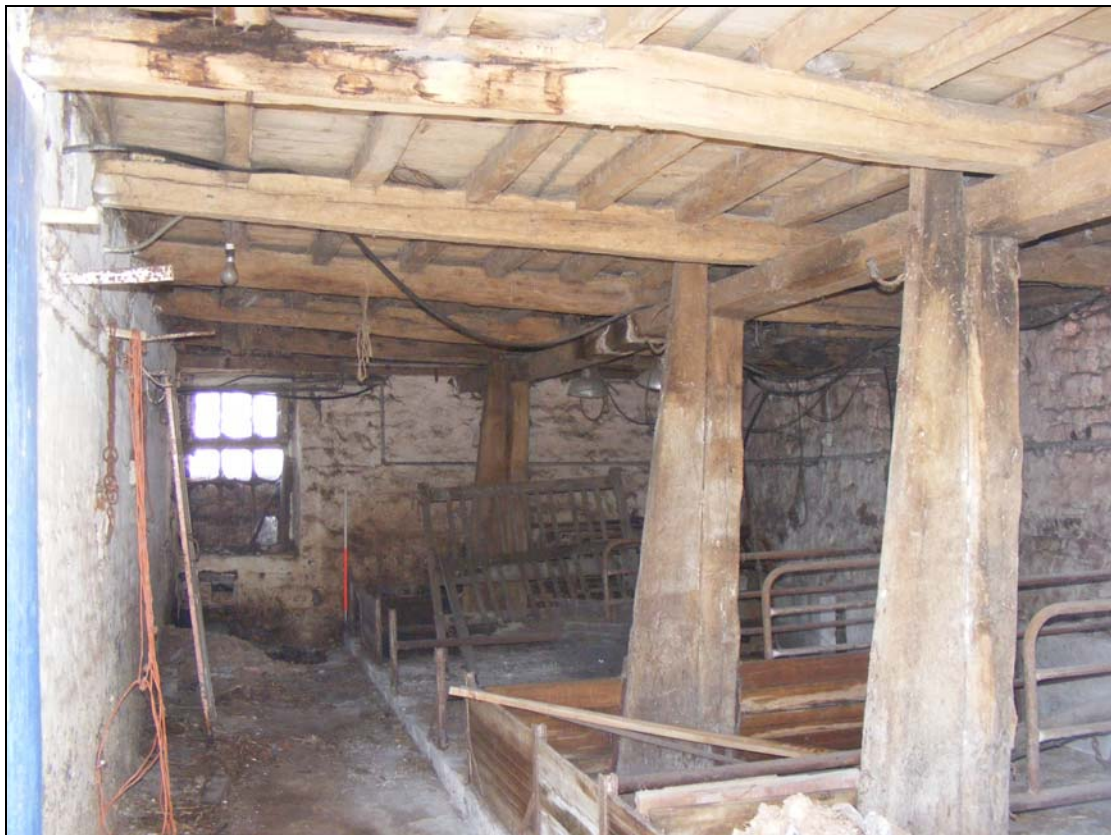
Fig 18: Old Shippon in North Section of Barn looking West

- 6.4.5 North Section. The north section comprises a small shippon with five stalls and a concrete floor (**Plate 18-jpeg 30**). The south wall is formed by the northerly of the two internal east- west brick walls within the barn and the other three walls by the stone built walls of the barn. All walls have a limewash finish. The ground floor room is accessed from the exterior through the ornate doorway in the south of the east wall (see para 6.3.1. above). This leads into the manuring passage. At the opposite end of this, in the west wall, is a recessed timber framed window. This has been partially blocked with machine made brick from the outside, but the frame shows evidence of having held twelve lights, with the top three opening. The stalls are located north of this passage. The stall dividers are comprised of metal pipes, rather than stone *boskins*. A drainage channel, which debouches through the east wall of the barn, is located between the manuring passage and the stalls.

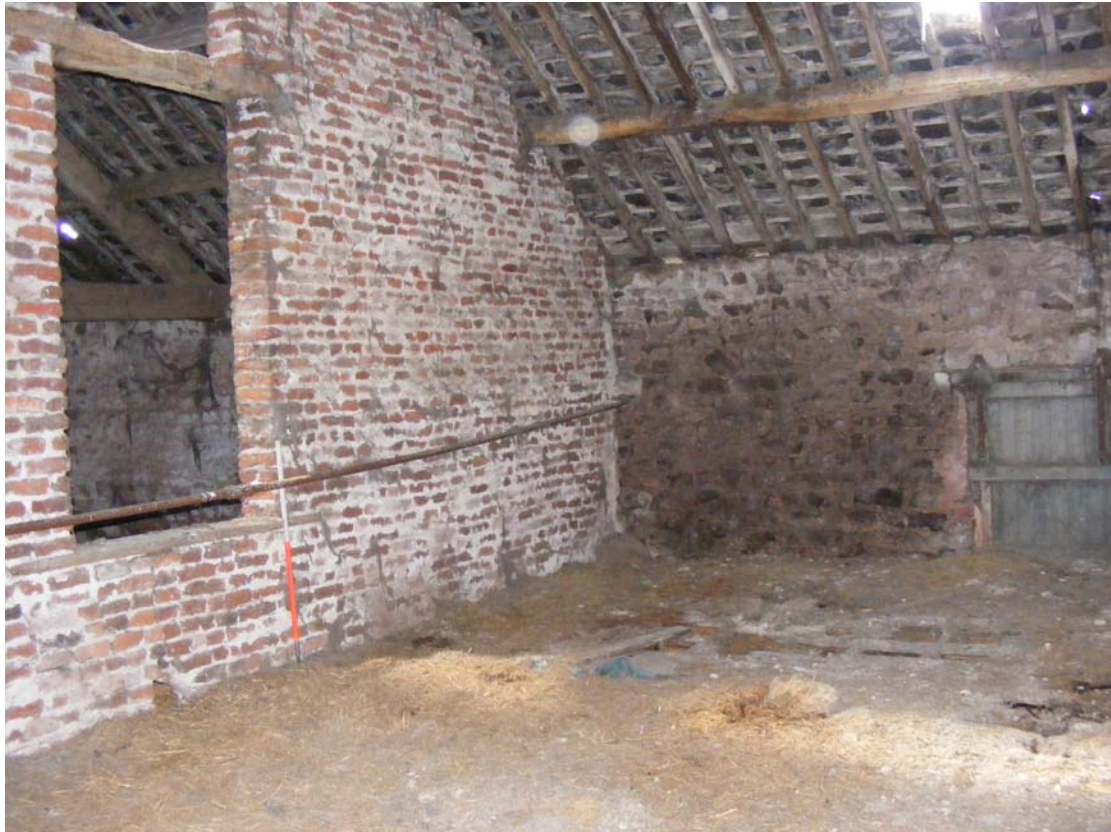
Fig 19: First Floor in North Section of Barn looking South-West

- 6.4.7 The first floor itself is accessed by the stairs on the exterior of the north wall of the barn which also lead to the provender store over the cart shed (see para.6.3.2 above). Internally, the south wall is formed by the northerly of the two internal east- west brick walls within the barn and the other three walls by the stone built walls of the barn (**Plate 19**). It has a timber boarded floor and it is open to the underside of the barn roof. In this section this comprises three sets of hand-cut purlins and a machine- cut ridge pole, modern rafters and battens and a Welsh slate roof. (**Plate 20**) In the brick wall are the two pitching holes already described at para.6.4.3 above. There is also a rectangular pitching hole with a sliding timber

door in the west wall (**Plate 19**) The exterior of this is just visible within the north-west shippon (see section 6.9 and **Plate 26** below).

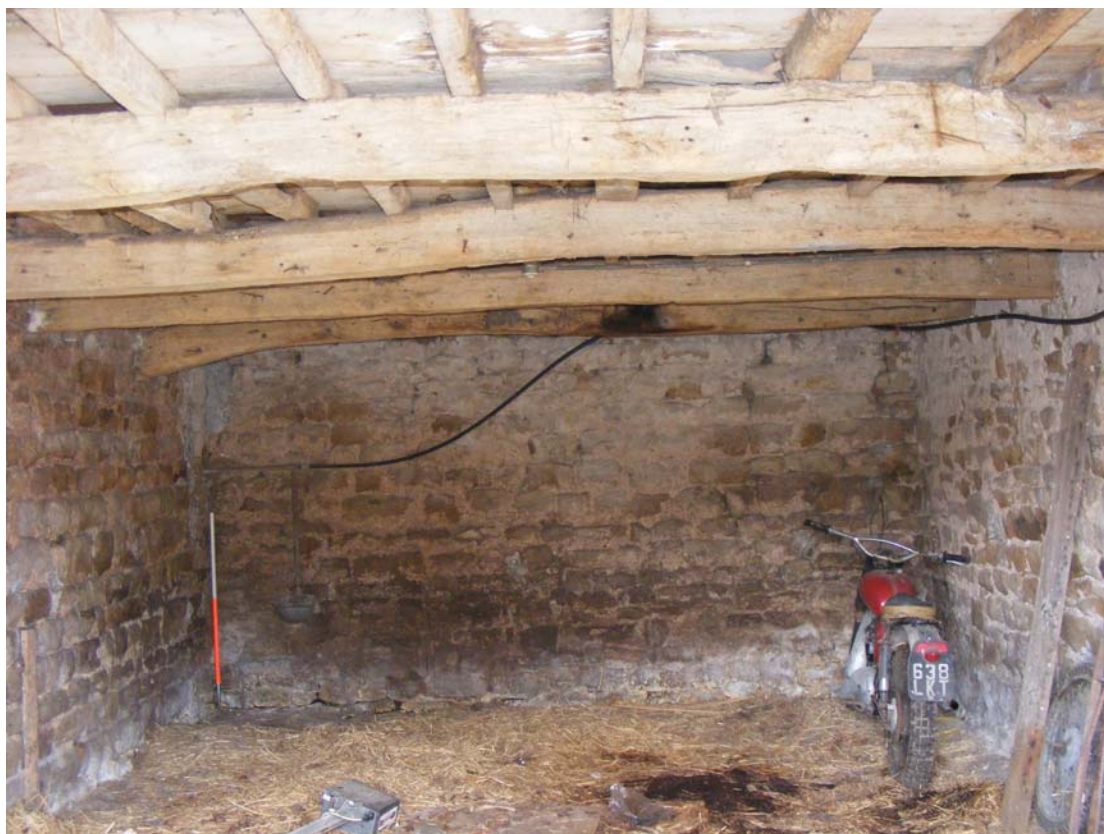
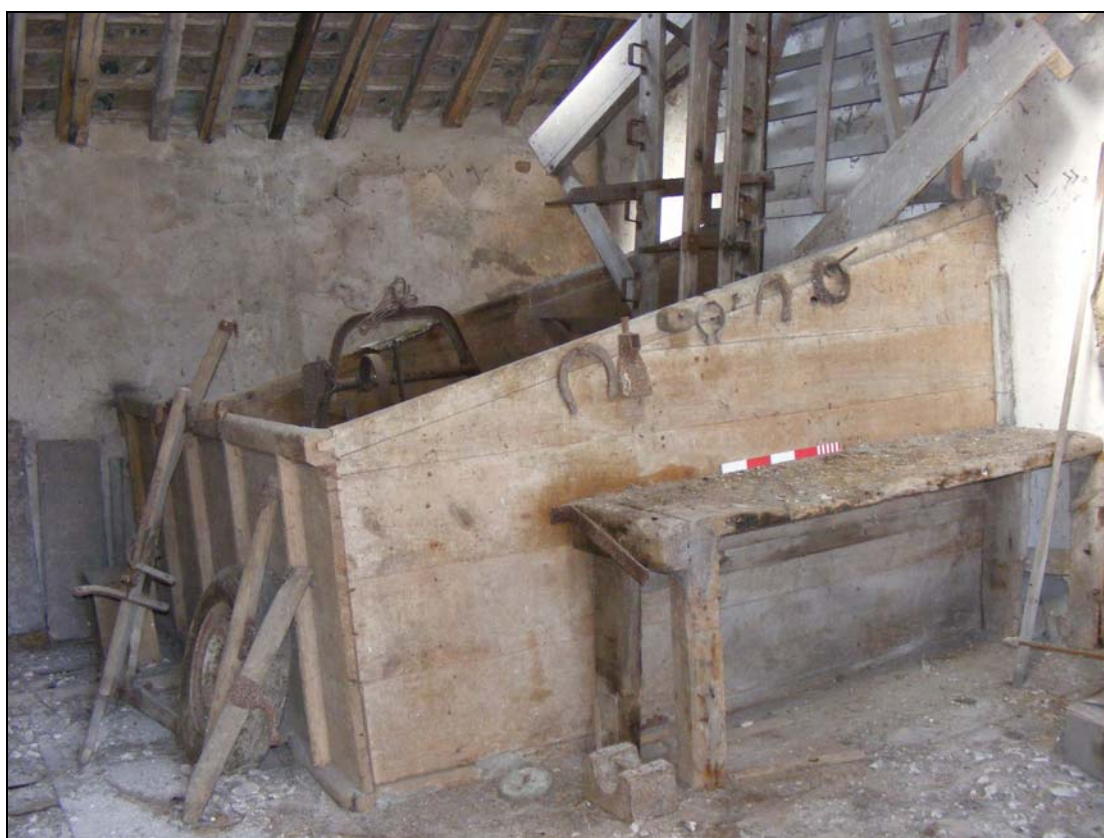
Fig 21: Interior of Cart Shed

6.5.2 Internal Description (Plates 21 & 22). The south wall is of uneven coursed stone blocks bonded with limestone mortar. It is apparent that this wall is the lower external north elevation of the barn. The other walls are constructed of somewhat rougher stone blocks again brought to uneven courses. The floor of the cart shed is concreted. The ground floor is open to the underside of the first floor above. This comprises handcut timber beams running north-south which support east-west joists upon which are laid wide butt-jointed timber floor boards. The first floor is accessed by the stairs on the exterior of the north wall of the barn (see para.6.3.2 above). The walls are roughly rendered and limewashed. It contains a large timber-built bin in the centre of the floor indicating that this room was used as a provender store and/or mixing shop.

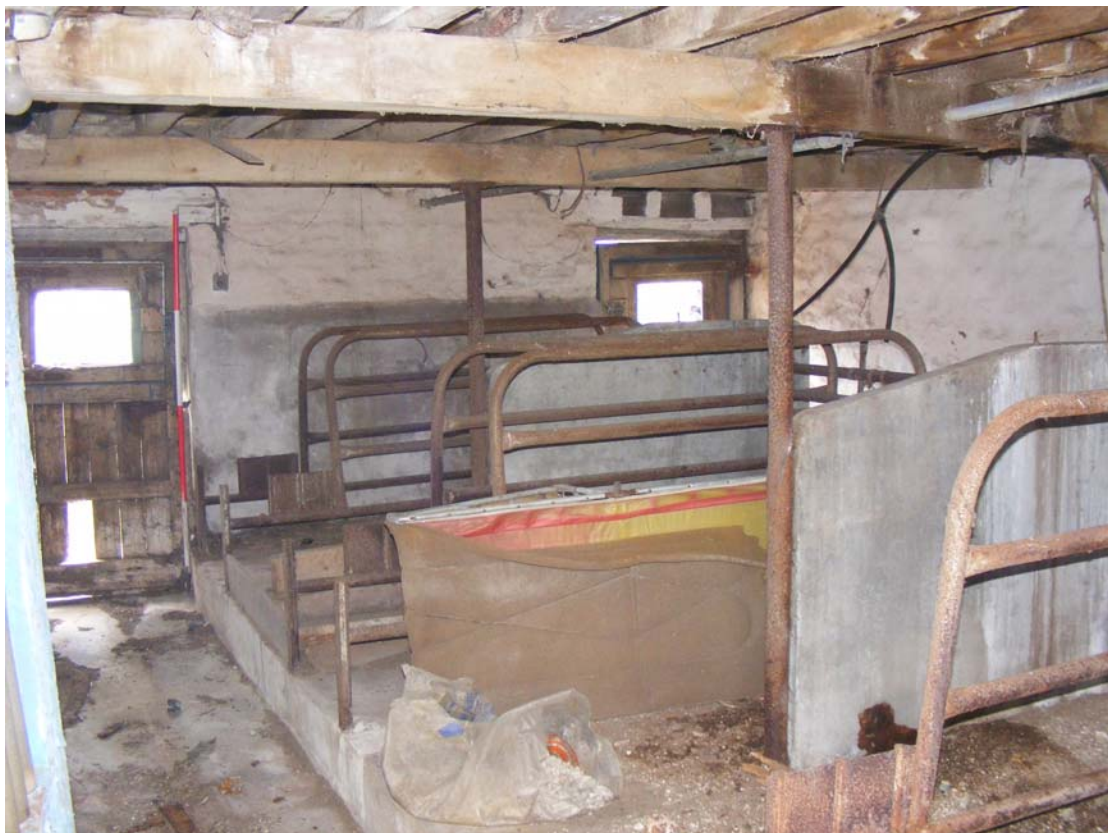
Fig 24: Interior of North Shippon Looking South-East

- 6.6.2 Internal Description (Plate 24). The concreted ground floor contains a central platform with concrete boskins and wrought iron rails providing four double stalls, an access/manuring passage along the north wall and a feeding passage along the south wall. The internal walls are roughly rendered and lime washed. The ground floor is open to the underside of the first floor above. This comprises machine-cut timber beams running north-south which support east-west joists upon which are laid wide butt-jointed timber floor boards. The first floor is accessed through a doorway from the first floor of the cart shed. The walls are roughly rendered and limewashed.

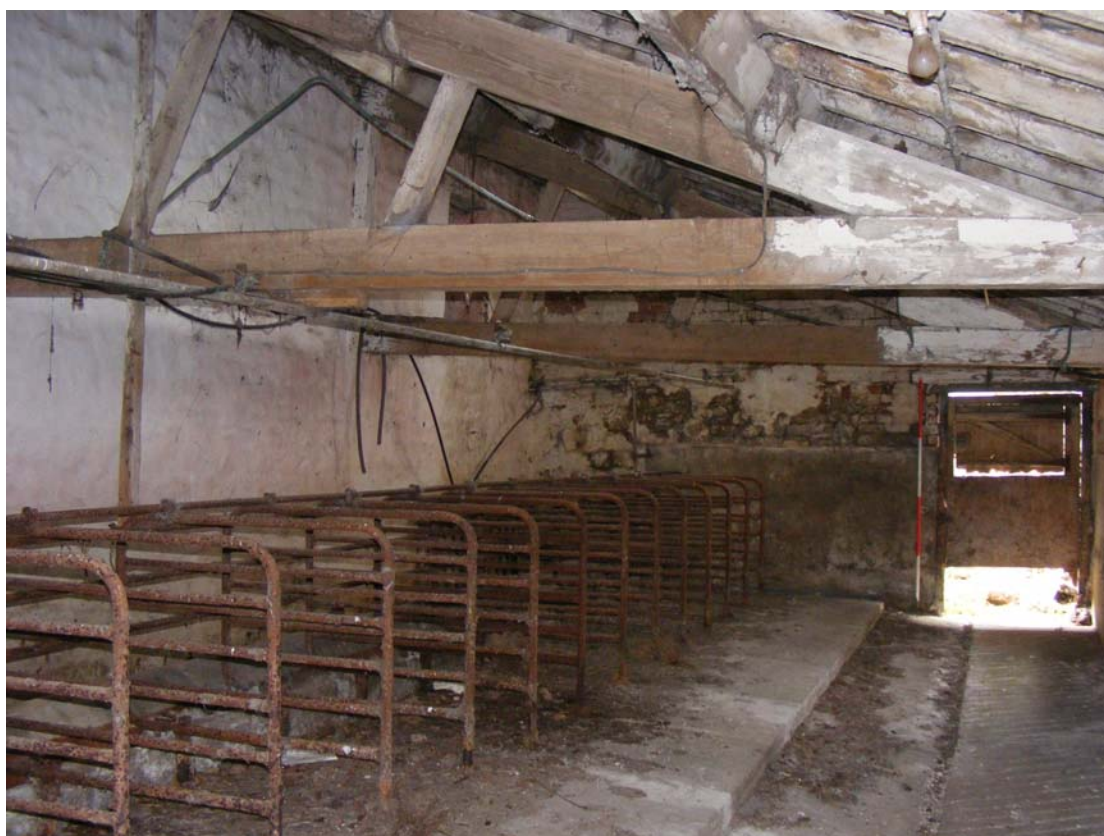
Fig 28: Interior of North-West Shippon Looking South

- 6.9.2 Internal Description (Plate 28). There is a raised concrete platform against the east wall which has wrought iron boskins providing 14 single cattle stalls. Manuring and access passages are provided via the two opposing doors.

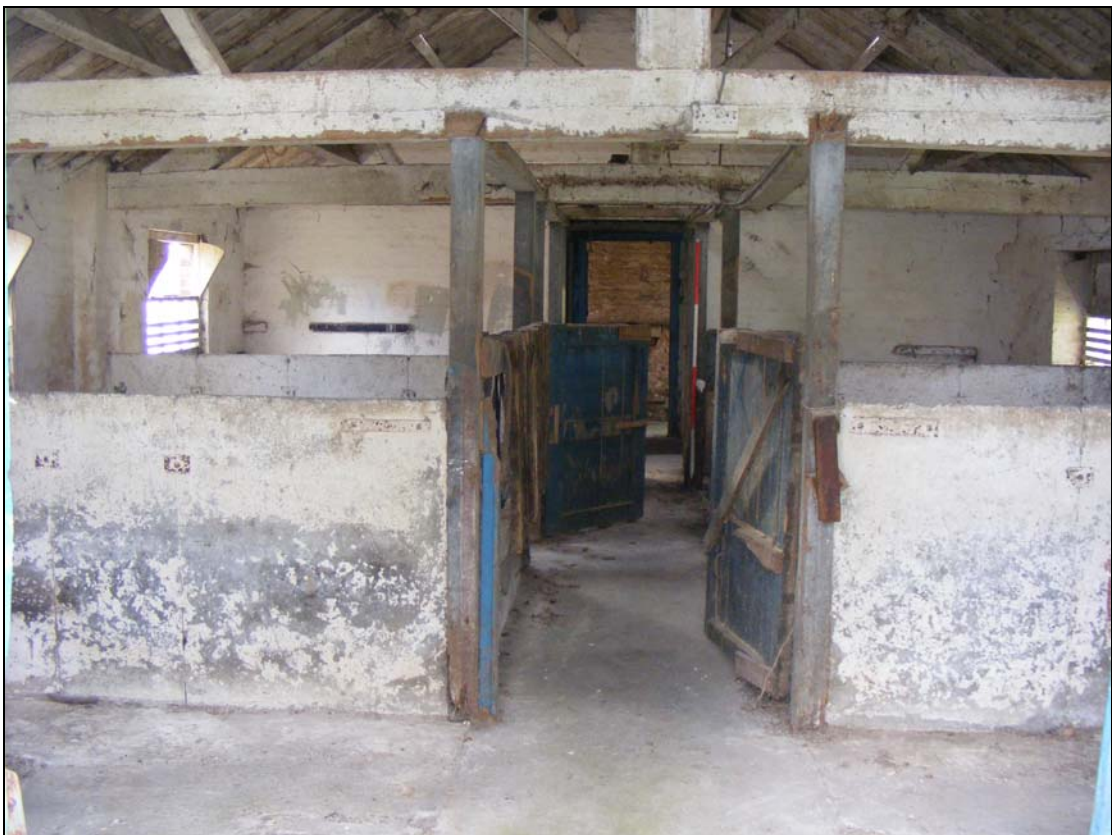
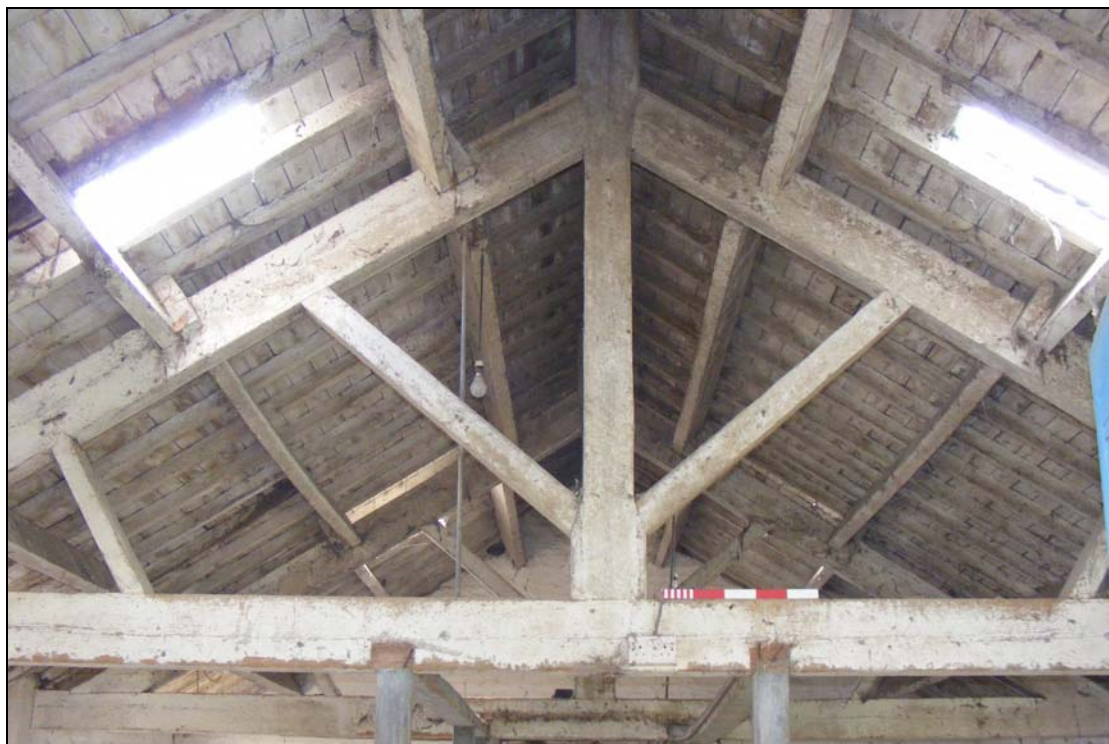
Fig 30: Interior of Loose-Box Range Looking South

- 6.10.2 Internal Description (Plates 30& 31-jpegs33&34). The walls are whitewashed and the interior is open to the underside of the roof which is underboarded. The rafters are supported by two sets of purlins on a single king-post truss which is braced and has two angled struts (cf south section of barn and the west shippon). The floor is concrete. At the south end internal brick walls provide a tackroom and store. Four stone slab half-height partitions within the main body of the interior provide four loose boxes.
