An archaeological building survey was required to inform a planning application for conversion to residential use of a barn at Lower Red Lumb Farm, Red Lumb, Rochdale (NGR SD 84011582). The work was carried out on behalf of Mr Harry Wright of 'Kasenmoor' Buckshaw Lane, Shaw, OL2 8LS by J. M. Trippier Archaeological and Surveying Consultancy. The buildings were found to be a small stone built combination barn and cottage which were attached to the adjoining house to form a *laithe house* type farmstead which was typical of this moorland region. Whilst *laithe*-houses could date from 1650 to 1880 the peak of development was between 1780 and 1820 (Brunskill 1987, 110) and this farmstead fits well within this period as demonstrated by the watershot stonework and the cartographic evidence. Both the barn and the adjoining cottage contained a number of attractive hand-cut roof timbers which appear to be largely in situ although it appears that the barn roof has been raised at some point.

6.1.1 The subject building comprises a two story rectangular three bay detached stone built barn with an attached cottage to the east. The farmhouse is attached to the east of the cottage (**Plate 1**).

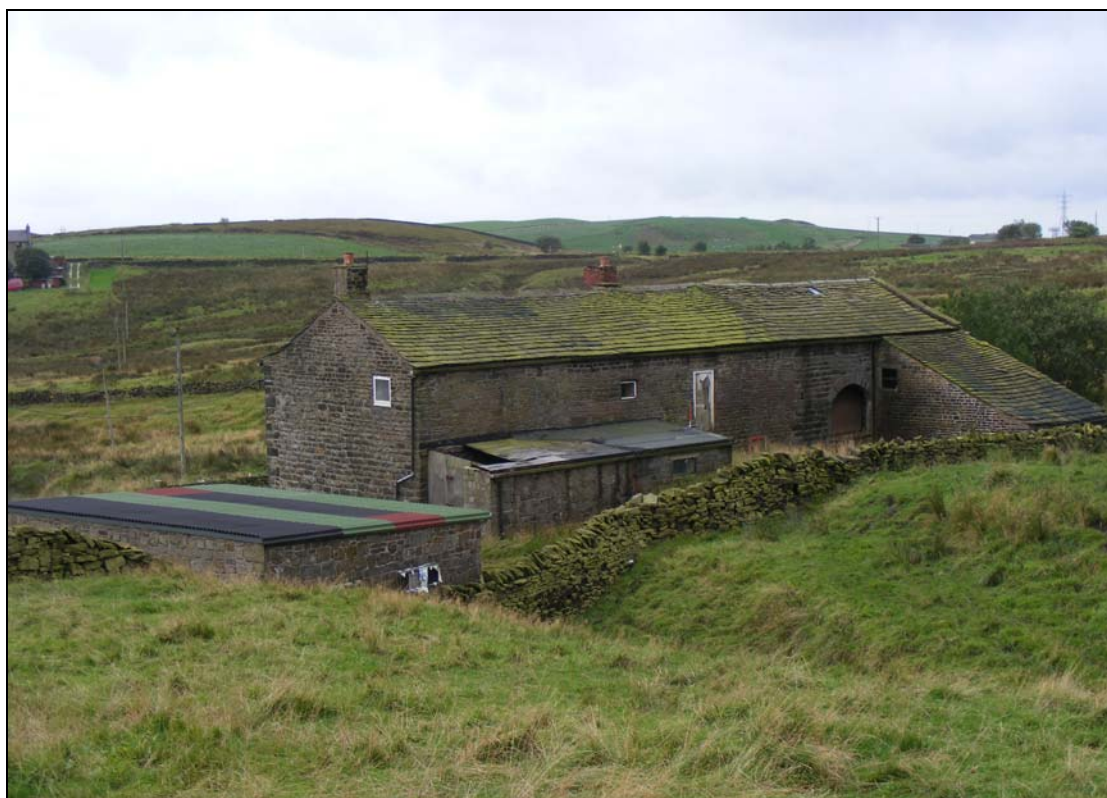
**Plate 2: Farmstead from north east**

- 6.4.4 North Elevation. This comprises the south wall of the barn described at para. 6.3.1 above.
- 6.4.5 East Elevation. This face is comprised entirely of modern plywood boarding, with a large rectangular entrance to the north (**Plates 2 & 4**).

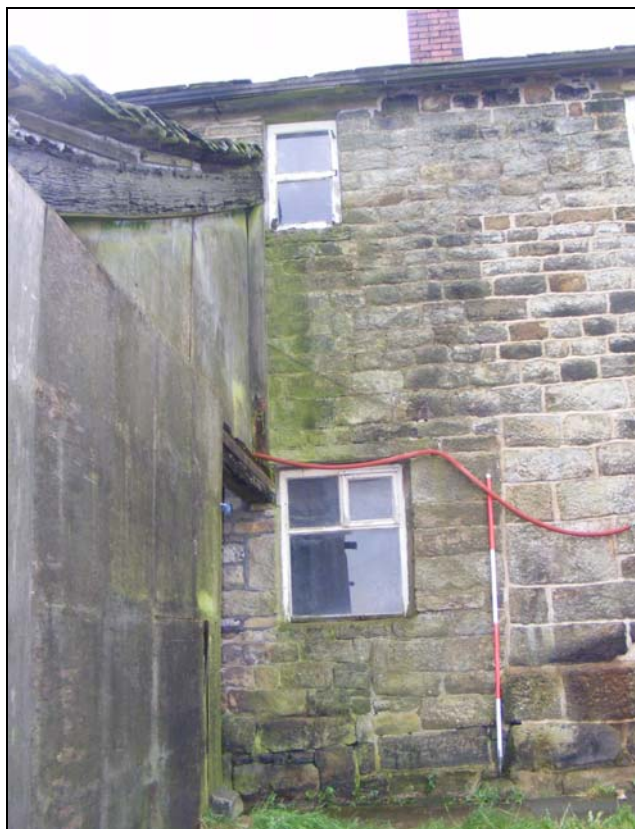
**Plate 3: South elevation of cottage**

6.2.1 South Elevation (**Plate 3**). This elevation comprises the front of the cottage. It is partly hidden by plywood panels enclosing the eastern end of the southern outrigger. The elevation is constructed of roughly shaped sandstone blocks, regularly coursed and similar to those of the adjoining farmhouse. The door is located at the western end of the elevation within the outrigger. The doorway has a sandstone block surround and lintel and a timber brace and batten door (**Plate 4**). A small plinth, two courses high, runs along the base of the wall east from the door towards the farmhouse. The elevation has two modern timber casement windows one at ground level the other at first floor level located at the eastern end of the elevation. The ground floor window has three lights, while the upper window has two. Both have sandstone cills, lintels and jambs. At the east end of the ground floor window there is break in the plinth described above possibly indicating the position of a former doorway?

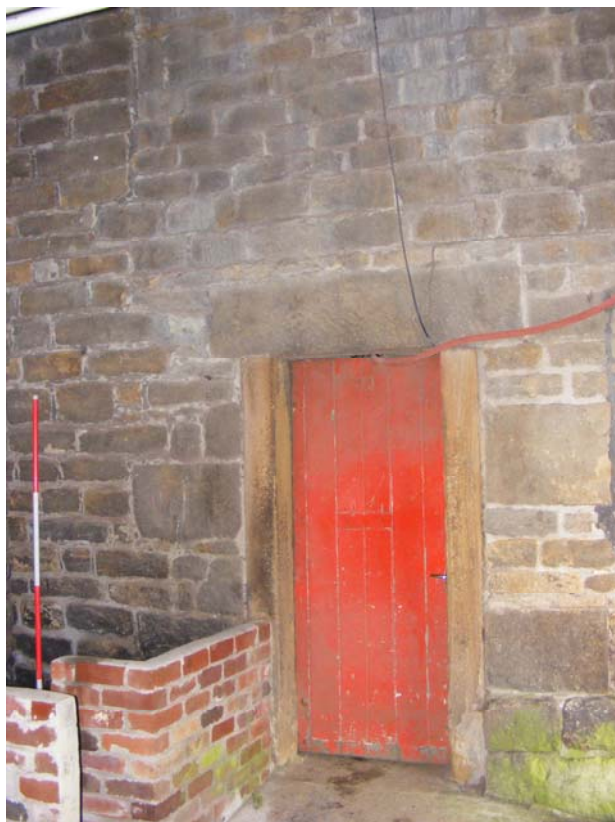
**Plate 4: South elevation of cottage and door**

- 6.4.7 The eastern space partly covers the south elevation of the barn and the cottage which forms its north wall (see **Plate 4**). Both the south and west walls are regularly coursed, but the southern is constructed of rough sandstone and the western of watershot sandstone. This indicates that the latter was originally an external wall and that the covered area comprising this east space was added later. The south wall appears to butt up against it. The OS 25" map of 1910 (Fig 10) confirms that the addition was not made until after that date. The east wall is constructed

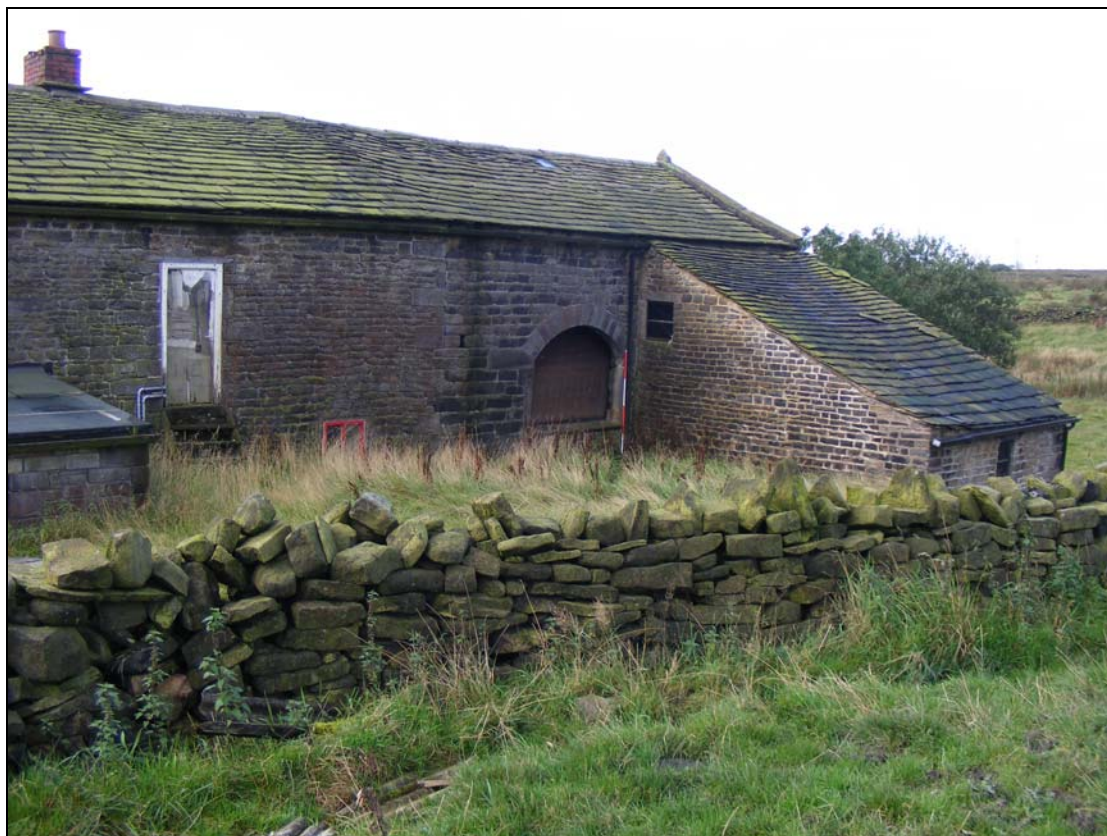
**Plate 5: North elevation of cottage and barn**

6.2.2 North Elevation (**Plate 5**). This elevation comprises the rear of the cottage and is constructed of regularly coursed roughly shaped

sandstone. This face is characterised by a small two light window, level with the ground at the west of the elevation and a personnel door approximately 0.5m above ground level at the eastern end. The window is timber framed and looks into the ground floor of the cottage. The door is of rough plywood panels in a timber frame with several timber steps leading up to the first floor of the cottage. Quoins are visible on the western end of the elevation, where the barn butts up to it (**Plate 6**).

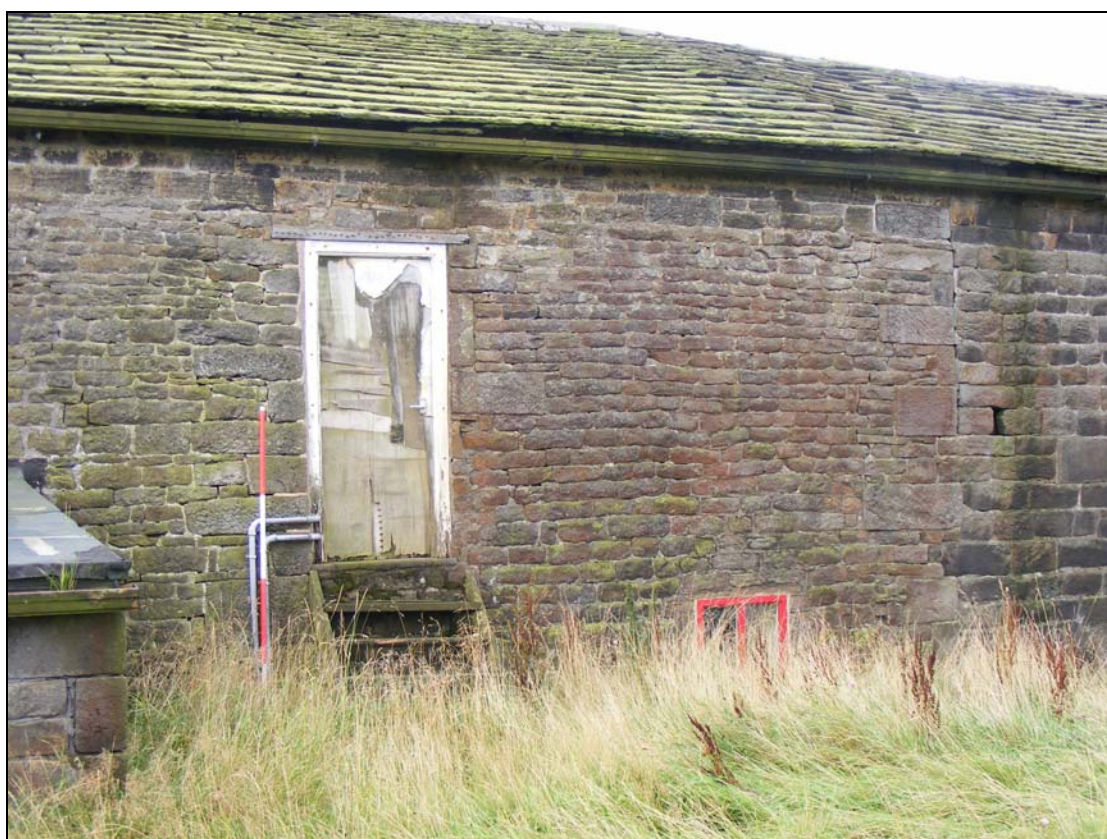
**Plate 6: North elevation of cottage**

- 7.2 It is apparent that the types of stonework employed in the building of the farm house and cottage differ from those of the barn and outriggers. The former are of regularly coursed but rather roughly shaped sandstone blocks largely resting on significantly larger blocks at the bases of the walls which have plinth-like appearance. By contrast the barn is built of regular blocks of millstone grit laid in watershot fashion so the top of each block tilts outwards slightly (see **Plates 6&15**).

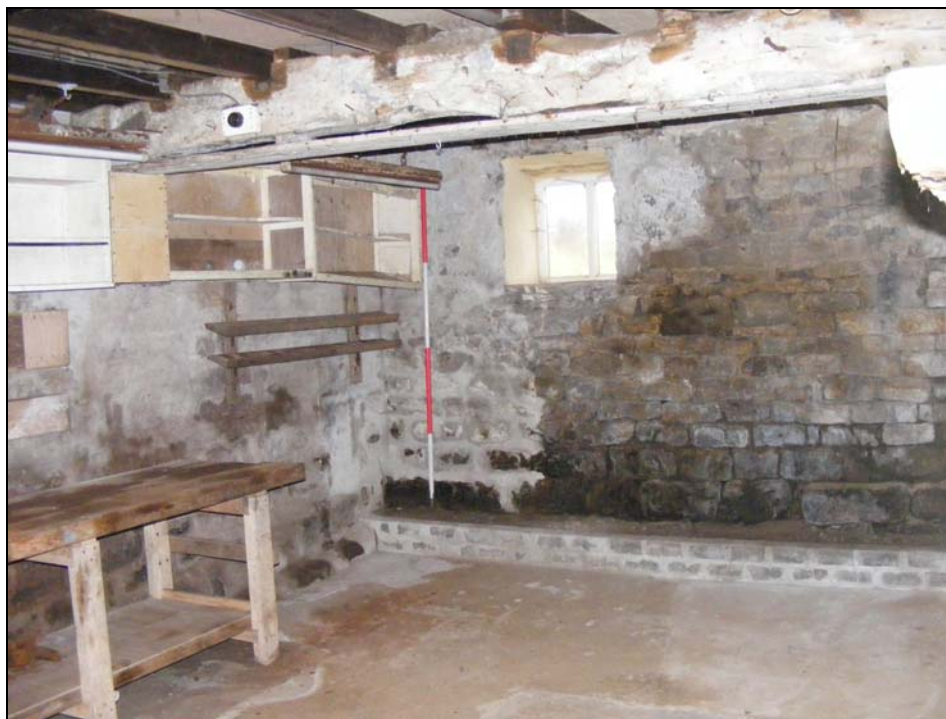
**Plate 7: Ground floor of cottage**

- 6.2.6 Ground Floor (Plate 7). The ground floor comprises a single room with a sandstone flag floor and an inserted ply board ceiling on timber joists. The latter are supported by one hand-cut and one machine-cut timber beams running east-west. The walls are roughly shaped sandstone, regularly coursed, with lime plaster over parts of the west and south ones. Access from the exterior is via a timber personnel door in the western end of the southern wall (**Plate 8**). Another door is located in the southern end of the west wall. This is blocked with concrete blocks and would have, at one time, given access to the barn. The jambs of this door are rough, suggesting the door was not original. There are two windows in this room. In the southern wall, east of the door, is a timber framed casement window with three lights. The lower two lights are fixed. In the north wall at a higher level is a square timber framed window, with two fixed lights (**Plate 9**). A stone fireplace with a brick flue-stack is located south of centre along the east wall (**Plate 10**). A low (0.18m) plinth runs along the north wall.

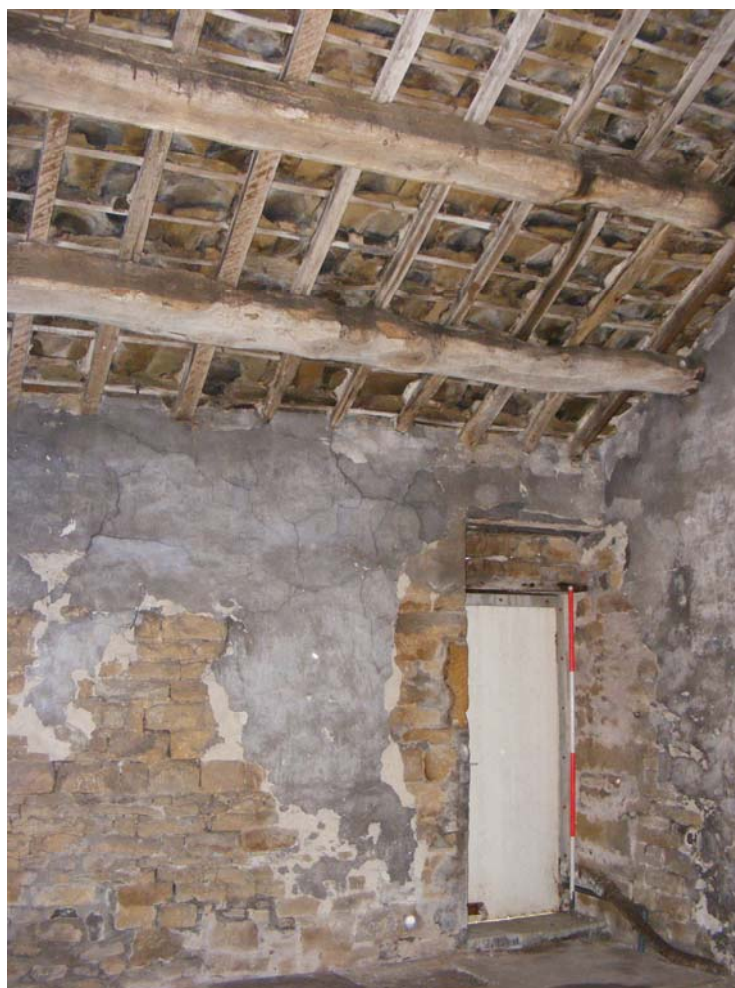
**Plate 11: Doorway in northeast corner of first floor of cottage**

- 6.2.7 First Floor (Plate 11). As with the ground floor, the first floor is a single room. The floor is of modern ply board, replacing the earlier timbers and the ceiling open to the rafters. Although there is no roof truss the two purlins north of the ridge pole are hand cut (**Plate 11**), as is the most southern purlin south of the ridge (**Plate 12**). The ridge pole and the remaining purlin are machine cut. The walls are rough sandstone blocks brought to course in places. Patches of lime plaster are found on all of the walls. A small timber trap door is located in the southwest corner of the room, giving access to the ground floor, although there is no evidence of a staircase. Access to the exterior is via a solid modern timber door in the eastern end of the north wall, which leads out to a series of small timber steps to ground level. The western jamb of this has been partly rebuilt with concrete. At the eastern end of the southern wall is a timber framed casement window with two fixed lights. The walls

around this have been rendered with concrete. The flue-stack from the ground floor fireplace runs up the east wall, south of centre. It is covered with a plaster render, although bricks are visible.

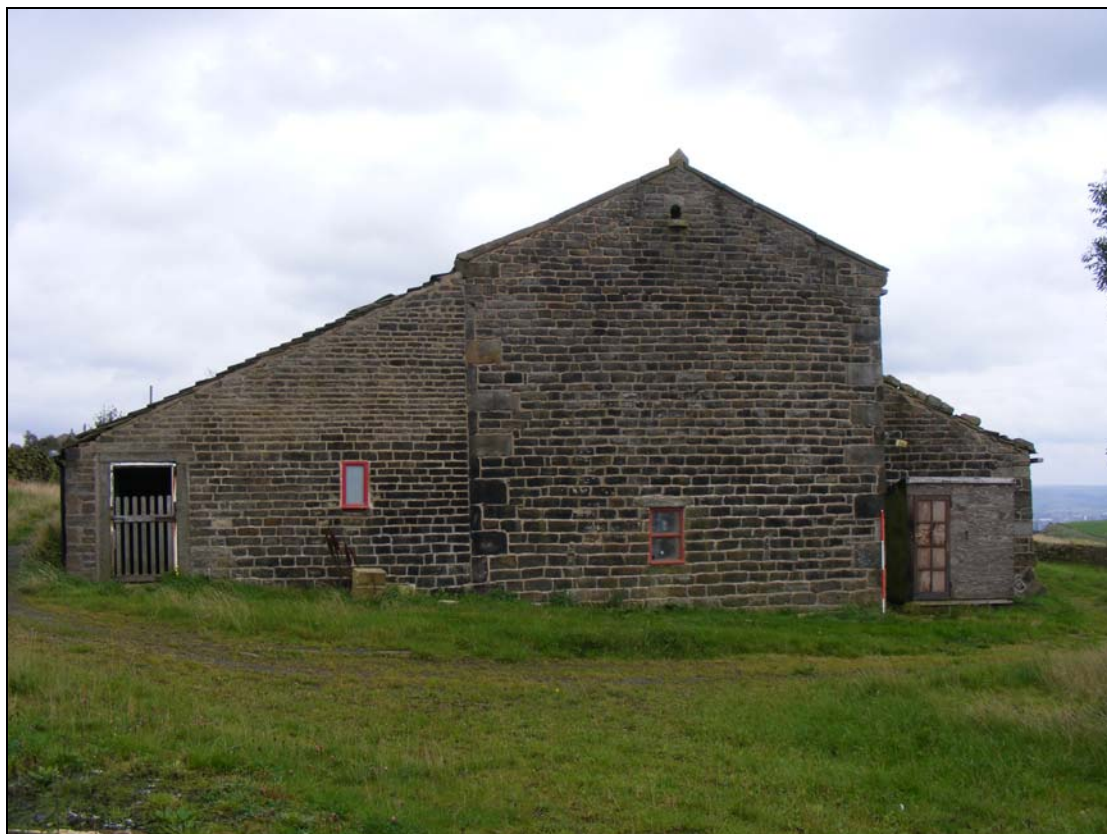
**Plate 13: West elevation of farmstead**

- 6.3.1 South Elevation (Plate 13). This elevation forms the long wall of the barn and is the front of the building although it is now largely obscured by the southern outrigger. The elevation is constructed in watershot regularly coursed sandstone although to the west of the southern outrigger it appears to change to millstone grit (**Plate 14**). A ledge, batten and braced timber personnel door with a sandstone external lintel and recessed timber frame is located at the western end of the elevation. A large barn door with a semi-circular arch and quoined surround is located slightly east of centre. It is blocked with brick and stone and is now contained within the southern outrigger. There are no windows in this elevation.

- 6.5.1 West Elevation (Plate 13). This elevation is constructed of regularly course watershot sandstone, which has been re-pointed in cement. At the north end is a timber framed personnel door with sandstone jambs and lintel fitted with a half-height timber gate. A timber framed casement window is located south of this.

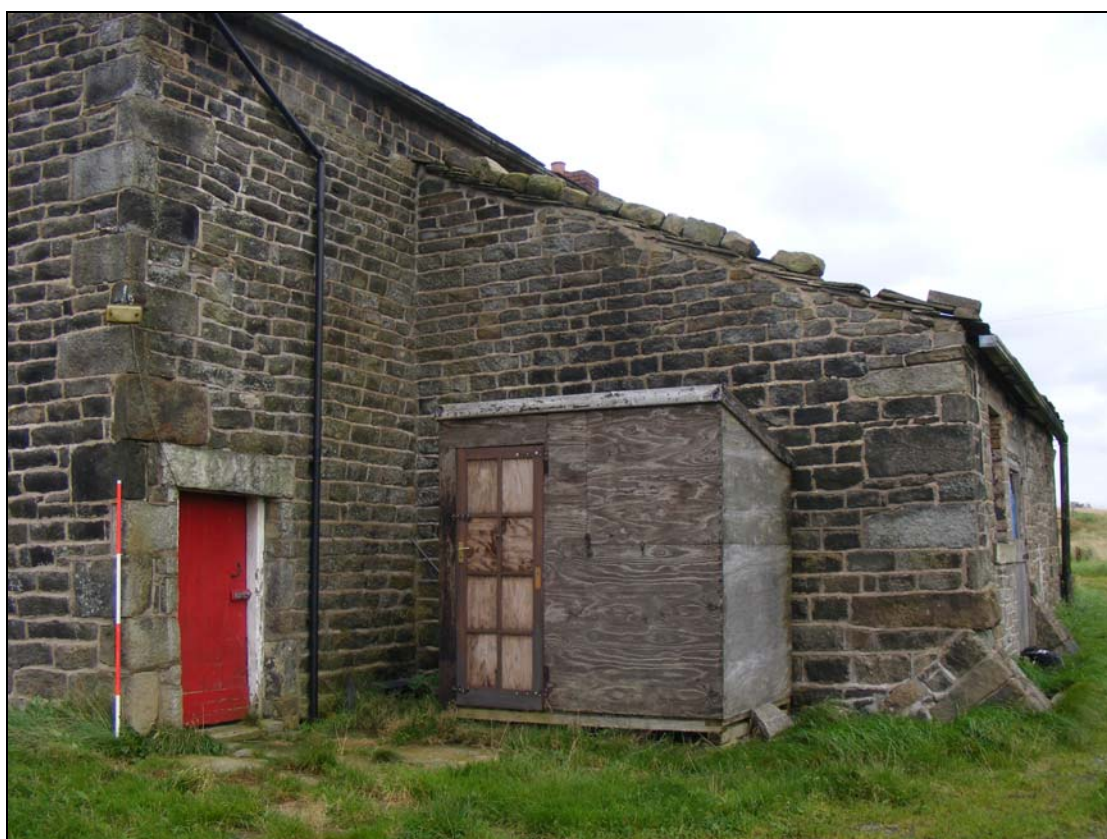
**Plate 14: South elevation of barn and west elevation of southern outrigger**

- 6.4.3 Western Elevation. This blank elevation is constructed with watershot sandstone blocks, regularly coursed and with large quoin stones (**Plate 14**).

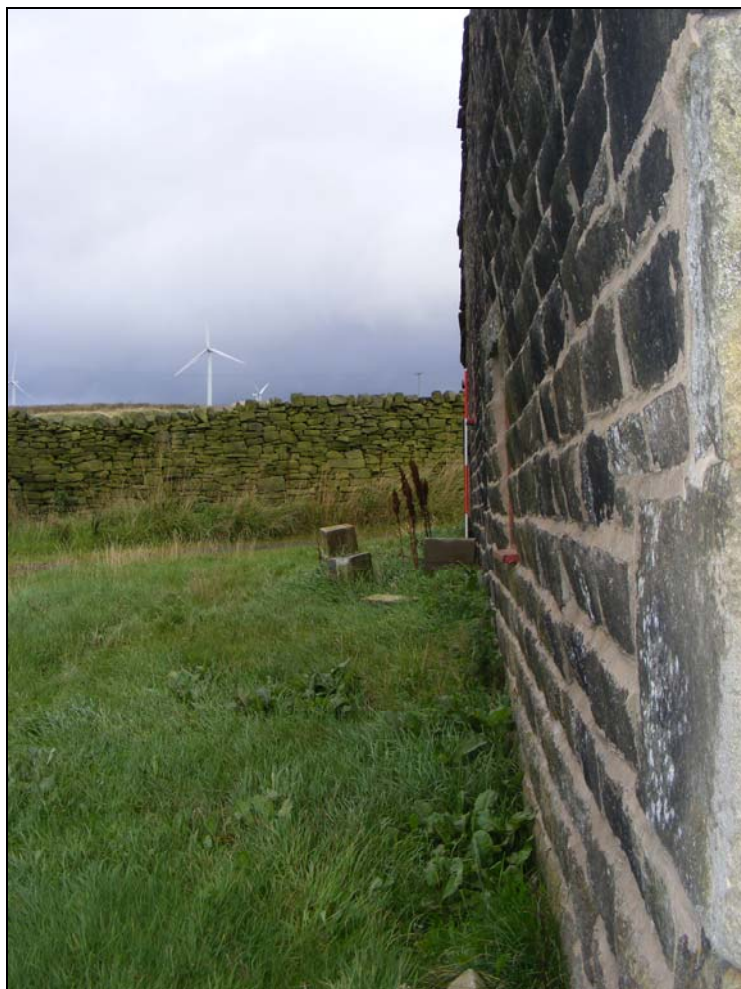
**Plate15: Watershot west elevation of barn**

- 6.3.2 West Elevation(Plate 15). This elevation comprises one of the gable ends of the building and is constructed of watershot millstone grit blocks, regularly coursed, with quoins at either end. It has a timber framed casement window with two fixed lights located centrally at ground floor level. There are no other features other than a small owl hole near the top of the gable.

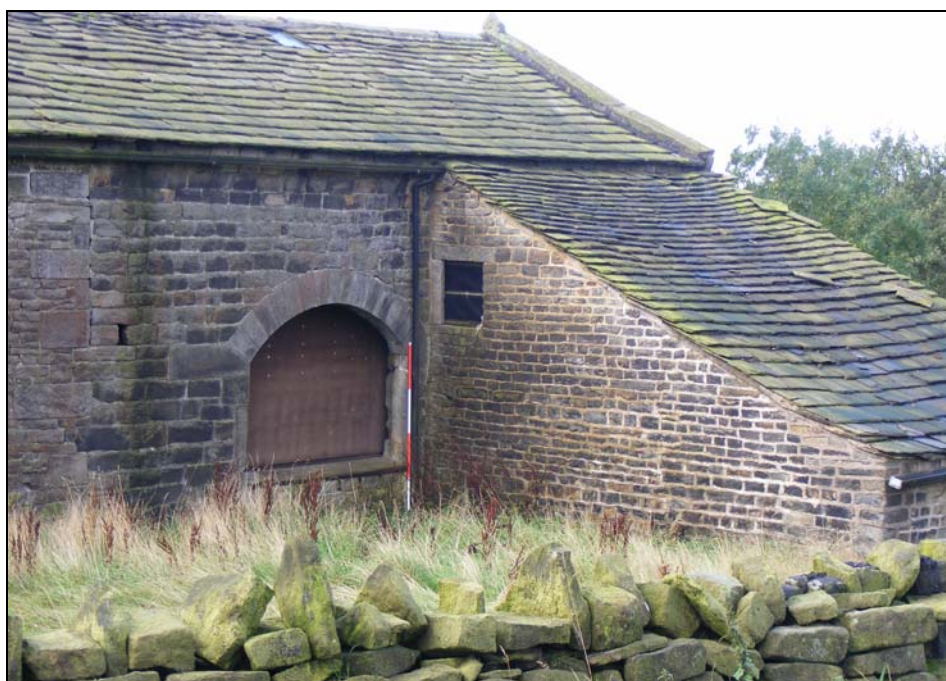
**Plate 16: North elevation of barn**

- 6.3.3 North Elevation (Plate 16). This elevation forms the original long wall of the barn and is the rear of the building. It is constructed of millstone grit blocks, regularly coursed but not watershot unlike the southern and western elevations. This face is characterised by a 'barn door' to the east end, with a semi-circular sandstone arch and quoin surround. The lower part has been infilled with stone up to 0.65m above the current ground level which appear to have been made up and the jambs may extend lower down. This door now only gives access to the first floor of the barn. A modern timber panel now blocks the door.

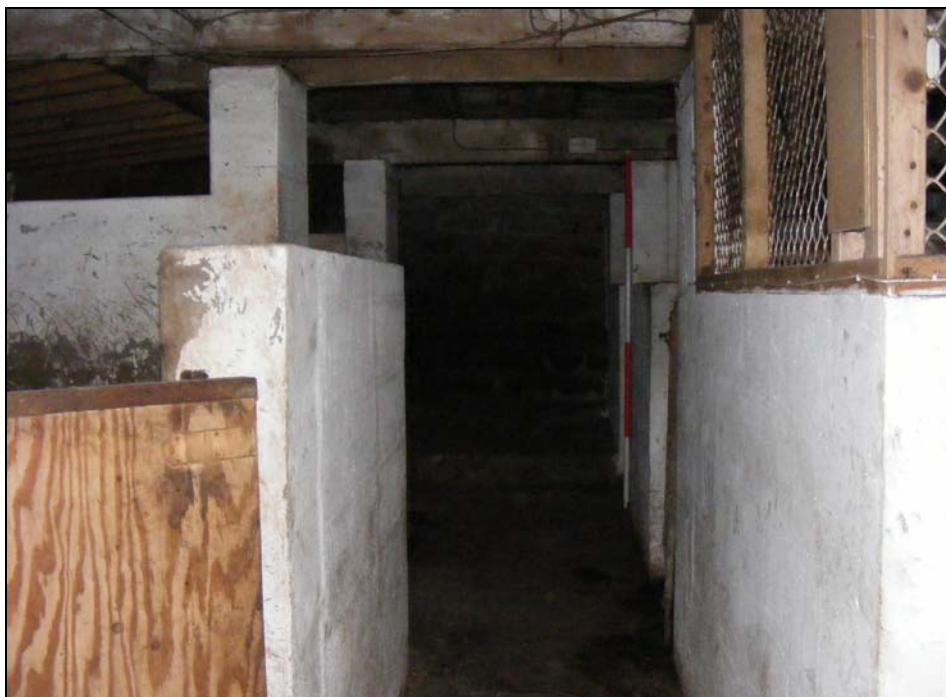
**Plate 17: Pens in ground floor of barn**

- 6.3.5 Ground Floor (Plate 17). This area has been substantially altered from its original use and now comprises an open room with a mainly concrete floor and several concrete walls, approximately 1.5m high, forming five pens of varying size fitted with timber gates. The external walls within the pens are rendered smooth as are the north wall and the southern end

of the east wall. Otherwise they are all shaped sandstone brought to courses and lime washed. The sandstone blocks at the south end of the west wall are watershot. A sandstone plinth, similar to that on the southern elevation of the cottage runs along the base of the east wall. The space is accessed from the exterior through a timber ledge, batten and braced door in the western end of the southern wall. It has a hand-cut timber lintel (**Plate 18**). There is a single timber framed casement window in the west wall with two fixed lights.

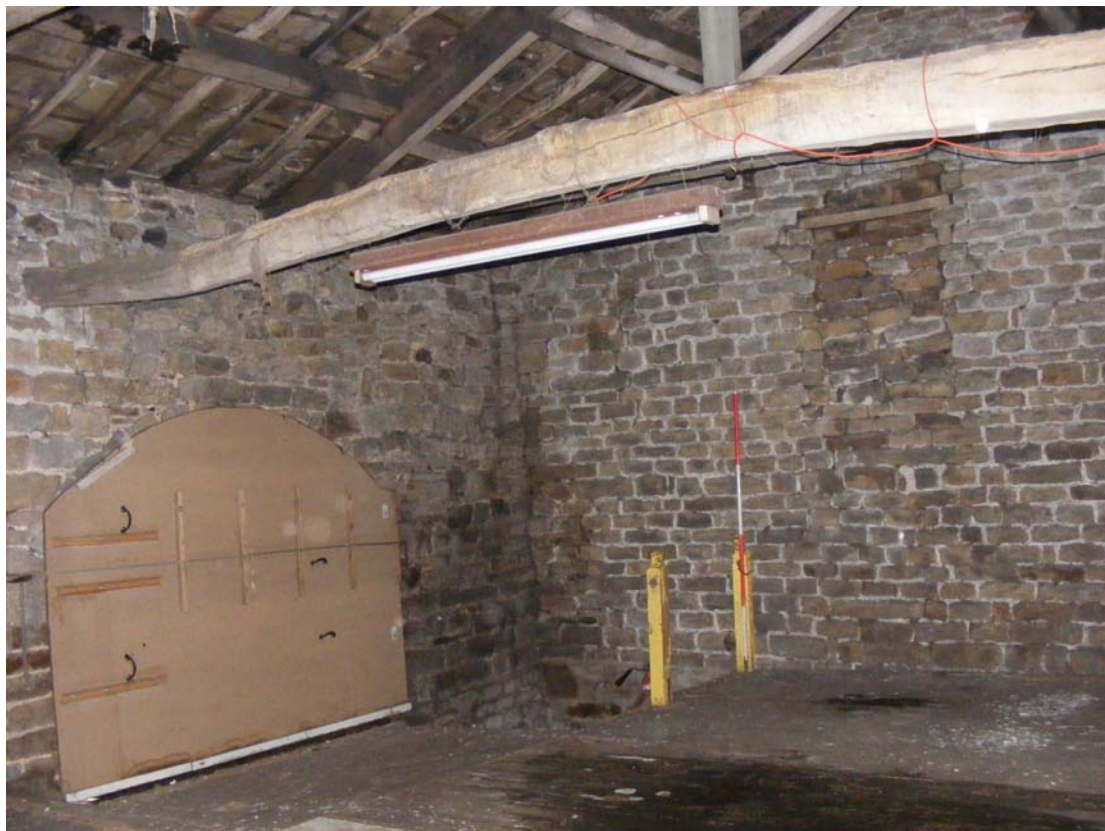
**Plate 21: First floor of barn showing stairwell and north barn door**

6.3.7 First Floor(**Plate 21**). The first floor comprises a single room open to the underside of the roof. The walls are of shaped sandstone occasionally brought to course. The floor is of timber T&G boarding. It is accessed from the floor below by the stairs in the north-east corner. The roof is supported by two machine cut king post trusses running north to south. A hand-cut beam, also running north to south is located between these trusses (**Plate 22**). A number of purlins are also hand cut. It appears from the stonework at the top of the north and south walls that the roofline has been raised at some time-presumably when the king trusses were inserted (**Plate 23**). The room can also be accessed from the exterior by the barn door in the north wall the foot of which is aligned with this floor. Opposite this is the top of the barn door in the south wall now blocked with bricks (**Plate 24**). This runs down to the floor below, but is not visible on the ground floor due to the rendering. In the centre of the east wall is a rectangular opening, now blocked with sandstone. It seems likely that this was a pitching hole between this floor and the first floor of the cottage next door

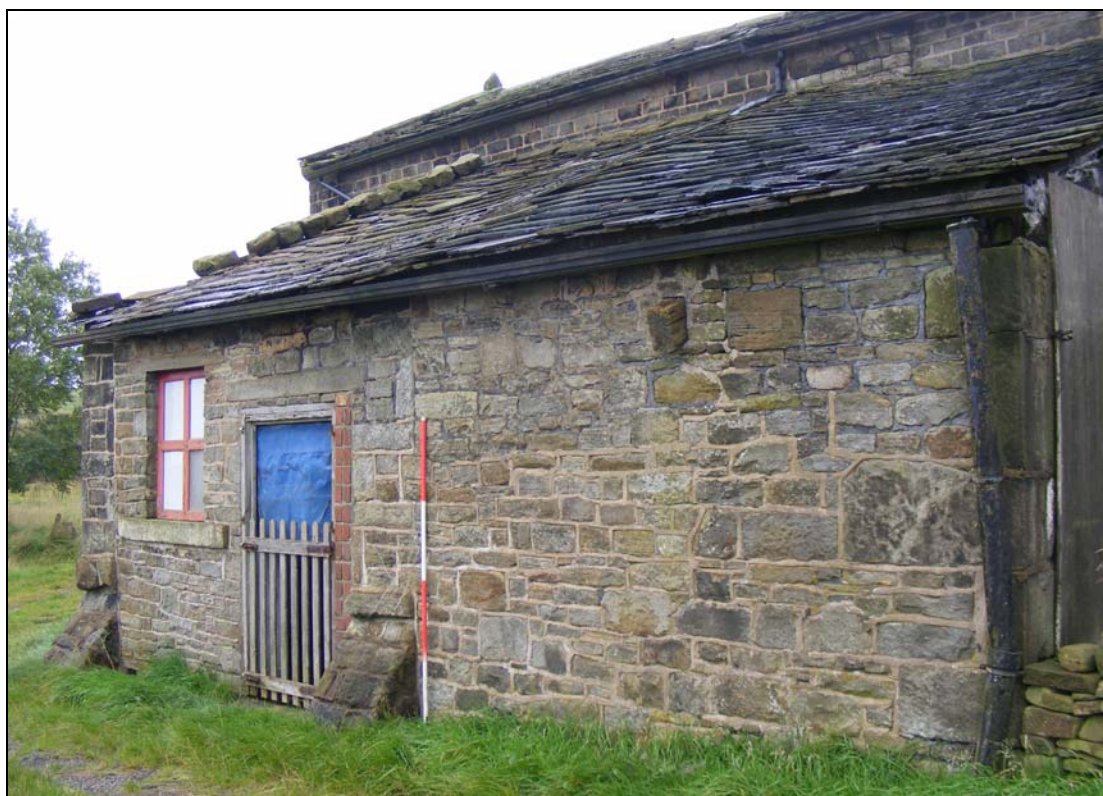
**Plate 25: South elevation of southern outrigger**

- 6.4.2 South Elevation (Plate 25). This elevation is largely constructed of roughly squared sandstone rubble only occasionally brought to courses with very large quoin stones at the eastern end. There a timber framed personnel doorway west of centre on this elevation. It is fitted with a timber gate to half height. The eastern jamb of this doorway is formed of modern brick, which butts up to the stone wall east of it and a concrete lintel has also been inserted. West of the door is a timber framed casement window with four fixed lights. The extreme western end of this elevation is a separated by a visible straight joint and is constructed of regularly coursed sandstone blocks matching those on the west elevation. A stone 'buttress' has been added to the base of the wall and there are quoins above. There is a matching buttress immediately east of the doorway.

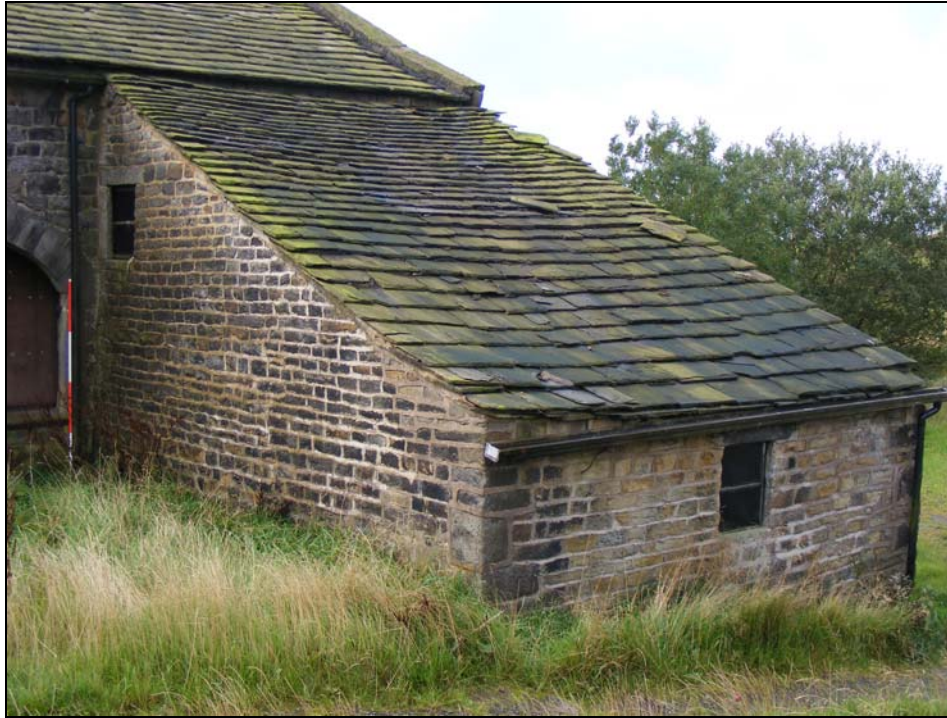
**Plate 27: North and east elevations of northern outrigger**

- 6.5.2 North Elevation (Plate 27). This wall is of regularly coursed partly watershot sandstone re-pointed with cement mortar. It has a single timber framed two lights casement window located centrally.

- 6.5.3 East Elevation (Plate 27). This elevation is of regularly coursed slightly watershot sandstone re-pointed in cement. This face clearly abuts the north elevation of the barn where it lies right up against the quoins of the barn door. This seems to indicate that, whilst the door was still capable of use, the close proximity of the outrigger was something of a compromise which would not have been necessary if both buildings had been constructed as part of the same overall scheme. High in the southern end is a single square timber framed window with a sandstone southern jamb and lintel.

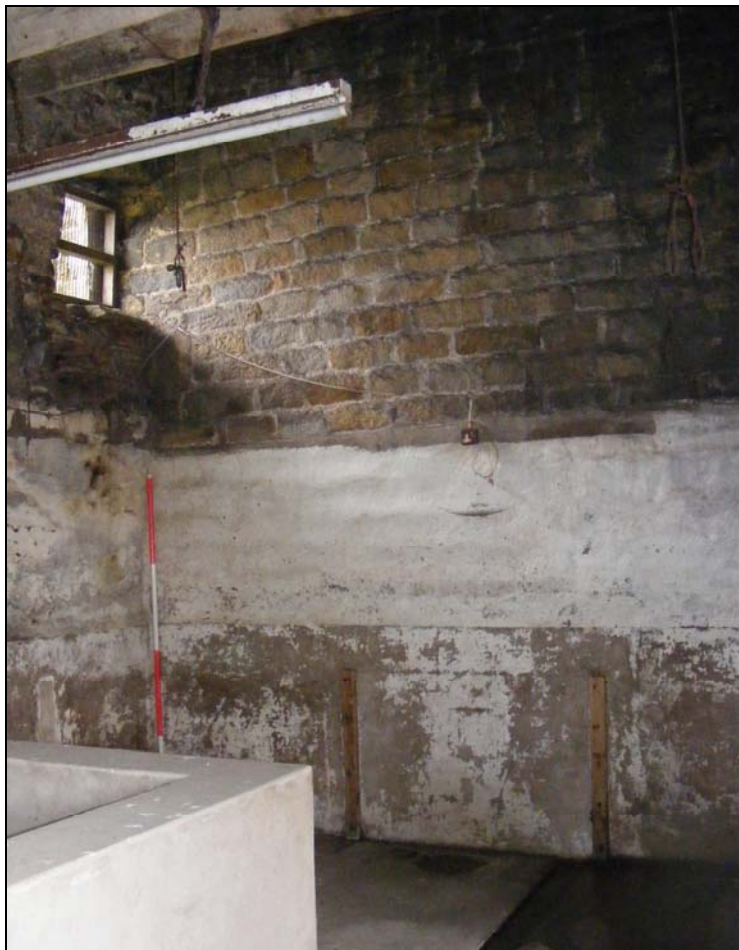
**Plate 28: Interior of northern outrigger**

- 6.5.4 Internal (Plate 28). This comprises a single space the southern wall of which is the northern elevation of the barn. It has a concrete floor and the ceiling is open to the underside of the timber rafters of the single pitch roof which has a stone slab covering. The walls are rough rubble with random coursing, with the exception of the south wall. All of the walls, including the south are rendered in concrete up to a level of 1.15m, with the stonework whitewashed above this, to a level of 2.87m. A low 'L' shaped concrete wall runs from the east wall and turns north, to form a pen. A drainage channel runs from the south wall towards the north and along the west side of this low wall. The only entrance to this building is from the personnel door in the north end of the west wall. There are three windows in this room. A timber framed casement window is located at the south end of the west wall. This contains a single fixed light and has concrete rendered surround and cill. Another timber framed casement window with cement rendered surround and cill is located centrally in the north wall. Finally, a timber framed window with two lights is located high in the southern end of the east wall.

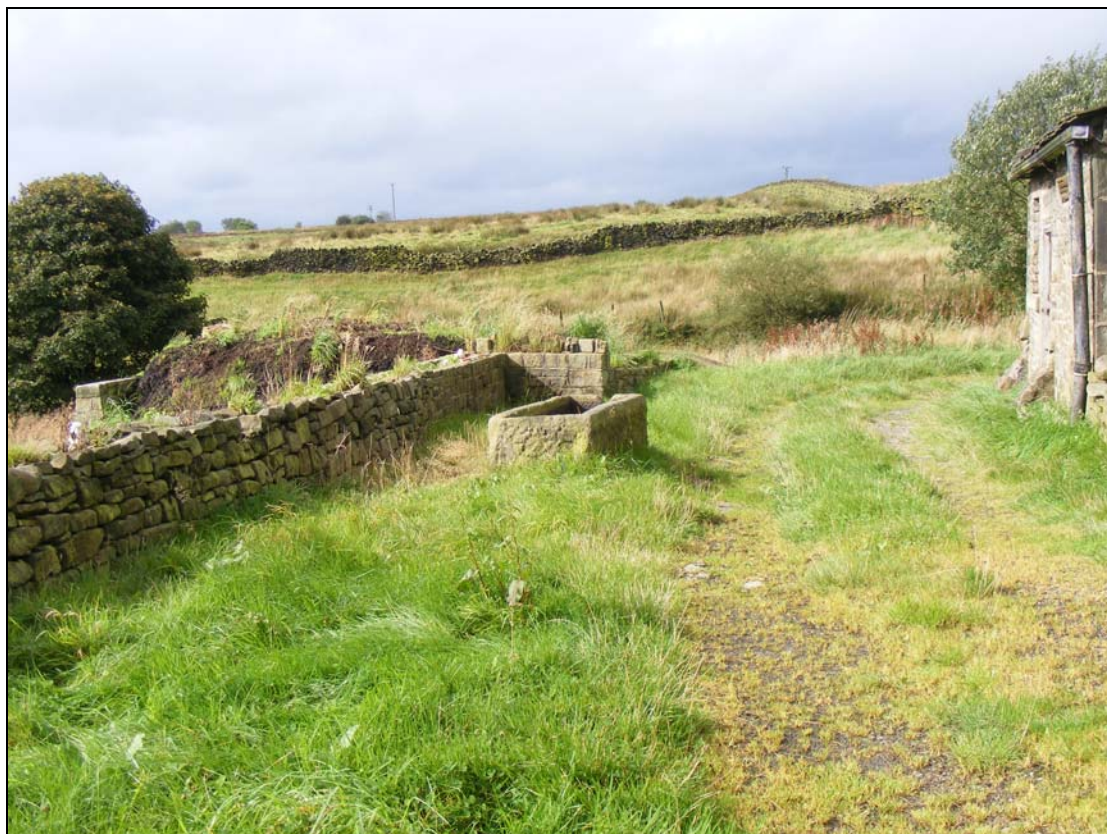
**Plate 29: Water trough and wall of midden**

- 6.6.1 In front of the buildings is a midden area with a stone built surround and a stone

trough (**Plate 29**).
