NON-TECHNICAL SUMMARY

An archaeological building survey was required as a condition of planning permission for the redevelopment of Britannia Mill, Mill Street, Haslingden (NGR SD 7853 2404). The work was carried out on behalf of Mr Dale Winfield by J. M. Trippier Archaeological and Surveying Consultancy. The mill was found to have been built in the 1850s and comprised a cotton weaving shed with a 3-storey preparation and warehouse block, which was extended in the early 20th century, and a power plant comprising an engine house, boiler house and square stone built chimney. Although latterly used for the shoe trade the mill remains a good example of the weaving mills that were being built at the height of the cotton trade expansion in the mid-19th century and is an evocative reminder of Haslingden's industrial past.

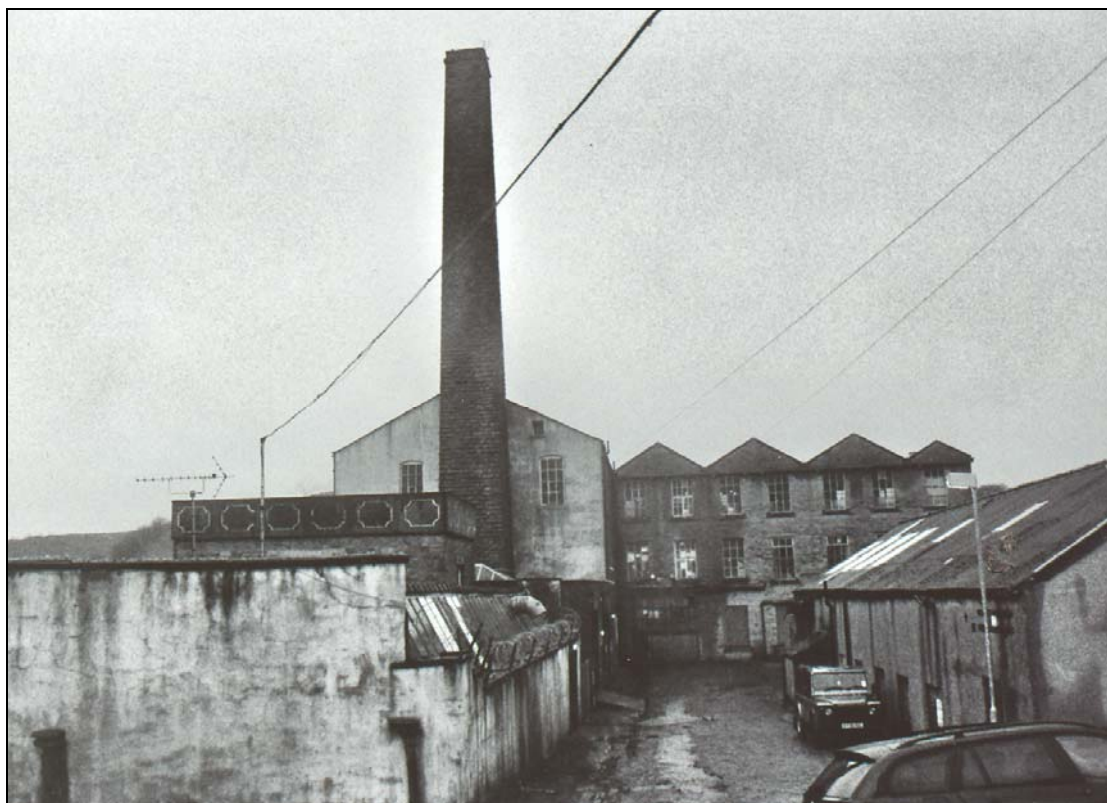
Plate 1

- 6.1.1 Britannia mill (**Front cover and Plates 1 and 29**) comprises a three storey rectangular stone built building with a chimney, engine and boiler house located against the east elevation and a single storey north-light weaving shed to the south and east of these buildings. The original three storey building was subsequently extended to the north by the addition of a three storey stone building aligned north-south creating an 'L' shaped plan with a total footprint of approx.1125 sq.m. including the boiler and engine house. The original three storey building has a double pitch roof aligned east-west and covered in Welsh slates whilst the extension carries four small double pitch roofs also aligned east-west also covered in Welsh slates. The original boiler house and part of the engine room have been rebuilt and extended in machine made brick forming a single storey structure joining the main building and the weaving shed and totally enclosing the chimney. The single storey weaving shed is enclosed by a 3m high perimeter wall and has a footprint of approx. 2665sq.m.including a rectangular two-storey office building located in the south-east corner of the weaving shed.

- 6.2.4 East Elevation (Plates 1 & 5) The east elevation of the original mill building is constructed of sandstone rubble smooth rendered with cement. The remains of a gable with a double pitched roofline are visible to the south of the chimney (Plate 5). This possibly indicates the position and style of the original boiler house running alongside the southern side of the chimney. Four windows are visible in this elevation; two tall arched windows at first floor level constructed as those in the north elevation; a large rectangular window just below the apex and fitted with a timber frame containing nine fixed lights; and a small rectangular window with a timber frame and two fixed lights just below the northern verge (Plate 1). A personnel doorway fitted with a timber frame and door has been inserted between the two arched windows and provides access from the first floor of the mill building to the flat roof behind the chimney.

- 6.6.1 General Description. A square chimney constructed of regularly coursed sandstone blocks and tapering to a height of approx. 30m rises immediately east of the east elevation of the original three storey building (**Plate 1**). Immediately east of this is a single storey flat roofed brick building (**Plate 20**), which also wraps around the chimney to the north and south as well as filling the small gap between the chimney and the east elevation of the original three storey building. This building is used as a boiler house and probably replaces and earlier one on the same site. There is a raised skylight on the flat roof that now looks down into the boilerhouse. The east wall of this brick building slightly overlaps and butts up against a taller mainly stone built building which lies immediately to the east and is topped with a steel tank (**Plate 21**). This building has now been converted to an electricity sub-station but was probably originally the engine house.

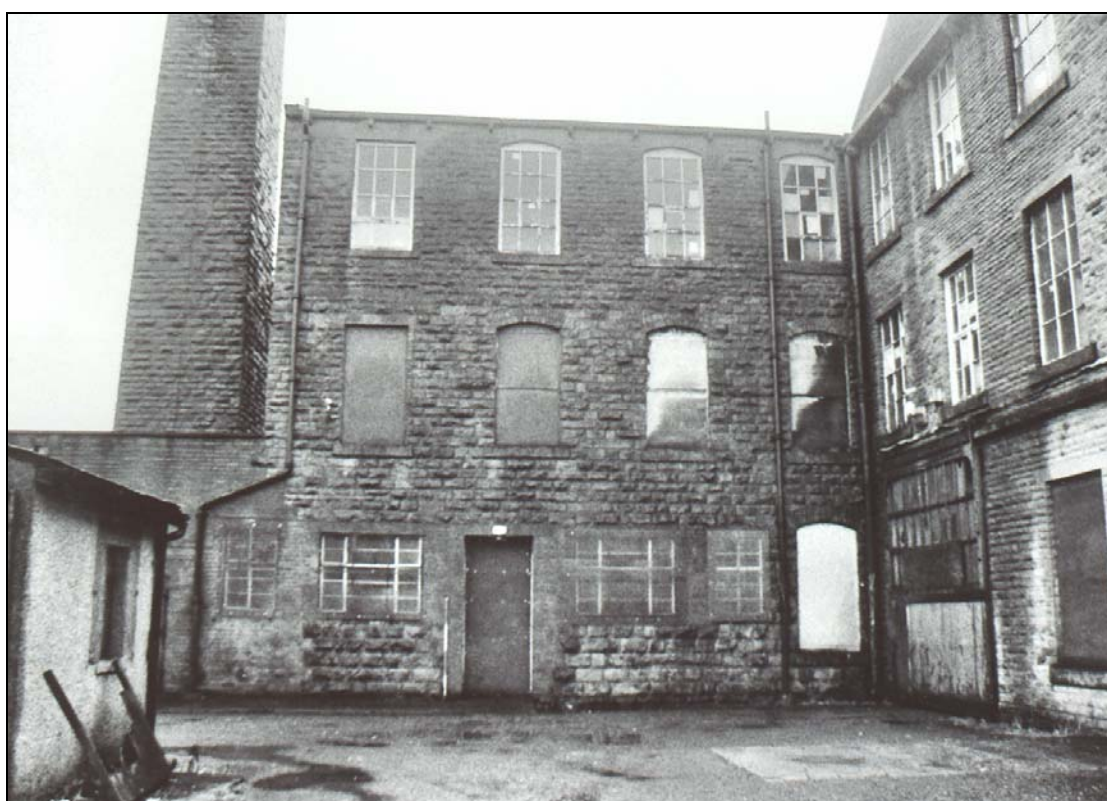
Plate 2

- 6.2.1 North Elevation (Plate 2). The north elevation of the original building is constructed of pitch (or rock) faced yellow sandstone blocks varying in size from 400mm x 260mm to 300mm x 200mm laid in regular courses and bonded with lime mortar. The western part of this elevation is now concealed by the northern extension which butts up against it. The ground floor of the visible eastern portion has a large infill of machine-made brick apparently inserted at the same time as the boiler/engine house rebuild which enclosed the chimney (see para 6.1.1 above). Fenestration consists of a row of four tall windows (2m high x 1.3m wide) on each of the upper floors and four windows of varying size on the ground floor. The three westernmost windows on the first and second floors have segmental arched heads comprising two rows of stone headers, adjoining stone jambs and sandstone sills. The easternmost ones have horizontal sandstone lintels. The frames are constructed of timber and contain twelve fixed lights but the first floor windows are boarded over with timber sheets. The ground floor windows have largely been rebuilt with machine made brick with only the most westerly one retaining the form of the upper windows; this has been blocked with a steel sheet. The three remaining windows have concrete lintels, adjoining brick jambs and timber sills. The frames are constructed of timber; the two easternmost each have fifteen fixed lights and the westernmost one has ten. A timber framed personnel door has been constructed in the brickwork between the two easternmost windows.

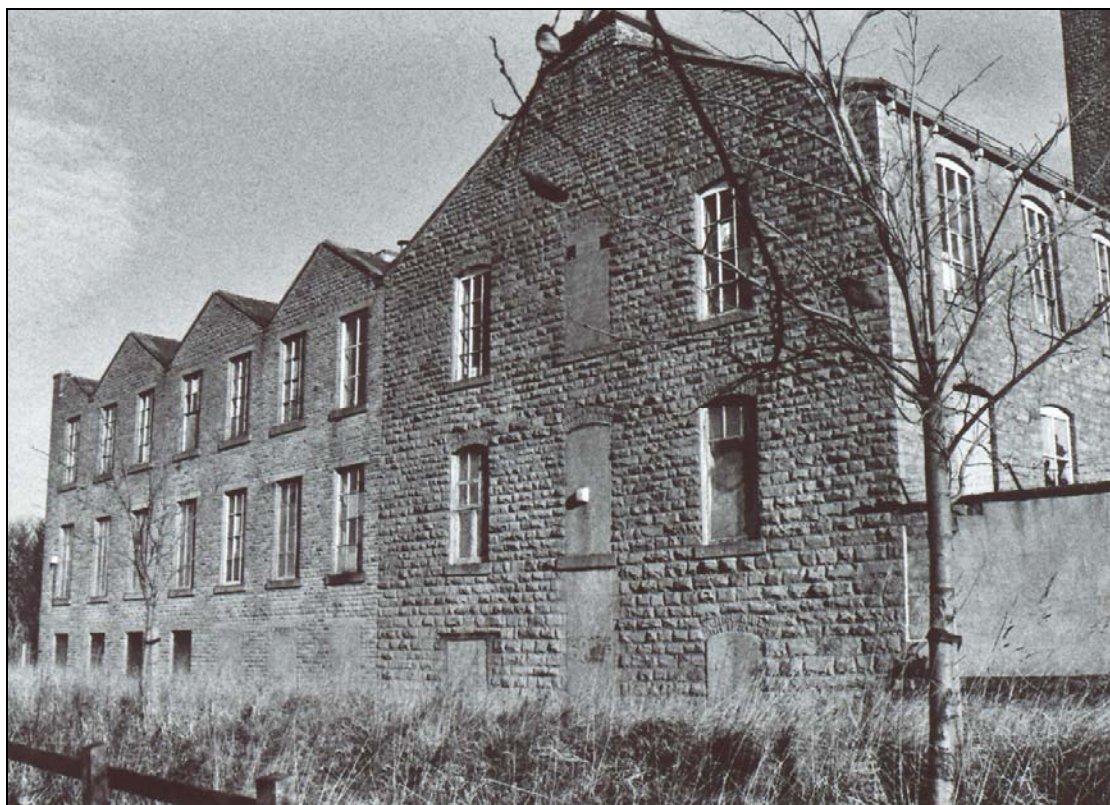
Plate 3

- 6.2.2 West Elevation (Plate 3). This elevation comprises the gable end of the original three storey building and is constructed of pitch (or rock) faced yellow sandstone blocks varying in size from 230mm square to 660mm x 25mm, regularly coursed and bonded with cement mortar. Fenestration comprises a row of three tall windows (2m high x 1.3m wide) on the two upper floors. All have stone segmental arched heads, adjoining stone jambs and sandstone slab sills. The central windows have been blocked with brick, cemented over and fitted with ceramic air vents. All remaining windows are fitted with timber frames containing twelve fixed lights. The northernmost ground floor window has a steel or wrought iron lintel, cement jambs and a stone cill. The southernmost one is as those on the upper floors. Both have been blocked with brick and cemented over as has the central aperture on this floor. However sandstone quoins are visible around the latter and appear to form the jambs to a now blocked doorway. The roofline consists of a large gable with stone covered verges. Athwart the apex is a 1m high rectangular stone tower with a stone coping and an iron strap around the base. This was the tower for an internal lift shaft.

6.4.3 **West Elevation (Plate 3).** This elevation of the two storey extension is a northern continuation of the gable end of the original three storey building. It is constructed of machine-cut rusticated yellow sandstone blocks with an average size of 400mm x 100mm laid in regular courses and bonded with cement mortar. Fenestration consists of a row of seven tall windows on each of the three floors. They are all of identical construction with fine-particled sandstone slab lintels and sills with adjoining stone jambs. All windows are fitted with a timber frame containing twelve fixed lights apart from the most southerly one on the second floor which has six lights. The ground floor windows have all been blocked with brick or timber sheet and are partly covered by a rise in ground level. The roofline consists of four gables the northern one being narrower than the others. The stone chimney mentioned at para. 6.4.2 above is also visible at the extreme north of the elevation.

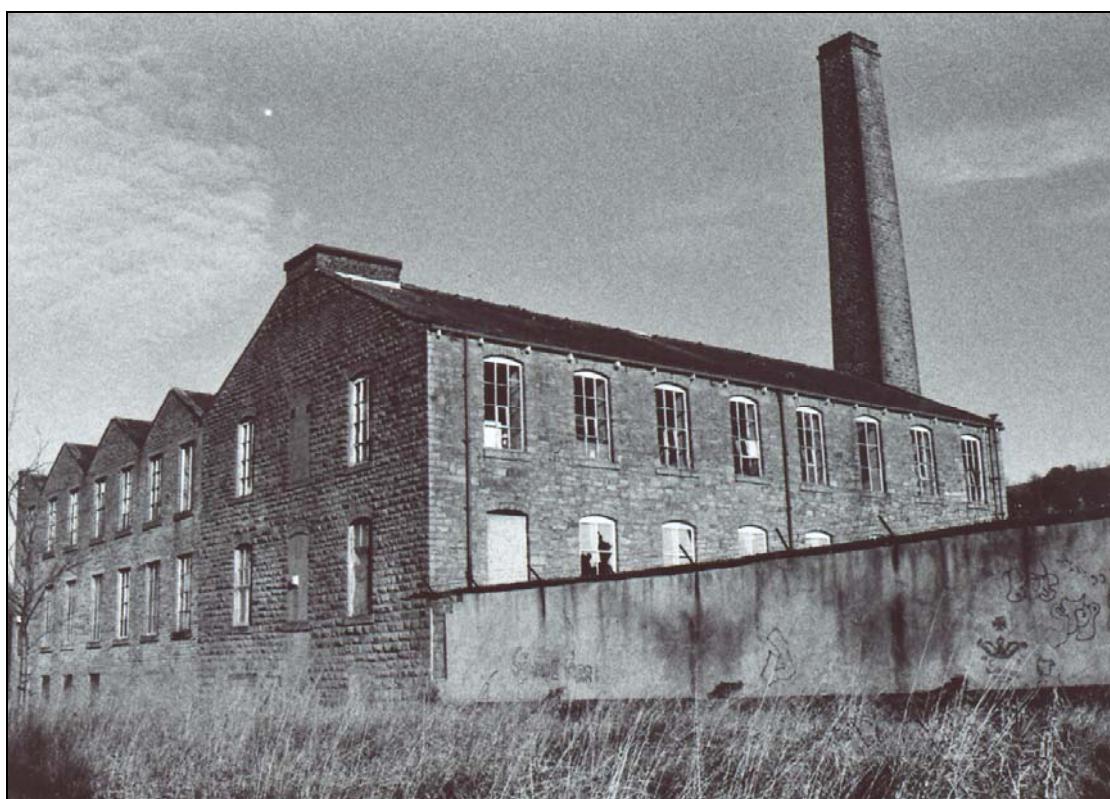
Plate 4

- 6.2.3 South Elevation (Plate 4). The ground floor of the south elevation of the building is obscured by the adjoining weaving shed and is only visible at first floor level and above. It is constructed in random sandstone rubble with a rows of eight windows tall windows (2m high x 1.3m wide) on each of the on each of the first and second floors. The windows have segmental arched heads comprising two rows of stone headers, adjoining stone jambs and sandstone sills. The frames are constructed of timber and contain twelve fixed lights on

6.7.3 West Elevation (**Plate 4**). This elevation consists of a blank perimeter wall of the weaving shed which is constructed of cement rendered random sandstone rubble. It is topped with a parapet and stone coping which protects the western end of the north light roof.

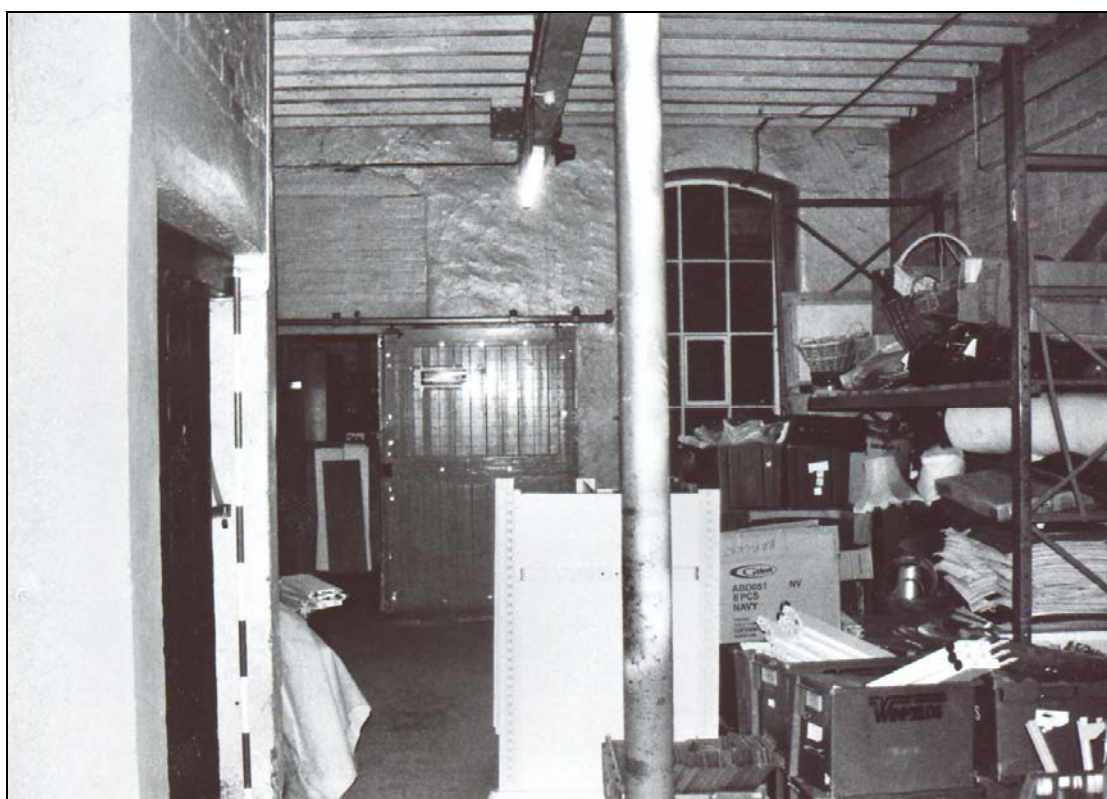
Plate 6

- 6.3.1 Ground floor (Plate 6). This originally comprised a rectangular area (approximately 25m x 12.5m) with the longer axis running east-west. The walls are constructed of painted random sandstone rubble. The floor of the mill consists of smooth concrete and the ceiling (3.8m high) is constructed of timber planks carried on east–west orientated joists supported by five large timber beams running north-south. These are let into the north and south external walls and are also supported by a row of cast iron columns. Along the line of these columns is a brick wall running east-west and then returning north. The area to the north of the wall has been subdivided to form ladies and gents toilets with another inaccessible room to the west of the latter. An L-shaped storage area remains to the south and west of the brick wall. In the south–east corner is a stairwell enclosing a concrete stairway that leads to the upper floors of the building. The east wall north of the stairwell has been broken through to give access to an area immediately west of the chimney stack which is incorporated into the ladies toilets mentioned above. An RSJ now supports the floor above. There is a brick-built lift shaft on the west wall of this floor (Plate 6). The only external access to this building is via a single personnel door on the north elevation (Para. 6.2.1 above) which leads into a passageway between the ladies and gents toilets. There are two doorways in the north wall of the weaving shed which also provide access to the building. On the north wall a doorway fitted with a timber sliding door has been inserted into an existing window and provides access to the three-storey extension (see Section 6.4 below). A window located to the east of the door looks out into the extension (Plate 6).

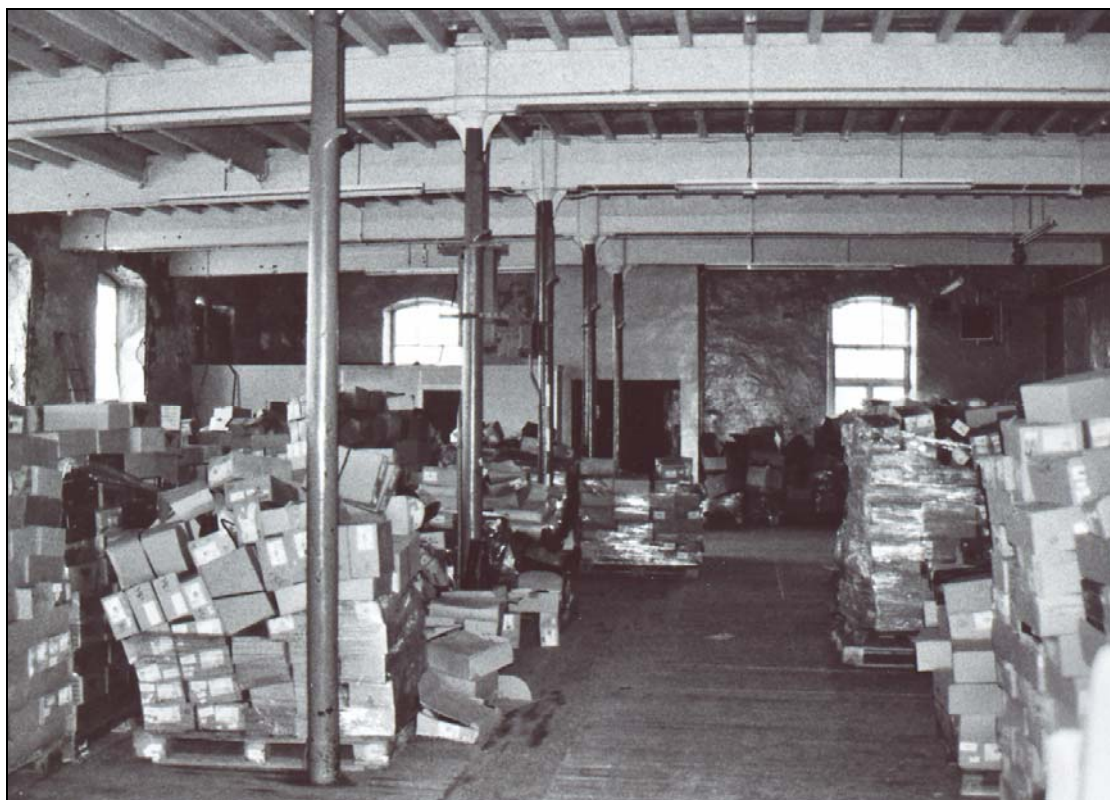
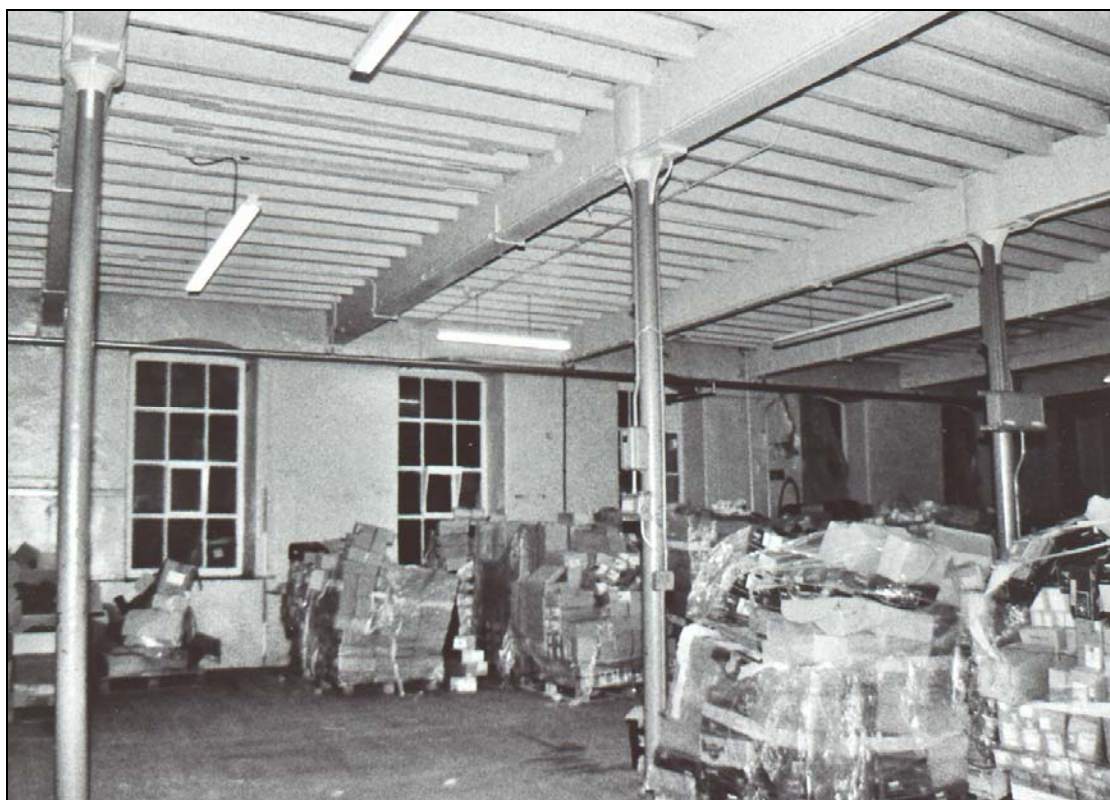
Plate 7

- 6.3.2 First Floor (Plates 7 & 8). This area is accessed via the enclosed staircase located at the southern end of the east wall and described above. All walls are constructed of painted sandstone rubble. The floor consists of flush timber planking. The ceiling (4m high) is constructed of timber planks carried on east–west orientated joists supported by seven large timber beams running

north-south. These are let into the north and south external walls and are also supported by a row of centrally located cast iron columns (2.92m spacing). Above the capitals of the latter are straps surrounding the beams and transferring the weight of the upper floors directly to ground level via the columns themselves without placing any additional load on the beams. The lift shaft mentioned on the ground floor is centrally located against the west wall with a window either side. The southern window is obscured by a timber partition office in the south-west corner. A small window is located to the extreme north. Seven windows are located in the south wall, two of which are obscured by the timber office. A timber fire door is located at the eastern end of the wall. The north wall now has seven windows, three of which now look into the extension to the north (**Plate 8**). An eighth (the most westerly) has been converted into a doorway providing access to the extension. The windows in the south wall have heavily chamfered stone cills, stone jambs and lintels. The others all have horizontal cills. A timber frame fitted with a timber personnel door in the east wall north of the stairwell allows access to the flat roof of the boiler house.

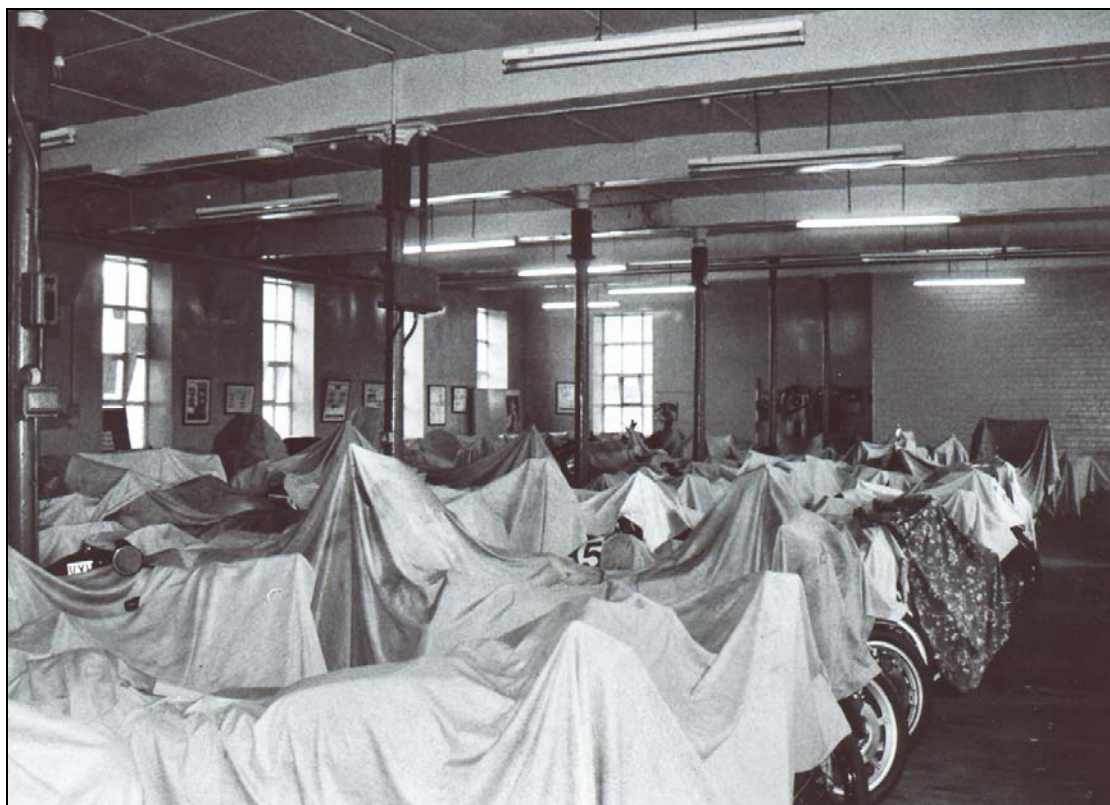
Plate 9

- 6.3.3 Second Floor (**Plate 9**). This floor is also accessed from the enclosed stairway in the south-east corner of the building. It is now in use as a store for a collection of motorcycles. The floor is boarded as for the floor below (see para.6.3.2). The west end of the original north wall has been removed creating an opening 8.3m wide and 2.8m high which leads through to the first floor of the extension to the north (**Plate 10**). A large RSJ supported by two cast iron columns has been inserted above the large opening at the juncture of the original building and the extension. To the west of the opening part of the original north wall remains for 2m exhibiting a single blocked tall window. Four windows remain in the north wall to the east of the opening. The layout and design of the windows in the west, south and east walls mirrors that on the first floor (see para.6.3.2 above). The ceiling (3.74m high), walls and window surrounds are all plaster-boarded. A row of cast iron columns runs east-west and supports seven timber beams which comprise the tie beams for the roof trusses described at para.6.3.4 below. The beams are also encased in plasterboard (**Plate 11**). Two hatches provide access to a loft area. One hatch is located to the south of the lift shaft with an iron ladder affixed to the wall allowing access to the attic; the other is centrally located to the north of the columns.

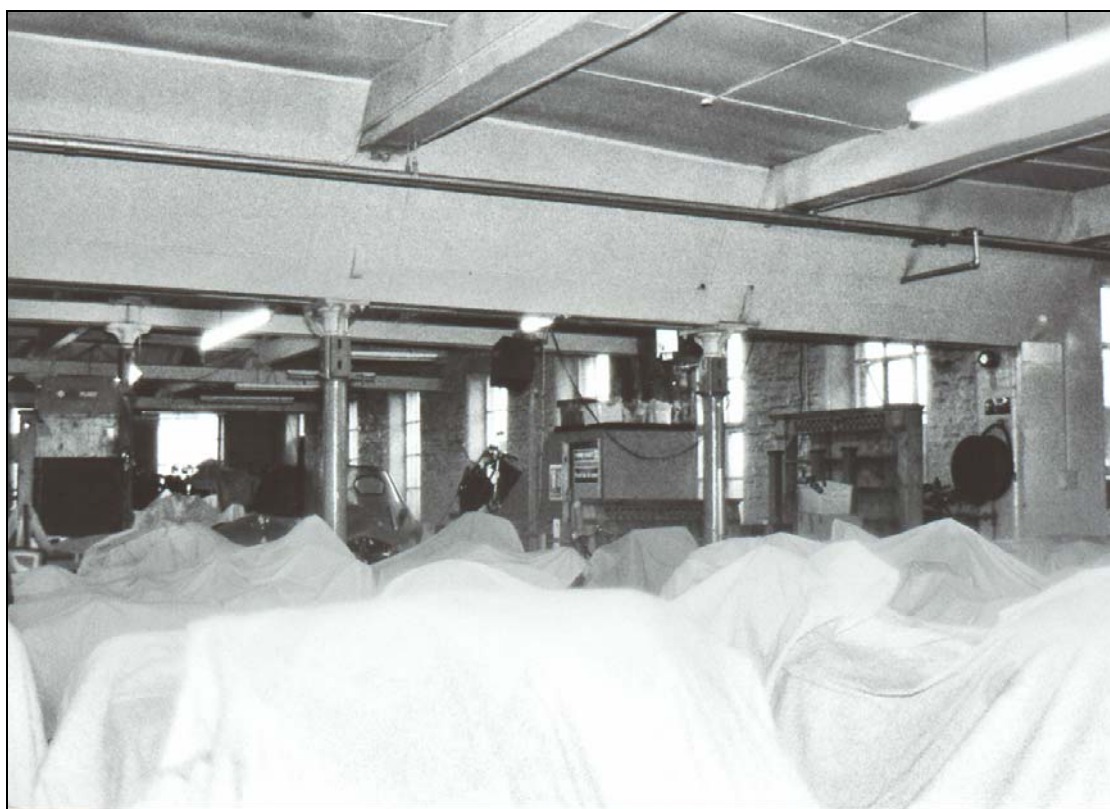
Plate 10

- 6.5.5 Second Floor (Plates 10 & 18). The layout and construction of the floor, walls and windows are as on the first floor (see para. 6.5.4 above). The south wall has been largely removed, as described in para 6.3.3 above, apart from the stonework above the RSJ where the tops and lintels of three windows are visible (**Plate 18**). The ceiling is open to the roof which consists of four double pitches running east-west; each one carried upon three 'king post' trusses (**Plate 19**). The most northerly of the three roofs is narrower than the others and the trusses commensurately smaller. The trusses are supported by three north-south orientated timber wall plates located under the valleys of the roofs and each supported by three cast iron columns spaced 6.4m apart, the most northerly located 3.5m from the north wall. The capitals have saddles matching those on the other floors but there are no straps. Both apertures for the hoist and conveyor on this floor are protected by 1m high timber fencing.

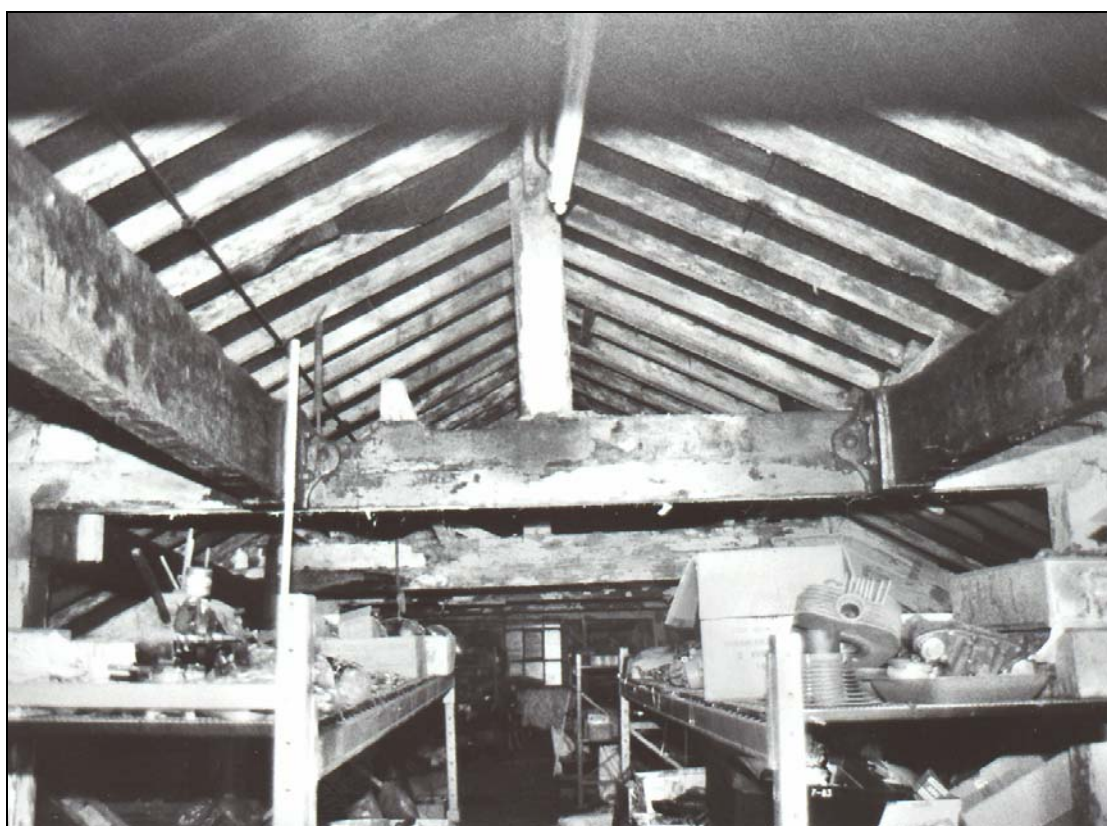
Plate 12

- 6.3.4 Attic and Roof Timbers(**Plate 12**). The attic has a floor consisting of timber planking and is open allowing inspection of the roof timbers. The double pitch roof is orientated east-west and is carried by seven 'queen post' trusses the tie beams of which are visible in the room below (see para. 6.3.4 above). The underside of the roof is open to the slates. A rectangular window is located below the apex in the east wall (see para.6.2.4 above).

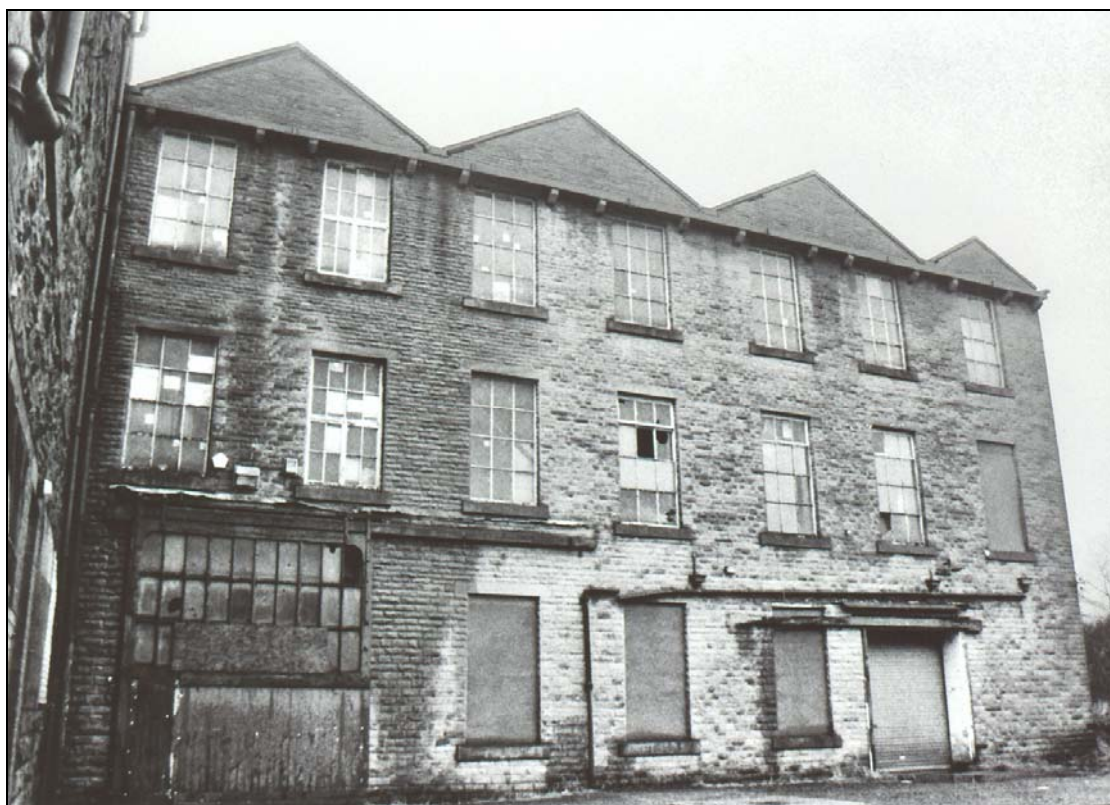
Plate 13

- 6.4.1 East Elevation (**Plate 13**). The east elevation of the extension is constructed of

machine-cut rusticated yellow sandstone blocks with an average size of 380mm x 140mm laid in regular courses and bonded with cement mortar.

Fenestration consists of a row of seven windows on each of the first and second floors and three centrally located on the ground floor. All windows are of the same construction with fine-particled sandstone slab lintels and cills with adjoining stone jambs and most are fitted with timber frames containing twelve fixed lights. The second south windows on the second and first floors are sixteen light sashes. The fourth, fifth and sixth from the south on the first floor have three opening top hung lights. The northernmost on the second floor and all three on the ground floor are boarded with plywood. Two large goods doorways are located at the north and south ends of the elevation, both with RSJ lintels. The southern one has adjoining stone jambs; those of the northern one are steel lined. The southern doorway is fitted with a large timber external sliding door and the northern doorway is fitted with a metal roller shutter door. Above the upper row of windows is a row of stone corbels upon which rests a timber box gutter running the length of the elevation. The roofline consists of four small gables, the most northerly being narrower than the others.

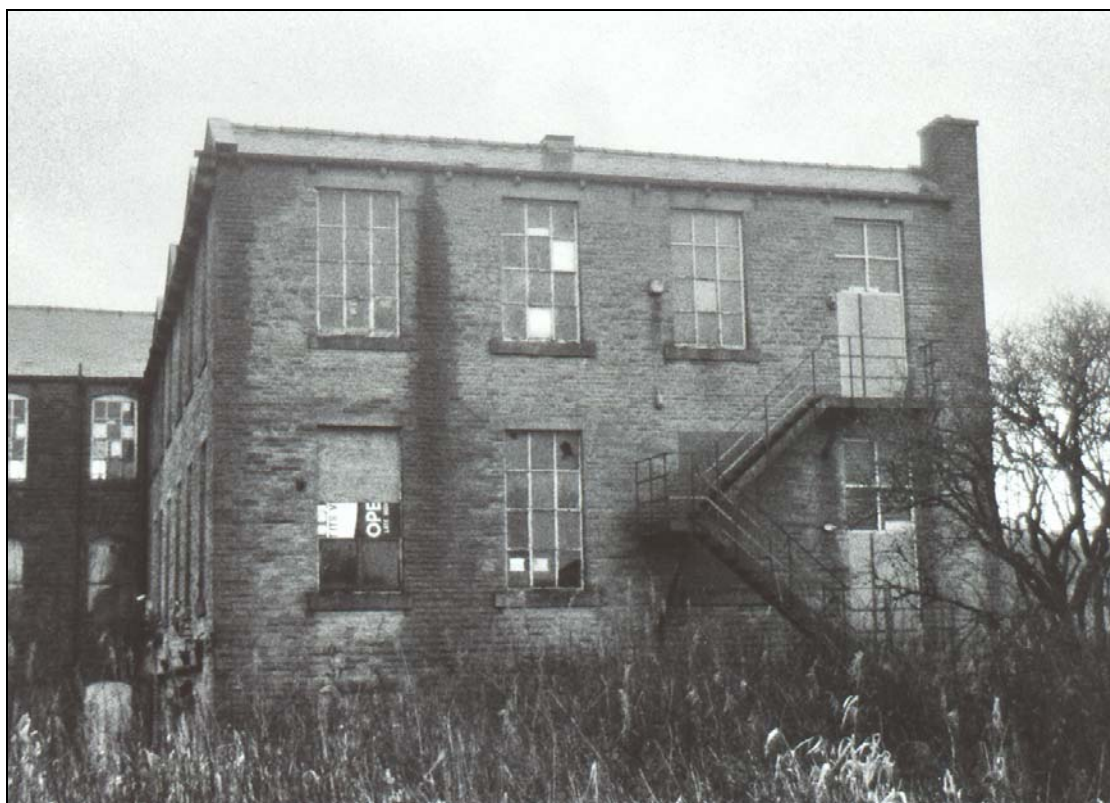
Plate 14:

6.4.2 **North Elevation (Plate 14).** The north elevation of the extension is constructed of machine-cut rusticated yellow sandstone blocks with an average size of 380mm x 150mm laid in regular courses and bonded with cement mortar. Fenestration consists of a row of four windows on each of the three floors. All windows (2.4m high x 1.4m wide) are constructed with fine-particled sandstone lintels and cills and adjoining stone jambs. The three easternmost windows at second floor level are fitted with timber frames containing twelve fixed lights. The westernmost ones at second and first floor levels have been converted to fire escape doors with four fixed lights in a timber frame above. The adjoining window at first floor level has been blocked with modern brick. The one to the east of that had been partially boarded over with two lights visible at the base whilst the easternmost one still holds twelve timber framed fixed lights. The ground floor windows have all been blocked up. A wrought iron or steel fire escape ladder links the second and first floors and zigzags to ground level. A modern alarm box is affixed to the wall centrally, at second floor level. At the extreme west of the elevation a small stone chimney is visible above the roofline.

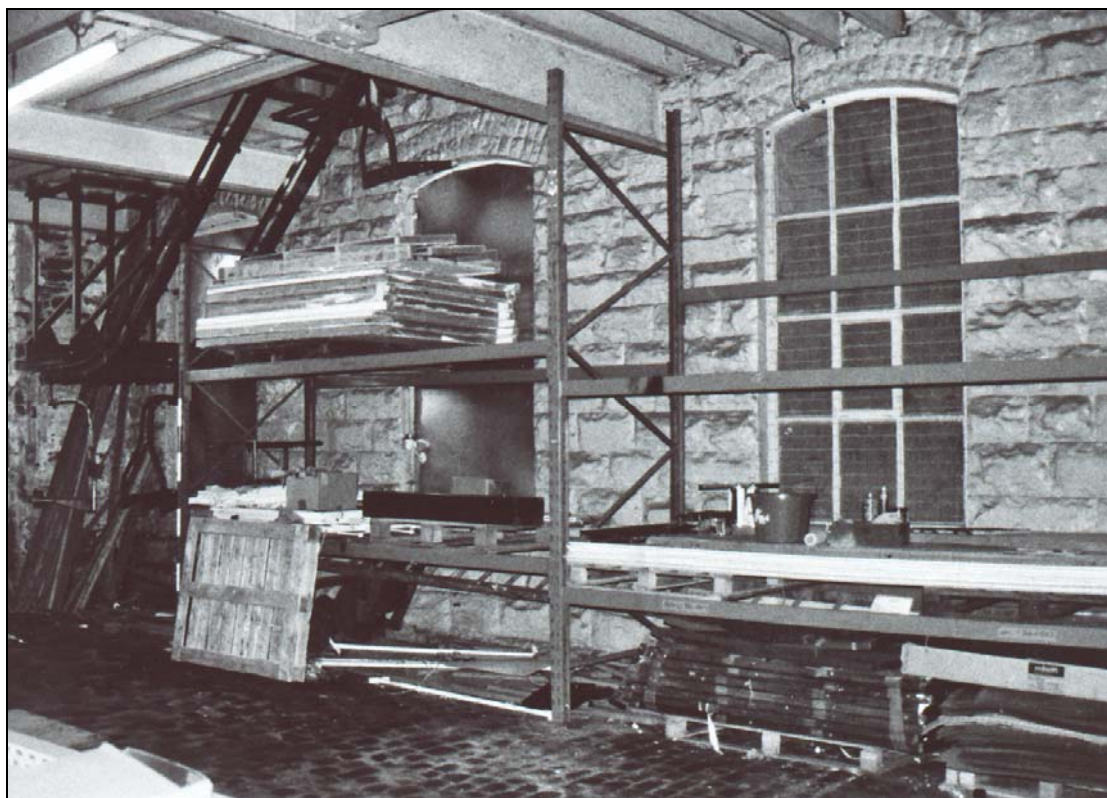
Plate 15

- 6.5.1 Ground Floor (Plates 15 & 16). This originally comprised a rectangular area (approximately 22m long x 12.5m wide) with the longer axis running north-south. The southern wall is the western half of the north elevation of the original three-storey building and is already described at para. 6.2.1 above. All walls are constructed of painted random sandstone rubble. A similar wall of east- west orientation divides the floor area into two sections. A large door located at its west end provides access between the two rooms.

- 6.5.2 The southern area (**Plate 15**) which is accessed from the exterior by the sliding door described in para. 6.4.1 above, is 12.5m long x 8.6m wide and was in use as a garage. Two windows are visible in the south wall, one blocked with aluminium sheet and the other looking into the area described at para.6.3.1 above. The west wall contains three rectangular tall windows (2.14m high x 1.25m wide). All have boarded sills, bull nose brick jambs, sandstone lintels and timber frames containing nine lights. They have been bricked up on the outside (see para. 6.4.3 above). The floor comprises stone setts and flags and the ceiling is constructed of timber planks and joists supported by two east-west orientated RSJs. The northerly RSJ is supported by a large cast iron column with a saddle and strap which transfers the load from the floor above directly thorough the column. Two large apertures located in the ceiling provide access to the upper floors for a conveyor belt (eastern aperture) and a hoist (northern aperture). To the north of the external door a timber partition encloses a timber L-shaped staircase providing access to the floors above (fire escape).

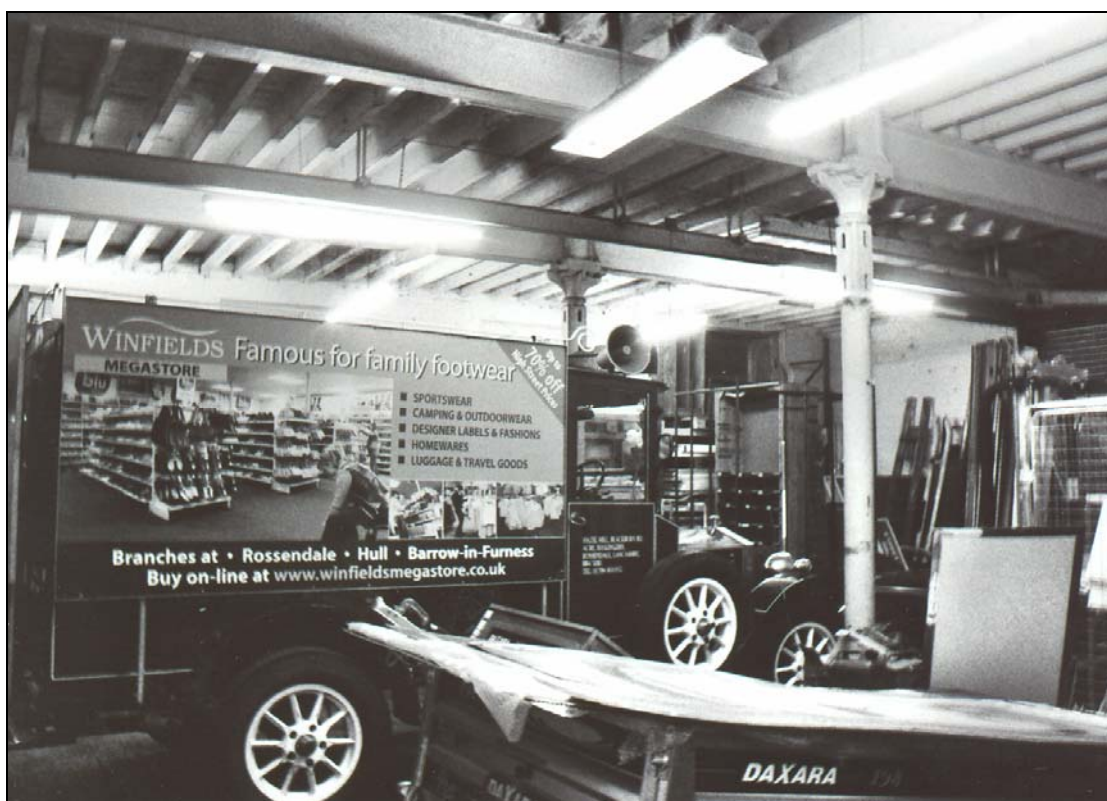
Plate 16

- 6.5.3 The northern area (**Plate 16**) is accessed from the exterior by the centrally located metal roller shutter door in the east wall as described at para. 6.4.1 above. This wall also has two painted windows of the same construction as the windows in west wall of the garage (see para. 6.5.2 above). The north wall has four similarly constructed windows. These are filled with cement blocks or bricks. The west wall has three painted windows of the same construction but blocked on the outside with timber sheets (see para. 6.4.3 above).The south wall contain a doorway at the west end that leads to the garage. There is a stone flagged floor and a timber plank ceiling carried on joists supported by three east-west orientated RSJs in turn supported by three centrally located cast iron columns running north-south. A triangular brick chimney rises from floor to ceiling in the north-west corner of the room

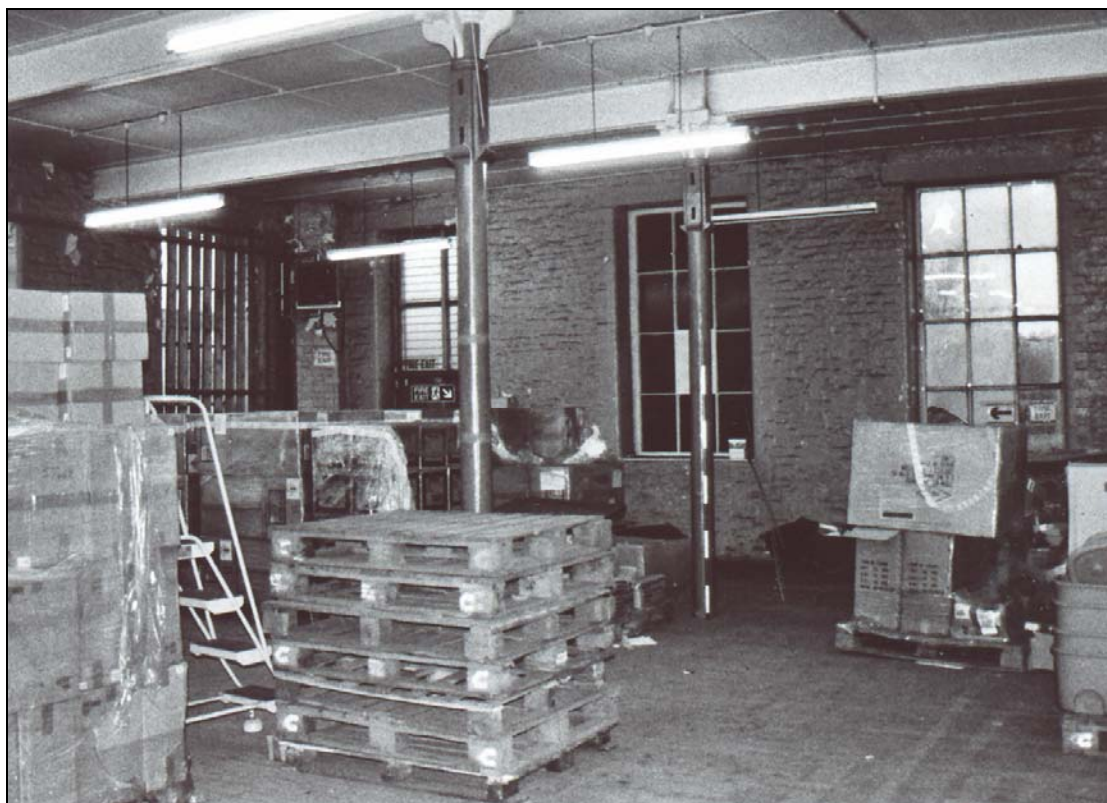
Plate 17

- 6.5.4 First Floor (Plate 17). This area also used for storage. All main walls are constructed of painted random sandstone rubble except for the southern wall which is the western half of the north elevation of the original three-storey building already described at para. 6.2.1 above. There are six windows with

brick jambs sandstone lintels and boarded sills as for those described at paras. 6.5.2 and 6.5.3 above. The most westerly window in the south wall has been converted to a doorway to provide access from the original three-storey building to the extension (see para. 6.3.2 above). The most westerly window in the northern wall has been converted to a fire escape door. There is a timber boarded floor and a boarded ceiling supported by north-south floor joists on east-west steel beams resting on a row of five centrally located cast iron columns (3m spacing) mirroring those on the ground floor. A timber stairway is located against the east wall and provides access to the upper and lower floors. A large aperture (2.7m x 1m) in the floor against the southern end of the east wall provides hoist access between floors and another aperture (2.4m x 1.7m) centrally located against the south wall allows a conveyor from the ground floor to access this floor. Both apertures are protected by 1m high timber fencing. A triangular brick chimney in the north-west corner of the room rises from floor to ceiling

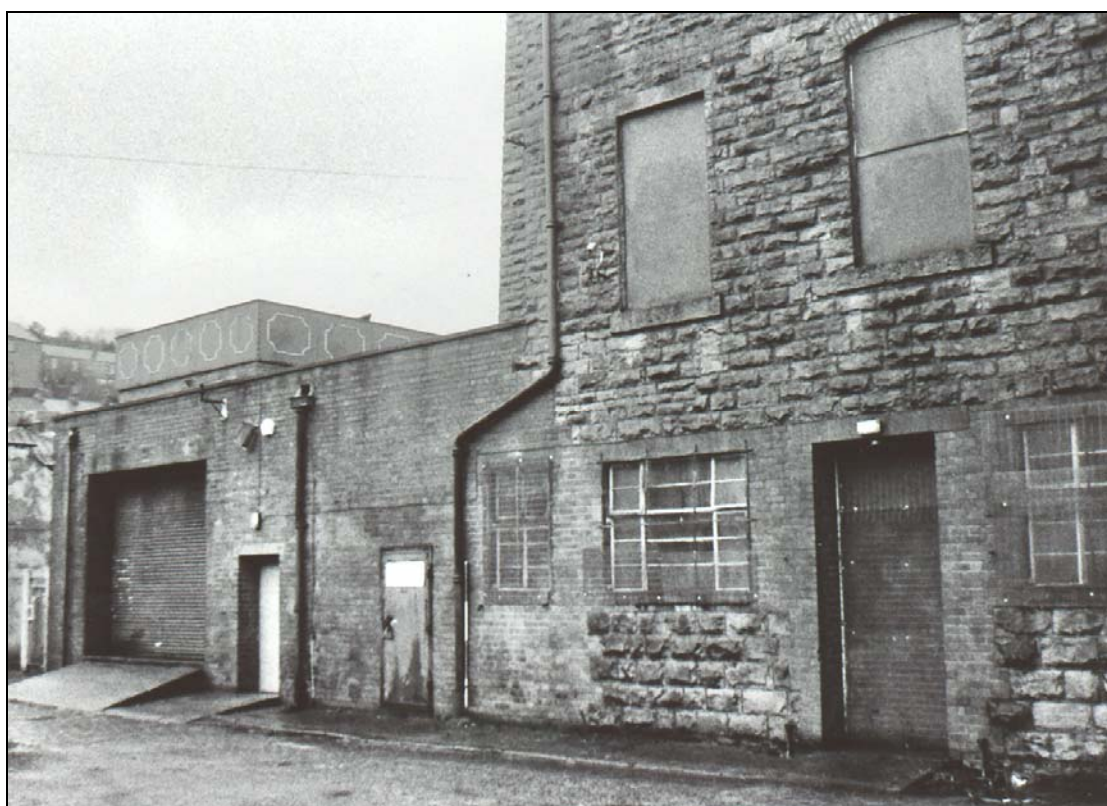
Plate 20

- 6.6.2 Boiler House - North Elevation (Plate 20). This elevation is built in machine made brick substantially keyed in to the north-east corner of the original three

storey building. It is built in English bond of alternate rows of headers and stretchers bonded in cement mortar. The elevation continues upwards as a parapet which protects the flat felt roof and is topped with a stone coping. From west to east the brick frontage contains a single window with a concrete lintel, a modern timber frame and ten lights the upper four of which are top-hung openers. Beyond this is a sealed steel door which may provide access to the chimney base. Continuing east a timber framed personnel door and a large doorway fitted with a steel roller shutter door provide access to the current boiler room.

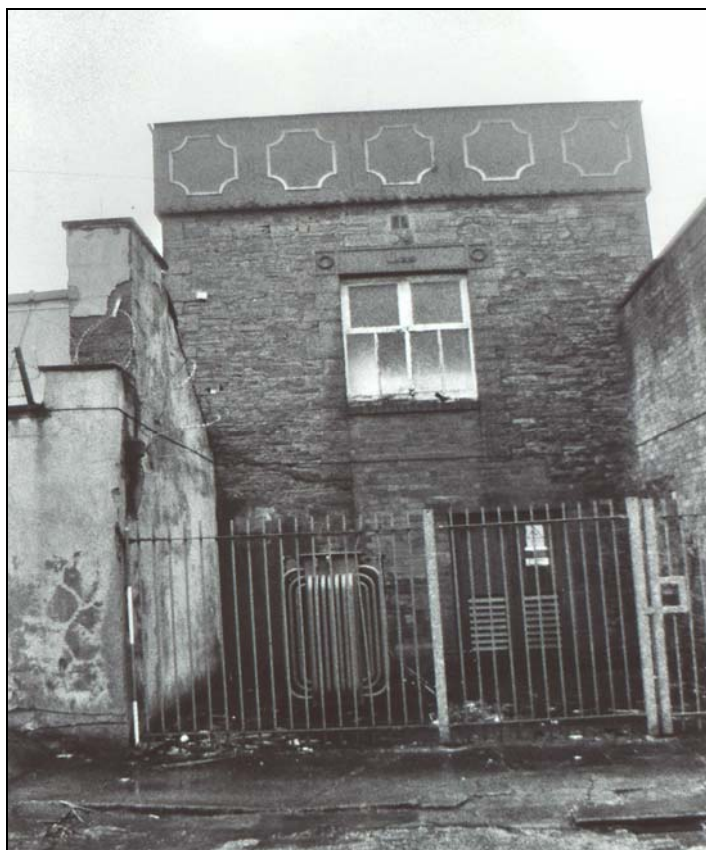
Plate 21

- 6.6.7 Engine House- North Elevation (Plate 21). This is set back approx. 6m. from the north elevation of the brick-built boiler house. It is constructed of random rubble sandstone with dressed sandstone quoins and has been repointed with cement mortar. There is a centrally located tall aperture with sandstone quoins which appears to extend almost to ground level. It now has a wrought iron lintel impressed with the date 1895. Below the lintel is a timber framed window with two opening and four fixed lights. The lower part of the aperture is now infilled with machine-made brick which extend to the east through the line of the quoins to surround a doorway below a concrete lintel. This holds a pair of double timber louvred doors giving access to an electricity substation. The building is topped with a decorated cast iron tank approx. 1m high and covering the area of the roof. This probably provided a reservoir for the internal sprinkler system. A large transformer has been located in front of this building and iron railings flush with the rest of the elevation prevent access.
