NON-TECHNICAL SUMMARY

An archaeological building survey was required as a condition of planning permission for the redevelopment of Britannia Mill, Mill Street, Haslingden (NGR SD 7853 2404). The work was carried out on behalf of Mr Dale Winfield by J. M. Trippier Archaeological and Surveying Consultancy. The mill was found to have been built in the 1850s and comprised a cotton weaving shed with a 3-storey preparation and warehouse block, which was extended in the early 20th century, and a power plant comprising an engine house, boiler house and square stone built chimney. Although latterly used for the shoe trade the mill remains a good example of the weaving mills that were being built at the height of the cotton trade expansion in the mid-19th century and is an evocative reminder of Haslingden's industrial past.

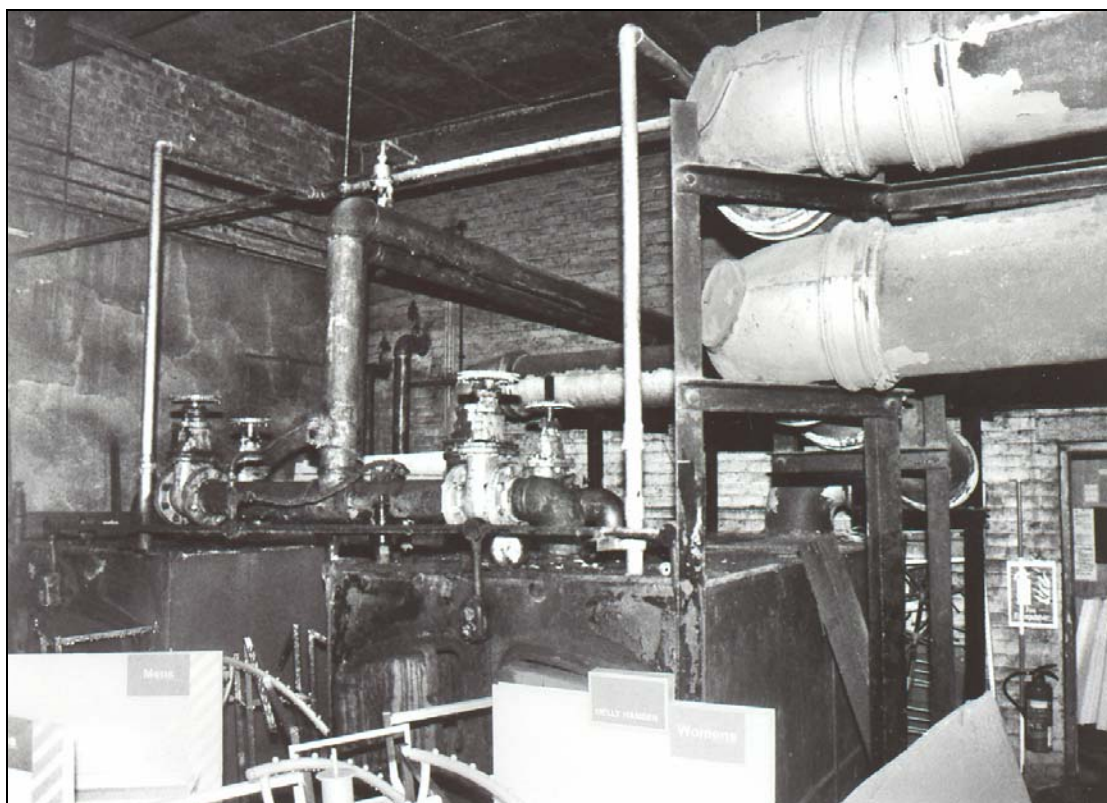
Plate 22

- 6.6.4 Boiler House - South Elevation (**Plates 22 & 23**). This elevation has also been built in machine made brick laid in English bond of alternate rows of headers and stretchers bonded in cement mortar. It now forms the north wall of a passage that separates the boiler house from the weaving shed to the south.

- 6.6.6 Boiler House Interior (**Plate 22**). This area is accessed via the roller shutter and the personnel door in the north elevation. These lead into a rectangular room (10.3m x 8m) constructed of brick in garden-wall bond with four rows of stretchers to one of headers and cement mortared. The east wall is mainly rendered with bare bricks above but the others are painted. There is a concrete floor and ceiling (5.09m high). The ceiling is fitted with a metal framed glazed box skylight. Within the room is a concrete block screen separating the coke store at the eastern end of the room from the area occupied by two redundant Britannia Ideal boilers. The boilers were auto fed by two screw mechanisms located in the coke store. A concrete ramped path located to the west of the boilers leads from the external personnel door through the boiler room to a personnel door located in the south wall. This door provides access to a broad corridor aligned east –west which leads to the former engine house to the east via a large opening, and also leads into an enclosed area approx. 5m x 6.4m to the west to the south of the stone built chimney. At the western end of the corridor a small timber office is attached to the south wall (**Plate 23**). The corridor has a concrete floor and ceiling like those in the boiler house. Two rows of windows, each with eight fixed lights and metal frames mullions and transoms, are located on the south wall of the corridor; the lower row facing into the weaving shed. This is the north wall of the weaving shed which was

originally stone built but has now been brick lined on the south side and is apparently the load bearing wall for the flat concrete and felt roof that now covers the whole area between the east wall of the original three storey building and the east wall of the boiler house. A transmission shaft fitted with pulleys is affixed to this south wall just below ceiling height and runs the length of the corridor into the engine house terminating in a bearing box in the east wall of the latter (see para. 6.6.11 below). Although this appears to be an original piece of transmission gear its current position above the roof of the weaving shed would be impractical for supplying motive power. It may have been re-sited (presumably when the brick lined load bearing south wall was built).

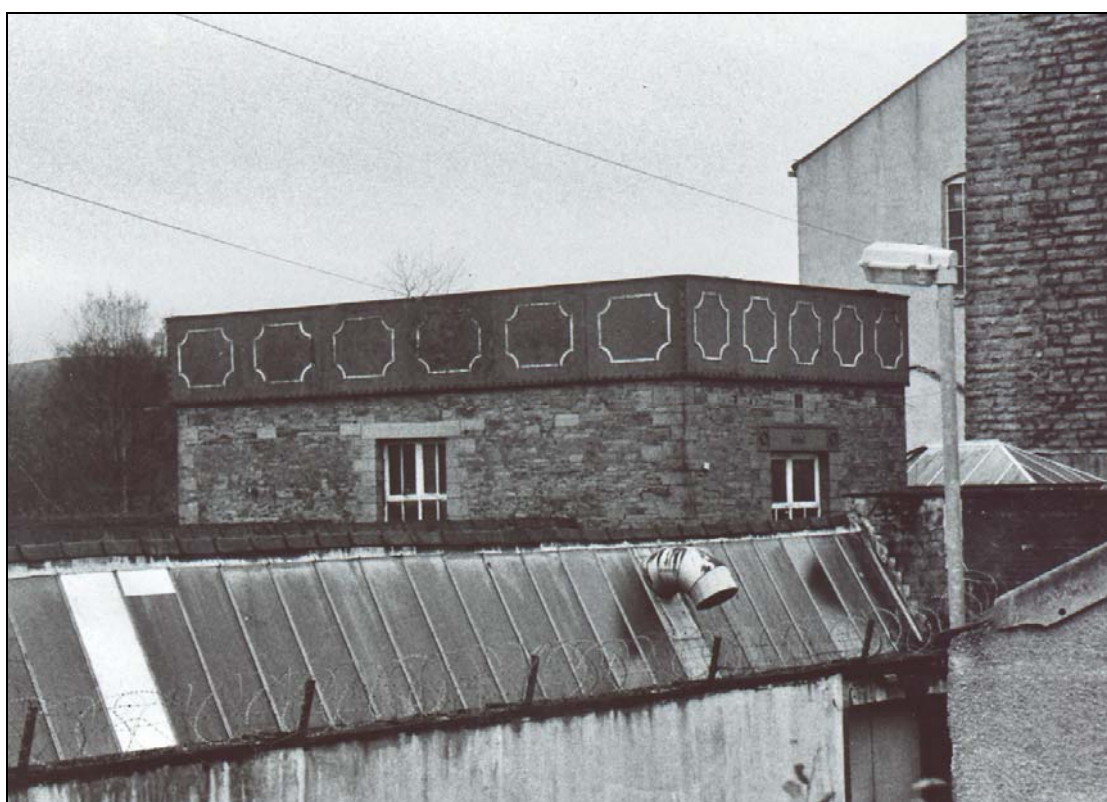
Plate 24

6.7.2 North Elevation (**Plate 24**). This elevation consists of the perimeter wall of the weaving shed which is constructed of cement rendered random sandstone rubble. At the eastern end it steps up slightly in line with the rising ground level. At the western end there is a short return with a parapet and stone coping which protects the end of the north-light roof (**Plate 21**). The return respects the northern wall of the former engine house which it overlaps and abutts. At the western extremity of the north elevation there is a set of steel fronted double doors below a concrete lintel (**Plate 24**).

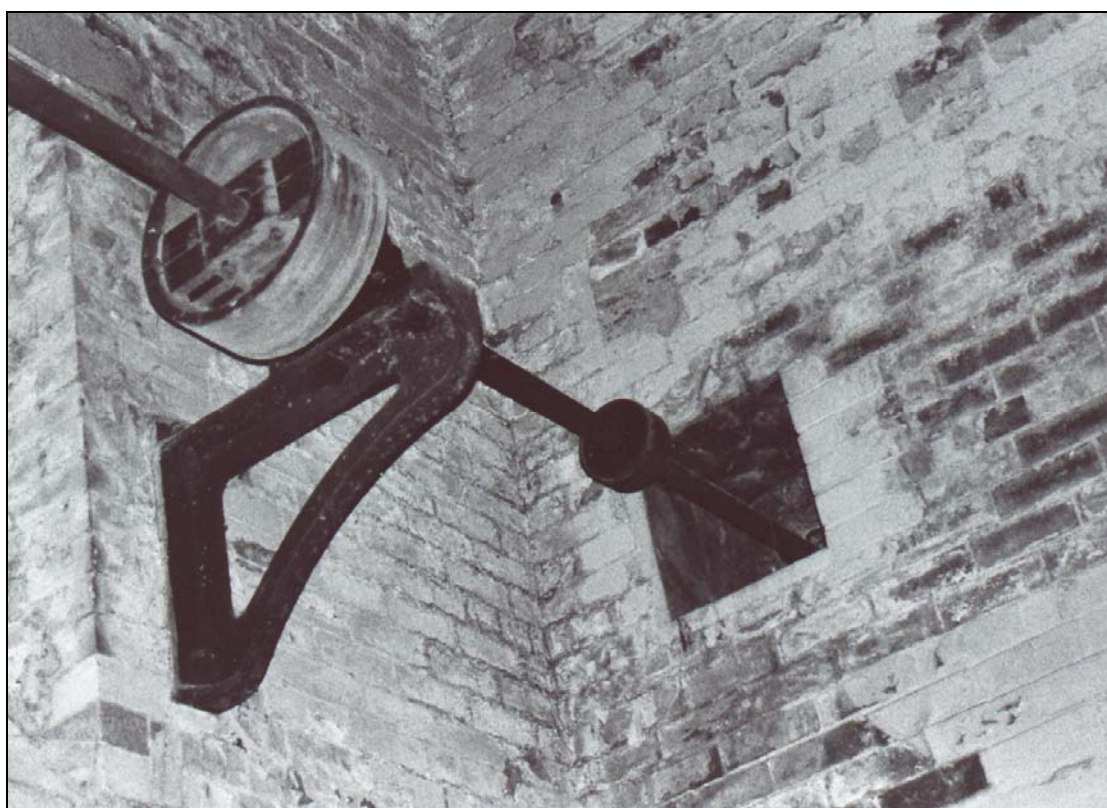
Plate 27

6.7.1 General Description. The weaving shed occupies the major part of the mill's footprint and is located to the south and east of the original three-storey building and the power plant (**Plate 1**). It is a sub-rectangular single storey building comprising a perimeter wall constructed of cement rendered random sandstone rubble surmounted by a north light roof which is aligned east-west. The northern pitches of the roof are glazed and the southern ones are slated externally and plasterboarded internally. The roof is supported by braced timber trusses and cast iron columns and saddles (**Plate 27**).

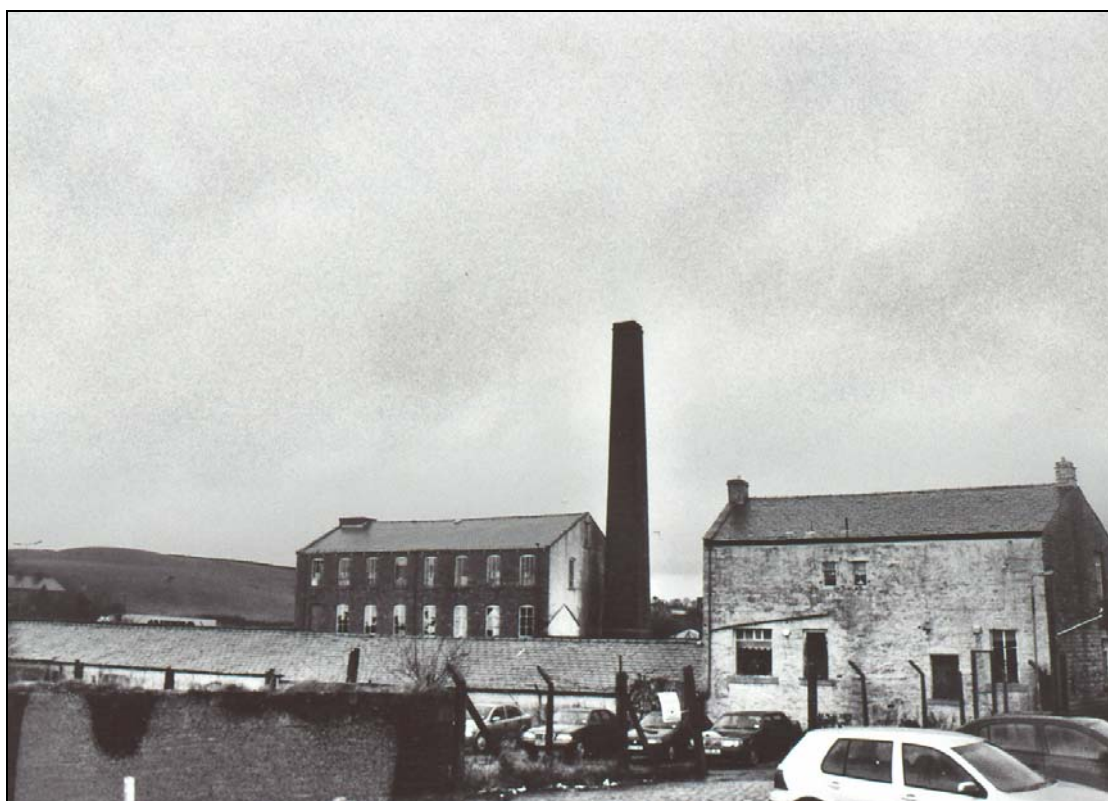
Plate 28

6.7.4 South Elevation (**Plates 28 & 29**). Most of this elevation consists of the perimeter wall of the weaving shed which is constructed of cement rendered random sandstone rubble. A timber personnel door with timber frame (fire exit) is located toward the western end of the wall. Midway along its length the wall is stepped back 1m. At the eastern end of the elevation is a two storey office block (**Plate 28**). It is mainly constructed of whitewashed random sandstone rubble although the east wall is of pitch (rock) faced gritstone. The east-west orientated double pitched roof is covered with Welsh slates. There is a stone built chimney on each gable. On the south elevation there are four windows of varying sizes on the ground floor and two centrally located windows on the first floor. All windows are constructed with stone slab lintels

and sills with adjoining stone jambs. The upper eastern window is fitted with a metal frame; the remainder are fitted with modern timber frames containing from three to six lights. On the west elevation of this building can be seen the shadow of an earlier pitched roof for a building that has been subsumed within the weaving shed.

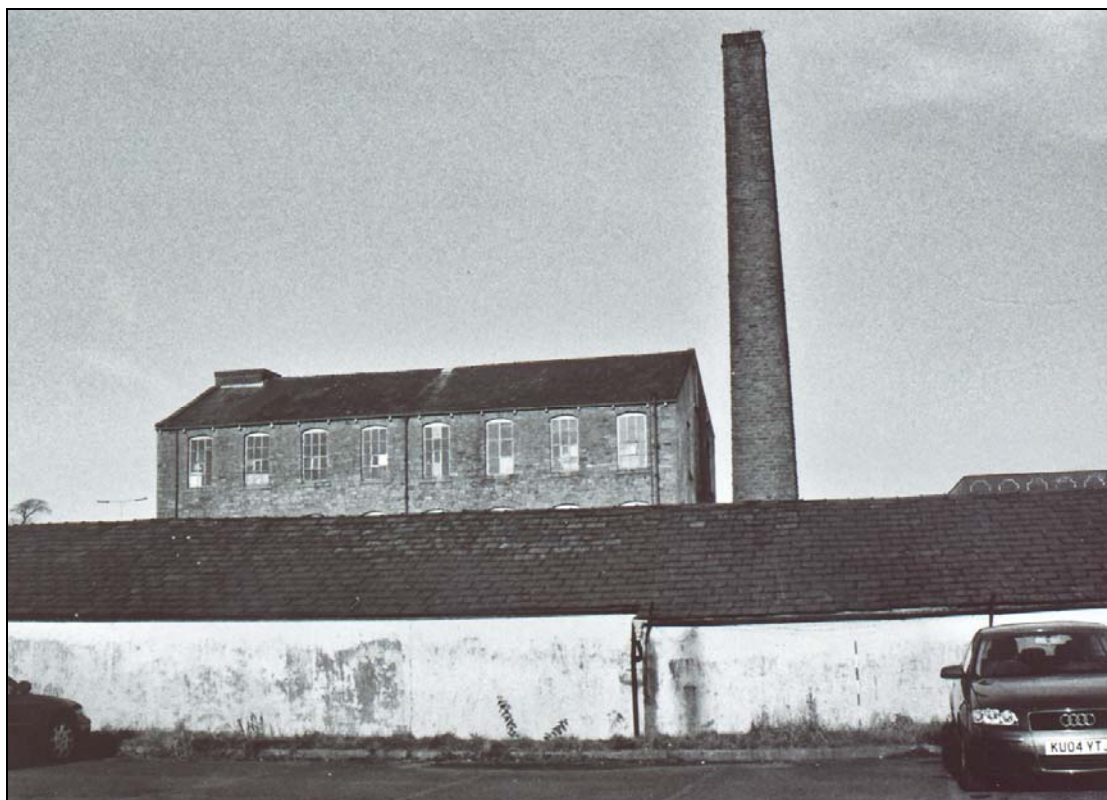
Plate 29

Plate 29: View of south elevation looking north across weaving shed roof to south front of original 3-storey building (lower levels obscured by weaving shed roof)

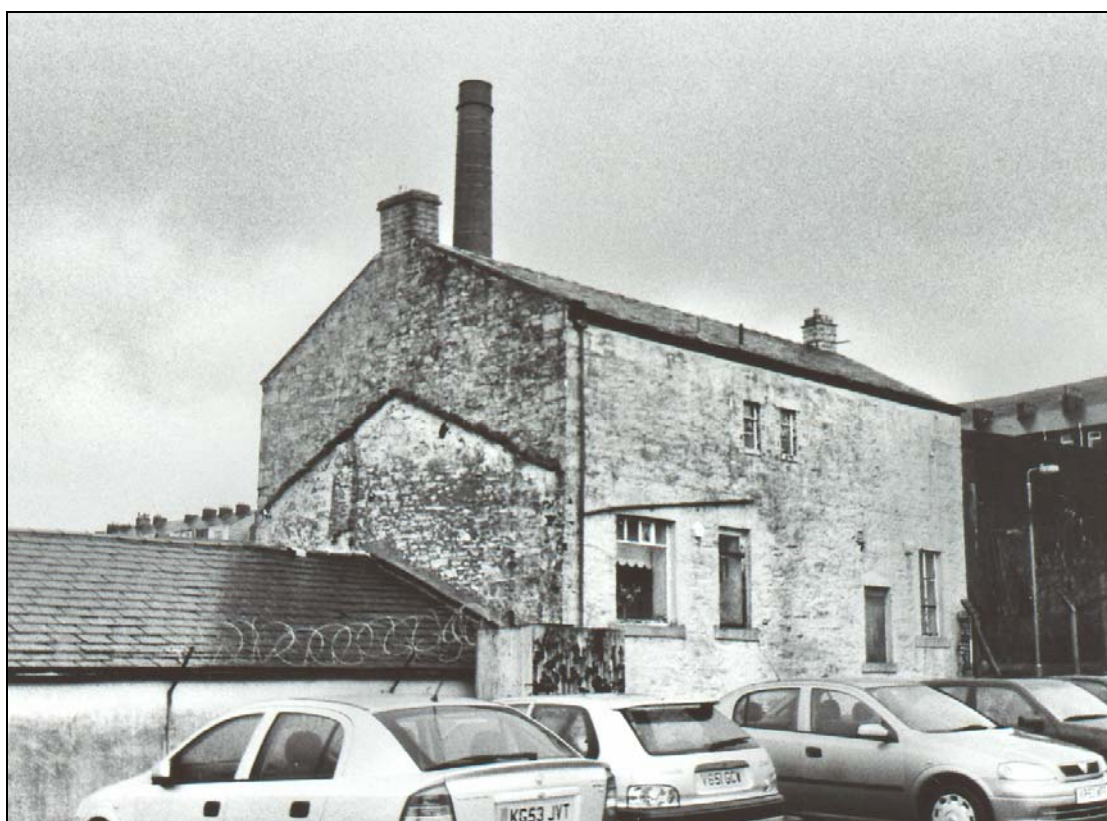
Plate 30

Plate 30: Shadow of former roof line on west elevation of office building
