**ARCHAEOLOGICAL ASSESSMENT
OF ST MARY'S SCHOOL AND ST MARY'S CONVENT,
BUCKFAST, DEVON**

Prepared for
the Diocese of Plymouth
by
Tim Gent and Pru Manning

Report No. 11.05

November 2011

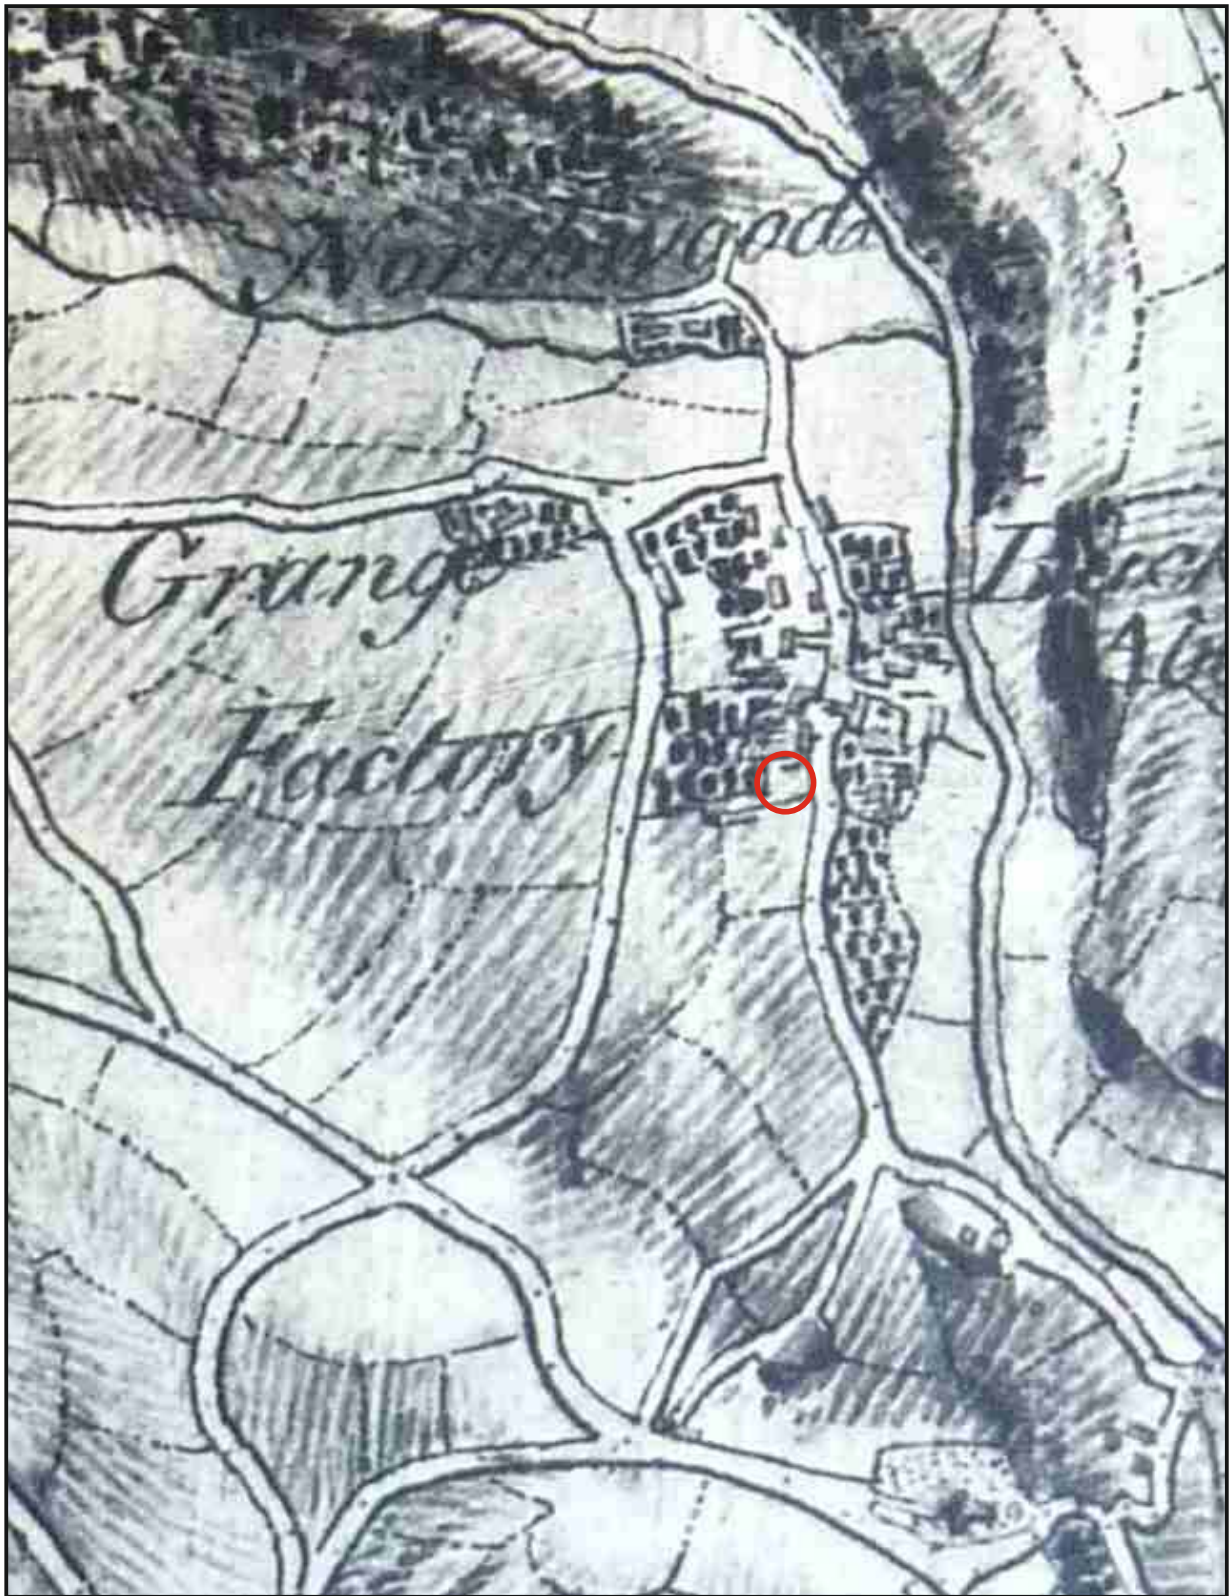
Fig. 3 The OS surveyors' drawing of 1802-3, showing the approximate position of the assessment site.

The OS surveyors' drawing of 1802-3 (Fig. 3) shows Buckfast, although the small scale and schematic representation make it difficult to identify the site area with any certainty. A small plot that may represent the site has a linear feature, possibly indicating an access lane, close to its northern boundary.

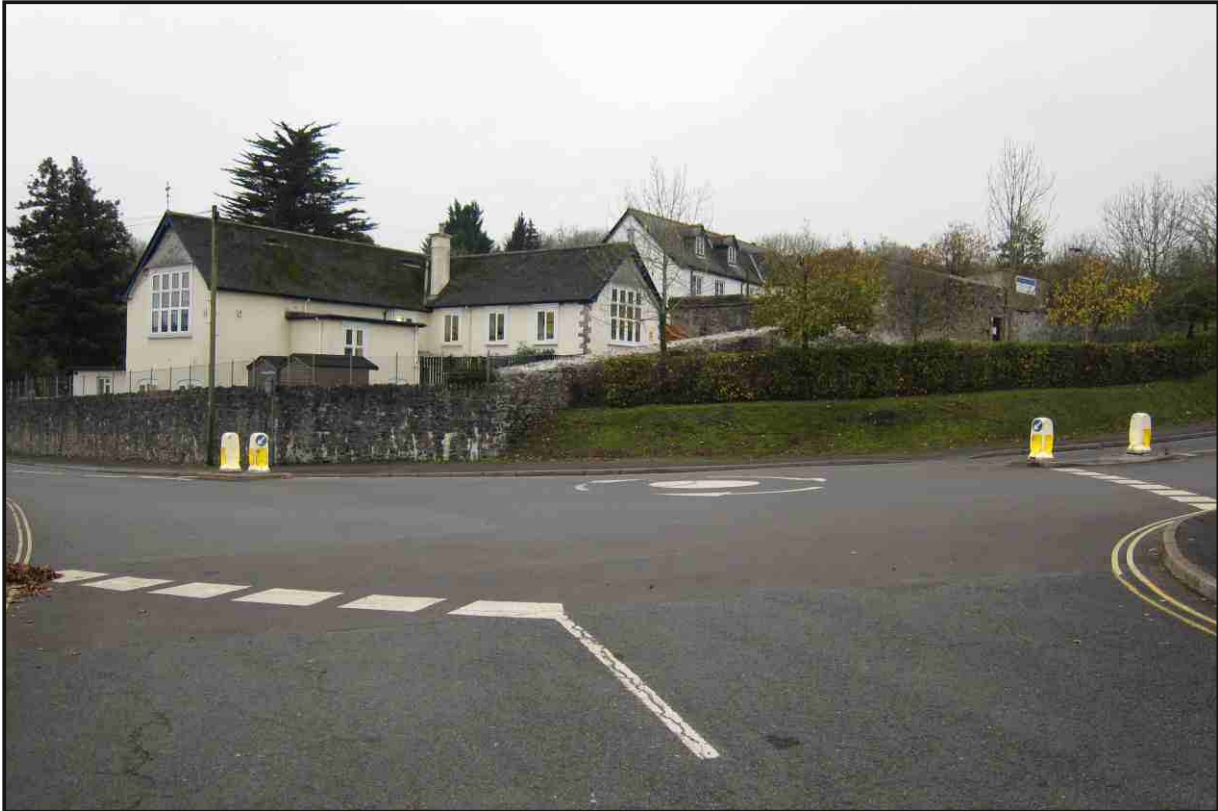
Photo. 1 The assessment site, looking south-west, with the convent on higher ground to the rear of the school.

The assessment site comprises a walled property bounded to the north by the 1982 link road and to the east by Buckfast Road (Fig. 2; Photo. 1). The area is subdivided by a NNW-SSE aligned wall, with the building and grounds of St Mary's Convent to the west and St Mary's School to the east. The area lies on ground that slopes to the east towards the River Dart, although the school grounds have been almost completely levelled, resulting in a difference in height of approximately 1m between the two plots at the dividing wall. The southern half of the convent grounds slope to the south towards the mouth of a narrow valley. This part of the convent garden holds a small canalised stream that presumably issues from this valley and which is culverted within the school grounds.

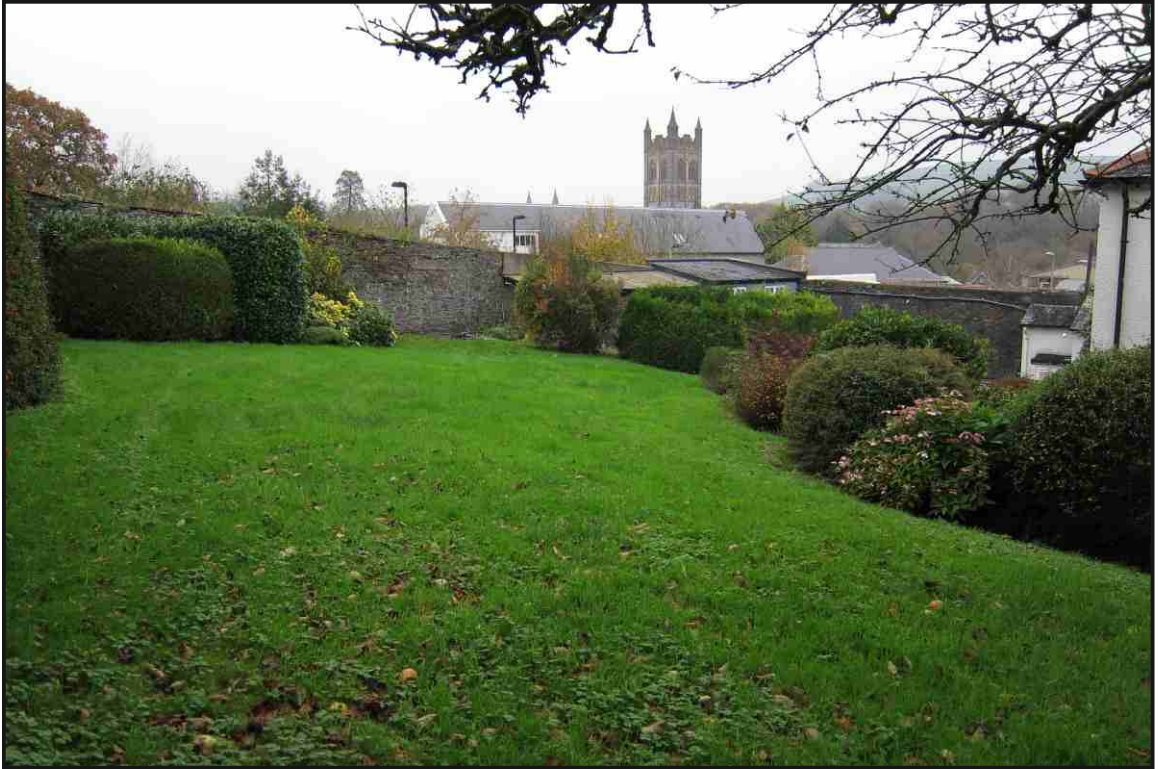
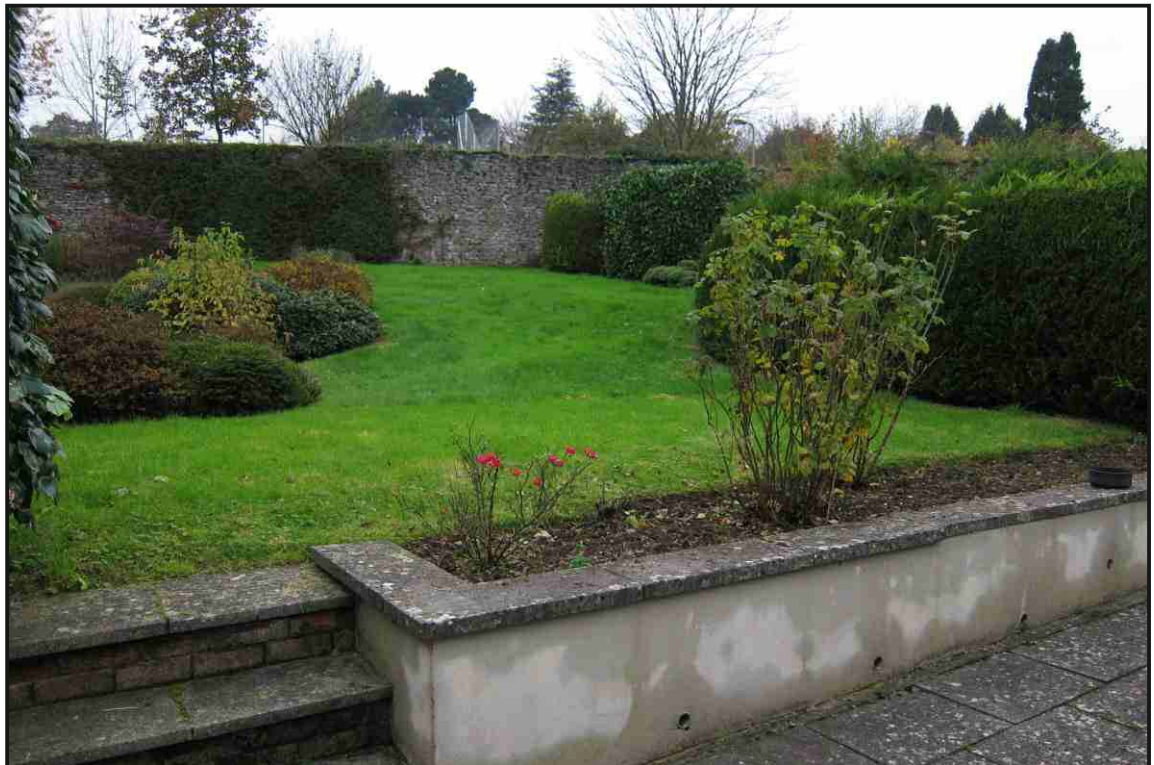
Photo. 3 The area of the proposed playground in the convent grounds, looking north-east.

Photo. 4 The area of the proposed playground in the convent grounds, looking north-west.

It is proposed to create a new playground within the northern part of the convent grounds (Photo. 3 & 4). This will entail some reduction of ground levels, although the area will not be fully levelled. A small gateway will be created within the convent boundary wall to the north of the new playground, and the existing gateway in the dividing wall to the east will be widened.

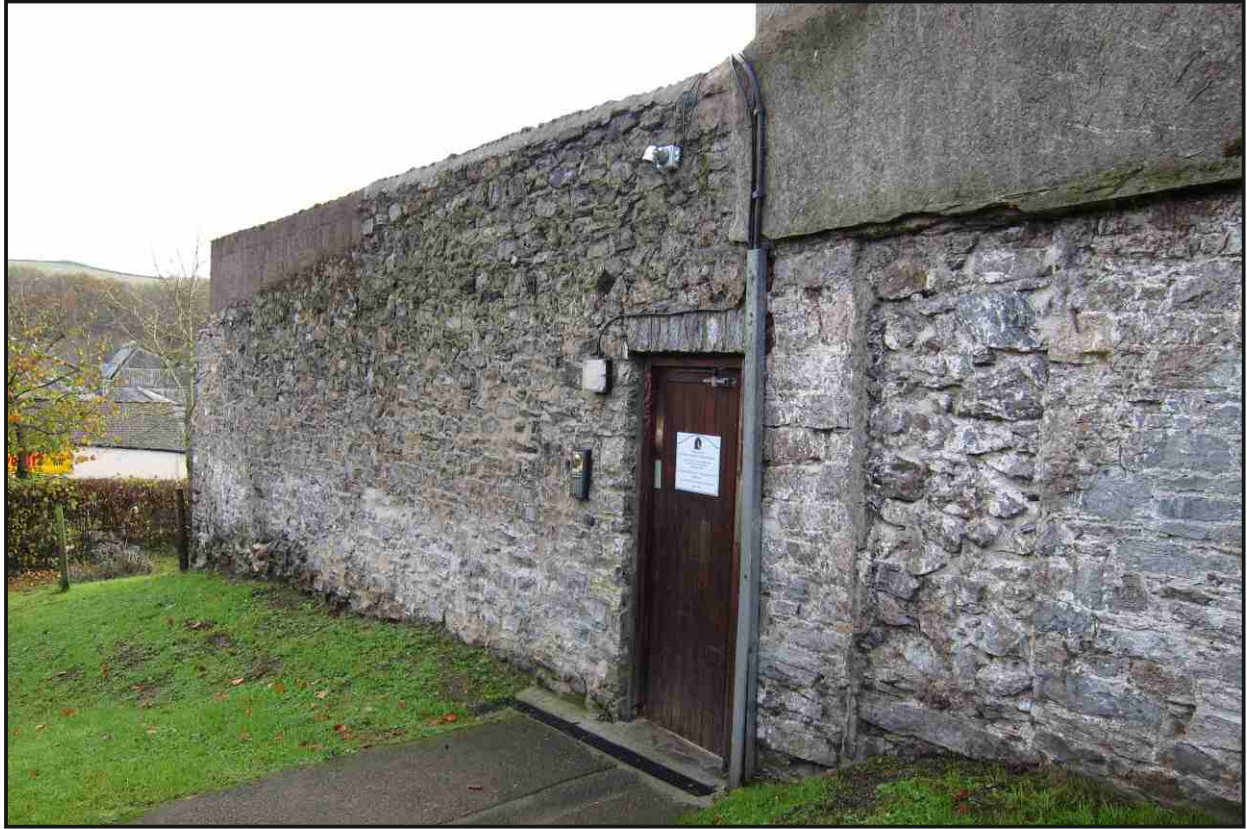
north boundary wall, directly to the west of the current entrance to the school (Photo. 5). This would appear to be situated at the point at which the dividing wall meets the boundary wall on the opposite side, suggesting that the dividing wall is a later addition. The exact alignment is, however, uncertain.

A small area of rubble stone build appears to underlie the north boundary wall to the school (Photo. 5). This may represent no more than a wide section of footings, although it has the potential to represent the remains of an earlier structure.

A small area of stone rubble build (Photo. 5) appears to underlie the northern section of the

school boundary wall, extending slightly beyond the outer face. This may represent only a wide section of wall footings, but has the potential to represent the remains of an earlier structure.

Photo. 5 The north boundary wall of the school and convent grounds, showing the blocked doorway and area of protecting stone build (site 3). Looking east.

A new reception area and offices will be constructed in the north-west corner of the school grounds, with a short section of the boundary wall removed to provide a new entrance to the property (Photo. 5). The new build will abut the northern boundary wall and north-south dividing wall. The existing reception wing of the school will be removed. Construction of foundation classroom against the northern boundary wall to the east of the reception area will result in two small breaches in this wall.
