**HERITAGE ASSESSMENT OF BUILDINGS
ASSOCIATED WITH THE FORMER
BUCKFAST SPINNING MILLS, BUCKFAST, DEVON**

Archædia

Report 13.12 Project 1113 18th November 2013

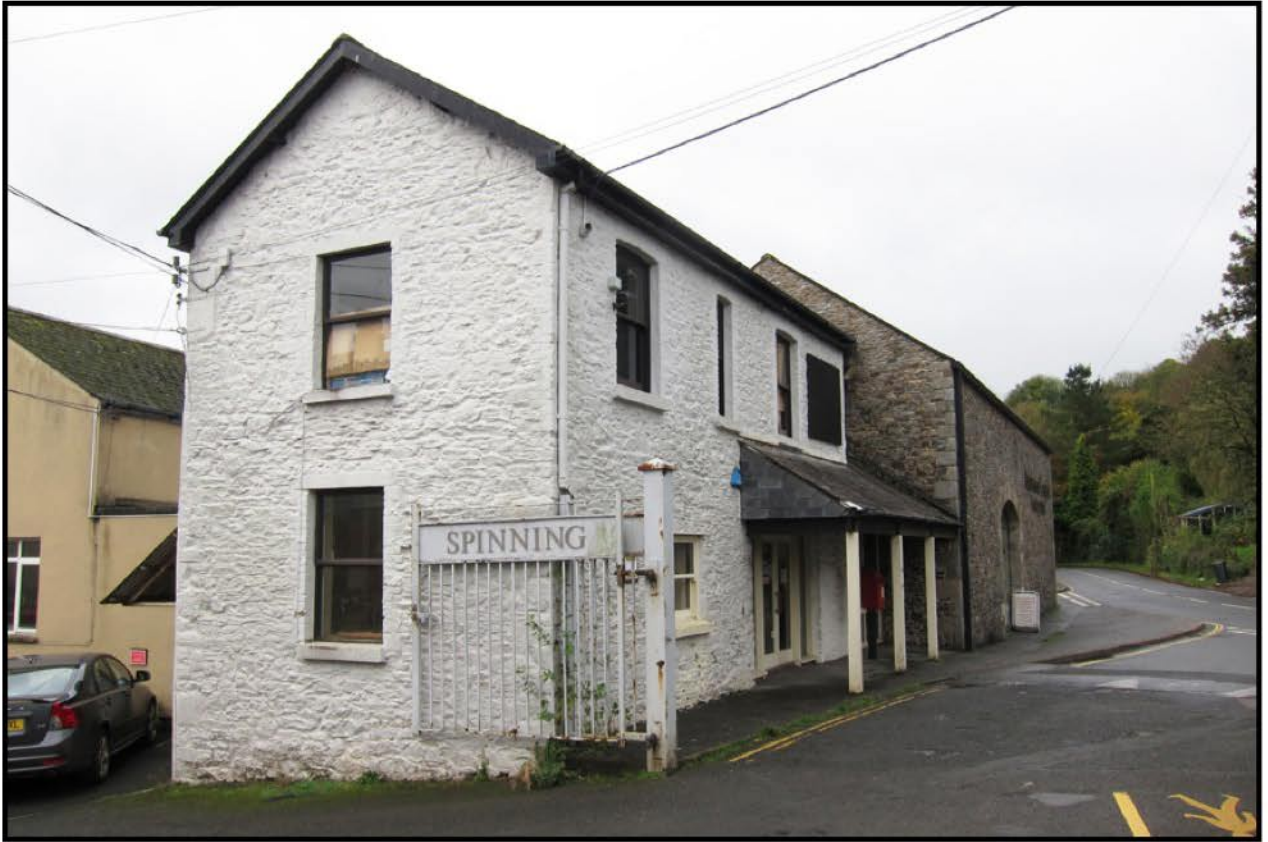
A number of the structures within the Site are evidently of modern construction. These include buildings A, C and H. Although stone-built, it is also known that building F (in the background in Photo. 1) was erected in the 1980s.

This building is of stone construction under a slate roof (Photo. 1). Although stripped of many of its internal features, and with mostly replaced windows, map and documentary evidence indicates that it represents the only surviving mill worker's cottage (asset 5 - there were originally three or four terraces), constructed between c. 1870 and 1887. A photograph of c. 1910 shows the western terrace.²⁷

Photo. 1 Buildings E and F, looking south.

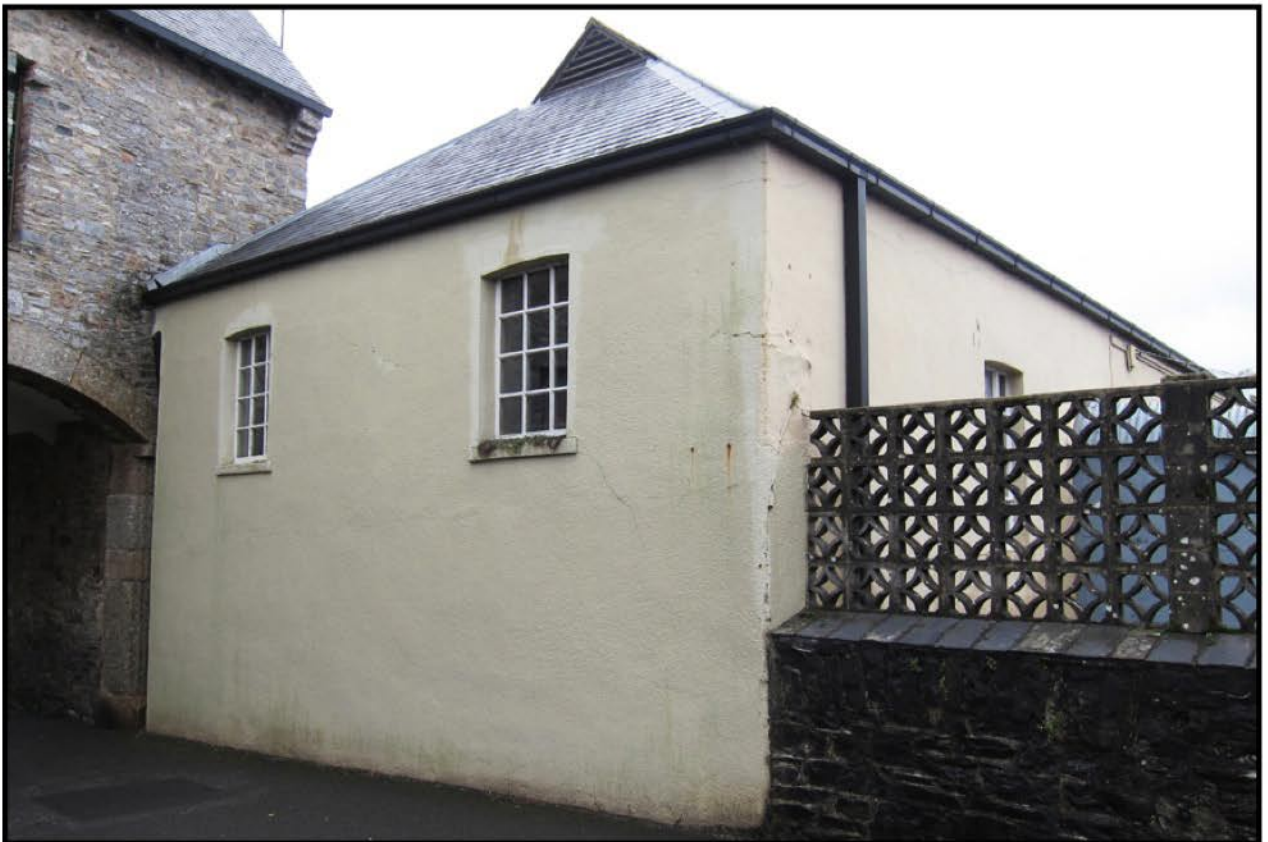
This building (Photos 2 and 3) is constructed on two levels under a hipped, slate roof, with a small louvre at each apex. Only the west, south and east exterior elevations were seen, and these are rendered. Where exposed on the interior of the ground floor, all four walls are of stone rubble. A photograph of c. 1912²⁶ suggests that the upper walls are also stone.

Photo. 2 The west elevation to Building 2, looking north-east.

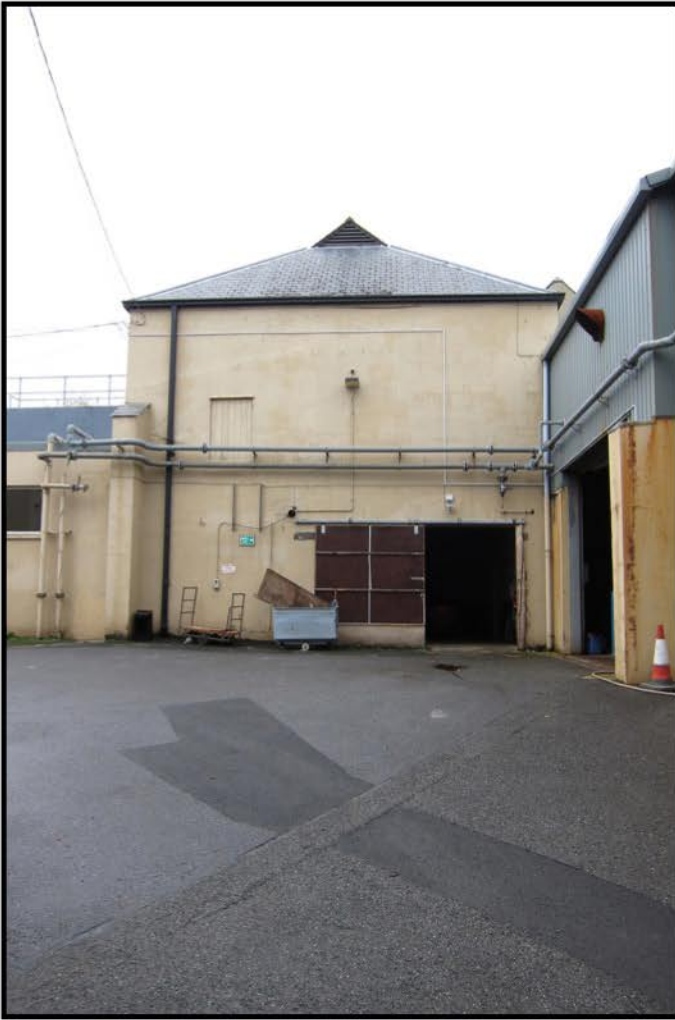
Photo. 3 The east elevation of Building B, looking west. Parts of Buildings A (to the right) and C (to the left) are also shown.

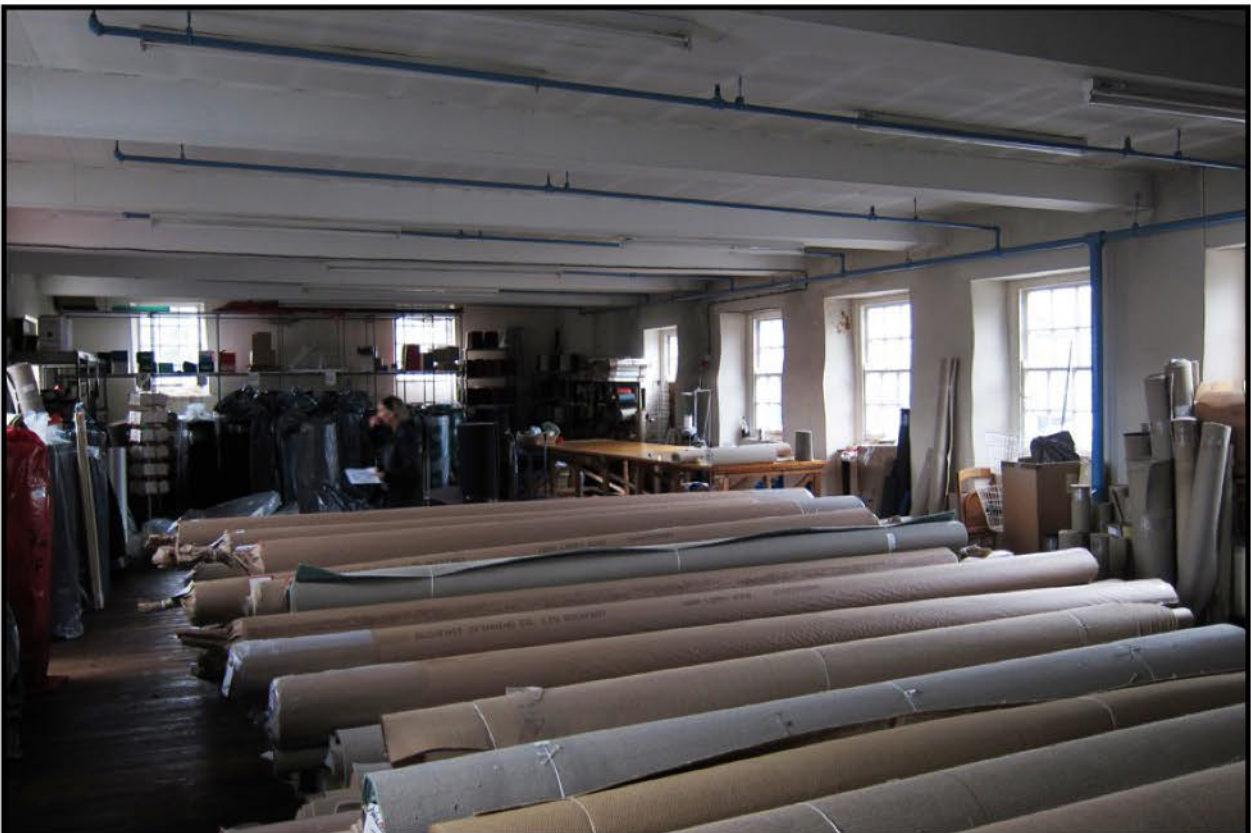
The first floor is entered through a doorway leading from the leat area immediately to the south. This floor contains a single room (Photo. 4), with a robust wooden planked floor, and is lit on both long sides by windows in widely splayed embrasures. Windows to the south, and in the west wall (Photo 2), are fixed, with twelve panes. On the north side, sash-windows are of probable later 19th-century date (Photo. 5). Brick jambs are visible in the elevation beyond. The internal roof structure was not seen.

Photo. 4 The first floor of Building B, looking west.

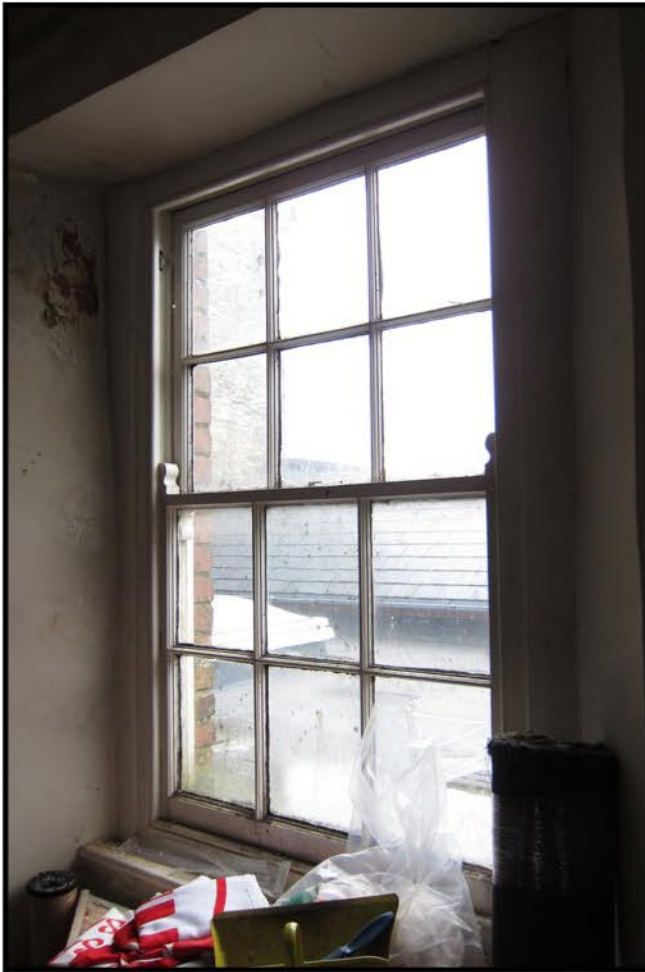
Photo. 5 A sash window on the north side of first floor to Building B.

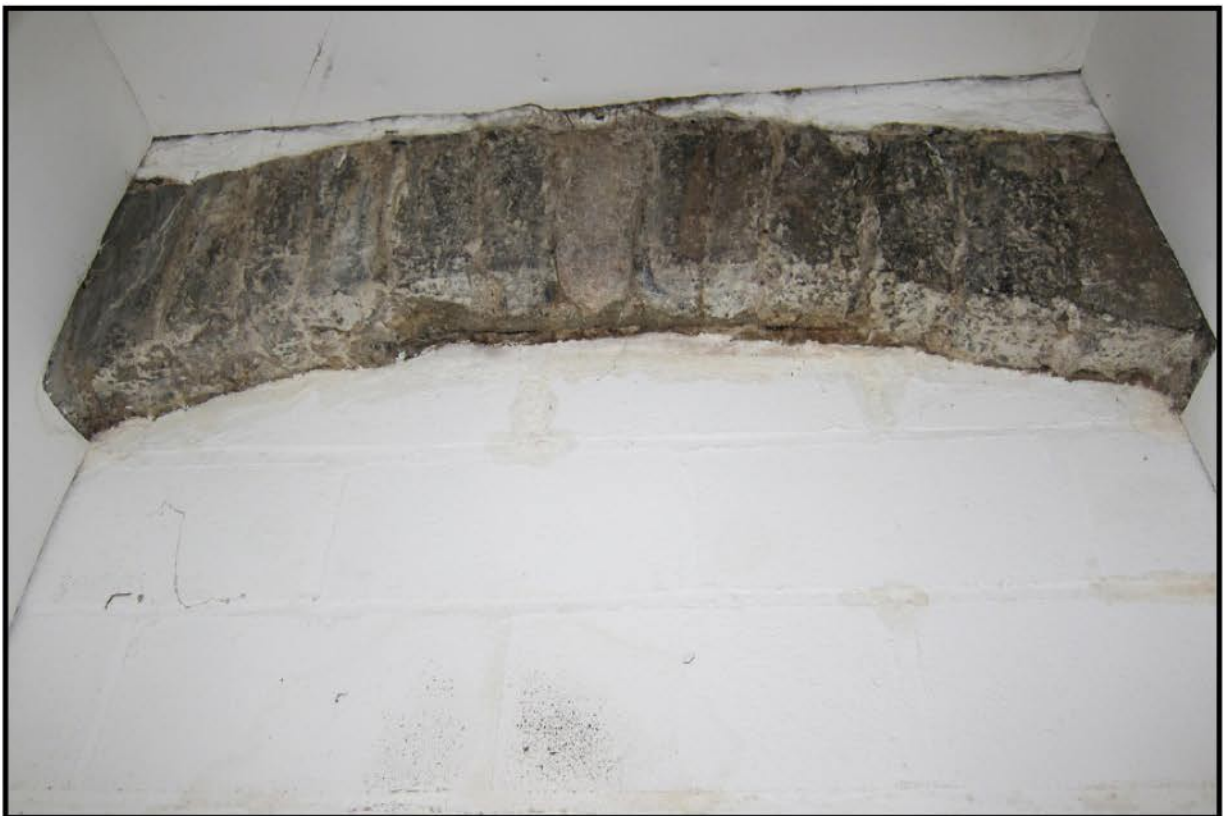
The ground floor is subdivided to produce a large main space with a high ceiling, and a corridor extending along the southern side. Substantial exposed timber joists support the first floor. At the west end, behind modern panelling, is a blocked aperture with a limestone arch (Photo. 6). This may represent a former water channel.

Photo. 6 The blocked entrance at the west end of the ground floor to Building B.

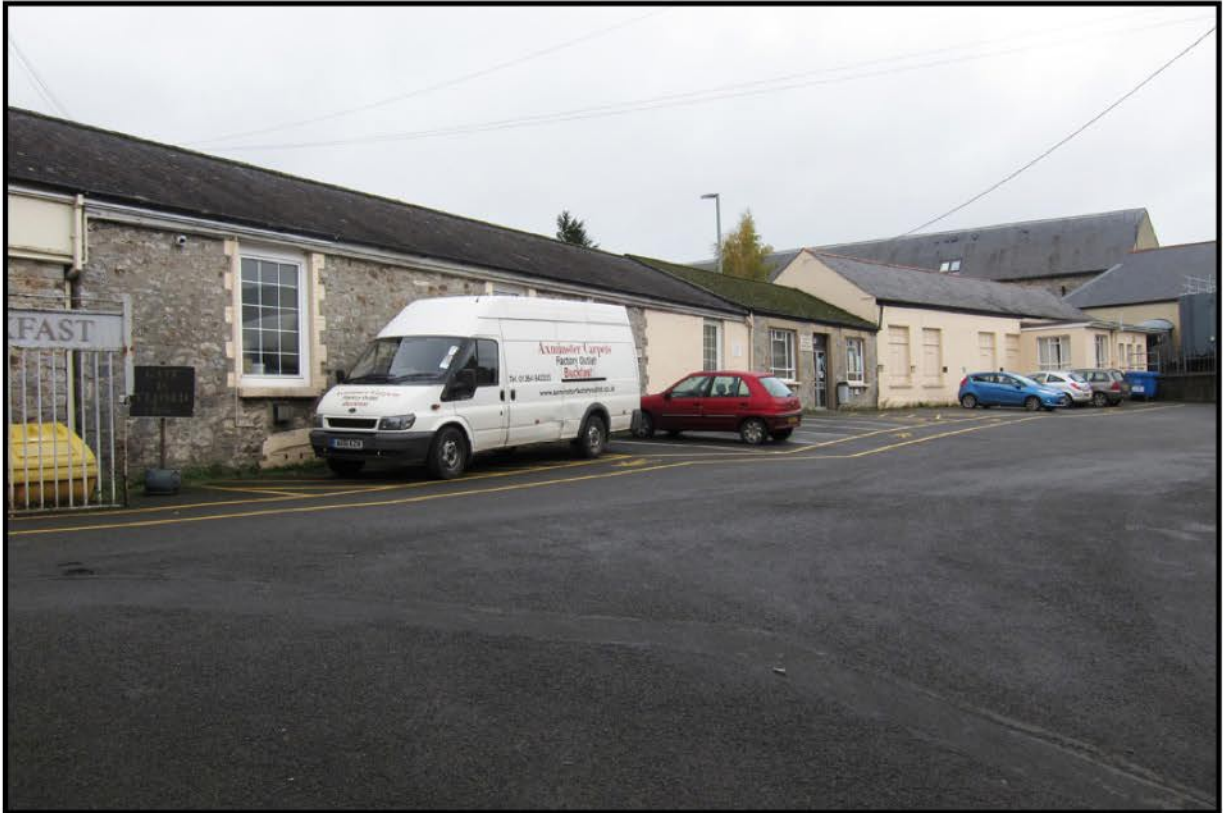
Building D extends along the western edge of the Site (Photo. 7), and comprises a number of structures, built at different periods.

The southern tip is known to have been built in the early twentieth century, possibly at the same time that a short section was infilled at the centre of the range. The remaining southern two-thirds of the range is suspected to have been built between 1887 and 1905 and appears relatively unaltered.

Photo. 7 The western range (Building D), looking north-west. The roof to Building B is visible at the far right. Later elements include the southern tip (to the left, and behind the gate) and a section of infilling (abutting the cream painted northern section).

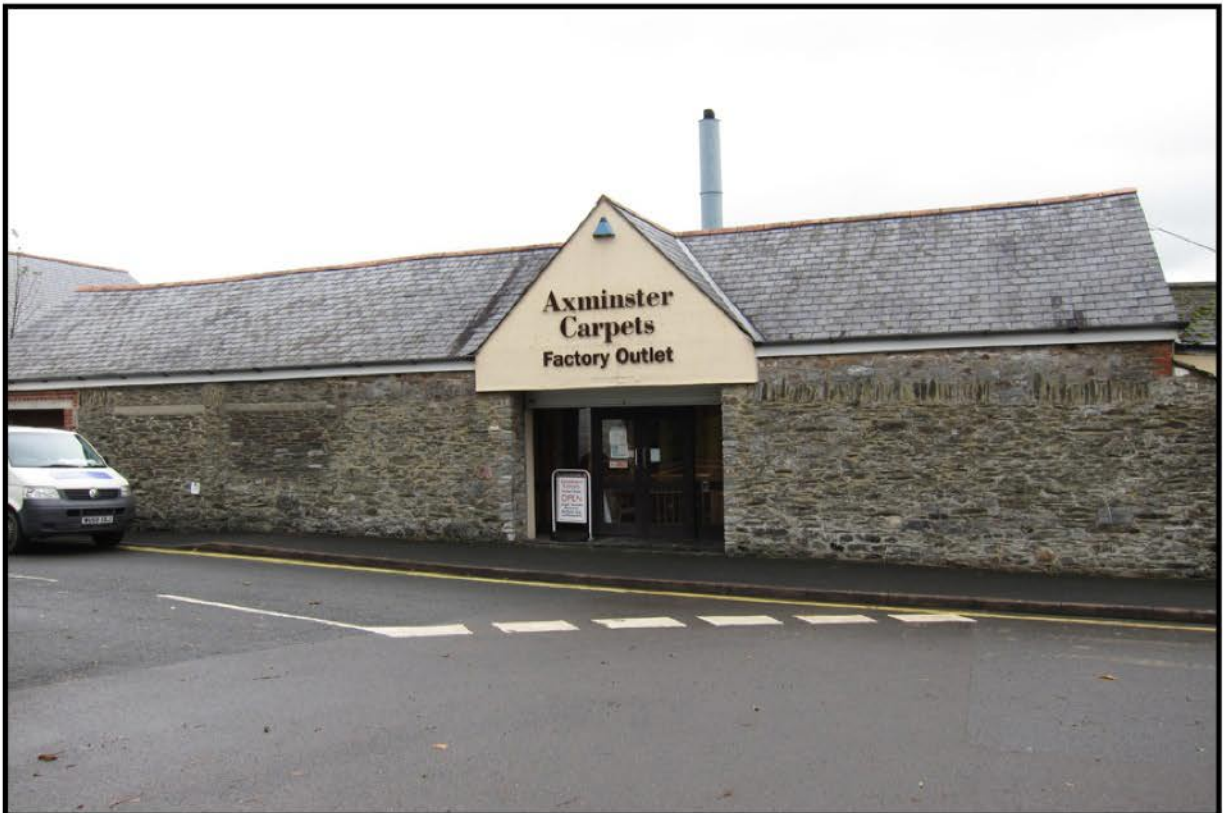
The building at the northern end of this range is less easy to date with certainty, although it is all believed to be of 19th-, or, in part, possibly early 20th-century construction. Map evidence indicates an isolated structure here in 1887, in a position that was empty in c. 1870, and the stone western elevation almost certainly represents part of this initial structure. Stone capping to what appears to have been a freestanding wall is evident within this elevation (Photo. 8), and it is believed that an earlier boundary feature was incorporated when this building was erected. This elevation has since seen either the enlargement or creation of openings, and subsequent blocking. Due to the modern cladding over all internal faces, and modern plaster on the eastern elevation, it is not possible however to determine the date of the remainder of the structure with certainty, although the eastern elevation appears to have been straightened between 1887 and 1905, and the remainder of the main fabric of this structure may well date to this period.

Photo. 8 The west elevation to the northern part of Building D, seen from the road. The capping to an incorporated boundary wall, and blocked openings, are visible.

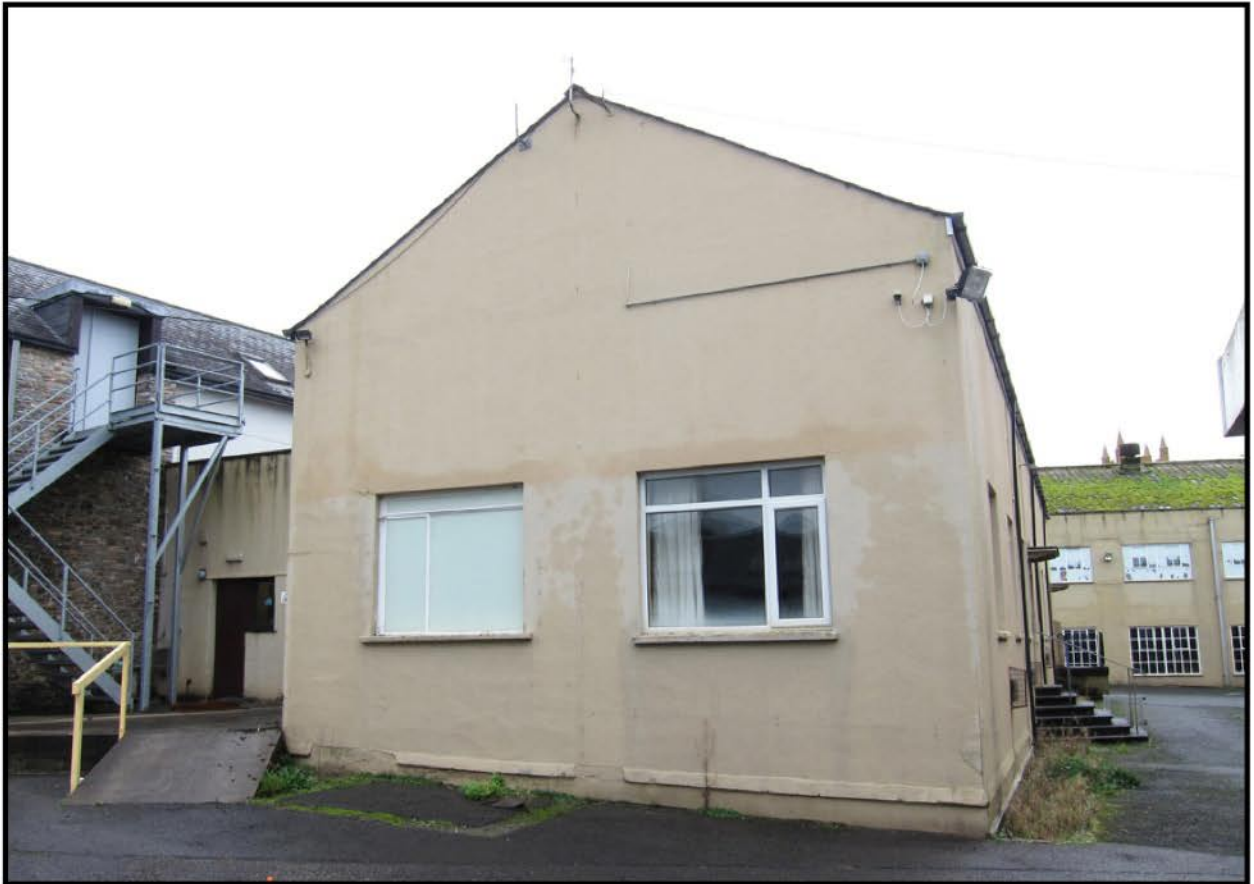
Although it appears to be on almost the exact position of a range of nineteenth-century dwellings (part of site 5), Building G (Photo. 9) shows no sign of construction during this period. As the cottages are shown on 1961 OS mapping (Fig. 9), it is assumed that it was constructed after this date.

Photo. 9 The south elevation of Building G, looking north.

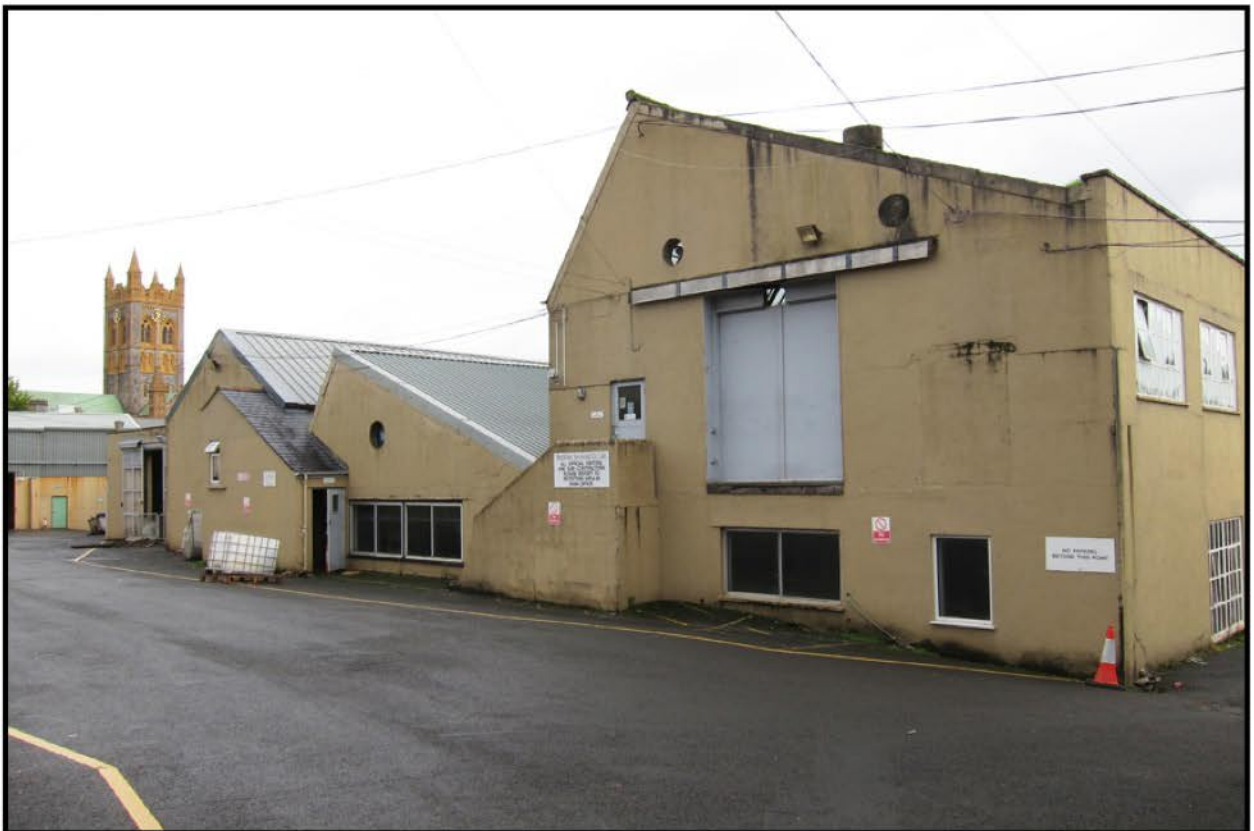
Building J (Photo. 10) covers a substantial part of the Site, and it is evident that development took place in a number of phases. On the basis of both map evidence and construction methods and materials, it is clear that much of the structure, including the whole of the southern half (Photos 10 and 11), and significant elements at the northern end, was built after 1961. Much of the south-west corner has been terraced into the hill slope, and linear channels of unknown function have also been cut into the floor across this most recent part of the building.

Photo. 10 The west elevation of Building J, looking north-east. The gabled roofline directly to the right of the church tower represents the only early roof structure. The flat roof below the tower covers the only range with all four surviving walls.

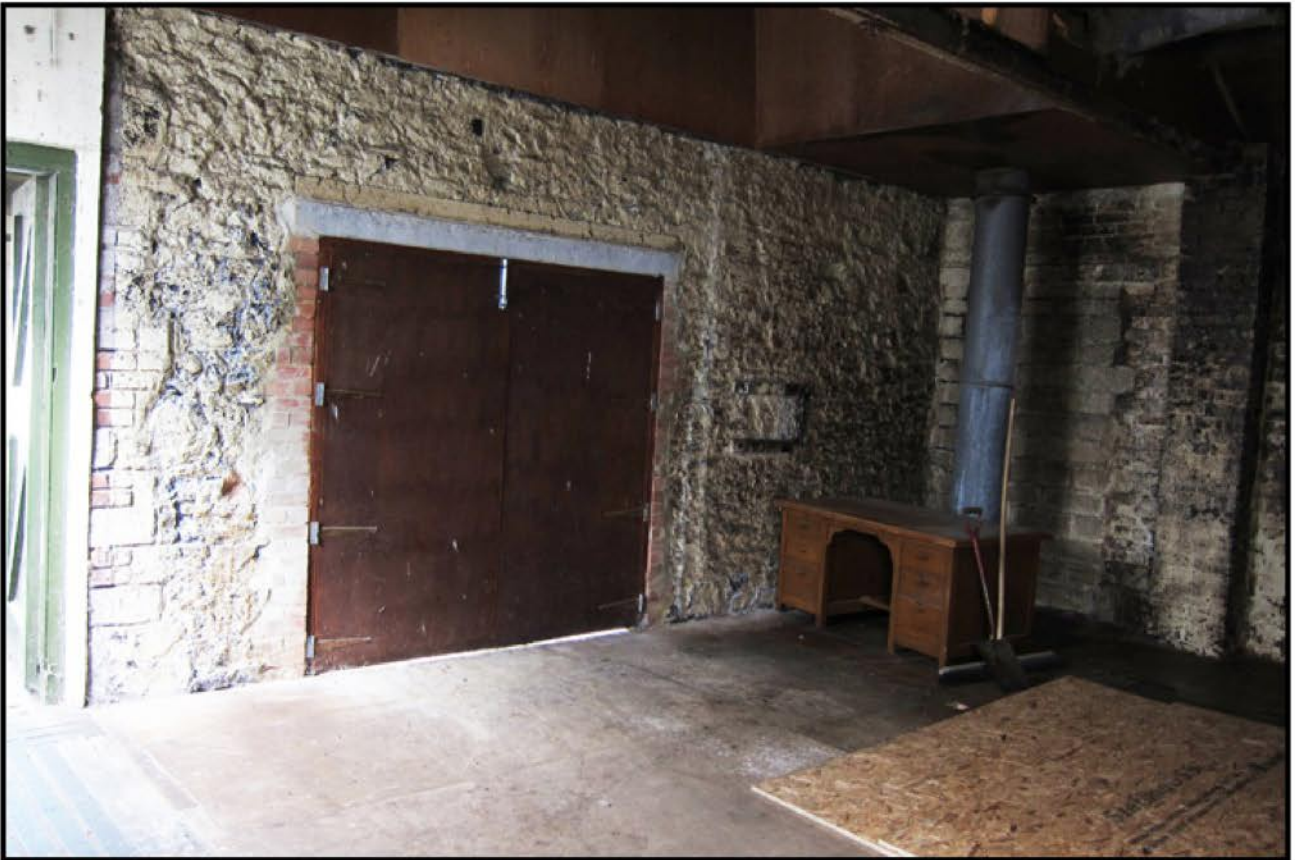
The roof trusses to the range immediately to the south are thought to be late 19th-century in date, although due to fire probably not original. On the north side these trusses rest on the brick southern wall to the range described above (Photo. 13), but to the south are supported by a brick wall of post 1961 date. The original stone end walls to this partial range also survive (Photos 13 and 14). This stone building is visible on a photograph of c. 1910.²⁸

Photo. 13 The western interior to the partial nineteenth-century range within Building J, showing the surviving end wall, the side wall shared with the range to the north, and the end to an original roof truss, resting on this wall.

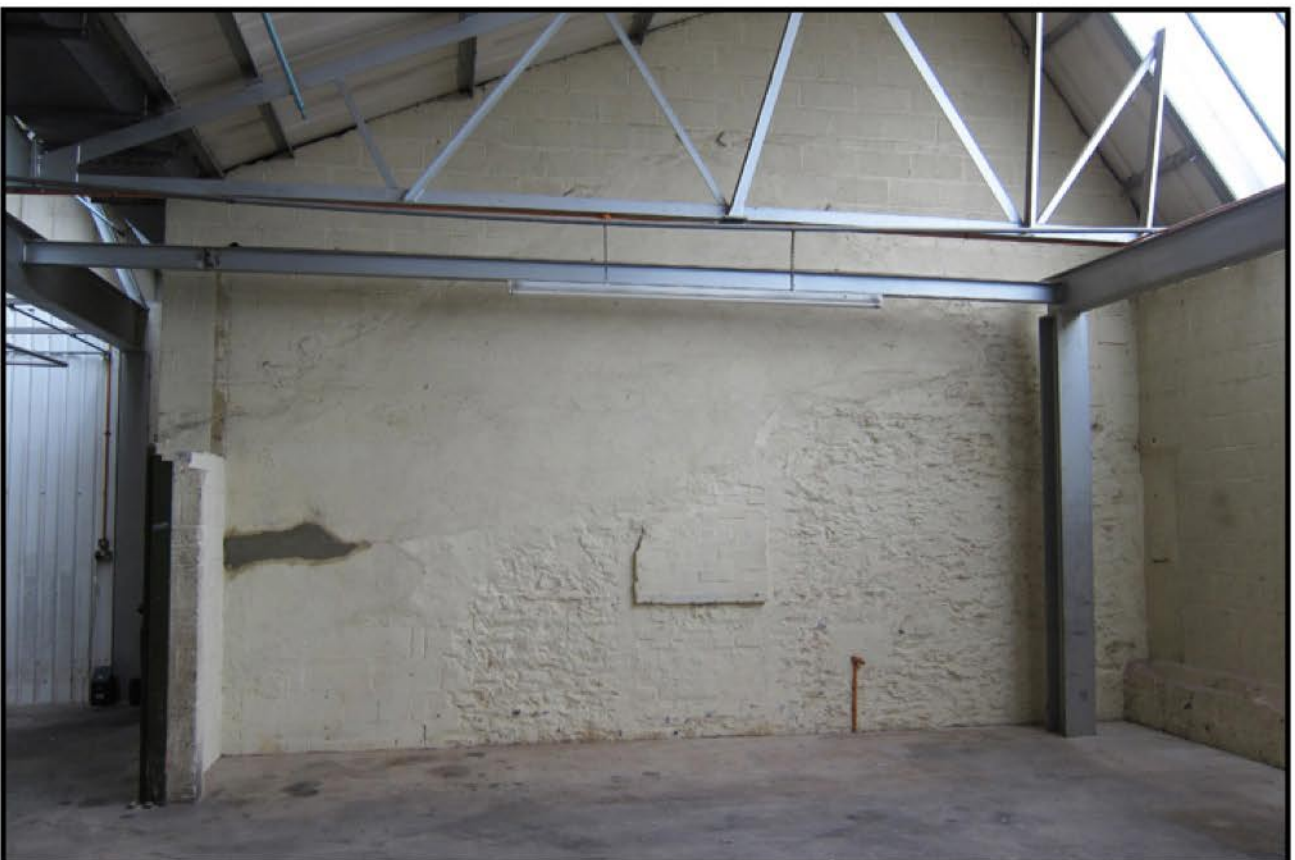
Photo. 14 What was once the eastern external elevation to the partial nineteenth-century range, now enclosed within the modern southern half of Building J.

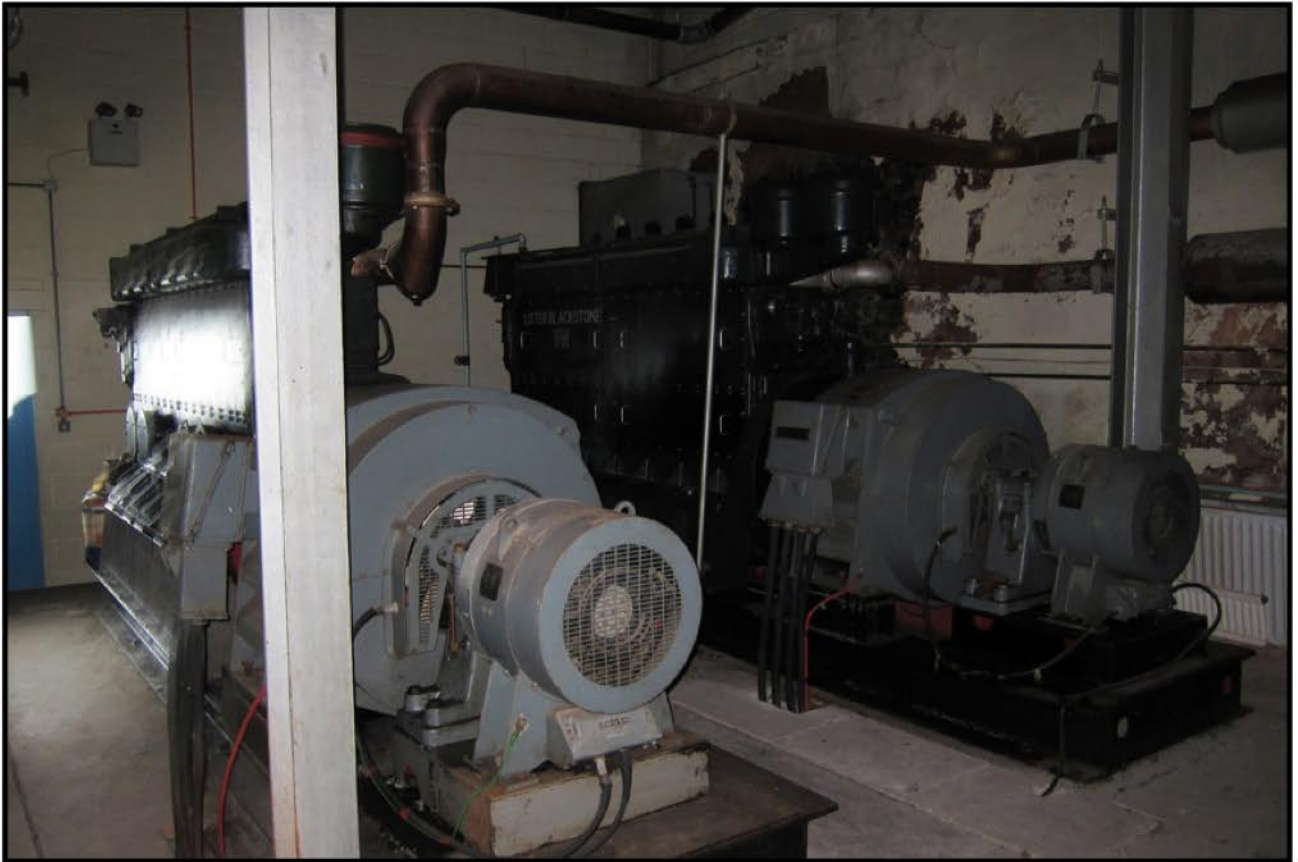
Other wall sections within the building also predate 1961, although none seem to represent complete rooms. Sections may survive on the west side of the boiler house for example, where the room has been terraced into the hill slope, and appear to support the eastern side of an adjoining engine house that contains two Lister diesel units (Photo. 15).

Photo. 15 Two Lister engines within the engine room in Building J. The east wall (beyond the farthest engine) may date to the early twentieth century.
