# EAST HOLME, NEWTON ST. CYRES, DEVON

## HISTORIC BUILDING RECORDING AND ARCHAEOLOGICAL WATCHING BRIEF

STEWART BROWN ASSOCIATES  
NOVEMBER 2011

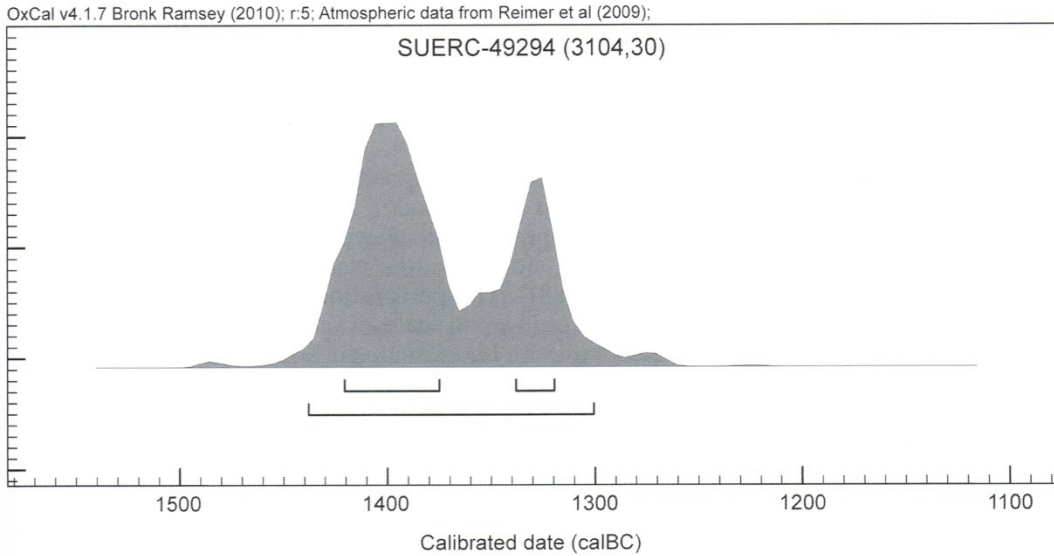
Fig. 3. Probability distributions of the radiocarbon date.

1439–1301 BC (95.4% probability) and to at 68.2% probability to 1421–1376 BC (51.1%) and 1339–1320 BC (17.1%) following OxCal v4.1.7 (Fig. 3).

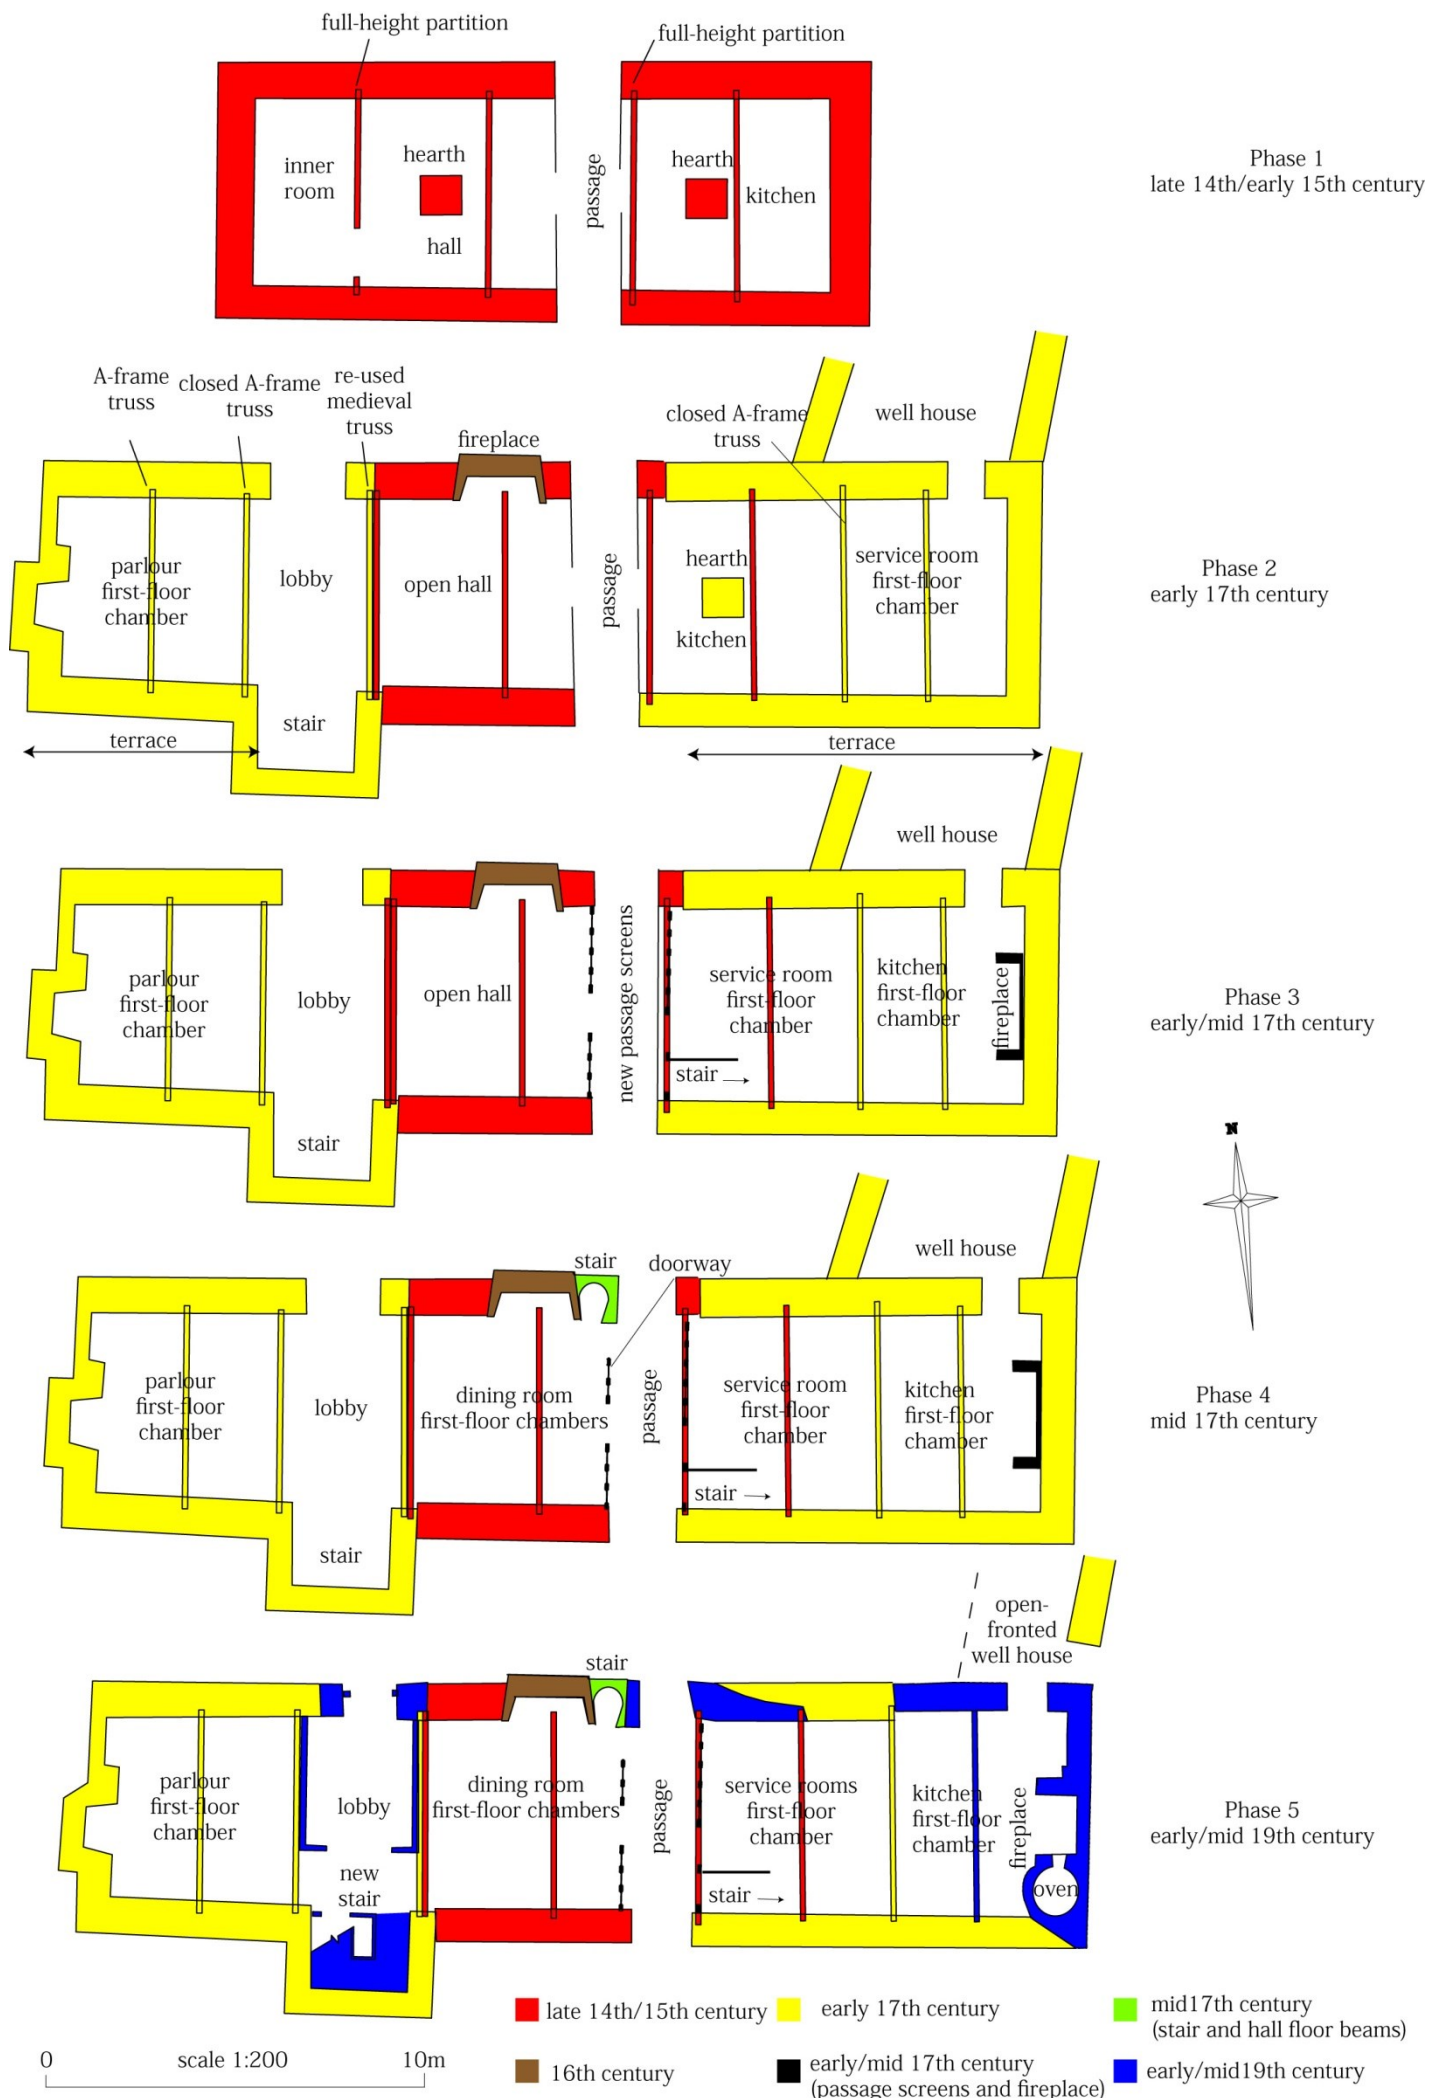
Fig. 1 Phase plans showing suggested development of the house up to the mid 19th century, including roof trusses.

The standing structure (Plates 1 and 2) retains elements from six different building phases dating from the late medieval period to the late 20<sup>th</sup> century (Fig. 1, Phases 1-5; Fig 2, Phase 6).

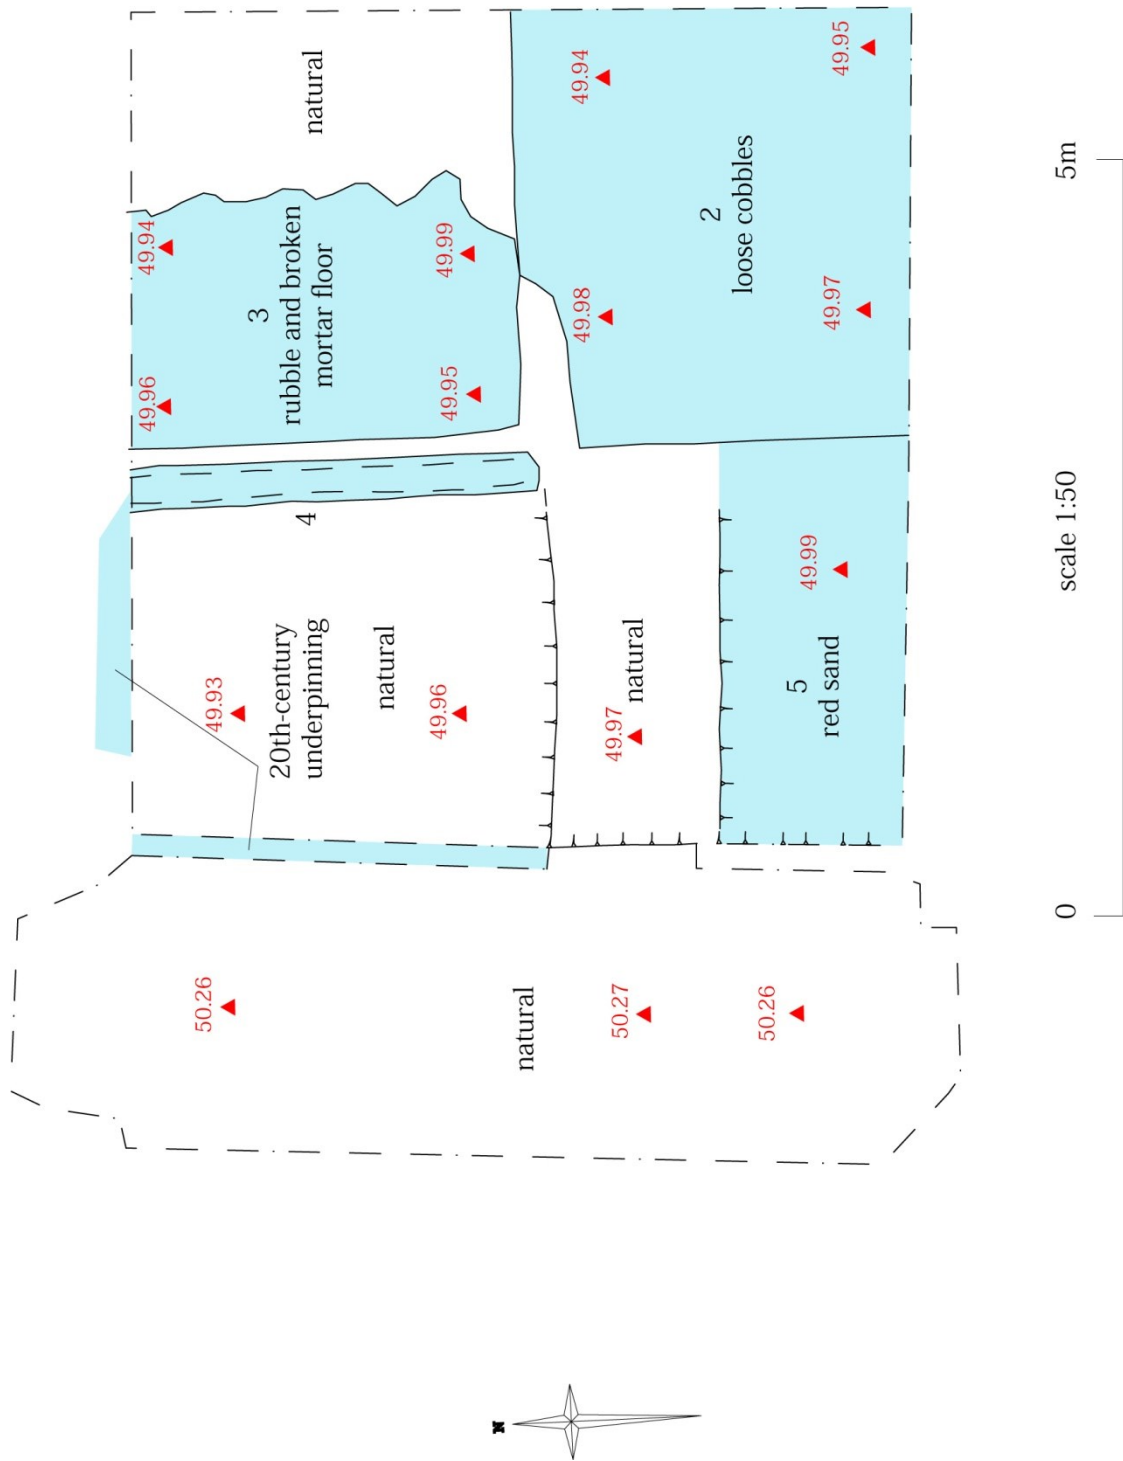
Fig. 5 Plan of excavations inside the house showing post-medieval features.

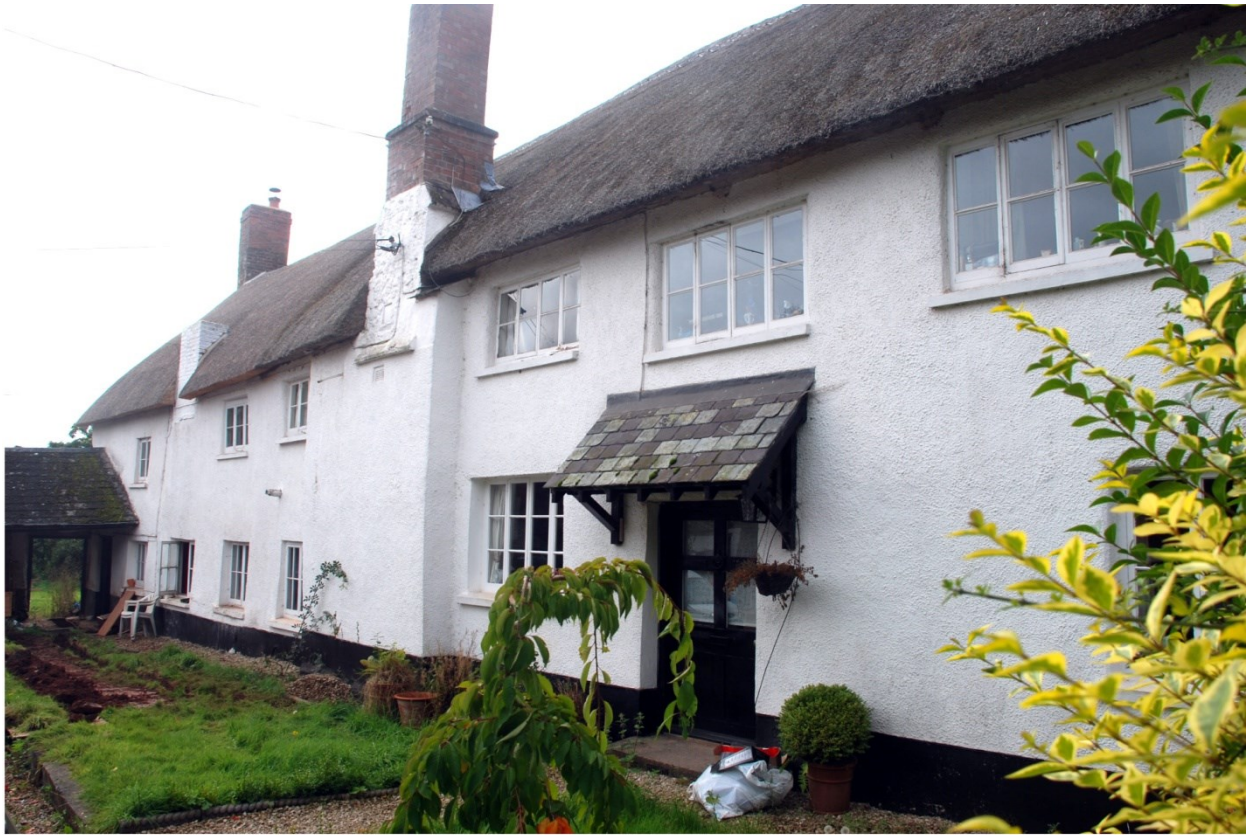
Plate 1 The front elevation of the house, looking northeast.

The 17<sup>th</sup>-century saw an enlargement of the house at each end and the insertion of first-floor rooms. These were common developments for the time in farmhouses across Devon and elsewhere in the country. More rooms meant greater flexibility to meet changing social conditions, and families increasingly desired greater comfort and privacy. Rooms such as the parlour came into being - the best living room, usually heated - whilst sleeping accommodation was moved from the ground to the first floor. The open hall, which had been such a prized symbol of status in earlier times, was by c. 1700 almost totally abandoned in domestic arrangements. Extensions to houses were made in many different ways, but it was common to make additions at either or both ends, since it was easier to extend the roof than build completely new wings or annexes. This did however result in an inconveniently long linear arrangement of up to five rooms not including the passage, as at East Holme. Because the extended house stood on sloping ground, the two ends of the house had to be part-terraced into the slope. They therefore had different floor levels. Consequently, there is also a difference in the level of windows and eaves at the two ends, seen most clearly in the front elevation (see front cover illustration).

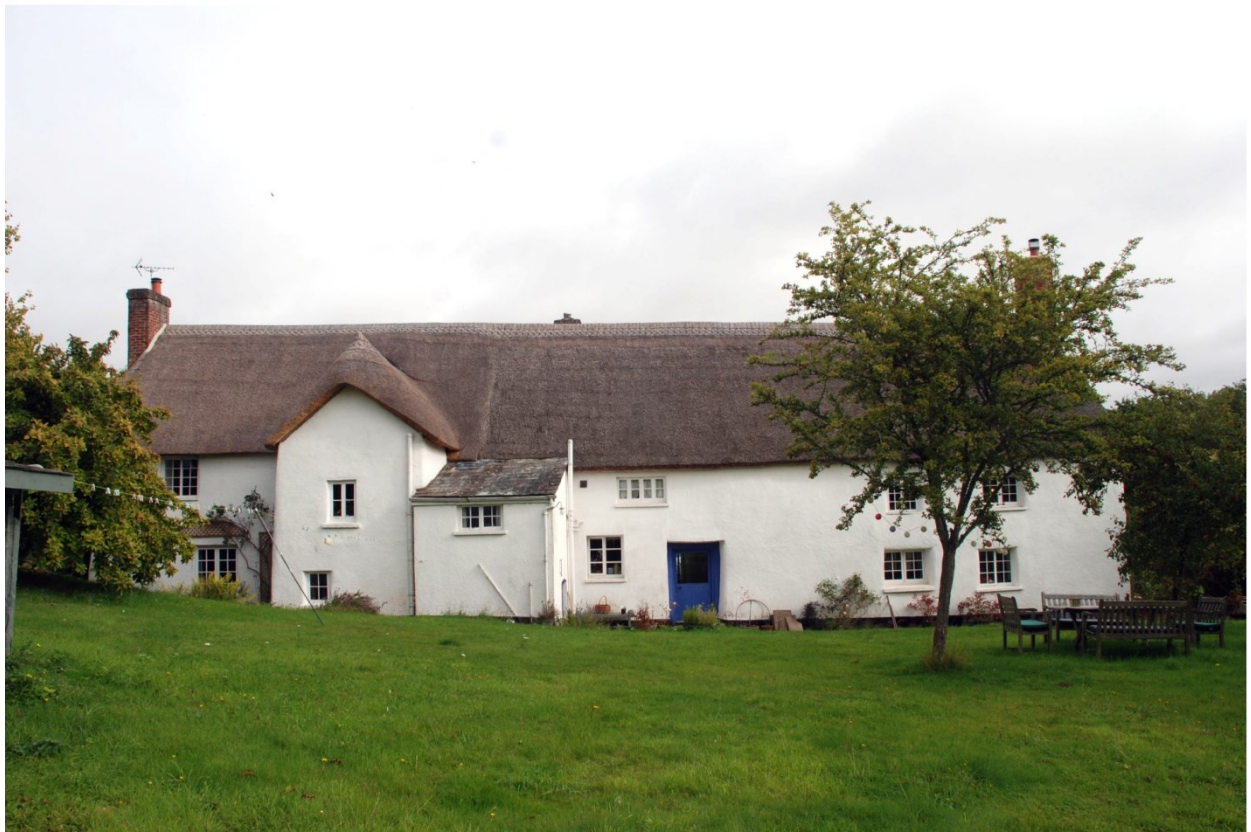
Plate 2 The rear elevation of the house, looking north.

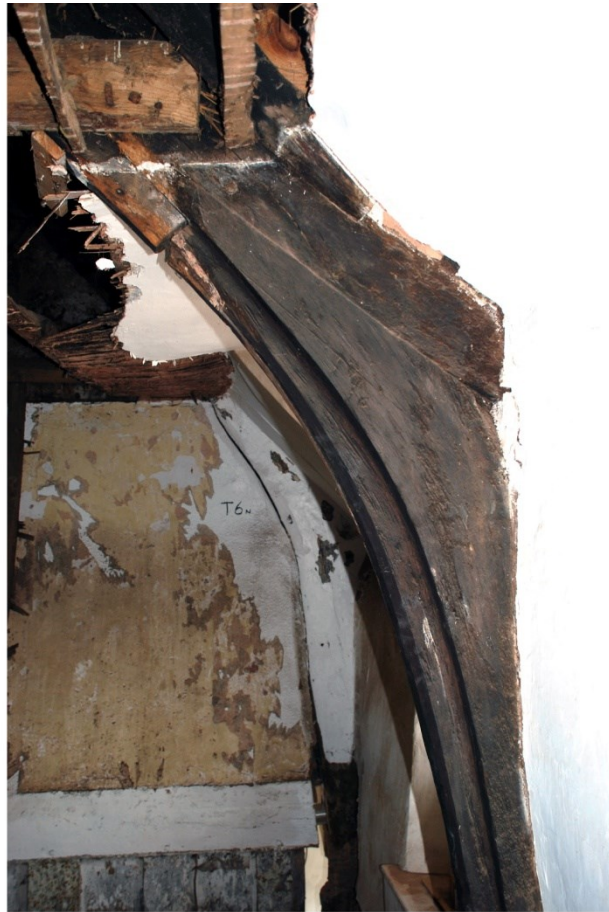
Plate 3 Elbow joint of jointed cruck truss over former kitchen, looking west.

The jointed cruck trusses have a mortise and tenon joint at the elbow with a long tenon on top of the curving head of the cruck post and a corresponding mortise cut into the underside of the principal rafter which extends to the apex (Fig. 3a; Plate 3). The cruck truss appears not to

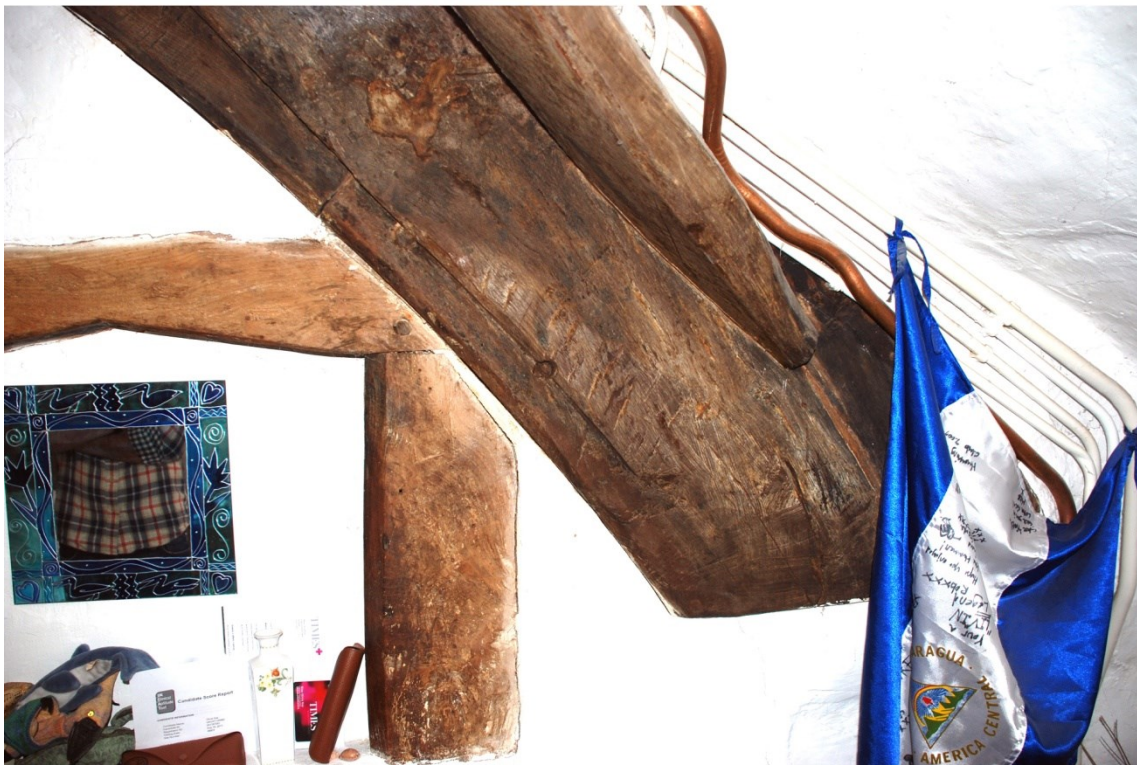
Plate 4 Elbow of probable true cruck truss over former hall, looking west.

have a joint at the elbow (Plate 4). The principals meet at the apex with a vertical butt joint and are held together by a triangular yoke tenoned and pegged into their undersides (Plate 5). There is a diagonal ridge piece which is pegged into a mortise cut into the two ends of the principals. The collars are either straight or slightly cranked and have a mortise and tenon joint at each end held by two pegs. The open trusses have chamfered arch-braces (Plate 6). The lower parts of the bracing are fashioned from the cruck posts, with decorative corbel stops at their base (Plate 7). The upper parts are separate timbers tenoned into mortises cut into the undersides of the principal rafters and collar. These rise to a small block beneath the middle of the collar which usually in such roofs is carved from the collar itself, but here is a separate piece tenoned into the collar's underside. The roof has two sets of butt purlins, the main set placed about half-way up the principals just below collar level, and an upper set placed between collar and ridge. The butt purlins extend from truss to truss and have end tenons set into mortises cut into the sides of the truss principals. The lower purlin was braced from beneath by curved wind-braces, two in each bay (Plate 8). Where the cruck posts are exposed, it can be seen that they comprise two separate timbers joined together with unpegged mortice-and-tenon joints.

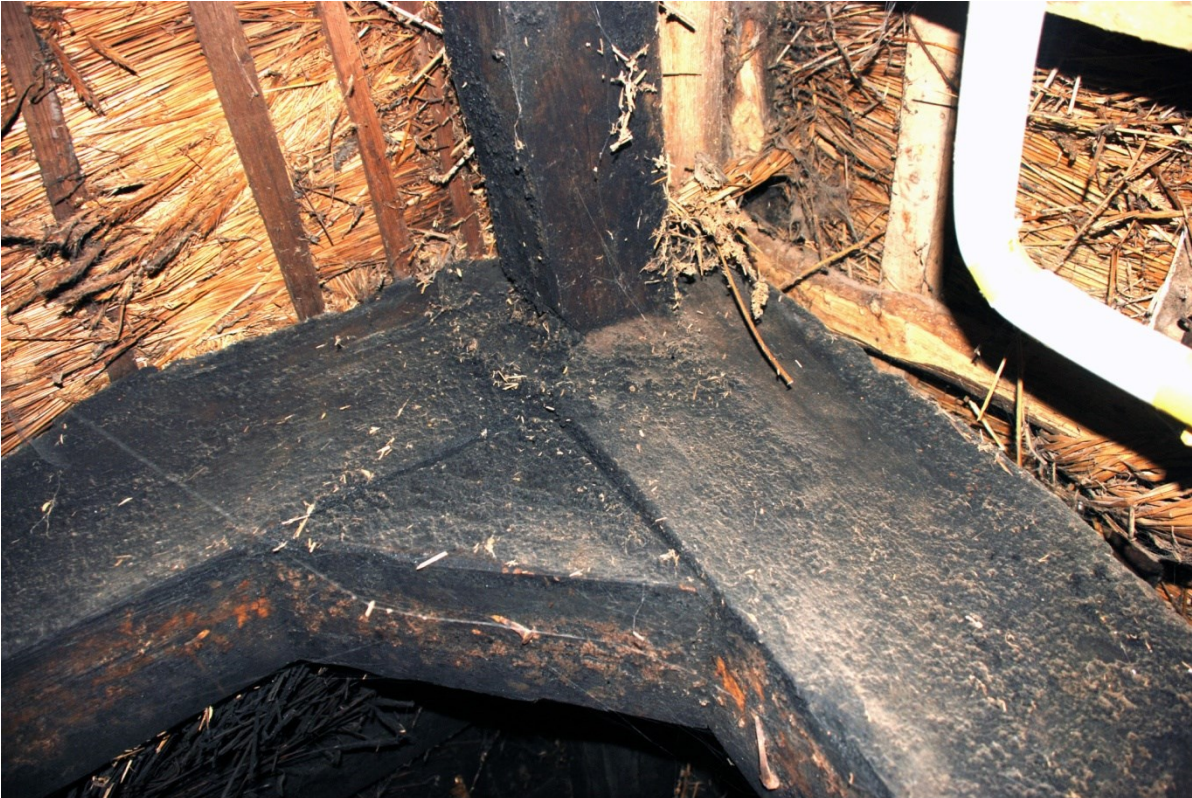
Plate 5 Triangular yoke and diagonal ridge of the medieval roof, looking west.

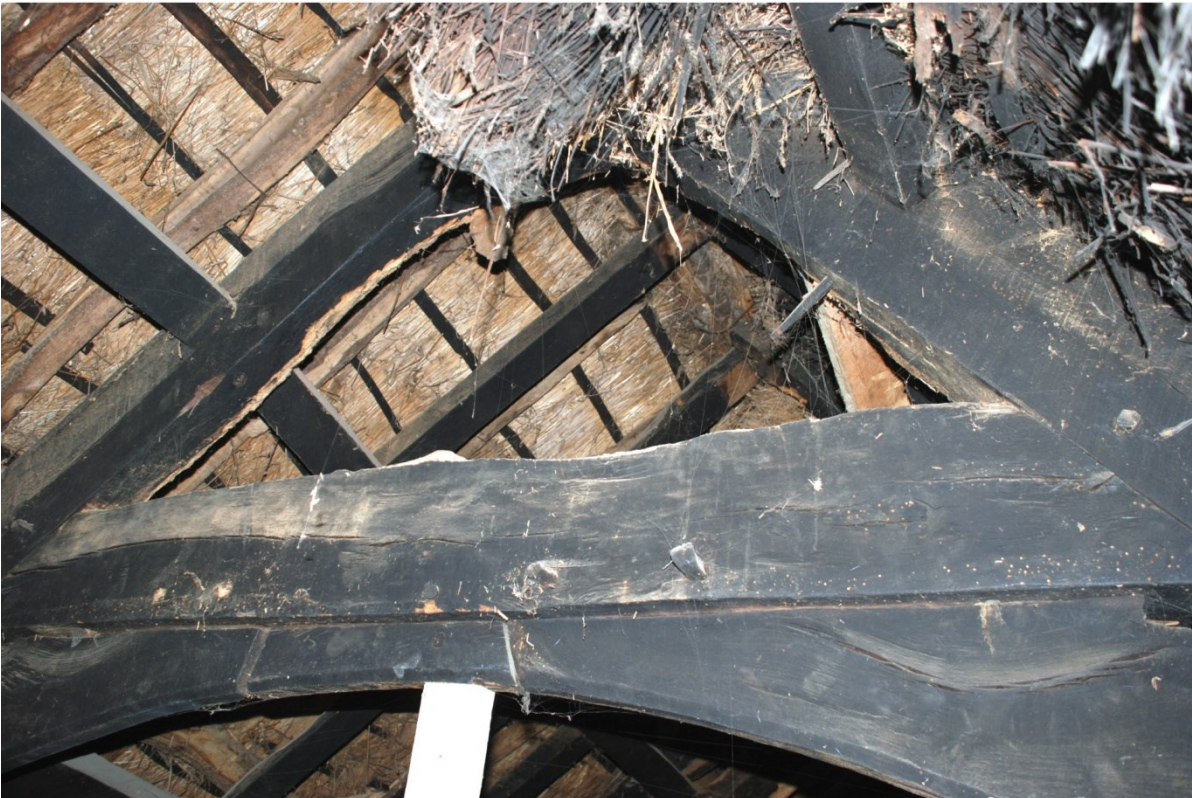
Plate 6 Arch braces beneath collar of the medieval roof, rising to separate block tenoned into the underside of the collar, looking west.

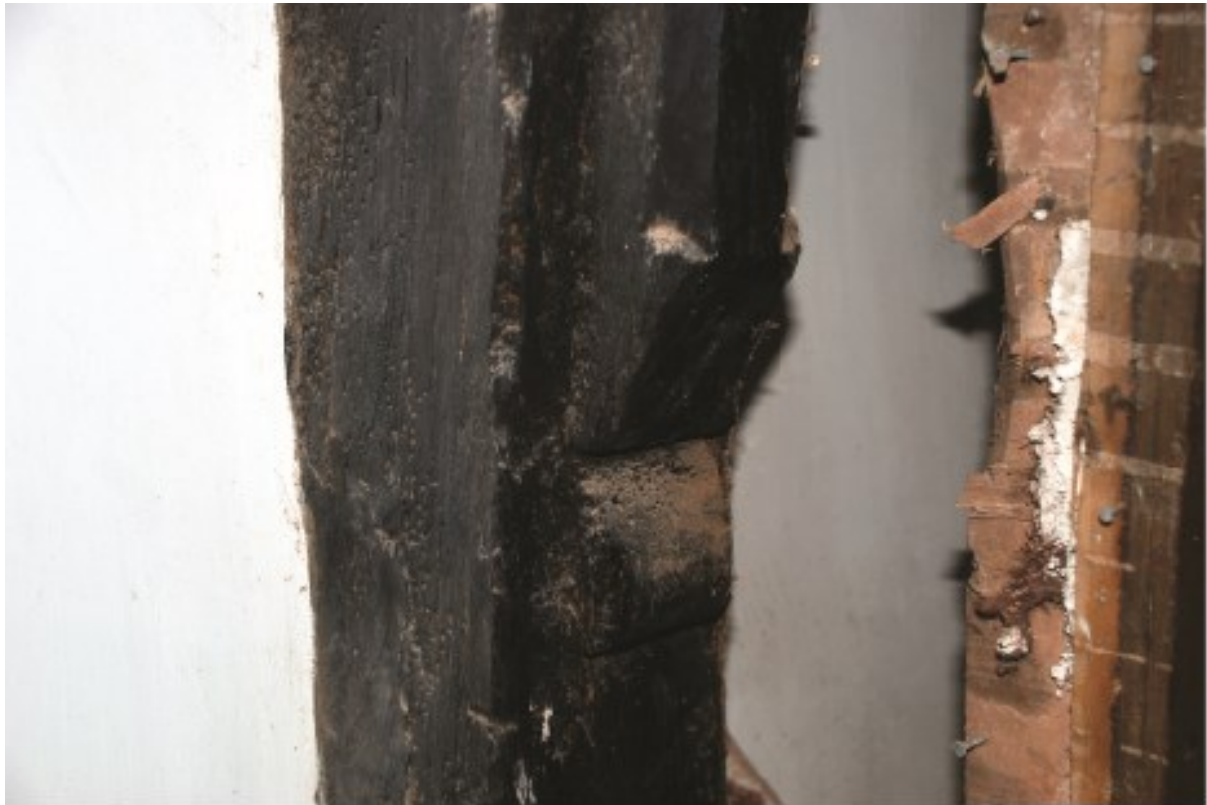
Plate 7 Decorative corbel stop at the base of the arch braces, looking northeast.

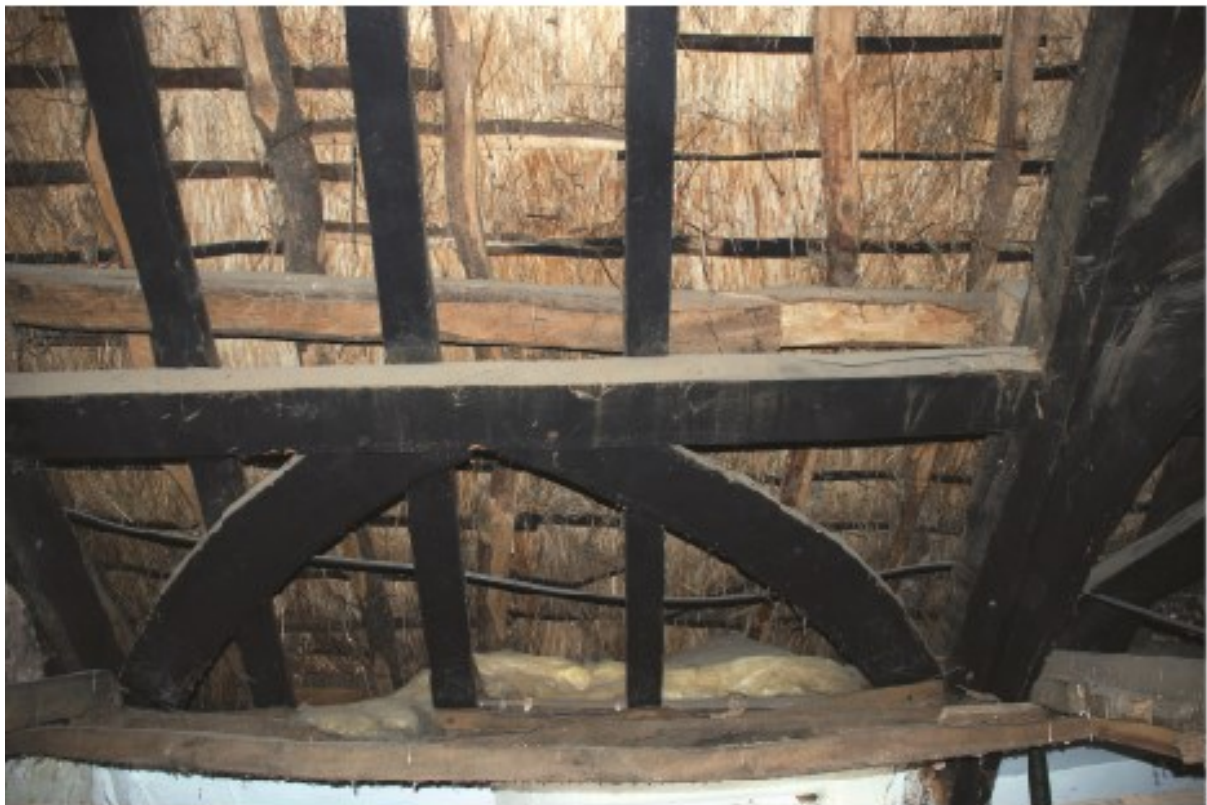
Plate 8 Windbraces beneath lower purlin, looking south.

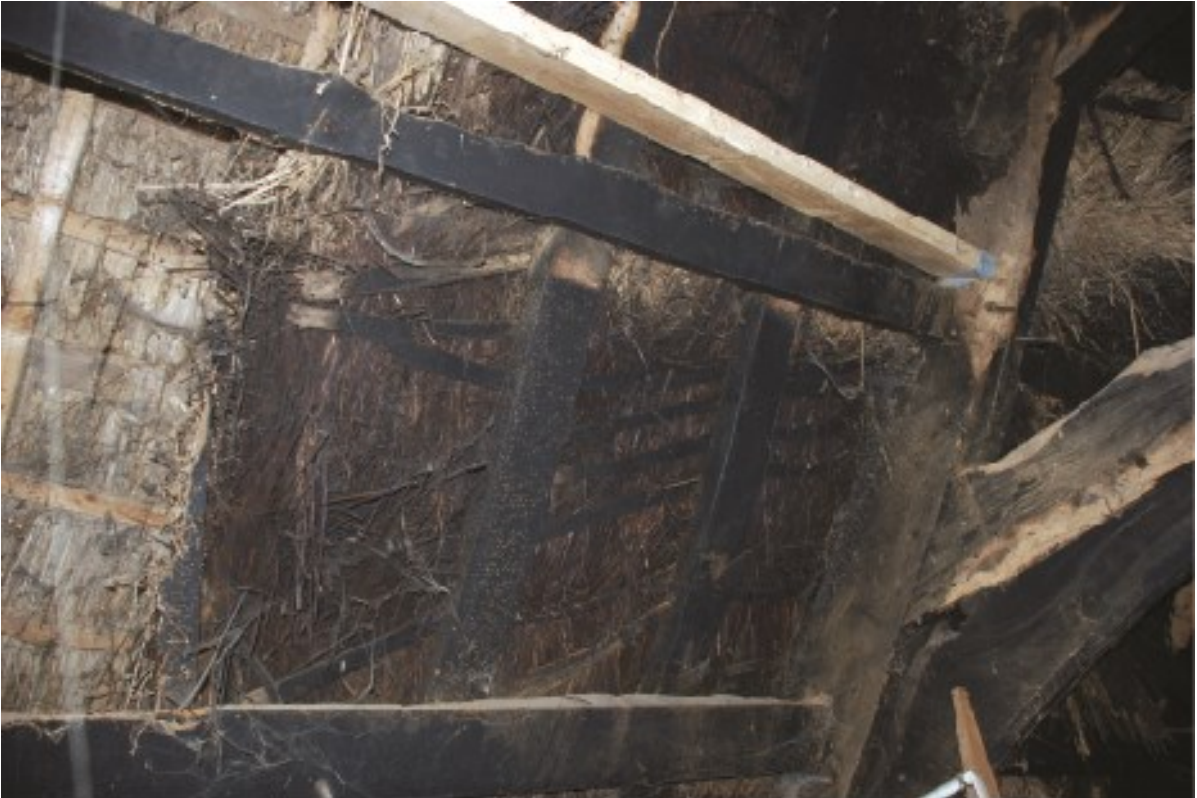
Plate 9 Smoke-blackened thatch above the former kitchen, looking southwest.

The roof is smoke-blackened throughout, including the original base coat of thatch (Plate 9). There must have been an open hearth in both the hall and kitchen, and the house must have been open to the roof. The timbers making up the full-height partitions are jointed and pegged to the trusses (Plates 10 and 11), apart from the ground-floor stud and panel screen in the partition between the passage and kitchen, which is not smoke-blackened like the timbers above and therefore later in date (Phase 3, below). The original partitions have wattle and daub infilling. The Phase 1 cross-passage would have been separated from the hall by a low screen some 2m high. The present stud and panel screen in this position is almost certainly not the original one since it is not smoke-blackened and is built in a matching style to the Phase 3 screen on the other side of the passage (Phase 3 below).

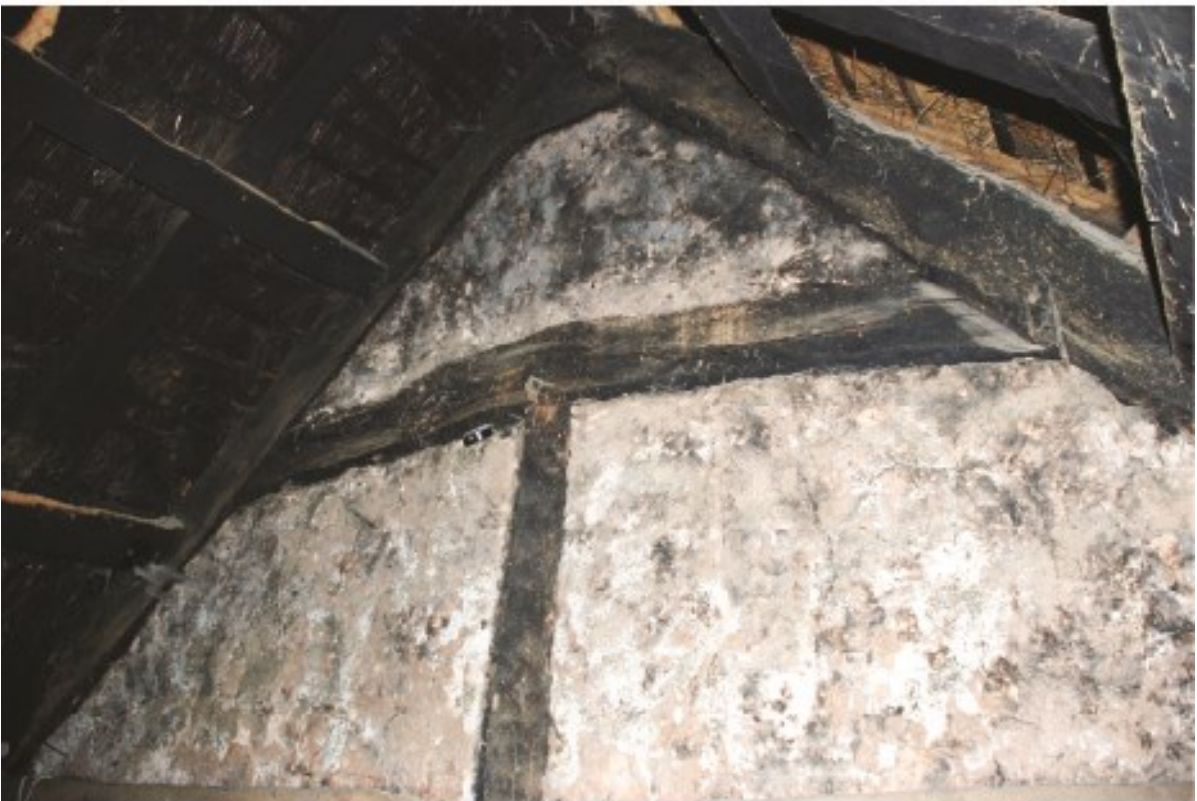
Plate 10 The full height partition between the passage and lower end, showing top rail pegged to the truss, looking southwest.

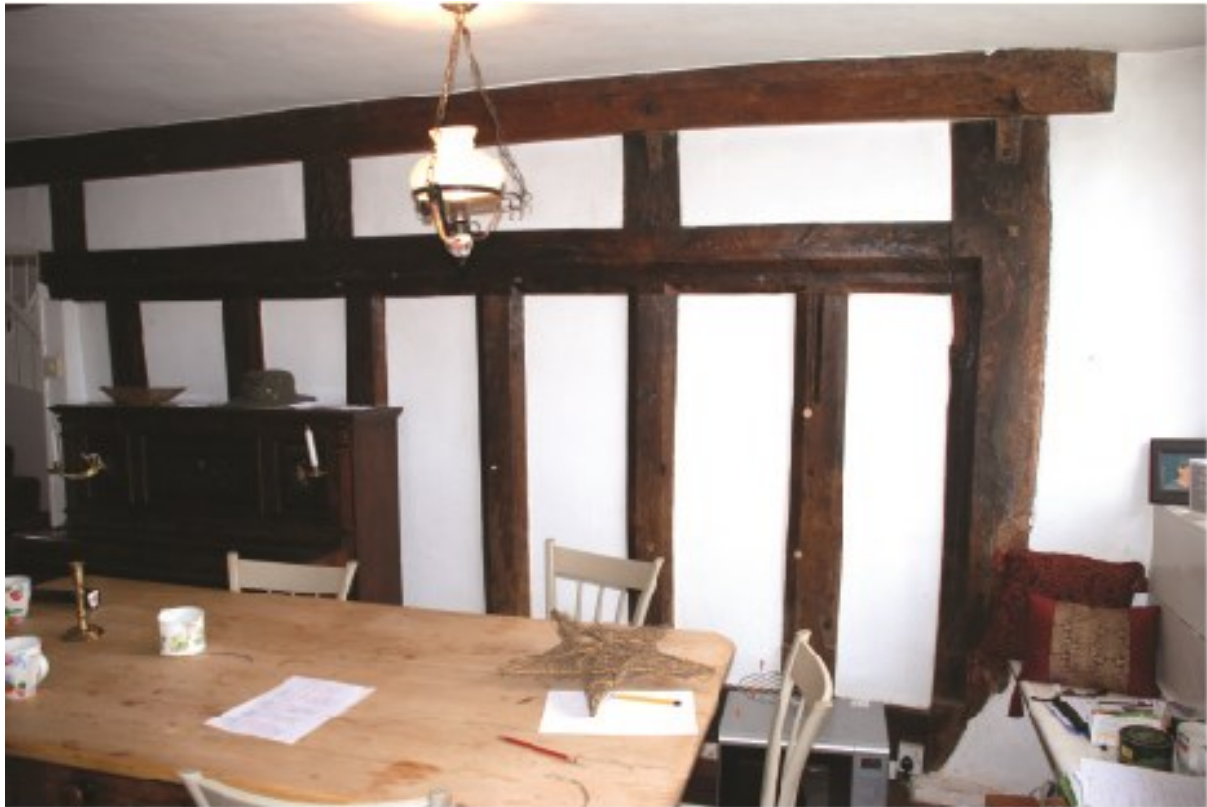
Plate 11 Screen at the bottom of the full height partition between hall and inner room, showing pegged joint to truss (to right), looking southwest.

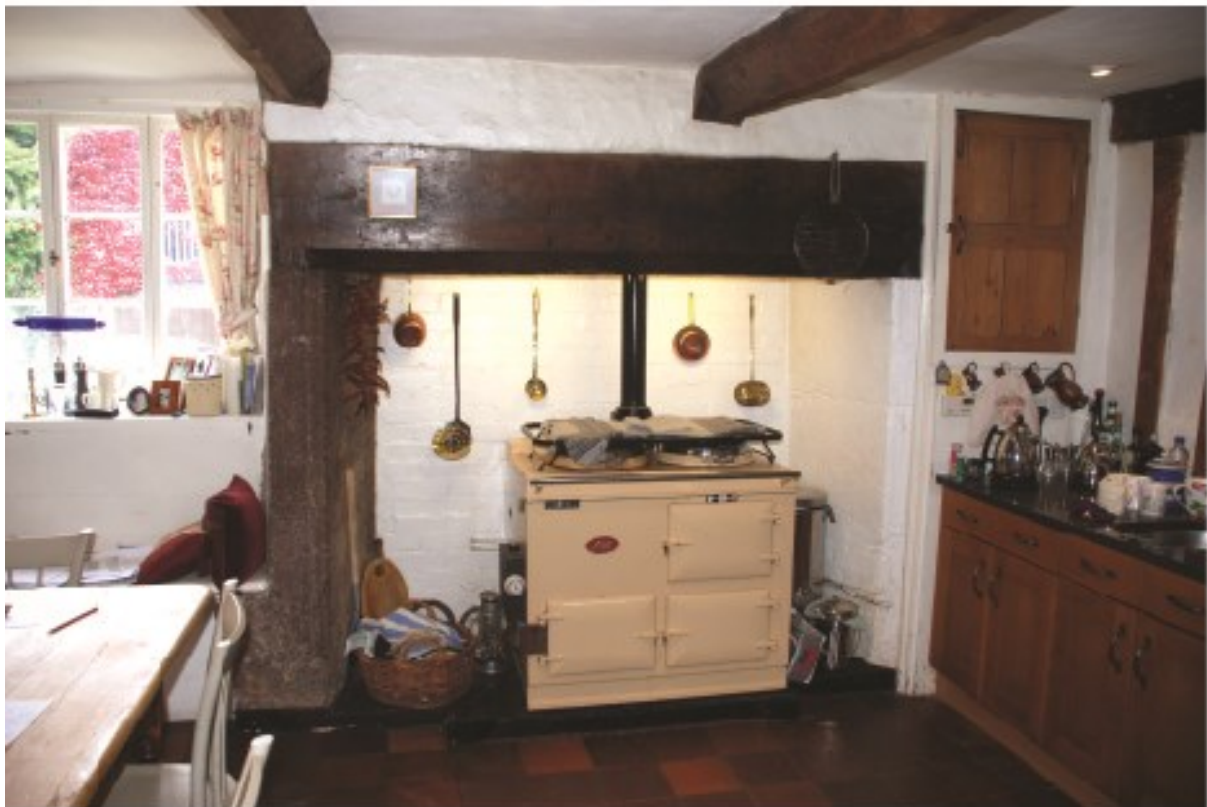
Plate 12 The hall fireplace, probably of early or mid 16th-century date, looking north.

The hall fireplace may well date from the early or mid 16<sup>th</sup>-century. It has volcanic stone monolithic jambs with wave mouldings ending in rounded pyramid stops (Plate 12). The present timber lintel may be a replacement (Phase 4, below).

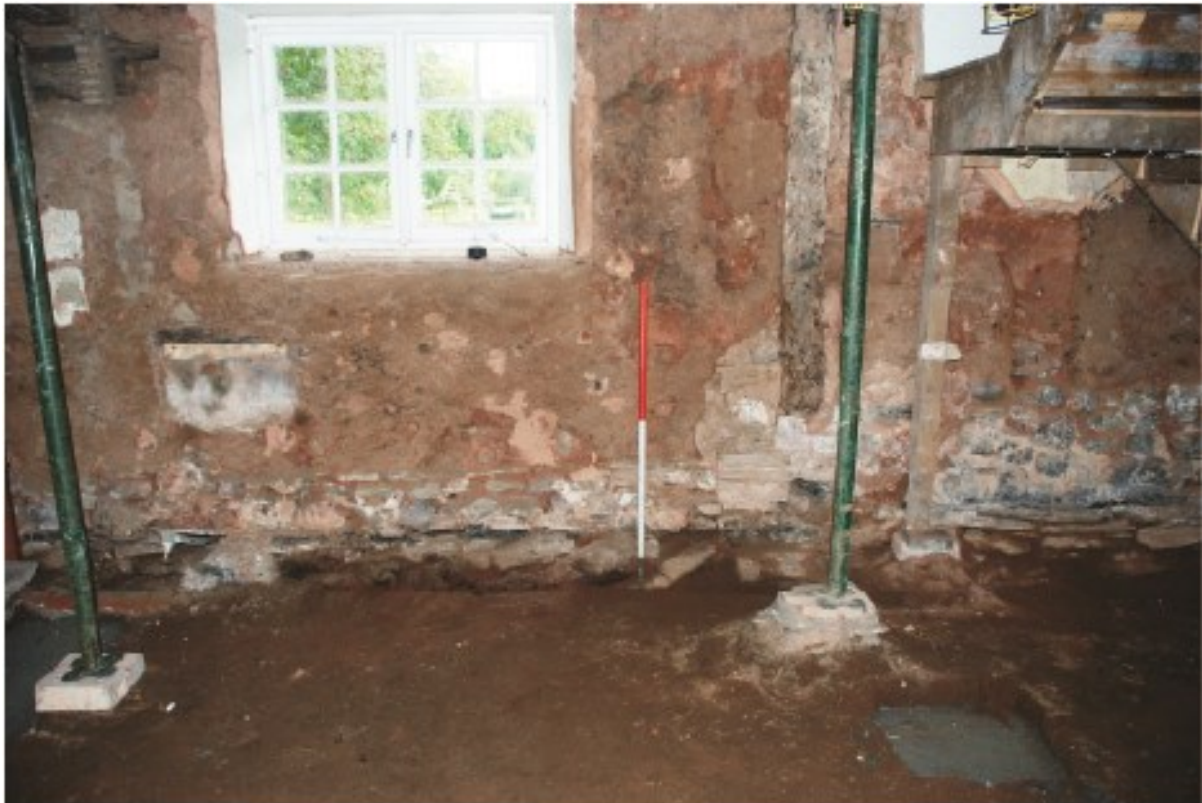
Plate 13 Trench-dug stone rubble footings exposed beneath the south wall, looking south.

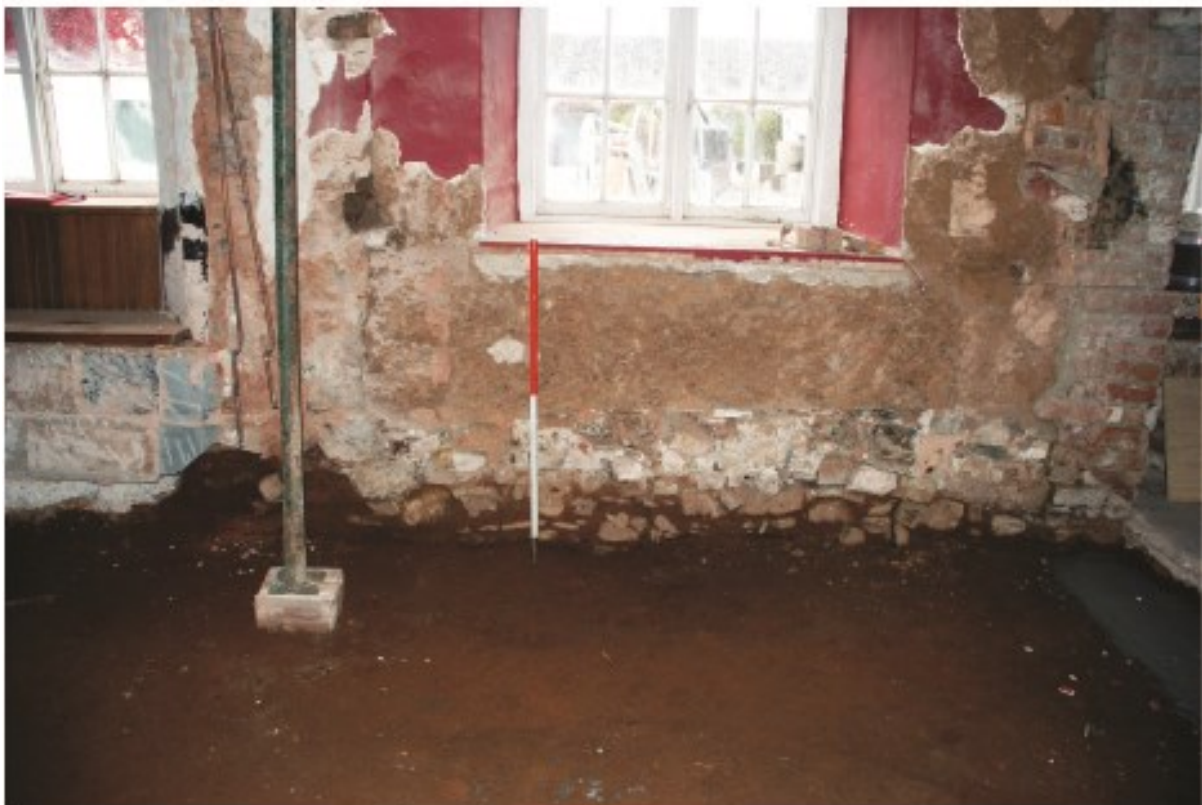
Plate 14 Trench-dug stone rubble footings exposed beneath the north wall, looking north.

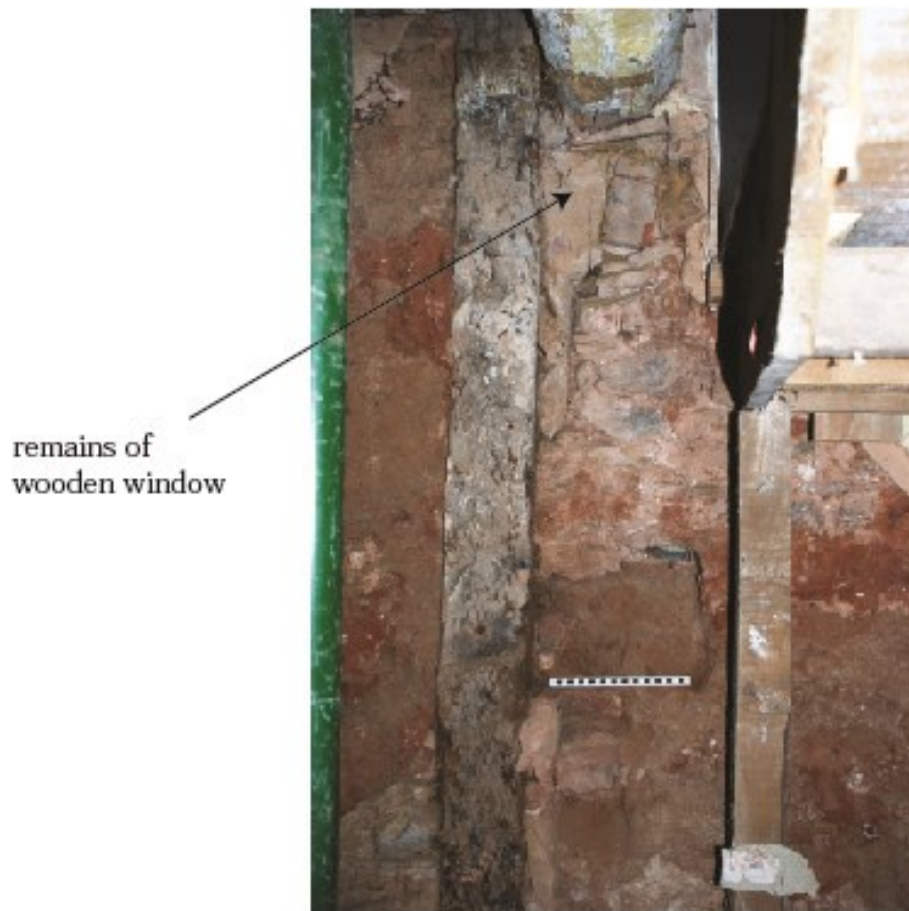
Plate 15 Remains of wooden window in early 17th-century south wall, looking south.

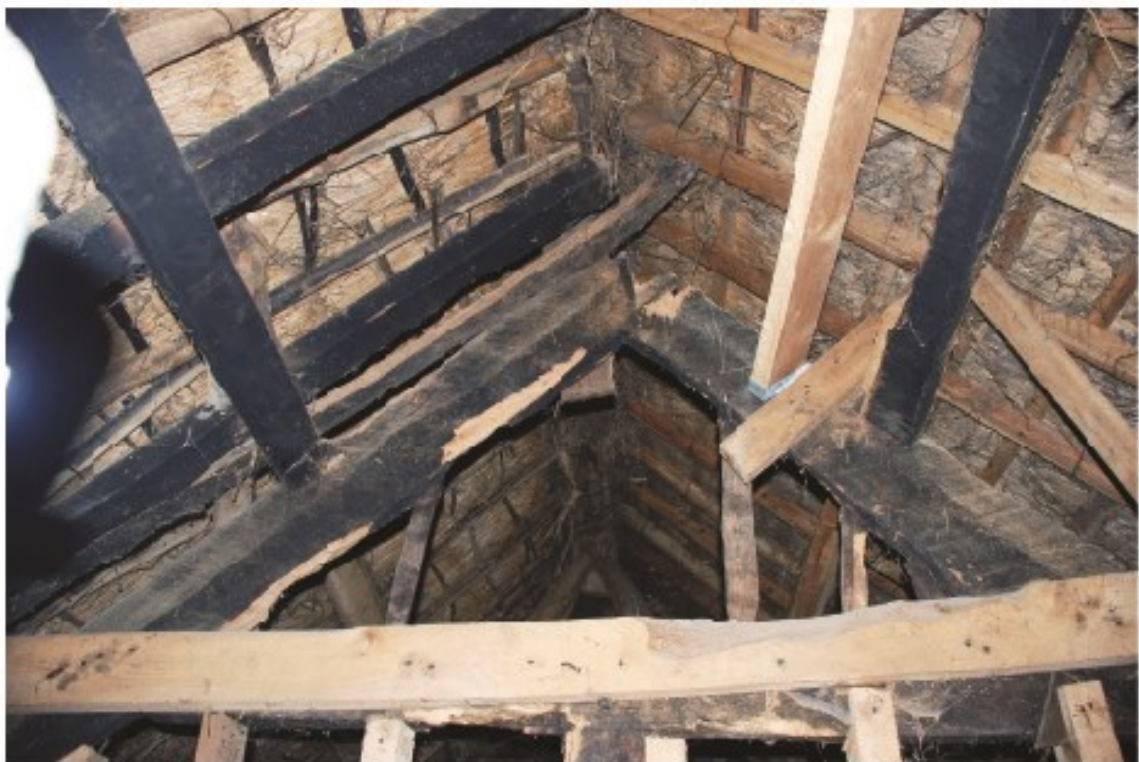
Plate 16 The early 17th-century A-frame truss supporting the east end of the medieval roof, looking east.

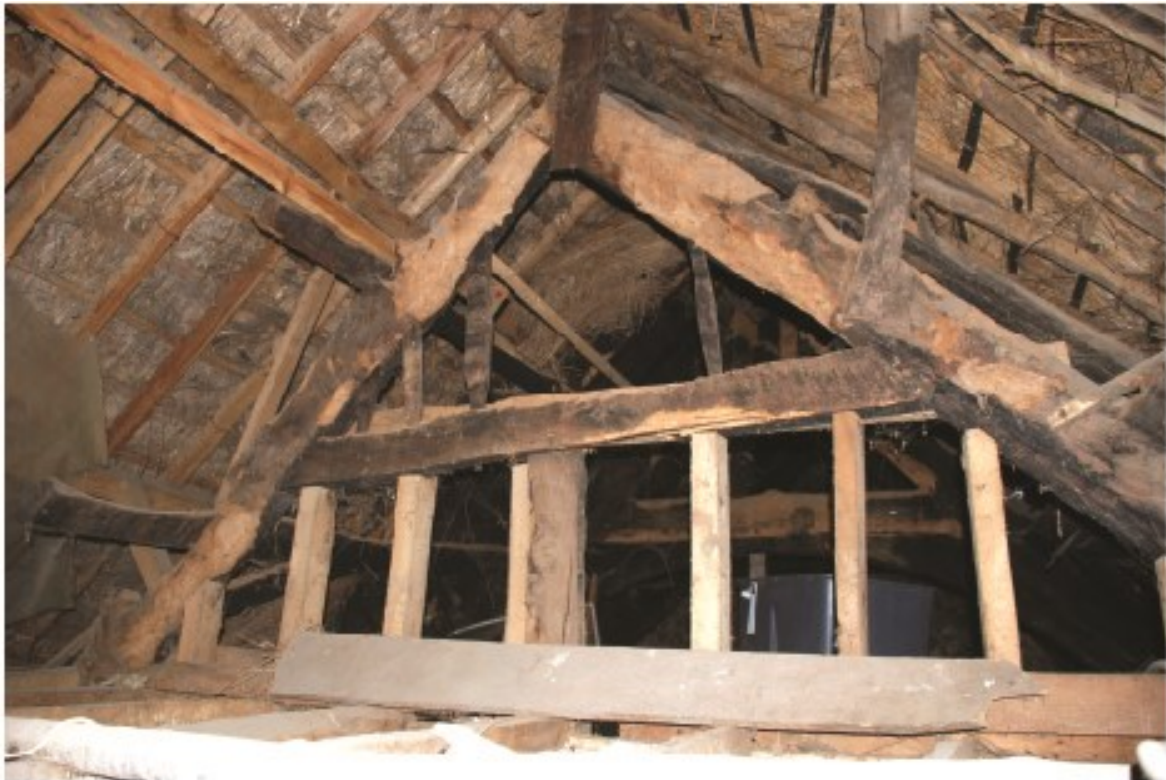
Plate 17 The early 17th-century A-frame truss supporting the east end of the medieval roof, showing struts nailed to its east side to support the phase 2 purlins and ridge, looking west.
