# EAST HOLME, NEWTON ST. CYRES, DEVON

## HISTORIC BUILDING RECORDING AND ARCHAEOLOGICAL WATCHING BRIEF

STEWART BROWN ASSOCIATES  
NOVEMBER 2011

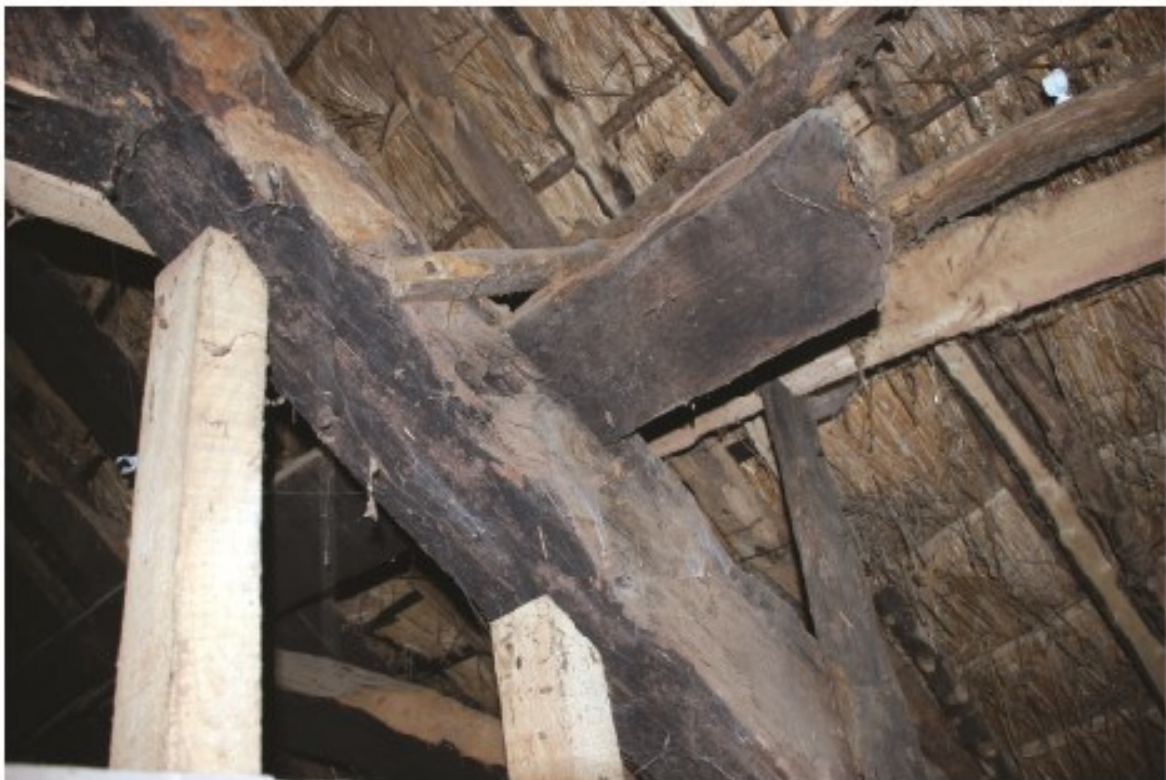
Plate 18 Close-up showing east end of medieval purlin supported by early 17th-century A-frame truss, and strut with v-shaped notch at its top supporting lower purlin of the later roof, looking northwest.

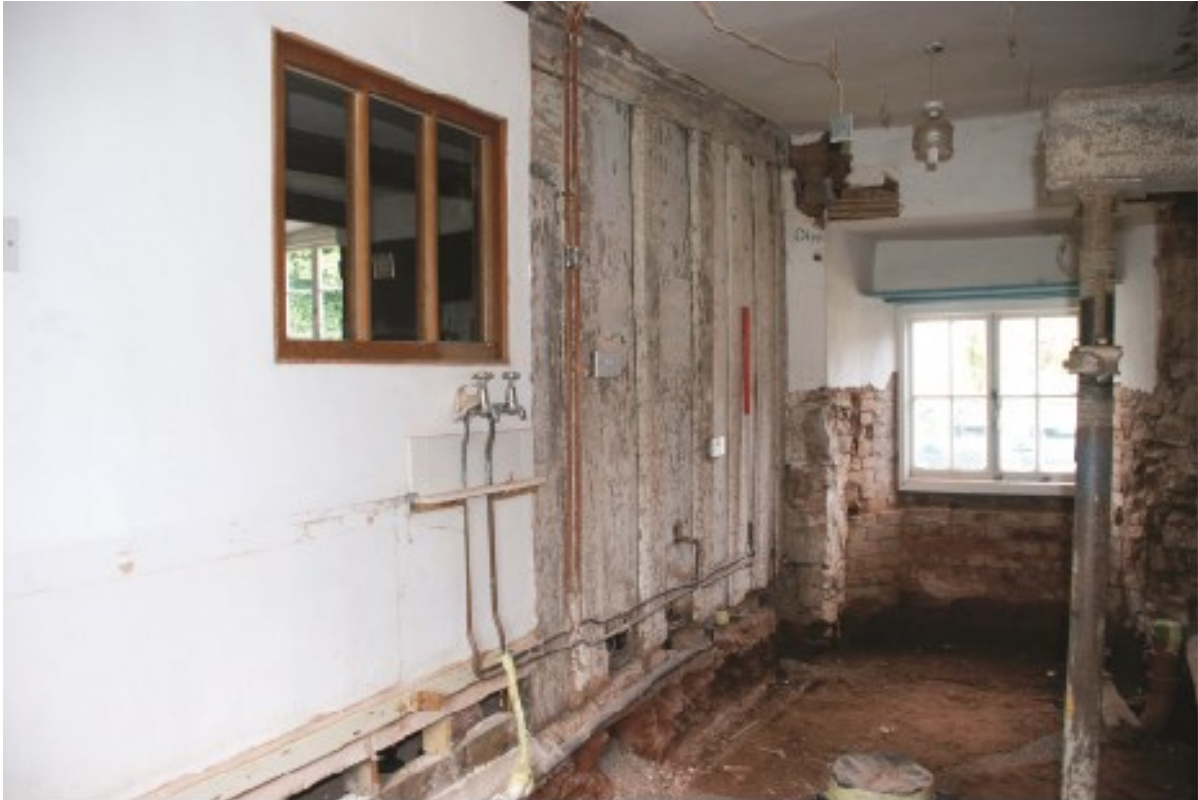
Plate 19 The screen on the upper, hall side of the passage, looking northwest.

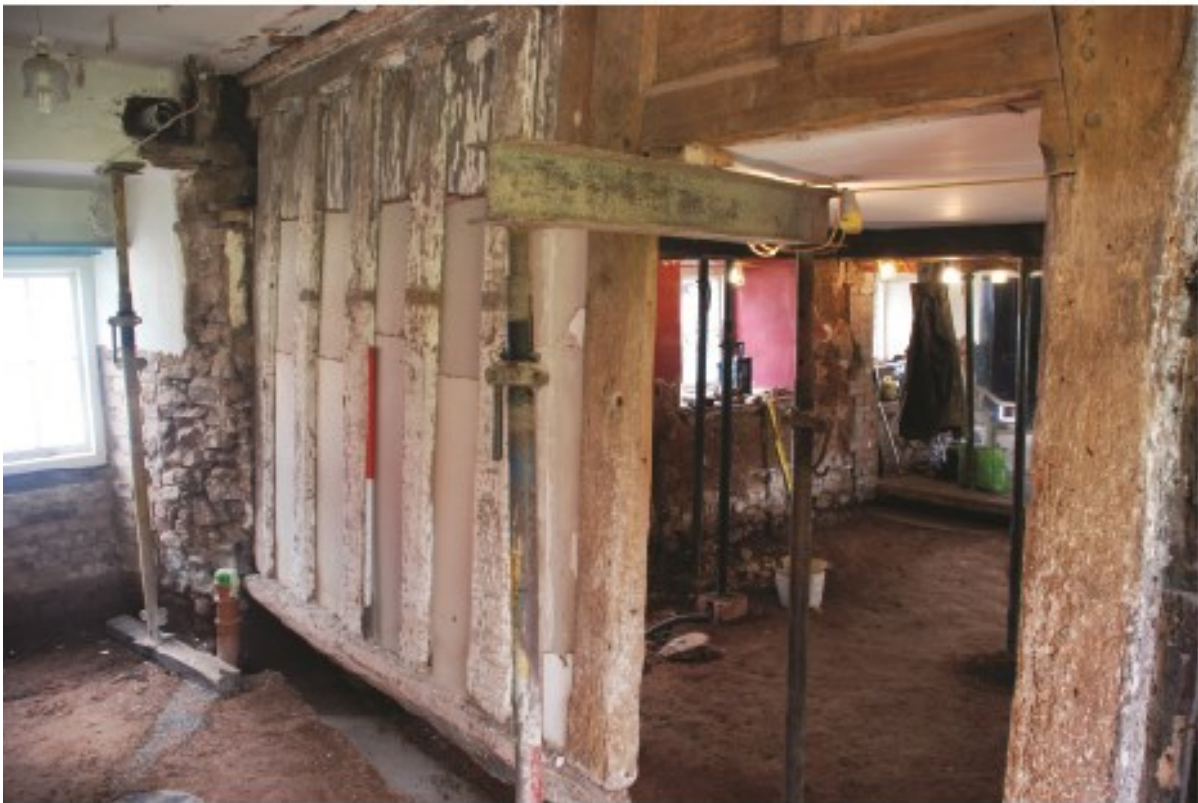
Plate 20 The screen on the lower, kitchen side of the passage, looking northeast.

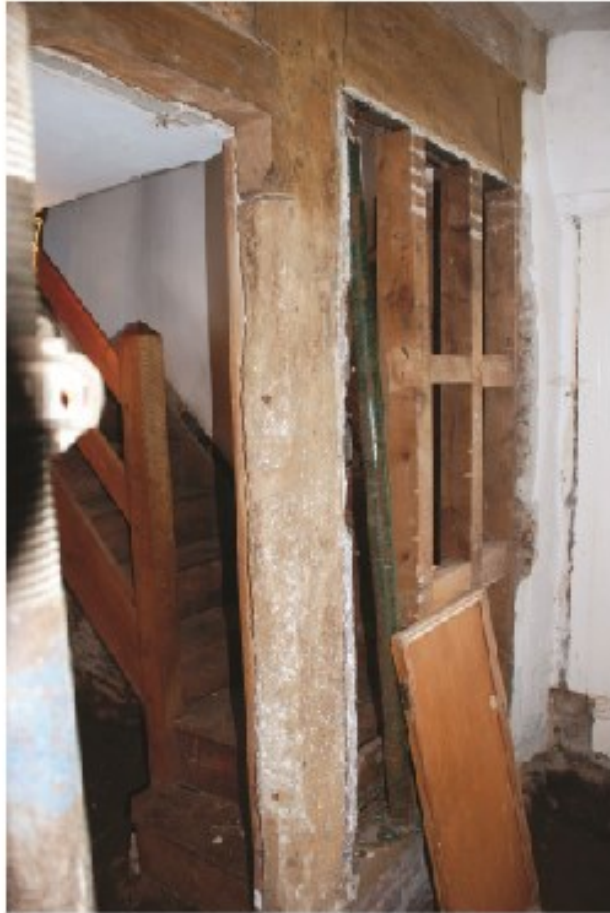
Plate 21 The kitchen and stair doorways through the screen on the lower side of the passage, showing the higher door head of the stair doorway, looking southeast.

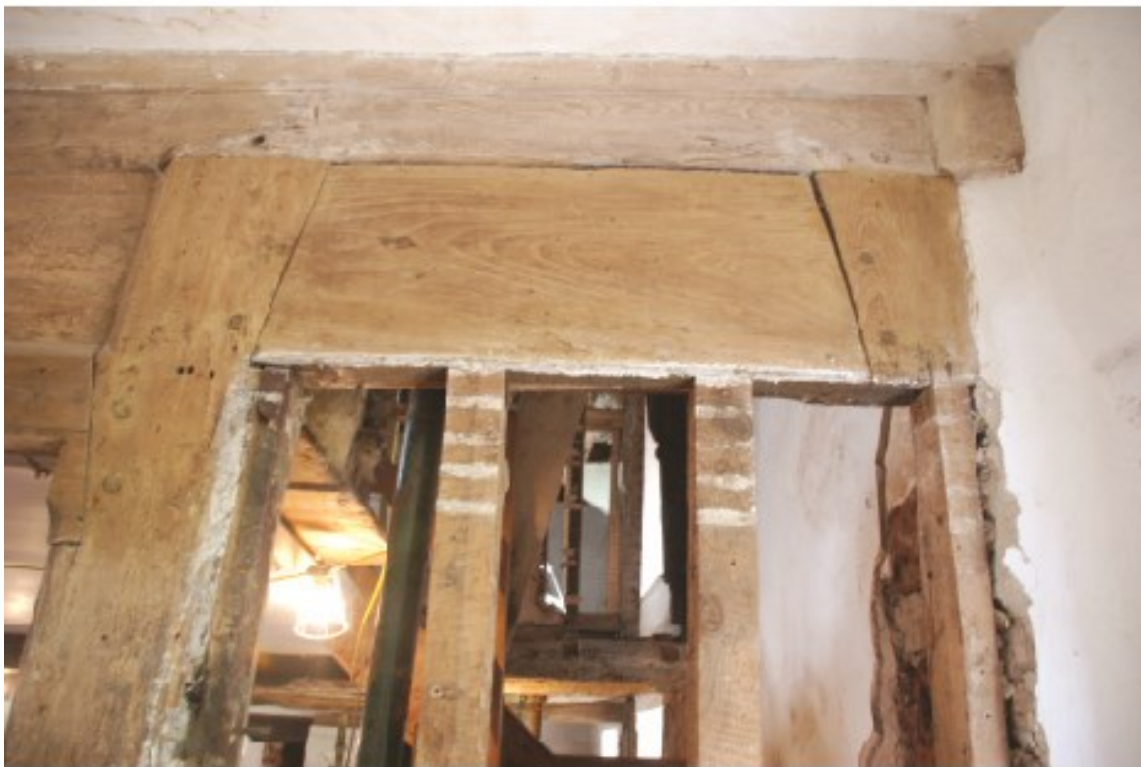
Plate 22 The door head of the stair doorway, looking east.

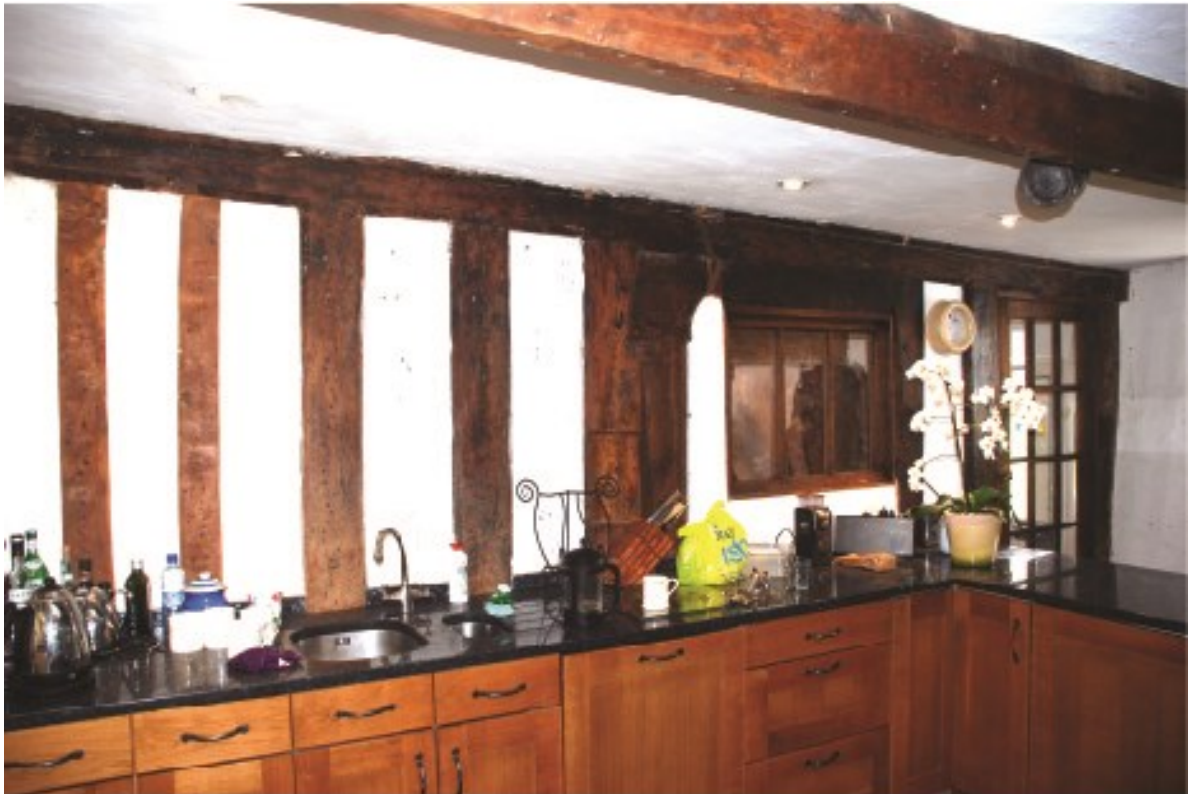
Plate 23 The screen on the hall side of the passage showing the original doorway toward the centre blocked by a later window, looking southeast.

independently as a low screen dividing passage and hall. There was a doorway leading from the passage into the hall toward the middle of the screen which has since been blocked and an internal window inserted (Plate 23). The present doorway at its south end is modern. A doorway which once existed at its north end belongs to the subsequent phase (Phase 4, below). The screen is very likely to have replaced an original one in the same position. Both present passage screens are built of fast-grown elm.

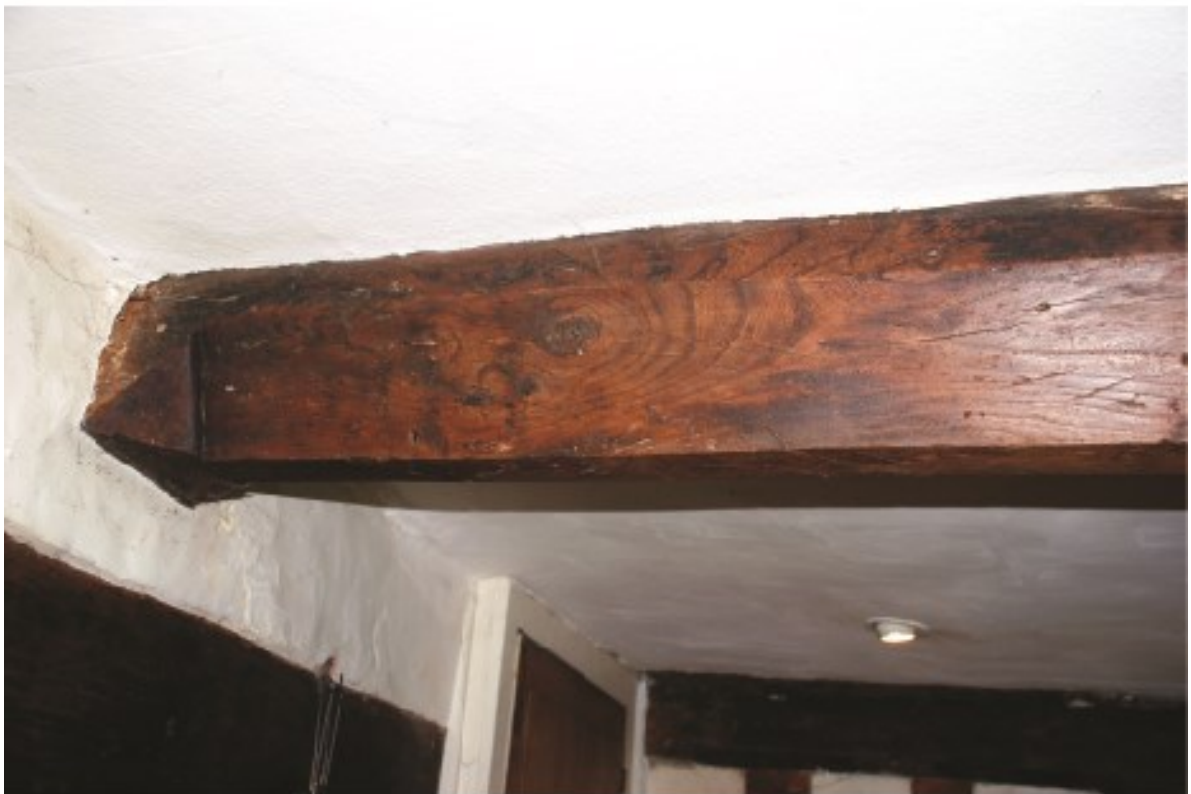
Plate 24 Phase 4 floor beam inserted into the formerly open hall, showing deep chamfer and stepped stop, looking northeast.

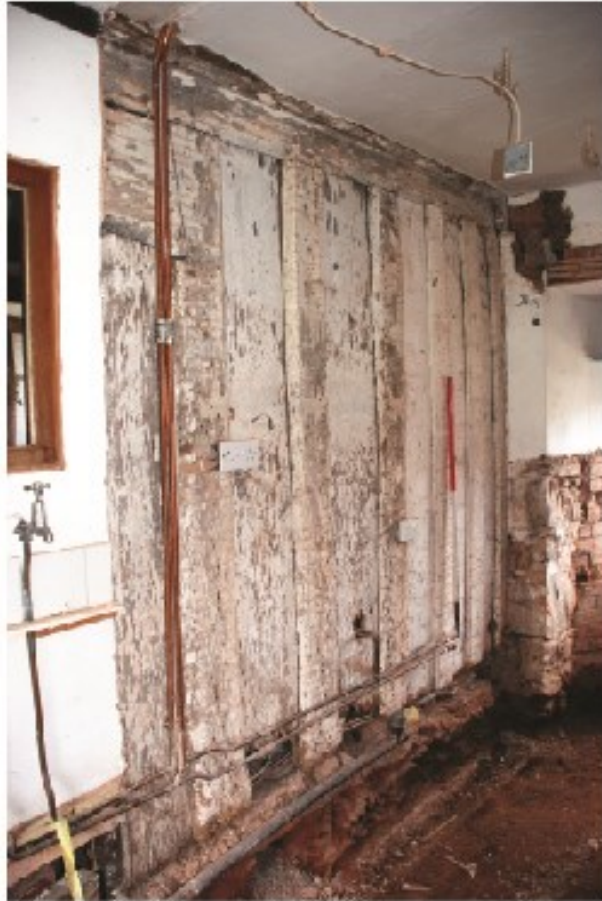
Plate 25 The screen on the hall side of the passage showing blocked Phase 4 doorway to rear, looking northwest.

Alterations made to the fireplace probably date from this period. The original lintel was seemingly replaced by one with a hollow chamfer along its bottom edge which is aligned with, but does not match, the mouldings on the two original stone jambs. The replacement of the lintel may have been associated with the insertion of the first-floor beams and the construction of a narrow newel stair to the east of the fireplace. The new stair was tucked tightly into the corner of the room and was probably a service stair leading up to new chambers on the first floor. Access to the stair from the passage was provided by a doorway forced through the passage screen at its north end, which removed one of the screen's upright studs. The doorway is now blocked by later infilling (Plate 25).

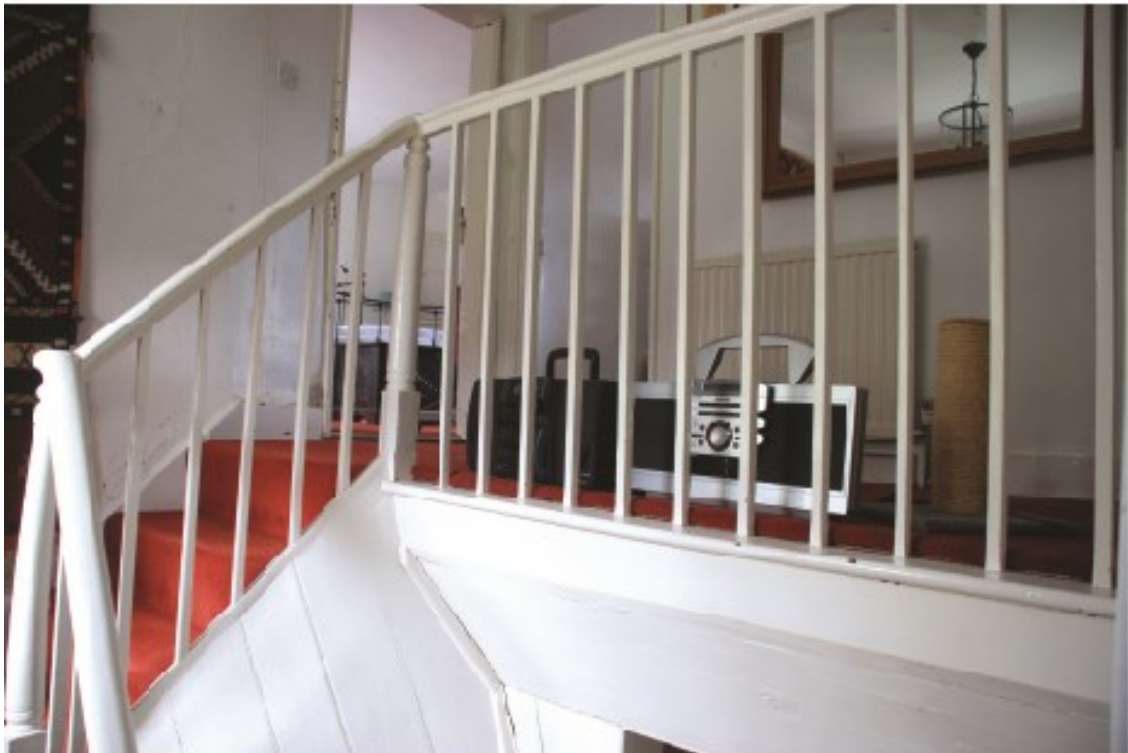
Plate 26 The 19th-century stair associated with the present entrance and lobby of the upper, east end of the house, looking southwest.

A number of alterations date from the early or mid 19<sup>th</sup> century (Fig. 1, phase 5). The main entrance and lobby in the upper, western end were refurbished and a new wooden stair inserted (Plates 26). The kitchen at the east end was largely rebuilt. Its north and east walls were rebuilt above foundation level with brick and cob. The north wall was rebuilt narrower than it had been before with a new window and doorway. The fireplace was rebuilt largely in brick, with a side oven for baking. The wooden lintel from the previous earlier kitchen fireplace was re-used (Phase 3, above). At first-floor level a new cast-iron fireplace with brick hearth was inserted into the north wall (Plate 27). The easternmost truss of the roof was replaced at this time with the present, crude A-frame truss made up of barely trimmed timbers (Plate 28). The truss has lap-jointed collar and apex with diagonal ridge and back purlins, fixed with pegs and large nails.

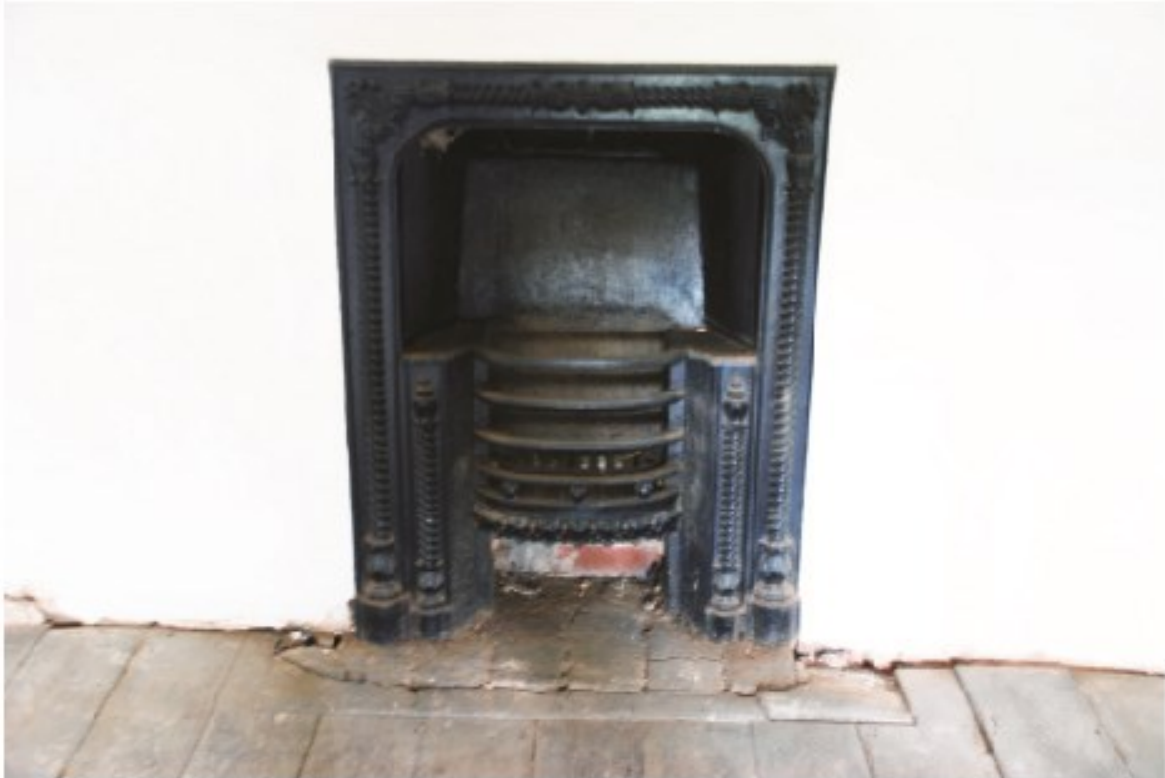
Plate 27 The first-floor 19th-century cast iron fireplace in the north wall of the lower end, looking north.

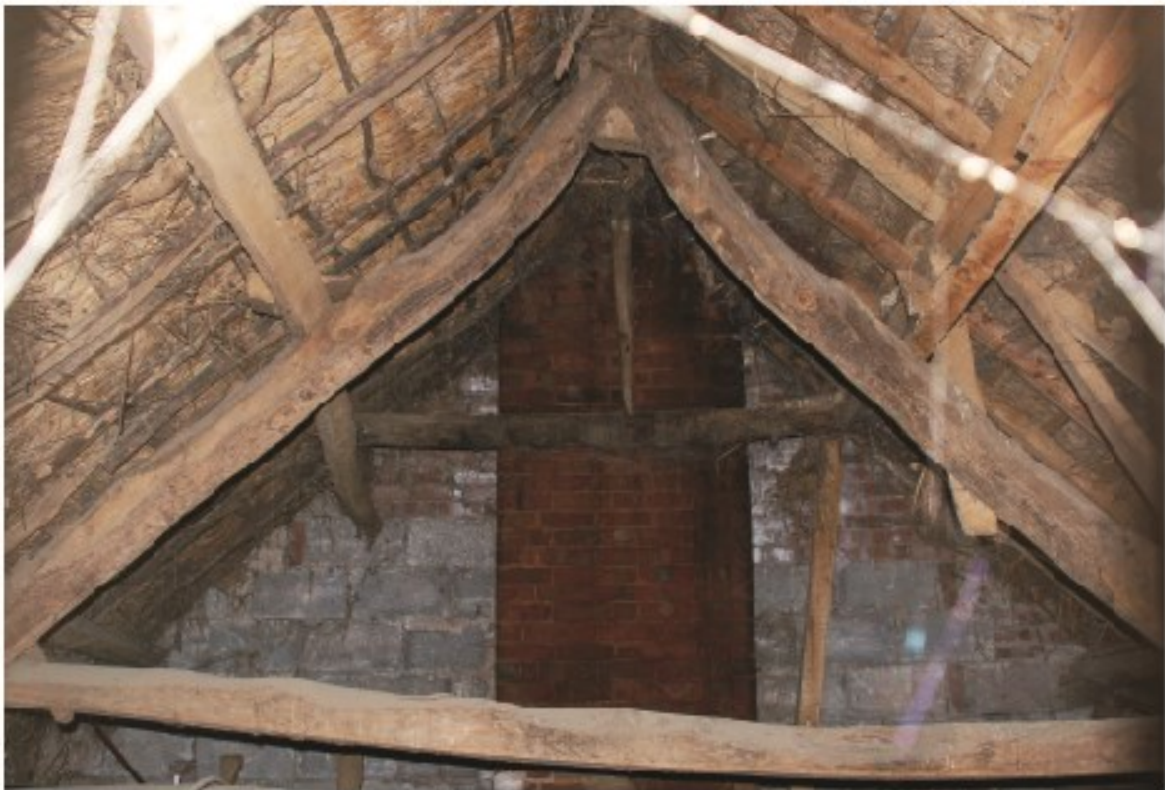
Plate 28 The 19th-century truss at the east end of the present roof, looking east.

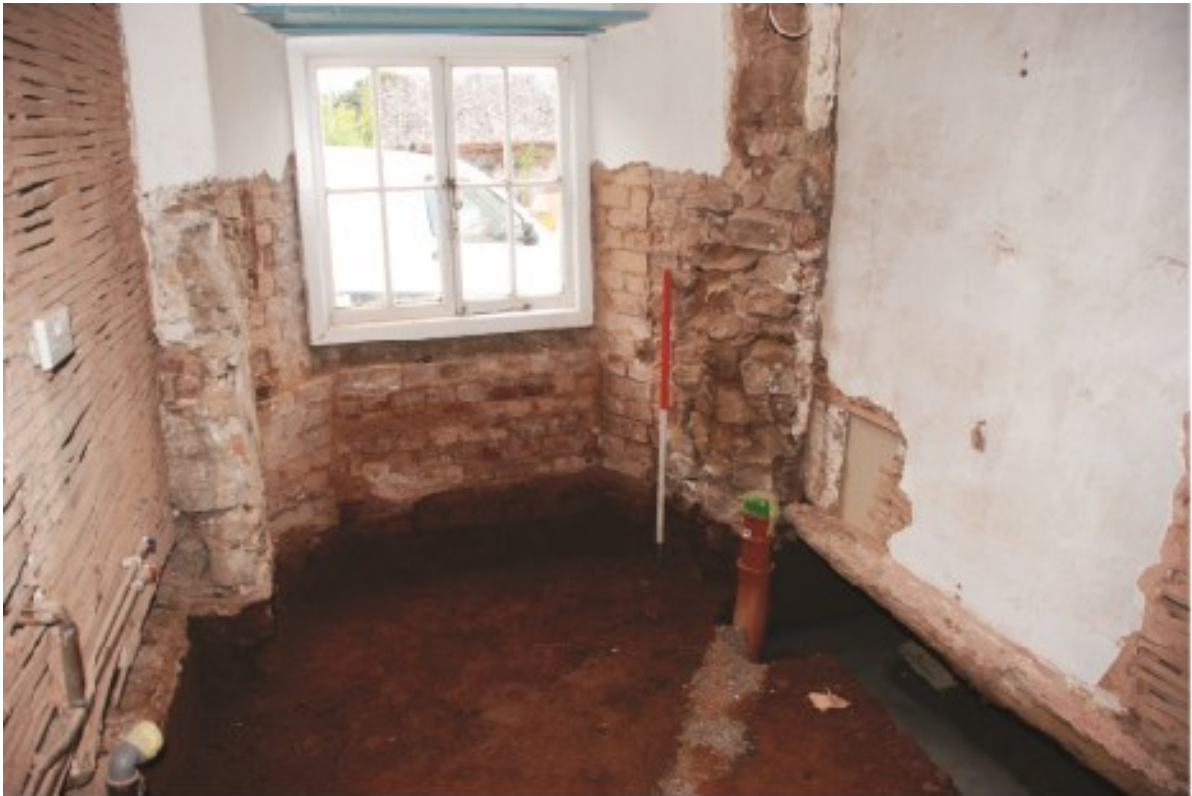
Plate 29 19th-century rubble masonry to each side of the north end of the former cross-passage, looking north.

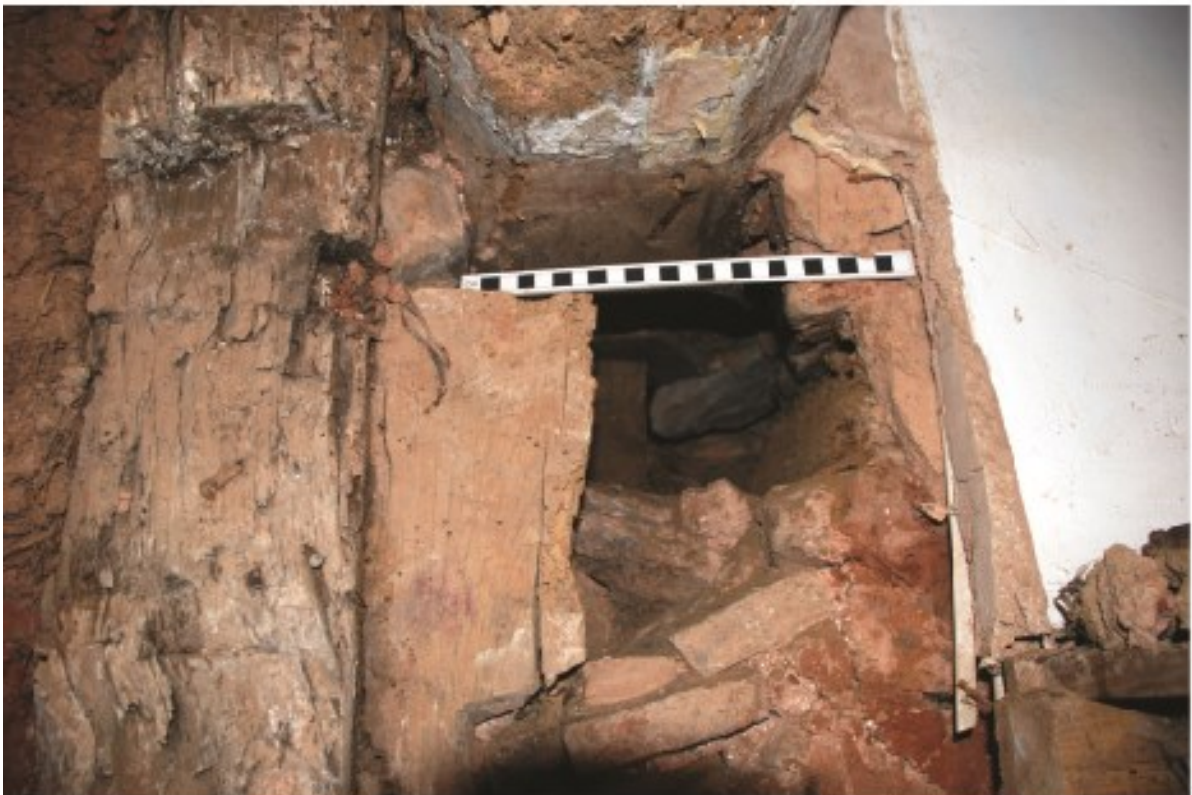
Plate 30 Rubble and brick packing beneath the 19th-century first-floor beam to the east of the cross-passage, and showing damage to the former wooden window in the south wall, looking south

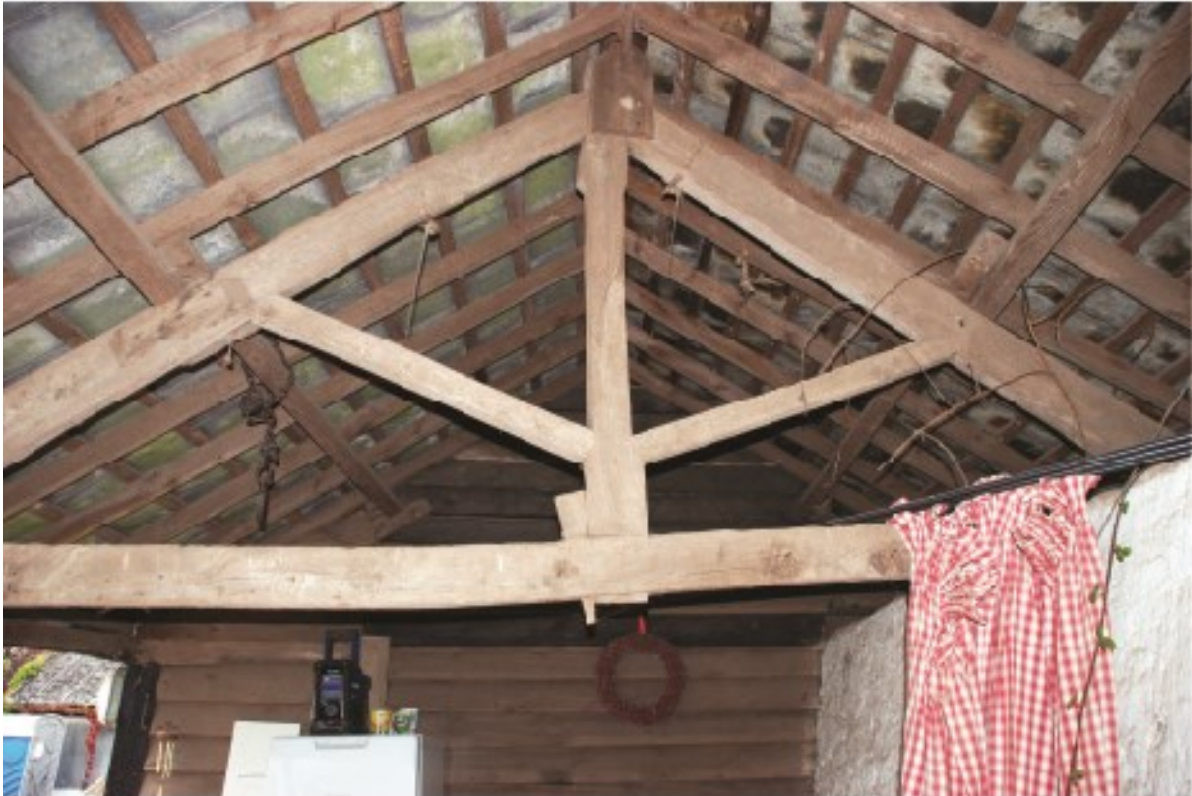
Plate 31 19th-century king-post roof over well house, looking north.

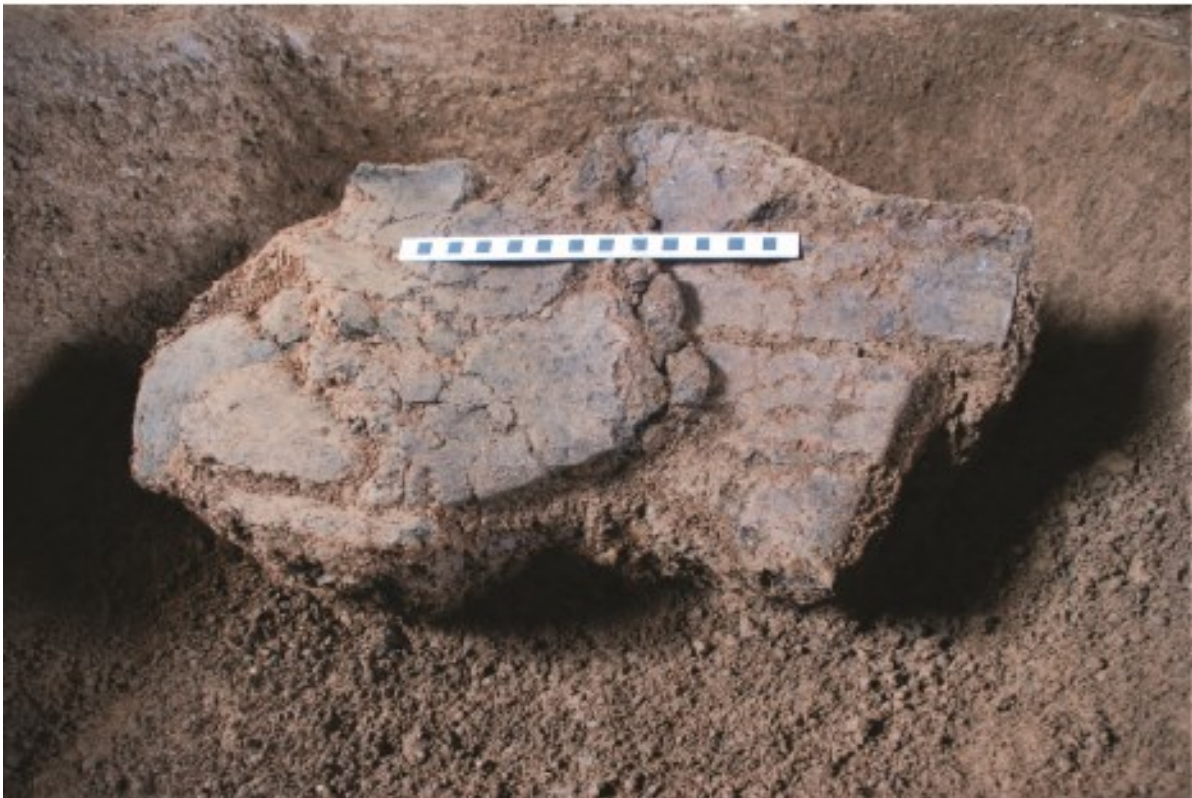
Plate 32 Prehistoric pot sherds buried in pit beneath the lower end floor, looking west.

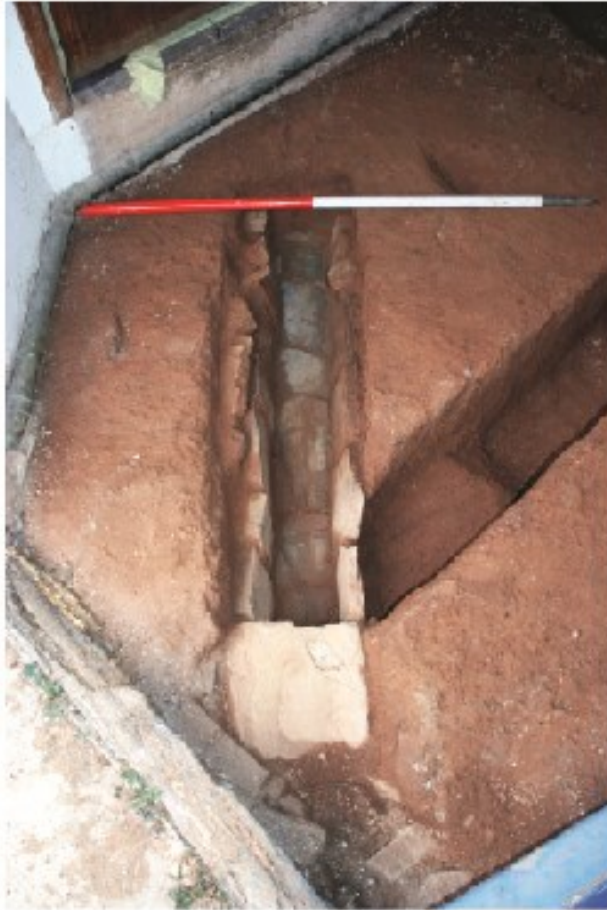
Plate 33 Medieval underfloor drain 6, looking northwest.

Feature 6 (trench 6) and feature 60 (trench 4) were two drains of probable medieval date. Feature 6 has been described above (Excavations inside the house, medieval). Drain 60 was built in a similar manner. Its alignment suggests that it passed out of the house through the nearby doorway at the north end of the passage, like drain 6 did at the opposite end of the passage. No trace was found of the drain during excavation of the passage however, so it may lie beneath the west jamb of the doorway which was rebuilt in the 19<sup>th</sup> century. Feature 57 (trench 3) was another stone-lined drain. Its walls were bonded with white mortar, which would suggest a later date, possibly in the 19<sup>th</sup> century. Feature 56 extending alongside the drain was a modern feature. It was a trench infilled with cobbles, bricks and lumps of concrete.

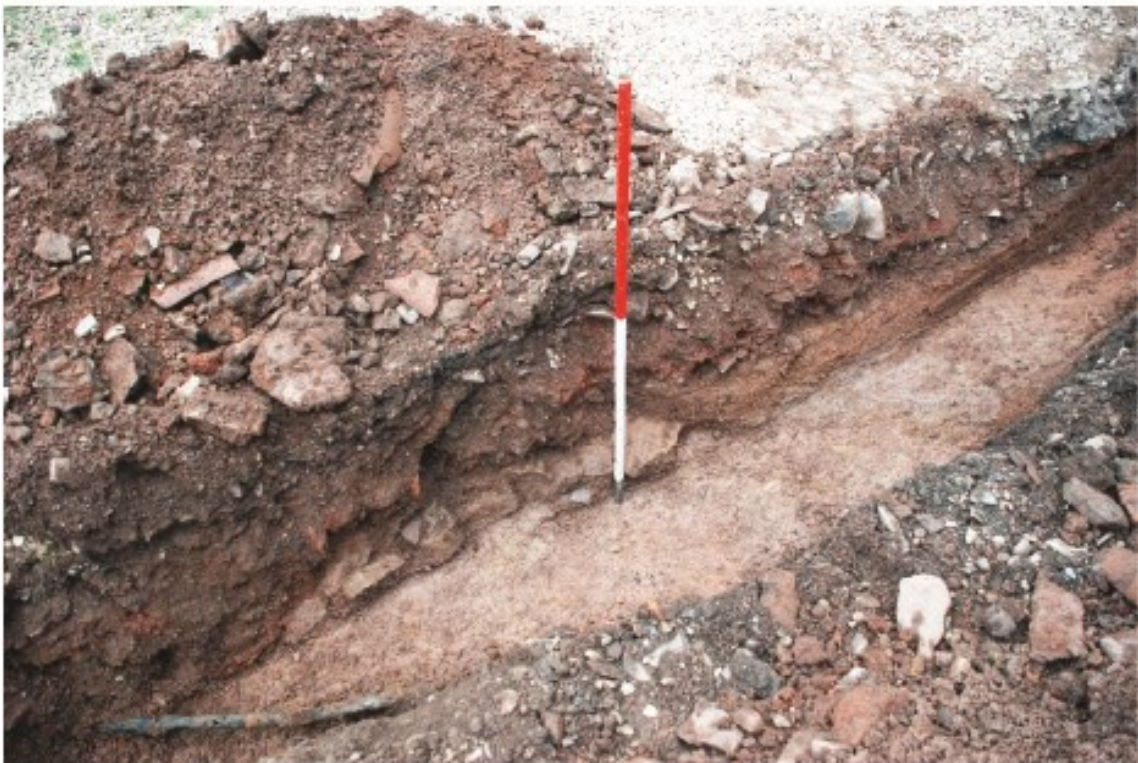
Plate 34 Remains of rubble footings for a wall of the range of 17th-century outbuildings to the northeast of the house, looking northwest.
